California Regional Water Quality Control Board, San Diego Region

**Subject: Inspection Report for West Miramar Landfill
Order Nos. 87-54 and 93-086**

West Miramar Sanitary Landfill

Pictures taken by Ms. Leah Canada and Mr. Alex Cali on October 16, 2014

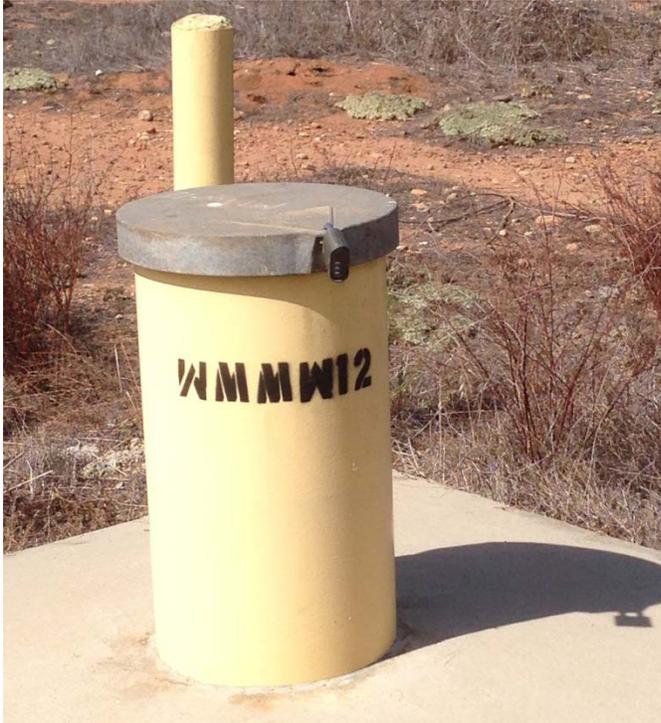
1. Employees in attendance included Cory Miyabara and Mike Thompson from the City of San Diego, as well as Daron Warkentin from the City of San Diego LEA.
2. Groundwater monitoring wells were found to be in good condition (Figure 1).
3. Drainage channels were observed to be free of debris and ready for the rainy season (Figure 2).
4. The detention basin was free of debris and ready for rainy season (Figure 3).
5. No liner was exposed during the inspection. According to landfill employees, the liner was fully covered 3-4 months ago.

Figure 1: Photo of ground water monitoring well (WMMW-12).

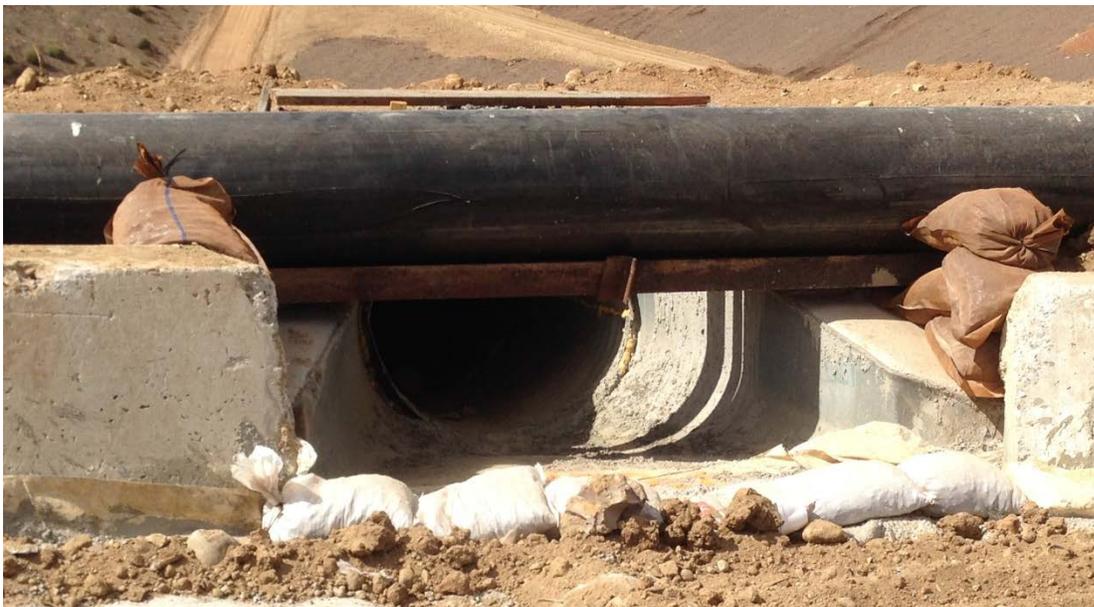
Figure 2: Photo of drain near active cell.

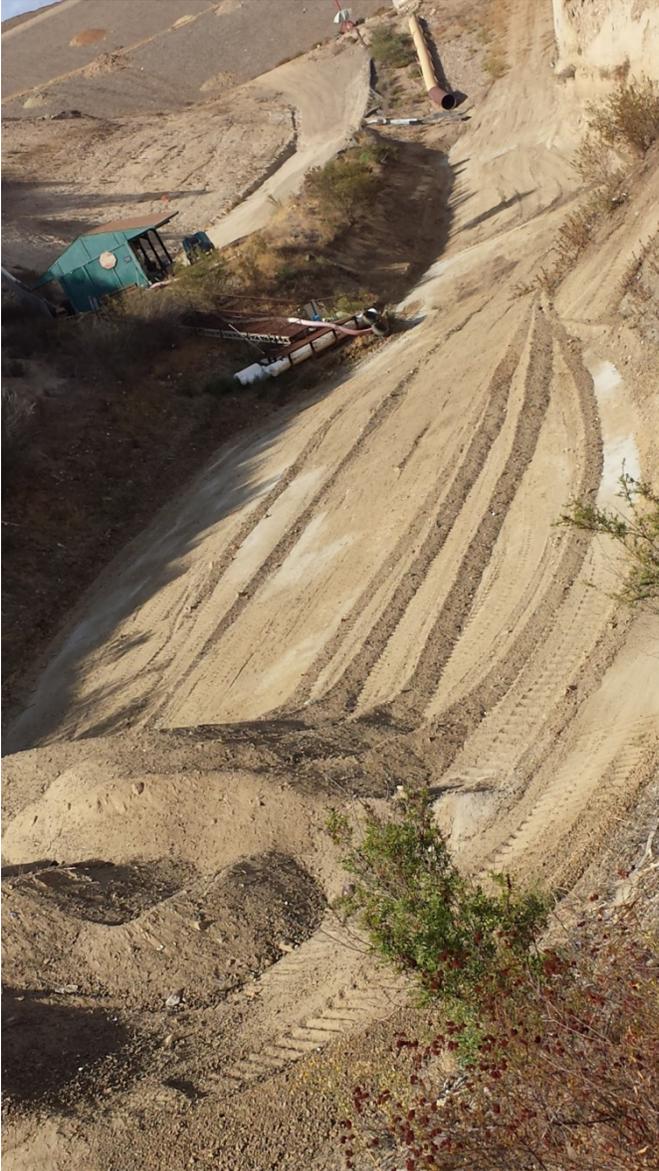
Figure 3: Photo of detention basin.

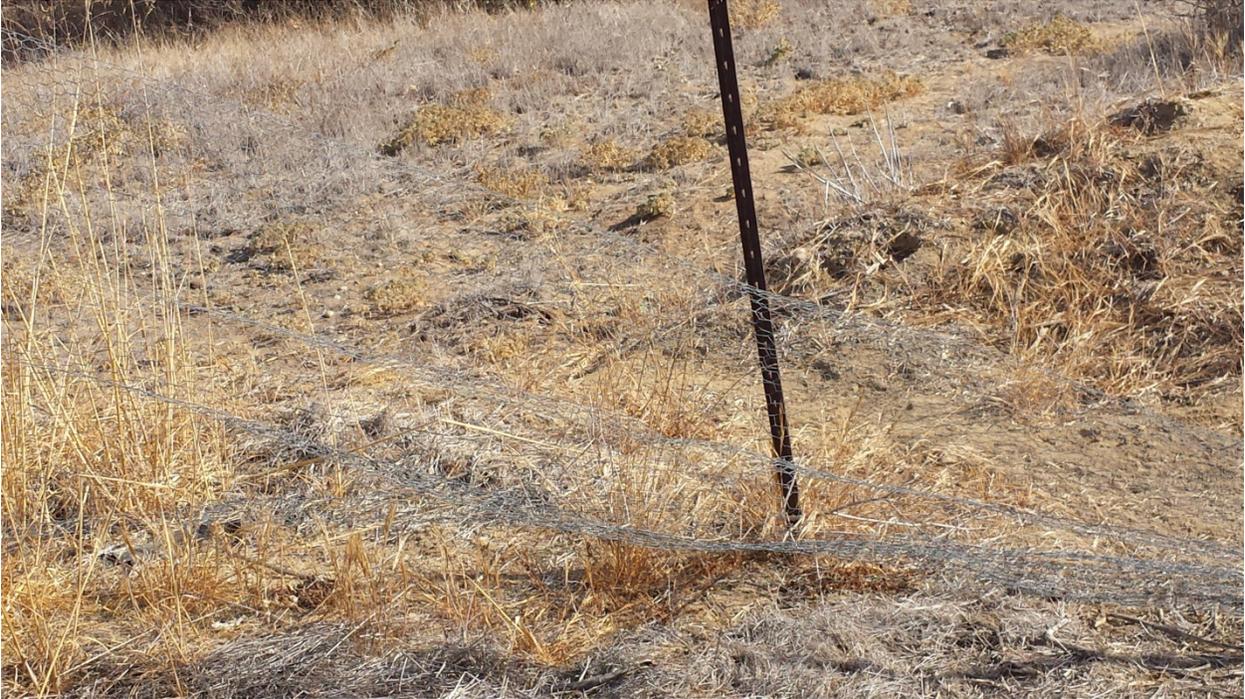
- 3. Security issues were discussed during the inspection. Specifically, the possibility to enter the Facility on foot, bike paths were observed near the northwest corner of the Facility and a downed fence was observed south of the detention basin (Figure 4).
- 4. At the time of the inspection, plastic bags had accumulated on the fence south of the active cell (Figure 5).

Figure 4: Photo of downed fence south of detention basin.

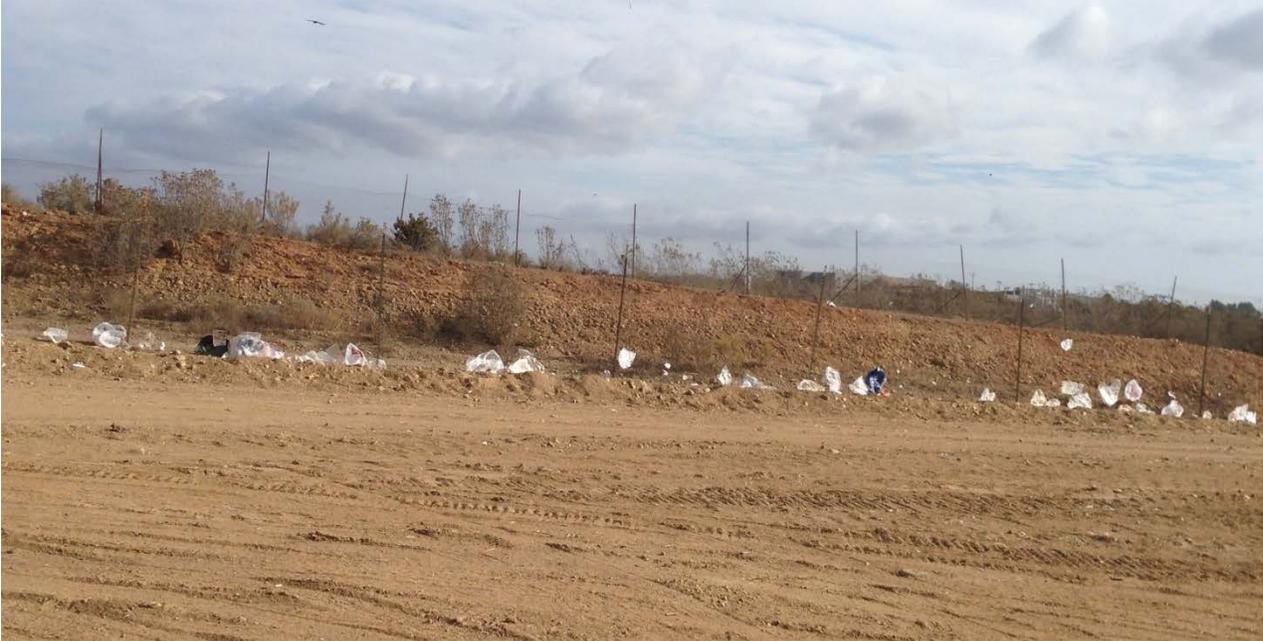
Figure 5: Photo of accumulated plastic bags on fence south of the active cell.

1. At southern drainage channel had straw waddles placed across the entire channel instead of staggered.
2. 55-gallon drum observed near northwest corner of site.
3. Security issues near northwest corner of site as well as near detention basin.
4. Large number of plastic bags accumulated on fence south of the active cell.
