California Regional Water Quality Control Board, San Diego Region

Subject: Notice of Violation No. R9-2015-0030, Harmony Grove Village Construction Project, Order No. 2009-0009-DWQ, NPDES Permit No. CAS000002, Construction General Permit

NOTICE OF VIOLATION
No. R9-2015-0030

FACILITY INSPECTION REPORT

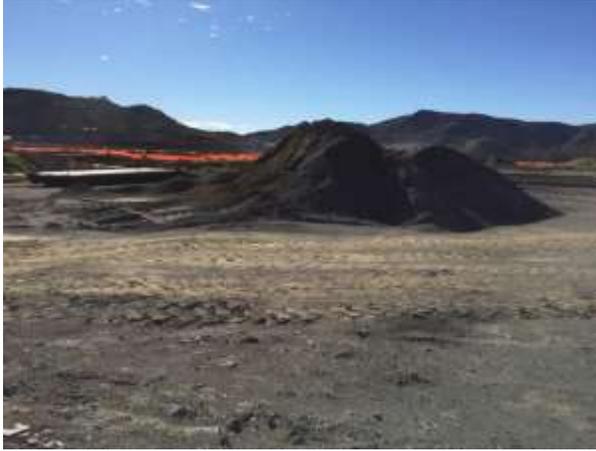
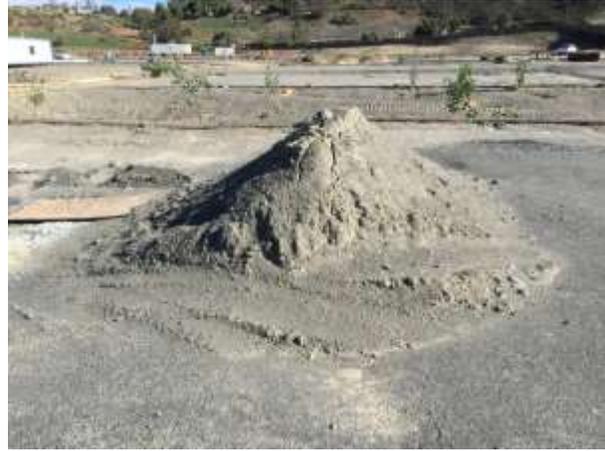
- c. Observation:** During the January 23, 2015 inspection, the San Diego Water Board inspector observed soil stockpiles without adequate cover, berm, containment or protection, resulting in erosion and sediment transport. See attached January 23, 2015 Facility Inspection Report Photos 1 and 2.

2. Several stockpiles observed without adequate containment (See Photos 1 and 2). Evidence of erosion and sediment transport from the stockpile observed during the inspection. All construction sites are required to contain and securely protect stockpiled waste material from wind and rain at all times unless actively being used.

Photos 1 and 2 show examples of soil stockpiles observed through the site without adequate cover or containment. Evidence of erosion and sediment transport along that base of the stockpile. Most stockpiles observed during inspection lacked available cover or containment.

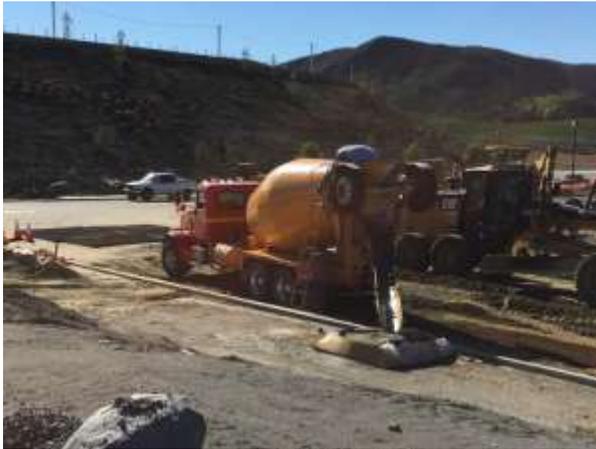
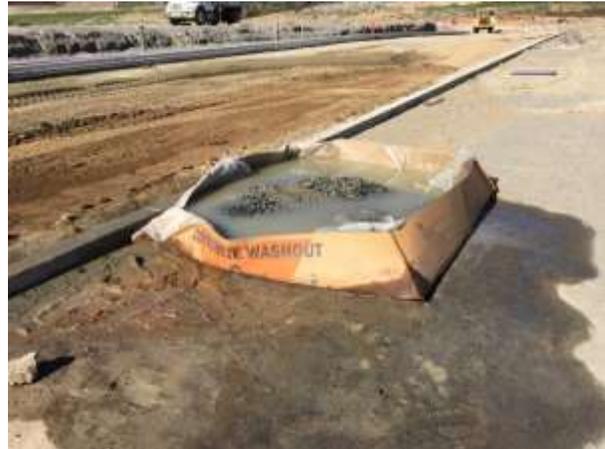
- e. Observation:** During the January 23, 2015 inspection, the San Diego Water Board inspector observed a temporary concrete washout area that was not adequately contained to prevent discharges into underlying soil and surrounding areas. See attached January 23, 2015 Facility Inspection Report Photos 3 and 4.

3. Lack of adequate designated concrete washout area observed on site. Observed concrete washout into a temporary container that had inadequate containment resulting in discharges to underlying soil and surrounding areas (See Photos 3 and 4). All construction sites are required to ensure the containment of concrete washout areas and other washout areas that may contain additional pollutants so there is no discharge into underlying soil and onto the surrounding areas.

Photos 3 and 4 show inadequate concrete washout management. Photo 3 shows concrete contractor washing chute into temporary concrete washout container constructed of cardboard lined with plastic without containment to protect underlying soil. Photo 4 shows temporary concrete washout container after concrete contractor departed, and the container appears to be failing and leaking concrete-laden water into underlying soil.

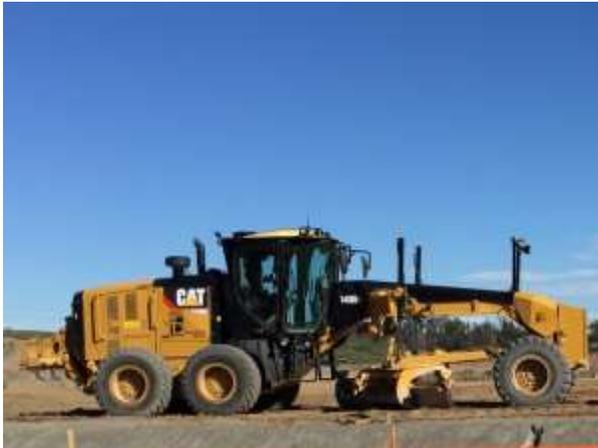
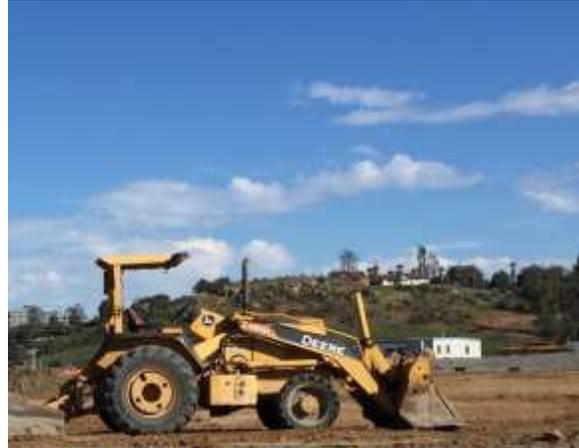
- c. Observation:** During the January 23, 2015 inspection, the San Diego Water Board inspector observed several construction vehicles stored without appropriate BMPs to prevent oil, grease or fuel to leak in to the ground, storm drains or surface waters. See attached January 23, 2015 Facility Inspection Report Photos 5 and 6.

4. Construction equipment and vehicles observed lacking appropriate BMPs (e.g. drip pans) to prevent oil, grease, or fuel to leak in to the ground, storm drains, or surface waters (See Photos 5 and 6). All construction sites are required to prevent oil, grease or fuel to leak in to the ground, storm drains, or surface waters, and to place all equipment and vehicles, which are to be fueled, maintained and stored in a designated area fitted with appropriate BMPs.

Photos 5 and 6 show construction equipment and vehicles without appropriate BMPs (e.g. drip pans) to prevent oil, grease, or fuel to leak in to the ground, storm drains, or surface waters.

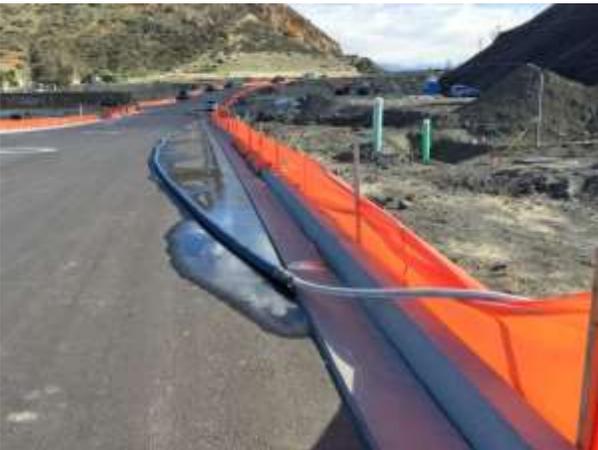
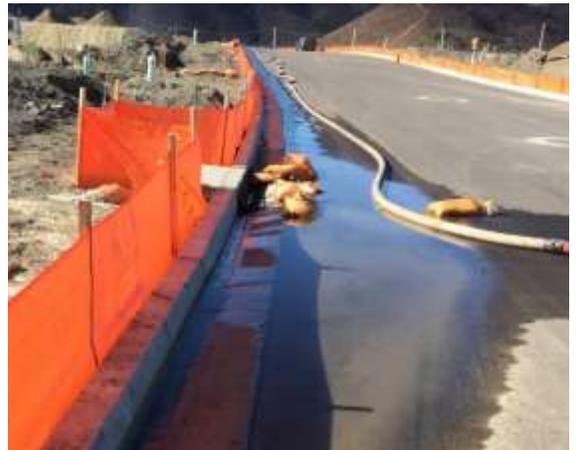
- b. Observation:** During the January 23, 2015 inspection, the San Diego Water Board inspector observed inadequate implementation of measures to control discharges of non-storm water runoff from a leaking hose to a storm drain inlet. See attached January 23, 2015 Facility Inspection Report Photos 7 and 8.

5. Observed inadequate implementation of measures to control discharge of non-storm water runoff from a leaking hose to a storm drain inlet (See Photos 7 and 8). All construction sites are required to implement measures to control all non-storm water discharges during construction.

Photos 7 and 8 show lack of measures to control discharge of non-storm water runoff from a leaking hose to a storm drain inlet. Photo 7 shows hose with a leak at a coupling that should have been repaired, or placed on the other side of the silt fence to contain discharge. Photo 8 shows storm drain inlet where non-storm water runoff from leaking hose flows into storm drain inlet, with gravel bags moved to allow flow into inlet.

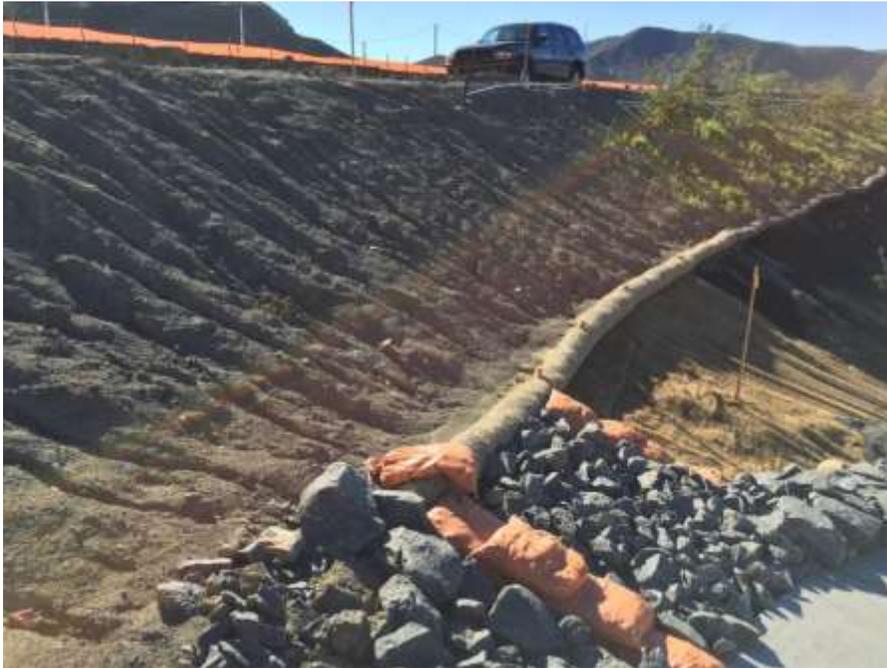
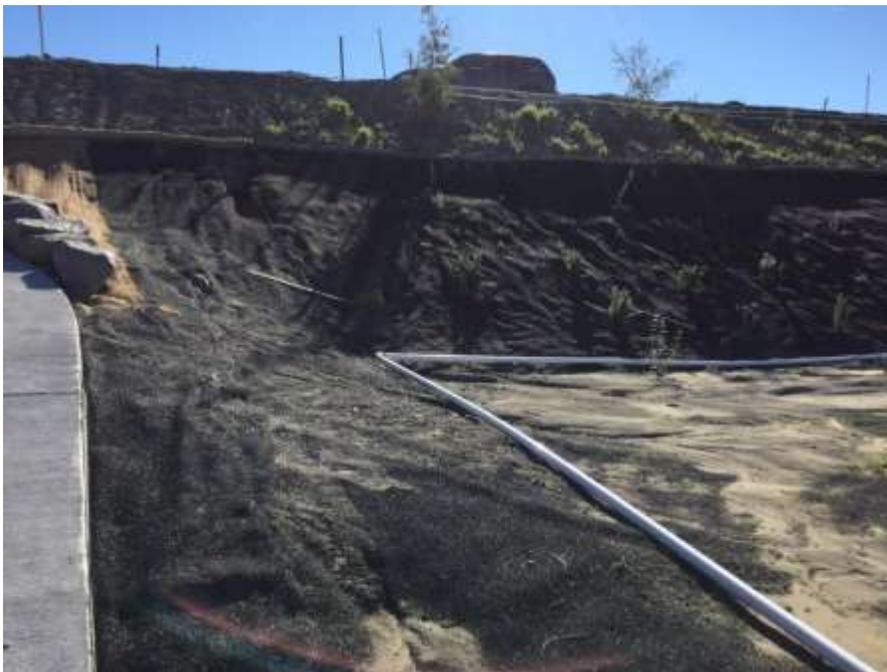
- b. Observation:** On January 23, 2015, the San Diego Water Board inspected the Harmony Grove Village construction site (WDID 937C364581). Standard Pacific Corporation is the Legally Responsible Person (LRP) enrolled under the Construction General Permit (CGP) for the site. On January 23, 2015, the San Diego Water Board inspector observed evidence of sediment discharged from the site to receiving waters due to inadequate and ineffective implementation of BMPs, constituting an unauthorized discharge of sediment from the site. See attached January 23, 2015 Facility Inspection Report Photos 9 and 10.

- c. Observation:** During the January 23, 2015 inspection, the San Diego Water Board inspector observed a lack of effective erosion controls and sediment controls required by the CGP, which directly lead to erosion and sedimentation that ultimately resulted in the discharge of sediment from the site to receiving waters. The discharge was a result of the implementation of controls, structures, and BMPs that do not achieve BCT. See attached January 23, 2015 Facility Inspection Report Photos 9 and 10.

6. Several areas were observed to be inactive, or could be scheduled to be inactive, without effective soil cover to control potential erosion. Several inactive slopes (See Photos 9 through 14) lacked effective soil cover, or had inadequately maintained soil cover for erosion control which resulted in at least one documented occurrence of an unauthorized discharge of sediment to waters of the state (See Photo 10). All construction sites are required to provide effective soil cover for inactive areas (i.e. areas that have been disturbed and not

8. Several slopes throughout the site were observed to lack linear sediment controls along the toe and grade breaks of exposed slopes (See Photos 9 through 14). Risk Level 2 and 3 construction sites are required to apply linear sediment controls along the toe of the slope, face of the slopes, and at the grade breaks of exposed slopes to comply with sheet flow lengths given in Table 1 of Attachment D or E to the CGP.

Photos 9 and 10 show a slope that is part of the channel mitigation project required to be implemented by the site under Clean Water Act Section 404 and 401 requirements. Evidence of erosion and sediment transport can be seen in Photo 9 in the form of rills and sediment build-up behind fiber roll. Photo 10 shows evidence of sediment transported from slope shown in Photo 9 and discharged into the channel, which is an unauthorized discharge of sediment to receiving waters.

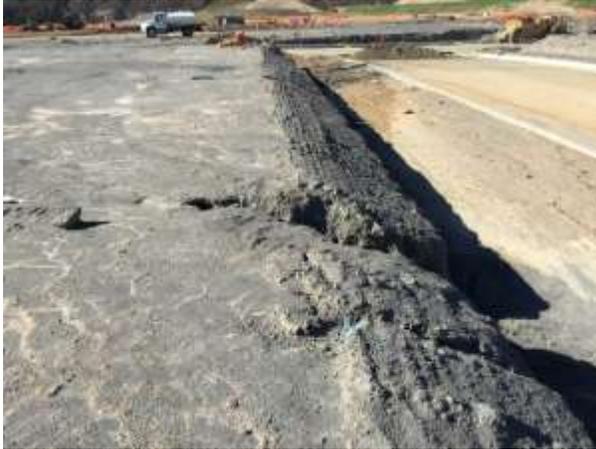
Photos 9 through 14 show several slopes observed to be inactive, or could be scheduled to be inactive throughout the site that lack effective soil cover, or inadequate maintenance of effective soil cover. Photos 9 through 14 also show lack of linear sediment controls along the toe of the slope, face of the slope, and at the grade breaks.

Photo 11 shows a completed building pad with no evidence of effective soil cover and evidence of erosion on the slope adjacent to the pad. Photo 12 shows another slope with no evidence of effective soil cover and evidence of erosion. Photo 13 shows a slope with evidence of erosion where there is evidence hydromulch had been applied, but no longer effective due to inadequate maintenance or re-application. Photo 14 shows the slopes of a building pad where one slope is protected with an erosion control blanket, but the adjacent slope has no effective soil cover.

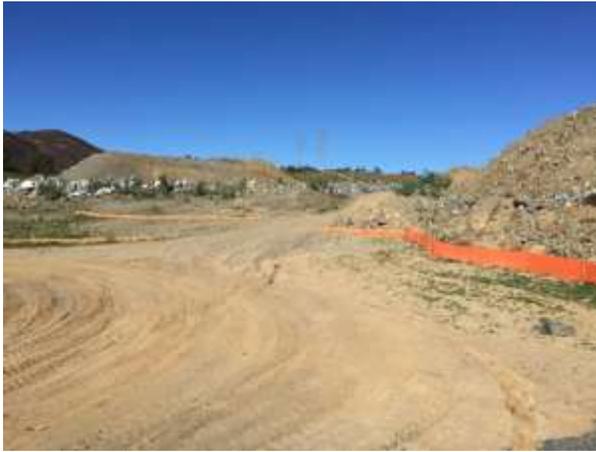
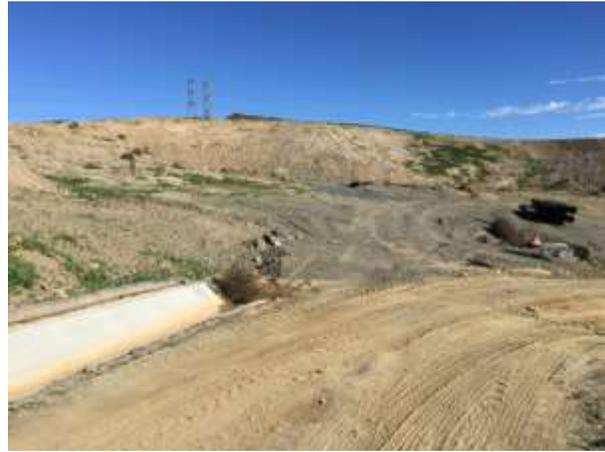
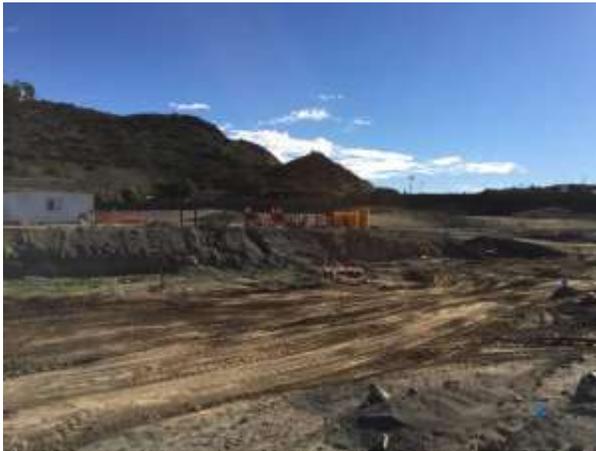
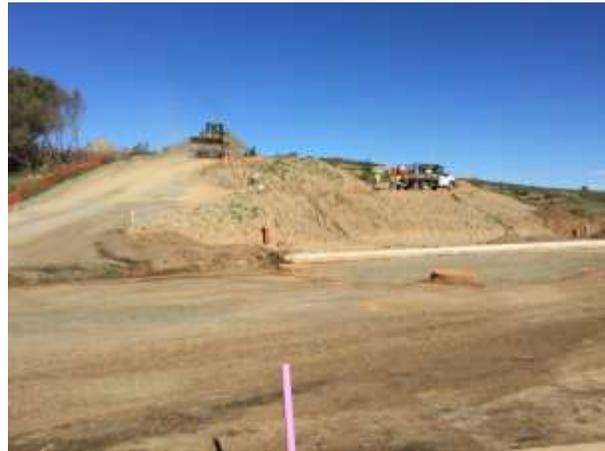
- a. **Pursuant to Provision X and Section E.3 of Attachment D of State Water Board Order No. 2009-0009-DWQ:** Risk Level 2 dischargers shall implement appropriate erosion control BMPs (runoff control and soil stabilization) in conjunction with sediment control BMPs for areas under active construction.
- b. **Observation:** During the January 23, 2015 inspection, the San Diego Water Board inspector observed several active areas of the site that did not have appropriate erosion control BMPs in place or ready to be deployed. See attached January 23, 2015 Facility Inspection Report Photos 15 through 18.

7. Active areas were observed to lack appropriate erosion control BMPs (runoff control and soil stabilization) to prevent erosion (See Photos 15 through 18). Risk Level 2 and 3 construction sites are required to implement appropriate erosion control BMPs (runoff control and soil stabilization) in conjunction with sediment control BMPs for areas under active construction.

Photos 15 through 18 show several areas observed to be active, or have signs or recent activity throughout the site that do not appear to have any appropriate runoff control and soil stabilization erosion control BMPs in conjunction with sediment control BMPs.
