ALMADEN QUICKSILVER COUNTY  
PARK AND SANTA TERESA COUNTY  
PARK MINE MATERIAL EVALUATION

AMENDED FINAL REPORT

Date: May 16, 2011

Project No.: 26817573

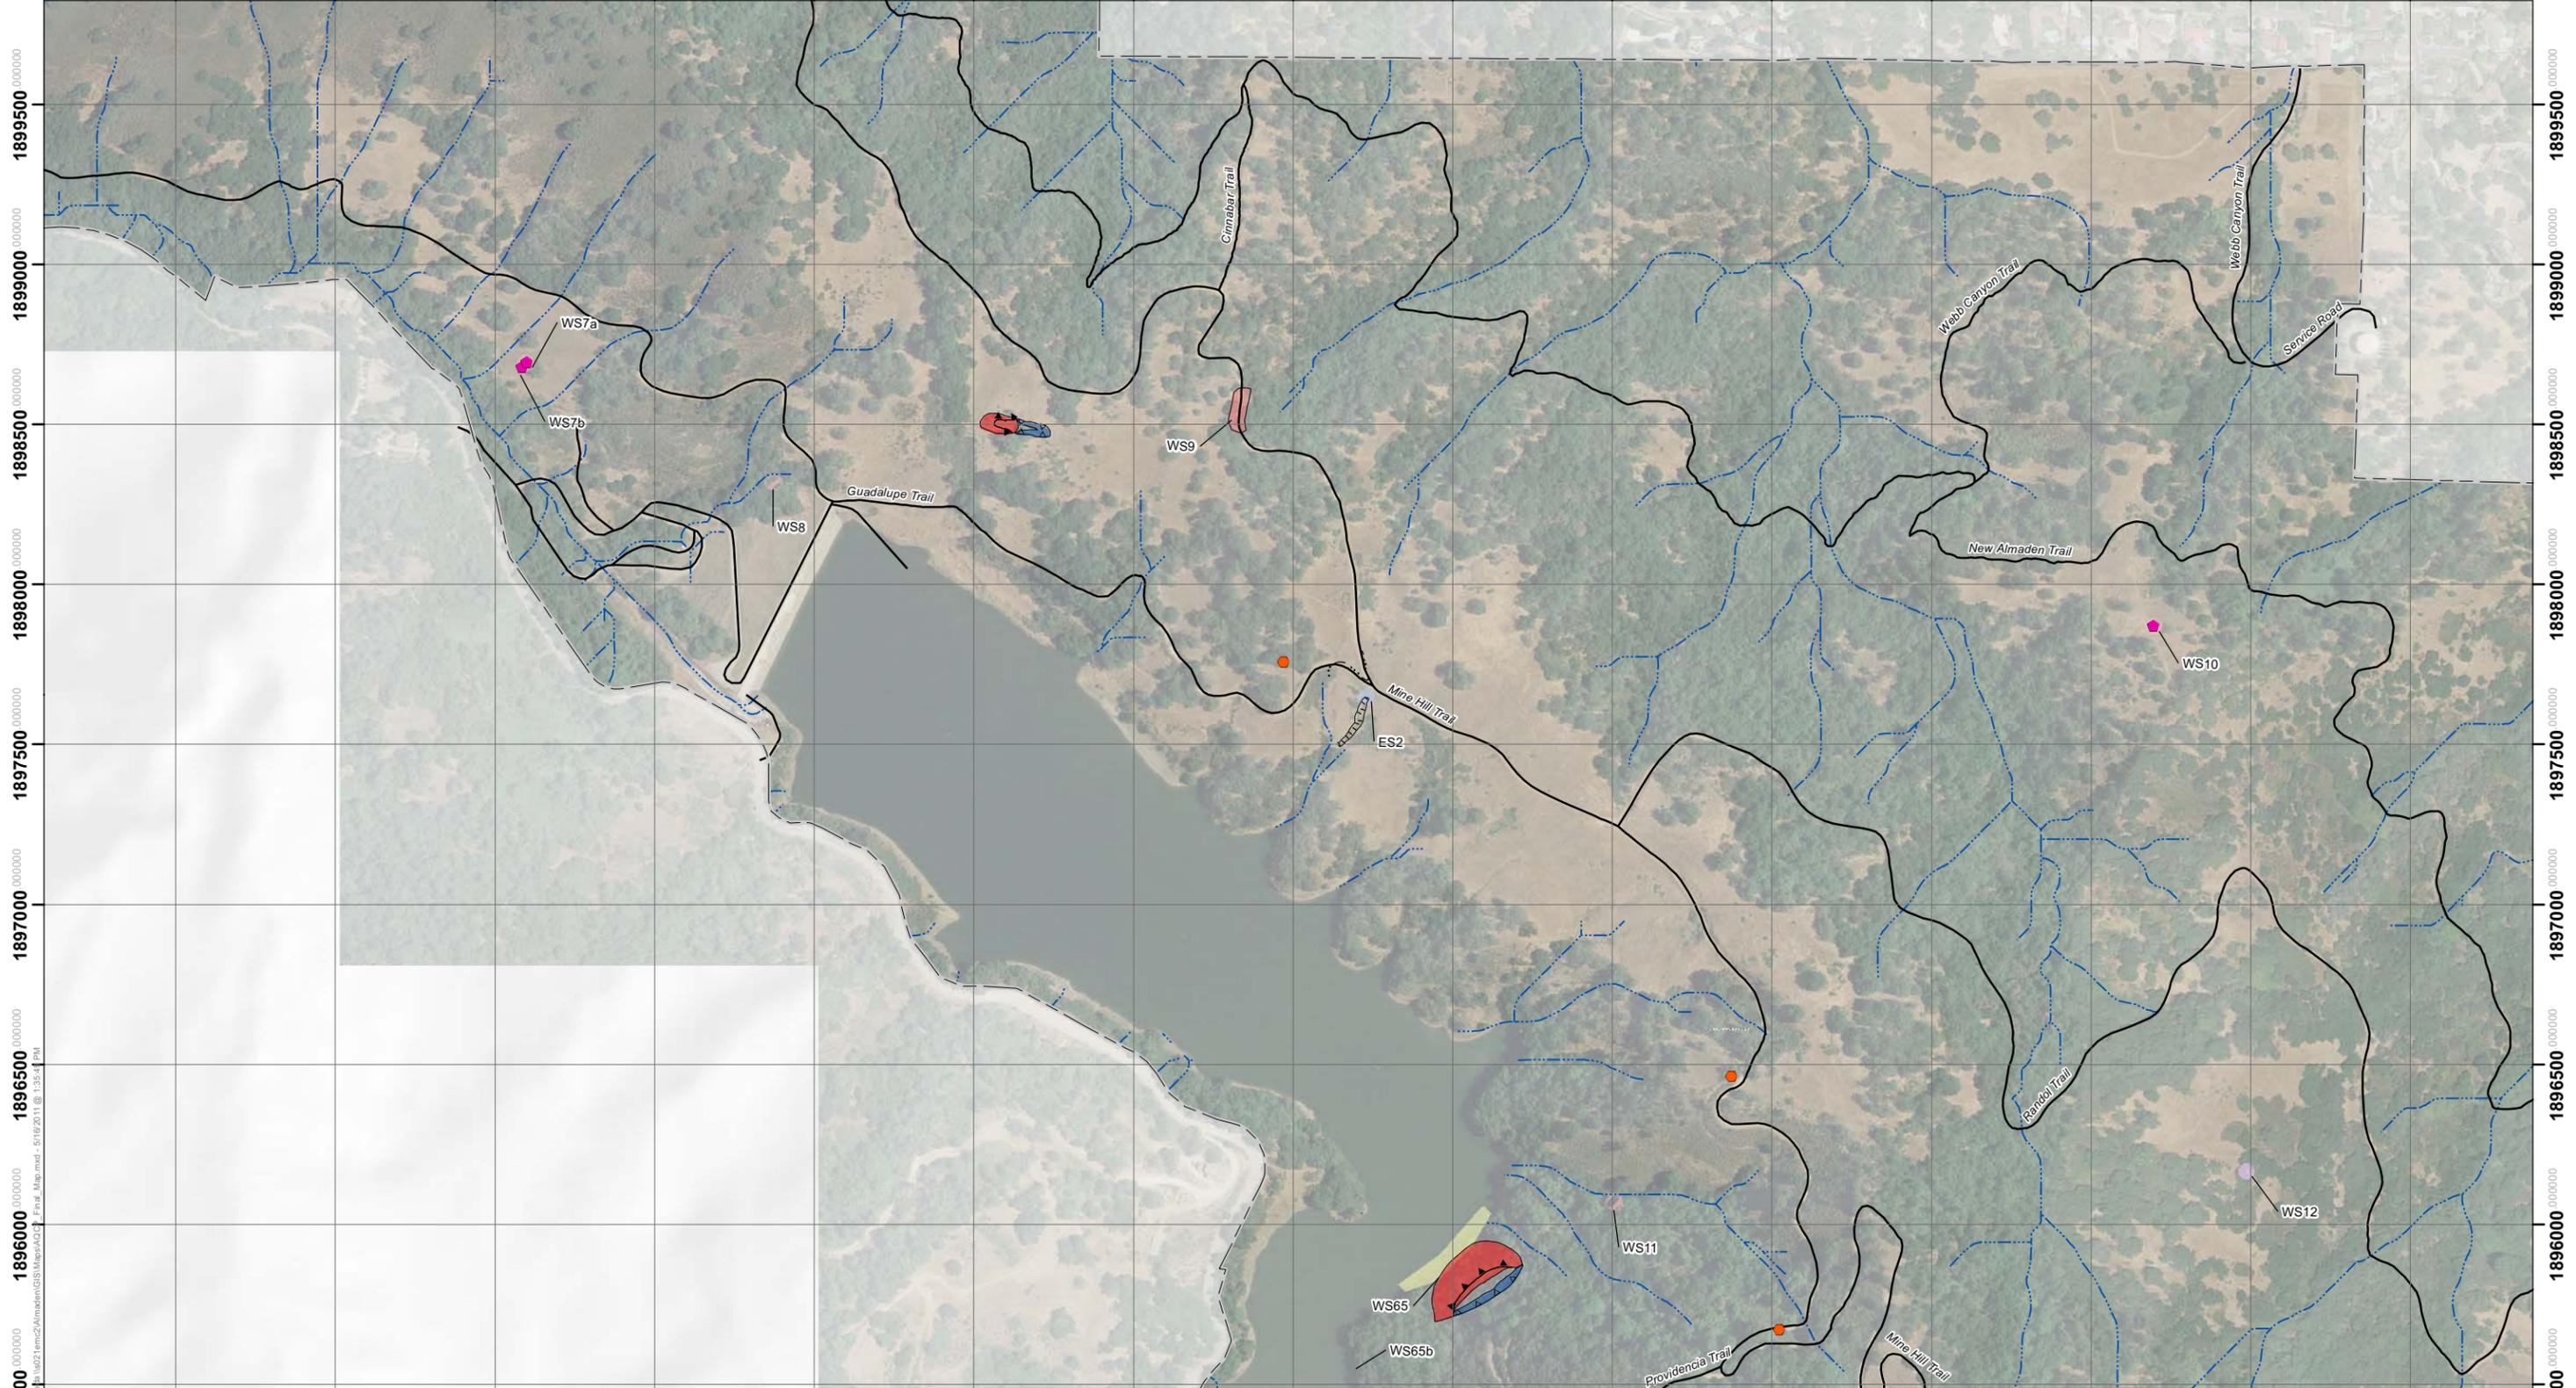
**Figure 1 - Tile 2**  
Feature mapping,  
Almaden Quicksilver County Park

This feature is an area of red soils on the Guadalupe Reservoir shoreline (Figure 1, Tile 2). It was not identified in any of the documents reviewed, but was observed in aerial photos. In general the waste consists of a dark red, moist to wet, loose silty sand with gravel, which was often observed near the location of mined ore bodies. The visible color on the shoreline appears to be the result of wave erosion of the lower margin of an approximately 200 foot wide waste pile extending down slope from mine workings associated with the Enriquita Mine. The waste appears to be relatively thin (<4 feet thick) at the shoreline. Active erosion and slumping into the Guadalupe Reservoir were observed (Photographs 9 and 10, Appendix A). The THg concentrations in one composite sample were 42 mg/kg, but the THg<sub>HCl</sub> concentration were low relative to the other locations, so it is not known how available the THg from this material is to methylating bacteria.

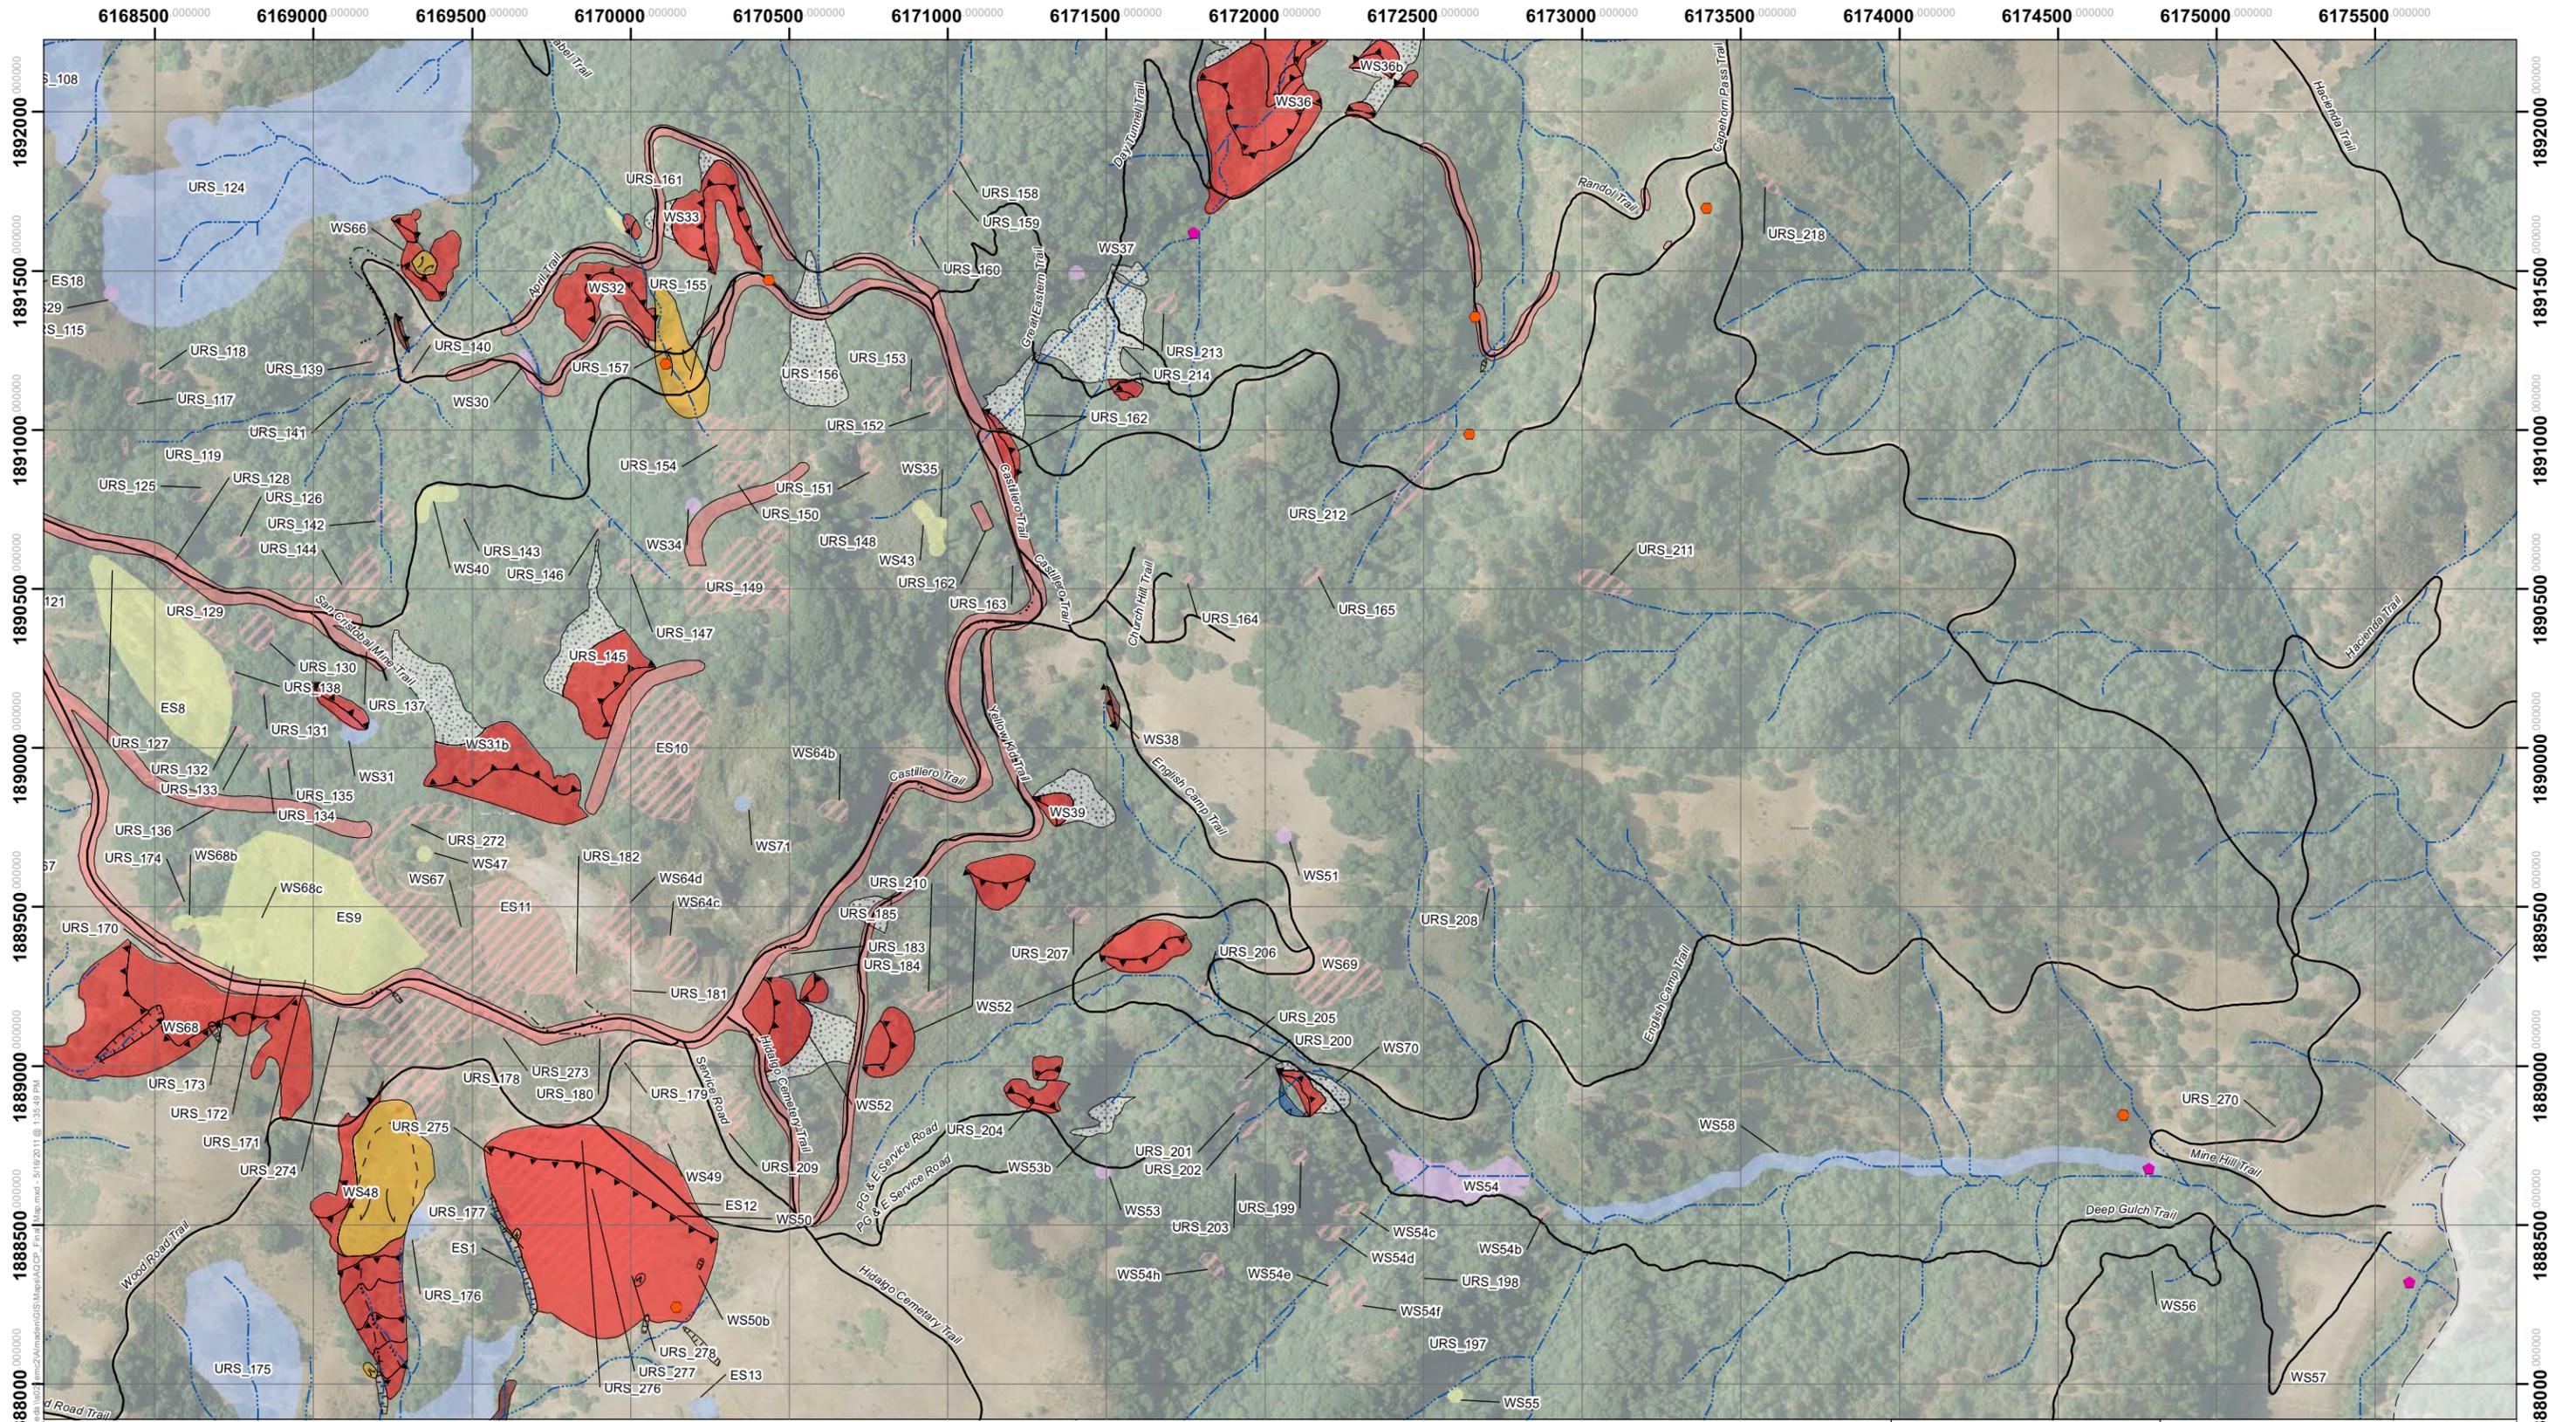
**Figure 1 - Tile 7**  
 Feature mapping,  
 Almaden Quicksilver County Park

The field surveys identified small areas on the Mine Hill calcine repository (Figure 1, tile 7) that require maintenance. This area was previously mitigated by regrading, capping and installing five concrete lined drainage ditches directing run-off into swales at either side of the fill. Two areas on the repository were observed where loss of drainage control and erosion have occurred (ES1 and ES12). Although these areas had been previously remediated, and thus excluded from the 13267 order, the County's Construction Services Division will address these areas through the ongoing maintenance plans already in place at the AQCP. Assessment of these areas in preparation for work is scheduled to commence in the first quarter of 2011 as weather permits.

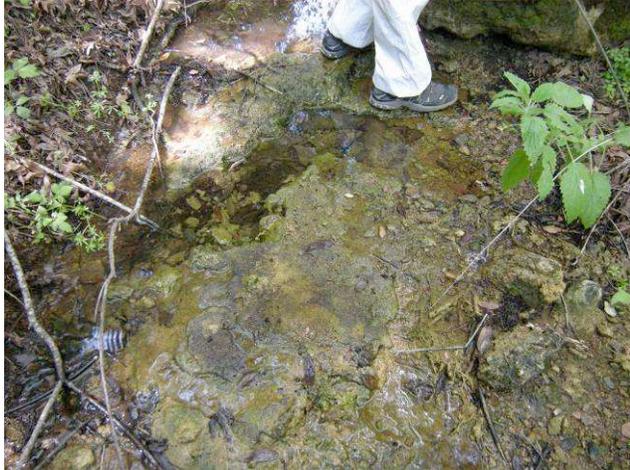
Photograph 1. WS20, a cemented creek receiving drainage from WS60, the Santa Isabel shaft dump, and WS61, the Buena Vista shaft and Randol dumps.

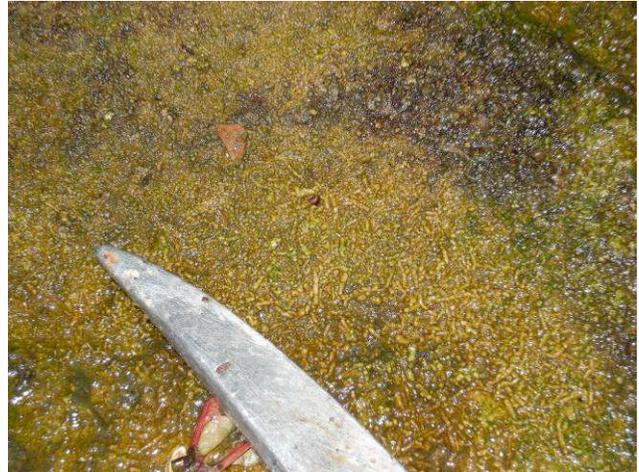
Photograph 2. Mineral encapsulated algae from WS20.

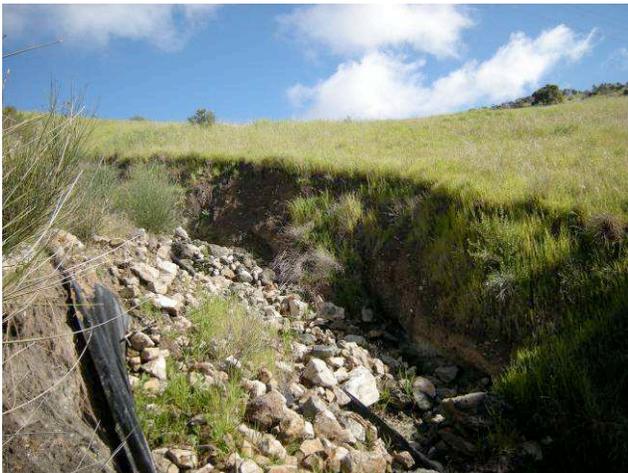
Two locations were observed where calcines are exposed to surface water and were sampled to assess their potential leachability. Calcines previously stored in the Mine Hill repository are being exposed in several small areas by erosion (Figure 1, tile 7; Photographs 3 and 4, Appendix A); the THg concentration were relatively moderate compared to other locations (22 mg/kg) and had low THg<sub>HCl</sub> concentrations (0.005 mg/kg).

Photograph 3. Erosion site ES1 in drainage channel on toe of Mine Hill repository.

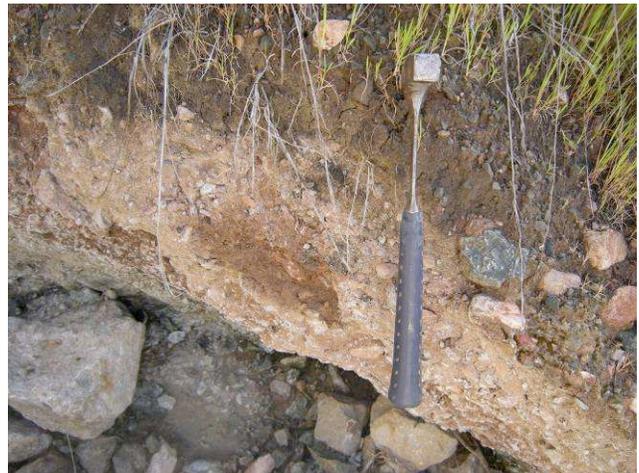
Photograph 4. Calcines exposed by erosion in drainage channel at ES1.

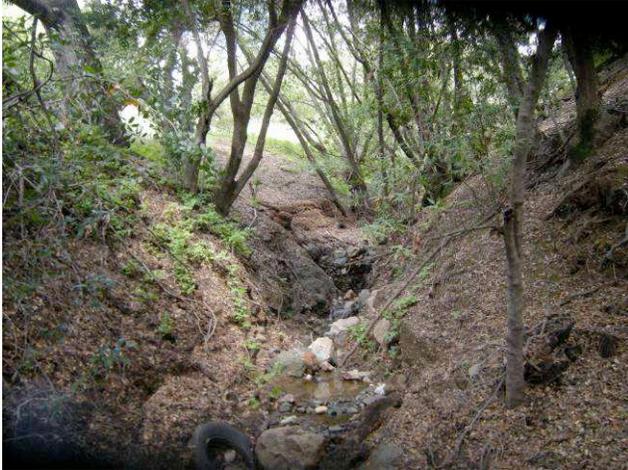
We observed masses of cemented calcines and calcine float<sup>1</sup> in a 3,500 foot high gradient reach of Jacques Gulch Creek between a wetland forming in an impoundment below ES12 and the AQCP Boundary (Figure 1, tile 6; Photographs 5, 6, 7, and 8). Calcines of up to 7 feet in thickness were observed, dissected by the creek banks and flowing water, and cemented calcines formed a solid mass across the creek bed over extensive areas.

Photograph 5. Beginning of upper Jacques Gulch calcine delineation transect.

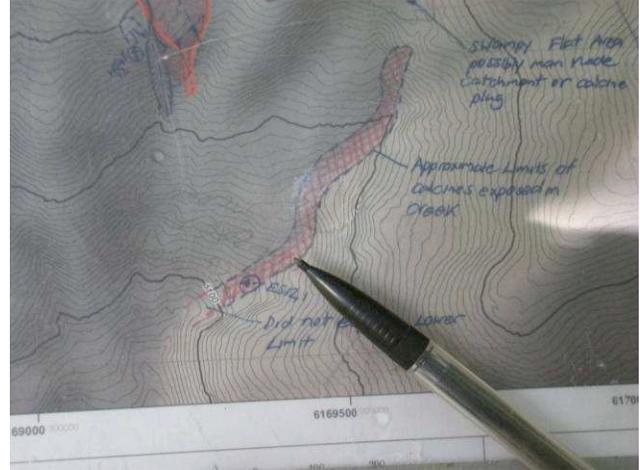
Photograph 6. Approximate extent of presumed calcine material in upper Jacques Gulch channel.

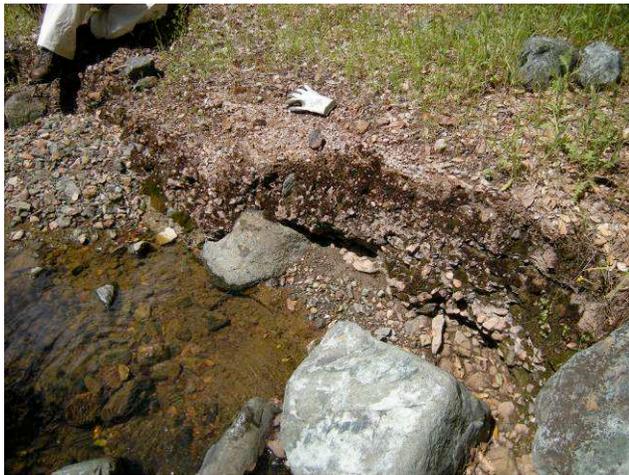
Photograph 7. Example of presumed calcine material in upper Jacques Gulch.

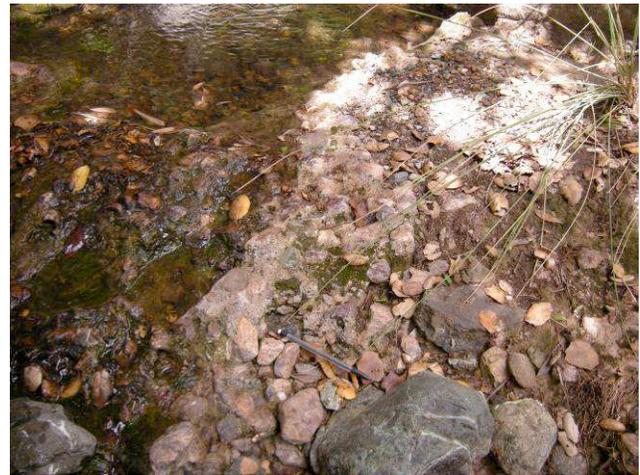
Photograph 8. Example of presumed calcine material in upper Jacques Gulch.

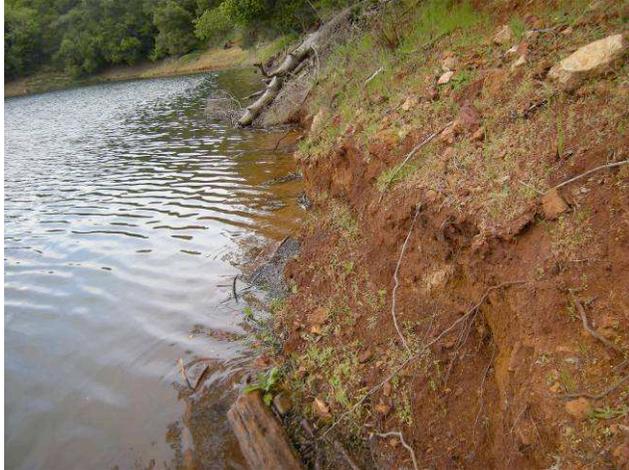
Photograph 9. WS65, an area of overburden from the Enriquita Mine on the shoreline of Guadalupe Reservoir.

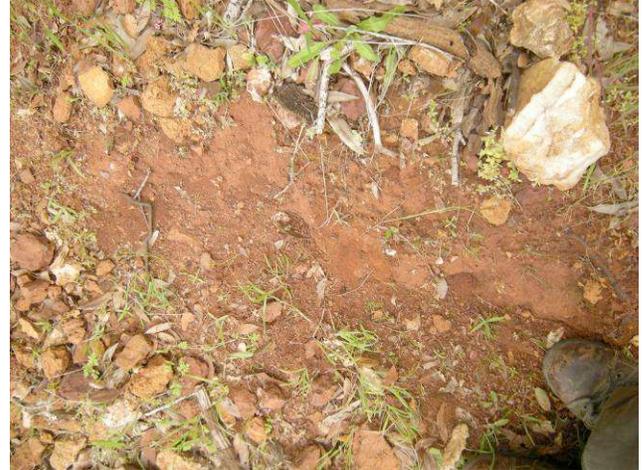
Photograph 10. Close up of overburden material at WS65.

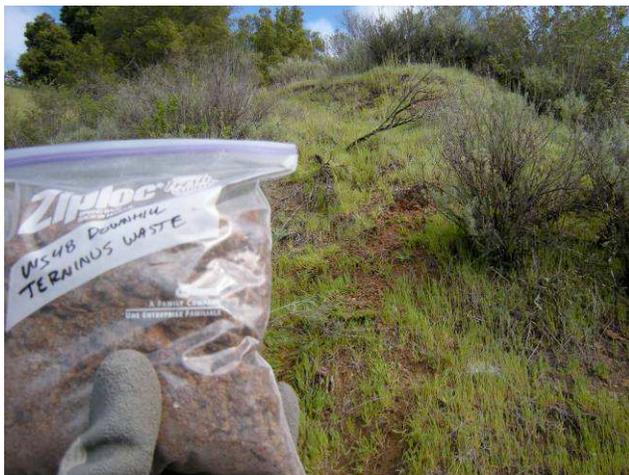
Several samples were collected on the trails and roads on the southwestern portion of Mine Hill. WS48 (Figure 1, tile 6) is a large complex of landslides on the southwestern slope of Mine Hill, approximately 300 feet from the main repository. The composite sample was collected from a small erosional area (Photograph 11, Appendix A) had a THg concentration of 379 mg/kg, the highest value observed. One composite sample was collected from ES9 (Figure 1, tile 6; Photograph 12, Appendix A), an erosional scar on the lower margin of eroding slopes along Castillero trail, and ES6 (Figure 1, tile 6; Photograph 13, Appendix A), an eroding upper margin of the America mine ore body. The THg concentrations were 26 mg/kg at ES9 and 10 mg/kg at ES6.

Photograph 11. WS48 overburden sample collection location.

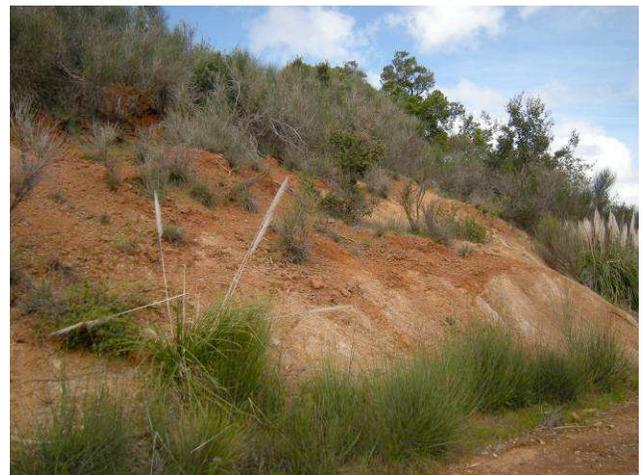
Photograph 12. Overburden at ES9 on Castillero Trail.

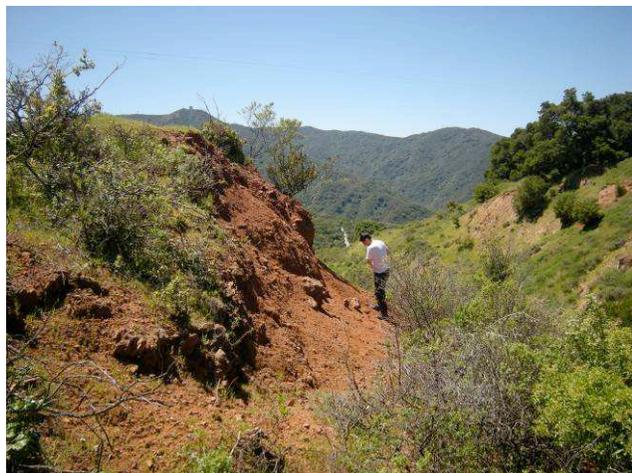
Photograph 13. ES6, overburden area on Mine Hill.

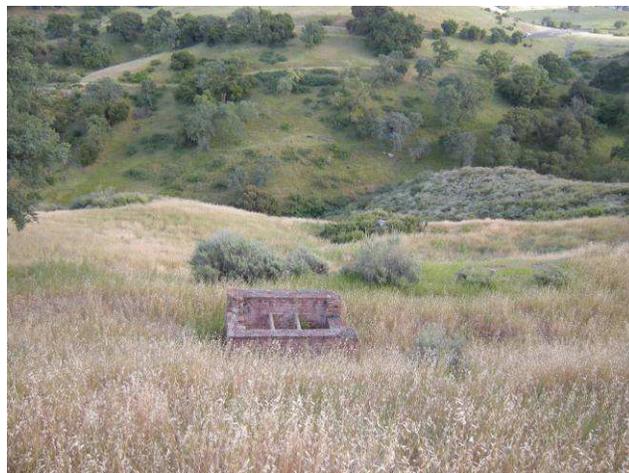
The field evaluation observed conditions consistent with the documentation reviewed, which suggested that there was no mercury production at the Bernal Mine (USBM 1965)

Photograph 14. Bernal Mine brick structure and surrounding area.

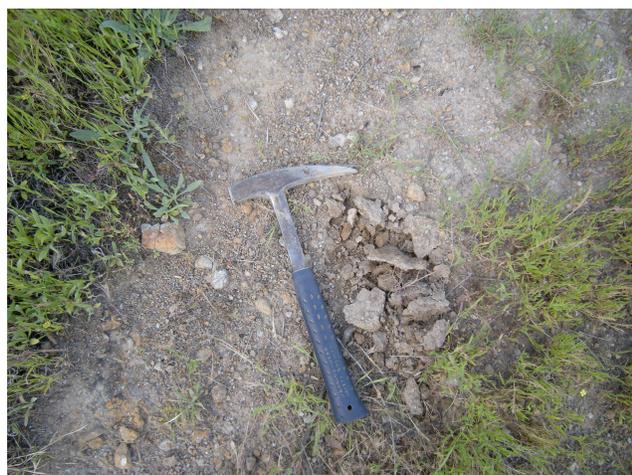
Photograph 15. Bernal Mine soil on fill slope.
