Daily Log for Chris Haynes
January 13, 2010
All times are approximate

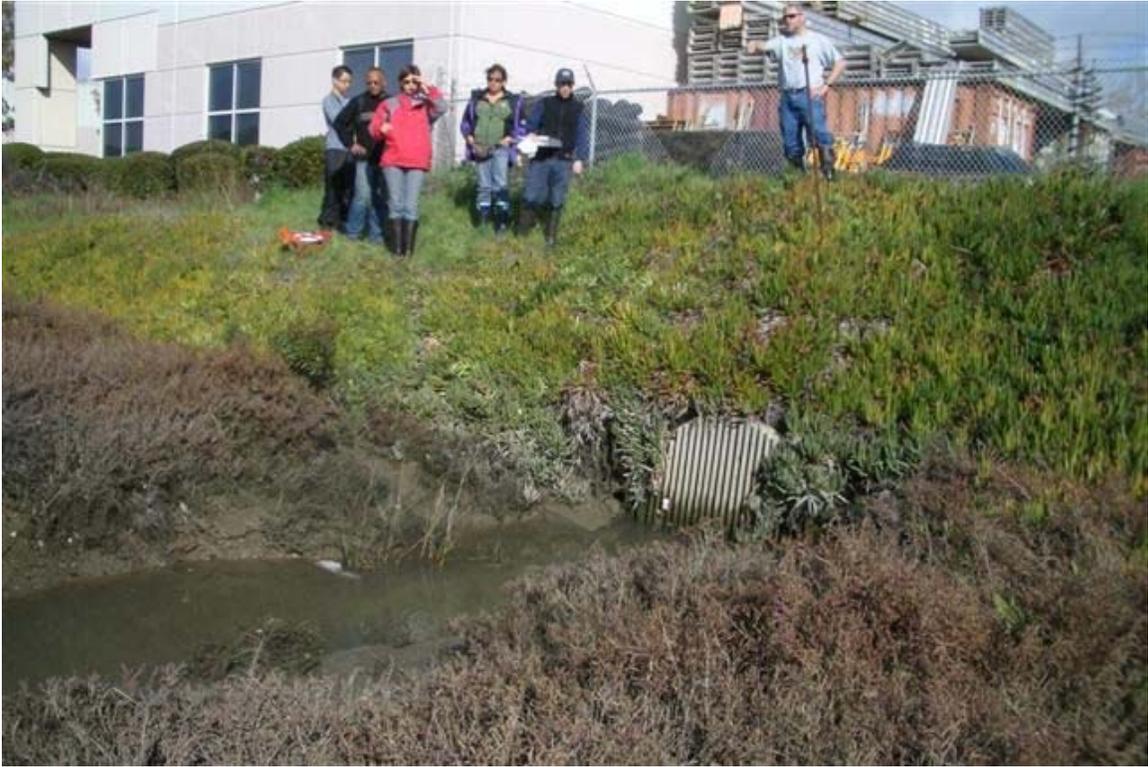
42 inch outfall

0915 – I walked south, from the above stormwater outfall to see if I could find the 42 inch storm water outfall that also may drain from the area of Metro Poly. I located the outfall and observed many pellets in this area. I collect a small sample as I was unsure if the tide change might make later sampling even more difficult.

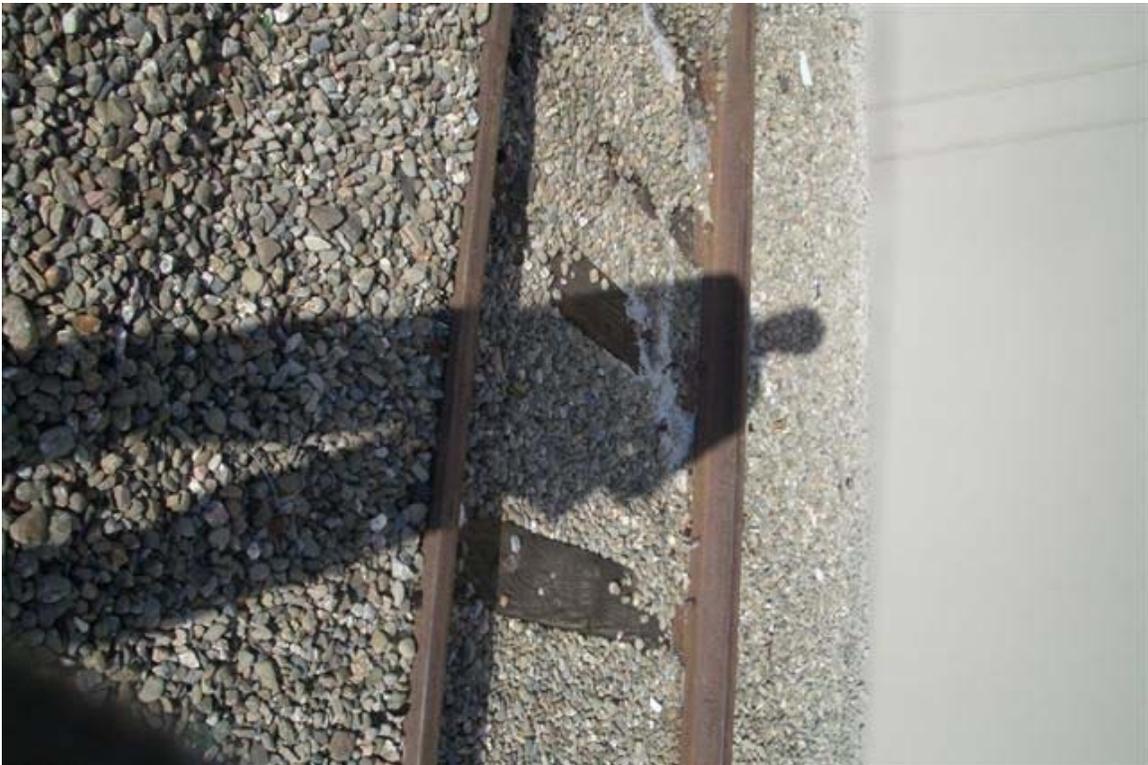
Behind Interstate Plastic Building

1520 – Walked across Williams St from Uni Poly to look at the railroad siding behind a building immediately across the street and behind Interstate Plastic. Small piles of plastic pellets were observed behind the building and I collect a sample and submitted it to Dylan. We will need to return later to inspect Interstate Plastic.

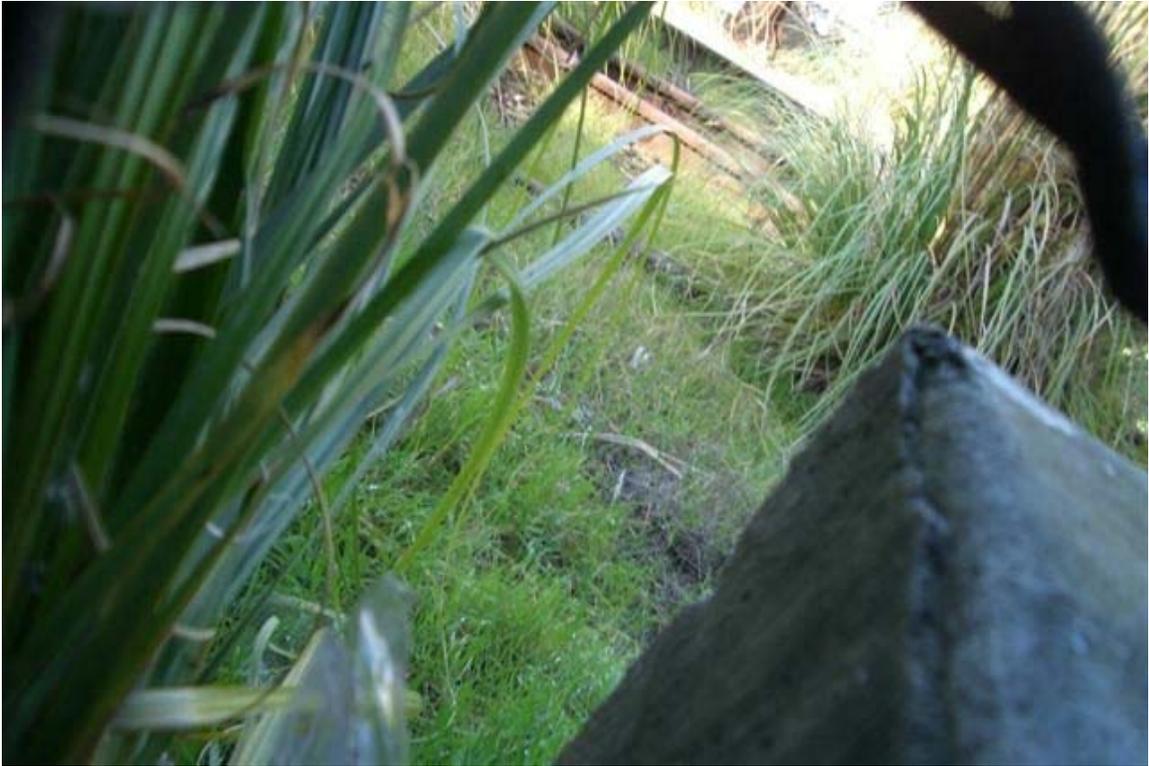
Area Behind Uni Poly Back Fence

- At the back fence area of the facility I observed a door accessing the inside of the facility (later discovered to be the recycling area) and lots of debris that appeared to have been washed off the landing near the door towards the Northern fence line (and into the raid spur area directly on the other side of the fence). John Camp from the City of San Leandro briefly joined us at this point in the inspection.

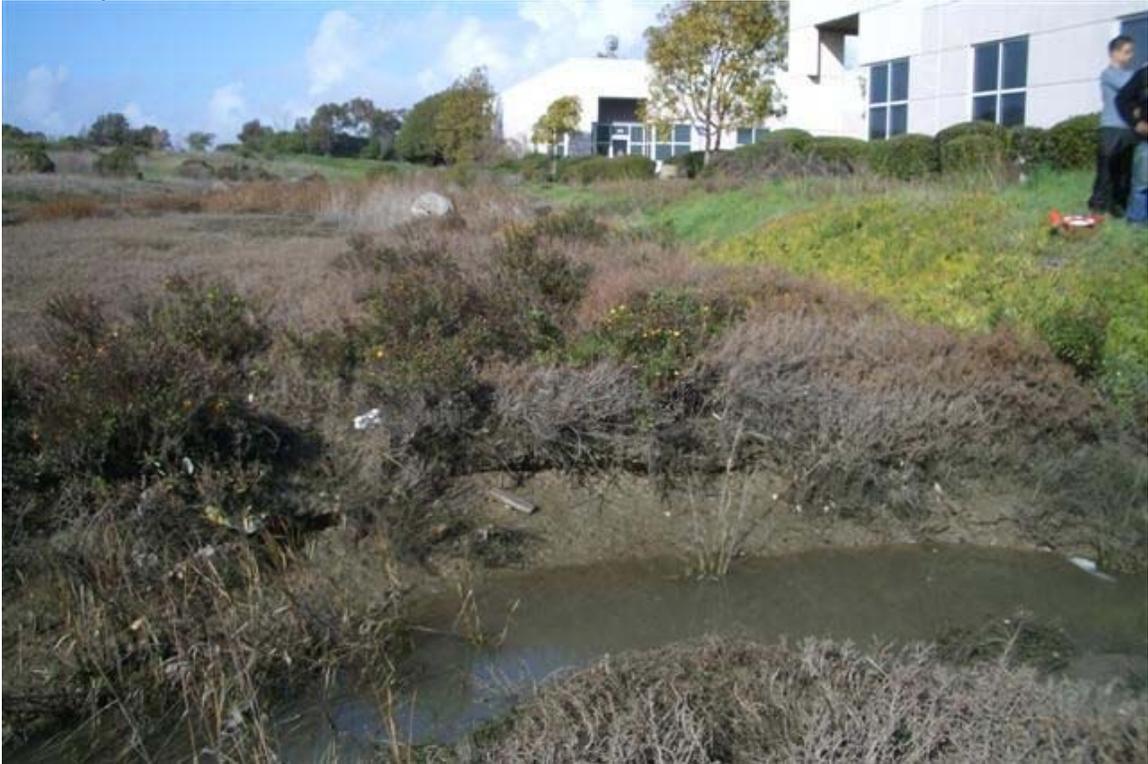
42 Inch Outfall Looking North

1230 - I joined the Water Board team headed to southern 42 inch outfall, referred to as ESTS, to inspect and possibly conduct assessment and sampling. Decided to break outfall ESTS into two areas, Northern bank and Southern Bank, and only sample (no rapid debris assessment) this area for plastic pellet debris. The tide was moving out and it was no longer under water. This area appeared to have much less debris, including plastic pellets, than ESTN area however a close examination of the vegetation and mud surface showed both the foam type and harder plastic type of pellets in abundance. The harder plastic type of pellets were very hard to see as they seem to collect some sediment on their surface and just blend into the background.
