REHABILITATION OF A 290 HECTARE SITE
IN REDWOOD NATIONAL PARK

Patrick Teti¹

Abstract. A 290 hectare (710 acre) site that had been tractor logged between 1969 and 1975 was mapped and treated for erosion control in 1980. Gullies up to 4.3 meters (14 feet) deep were the dominant erosion feature and were caused by the diversion of runoff by roads. A gully inventory in a 40 hectare (100 acre) sub-unit revealed management related erosion of 1.3 centimeters (one-half inch) in seven years although all mapped erosion occurred in gullies that occupied only a half a percent of the land area. The most cost-effective erosion control treatments were the de-watering of active gullies and the excavation of road fill from stream crossings.

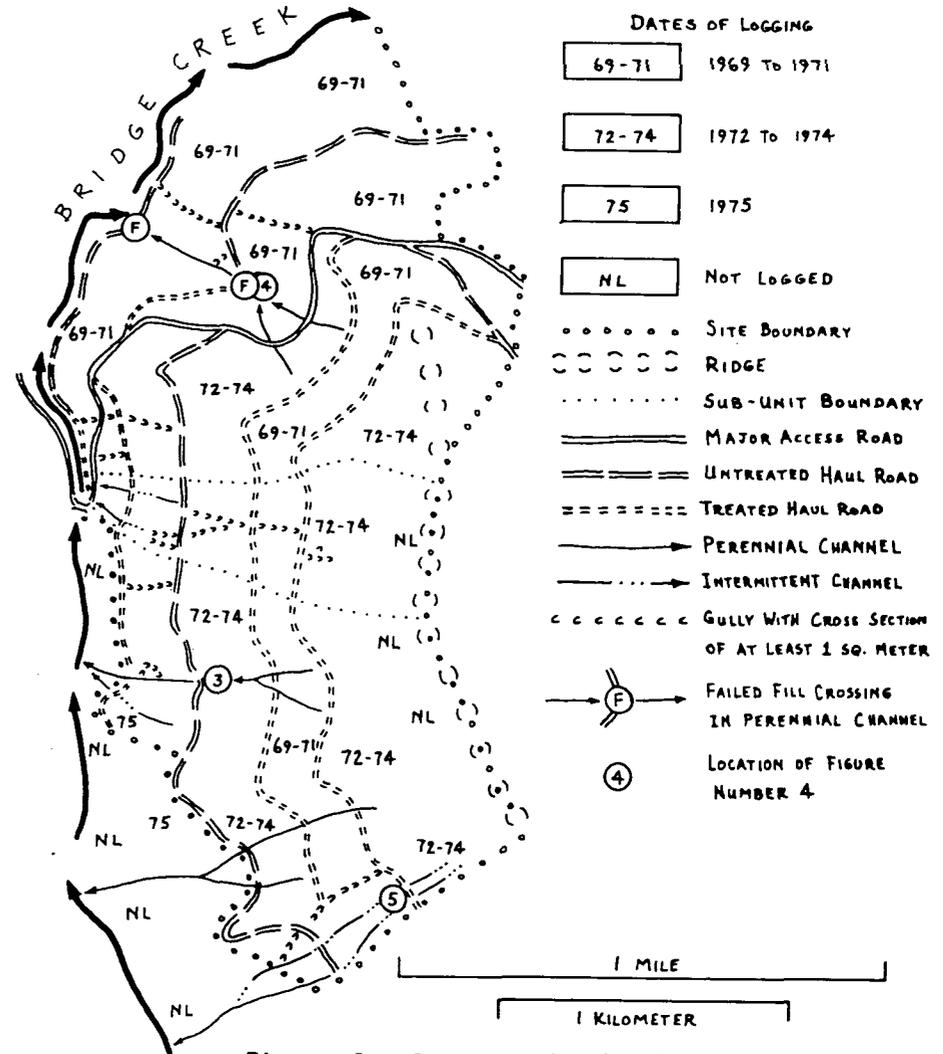
Figure 2. Streams, Roads, Dates of Logging, and Other Features on the Site

The mapping of gullies on this site includes width and depth measurements in sufficient detail to quantify all gullies larger than .09 square meters (1 square foot) in cross sectional area. However, at this time only those gullies in a 40 hectare (100 acre) sub-unit shown in figure 2, have been tallied for this site. This sub-unit spans the full 510 meter (1680 feet) elevation range of the hillslope and is crossed by four logging haul roads. It is not necessarily quantitatively representative of erosion on the rest of the unit but the character of management related sediment sources and erosional processes is representative. Total mapped gully volume in this 40 hectares was 5200 cubic meters (6800 cubic yards), most of which was derived from gullies with cross sections of at least 5 square meters (54 square feet). The largest gully cross sections were 11.6 square meters (125 square feet) and the deepest gullies were 4.3 meters (14 feet) in depth. The pattern of gullies on this unit reveals discontinuities in plan view and in long profile that are a direct result of interception of water by skid trails; diversions by inboard ditches, culverts, and landings; and an increase in the volume of diverted runoff downslope. Tractor logging between the ridge and the highest haul road left a network of skid trails (almost completely without waterbars) which converged downslope. This network of skid trails intercepted storm runoff into the inboard ditch of the first (highest) haul road. This runoff, which under natural conditions would probably have been spatially dispersed and not even emergent as surface runoff, formed a gully with a cross sectional area averaging .91 square meters (9.7 square feet) between the first and second roads. At the second road the flow spilled out onto a landing which diverted the runoff in three different directions. The resulting gullies, each with a volume of at least a few hundred cubic meters, formed in response to different runoff events and probably in different years, as indicated by their different ages of natural revegetation. The flowcourses which caused these three gullies converged at the third road and below this point there was no more major gullying.

Sediment sources in the 40 hectare watershed discussed earlier were related to disturbances of types 1 and 2, therefore treatments consisted of both the reconstruction of drainage networks and the excavation of road fill from stream channels. Between the ridge and the highest road, 29 waterbars were constructed to disperse surface runoff. The highest haul road was cross-road drained (in addition to being ripped) in order to keep surface runoff from becoming concentrated in the inboard ditch. At the second haul road the flow was considered sufficiently channelized, and draining a sufficient area (5.2 hectares, 13 acres) to justify the full excavation of road fill from the channel. Between the second and third roads, a trench diverted the flow out of a very active gully and into an older, well-vegetated, gully. This part of the hillslope was so disturbed that no stable, natural channel was apparent. The third haul road was left intact in 1980 and at this point, the flow passed through a culvert and into a well-defined, incised channel. At the fourth road the fill was fully excavated from the channel and at the fifth road, immediately above the right bank of Bridge Creek, the road was left intact and flow is accommodated by a properly placed culvert. Excavation of the untreated crossing was planned for a later date.

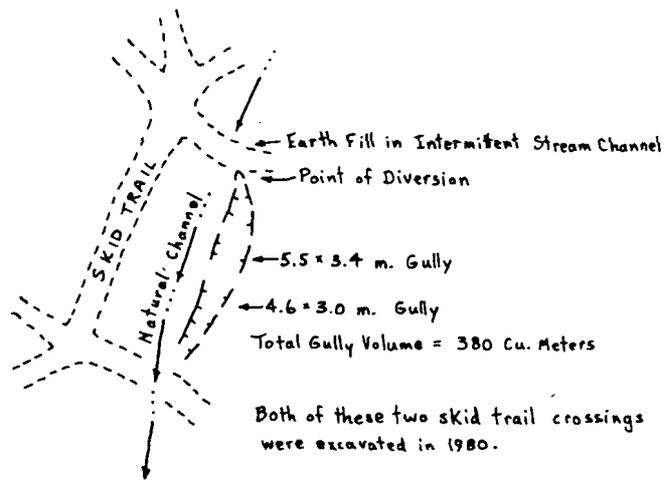
Figures 3, 4, and 5 show examples of three of the major sediment sources on this unit and also provide a sample of the geomorphic mapping. Figure 3 shows a skid trail crossing of a stream draining 28 hectares (68 acres). The crossing had been constructed by filling the channel with logs and earth fill to a depth of about 3 meters (10 feet). The major impact of this crossing as of the time of mapping was the diversion of flow out of the natural channel resulting in a gully from which 380 cubic meters (500 cubic yards) of soil had been removed in a distance of 46 meters (150 feet). The gully had become nearly inactive due to exposures of boulders in its bed and natural revegetation on its sideslopes, but the fill in the skid trail crossing constituted a future source of sediment.

Figure 3. Gully Caused by Diversion of Stream at Skid Trail Crossing

Figure 3 and 5 show examples of both types of sediment sources, as defined in the preceding paragraph. Both crossings in these two figures had sources associated with diversions (already eroded) and sources associated with fill in stream channels (potential erosion). Both crossings were excavated down to an approximate reconstruction of the corresponding channel long profiles and cross sections, thereby accomplishing both main types of treatments at the same time, that is, de-watering of active gullies and removal of fill from stream channels. Excavation of fill from the crossing in figure 4 and from most other crossings on this site falls under the second main category of treatment, or removal of earth fill from channels. The construction of waterbars and diversion trenches are examples which fall into the category of putting water back where it belongs on the slope, or the repair of micro-drainage networks.

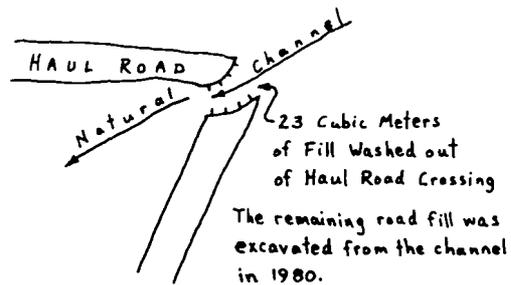
Figure 4 shows a road failure at the intersection of a haul road and a stream draining 28 hectares (a different stream than the one mentioned in the preceding paragraph). At this location, about 23 cubic meters (30 cubic yards) had already been eroded and the potential for future erosion (without treatment) was estimated to be 100 cubic meters (130 cubic yards).

Figure 4. Failure of Earth Fill at Haul Road Crossing of Stream

The partially failed road crossing shown in figure 4 was also excavated down to a close reconstruction of the original long profile and cross section. Approximately 23 cubic meters (30 cubic yards) of this road fill had failed prior to excavation but it was estimated that additional 100 cubic meters (130 cubic yards) could be eroded in the future. This potential erosion was considered sufficient to justify heavy equipment access and complete removal of the road fill from the stream channel.

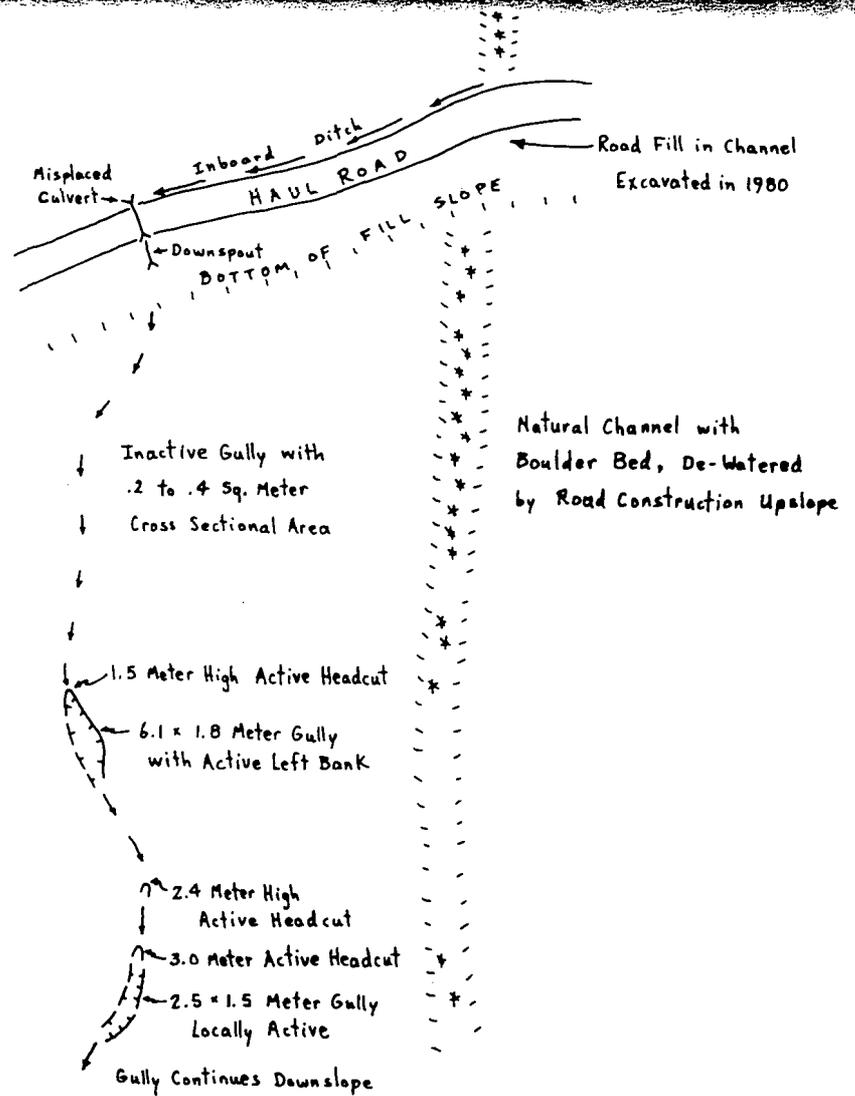
Figure 5 shows an example of one of the most important problems with haul roads on this unit, gullying due to a misplaced culvert. This problem was considered important for four reasons: 1) the volume of gullying was large; 2) such gullies on this site were still very active; 3) the problem was preventable at the time of road construction; and 4) the problem was easily treatable by rehabilitation techniques. In this example, a stream draining only 5.7 hectares (14 acres) was diverted out of its natural channel by the inboard ditch and through a culvert onto a slope about

Figure 5. Gully Caused by Misplaced Culvert

80 meters (260 feet) away. This diverted stream gullied its way downslope for a distance of 490 meters (1600 feet) and removed a volume of 1620 cubic meters (2120 cubic yards) before rejoining its natural channel.

Two worksites provide examples of the de-watering of active gullies and were the most cost-effective treatments on this unit. One of the two sites consisted of excavating the road fill from the crossing shown in figure 5, thereby also de-watering the gully associated with the misplaced culvert. The other gully, not shown in a figure, was de-watered by the installation of an additional culvert and flow dissipation structures in a haul road that was to remain within the unit after 1980. The added culvert intercepted inboard ditch runoff and diverted it into a low gradient (25 percent), slope with very good vegetative ground cover and dense fir seedlings. The gully that was de-watered formed on a slope of 45 percent. Estimates of potential erosion without de-watering of these two gully systems are based on bank sloughing back to 100 percent sideslopes, upstream migration of headcuts for a distance of between 15 and 30 meters (50 to 100 feet), and gully bed width enlargement to 1.5 meters (5 feet).

De-watering the first gully by the excavation of a small (92 cubic meter) road fill cost \$399 and it was estimated that the erosion of 1600 cubic meters (2100 cubic yards) was prevented, for a cost-effectiveness of 25 cents per cubic meter (19 cents per cubic yard). De-watering the
