AN EVALUATION OF EXPERIMENTAL
REHABILITATION WORK,
REDWOOD NATIONAL PARK

TECHNICAL REPORT
JULY 1987

Redwood National Park Watershed Rehabilitation
Technical Report Number 19

National Park Service
Redwood National Park
Arcata, California
July 1987

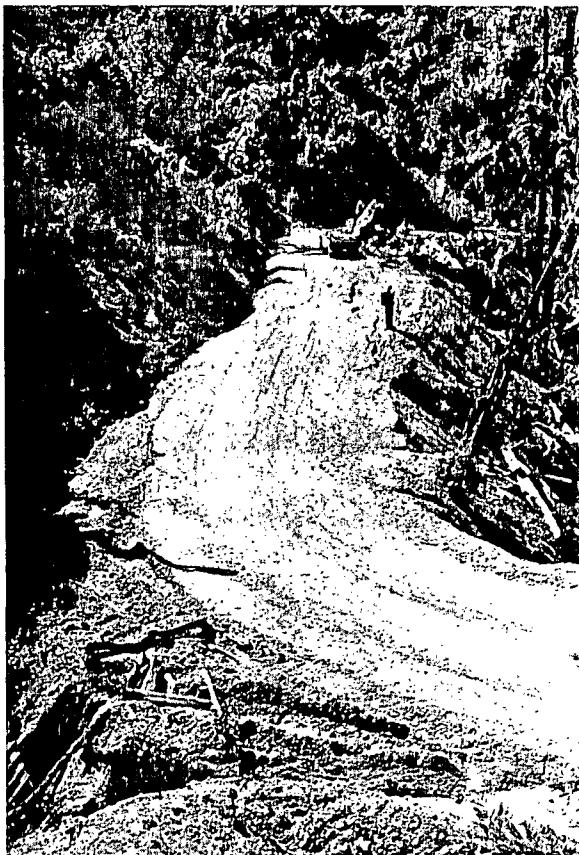
Bond Creek was chosen for rehabilitation for several reasons. First, sections of the L-1-5 logging road (both cutbanks and fillslopes) were unstable and likely to fail. Fillslopes along much of the L-1-5 showed numerous tension cracks and small scarps (Figure 3). These fills were located on steep slopes directly above stream channels. Second, a large cutbank landslide occurred during the 1978-79 winter as a result of

Fig. 3. Tension cracks in the fill slope, L-1-5 logging road.

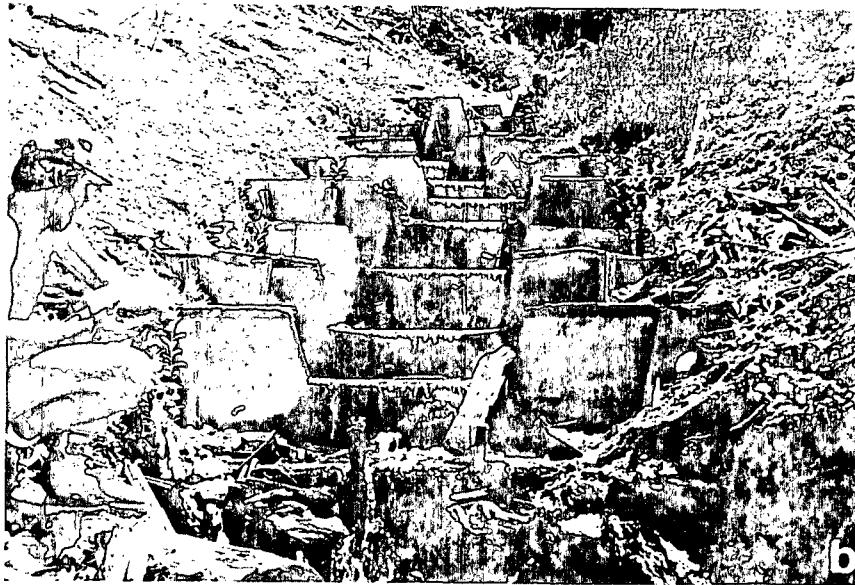
Fig. 15. The effect of checkdam construction on excavated stream crossing R2. Note down-cutting in the unprotected, excavated crossing following the first significant runoff of the 1979-80 winter (15A). A measuring tape is draped across the channel at the location of the former excavated ground surface. In 15B, the series of checkdams installed in the eroded channel caused aggradation and stabilization of the channel bed and banks,

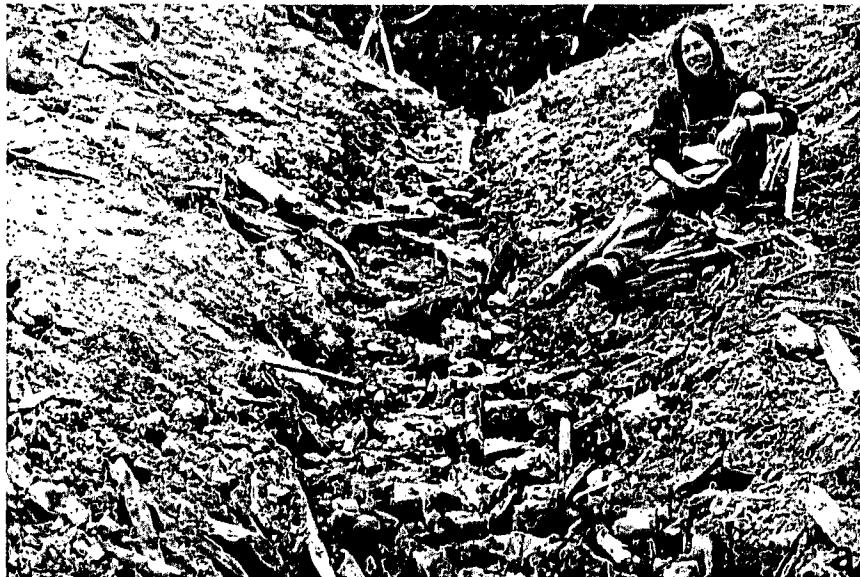
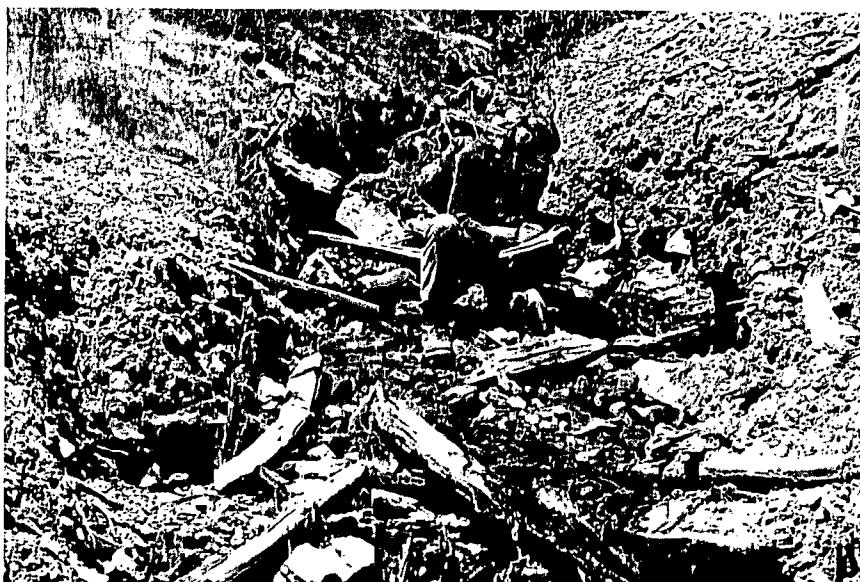
Fig. 17. Serial photographs of channel changes at the excavated stream crossing R1. Even though the crossing had not been fully excavated, abundant concentrations of organic debris buried in the fill helped minimize subsequent channel erosion. Figure 17A: October 1979; Figure 17B: June 1980.

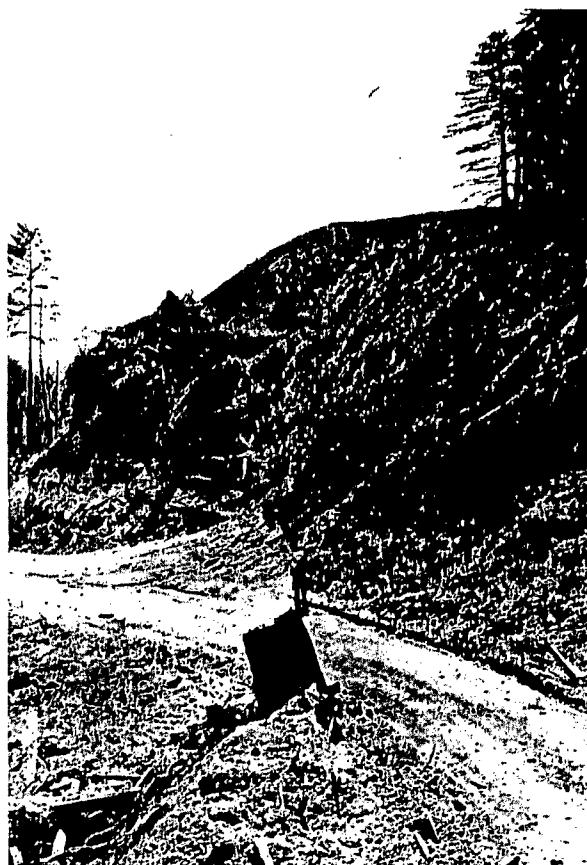
Fig. 23. Alluvial fan created by runoff from improperly drained yarder pad above the M-7-5-1 road.

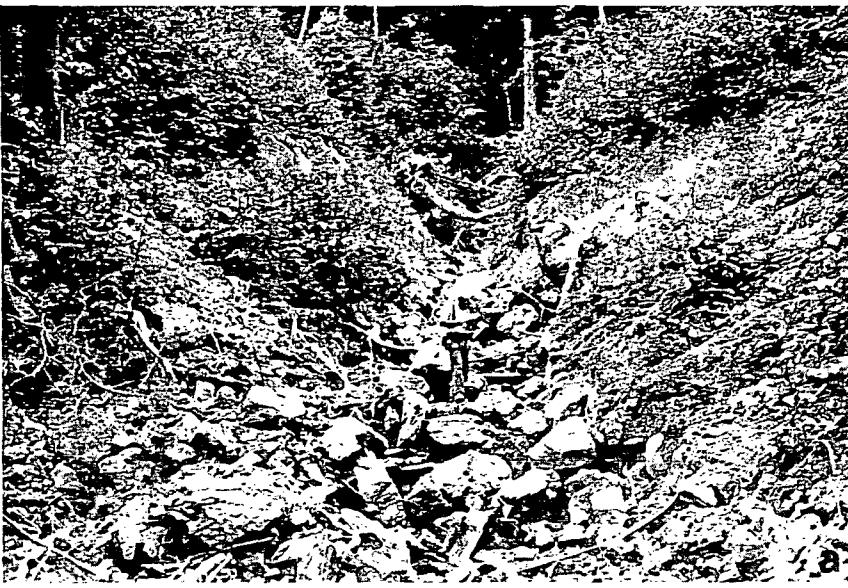
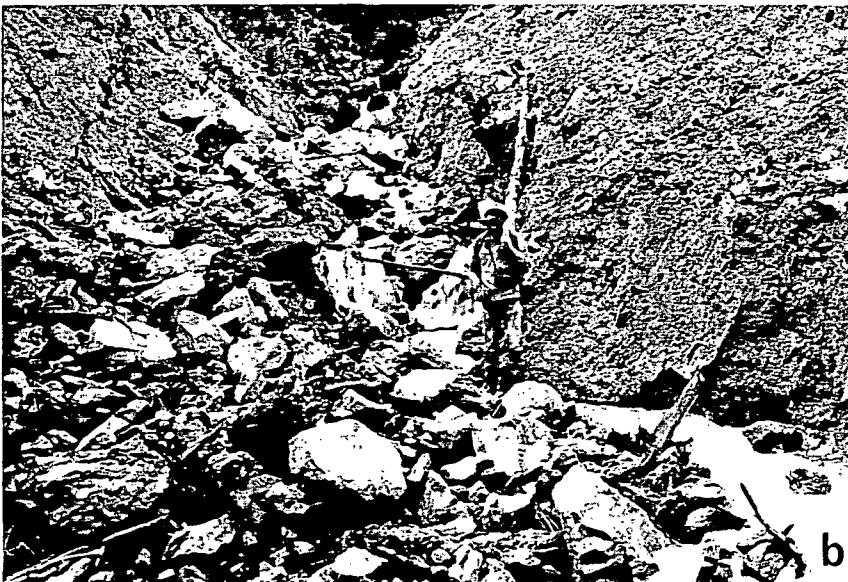
Fig. 31. Erosion of rock armored stream crossing R6. Sediment loss was caused by the presence of oversized rocks which diverted flow into and caused undercutting of the adjacent channel banks. Crossing R6 A) before heavy stream flows (October 1979) and B) after several winters (July 1982).

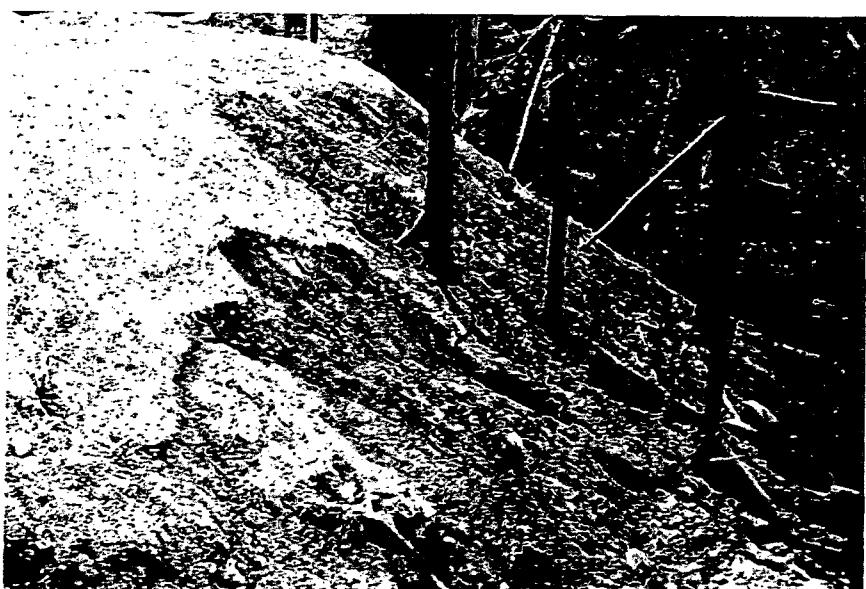
Fig. 33 (below). Small landslide caused by deflection of streamflow around large rock armor, crossing R6 (October 1979).

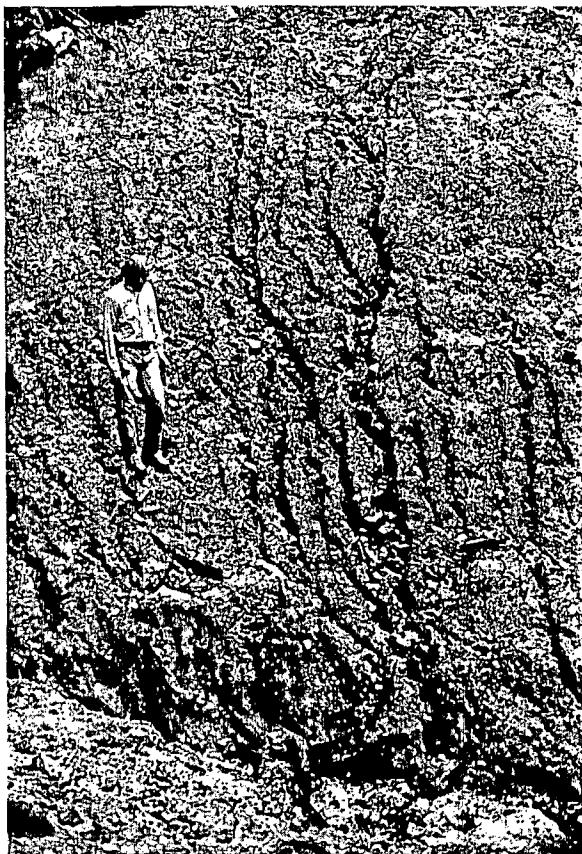
Fig. 34. Early winter rilling on the steep side slope of excavated stream crossing R7. Photo was taken prior to application of straw mulch and jute netting (October 1979).

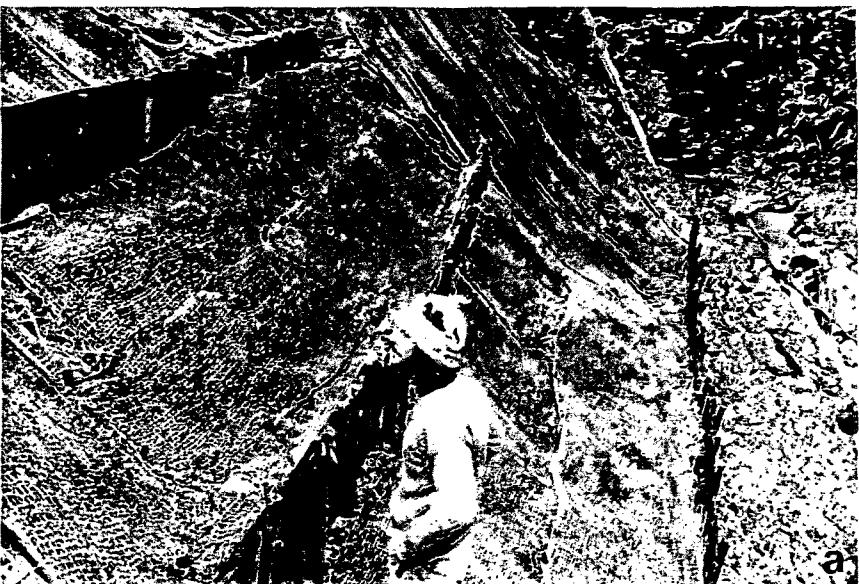
Fig. 38. Ravel catchers and jute-covered straw mulch on crossing R9. A) ravel catchers and jute-covered straw mulch were placed on the steep right bank of excavated stream crossing R9. B) following a small cutback failure on the former logging road at the top of the excavation, soil and rock passed over the jute (with no apparent damage) and either filled or toppled the ravel catchers.

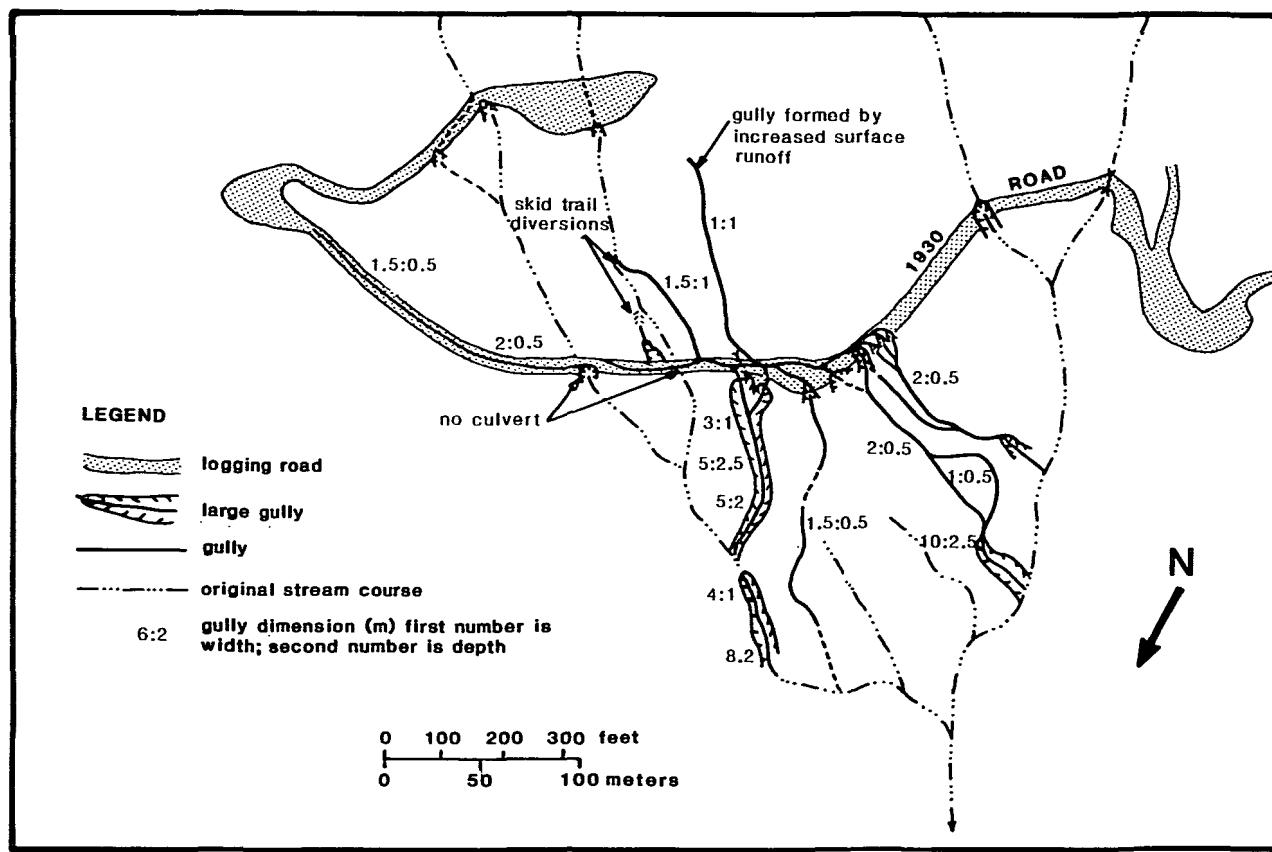
Fig. 48. Gully network mapped adjacent to the 1930 logging road. Gullies developed from increased surface runoff on skid trails and logging roads, stream diversions at skid trail watercourse crossings, stream diversions caused by plugged culverts on logging roads and stream diversions at road locations where culverts were never installed.
