WATERSHED REHABILITATION IN THE AIRSTRIP CREEK BASIN

Harvey M. Kelsey
Geologist
Redwood National Park
Arcata, California

National Park Service
Redwood National Park
Arcata, California
February 1981

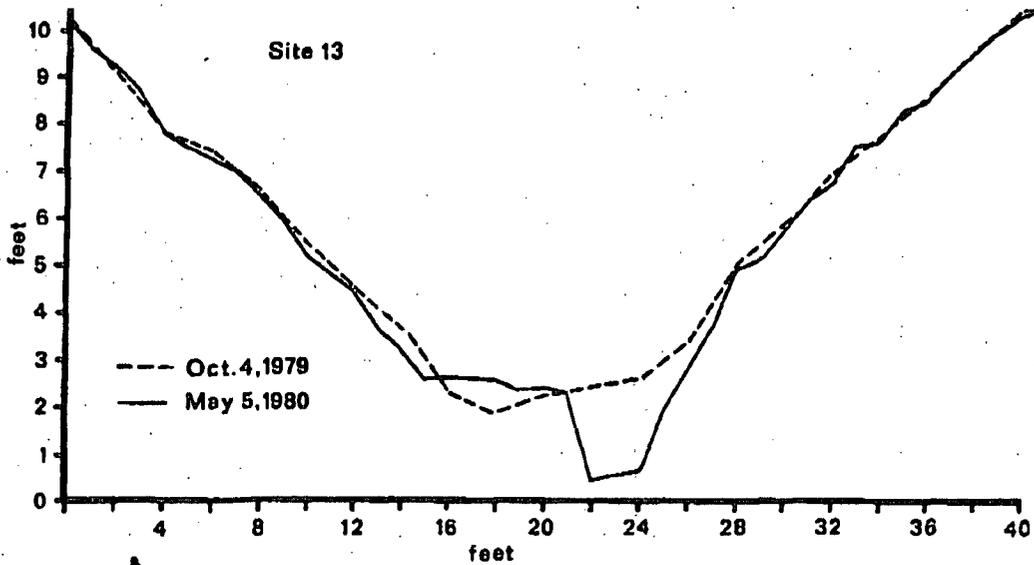
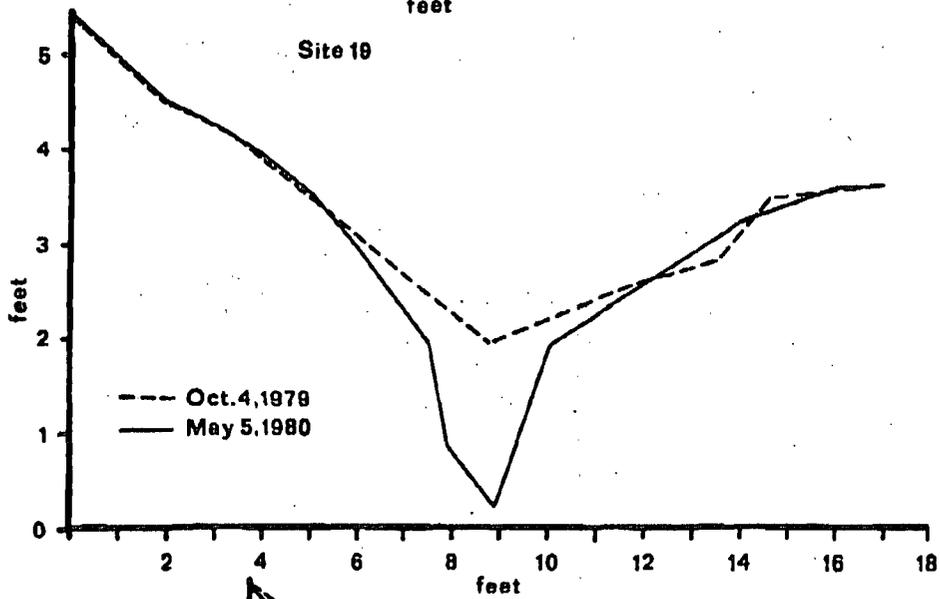
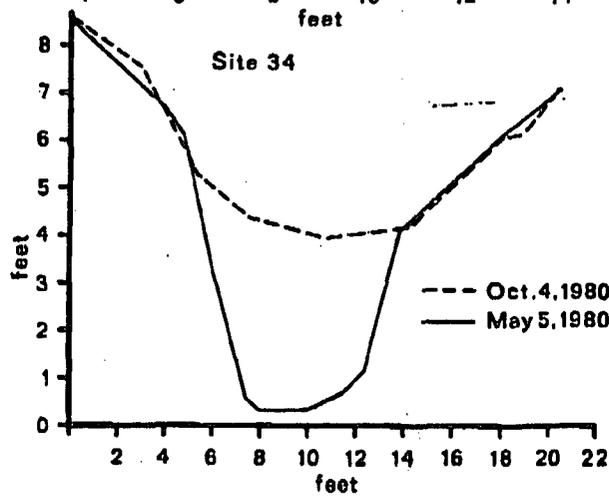
FIGURE 14

Downcutting after the onset of winter flows occurred in all channels. Figure 14 shows the extent of channel downcutting at representative cross sections of three excavation sites. The majority of downcutting occurred during the first three major storms (October 19, 1979 to November 30, 1979). During the remainder of the winter, downcutting decreased despite equally large storms later in the season. Although all the excavated channels except the uppermost (Site 34) and lowermost (Site 13) were hand rocked to prevent downcutting, the rock was too small (five to ten inches in size) and was transported downstream during storm events (Figures 15 and 16, Sites 29 and 30). At Site 17, near a quarry, the contractor carried large rocks to the site (sizes ranged from six inches to thirty inches; average size was twelve inches). These larger rocks effectively prevented downcutting only after they were moved by high streamflows and redeposited in a more stable channel bed configuration that developed following downcutting (Figure 17). Large rock placed in the channel did not prevent downcutting in cases where the channel excavation was not deep enough, the rock was not properly placed, and the rock cover did not completely blanket the channel bed.

In all cases, the greatest downcutting occurred at the downstream end of the excavated channel where the backhoe left a break-in-slope between the excavated channel and the undisturbed channel below. Downcutting was most pronounced where the excavated channel profile was distinctly convex at this slope break (Figure 18, Site 17). At two sites (Sites 13 and 30), where downcutting at the break-in-slope would otherwise have been severe, large chunks of organic debris formed a stable step in the channel that prevented erosion at the slope break. Organic debris also prevented plunge pool erosion below the step. Even a channel bed with negligible rocking (Site 13) did not significantly downcut where there was a stable organic debris step at the lower end of the excavated channel (Figure 19, Site 13).

Surveyed channel cross sections at three sites of heavy equipment excavation of fill from stream crossings showing the amount of channel downcutting during the 1979-1980 winter season. The profiles are exaggerated vertically two times.

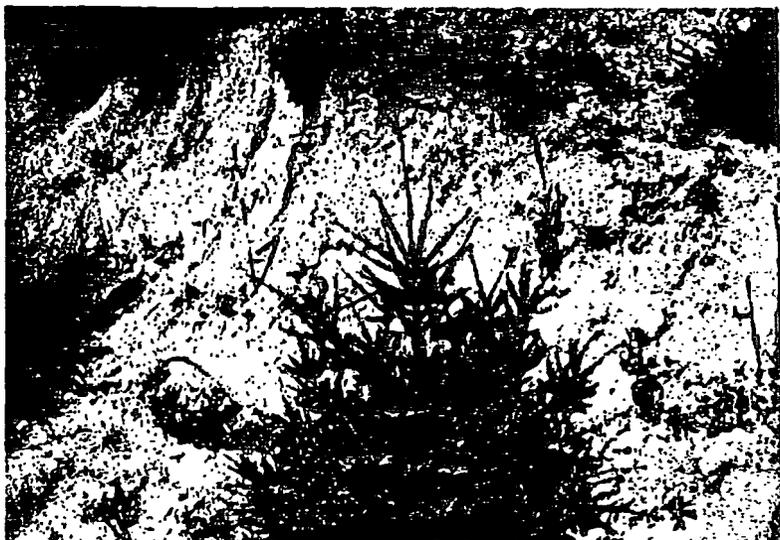
FIGURE 15

FIGURE 15B - October 16, 1979 - After backhoe work, hand-placement of rock in the channel and seeding, mulching and installation of jute, but before winter rains.

FIGURE 15C - May 6, 1980 - After winter rainy season, showing that hand-placed rock has been carried downstream and channel banks are undercut.
