**SEDIMENT SOURCES AND FLUVIAL
GEOMORPHIC PROCESSES
OF
LOWER NOVATO CREEK WATERSHED**

**Report to
Marin County Flood Control and Water Conservation District**

**Laurel Collins
2338 Valley St
Berkeley, CA 94702
~~(510) 549-1209~~**

JULY 1998

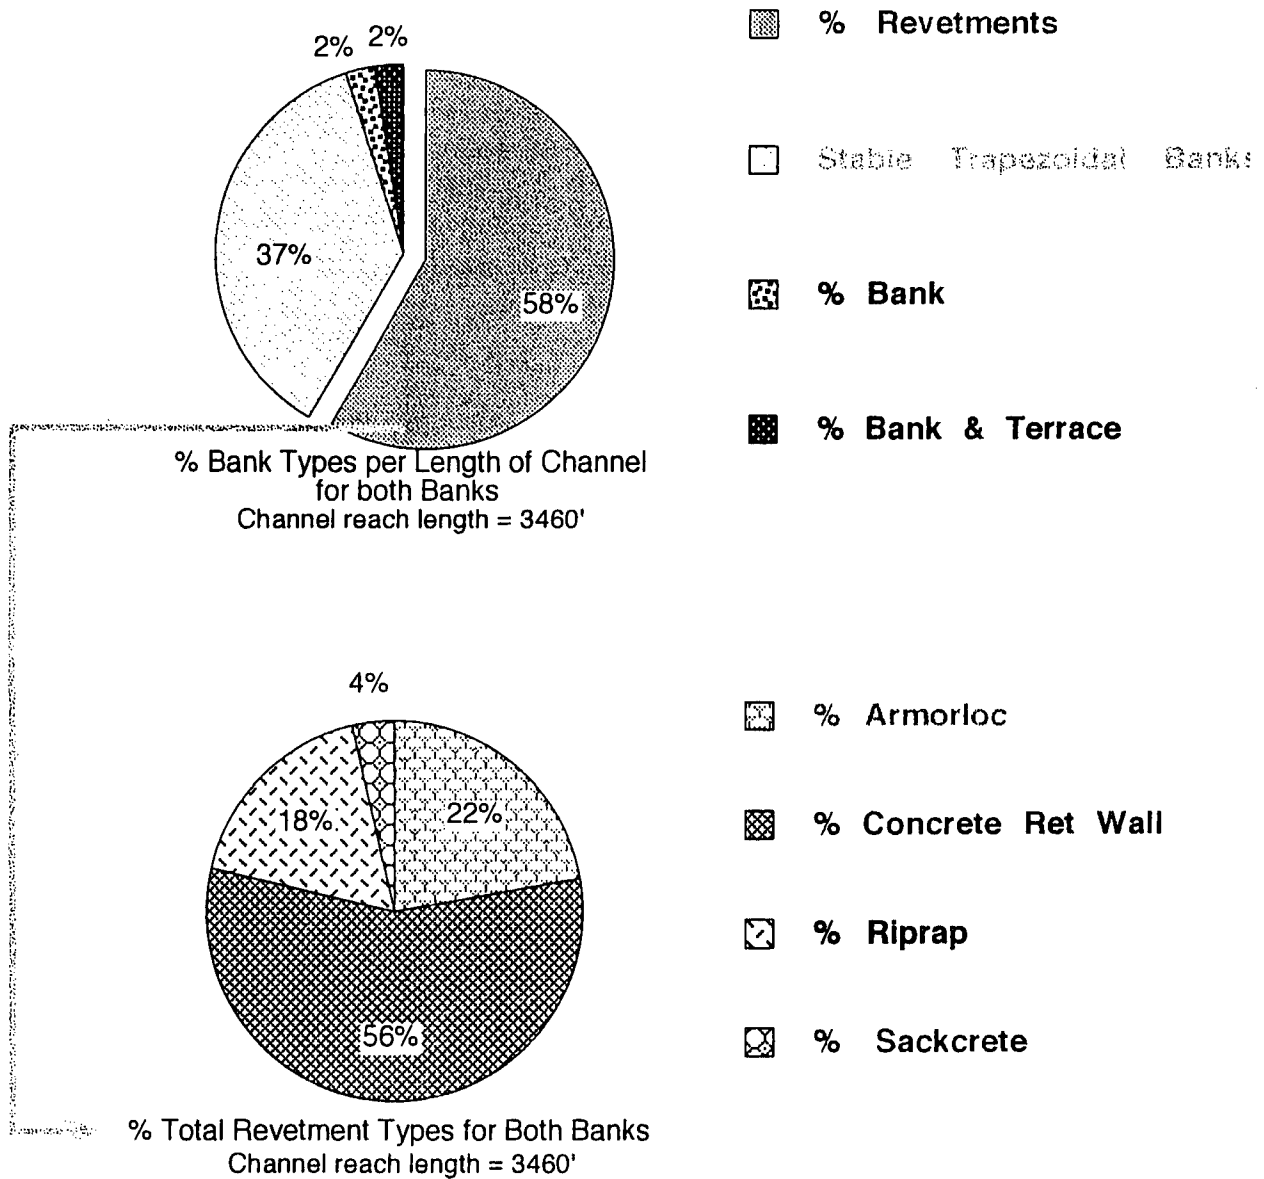
FIGURE 5

The lateral extent of eroding banks and revetment within the NFCP was measured to compare bank condition to upland reaches and to show whether any of the sediment within the NFCP was locally derived. The raw data are located in the Channelized Bank Condition Table, Appendix B1. Figure 5 shows two pie charts that represent channel conditions from Diablo Avenue to Redwood Blvd. bridge crossings. The top diagram shows the percent length of stable and eroding trapezoidal banks and the percent revetted bank, while the lower diagram shows the total percentage of different types of revetment used. Stable banks represent 37% of the length, while only 4% of the channel bank is eroding and contributing sediment to the project bed. About 58% has been revetted. Most of the revetment is poured concrete walls. Natural bank conditions do not exist along this reach.

Novato Flood Control Project Bank Physical Conditions From Redwood Blvd to Diablo Avenue

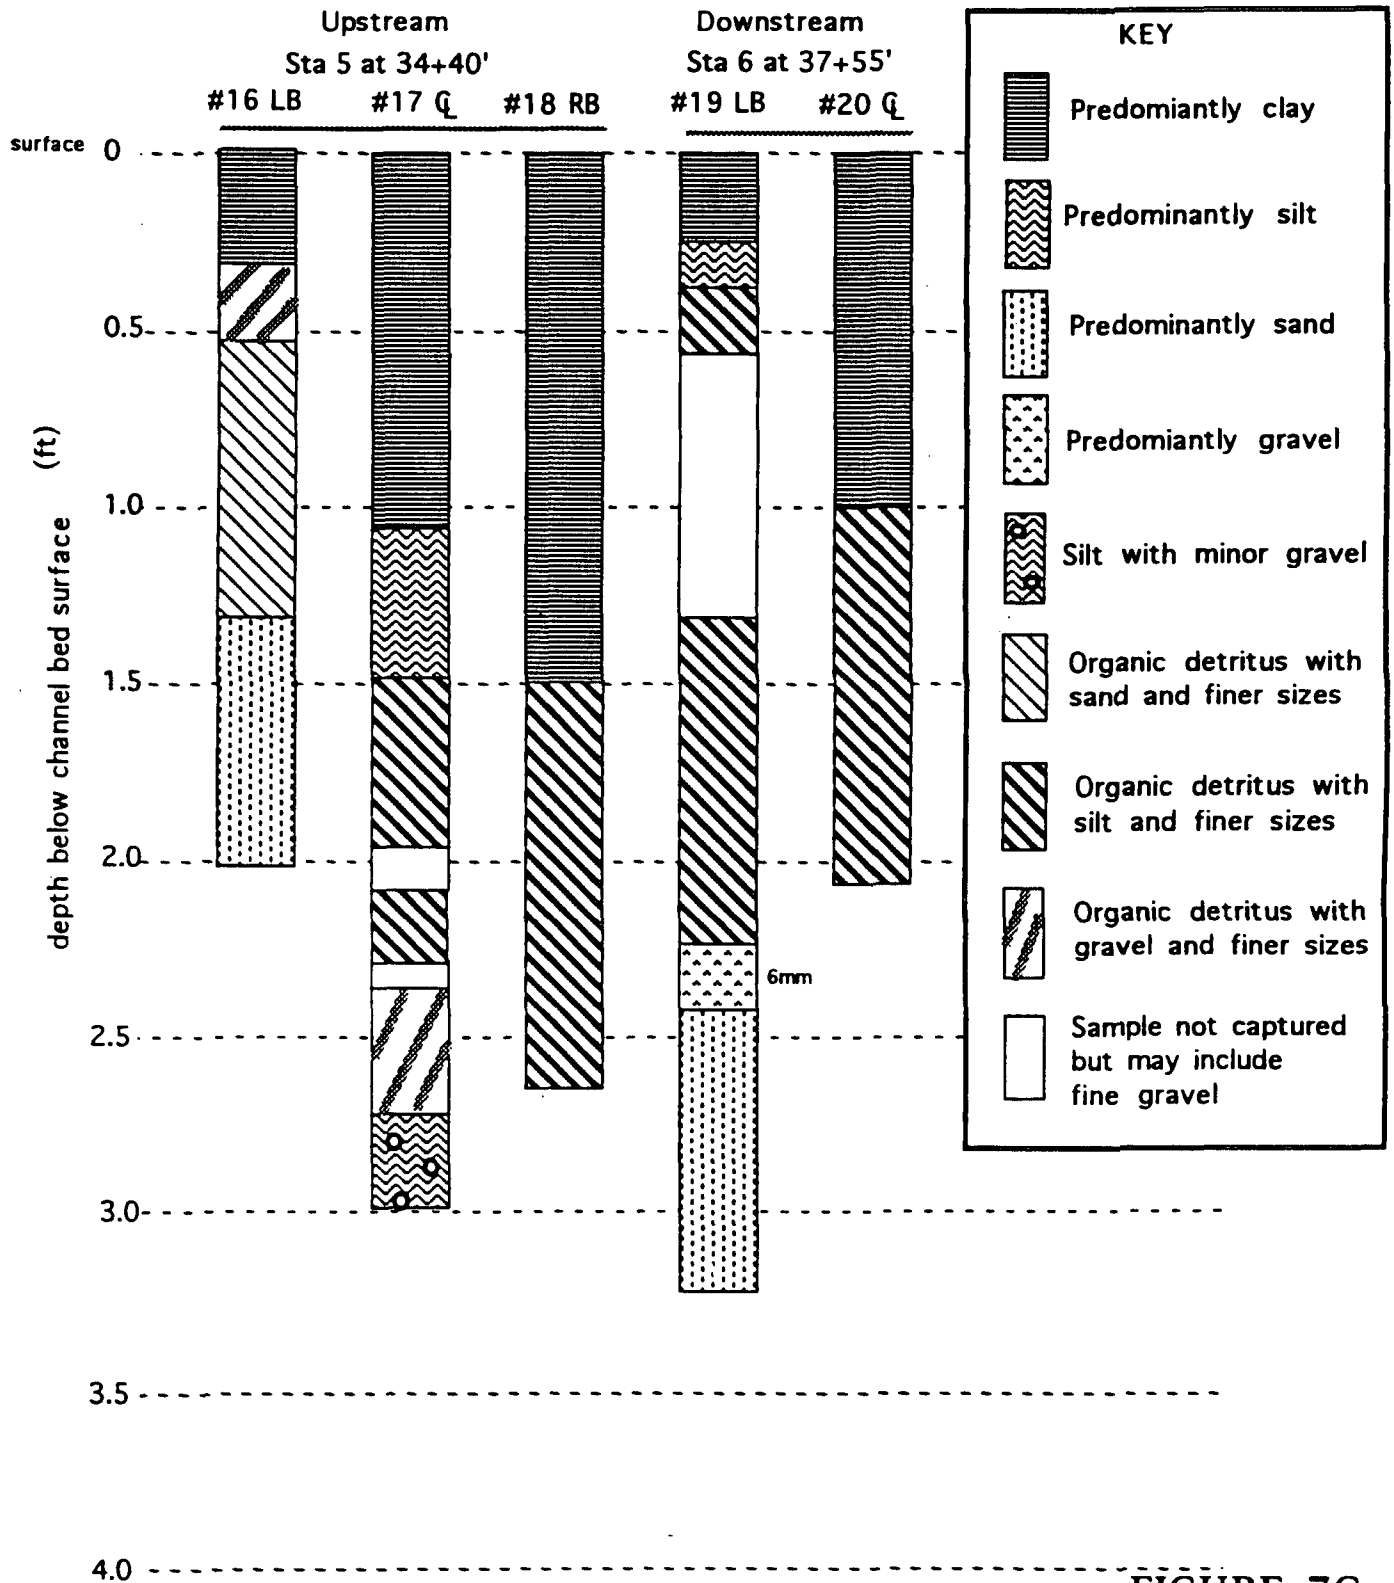
FIGURE 7C

The three cores at core station 2 (19+30') show an insignificant veneer of silt at the top of the core and sand to gravel-sized sediment at the transect. Gravel up to 26 mm was observed. The voids in most of these cores may have been noncohesive, sands and gravels. Varying amounts of gravel were found at core stations 2 through 6, with particle sizes up to 6 mm at the latter station. Core stations 1, 7 and 8 were not recored. The cores at stations 5 (34+40') and 6 (37+55') showed that the organic leaf litter and debris accounts for over 40% of the volume. Evidently, the detrital matter that washes downstream during the first significant winter flows substantially bulk and contribute to filling of the tidal channel. When there was a functional marsh system, before diking and reclamation, these rafts of organic litter would have settled onto the marsh surface or channel banks, or they would have been washed to the bay.

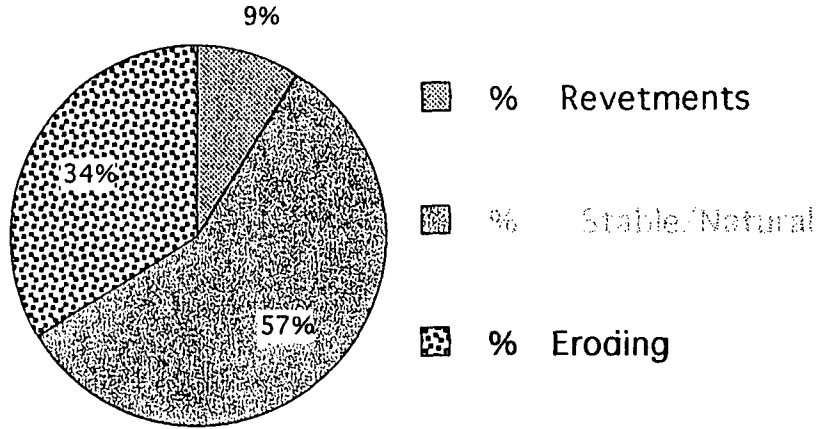
The lateral extent of eroding banks and revetment upstream of Diablo Avenue Bridge to Stafford Dam spillway was measured to determine the existing conditions of the channel and terrace banks and to establish whether bank erosion was a significant source of sediment supplied to the NFCP. The raw data are compiled in the Novato Bank Data Table, Appendix A2. Figure 8 shows three pie charts that represent channel bank condition and revetment

while the middle chart shows the percentage of these conditions when terrace banks are combined. For both pie charts, the percent revetment is the same because its vertical extent was not measured separately for bank and terrace.

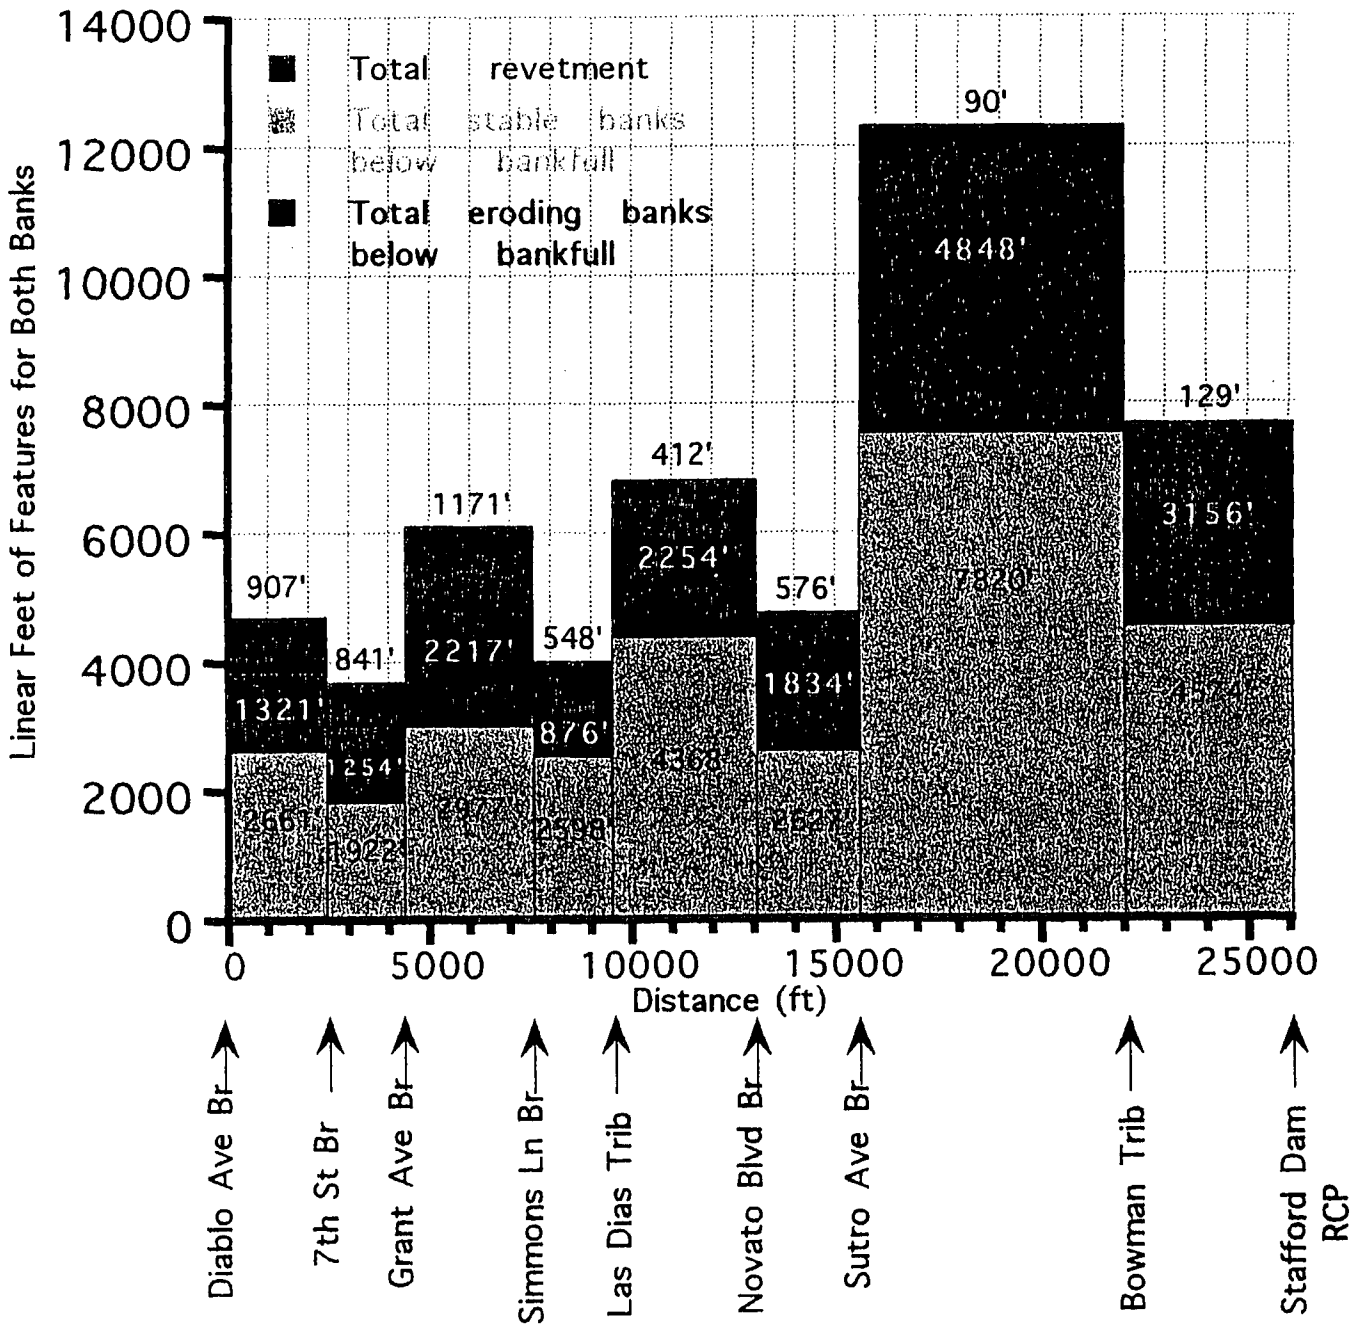
FIGURE 9

The abundance of bank erosion in the Novato Creek reach upstream of Bowman tributary is likely due to the immediate effects of the trapping of bedload by the dam. Subsequent adjustments in channel geometry and gradient were caused by changes in sediment and water supply. The abundance of eroding and revetted banks in the first three downstream reaches may be due to grade adjustment that propagated upstream from

Extent of Eroding and Revetted Banks Below Bankfull Height,
for Both Right and Left Banks Along All Study Reaches
upstream of Diablo Ave Bridge

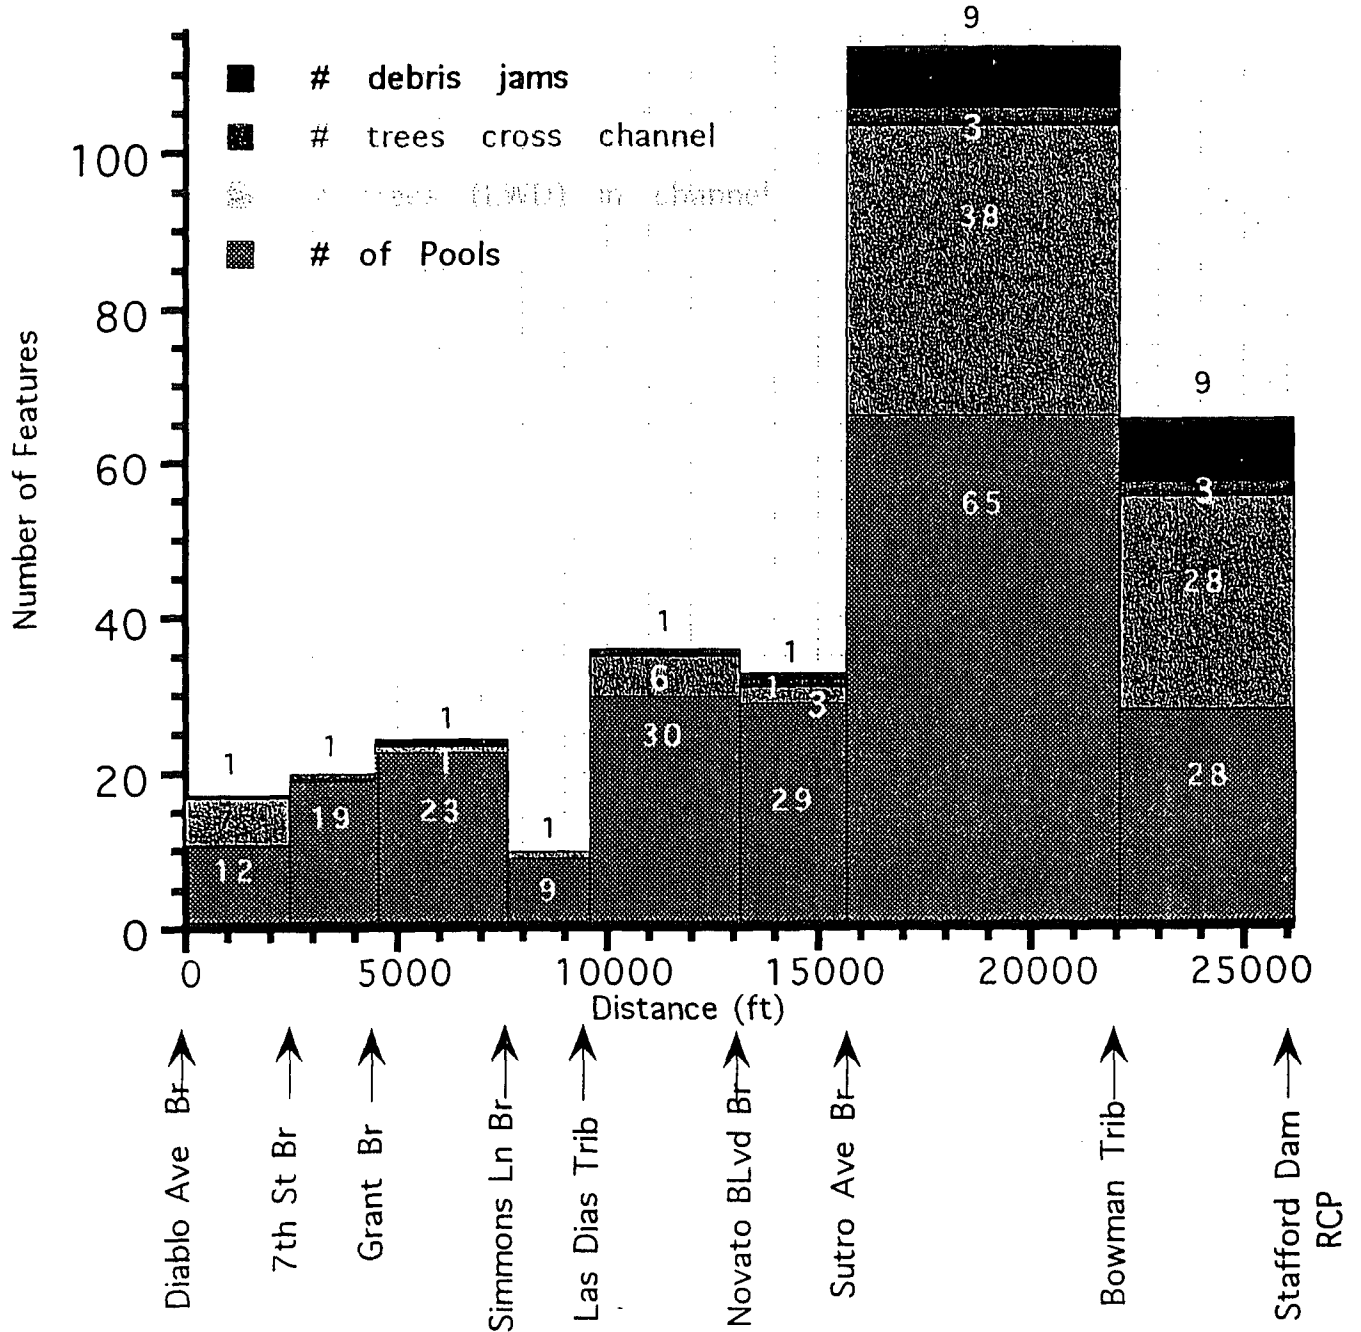
FIGURE 14

Quantity of Pools > 1' Deep and Large Woody Debris,
 Along Novato Creek
 from Diablo Ave Bridge to Stafford Dam

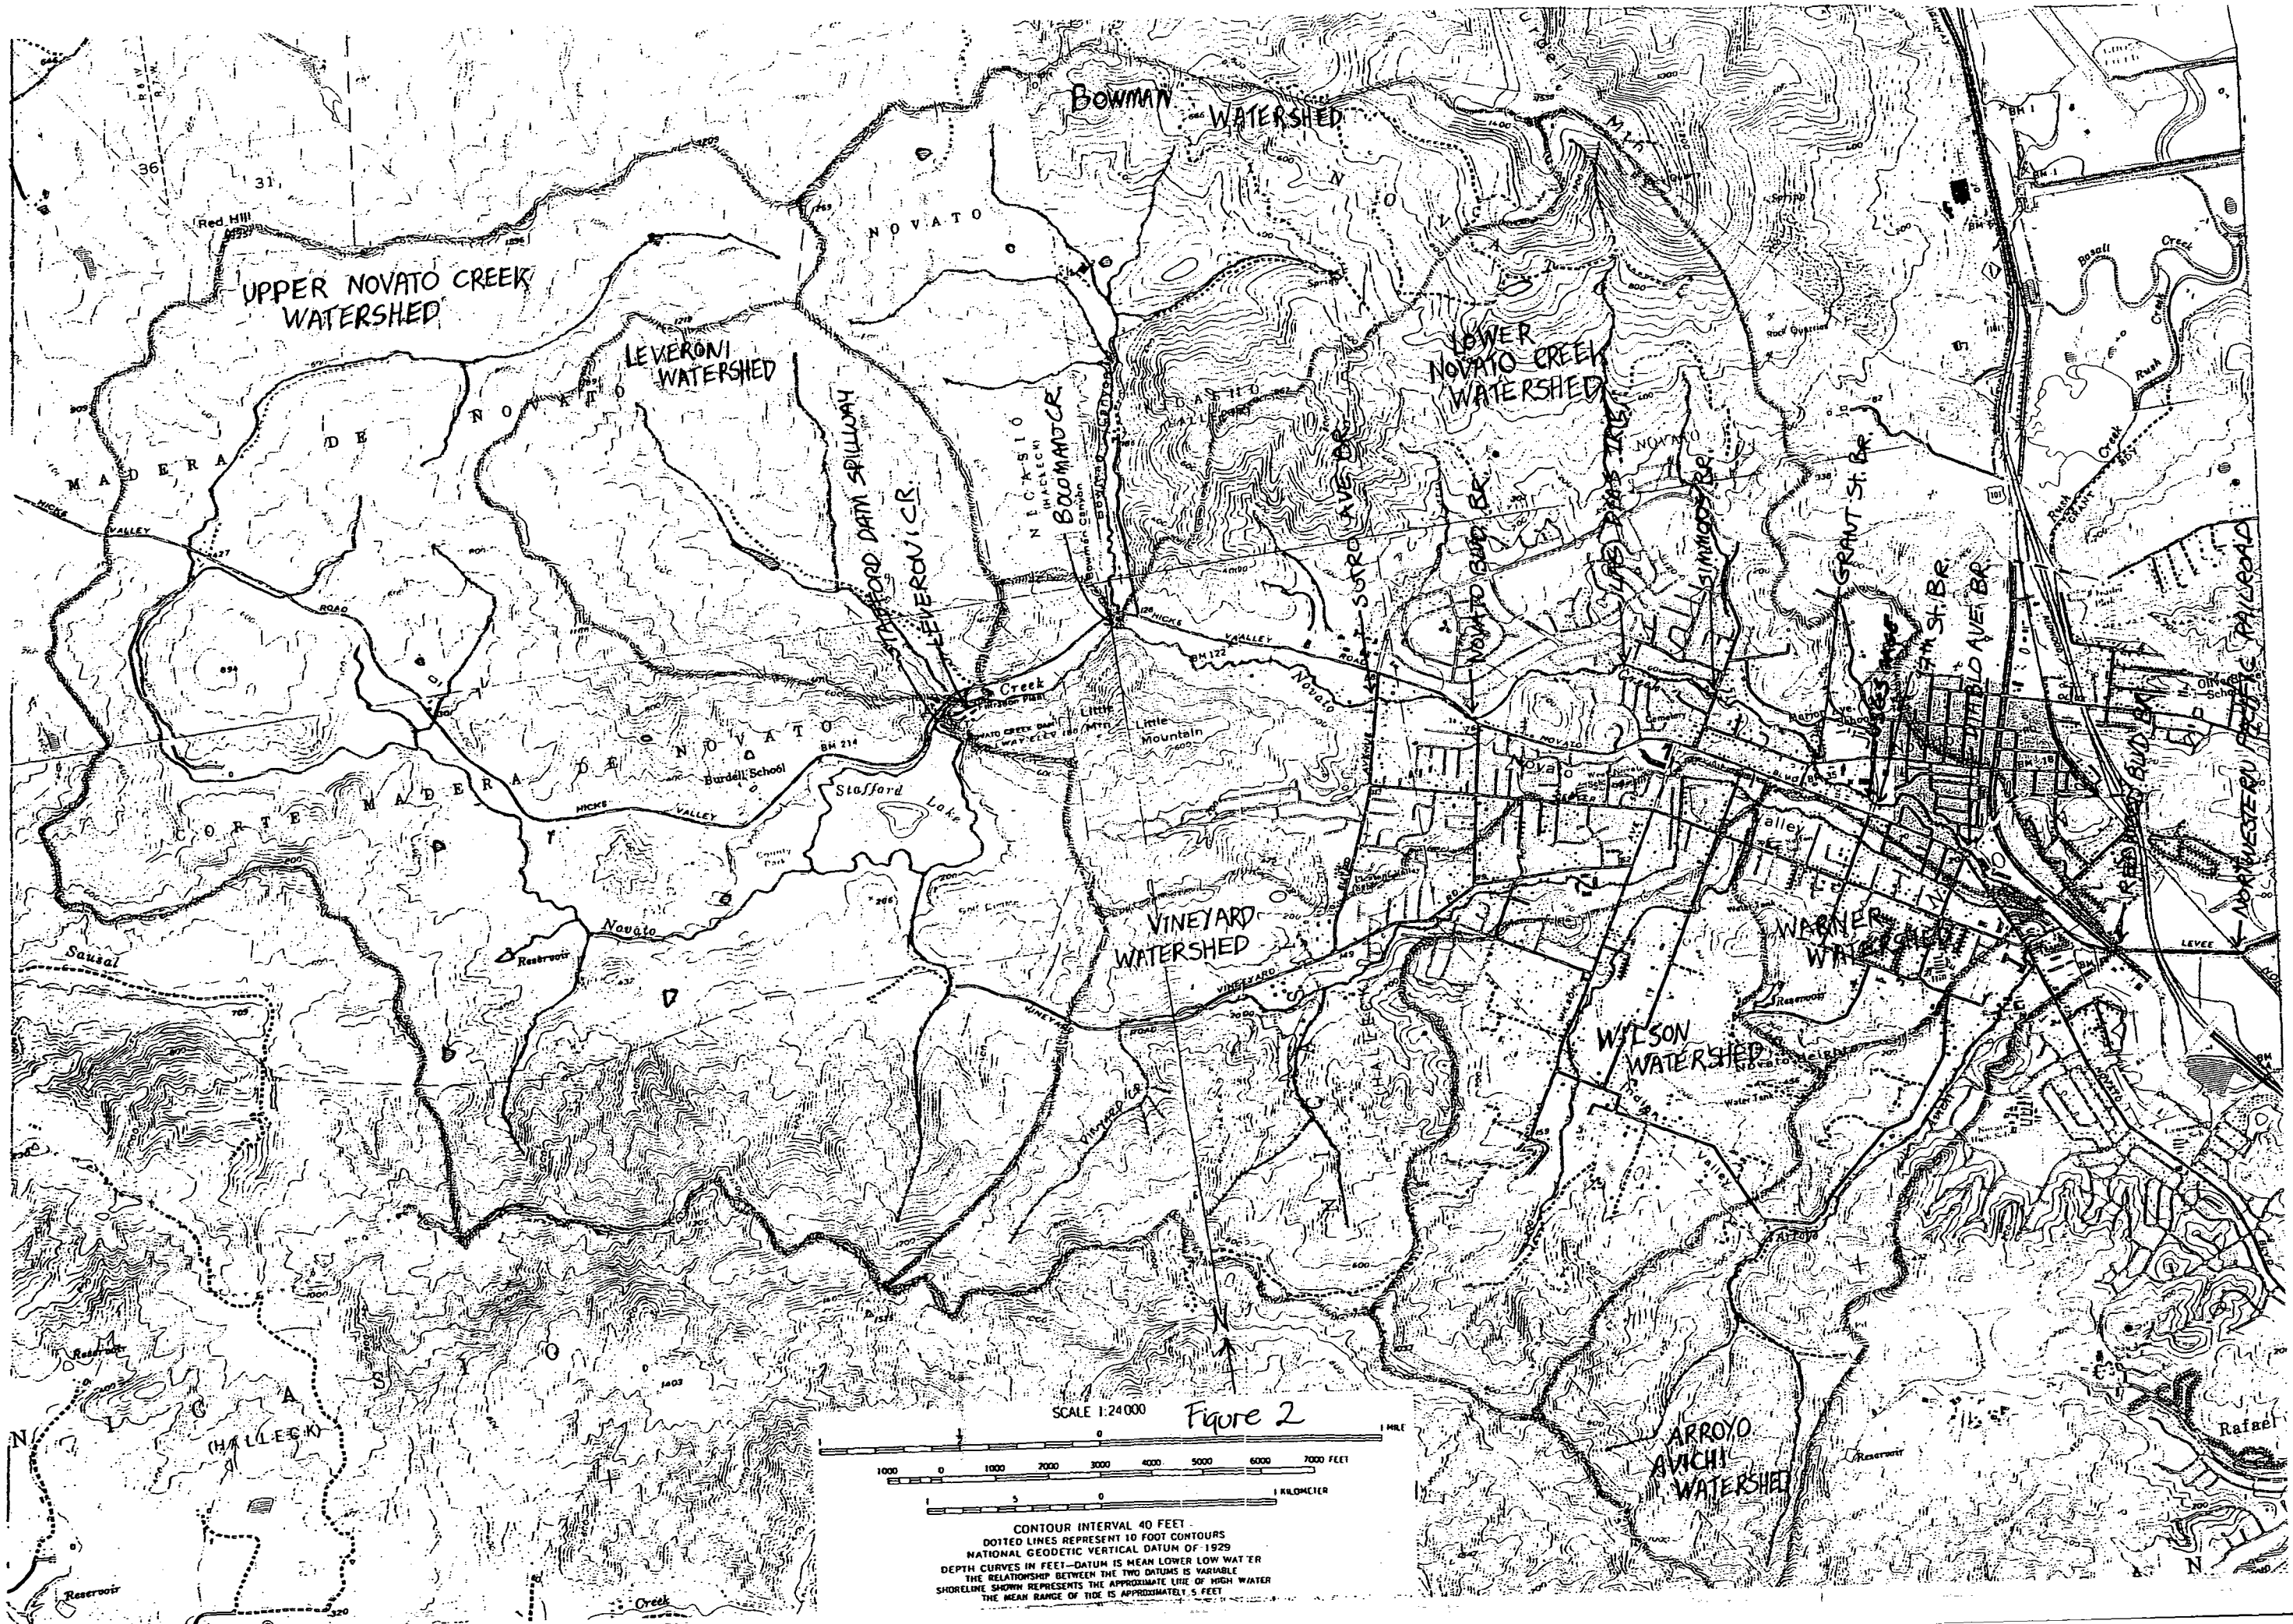
SCALE 1:24,000 **Figure 2**

To account for this incision it may be valuable to consider the impacts of the realignment of the tidal reach that is estimated to have occurred about 1925. Roughly 1,750' of channel length was removed, Figure 2. If the channel
