THOMAS BICKELL
INSPECTION PICTURES: 11/8/2011
RESERVOIR ID Nos. 1946, 1952, and Unlisted

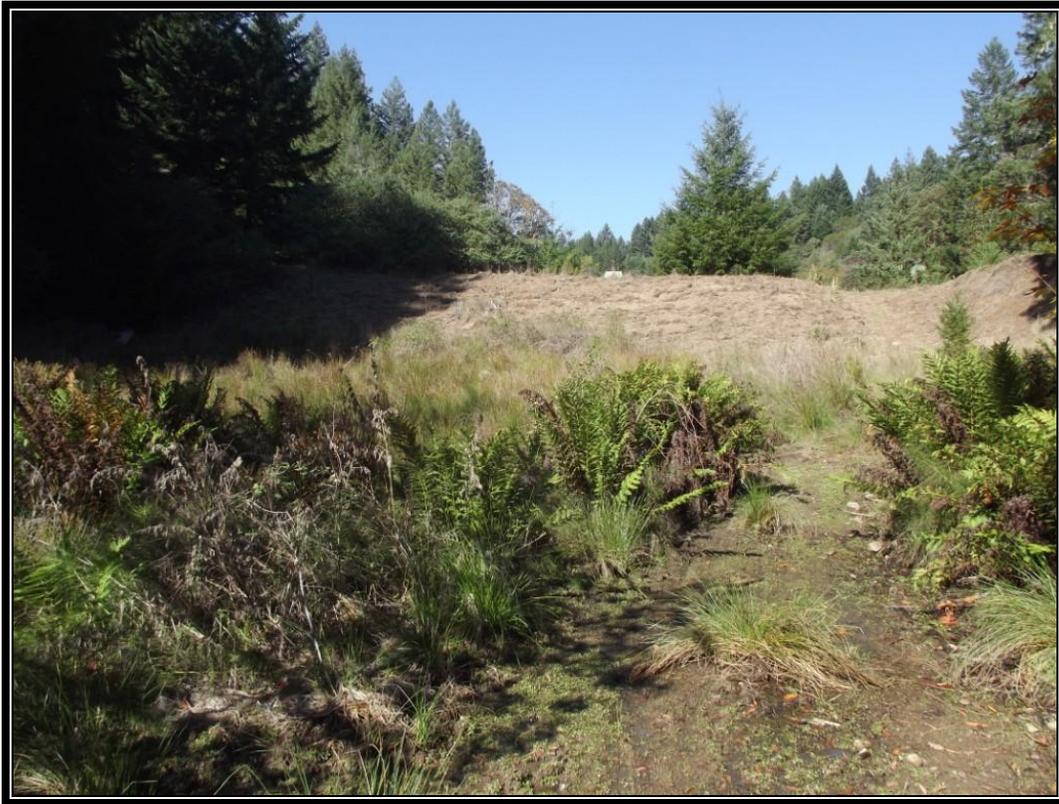
Reservoir 1946 – Front-side of dam for reservoir. (Facing northwest.)

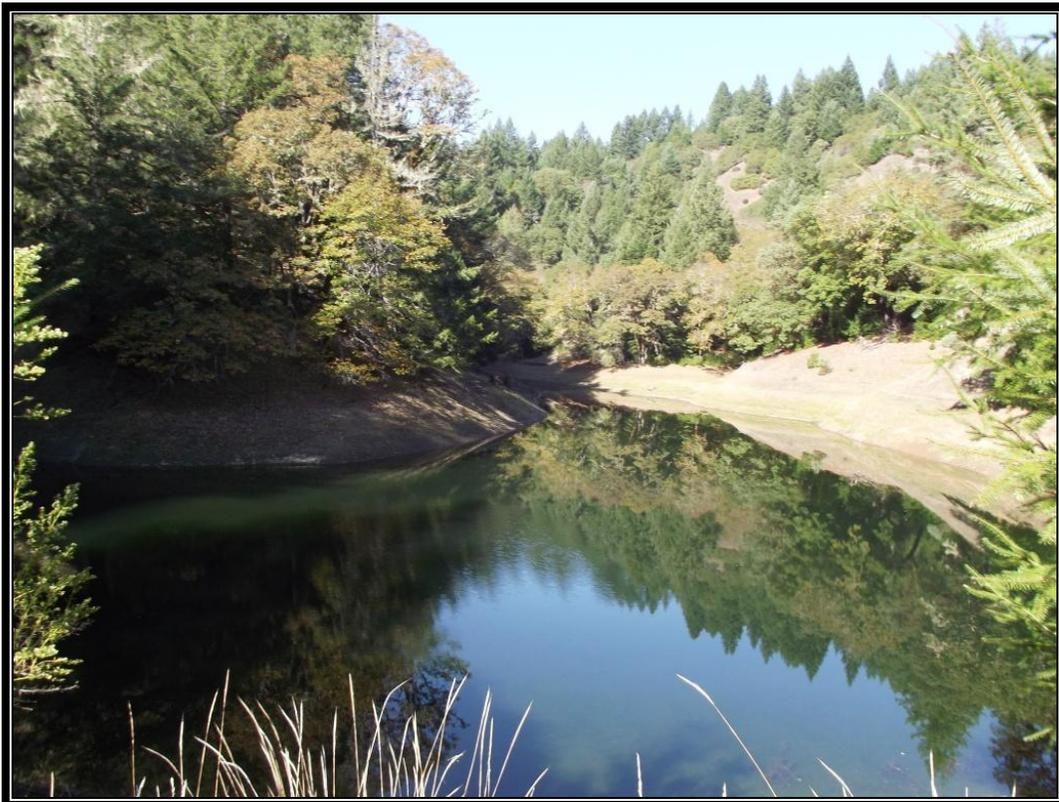
Reservoir 1946 – Looking across reservoir facing northwest.

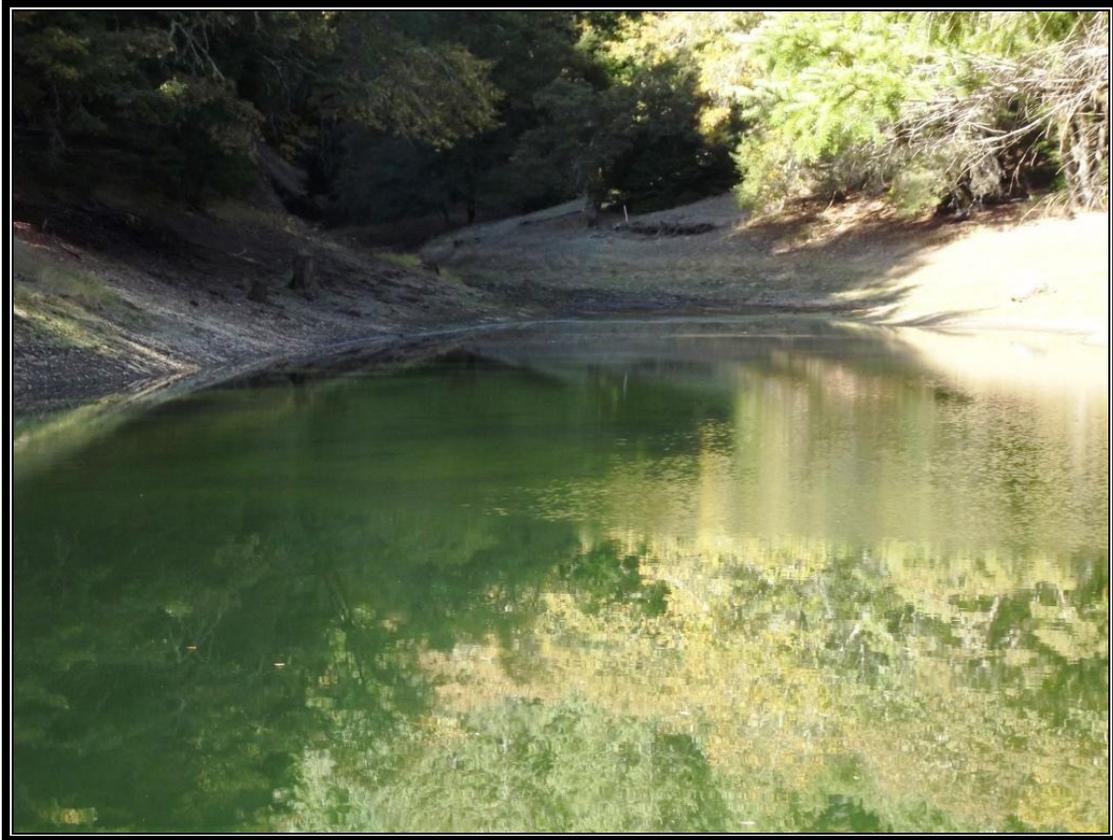
Reservoir 1946 – Looking at rear of the reservoir, and at the upstream channel in the background. (Facing northwest.)

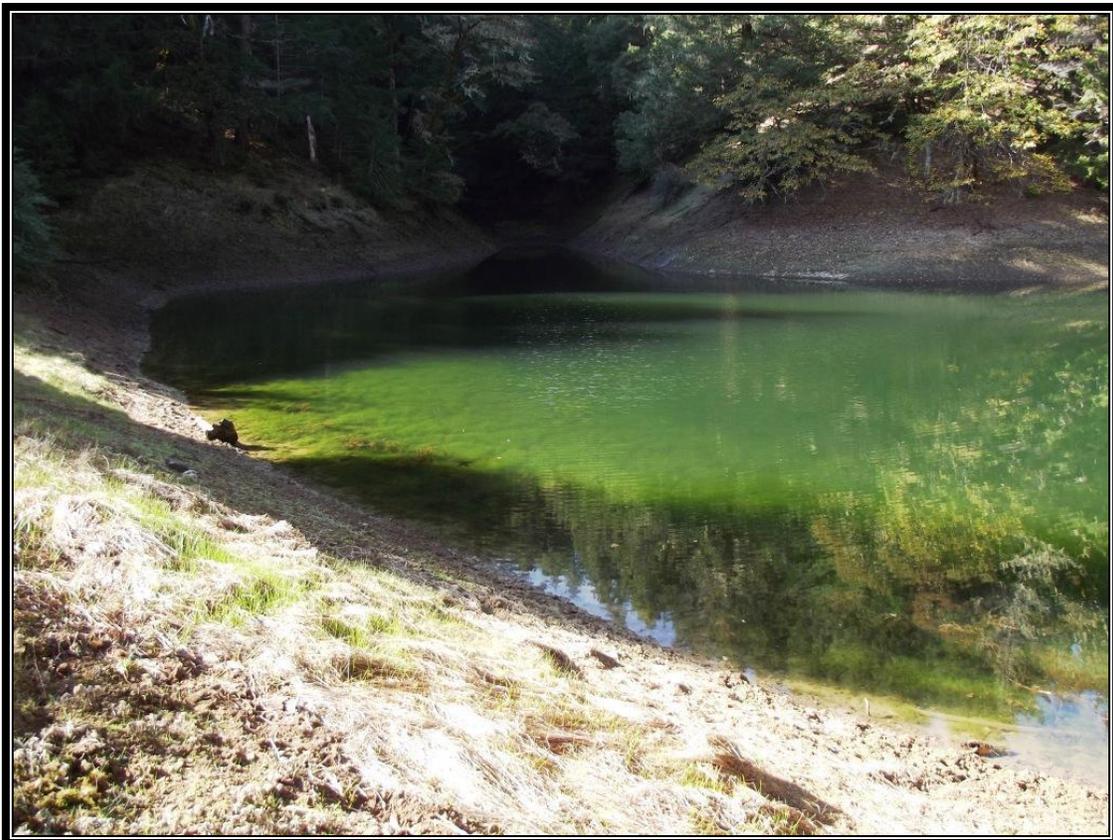
Reservoir 1946 – Looking across reservoir towards stream channel in southwestern corner of reservoir. (Facing southwest.)

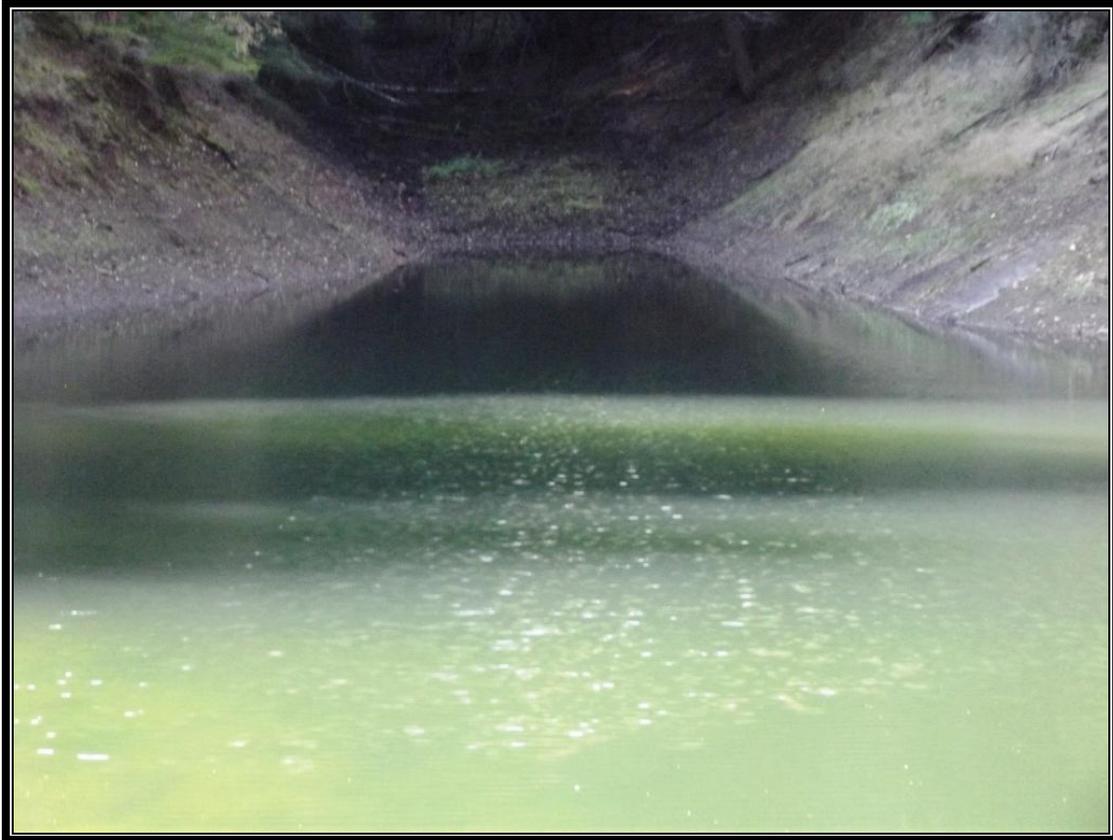
Reservoir 1946 – Stream-channel in southwestern corner of reservoir. (Facing southwest.)

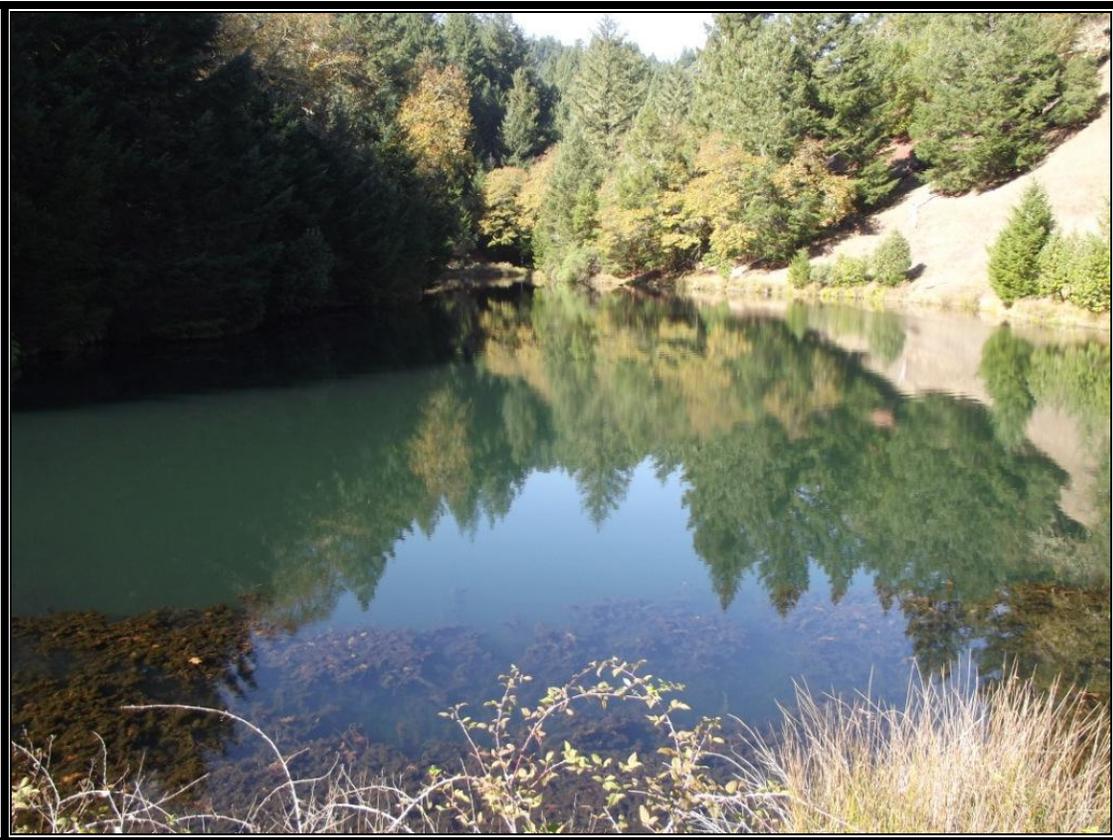
Reservoir 1952 – Looking west across reservoir.

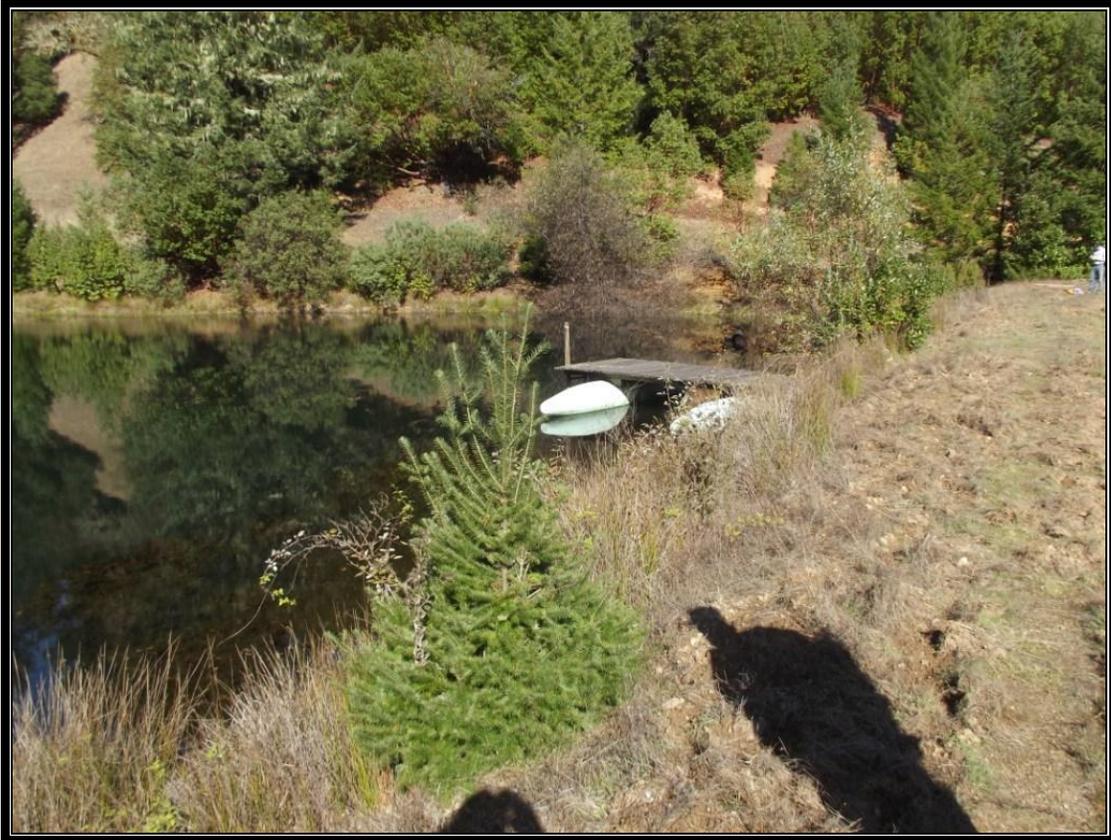
Reservoir 1952 – Floating dock is in center of frame and part of dam is to the right. (Facing north.)

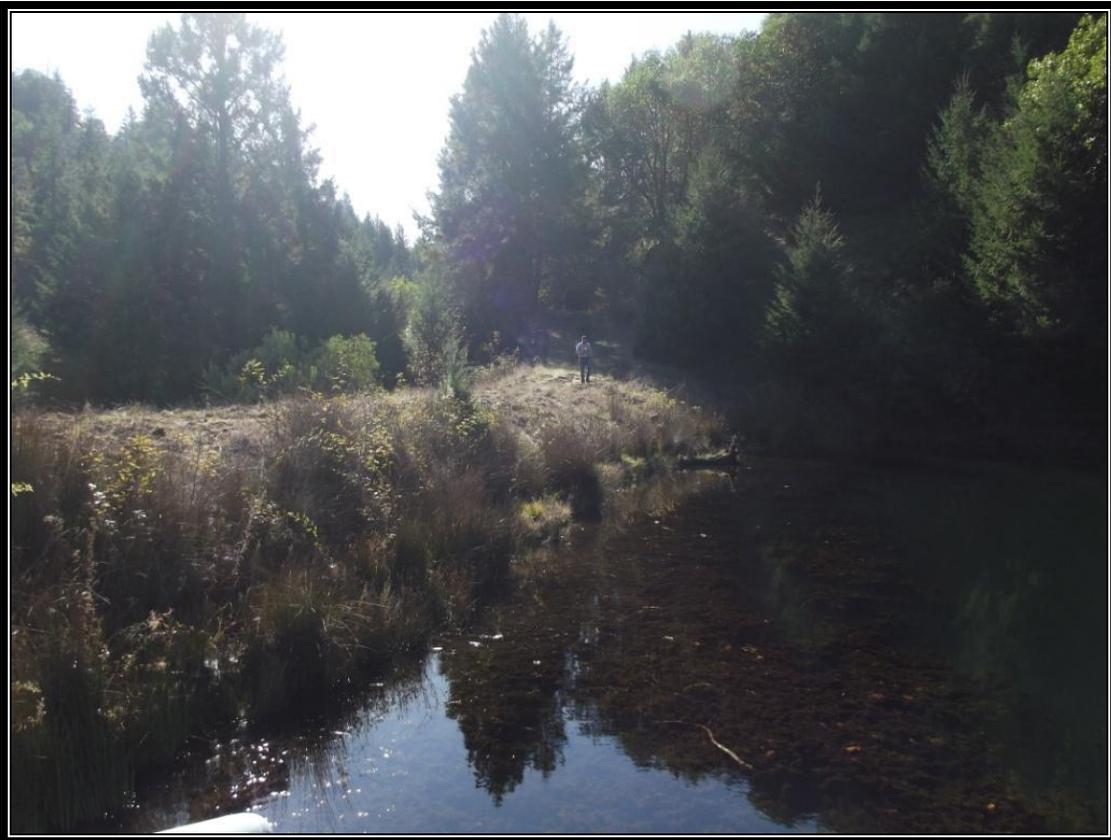
Reservoir 1952 – View of back-side of dam from the floating dock while facing south.

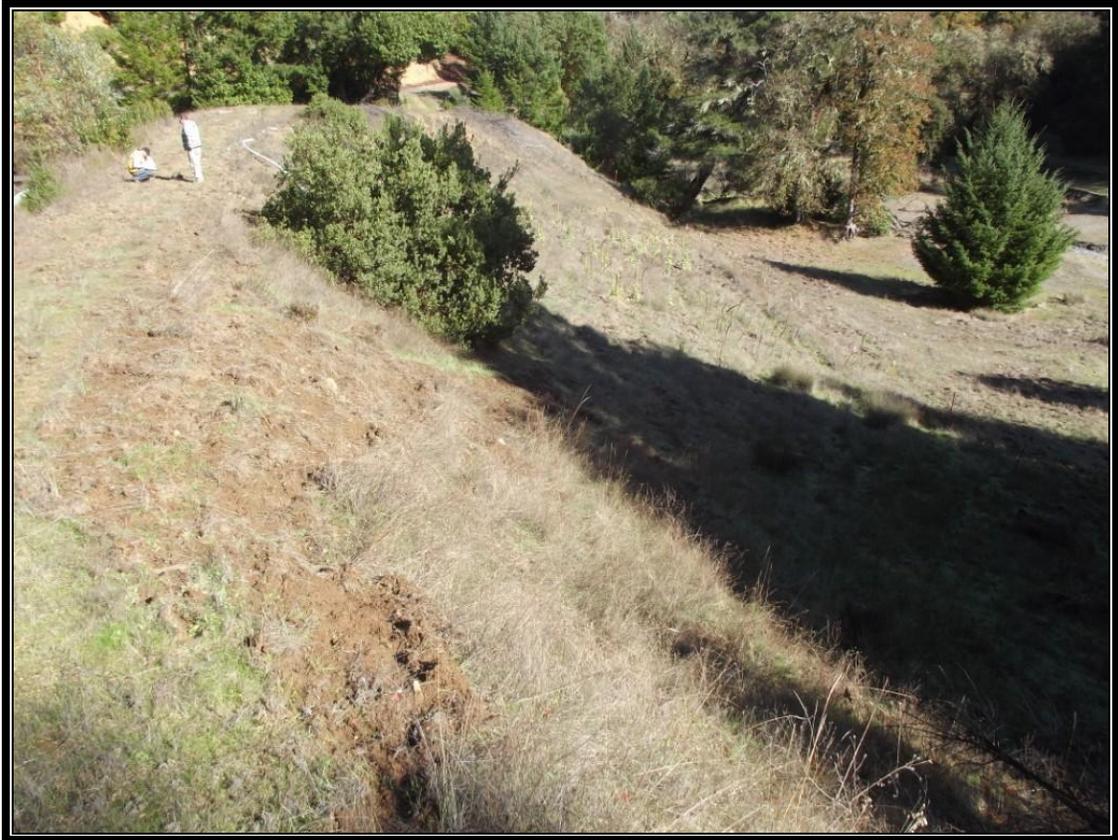
Reservoir 1952 – View of front-side of dam while facing northeast.

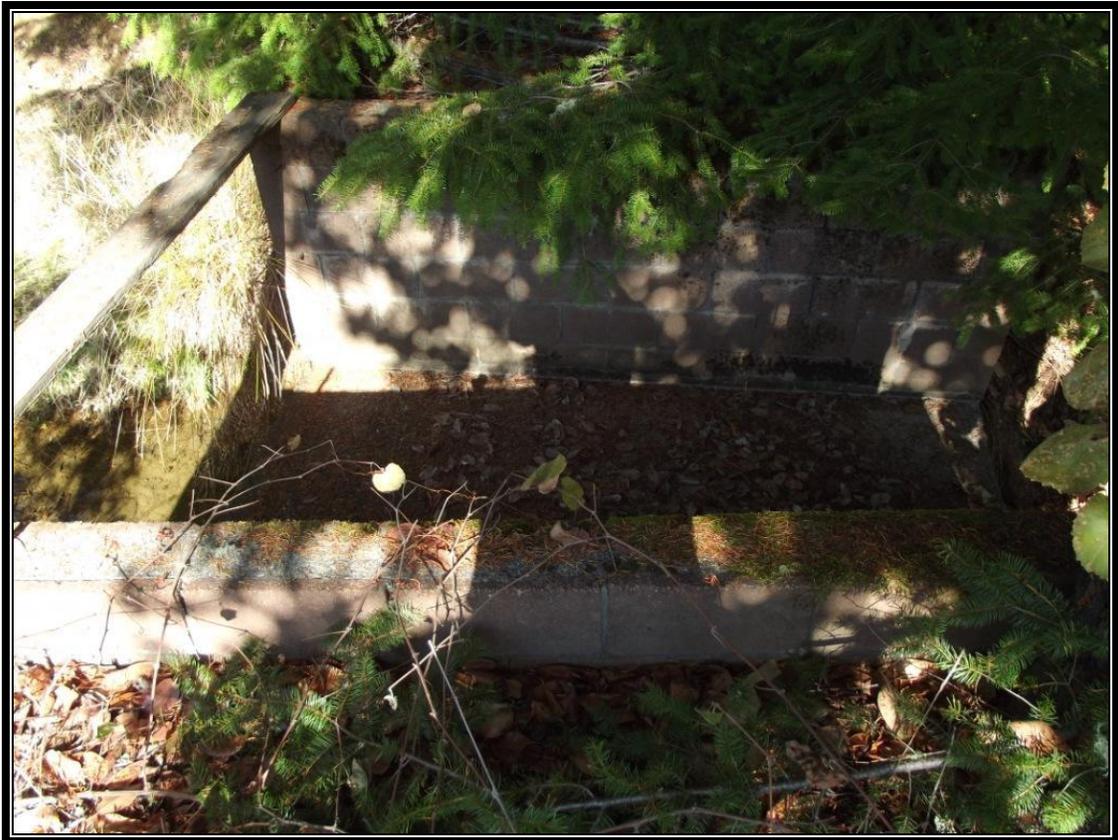
Reservoir 1952 – View of spillway facing northwest.

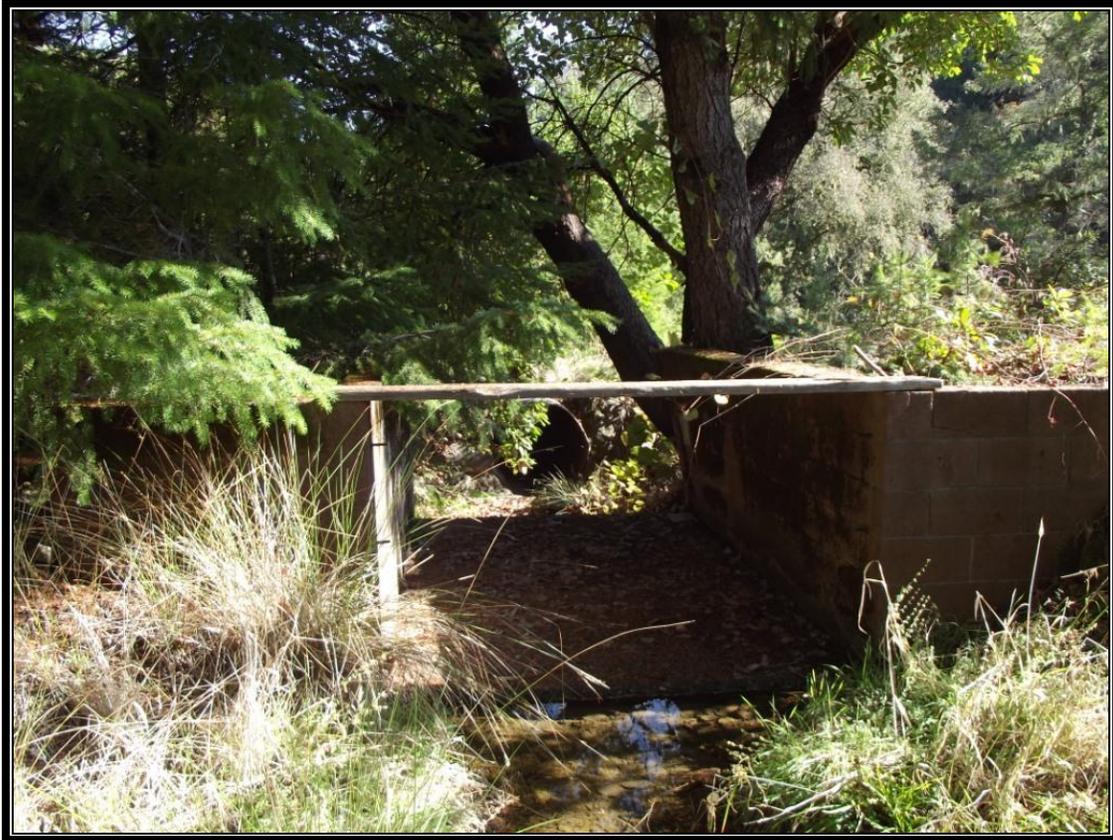
Reservoir 1952 – View of spillway from pond. (Facing east.)

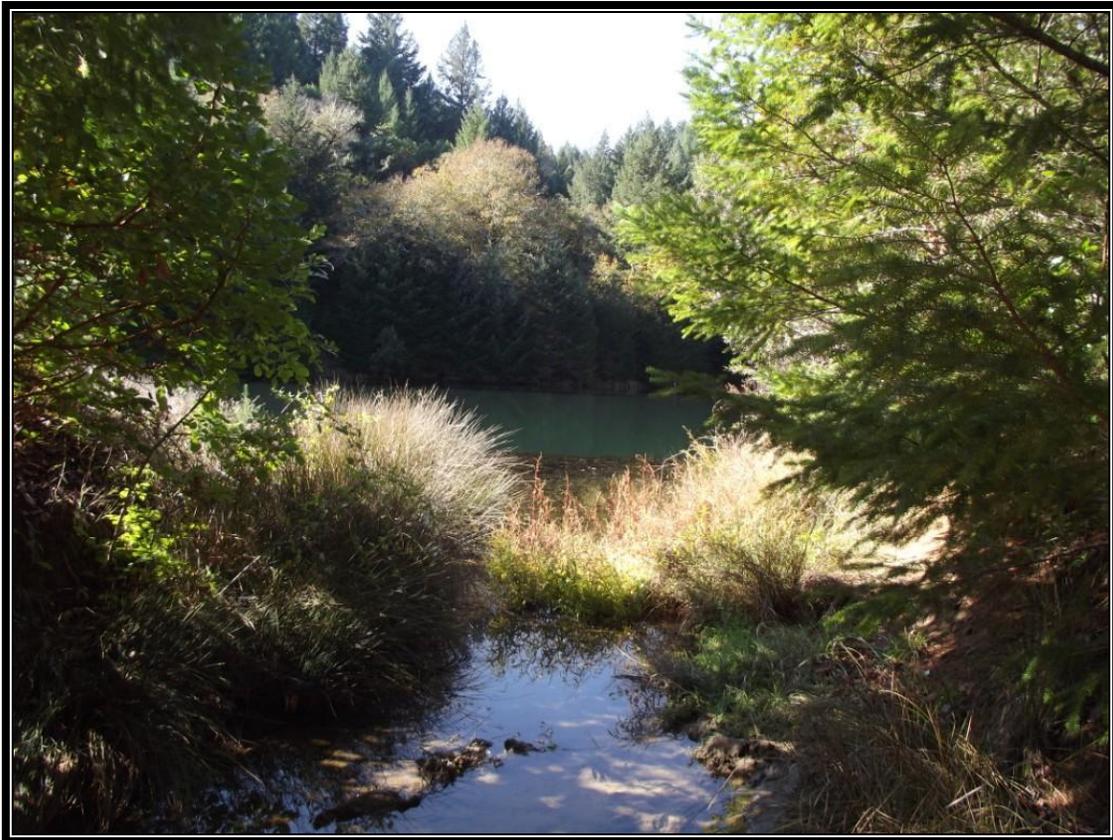
Reservoir 1952 – View of pond from spillway. (Facing southwest.)

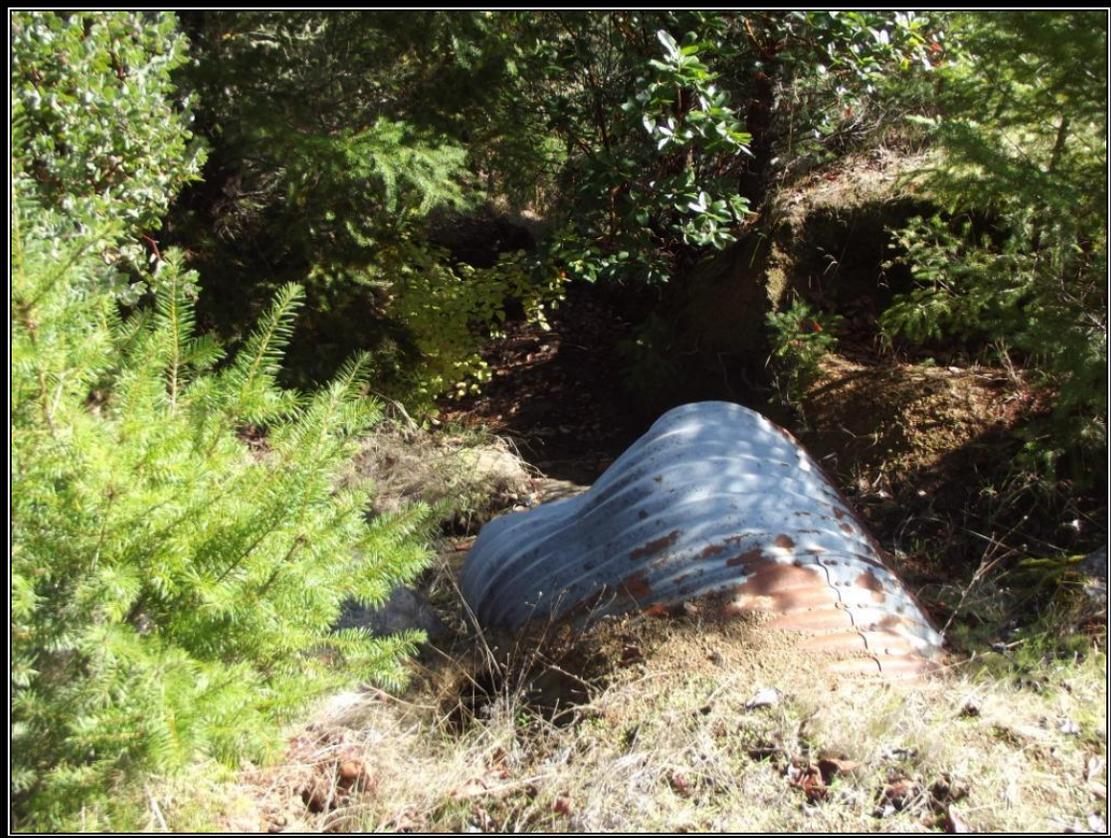
Reservoir 1952 – View of discharge pipe on backside of dam from spillway. (Facing east.)

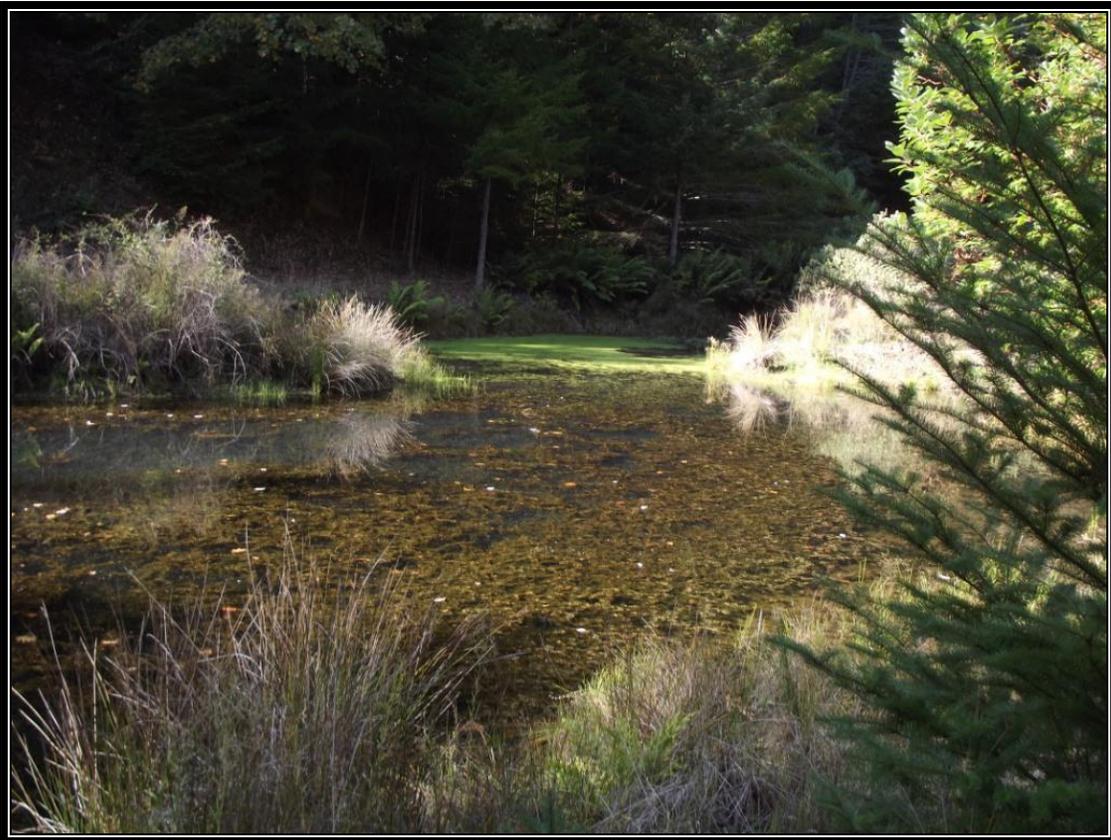
Reservoir 1952 – Looking northwest towards upstream end of pond.

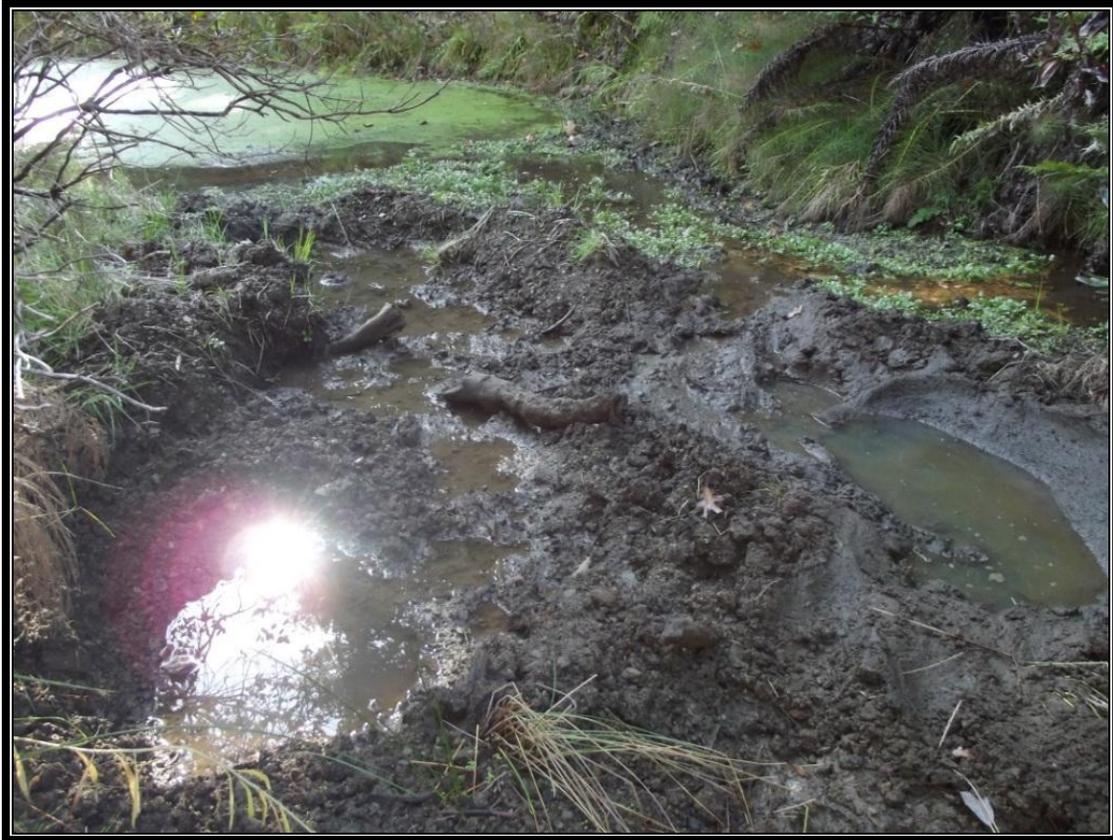
Reservoir 1952 –Near the upstream side of pond.

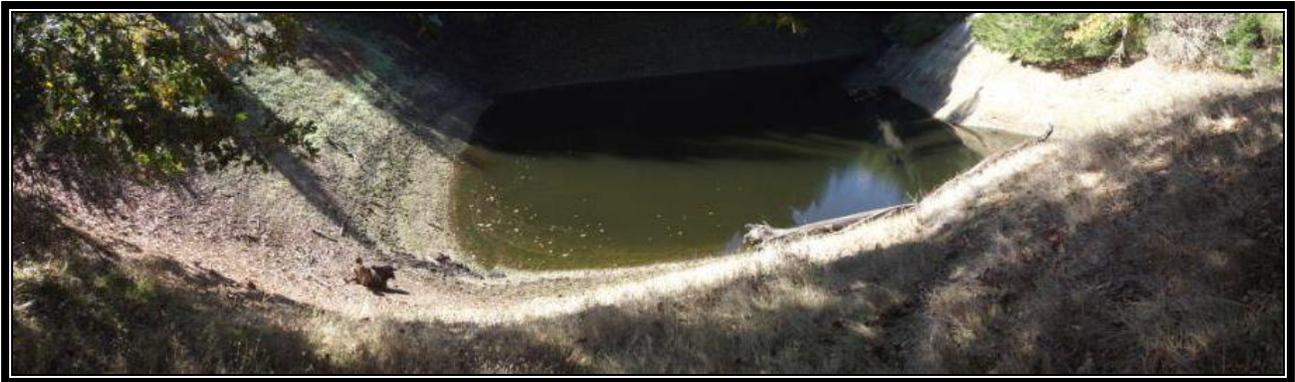
Unlisted Reservoir – Looking southwest across reservoir. Water-level in reservoir appears drawn-down.

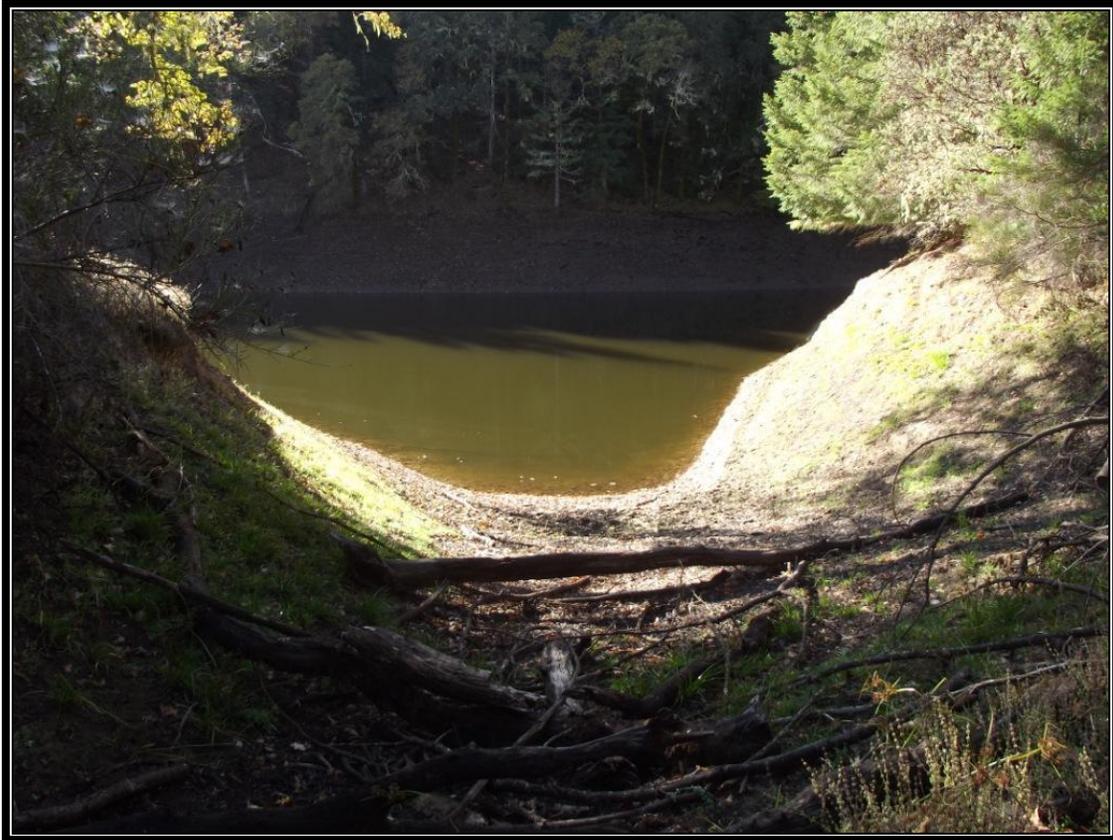
Unlisted Reservoir – Looking at reservoir, facing south, from stream-channel on north side of reservoir.

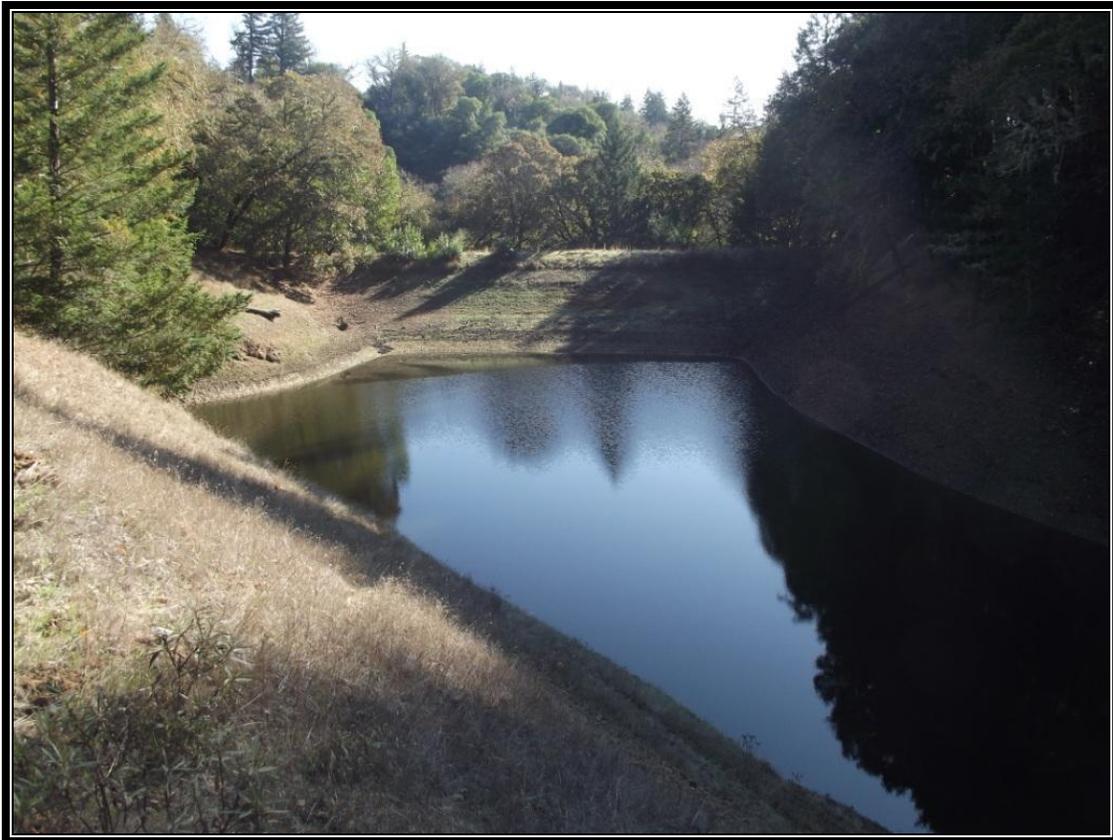
Unlisted Reservoir – Looking east across reservoir.

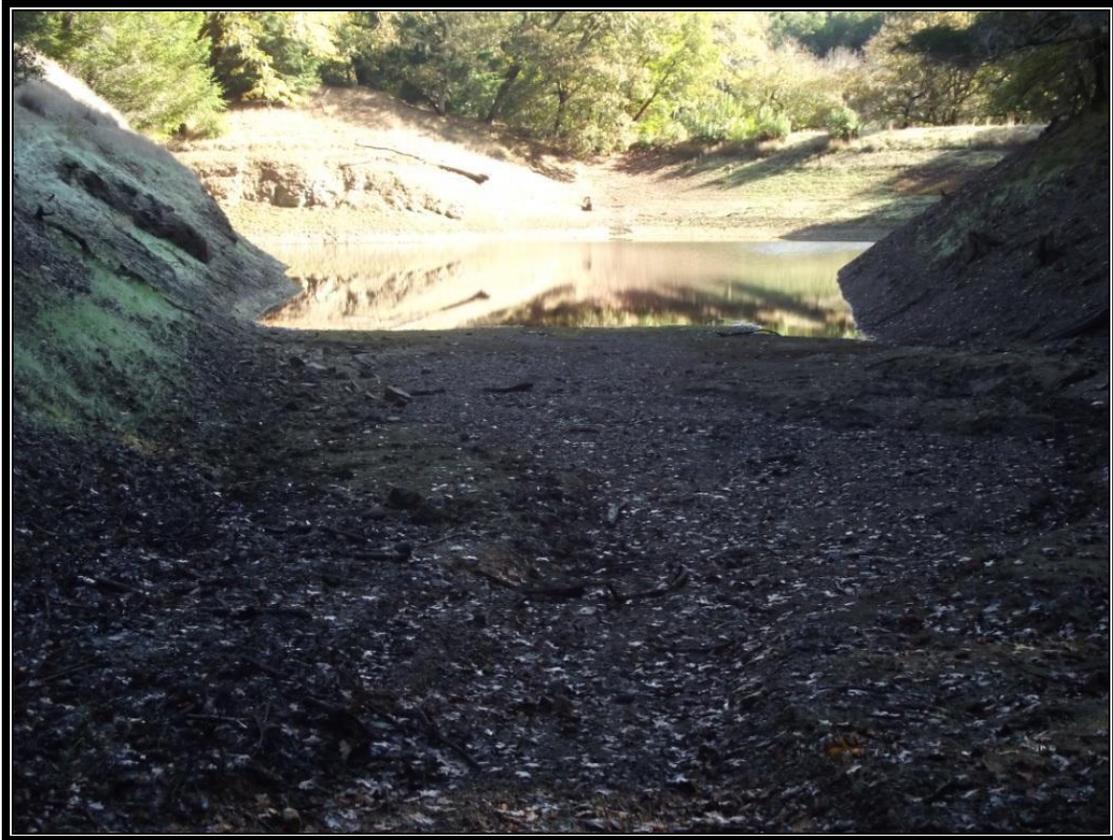
Unlisted Reservoir – View of reservoir in background from streambed in upstream channel. (Facing east.)

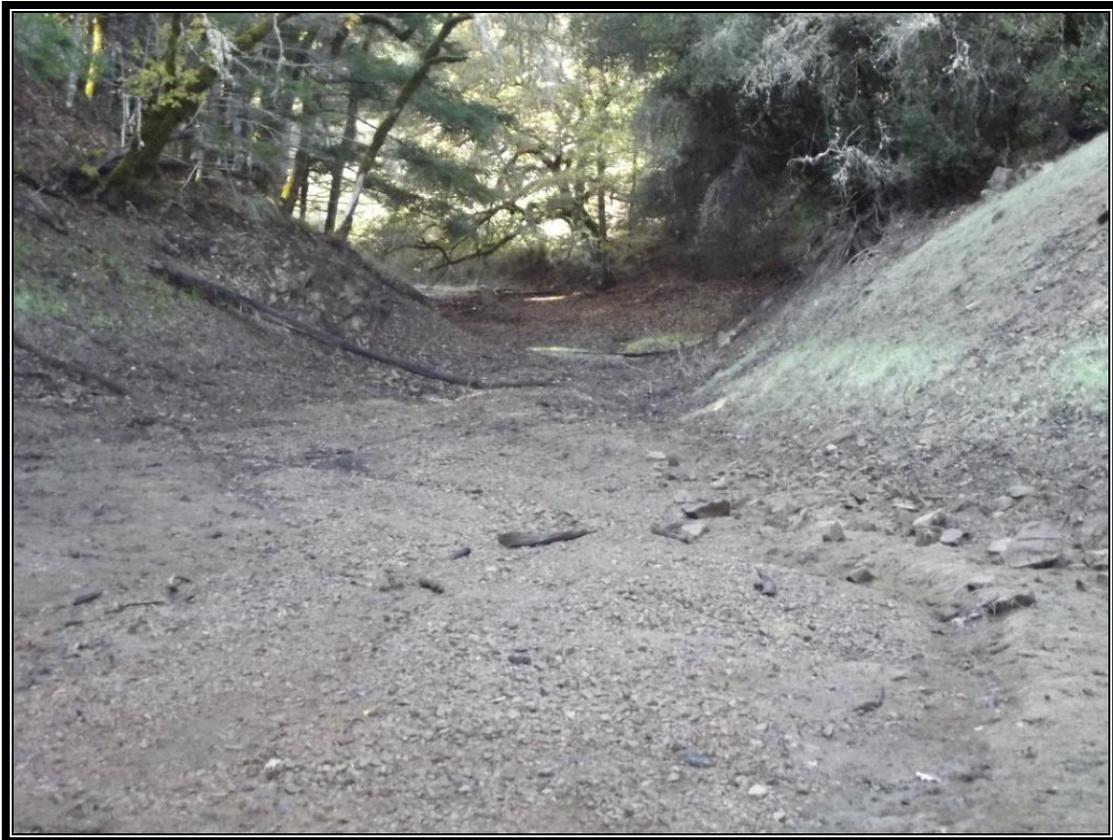
Unlisted Reservoir – Looking upstream (west) in unnamed stream channel.
