State Water Resources Control Board

Sonoma County Reservoir ID 543

DATE: March 23, 2015

SUBJECT: STATUS OF RESERVOIR ON APN 068-110-007, FLOCCHINI ESTATE LLC

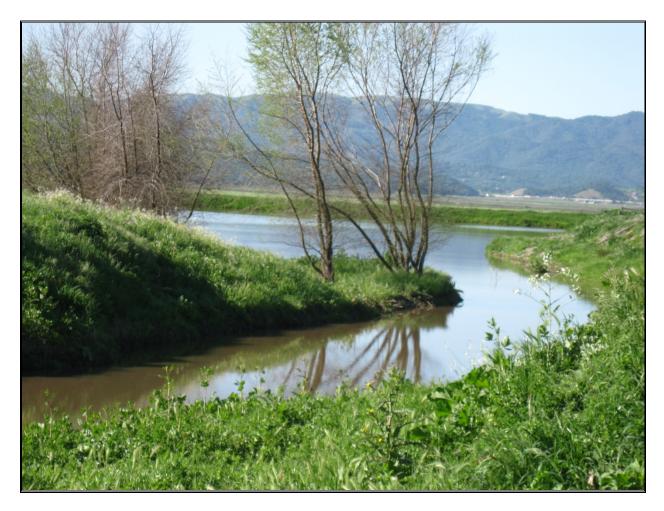
Photo 1 - Reservoir ID 543 – Southwest view from Old Lakeville Highway (photo taken 3-18-15)

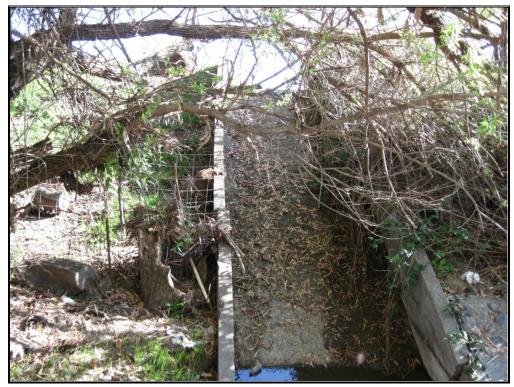
Photo 2 - View of upstream reservoir (D032167) spillway

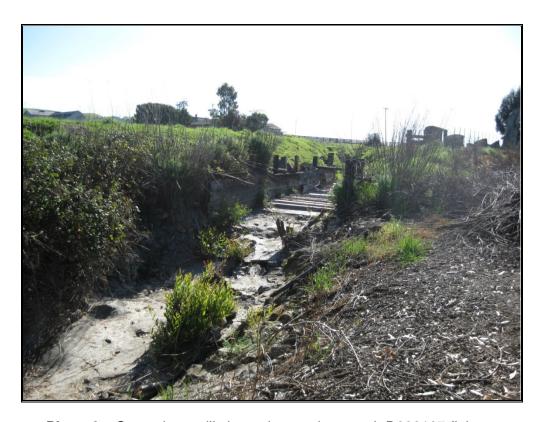
Photo 3 – Secondary spill channel around reservoir D032167 (inlet to Reservoir ID 543)

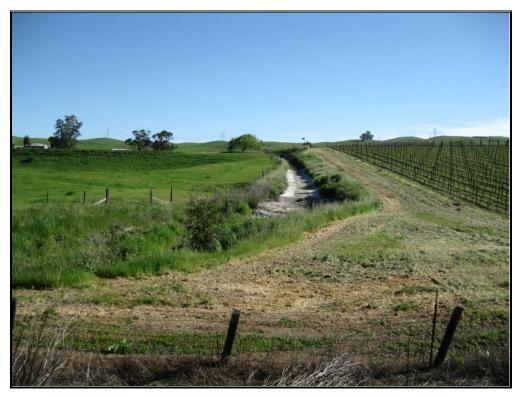
Photo 4 - Reservoir ID 543 Northeast view of dam, spillway and vineyard from Lakeville Hwy. Reservoir is not spilling (photo taken 3-18-15)

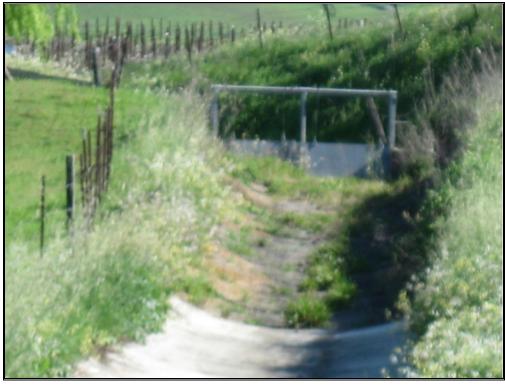
difference in two reported reservoir depths. In contrast to the 12 foot depth reported to Division staff by the owner during the 2011 inspection, Kelder engineering measured a maximum reservoir depth of 8.4 feet. The 15.25 acre-foot discrepancy in reservoir capacity is likely accounted for by the difference in the depth reported to the top of the spillway weir gate (by the owner), and the measured depth to the spillway invert (reported by Kelder Engineering).

Photo 5 - Reservoir ID 543 Spillway weir gate (photo taken 3-18-15)

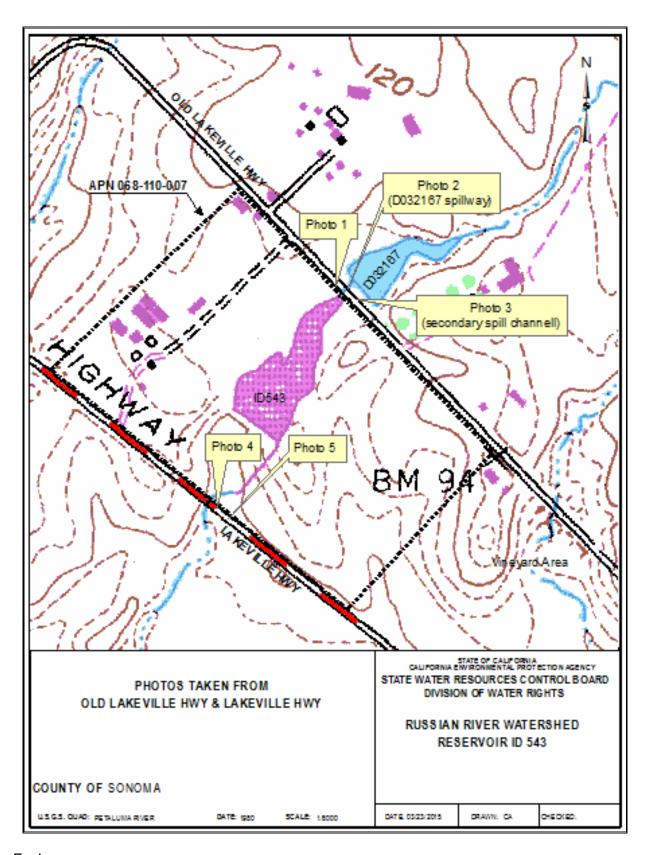
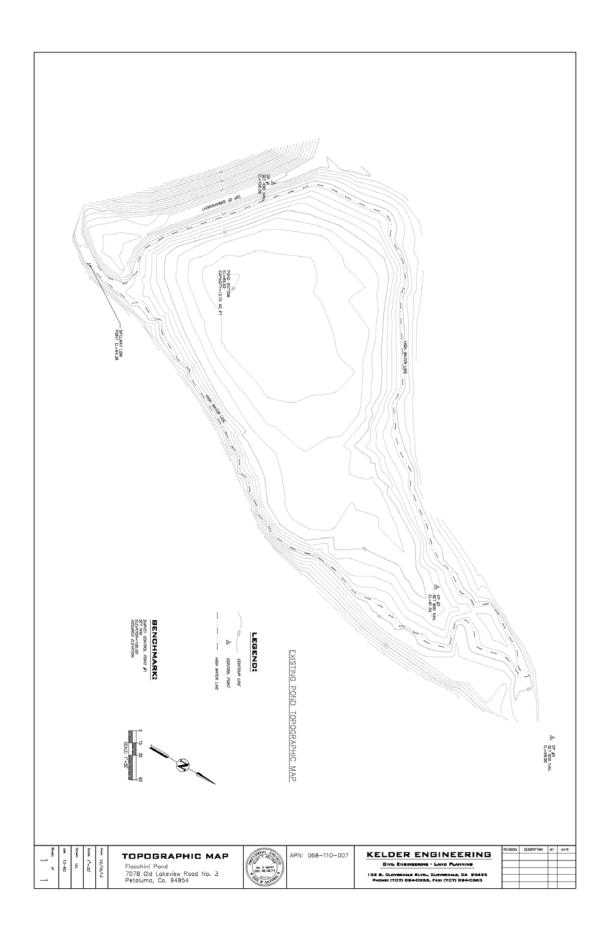
• Survey map of reservoir dated October 15, 2013

There is a discrepancy between the reservoir capacity (29 acre-feet) reported by Division staff on February 7, 2011, and the reservoir capacity (13.75 acre-feet) reported by owners' consultant on the October 15, 2013 reservoir survey. The discrepancy can be explained by the
