STATE WATER RESOURCES CONTROL BOARD DIVISION OF WATER RIGHTS

RESERVOIR INVESTIGATION Reservoir ID No. 1771

Date of Inspection: September 9th, 2011

MANN INSPECTION PICTURES: 9/9/2011

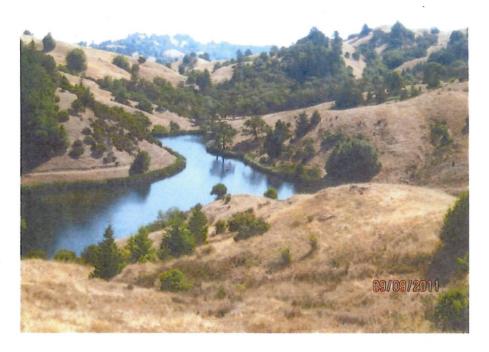
1. LOOKING SOUTHEAST OVER THE RESERVOIR.

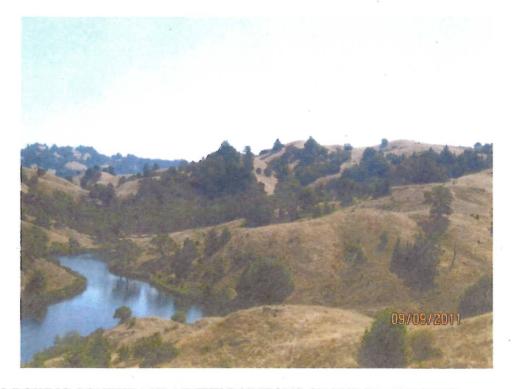
2. LOOKING SOUTHEAST AT THE PORTIONS OF THE WATERSHED.

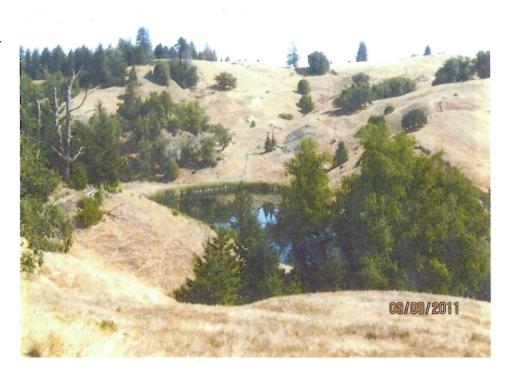
3. LOOKING NORTH TOWARDS THE DAM.

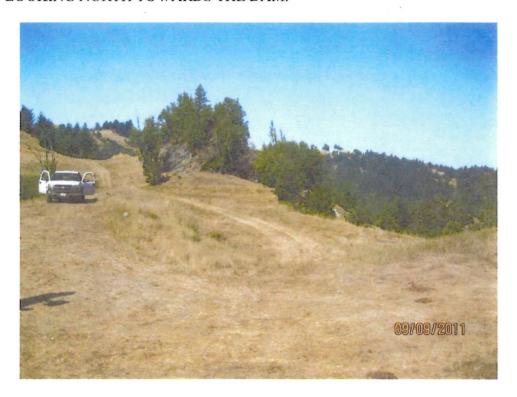
4. LOOKING WEST AT THE DAM.

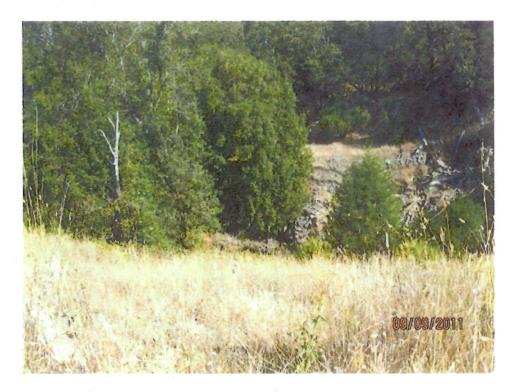
5. LOOKING NORTH OVER THE DAM AND DOWNSTREAM.

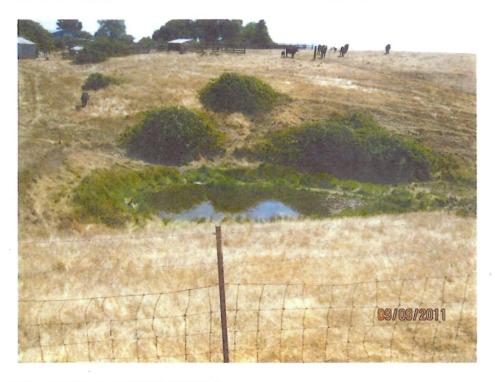
6. LOOKING EAST AT THE SPRING.

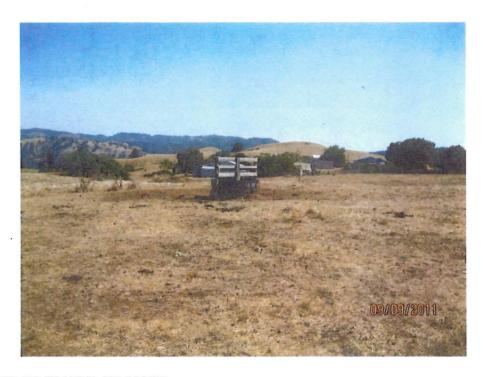
7. STOCK WATER TROUGH.

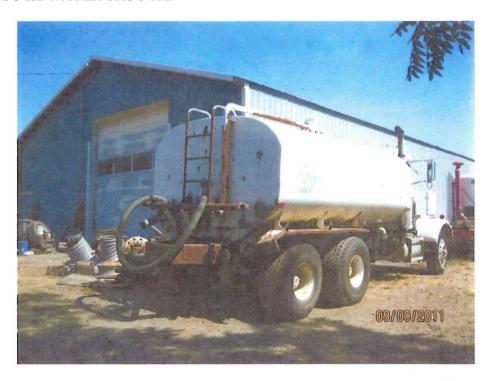
8. WATER TRUCK.
