## Central Coast Regional Water Quality Control Board

### Cannabis Water Quality Inspection Report – Permitted Site

June 19, 2025

Farming First LLC

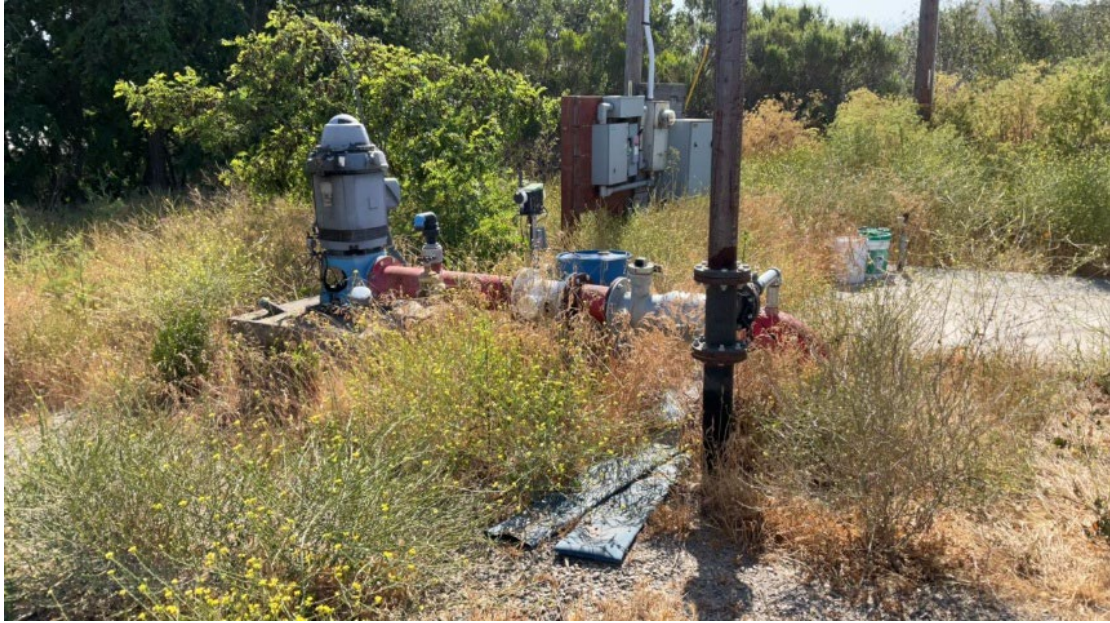
| Location: Well α - 9451 Batchelder Road | Photos 1-2 |
|---|---|
| <b>Photo Number 1 (Well α)</b> | |

| Location: Well α - 9451 Batchelder Road | Photos 1-2 |
|---|---|
| <b>Photo Description:</b> Facing NE. Well-head, electrical panel for well, and pipe manifold with pressure relief valve and flowmeter. | |

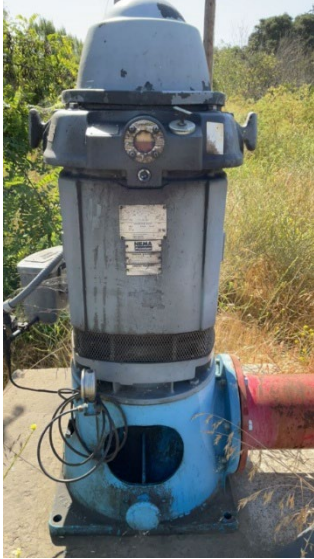
| Location: Well α - 9451 Batchelder Road | Photos 1-2 |
|---|---|
| <b>Photo Number 2 (Well α)</b> | |

| Location: Well α - 9451 Batchelder Road | Photos 1-2 |
|---|---|
| <b>Photo Description:</b> Facing E. Close up of well-head shown in previous photo. | |

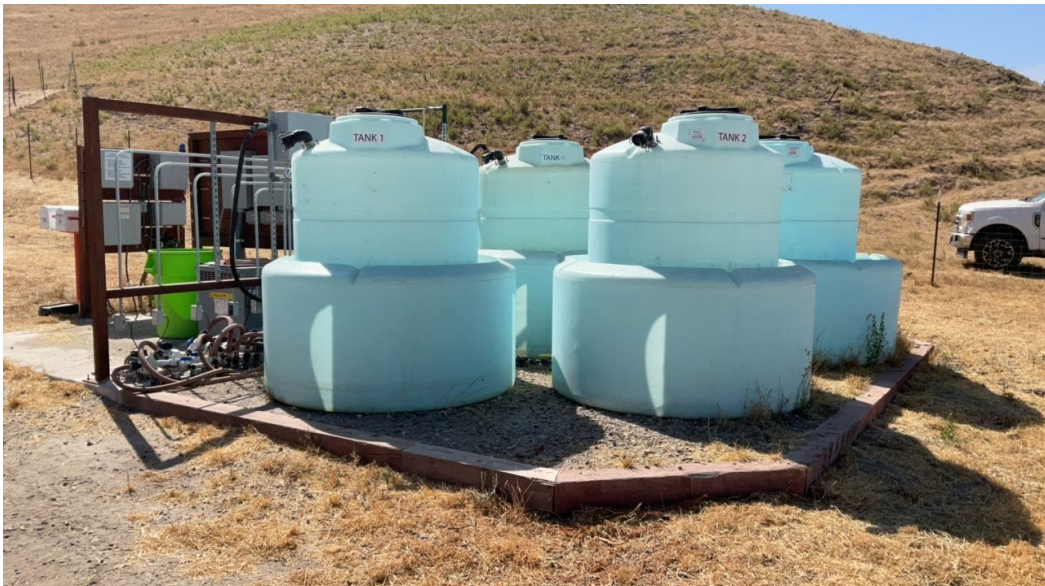
| <b>Photo Description:</b> Facing SE. Plastic fertigation tanks next to the primary well and electrical panel. | |

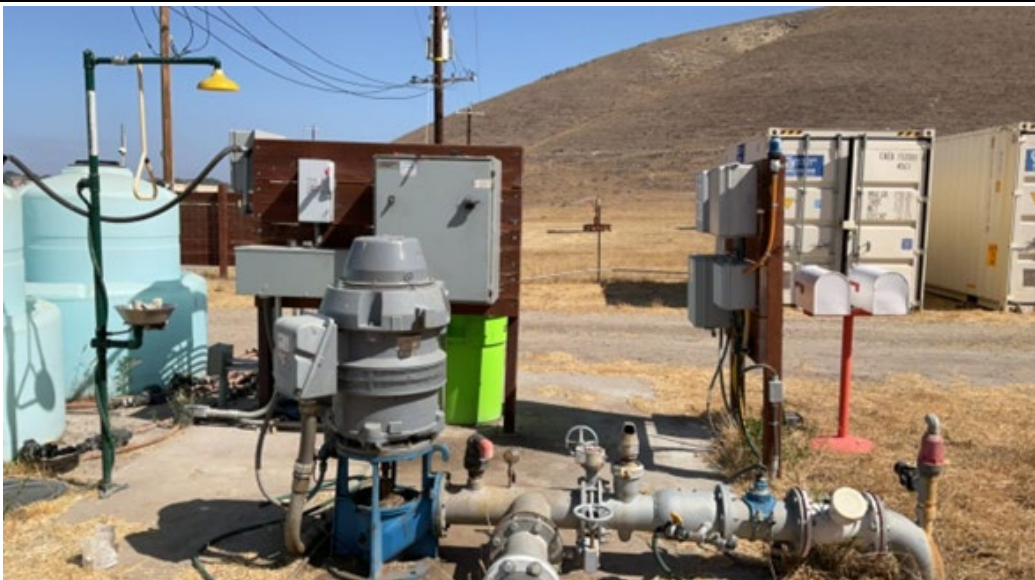
| <b>Photo Description:</b> Facing N. Well head and electrical panel. Two metal shipping containers used for storage are in the background. | |

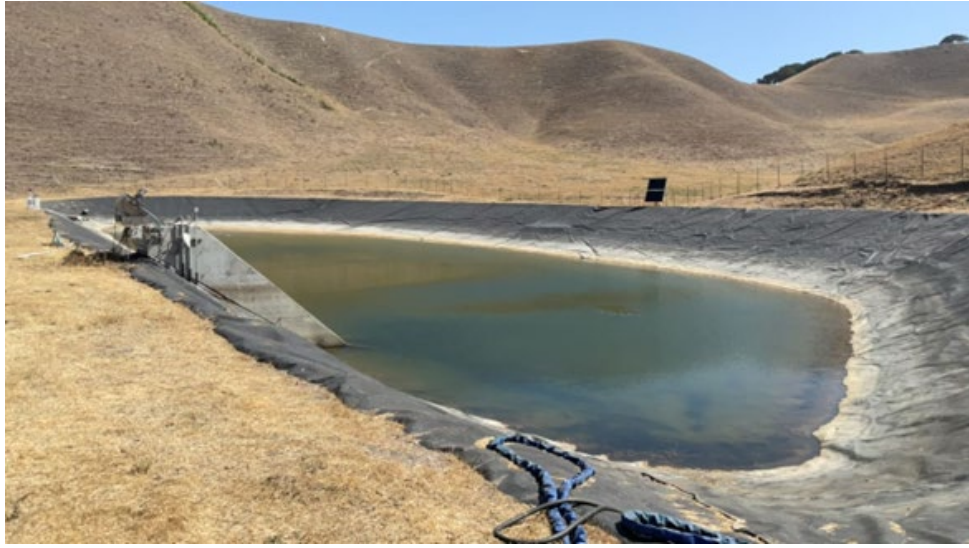
**Photo Number 5**

**Photo Description:** Facing NE. Reservoir used to store well water before entering the irrigation system.

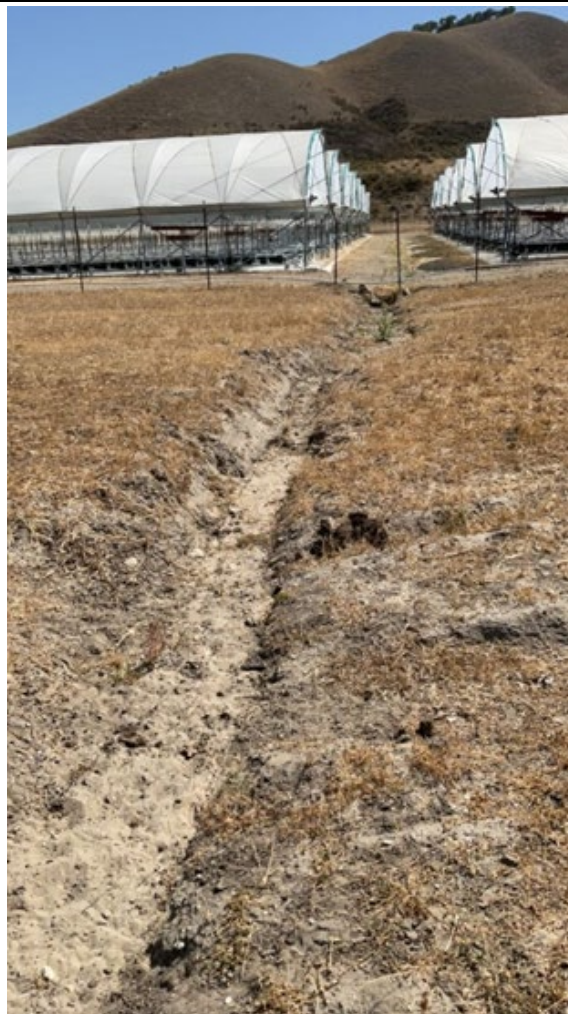
**Photo Number 6**

The riparian setback is down-cut by multiple rills, ditches, and other erosional features that originate from the rows between sections of hoop houses. Many of these features are also down-cut into the stream bank, channeling runoff from the hoop houses and discharging into the stream channel. Several prominent gullies have incised into the banks of the watercourse and riparian setback.

Hoop house runoff is believed to accelerate incision rates above those caused by natural denudation. Observations made of the lithologic unit underlying the topsoil in the riparian setback suggest erosion rates are likely accelerated once the topsoil has been removed. Where it is exposed, the sandstone is poorly cemented and friable.

**Photo Description:** Facing NE. View towards the hoop houses showing a drainage feature that discharges from a row between two hoop house sections into the riparian setback and watercourse . The Discharger reports that site workers modified the drainage feature to channel runoff away from the hoop houses and towards the watercourse. The hoop houses are up-slope of the watercourse bank and riparian setback.

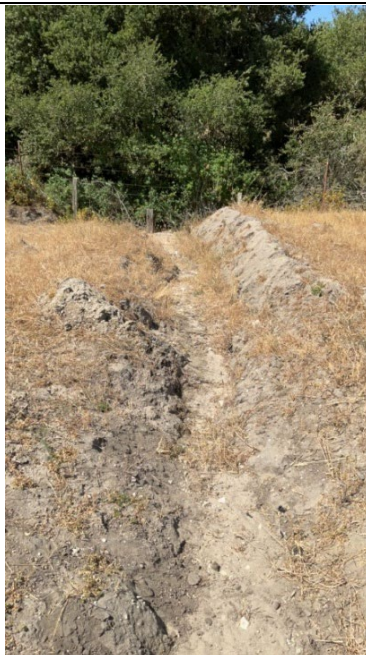
**Photo Number 7**

**Photo Description:** Facing SW toward the watercourse. Discharge point of the drainage feature shown in the previous photo at the top of bank of the watercourse. The riparian vegetation in the setback has been severely degraded or completely removed by the discharges from the drainage feature.

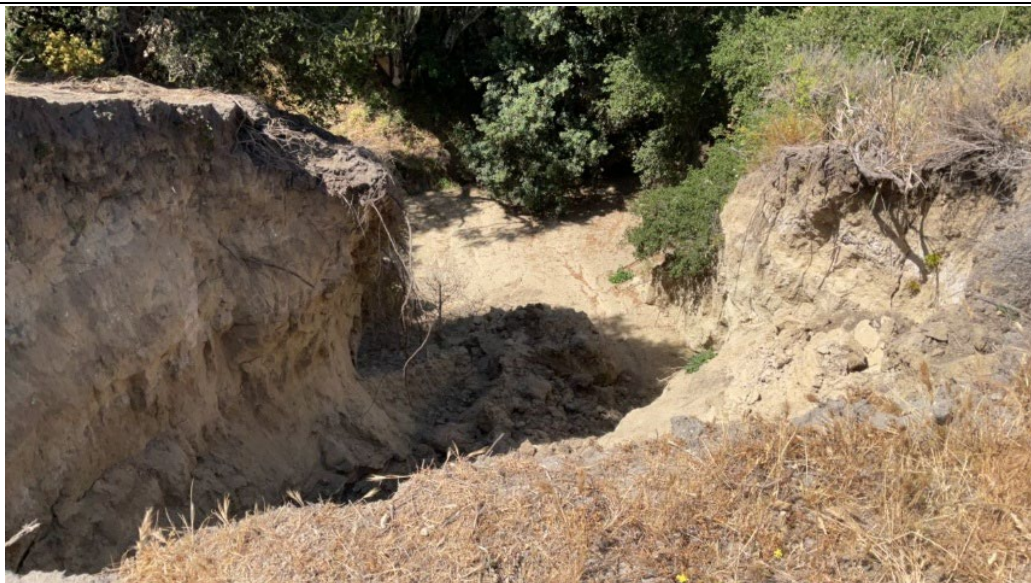
**Photo Number 8**

**Photo Description:** Facing W. Standing near the top of bank of the watercourse, looking down-slope into a large gully that has formed along the bank of the watercourse near the southern end of the hoop houses, where one of the drainage features originating at the hoop houses discharges to the riparian setback and watercourse.

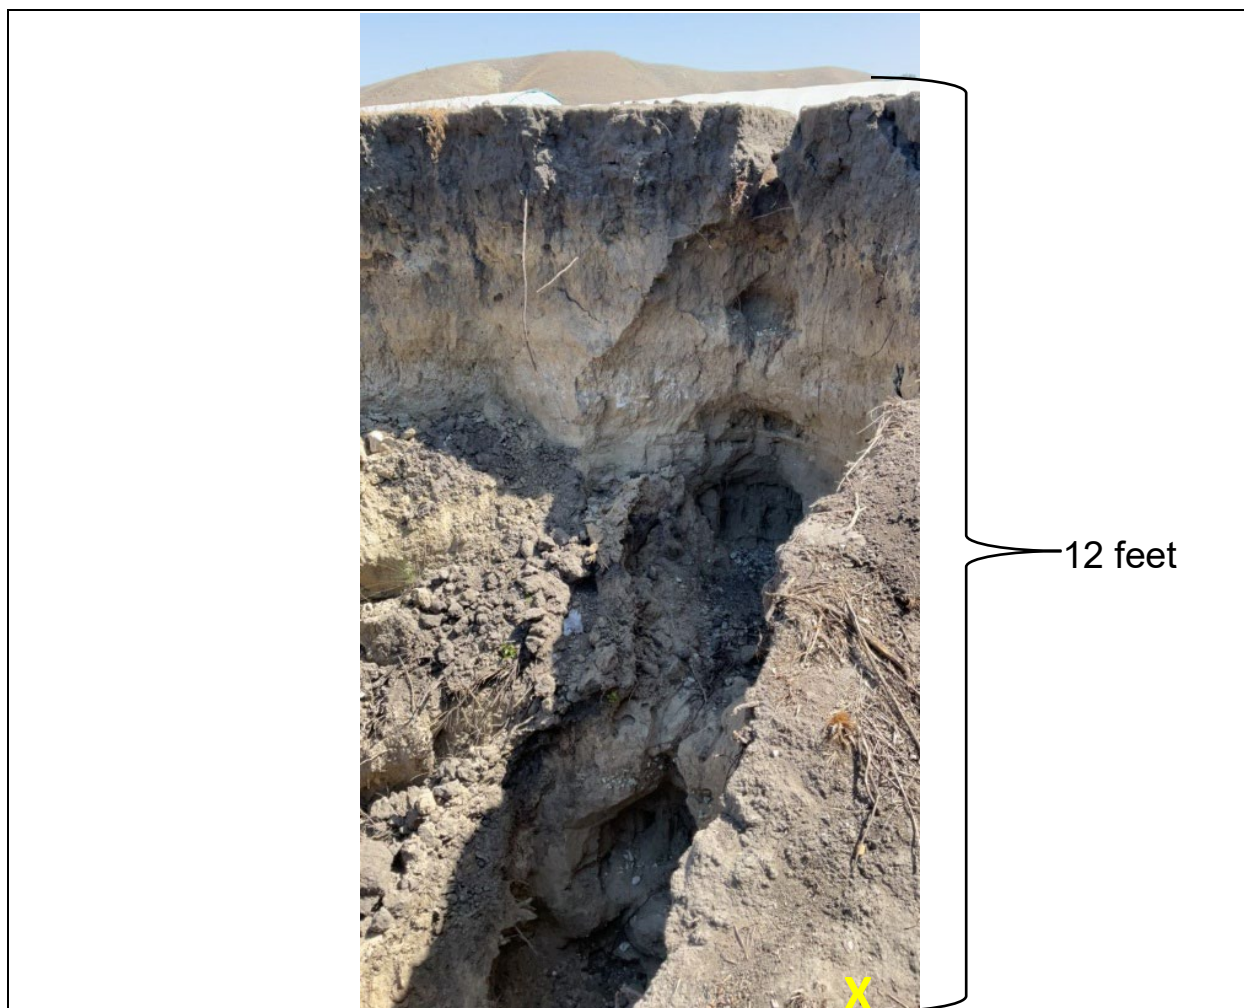
**Photo Number 9**

**Photo Description:** Facing E. Standing on the slope bank of the watercourse, looking up-slope of the gully shown in the previous photo. The watercourse bank and overlying ground surface have been undercut by runoff caused erosion. The estimated height from the top of the stream bank to the point on the slope bank where the photo is being taken (yellow X) is 12 ft.

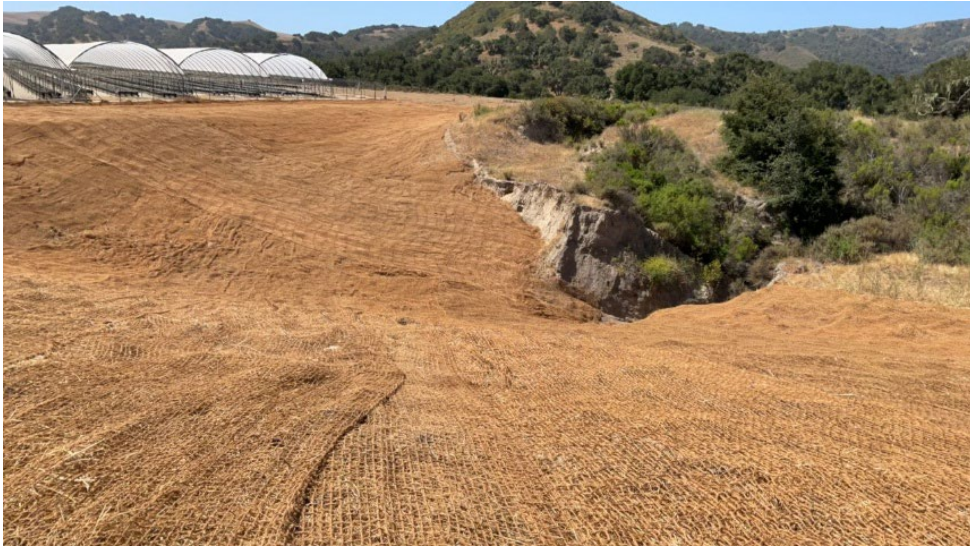
**Photo Number 10**

**Photo Description:** Facing S. Standing near the edge of the large gully near the center of the hoop houses. Looking downslope towards the eroded watercourse bank. The cultivator covered the ground surface with fiber netting as an erosion control measure after the end of the 2024-25 rainy season. The size of the erosional surface area is estimated to be between 9,000-11,000 square feet.

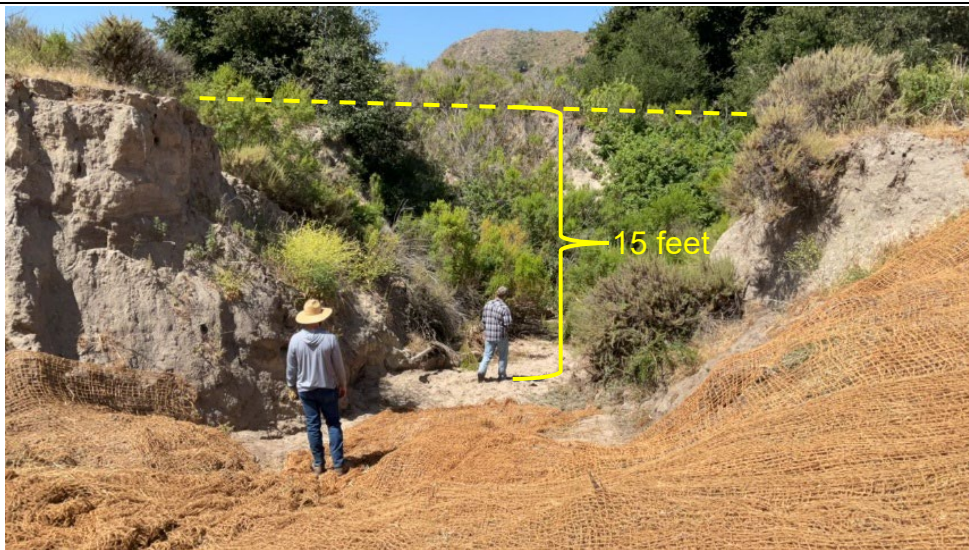
**Photo Number 11**

**Photo Description:** Facing W. Looking down-slope at the gully shown in the previous photo. Workers are shown for scale. The estimated height from the ground surface seen in the upper right and left sides of the photo, to the surface the workers are standing on, is an estimated 15 feet.

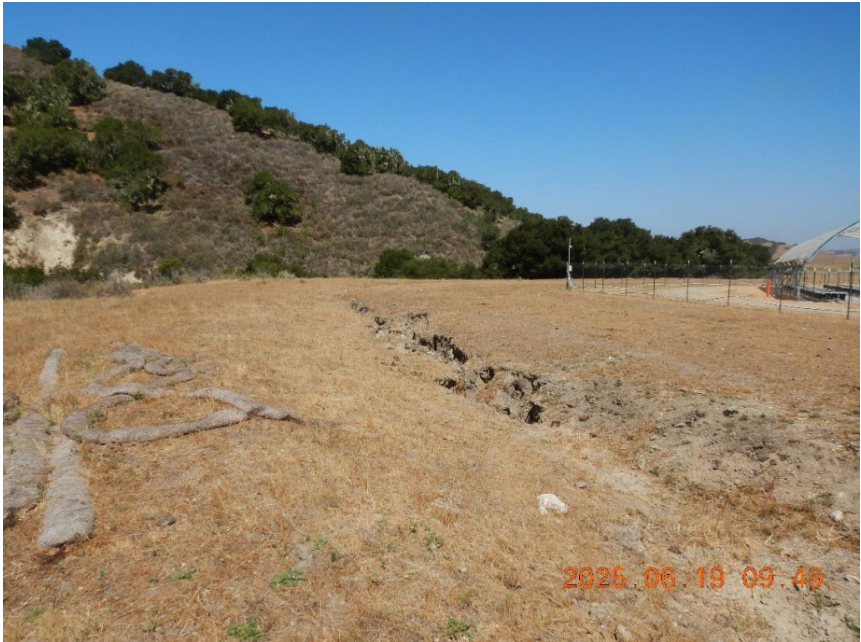
| <b>Photo Number 12</b> | |

| <b>Photo Description:</b> Facing N. Decomposing straw wattles lie next to a channelized erosional feature trending parallel to the hoop houses. | |

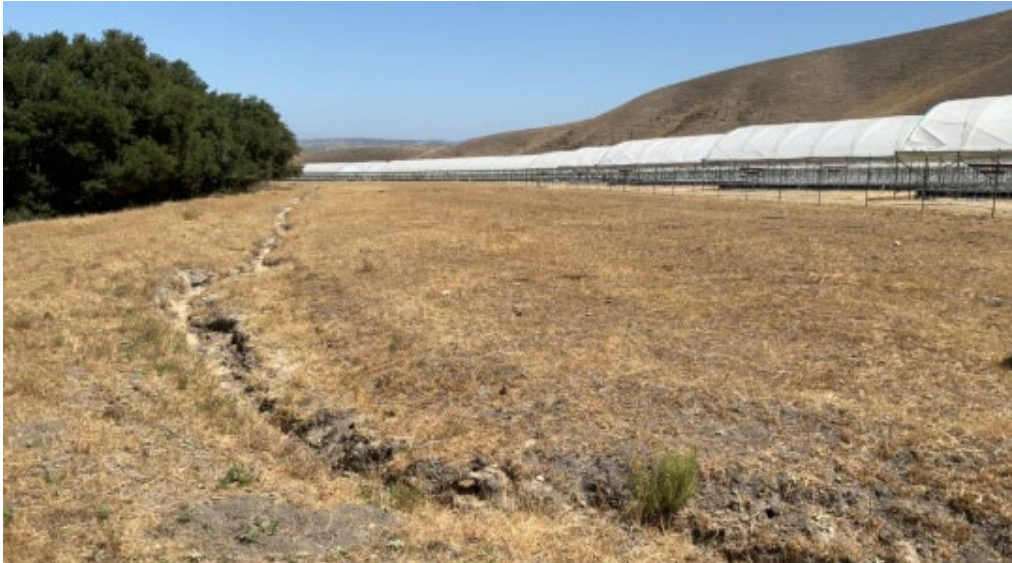
| <b>Photo Number 13</b> | |

| <b>Photo Description:</b> Facing N. Continuation of the erosional feature shown in the previous photo. Along this section, the channel trends north-south, parallel to the stream channel. | |

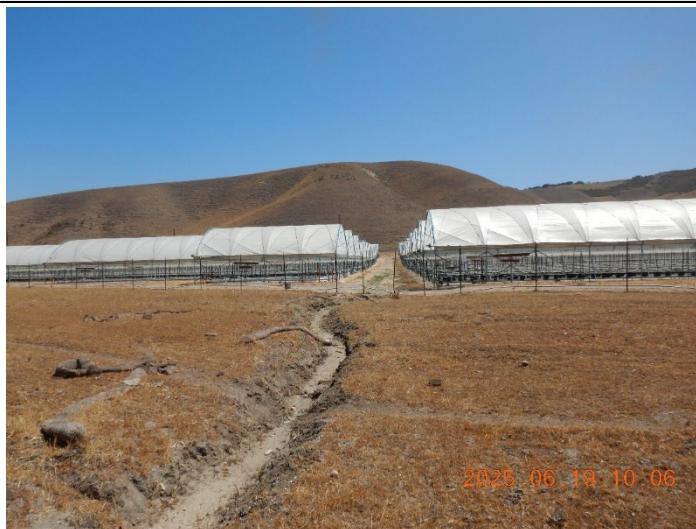
**Photo Number 14**

**Photo Description:** Facing NE. Standing near the watercourse bank, looking up-slope at a drainage ditch originating in the hoop house. The ditch was either excavated into an existing channel eroded by runoff from the hoop houses or may have been partially excavated prior to runoff induced erosion. The ditch channels runoff from the hoop houses into the watercourse. Straw wattles, visible on the left side of the photo, are strewn along the sides of the ditch.

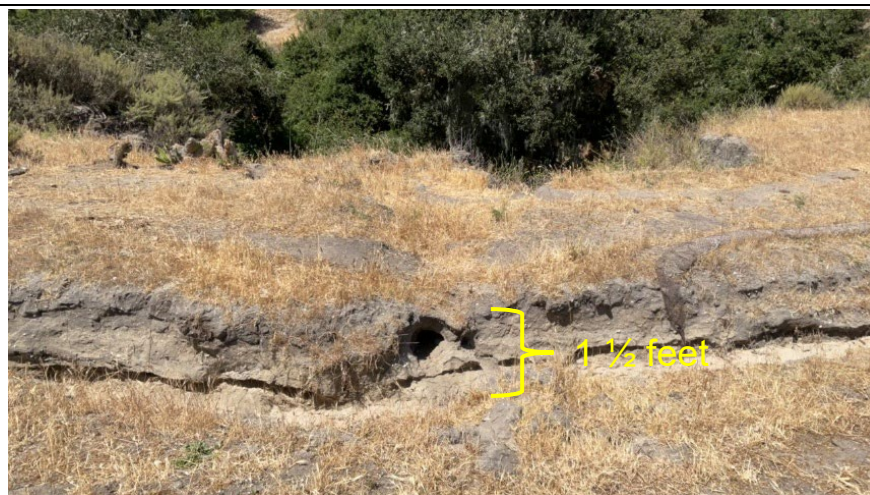
**Photo Number 15**

**Photo Description:** Facing W. Looking down at a cross-section of a segment of an erosional channel. Visible below the annual grasses, is a grey, organic rich layer of topsoil, which overlies a light brown, friable sandstone unit (Careaga formation). The

depth of the channel along this cross-section is 1 to 1 ½ feet. The channel cross section is 1 to 1 ½ feet wide.

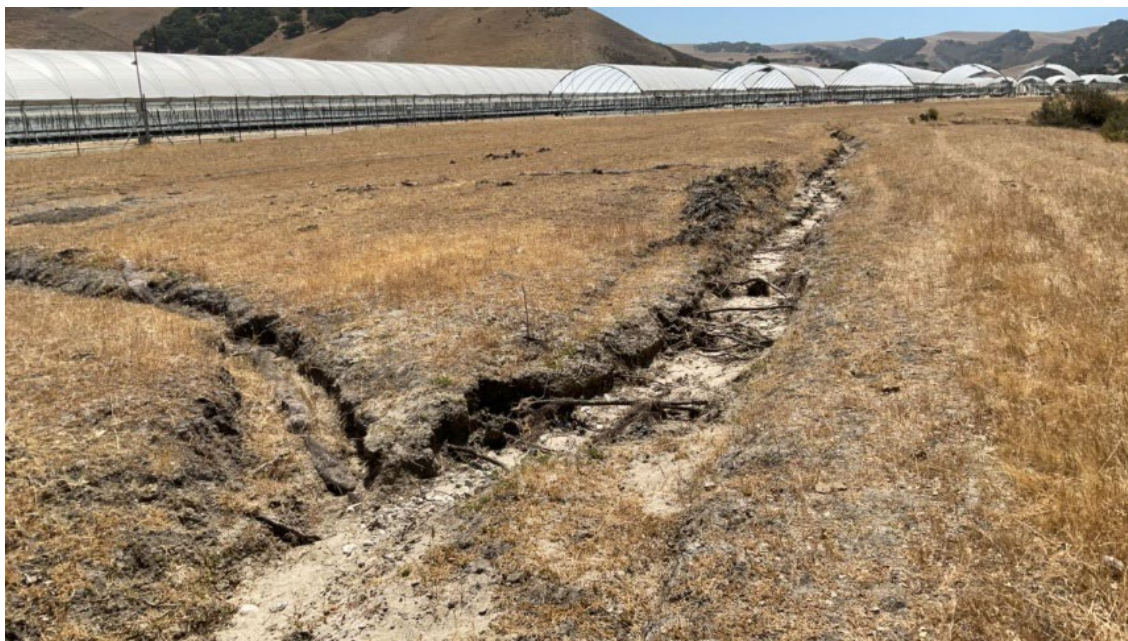
**Photo Number 16**

**Photo Description:** Facing S. Two erosional features converge in the riparian setback between the hoop houses and the watercourse. Excavated soil is visible along the left side of the ditch trending parallel to the hoop houses.

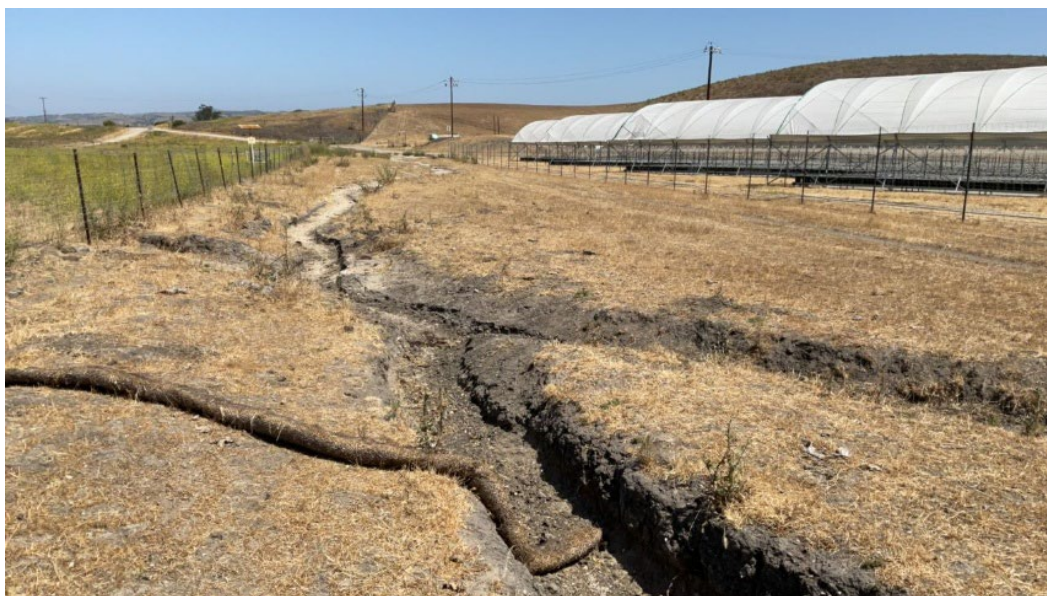
**Photo Number 17**

**Photo Description:** Facing N. Standing near the north end of the hoop house area. Several erosional features intersect. In the foreground, a straw waddle is lying perpendicular to one of the channels as an erosion control measure.
