**EROSION REDUCTION PLAN  
HIGHWAY 58-229 FIRE  
Summary Evaluation of the Existing Conditions Following Fire  
Findings and Recommendations**

Prepared By:  
**Upper Salinas-Las Tablas Resource Conservation District**  
Donald J. Funk and Adriana Morales

August 14, 2002

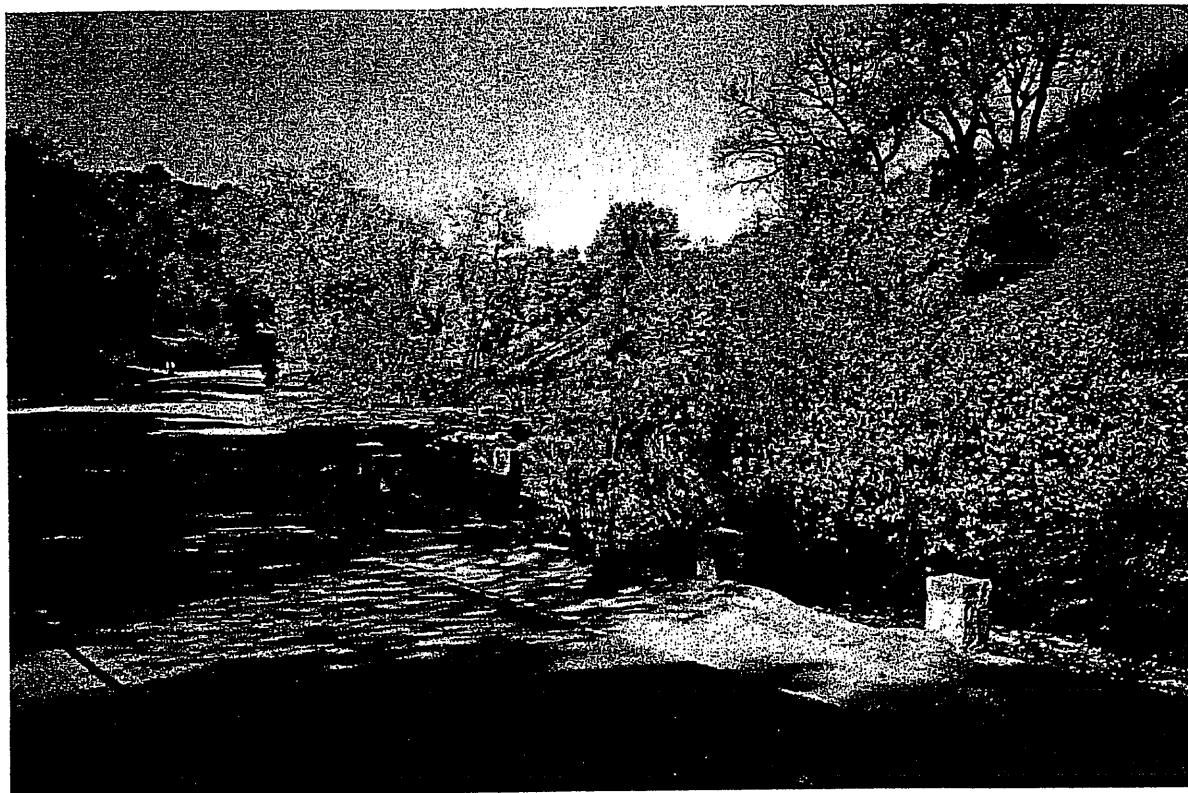
**View of burned area looking east from Highway 58. Note that oak canopy in background is still green.**

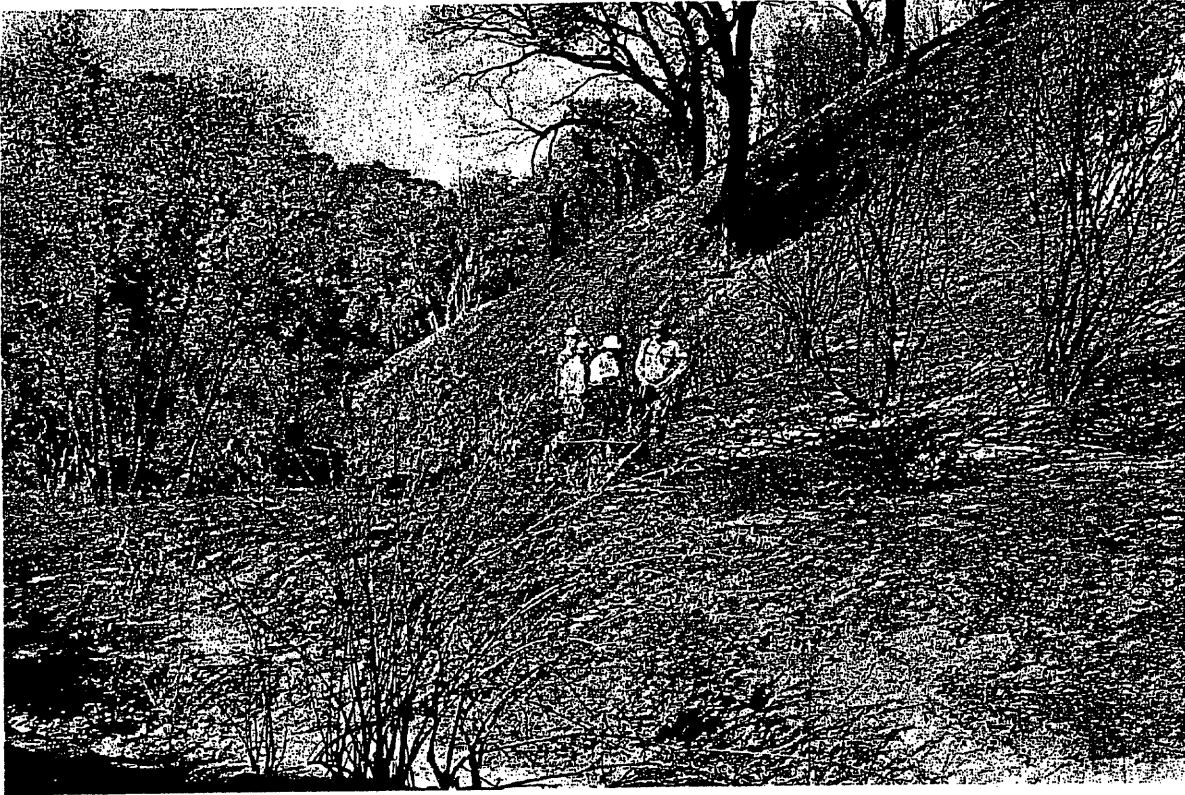
**Burned hillside south of Highway 58 looking northwest. Ash contains seeds for future native chaparral regeneration.**

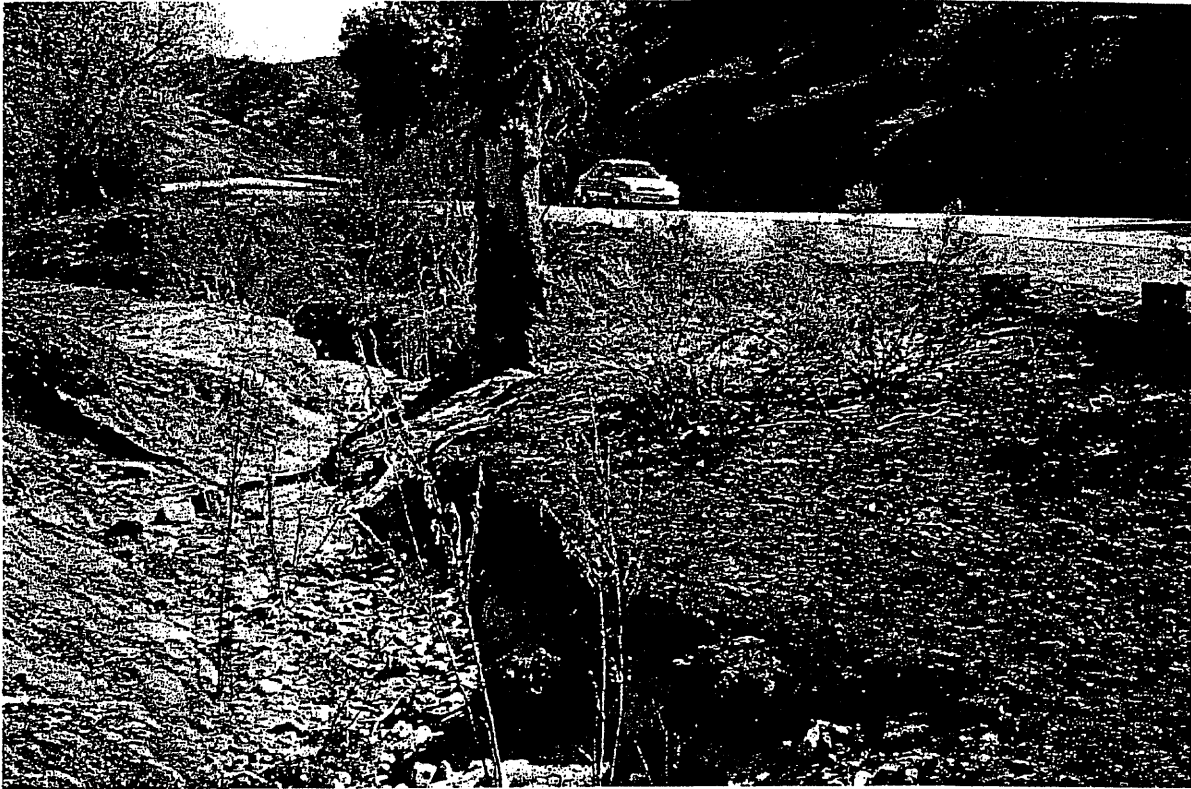
**Eroded unnamed channel paralleling the north side of Highway 58. This blue line stream is a tributary of the Salinas River.**

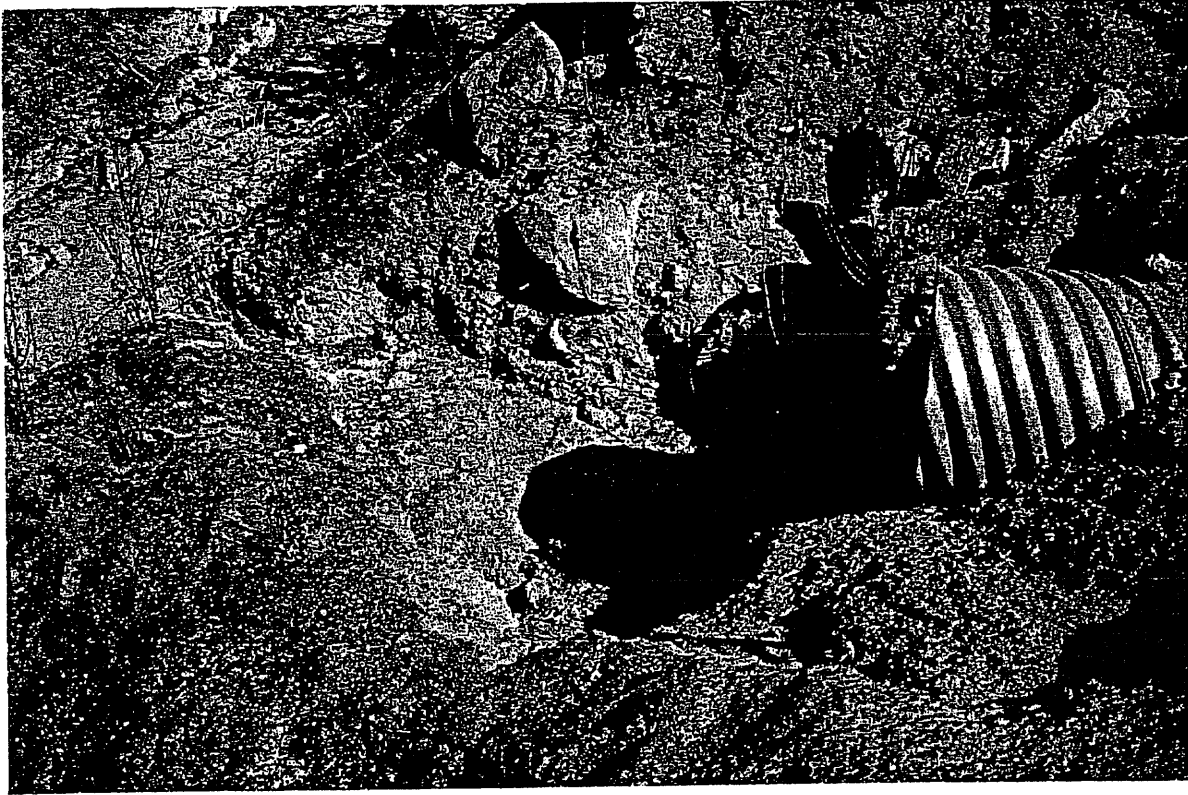
**Existing highway culverts do not have adequate energy dissipation. Culvert size may not be adequate to handle storm runoff.**

8. Enlarge undersized culverts as necessary (recommend working with Caltrans to ensure adequacy of highway culverts)
9. Clean out culverts. Replace damaged culverts at road crossing of Huerhuero Creek (engineering suggested to properly size these culverts. Contact agencies for possible permit approval).

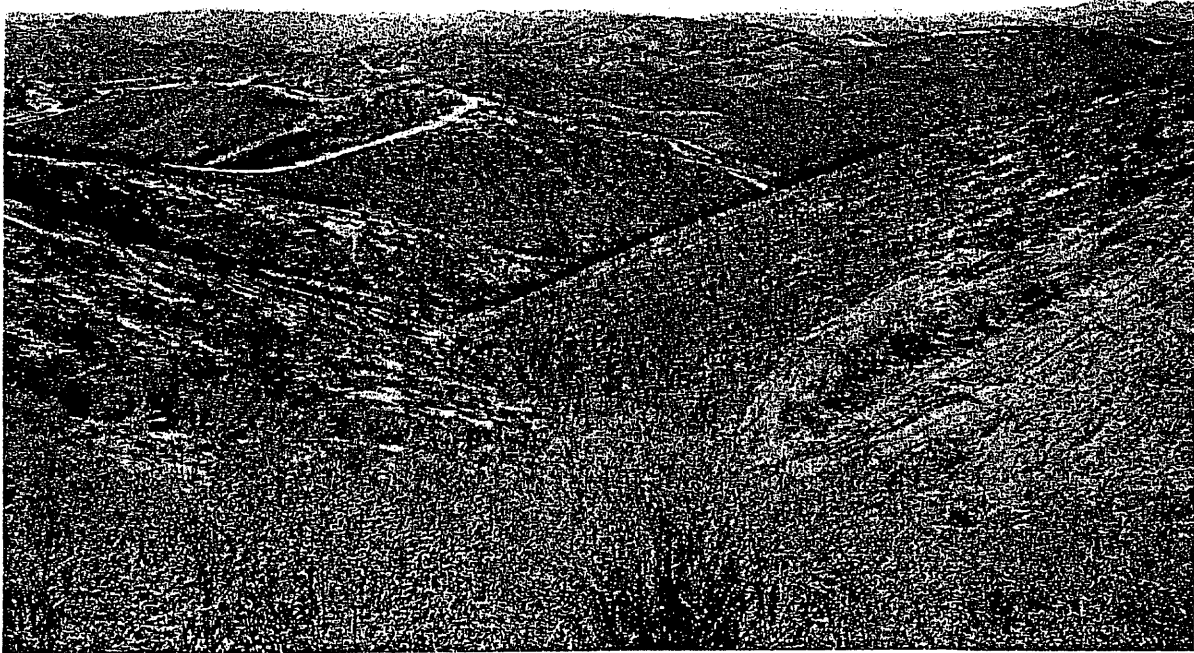
**Burn area viewed from hilltop looking southwest from edge of fire perimeter.  
Note the scar from the bulldozer. Vegetation in the foreground was not burned.**

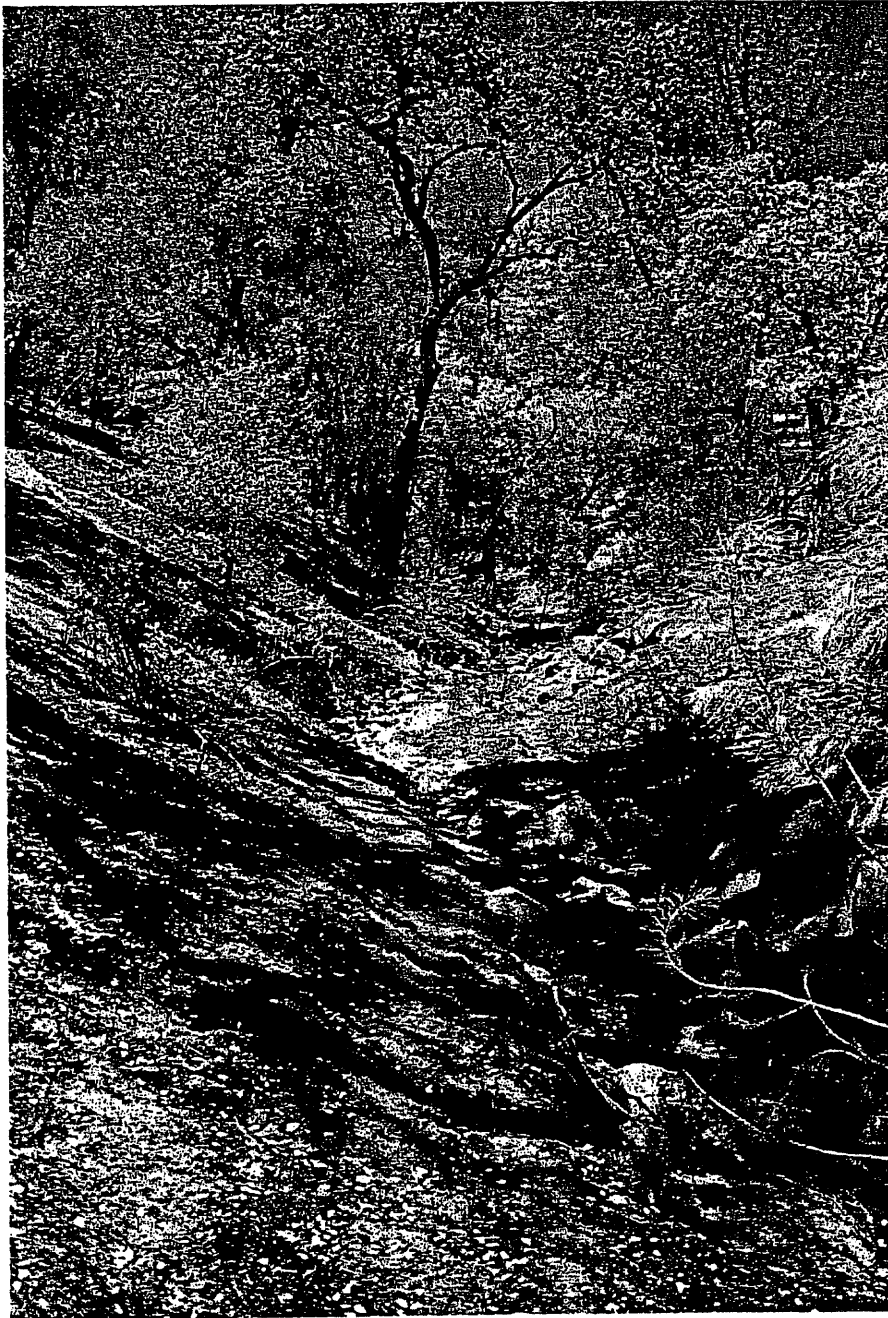
**Unnamed blue line creek channel near Huerhuero Creek. Photo taken near possible location for large sediment basin (engineering required)**

7. Temporary sediment basins (engineered to handle anticipated flows) in major drainageways. These basins are recommended to only be used high in each drainage in locations of low slope-swales and where access does not impact hillsides. (to be determined on field inspections by RCD and owner's engineer)  
Perforated vertical inlets to reduce plugging of drain pipes  
Remove after vegetation has re-established unless county and RCD approve longer term or permanent use  
Large basin in eastern blue line stream may be effective in reducing sediment into Huerhuero Creek, but engineering may make this basin too expensive.

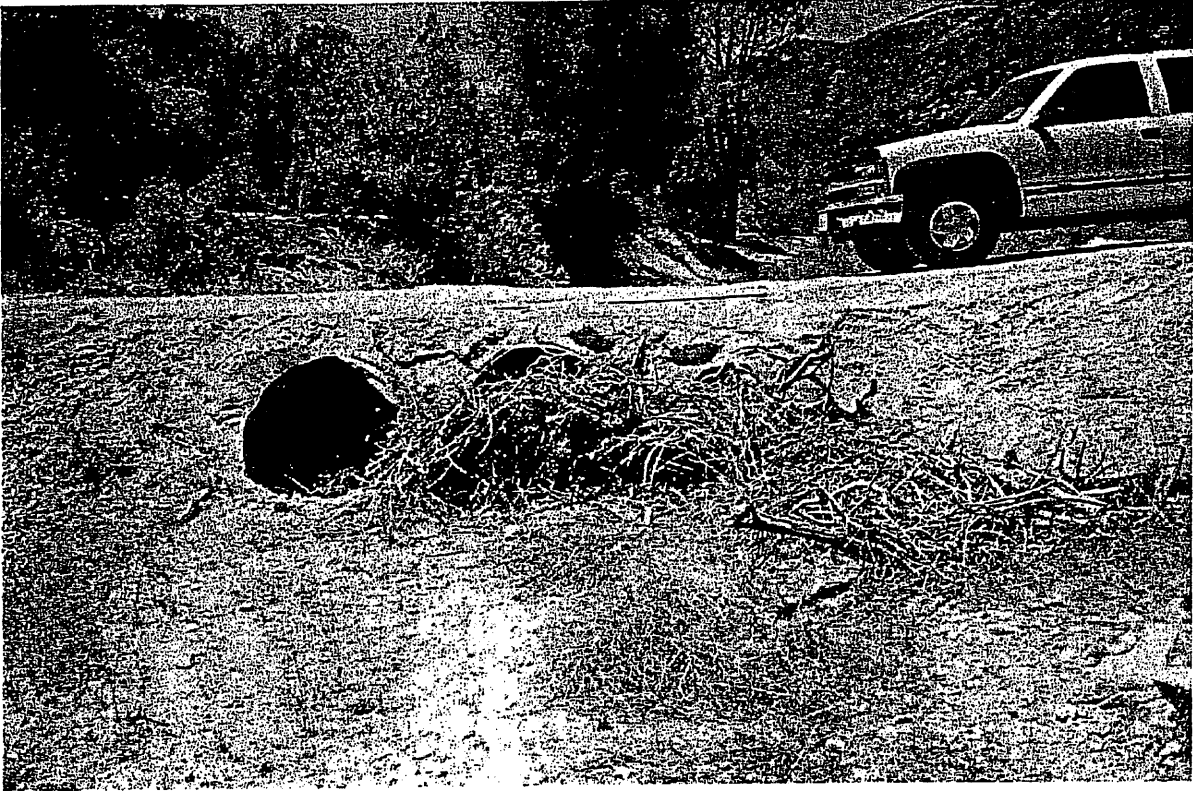
**Culverts in Huerhuero Creek choked with debris severely limiting capacity.**
