December 21, 2004

NOTICE OF VIOLATION – DE LAVEAGA GOLF COURSE, SANTA CRUZ, SANTA CRUZ COUNTY; WDID# 3 44C330064

Inspection Photos
De LaVeaga Golf Course, Santa Cruz
December 8, 2004

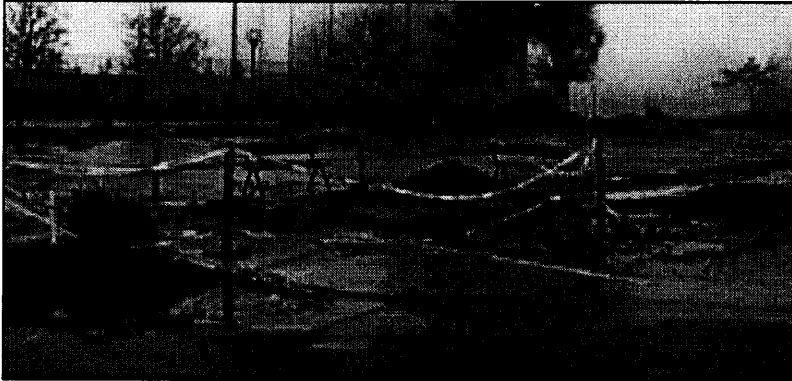
Above: Parking lot area with unprotected stockpiles and no sediment controls.

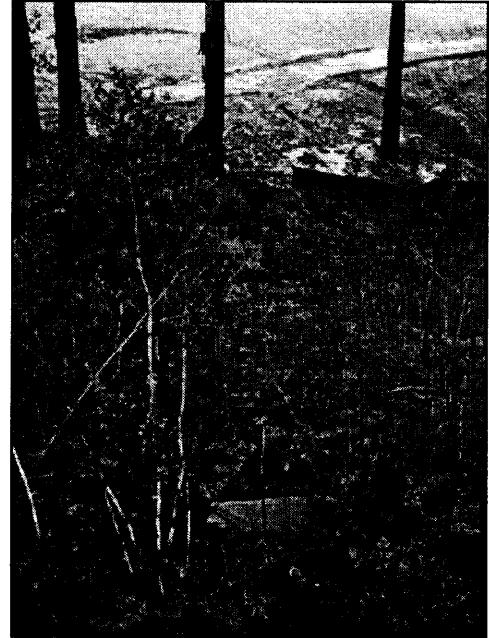
Right: Discharge of sediment-laden water from parking lot to surface waters.

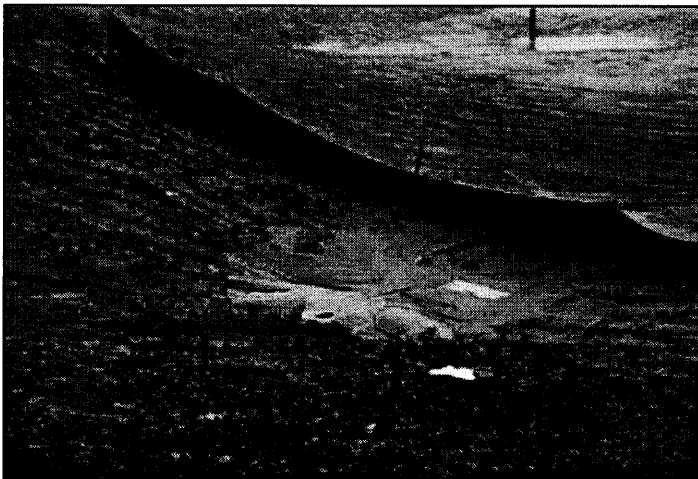
Above: Erosion at Greens Complex 18 and storm water drainage into pipe. No erosion controls.

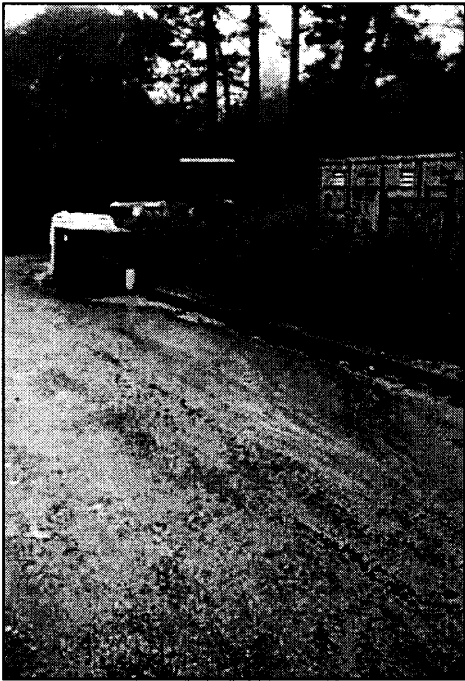
Left: Sediment in streets near construction staging area.

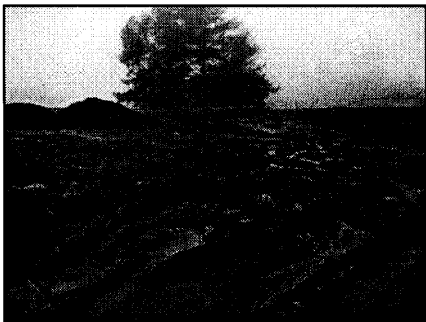
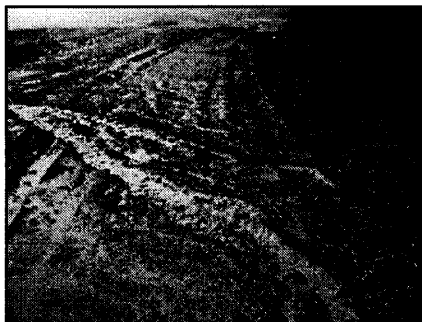
Below and Right: Greens Complex 1 area with no erosion control, unprotected stock piles, and failing sediment control. Discharge of sediment-laden water to surface waters.

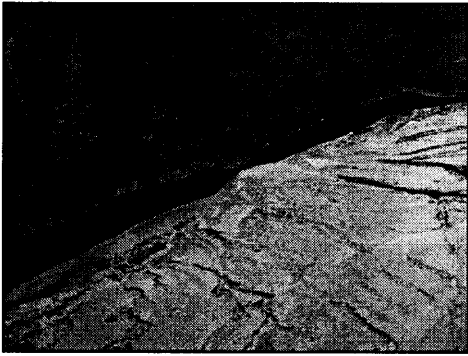
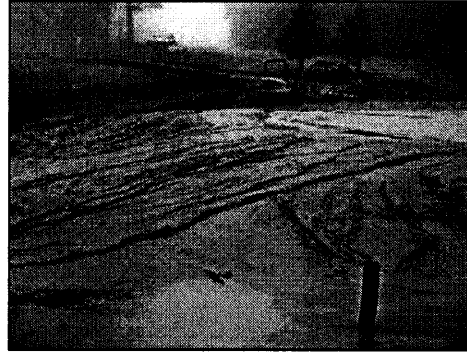
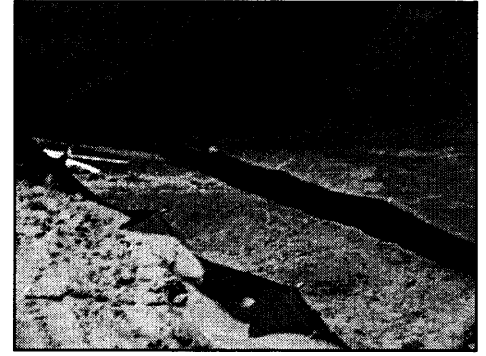
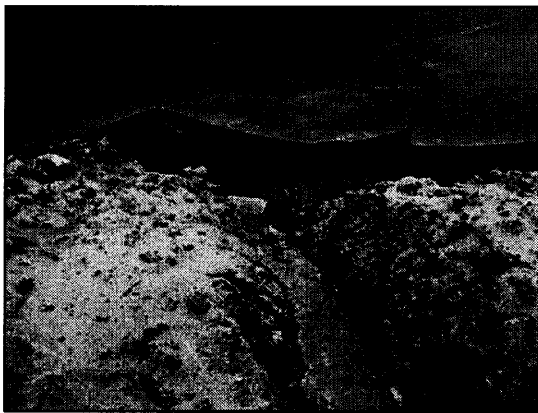
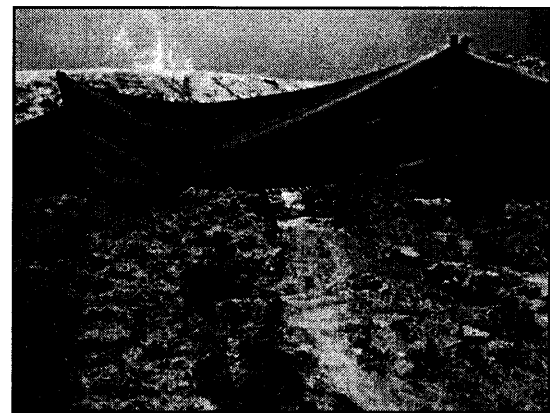
This Page: Sediment overwhelming silt fences in Greens Complex 5 area. Widespread erosion and no erosion controls in disturbed areas. Discharges of sediment to surface waters.

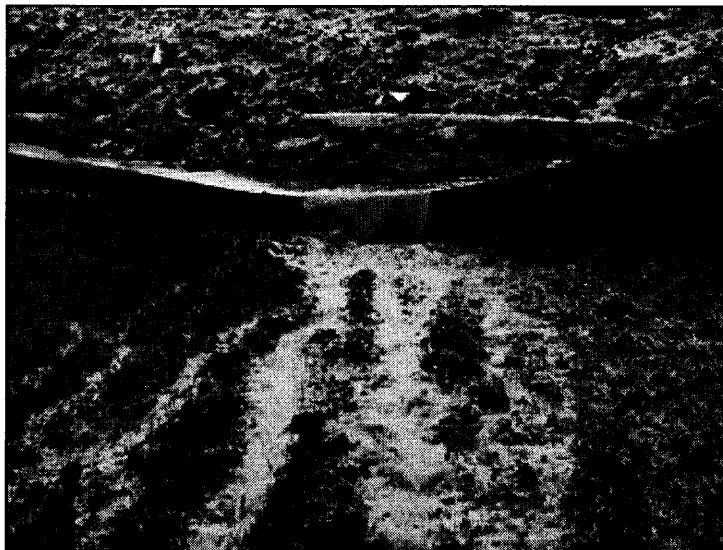
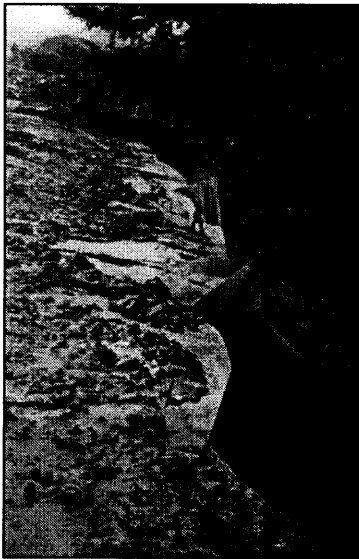
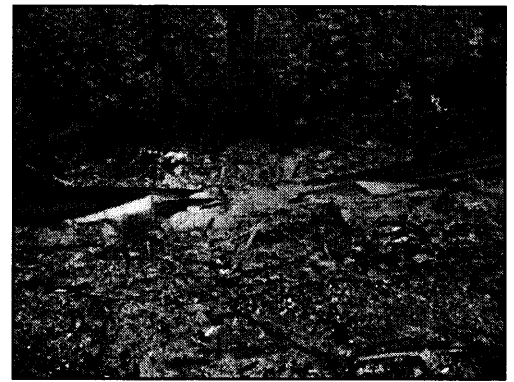
Above and Right: Sediment overwhelming silt fences at various tees, all resulting in discharge of sediment-laden water to surface waters.

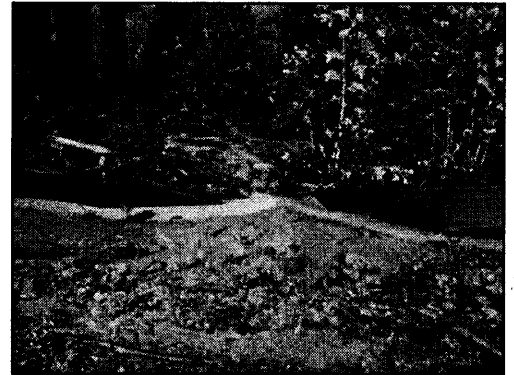
Left: Tee area with no erosion controls.
