3rd USTCF 5-YEAR REVIEW SUMMARY

USTCF Claim No.: 3672
Claimant Name: John Wolf
Site Name: San Paso Truck and Auto
Site Address: 81 Wellsona Road
City: Paso Robles, CA 93440
LOP: San Luis Obispo County
Regional Board: Central Coast (Region 3)

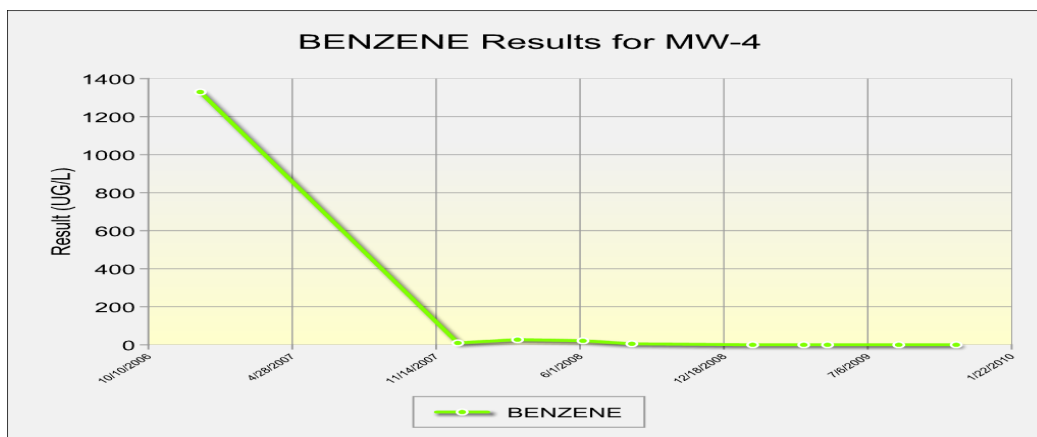
- D. Groundwater Concentration Trends:** Groundwater contaminant concentration trends from monitoring well MW-4 are presented below.
