Re: NPDES Compliance Evaluation Inspection (CEI) reports

NPDES Compliance Evaluation Inspection (CEI) Report

Name and Location of Facility Inspected Carpinteria Sanitary District Wastewater Treatment Facility 5351 Sixth Street Carpinteria, CA 93013		Entry Date 12/14/2011 Entry Time 8:05 AM	Permit Effective Date 3/25/2011
NPDES Permit Number CA0047364	Order Number R3-2011-0003	<input checked="" type="checkbox"/> Major <input type="checkbox"/> Minor	Permit Expiration Date 3/25/2016
Name(s) & Title(s) of On-Site Representative(s) Craig Murray (General Manager) Mark Bennett (Operations Manager) Mark Reynolds (Treatment Supervisor) Frank Gonzalez (Laboratory Director)		Contact Information Phone: (805) 684-7214 ext. 17 Fax: (805) 684-7213	Notified of Inspection? <input checked="" type="checkbox"/> Yes <input type="checkbox"/> No
Name, Title & Address of Responsible Official Craig Murray (General Manager) 5300 Sixth Street Carpinteria, CA 93013		Contact Information Phone: (805) 684-7214 ext. 12 Fax: (805) 684-7213	Official Contacted? <input checked="" type="checkbox"/> Yes <input type="checkbox"/> No

**Carpinteria Sanitary District Wastewater Treatment Plant
(NPDES No. CA0047364) Photo

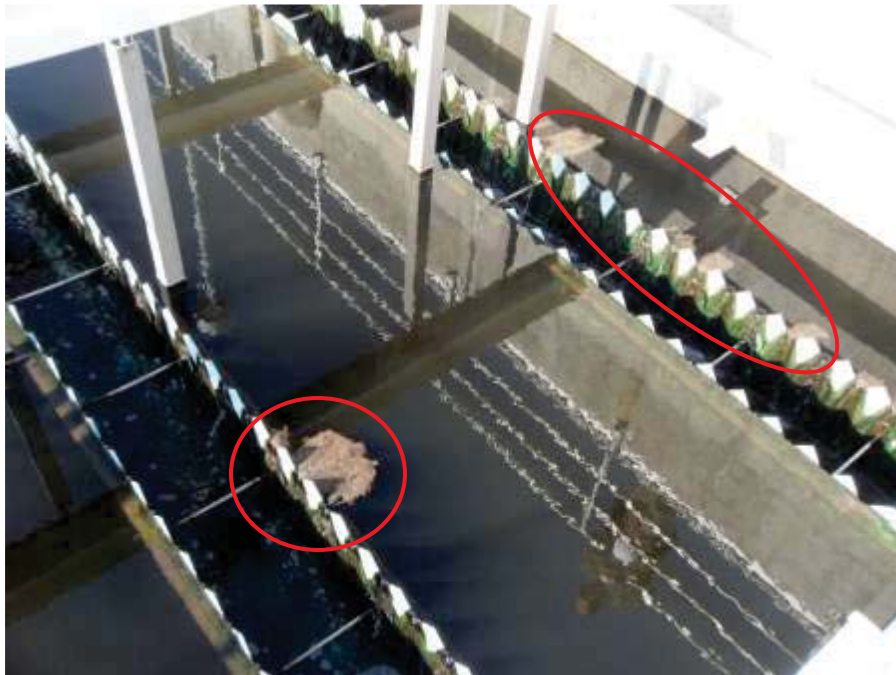
1. Central Coast Water Board Order No. R3-2011-0003, Attachment D – Standard Provisions, Section I.D requires that the Discharger “shall at all times properly operate and maintain all facilities and systems of treatment and control (and related appurtenances) which are installed or used by the Discharger to achieve compliance with the conditions of this Order.” Algae build-up and solids accumulation was observed along the secondary clarifier overflow weirs which appeared to be causing uneven flow distribution (refer to Photos 2 and 3). Note that algae build-up and solids accumulation were observed in numerous locations in both clarifiers. According to the Facility’s Operations Manager, the secondary clarifier weirs are scheduled to be cleaned on a weekly basis and he stated the condition seen during the inspection was not typical and would be investigated and addressed immediately.

3. No operational problems caused by hydraulic "short-circuiting" in treatment units. Solids accumulation was observed at the secondary clarifier overflow weirs which appeared to be causing uneven flow distribution. This checklist item is accounted for in the 'Facility Site Review' section of this report.	U

Photo 2: Example of algae build-up and solids accumulation along secondary clarifier overflow weirs.

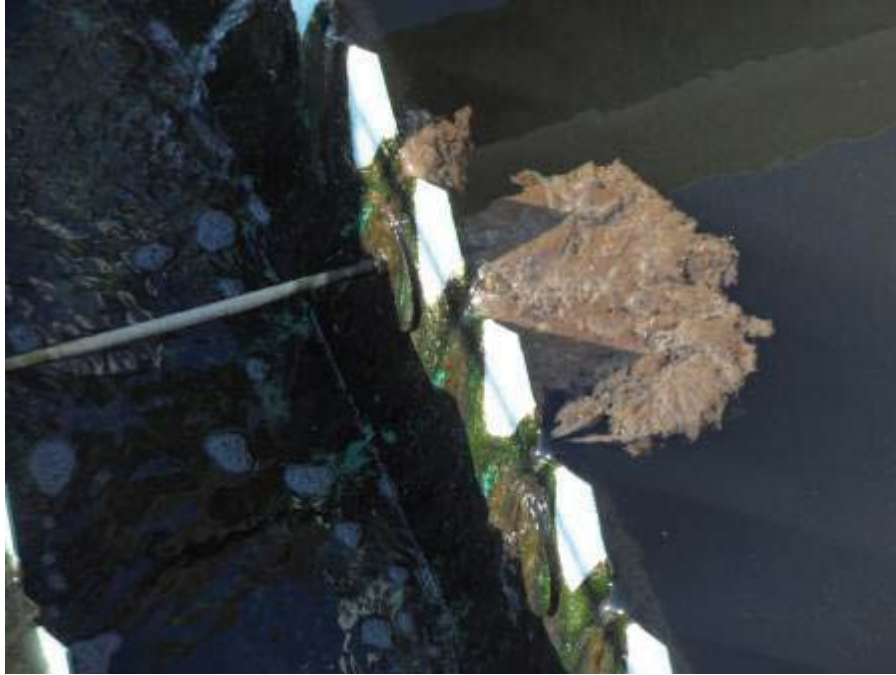
Photo 3: Close-up of algae build-up and solids accumulation shown in Photo 2. Solids accumulation appeared to cause uneven flow distribution over the weirs.

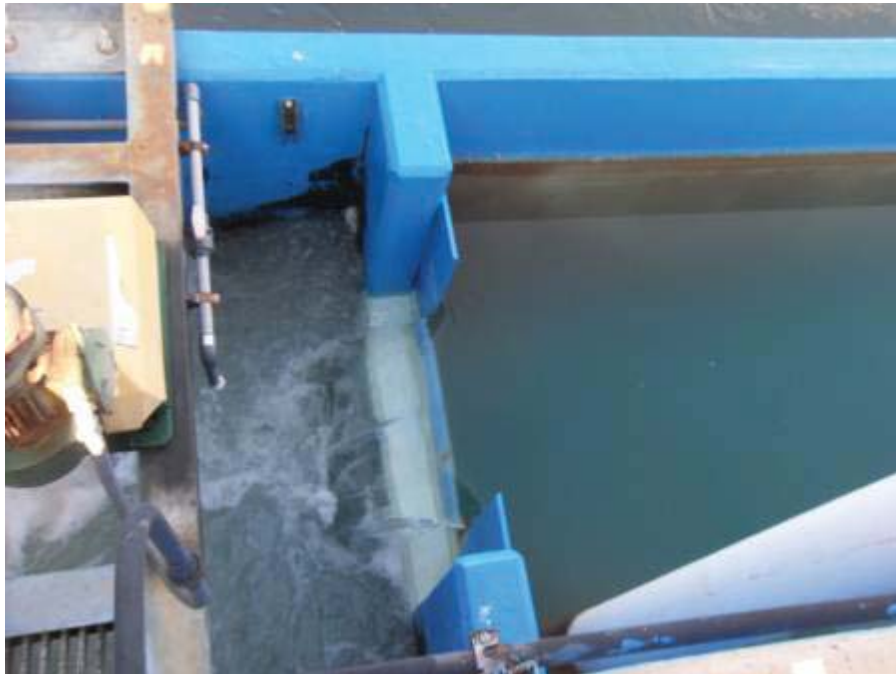
Photo 4: View of final effluent flowing over rectangular weir at the terminus of the chlorine contact basin.
