## Central Valley Regional Water Quality Control Board

### ***OFFER TO SETTLE ADMINISTRATIVE CIVIL LIABILITY, RELP METRO LLC, METRO AIRPARK, SACRAMENTO COUNTY, WDID 5S34C376516***

# County of Sacramento Notice of Violation

### ***NOTICE OF VIOLATION, METRO AIRPARK, SACRAMENTO COUNTY, W DID 5S34C376516***

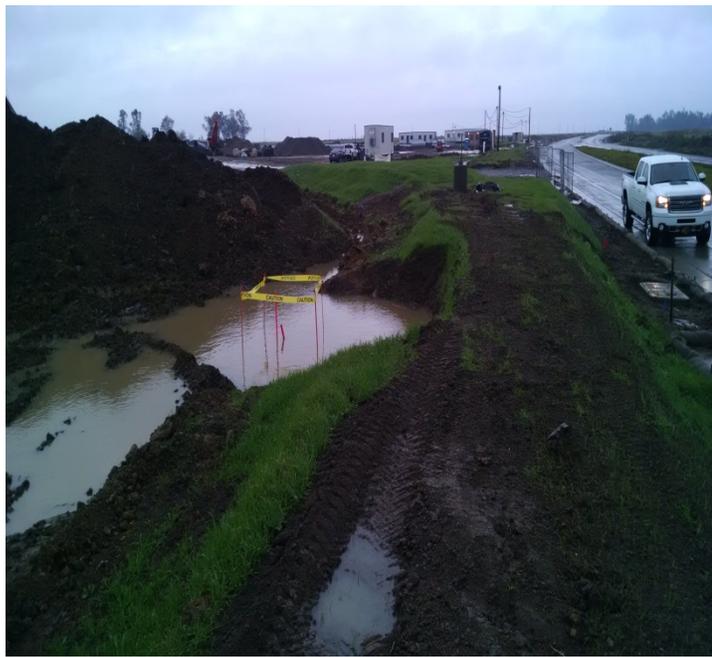
Photo #1 - 12/10/16 - Sediment laden water at onsite connection to active system. Southside of site

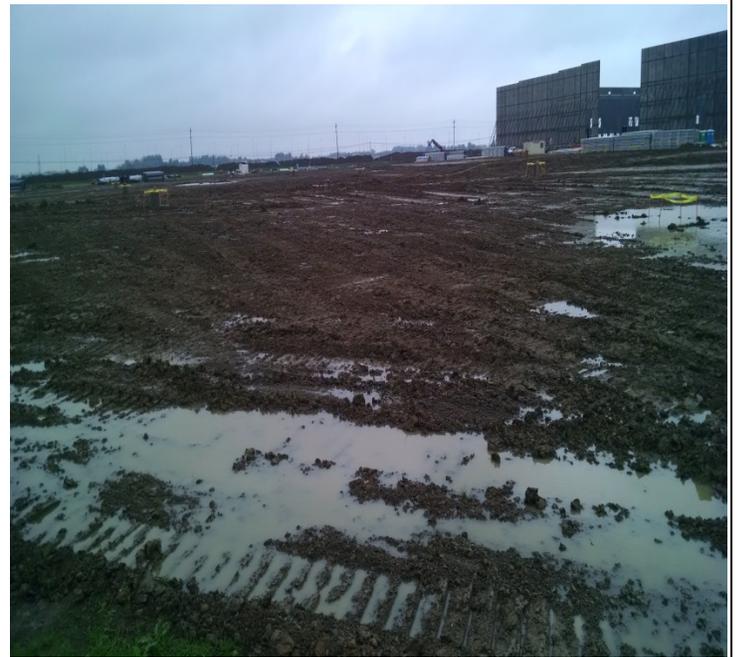
Photo #2 - 12/10/16 - Severe lack of erosion control throughout project. Water from this area flows to active drainage system. Southside of site

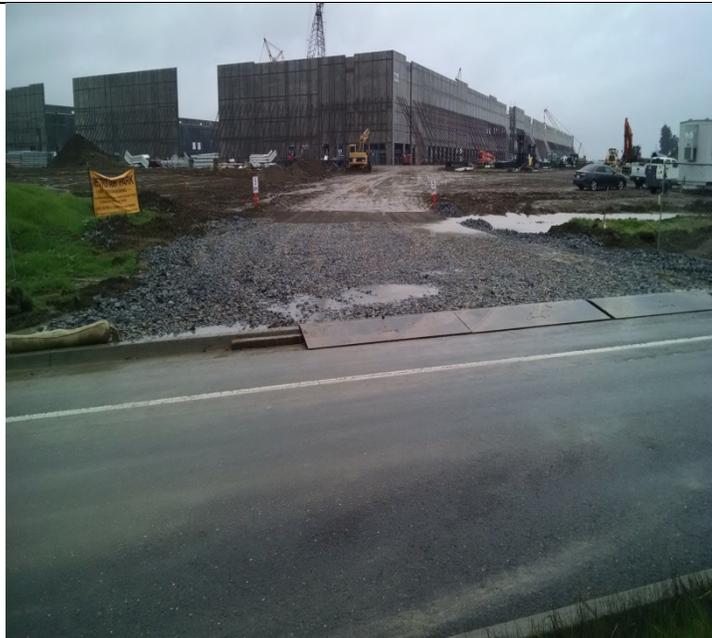
Photo #3 - 12/10/16 - Ineffective tracking control. Sediment deposition on West Elkhorn. Southside of site.

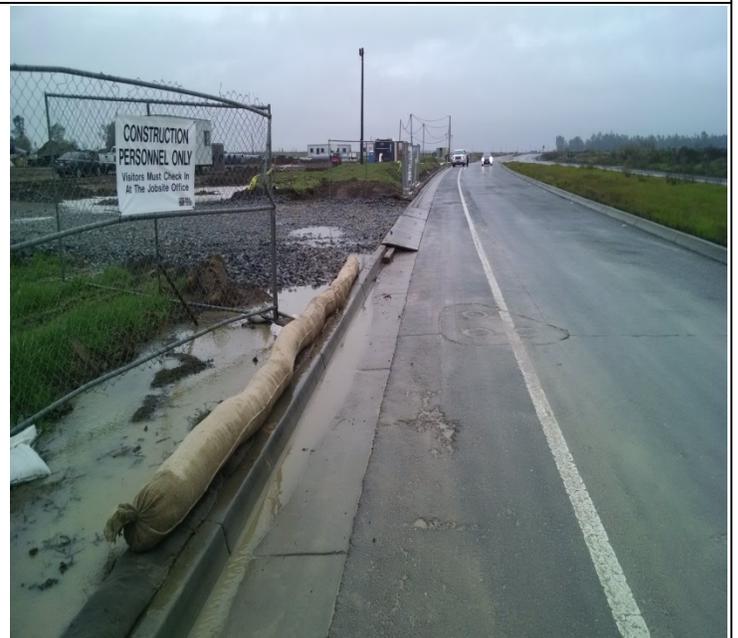
Photo #4 - 12/10/16 - Ineffective perimeter protection. Turbid water flowing off site. Southside of site

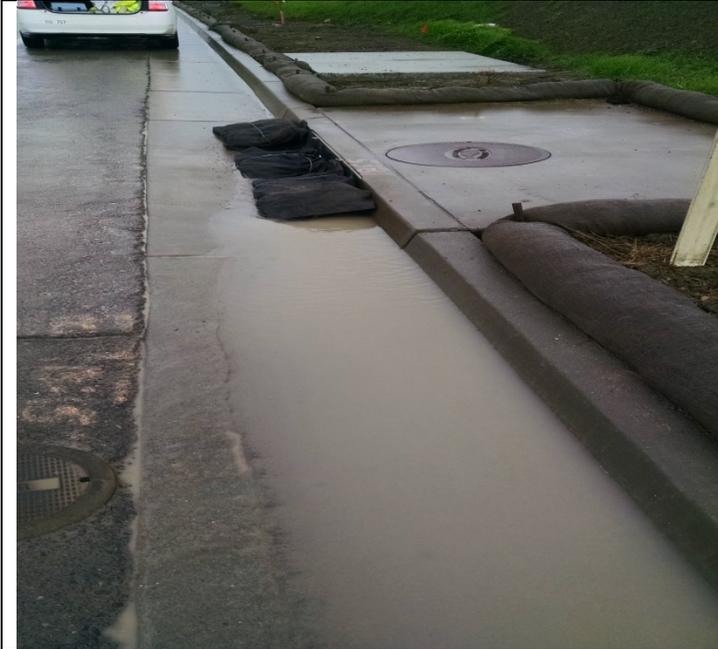
Photo #5 - 12/10/16 - 12/10/16 - Sediment laden water discharging into County of Sacramento Municipal Separate Storm Sewer System (MS4). Southside of site

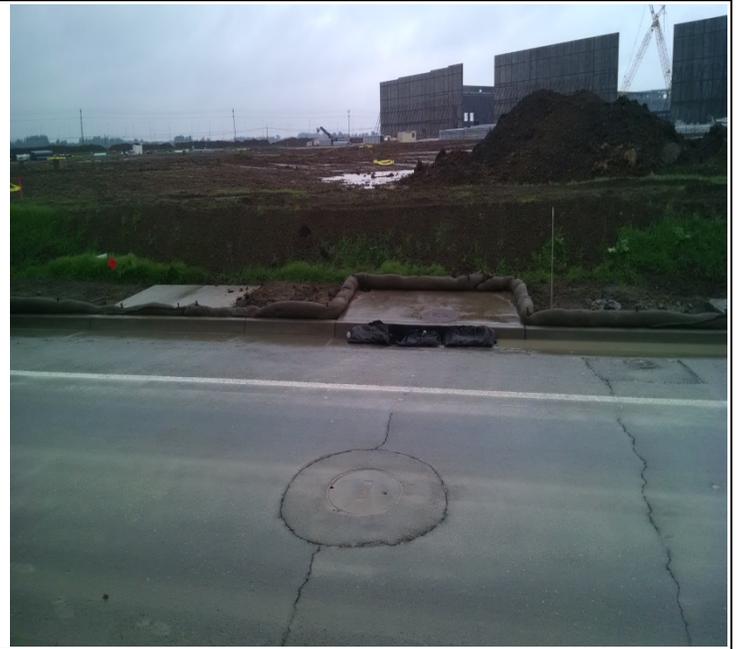
Photo #6 - 12/10/16 - Severe lack of erosion control and tracking. Southside of site

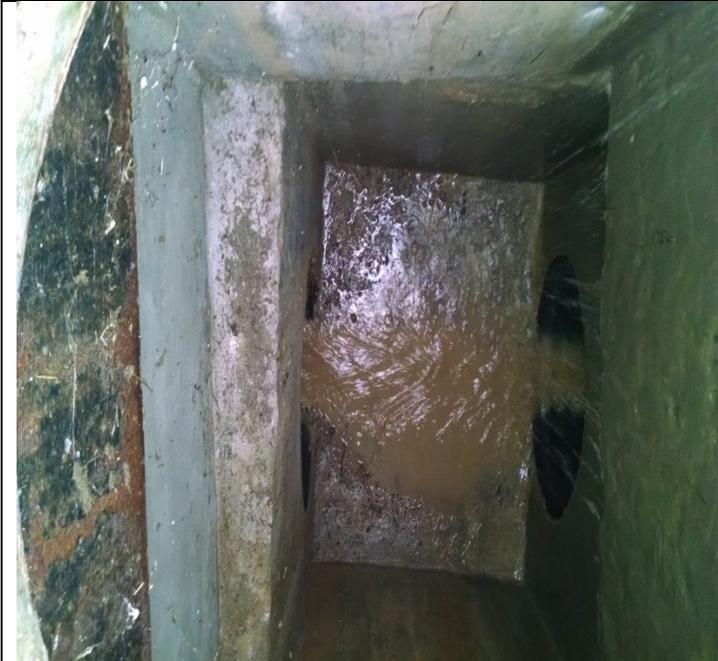
Photo #7 - 12/10/16 - Sediment laden water flowing through County MS4. Structure shown in photo #6

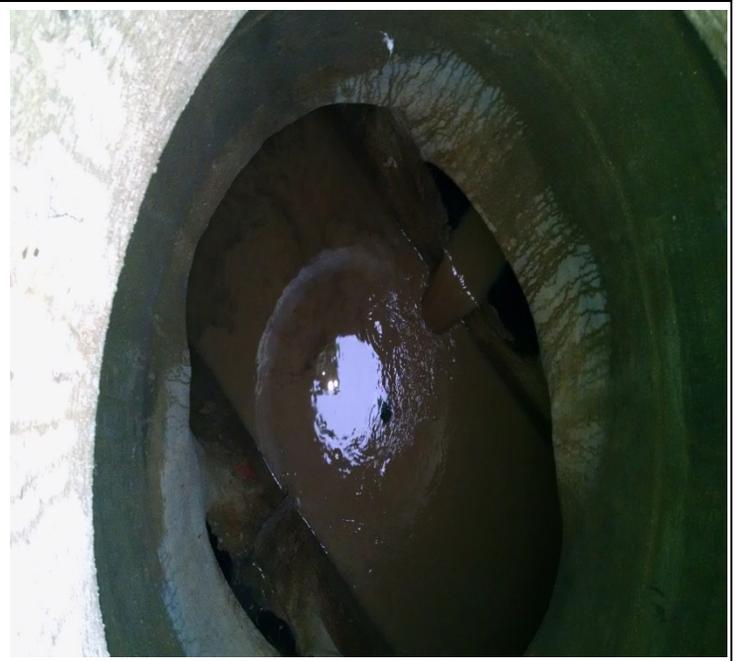
Photo #8 -- 12/10/16 - Sediment laden water discharging into County MS4. Manhole shown in photo #6

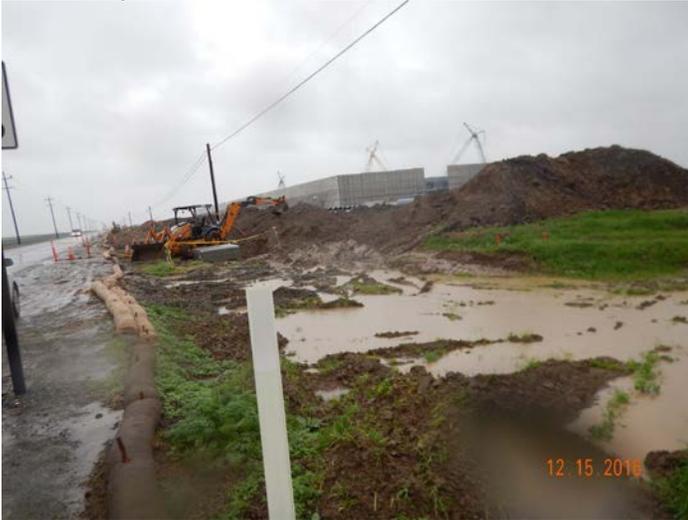
Photo 1. Unstabilized exposed soil throughout the site.

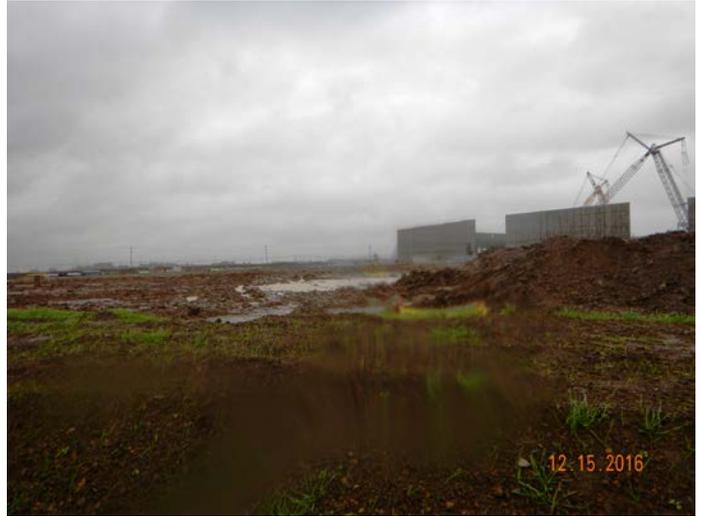
Photo 2. No erosion control BMPs observed. DI plugs are being used but are leaking.

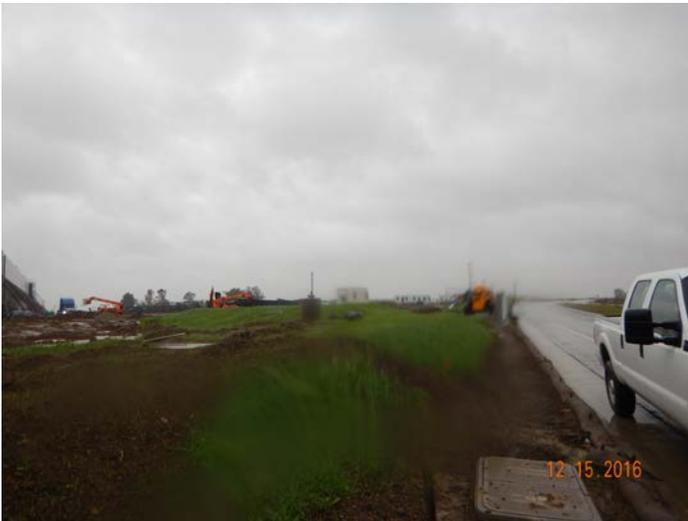
Photo 3. Another view of site conditions. Some vegetation along Powerline Road.

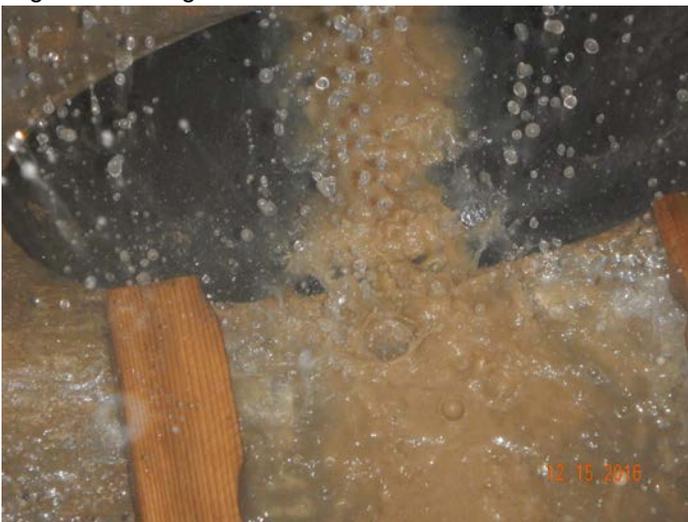
Photo 5. Sediment laden storm water discharging into manhole on West Elkhorn Blvd.

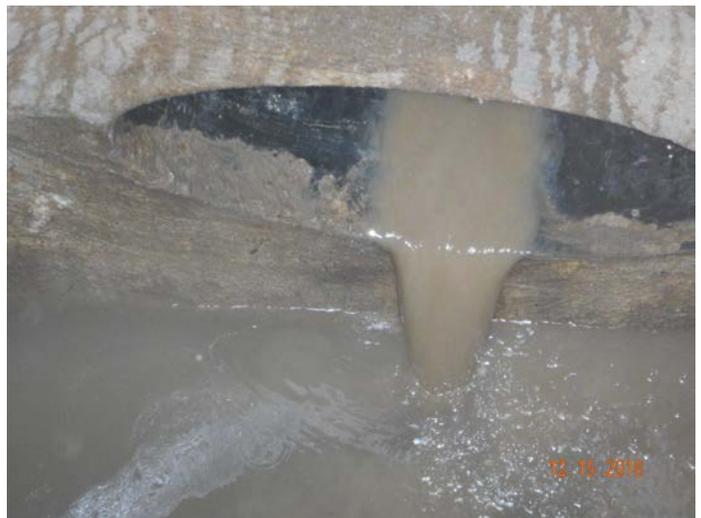
Photo 6. Another manhole on West Elkhorn Blvd discharging sediment laden storm water.

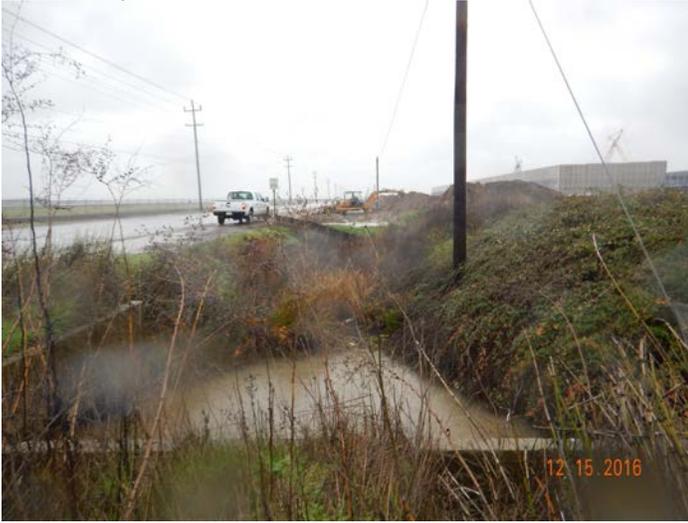
Photo 7. Drainage ditch along Powerline Road. Sediment laden storm water was discharging from the site into the ditch.

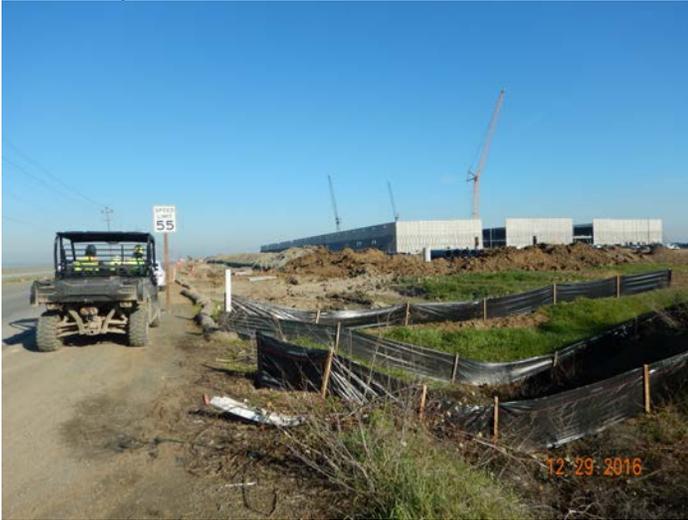
Photo 1. Unstabilized soil exposed throughout the site. Looking north along Powerline Road at ditch where previous discharge was observed. New silt fence in ditch.

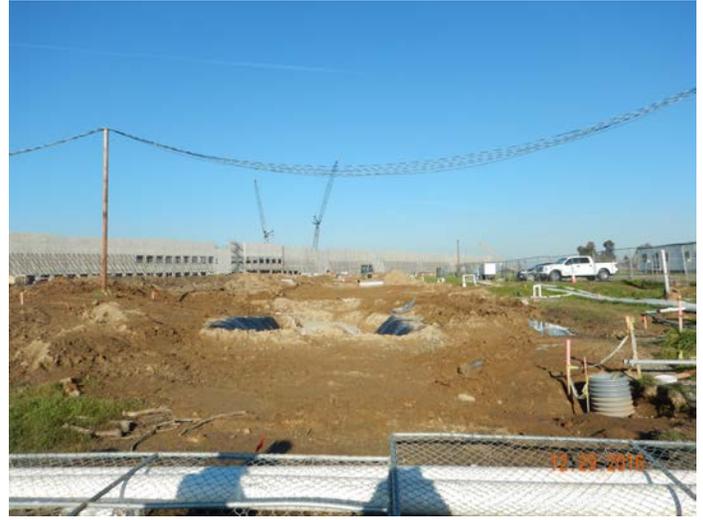
Photo 2. No erosion control BMPs observed. Looking north along east boundary of site.

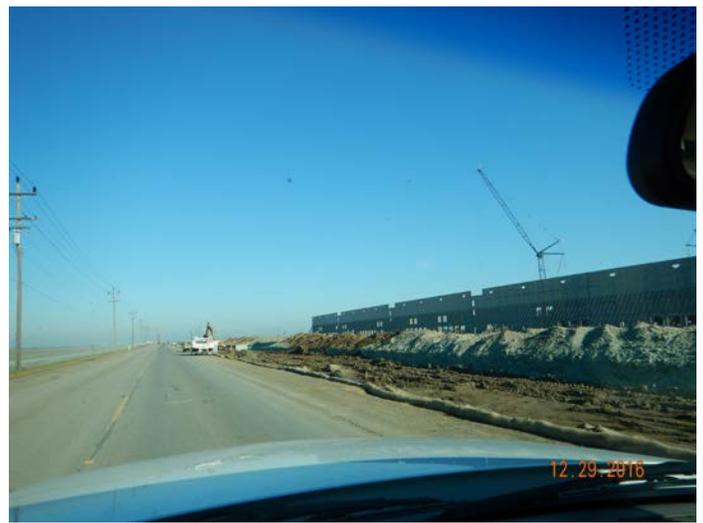
Photo 6. Looking north along Powerline Rd. Areas need erosion control. Some spray on erosion has been sprayed on some of the stockpiled soil.

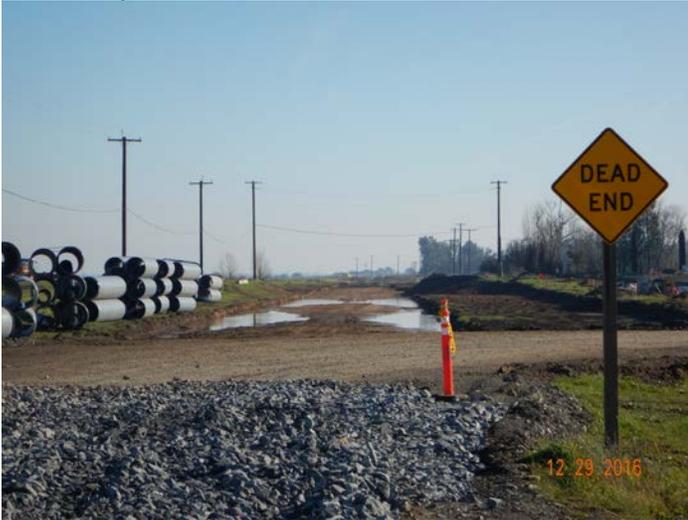
Photo 7. Skyking Road cut. Water is being pumped from east basins to road cut and then to adjacent north field.

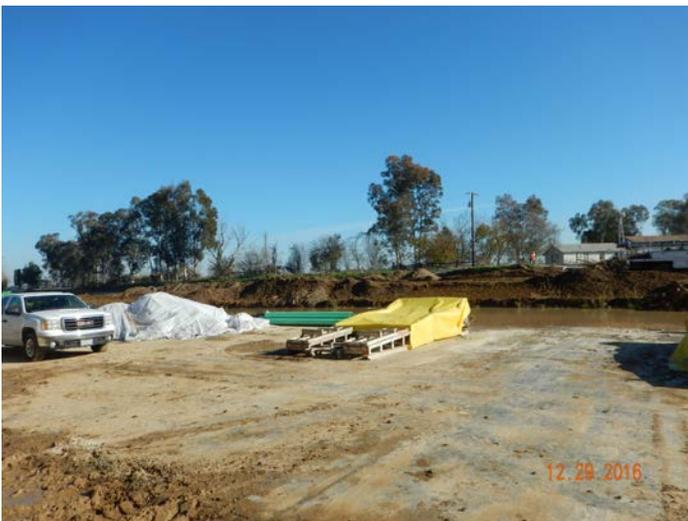
Photo 11. East basin area. Concrete washout area in Photo 12 had spilled or leaked on the ground.

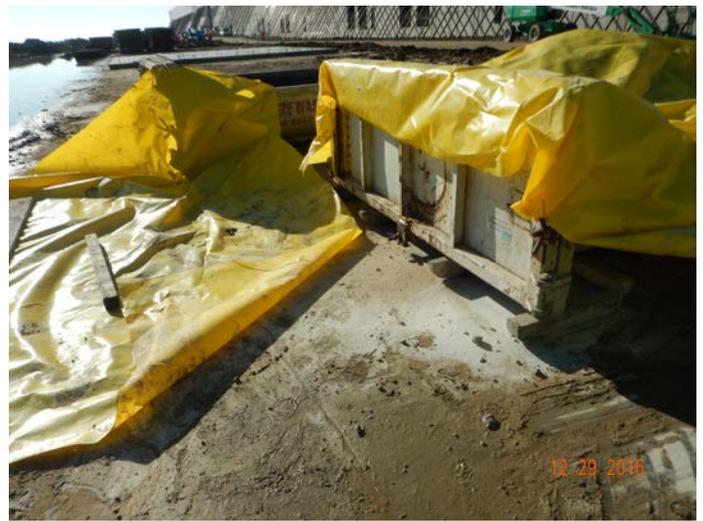
Photo 12. Concrete waste on the ground between bin and basin. High pH measured in basin water.

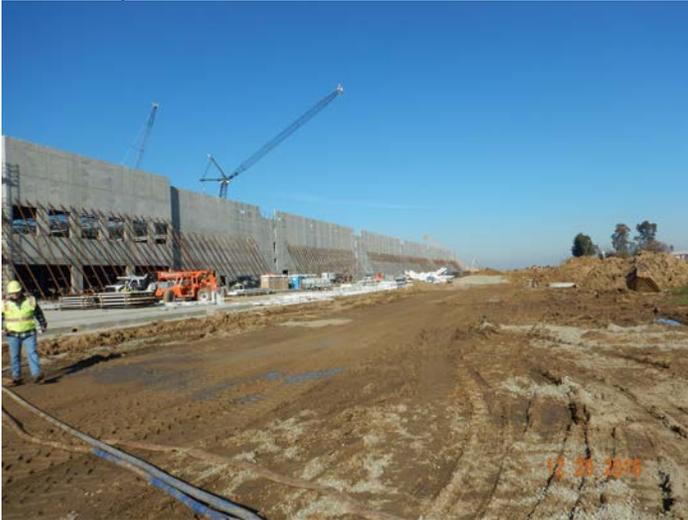
Photo 13. Looking north along east boundary. Building footings being pumped to second basin on east boundary.

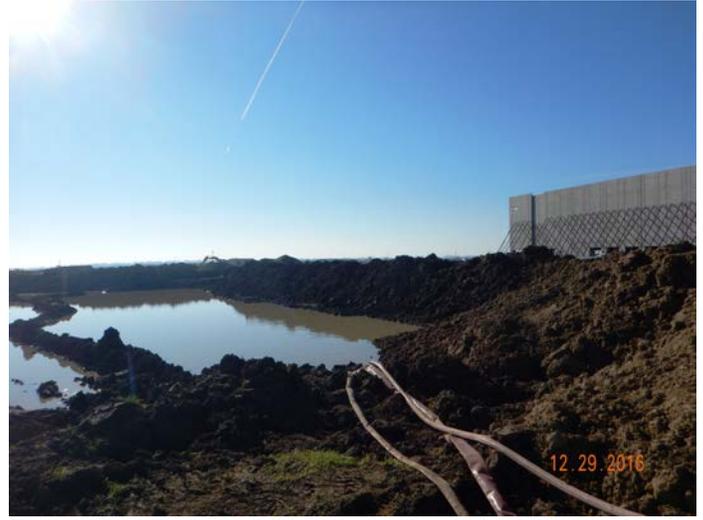
Photo 14. View of additional east basin looking south along east boundary. Building footings were being pumped into this basin.

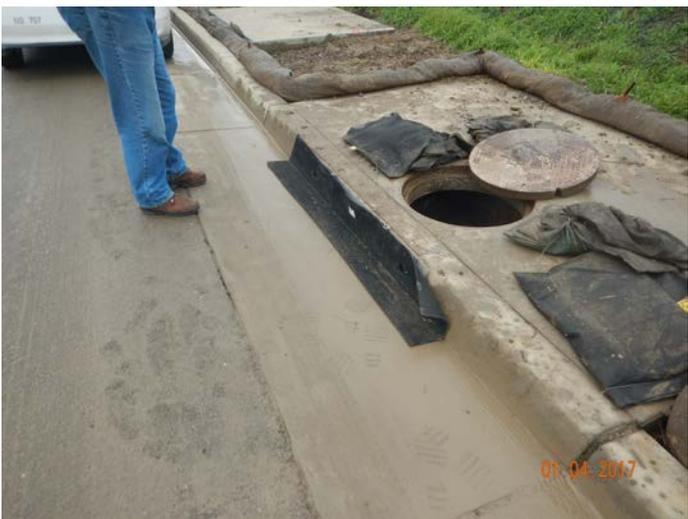
Photo 5. Looking at storm drain inlet and manhole along W Elkhorn Blvd. Sediment in gutter and around manhole.

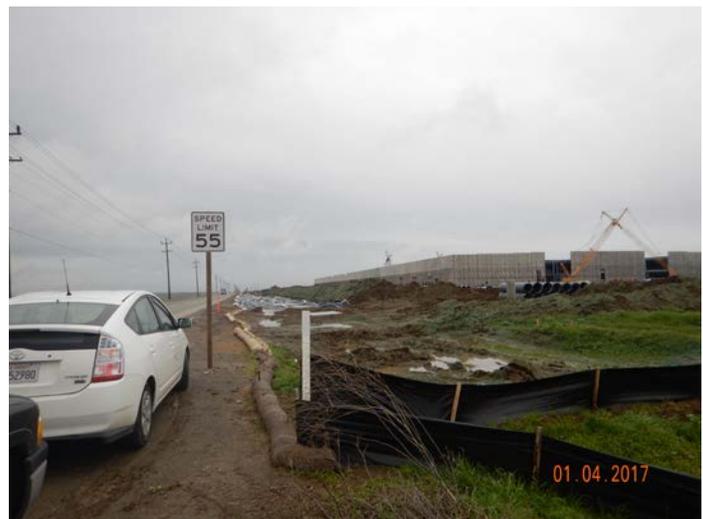
Photo 6. Looking north along Powerline Rd. Areas need erosion control. Spray on erosion control was applied on some of the stockpiled soil.

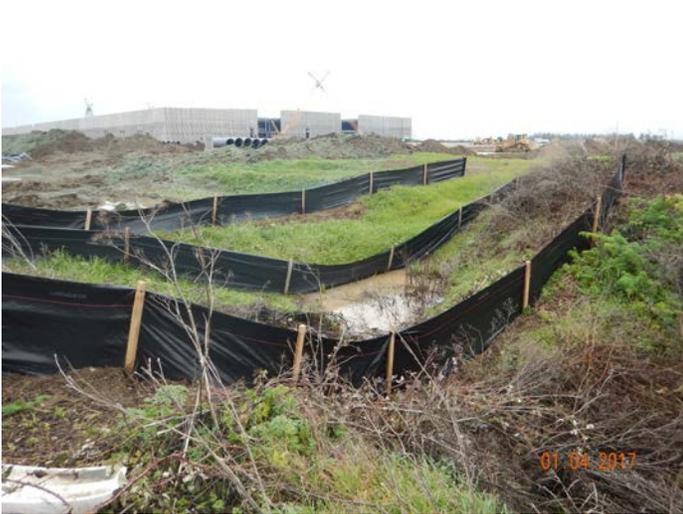
Photo 7. Looking northeast from RD 1000 ditch. Sediment laden storm water entering ditch.

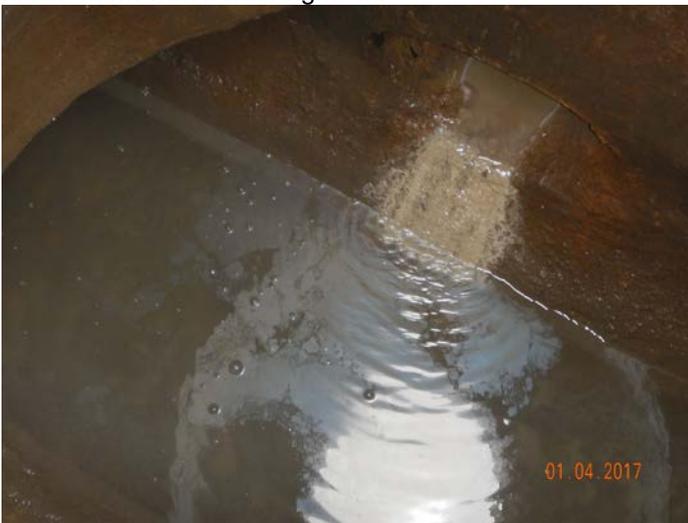
Photo 9. Discharge into manhole on W Elkhorn Blvd. adjacent to recently lime treated area.

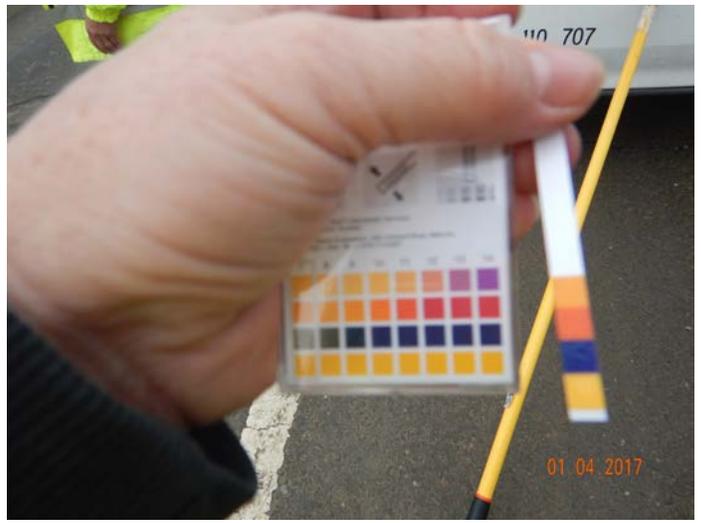
Photo 10. Sampled water in manhole from photo 9 shows pH of approximately 11.

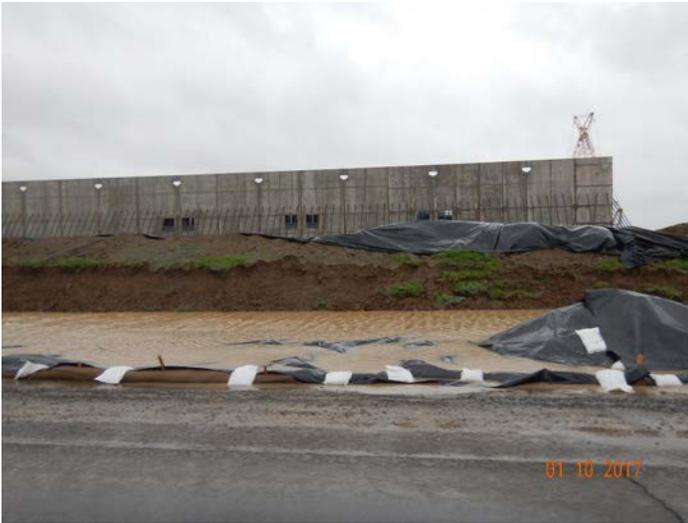
Photo 1. Failing spray on erosion control on Powerline Road..

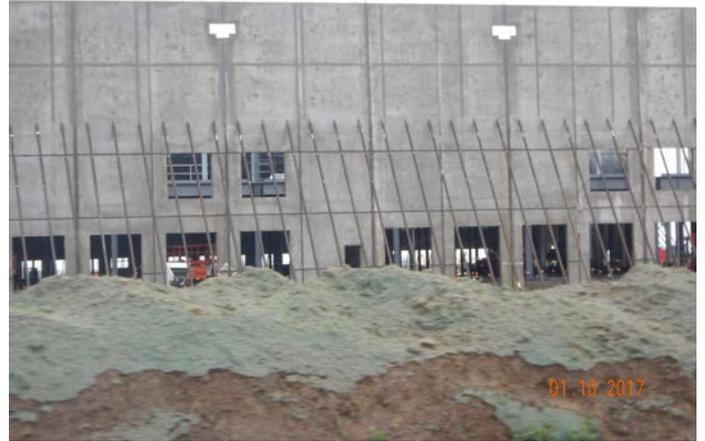
Photo 2. Erosion along Powerline Road into drainage ditch.

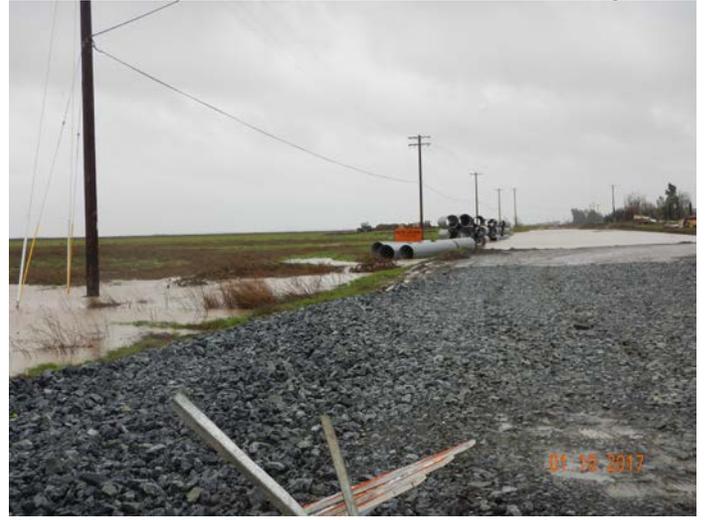
Photo 8. Skyking Road storage basin was full.

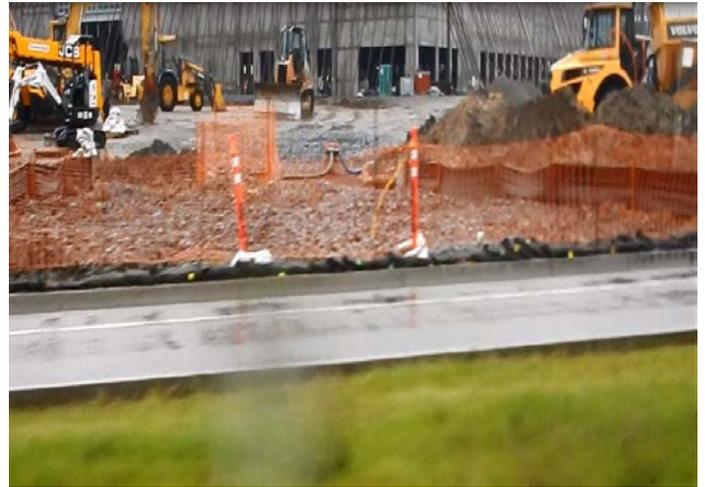
Photo 10. Entrance to site. Pumping and rock bags installed to help prevent discharge to street.

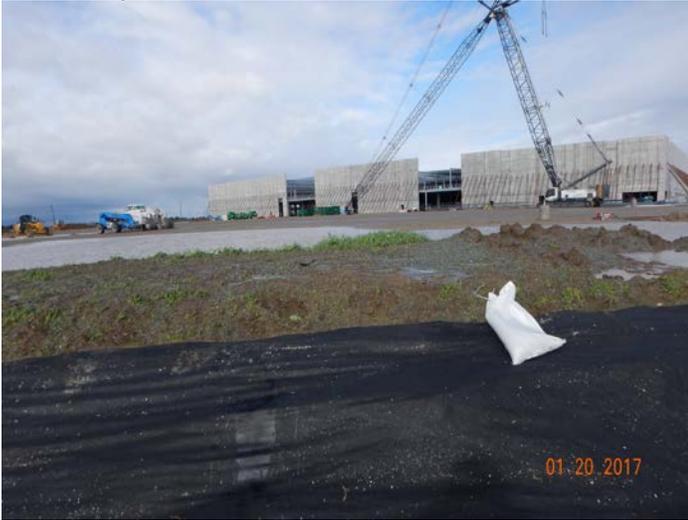
Photo 1. W Elkhorn Blvd looking northwest. Spray-on erosion control BMP on berm has washed away.

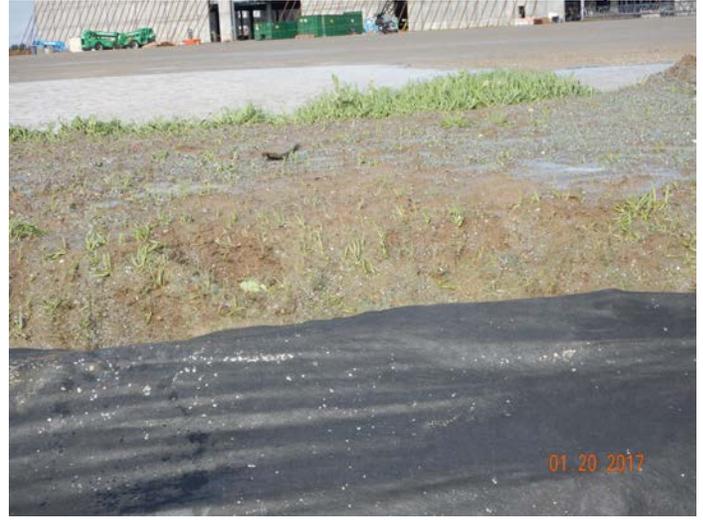
Photo 2. Close-up of sprayed area from Photo 1 shows spray-on erosion control BMP has washed away.

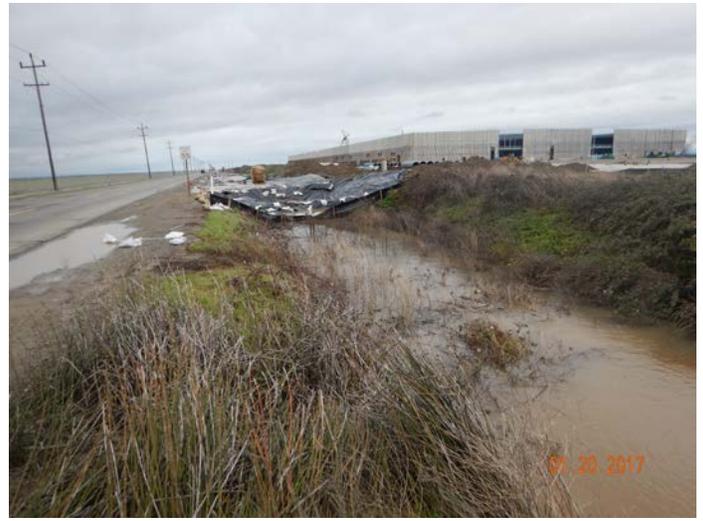
Photo 4. RD 1000 channel disturbance covered with plastic. Turbid water from the airport was discharging into the RD 1000 channel through a culvert under the road.

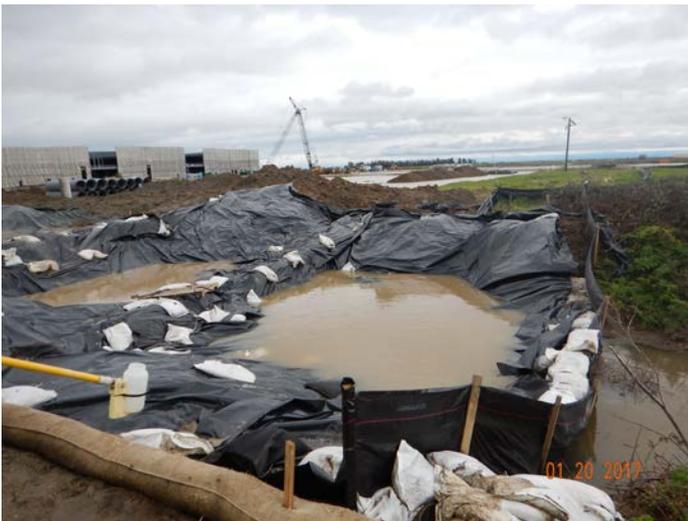
Photo 5. Powerline Road at RD 1000 channel disturbance looking northeast. Basin has potential to discharge into the channel during storm events.

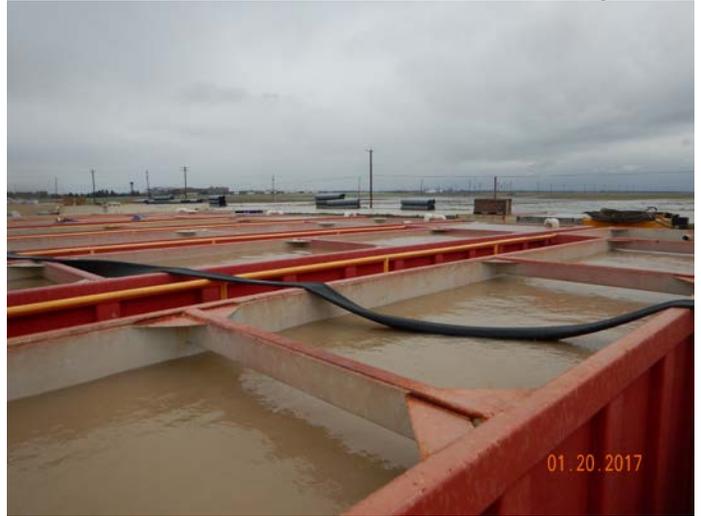
Photo 8. ATS tanks staged along north perimeter of site full of storm water. The ATS system installation was not complete at the time of the inspection

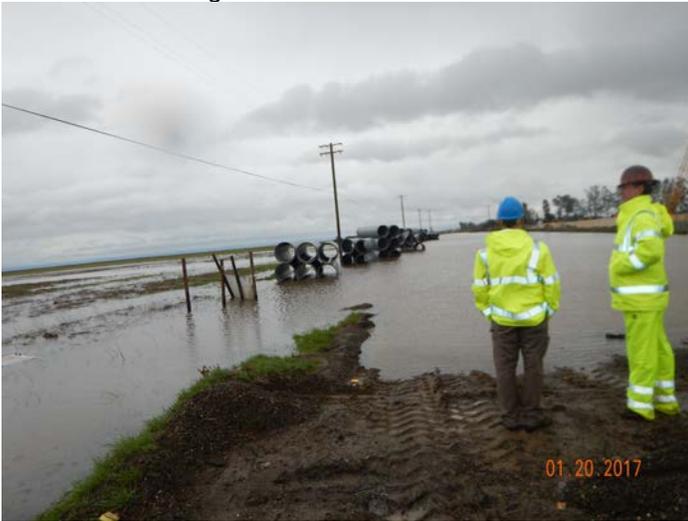
Photo 9. Skyking Road cut basin looking east. Road cut is flooded and receiving run-on at the northwest corner of the Project from the fields to the north.

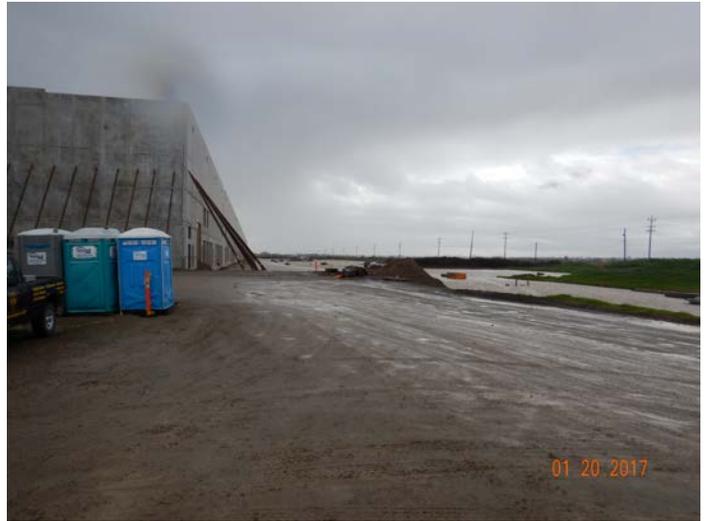
Photo 10. Low area on the west side of project was flooded.
