THERMALITO IRRIGATION DISTRICT

April 2, 2004

Re: Discharges into Thermalito Power House Tail Channel between Wilber Road,
and Thermalito Power House.

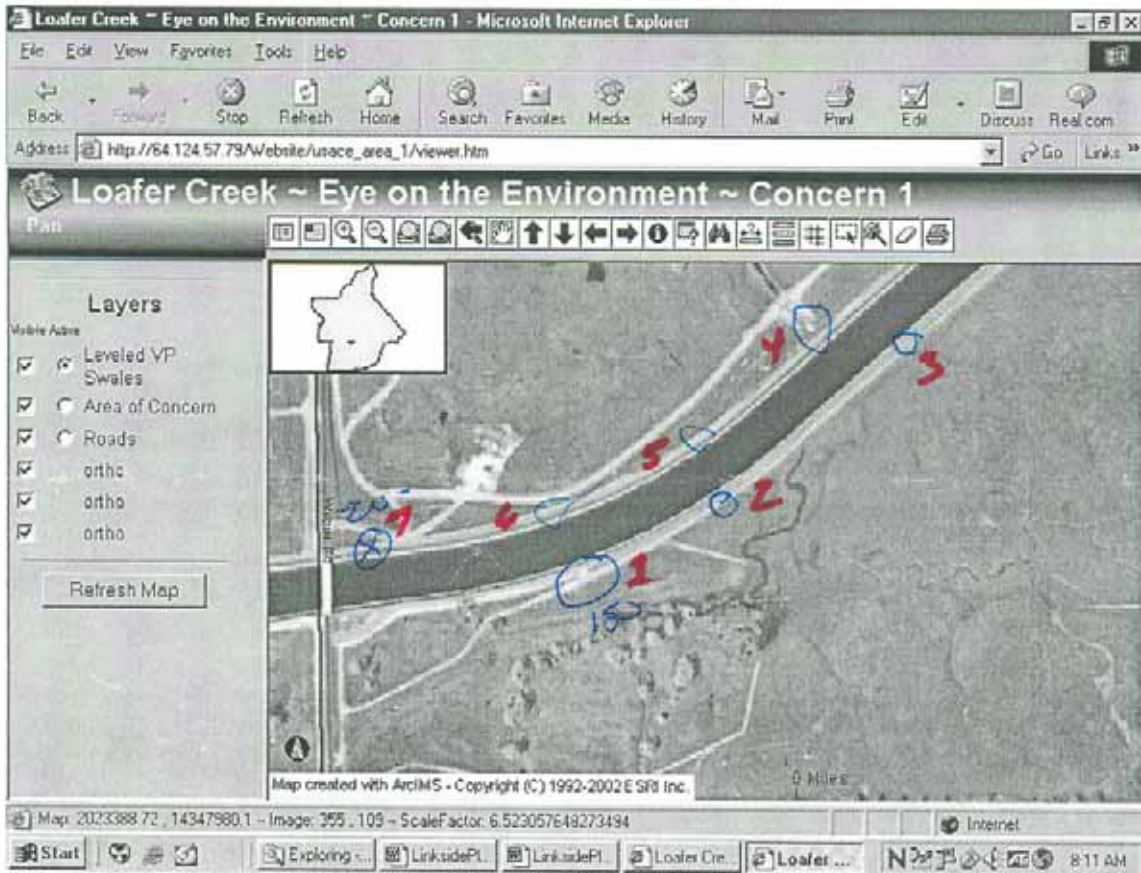
PHOTO #1

After our last conversation regarding the above referenced subject, I walked the Winding Creek in question from the 36' box culvert Item 1, Photo No. 1, to a point due North of the Table Mountain Golf Course, as shown by the red line in Photo No. 2. For lack of a better name, I will call the Winding Creek "Snake Creek", which appears to be the main drainage conduit for approximately 1500 - 2000 acres of mostly unimproved pasture land, both North and South of State Hwy 162. Items 2 thru 7 on Photo No. 1 are various diameter culverts discharging into the Tail Channel and essentially serve localized areas (depression, swale and the like) with the exception of Culvert No. 4 which seems to drain a larger North of the channel area.

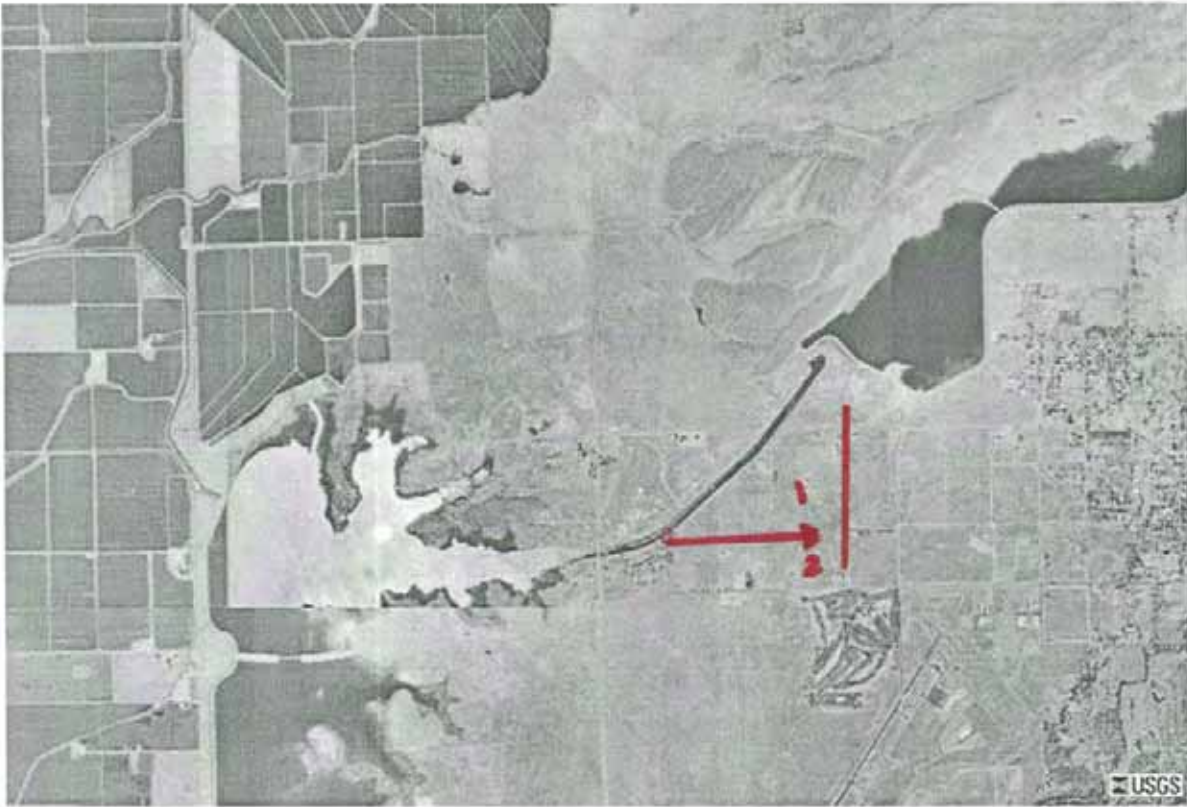
PHOTO # 2

I also noticed excavations and spoil piles of red clay at two (2) residence's which approximate locations are shown as 1 and 2 on Photo No. 2. It is reasonable to surmise that run off from these excavations communicate with Snake Creek. In addition, the entire Snake Creek drainage basin is infested with gophers, generating countless small dirt piles, which to some unknown degree affect water quality, during periods of high runoff.
