Red Ink Mine Waste Pile #5 Review

An onsite meeting concerning the stability of the Red Ink mine waste pile #5 occurred on October 4th, 2011. The following were in attendance,

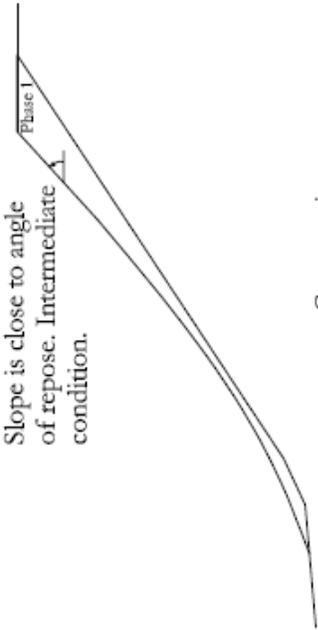
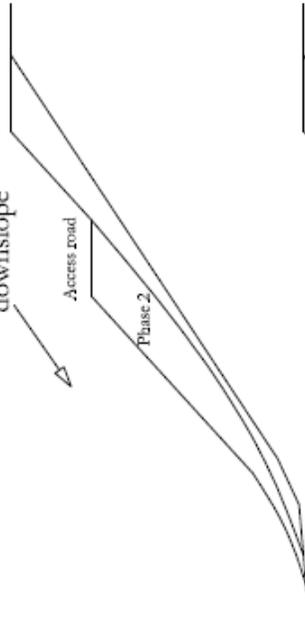
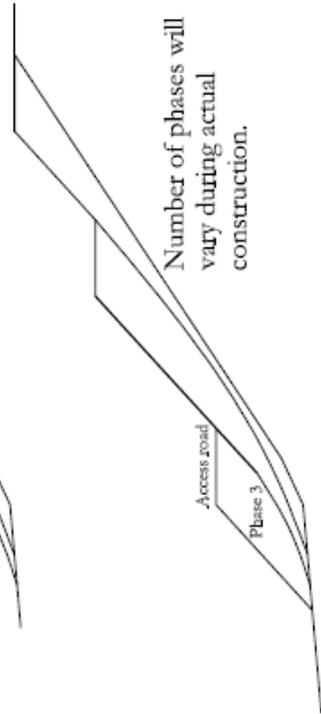
FIGURE 1

~42 degrees currently.
Slope is close to angle of repose. Intermediate condition.

Micropiles: Shear key or micropiles can be placed at toe to augment global stability of waste dump - particularly during seismic event.

Once stable toe is constructed waste rock shall be placed at an angle less than or equal to the required final outslope angle. Proceed upslope to bench elevation.

Horizontal reinforcing elements allow steeper outslope to be achieved.

33 deg maximum

Final grade shall equal stable slope angle specified in Holdrige and Kull report of 33 degrees. Final design details for alternatives depicted is the responsibility of the Operators engineering representative. The construction sequence depicted is interpretive and may not accurately represent the intermediate construction configuration(s). The Operator is responsible for stability of both intermediate and final outslope configurations.
