CENTRAL VALLEY REGIONAL WATER QUALITY CONTROL BOARD

INSPECTION REPORT

DISCHARGER: Walker Mine

INSPECTION DATE: 24-25 October 2006

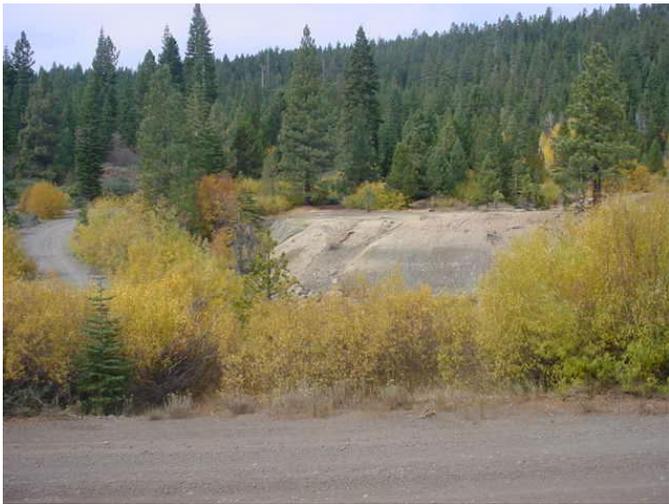
Walker Mine Portal Area, waste dump located up gradient of Dolly Creek.

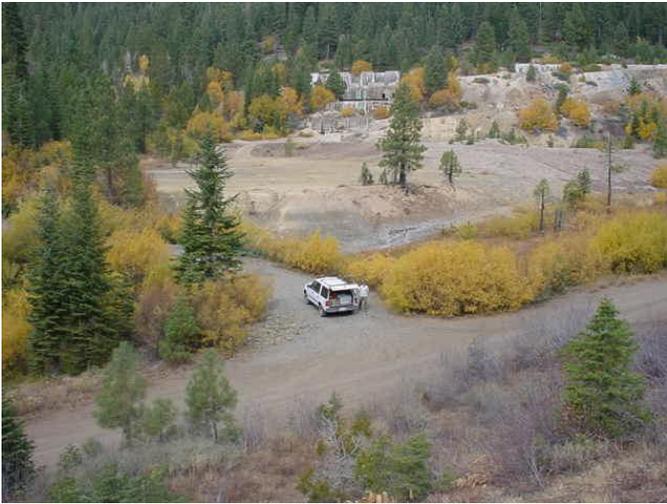
Walker Mine #3. Dolly Creek drainage is located just forward of the vehicle.

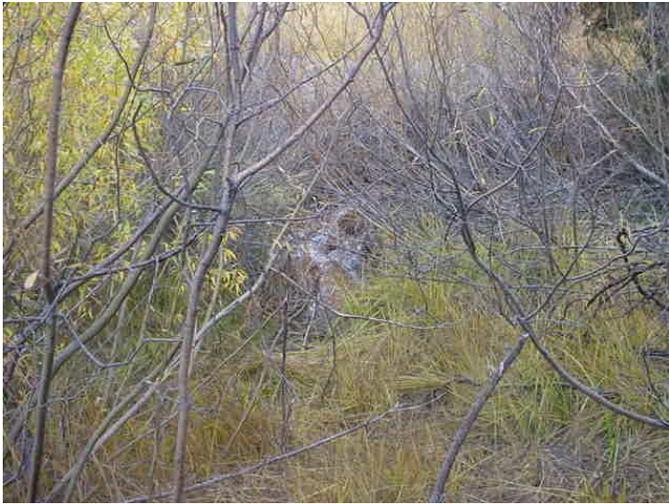
Walker Mine #3. Dolly Creek below mine access road.

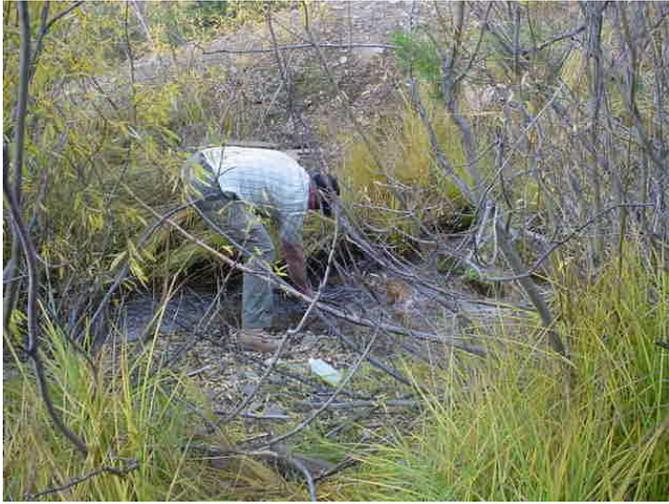
Walker Mine #3. Dolly Creek below mine access road.

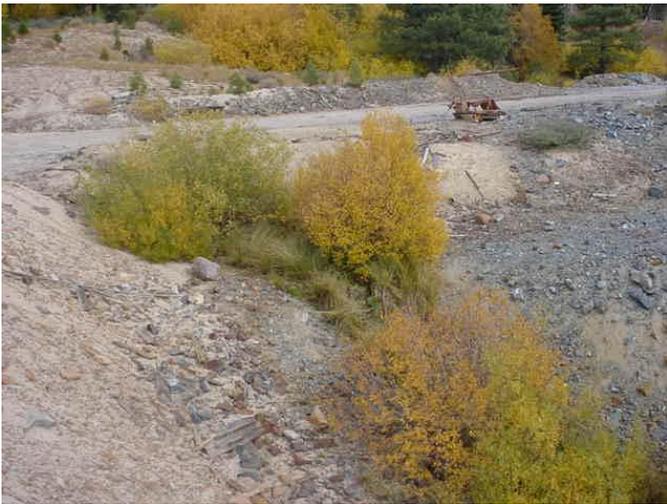
Walker Mine #1. Portal discharge sampling location.

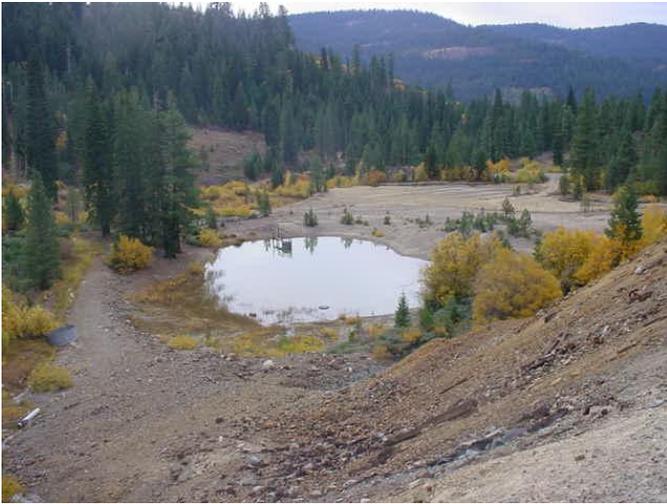
Surface water samples were taken from all but three of the usual sampling locations. There was no discharge from the settling pond (sample location number 19), thus no sample was taken from this location. Sample location number 10 was not sampled because of time constraints, and sample location number 23 was omitted. The South Branch of Ward Creek (sample location number 11) was dry. However sufficient water was present in a small pool at the culvert outfall to obtain a sample. All of the other sample locations had sufficient surface water to sample. Laboratory results are pending.

Walker Mine # 19. Settling pond downstream of mine portal.

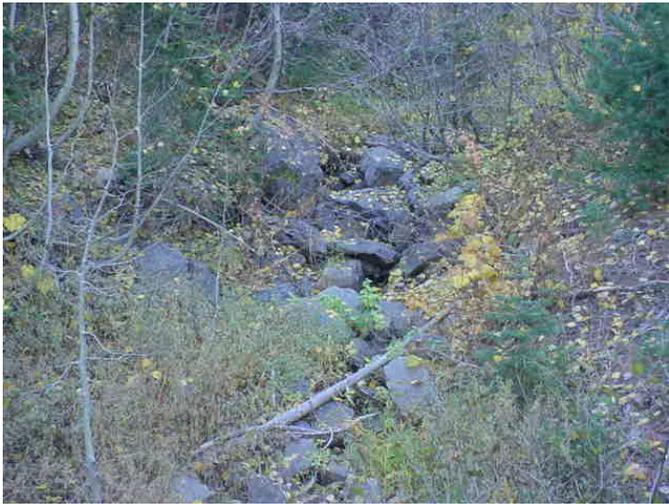
Walker Mine #11. South Branch of Ward Creek at USFS Road 25N42.

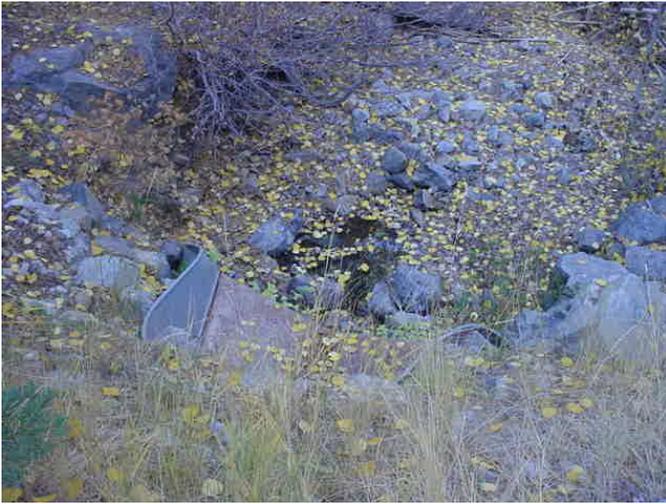
Walker Mine # 11, South Branch of Ward Creek (Road 25N42) Culvert Outlet. South Branch of Ward Creek was dry, however a small pool existed at the culvert outlet and this became the sample point.

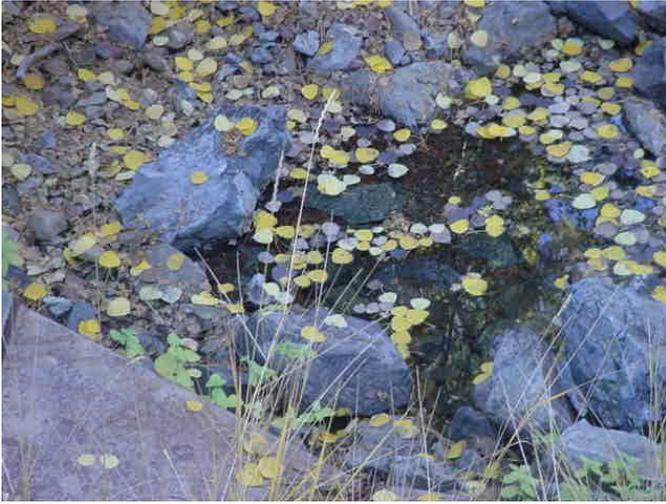
Walker Mine #11. South Branch of Ward Creek, Culvert Outlet Pool.
