CENTRAL VALLEY REGIONAL WATER QUALITY CONTROL BOARD

INSPECTION REPORT

DISCHARGER: Walker Mine

INSPECTION DATE: 11–12 June 2007

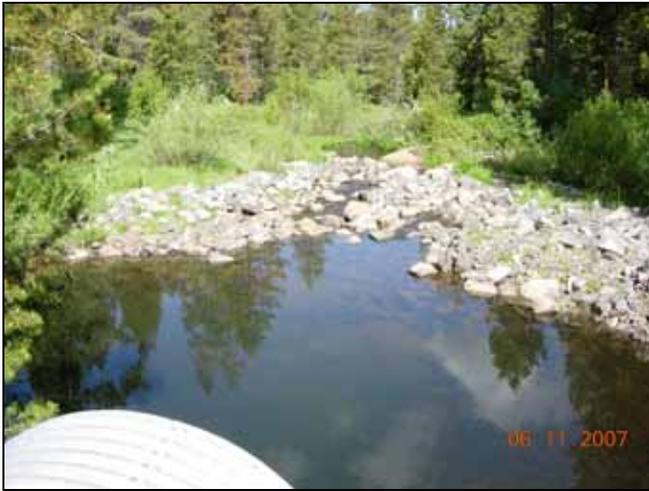
Surface water samples were taken from 18 of the 25 sampling locations. There was no discharge from the settling pond (Photo 9), thus no sample was taken from this location (sample location number 19). All of the sample locations had sufficient surface water to sample, however water flow in general was low (Photo 2). Laboratory results are pending.

2. Same as previous photo. Looking downstream.

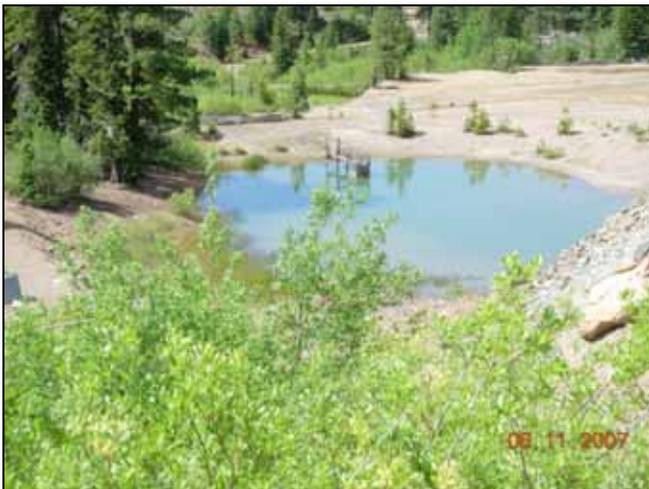
9. Small sediment pond below the Walker Mine portal.

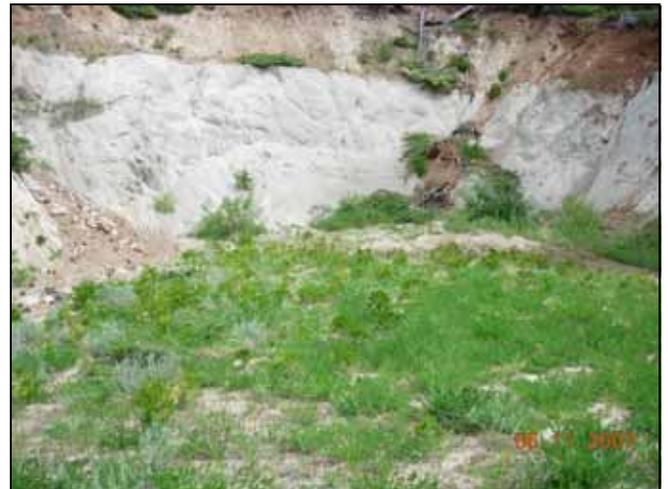
12. Same view as previous photo. Note the poor vegetative cover and erosion from the cut slopes.

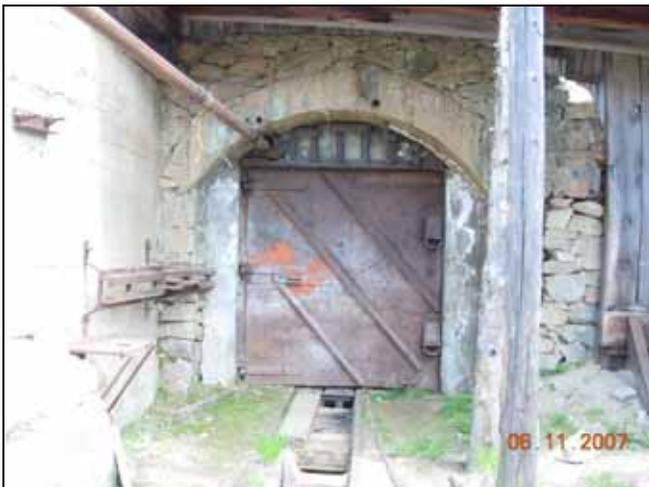
Board staff arrived on site at the Walker Mine Portal area at 10:00am. The portal door at the mine entrance was securely locked. There was some evidence of minor vandalism of the wooden planking (Photo 14) that covers the drainage conduit at the entry into the mine and one of the portal door locks. There were several new bullet holes in the steel portal door (Photo 15). Inspection of the ventilation fan, the ventilation ducting and the Telog pressure data recorder showed no apparent damage from the shooting. However, ventilation ducting suspended with large plastic zip ties from the 200 station to the 700 station has fallen to the ground and is unusable for ventilation purposes.

14. Same view as previous photo.

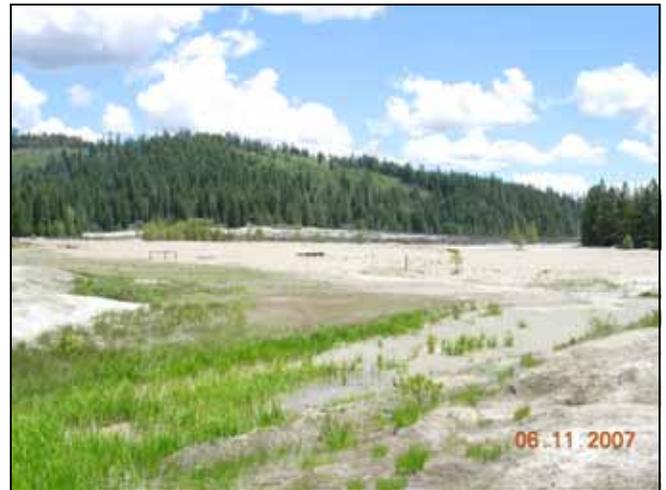
17. Same location. Note the limited vegetative growth.

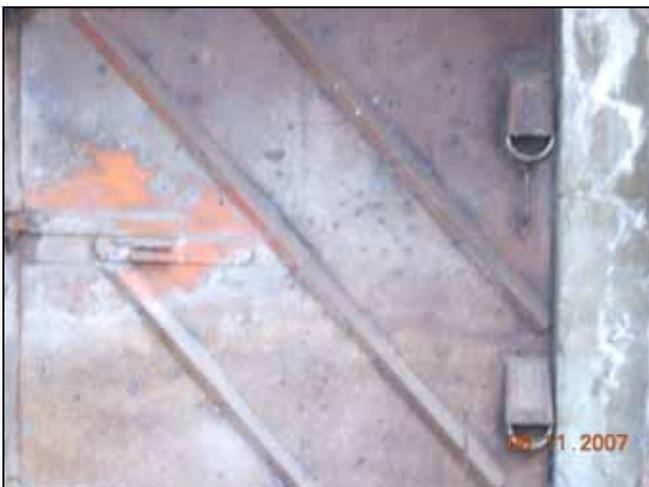
15. Close-up view showing numerous bullet holes in the portal door. The portal access is repeatedly vandalized. Successful entry has been limited.

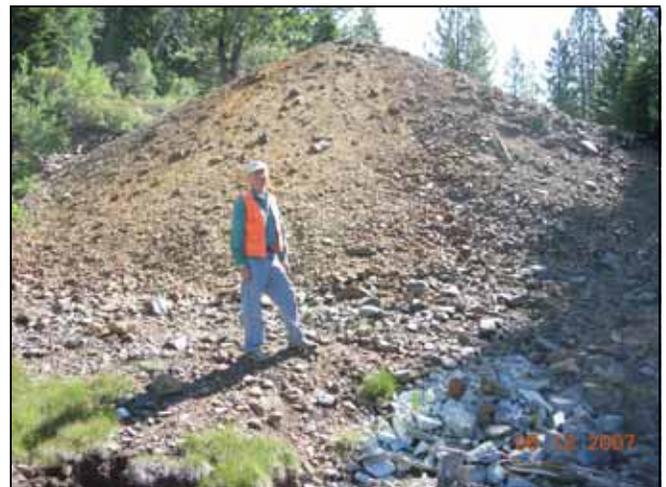
18. Small waste dump from the Central ore body of the Walker Mine. The South Branch of Ward Creek cuts the toe of the small waste dump.

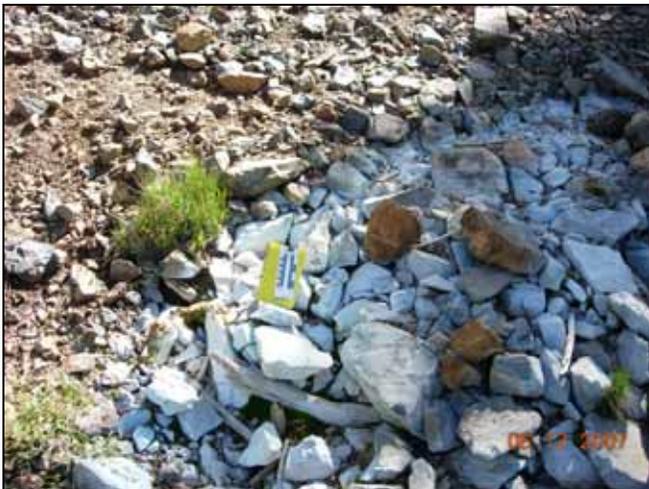
20. Close-up of previous photo showing copper leaching from the toe of the waste dump.

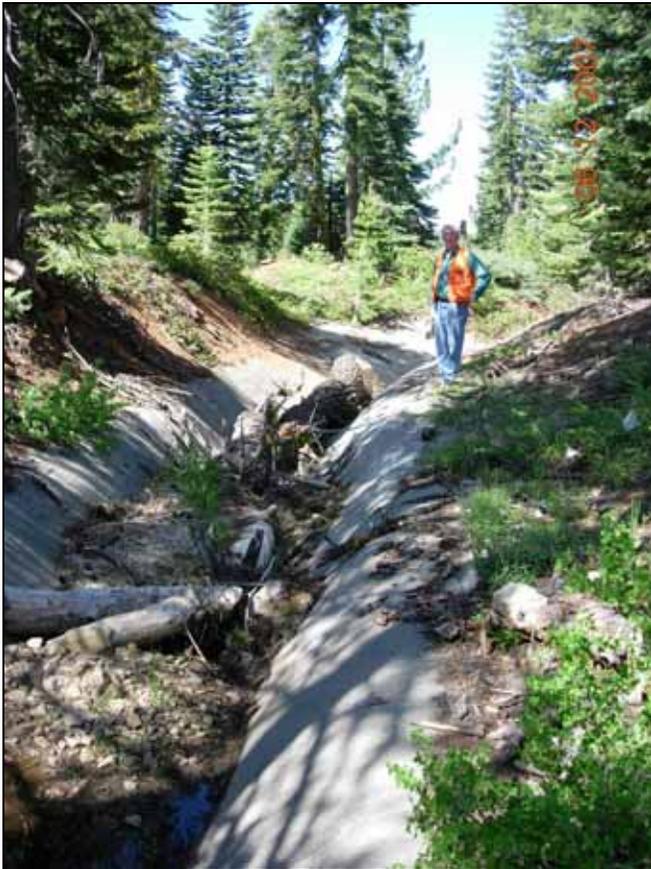
23. Fallen tree and debris in the shotcrete-lined diversion ditches near the Central ore body.

The Central orebody diversion ditch needs to be cleared of fallen trees and debris in order to contain runoff within the shotcrete channel and prevent overflow and potential erosion of the surrounding area. This work could be accomplished using a small hand crew.

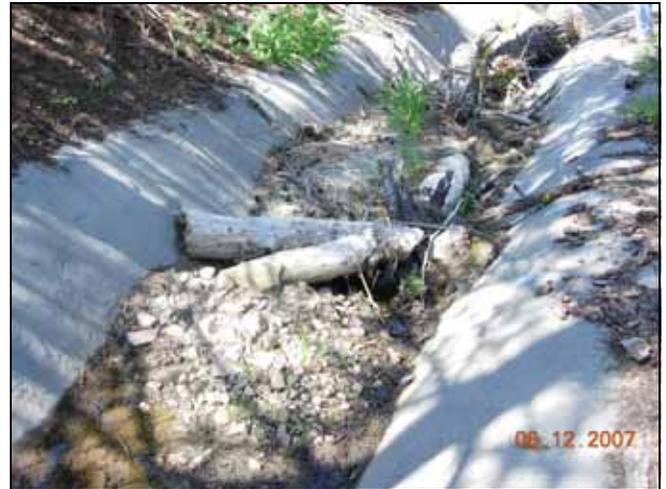
Staff inspected the diversion channel structures in the area of the Central and Piute orebody workings. There was very little water flowing in the diversion channels at the time of the inspection and it appeared that water flow has been minimal for some time. Some fallen trees and debris are partially obstructing the Central orebody diversion ditches (Photos 23–25). A vertical ventilation shaft was identified above the Central orebody (Photo 27–29). This shaft is unprotected and open at least several hundred feet deep. This shaft represents a high risk to anyone who unknowingly comes across the area.

25. Debris partially blocking the diversion ditch near the Central ore body.

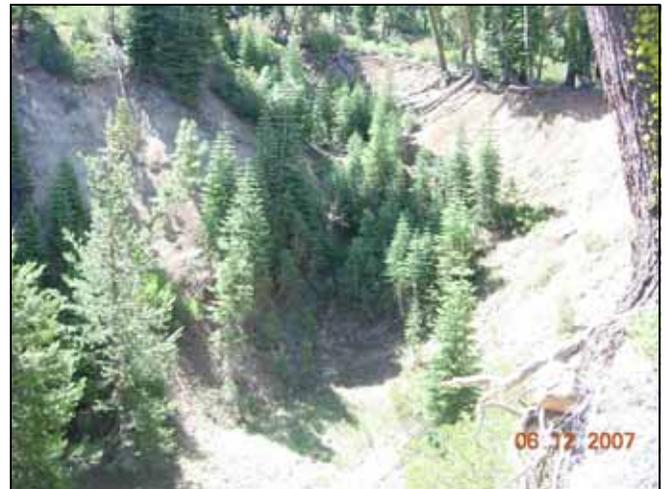
26. One of the sinkholes of the Central ore body

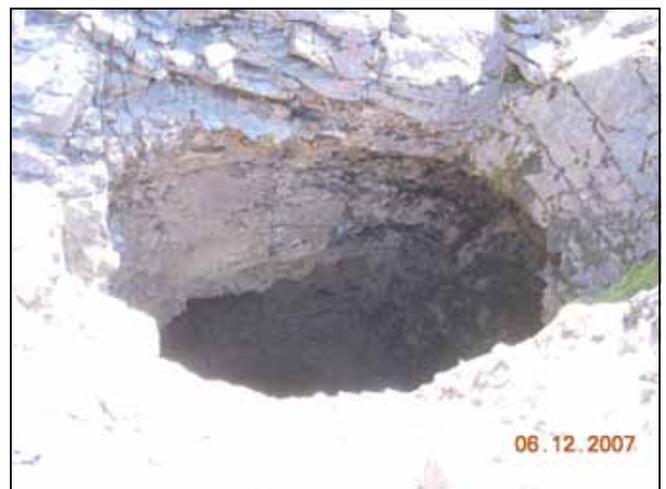
27. Open air shaft of the Walker Mine workings. Located between the Central and Piute ore bodies. The airshaft opening is approximately 9 feet by 15 feet and is at least several hundred feet deep.

Finally, the open ventilation shaft identified above the Central orebody must be guarded or plugged. Board staff will contact the California Department of Conservation Office of Mine Reclamation, Abandoned Mine Lands Unit to request that they immediately act upon this information.
