BECK'S ENTERPRISES

Project: IFB No. 10-038-150

Regarding: Safety and stabilization of the Walker Mine 700' Access Tunnel.

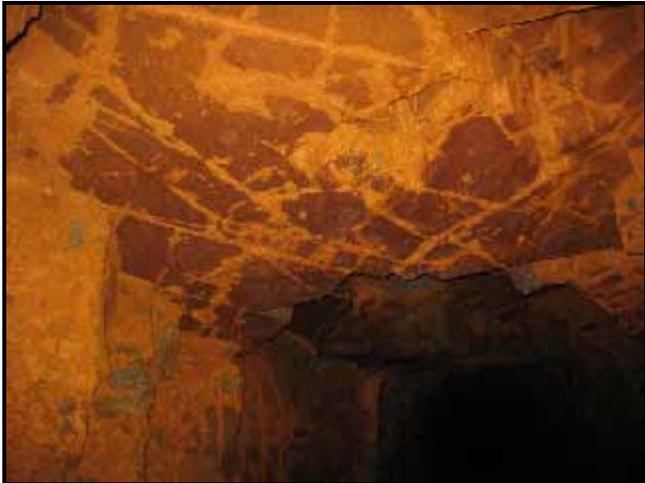
Photo 1. Walker Mine Seam

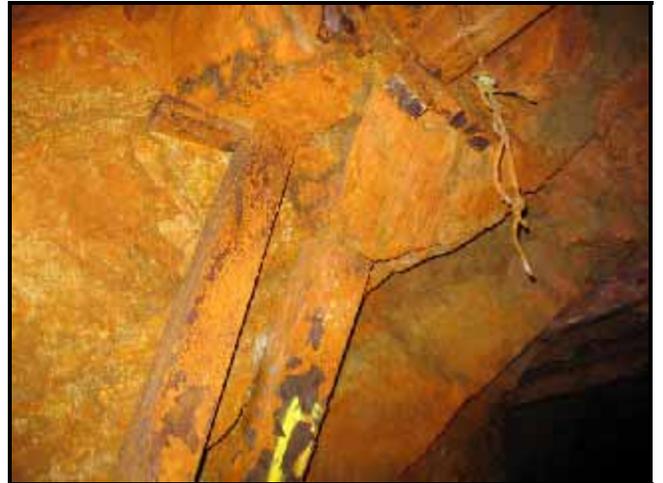
Photo 4. Stalls under Rock.

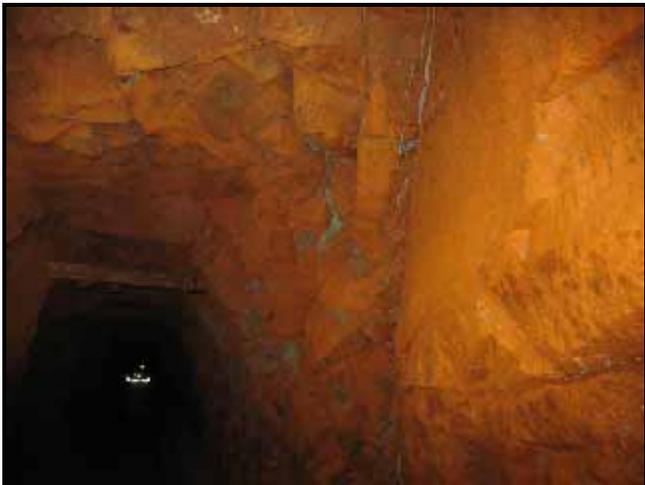
Photo 2. Vertical Seam without Support.

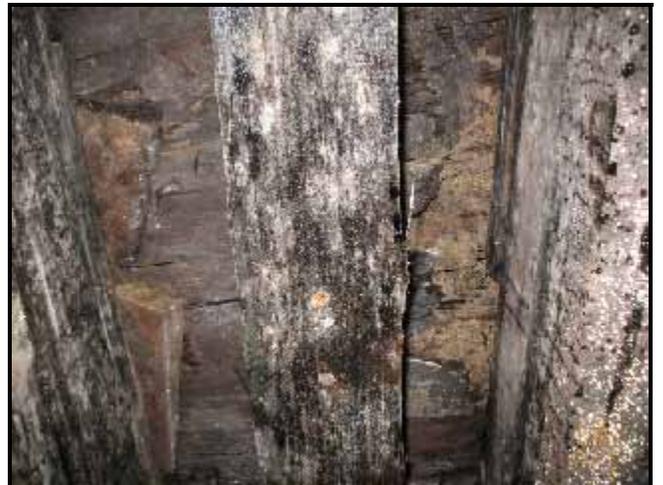
Many of the timbers throughout the Timber Set reach of the Walker Mine 700 Level Adit that have once supported the rock above, have oxidized and rotted. Although they may remain in-place and appear to provide support, they could be totally ineffective. In order to provide future access and maintain safety for personnel for maintenance and inspection purposes some of the timber sets should be replaced.

Photo 5. Rotten Timber – 4 inch penetration.

Beck's enterprises recommends, the Central Valley Water Board consider replacing rotten timber sets, post and caps as outlined above in this report.

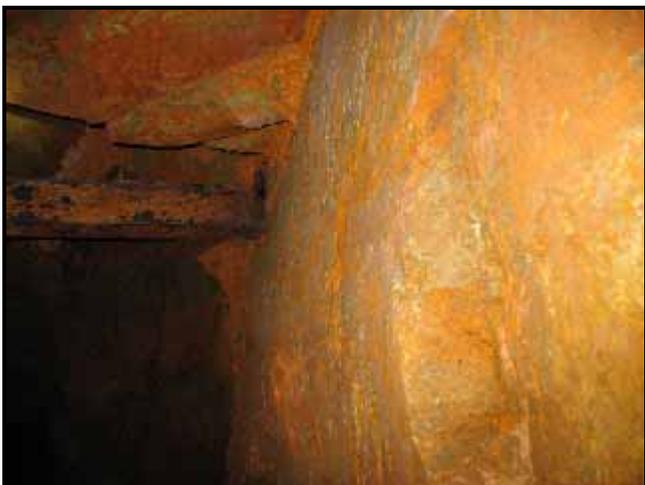
During the inspection of the Bald Headed section, areas in the Walker Mine 700 Level Adit were noted and addressed as potential hazards, due to the excessive amount of mud that is seeping into the mine through fractures and seams located in the back and ribs of the mine. Unlike caves, mines are artificial, temporary openings designed to last as long as it takes to extract the ore. When a mine is abandoned, there is no longer a maintenance program to address deteriorating rock conditions and weakened ground supports. Naturally occurring caves are formed over thousands of years by relatively stable processes, whereas mines are created by blasting, which destabilizes the rock that is left in place. Soft, stratified rock types, such as shale, tend to collapse easily, but often in small pieces. Harder, more massive rock types such as granite, limestone, or sandstone collapse less frequently, but often more catastrophically in large blocks. Keep in mind that mines often follow fault zones, which are inherently unstable.

Photo 3. Vertical Mud Seam.

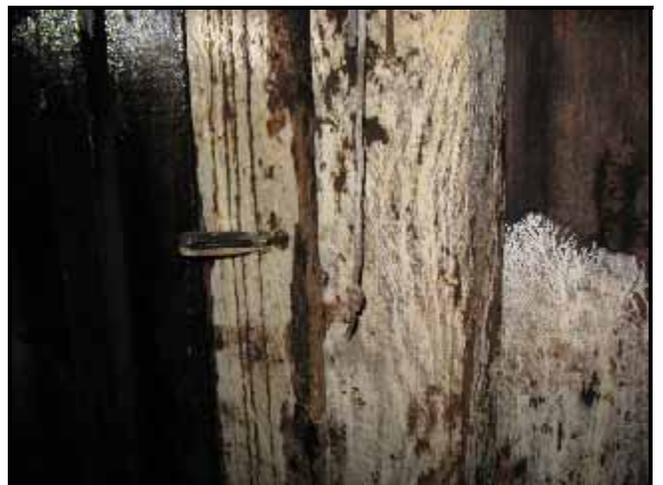
Photo 6. Rotten Timber – 4 inch penetration Vertical Mud Seam.

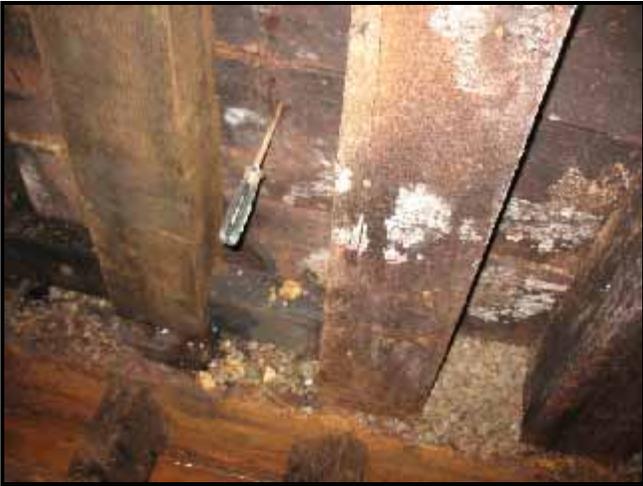
The third reach of the tunnel (station 2+55 to station 11+35) is Timbered Sets, Posts and Caps. There are signs of long term staining and deteriorating timbers with water seepage coming through the fractures and joints of the rocks. Areas could be seen where timbers sets had been replaced during previous repairs. Timber Posts and caps are placed skin to skin to support the heavy weight of loose ground and displaced rocks, extending approximately 350' into the tunnel from the west portal beneath the ancient slide. During the inspection July 23, 2010 it was noted 10% of the existing timber sets need to be replaced due to continuing deterioration (refer to Timber Pictures).

Photo 7. Rotten Timber 4.

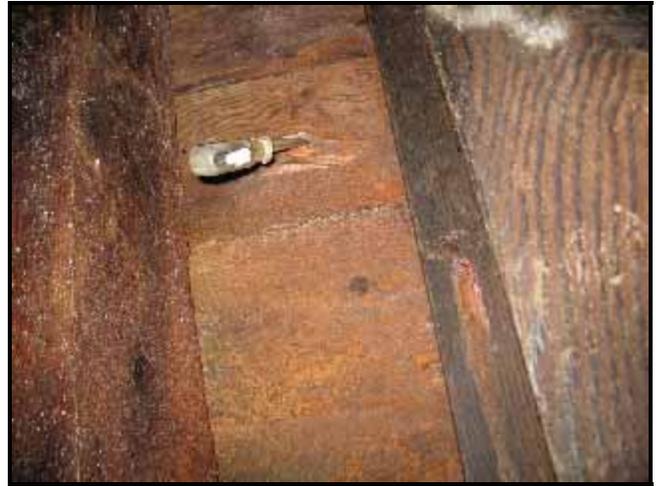
Photo 10. Rotten Timber 1.

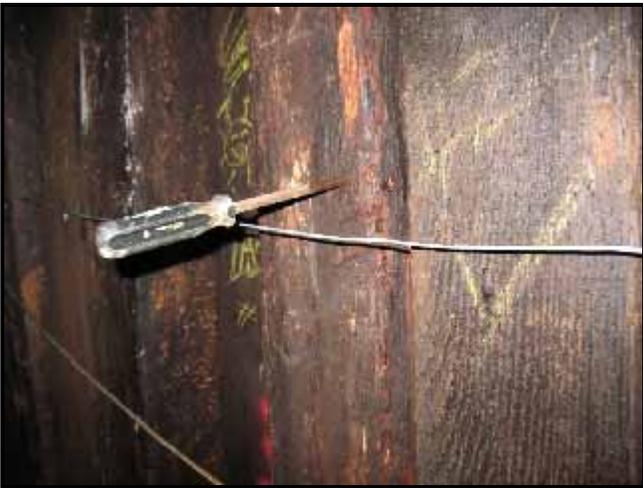
Photo 8. Rotten Timber 3.

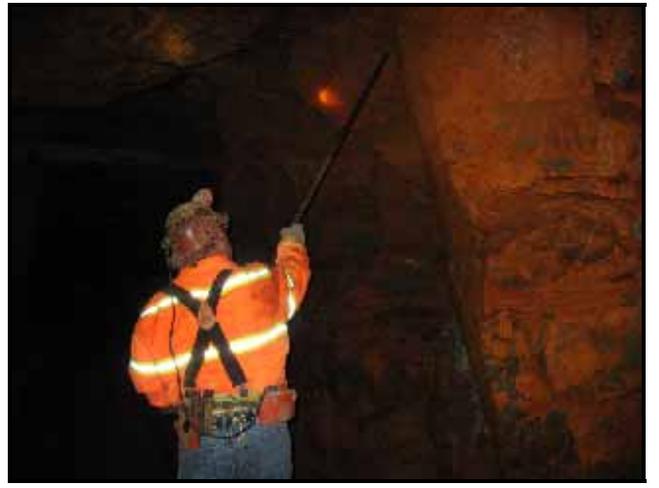
Photo 11. Rock Scaling and Sounding.

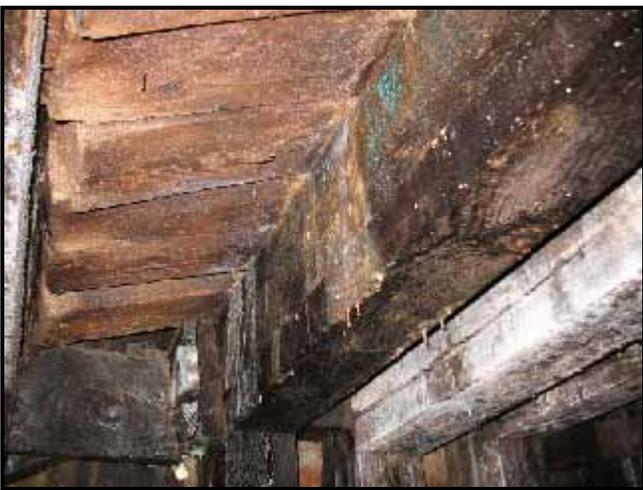
Photo 9. Rotten Timber 2.

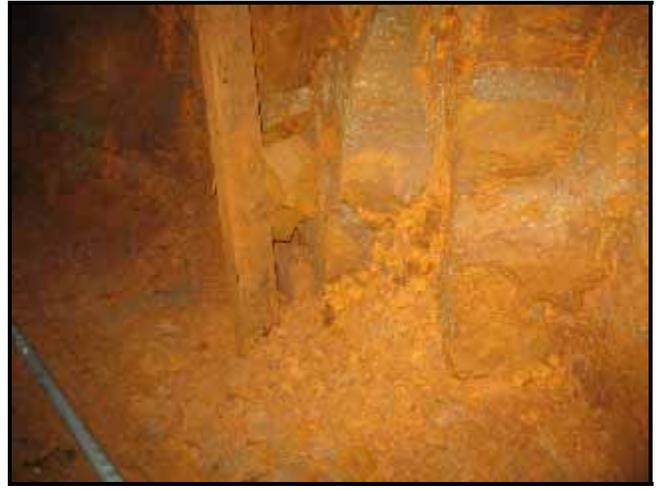
Photo 12. Rock Fall and Mud.

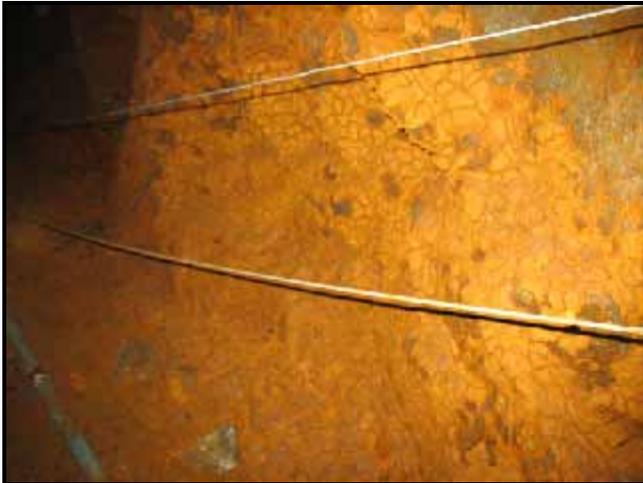
In conclusion of the Walker Mine Level 700 Adit Repairs and Inspection and Safety Inspection the primary potential hazards that has been identified by Beck's Enterprises are the high levels of mud that is seeping through the fractures and seams weakening the integrity of these localized areas throughout bald headed section. Many areas throughout the timber section were identified as oxidized and rotted. In addition the current 18" Jet Air 3 hp Ventilation System in the Walker Mine 700 Level Adit should be replaced by a larger fan with higher pressures to support any future construction/maintenance activities. For the safety and integrity of the Walker Mine Level 700 Adit for future inspection and maintenance procedures these areas should be addressed.

Photo 13 Mud Seeping into Invert.

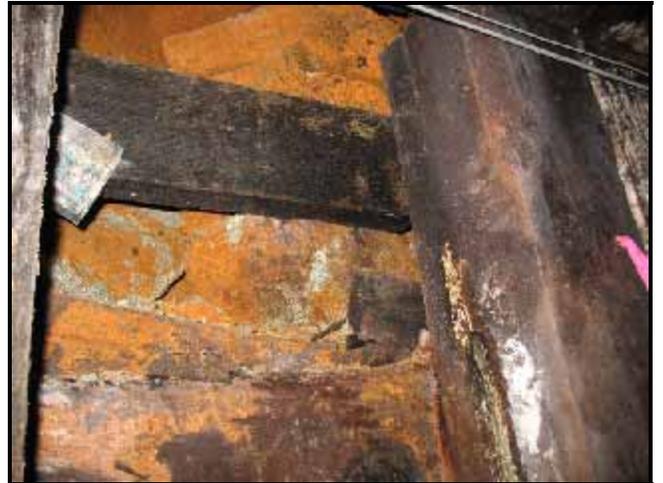
Photo 16. Loose Rock-Rotten Timber.

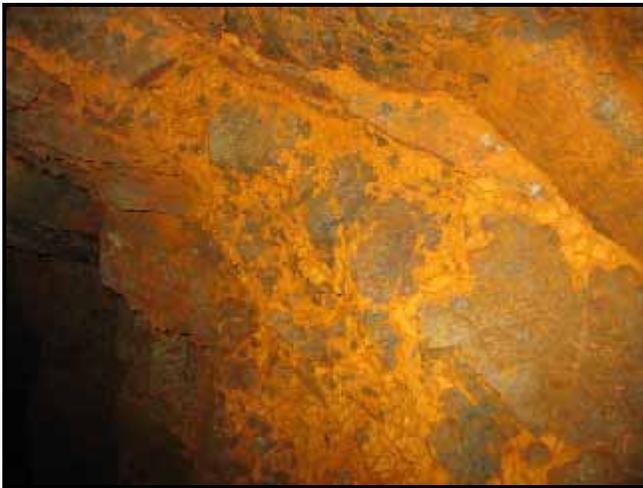
Photo 14. Mud Seam 2.

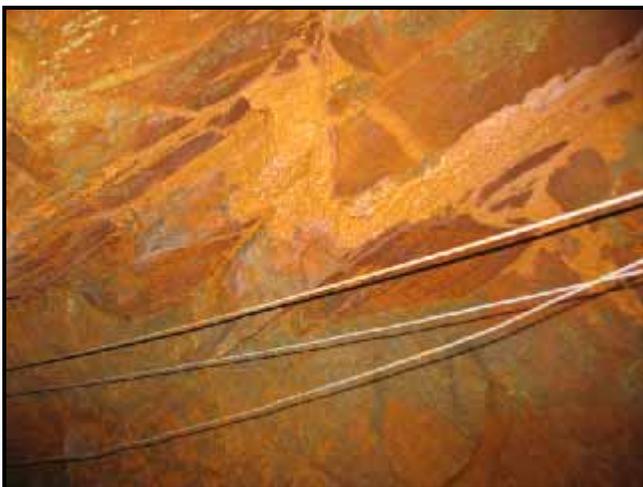
Photo 15. Mud Seam.

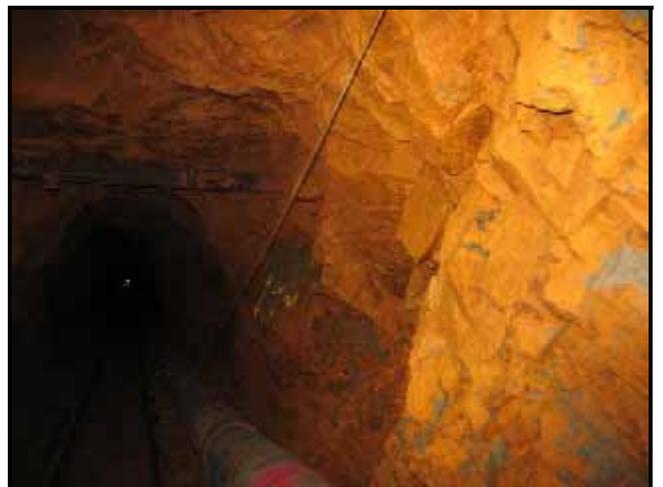
Photo 18. Fractured Rock.

Beck's Enterprises recommends, the Central Valley Water Board consider installing rockbolts as required. Conditions in unlined tunnels with highly jointed rock and fractures such as these can change rapidly.

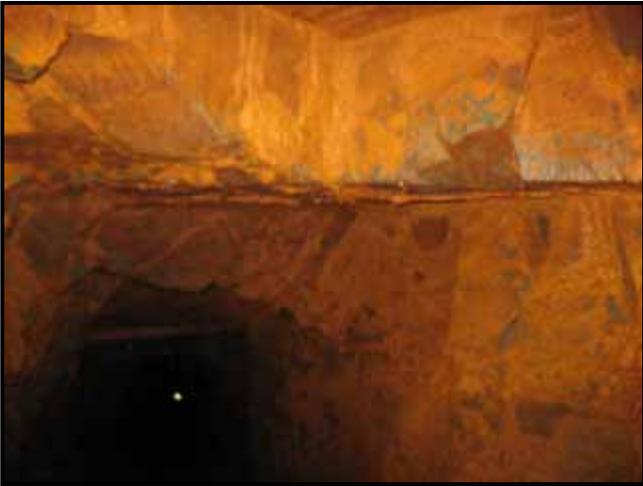
Photo 19. Flat back (mud forced through cracks, mud seeping).

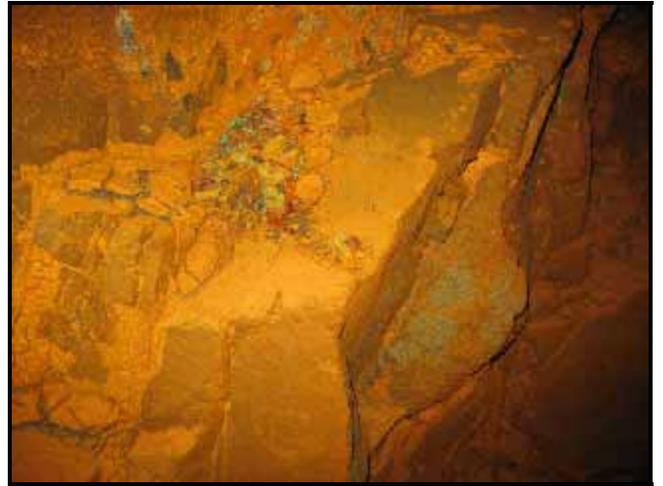
Photo 22. Copper Contaminated Mud.

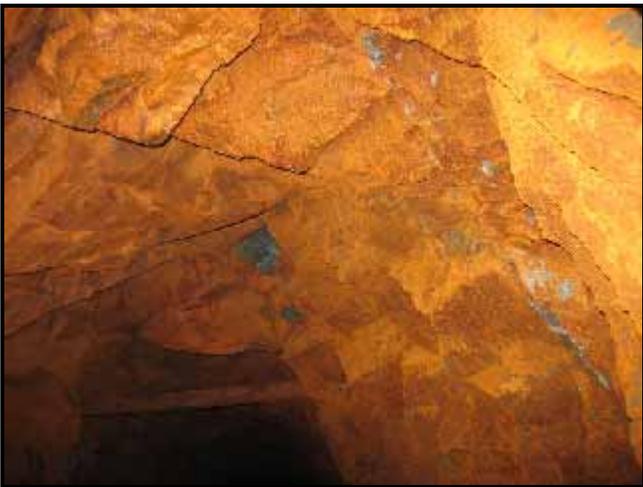
Photo 20. Discontinuous Seams and Wedges (Needs rock bolts).

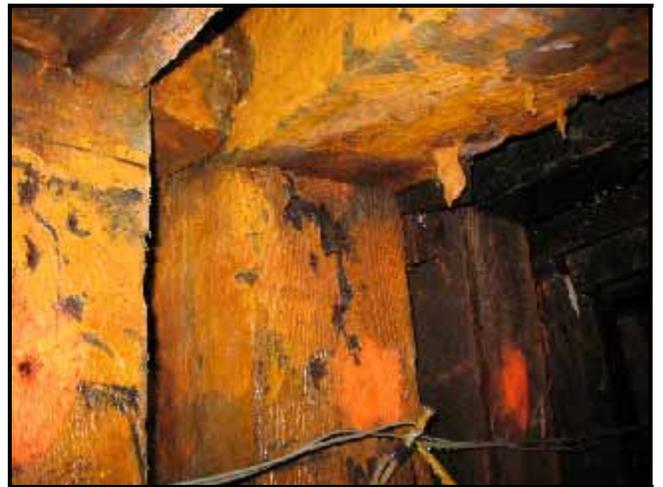
Photo 23. Compressed Rotten Timber 2.

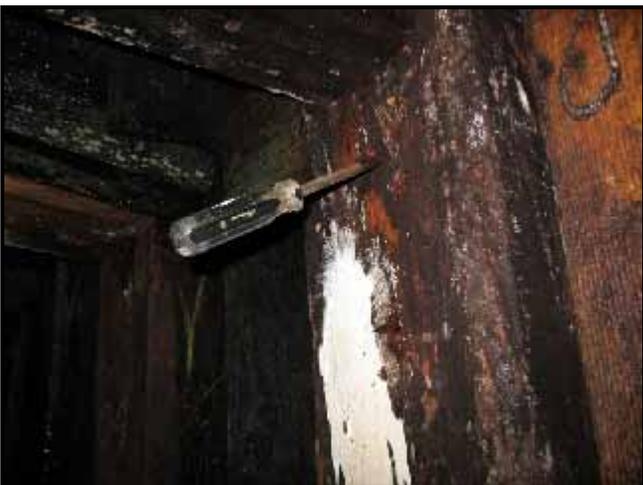
Photo 21. Deteriorating Timber.

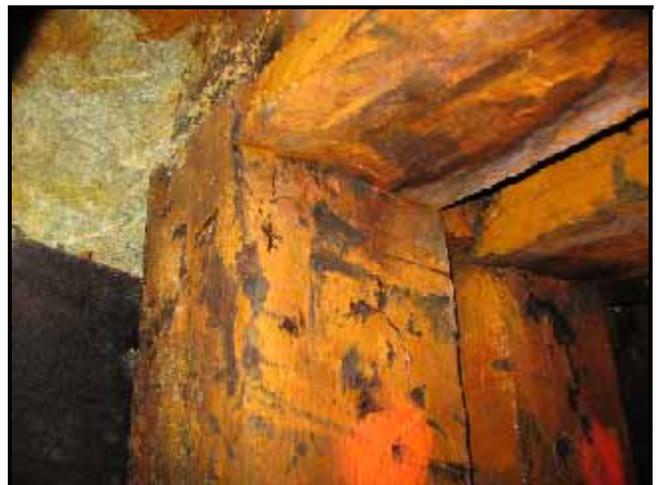
Photo 24. Compressed Rotten Timber.

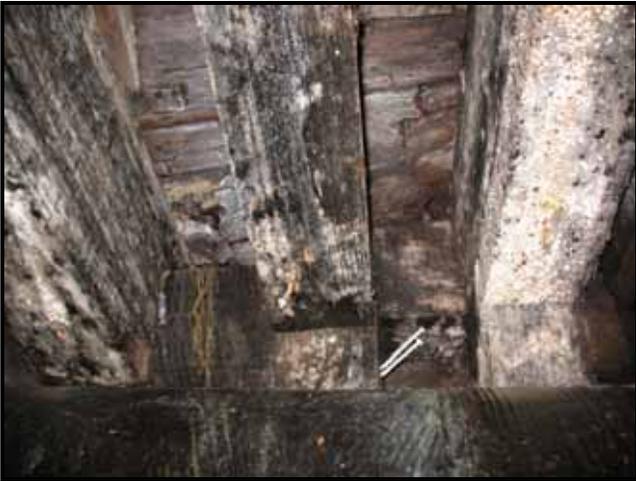
Photo 25. Broken Timber-Loose Rock-Weight 2.

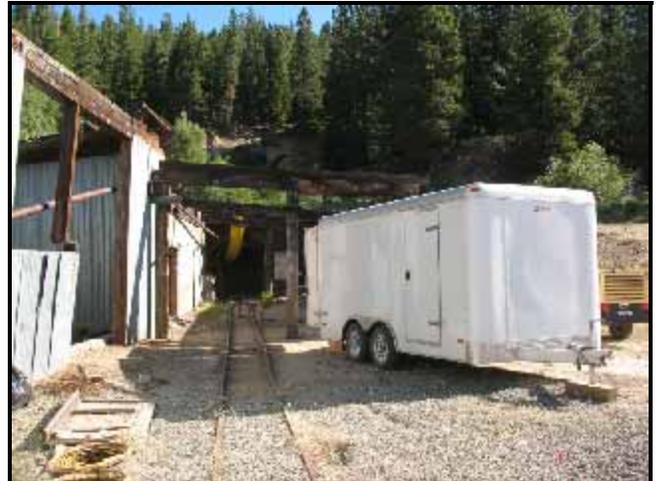
The west reach of the 700' level access tunnel at the Walker Mine from station 0+00 to station 3+50[±] has experienced an ancient major slide above the portal, causing partial tunnel collapses (possibly during construction of the access tunnel or while mining operations were on going), leaving loose displaced rock and ground above the tunnel in heights from 8' to 60'. The scarp on the hillside is 60'[±] High 150'[±] wide.

Photo 014. Ancient Landslide (scarp at tree line).

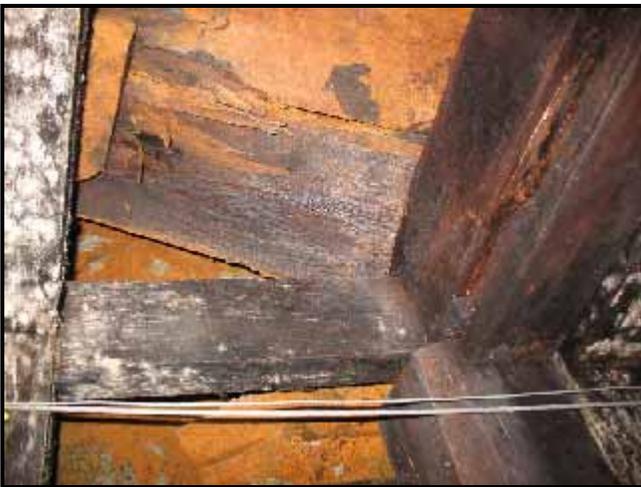
Photo 26. Broken Timber-Loose Rock-Weight.

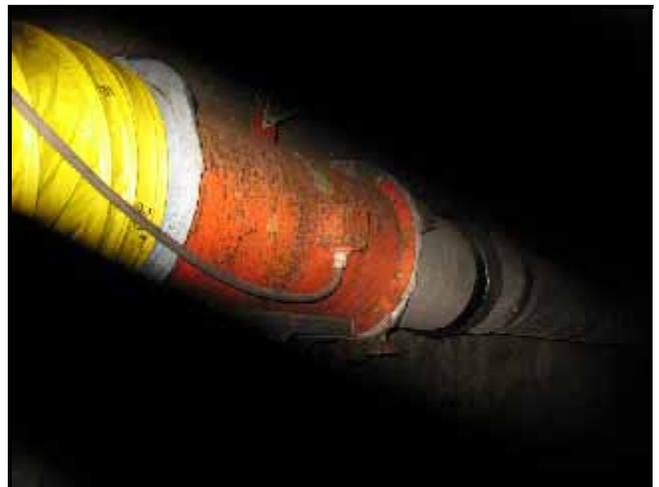
The 18" Jet Air 3 hp ventilation fan motor would not run on 3-phase 480 voltage as indicated on the fan motor plate, this problem required the services of a qualified electrician to inspect, test and diagnose. The electrician found that the fan motor had been rewired for 3 phase 208/240 voltage. The fan could potentially perform better if rewired for 3 phase 480 voltage, but probably it is too small (won't produce sufficient ventilation) for future construction activities. Ventilation fans are designed to run both in forward (exhaust) or reverse (blow). Beck's Enterprises performed tests on both directions and recommends that running the fan in the forward (exhaust) position in order to provide proper air flow.

Photo ?. Walker Mine ventilation fan.

It is recommended that the current 18" inch Jet Air 3 hp Ventilation System in the Walker Mine 700 Level Adit should be increased or changed to support any future construction activities. The air velocity in the Walker Mine varied through the different reaches in the Adit Tunnel. Due to the reduction in size of some reaches in the Adit Tunnel, and distance the ventilation fan had to maintain the positive pressure through out these reaches.

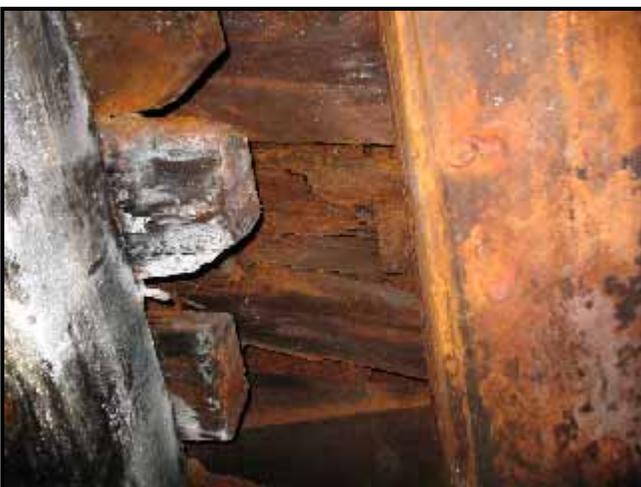
Photo 27. Broken Timber and Crown Bars.
