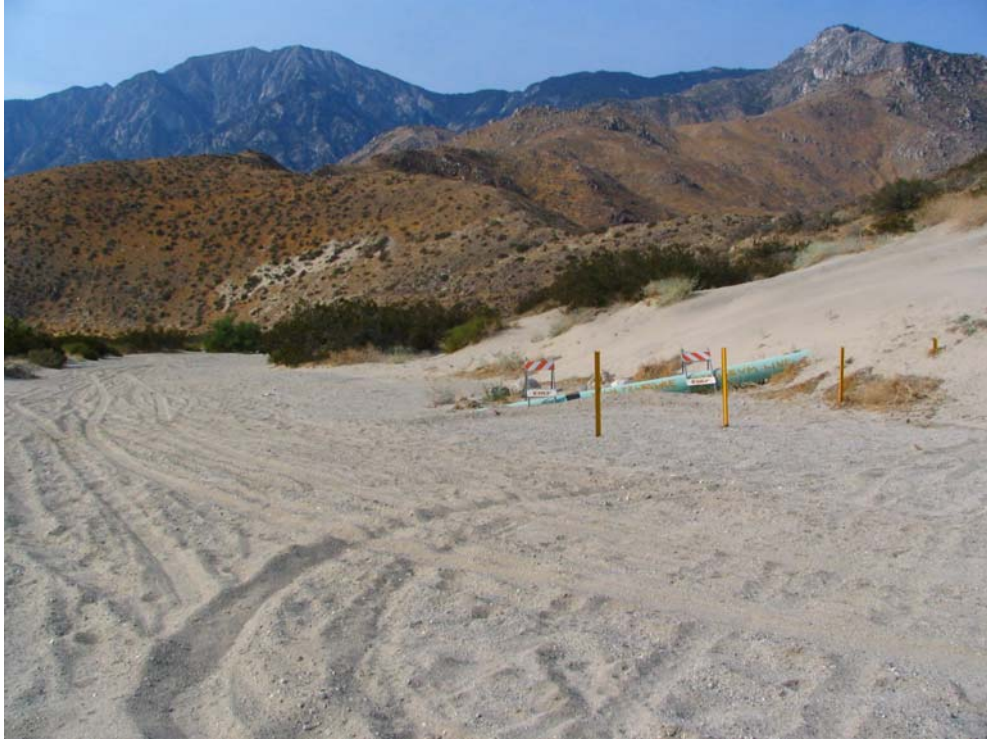
Photo 1: Area 1-looking south at washout.

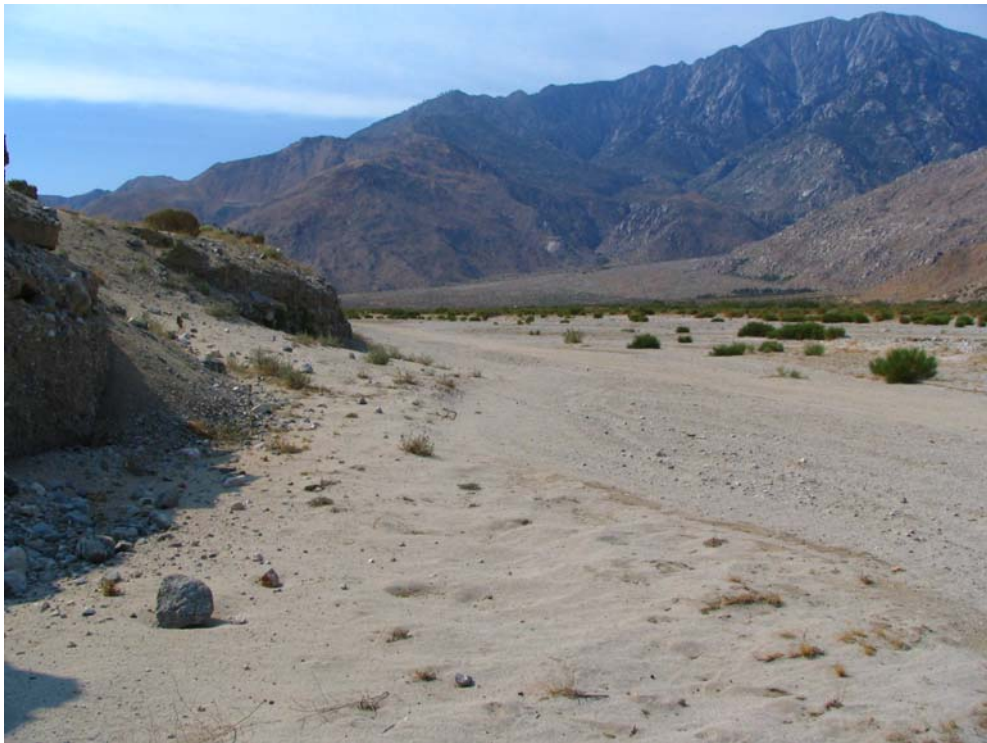
Area 2- looking south at washout (slumping has buried pipeline in left of photo).
