### Memorandum

Subject: Engineering Geologic Assessment of Grading Operations at 29880 and 30010 Highway 101, Willits, CA; Cal Fire LE Case # 11CAMEU004127-46

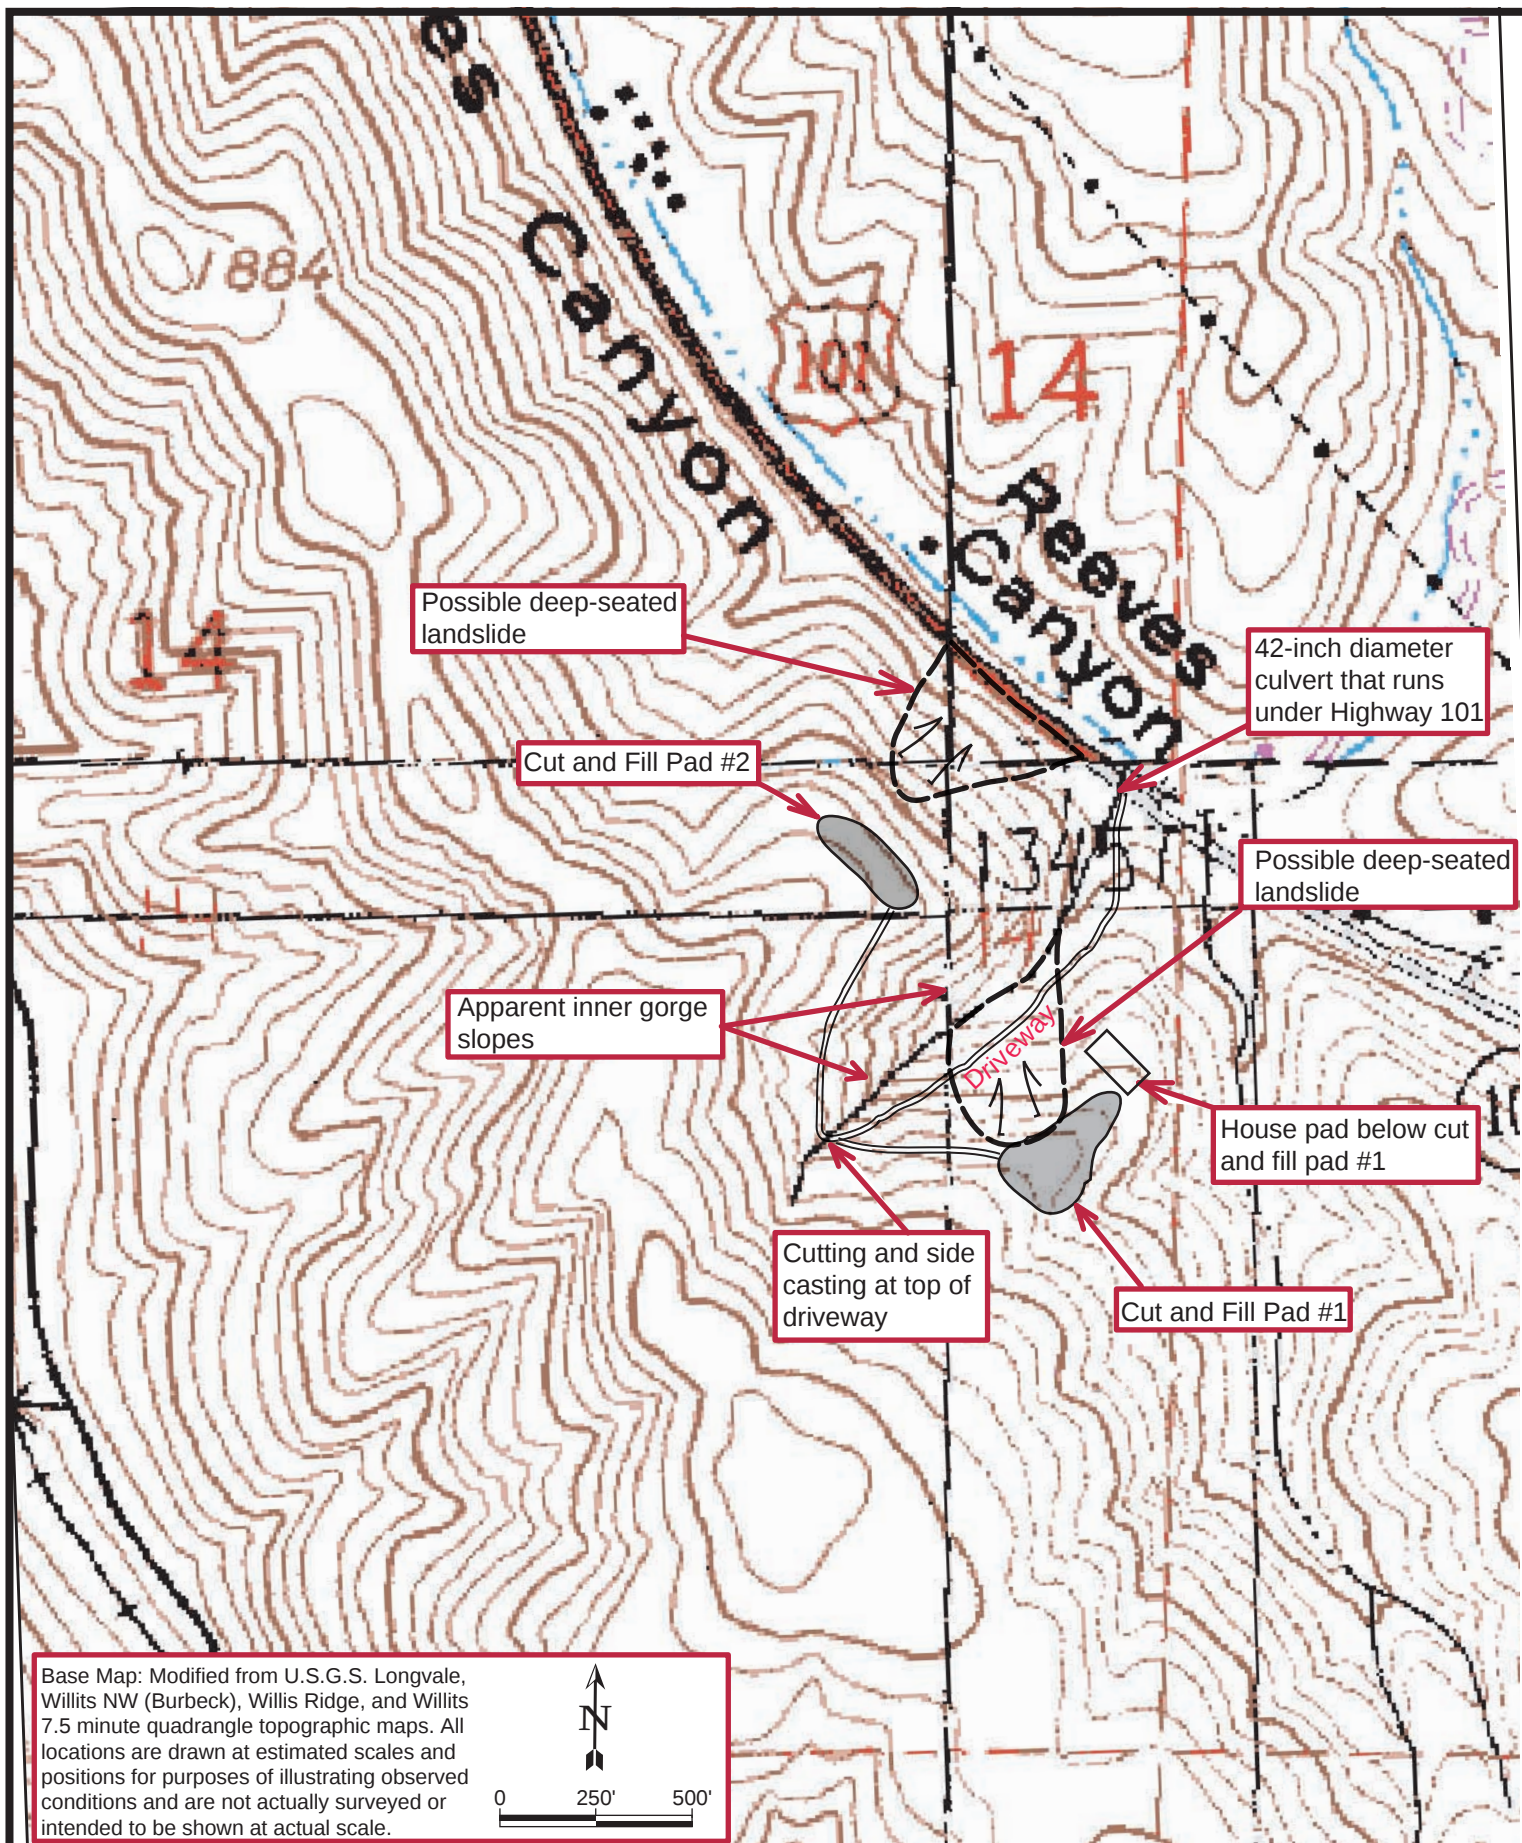
Figure: 3

A house pad with what appears to be a manufactured home is located immediately below and northeast of Pad Area #1 (Figure 3). This is immediately below what is estimated to be the thickest fill slopes at the northeast end of Pad #1.

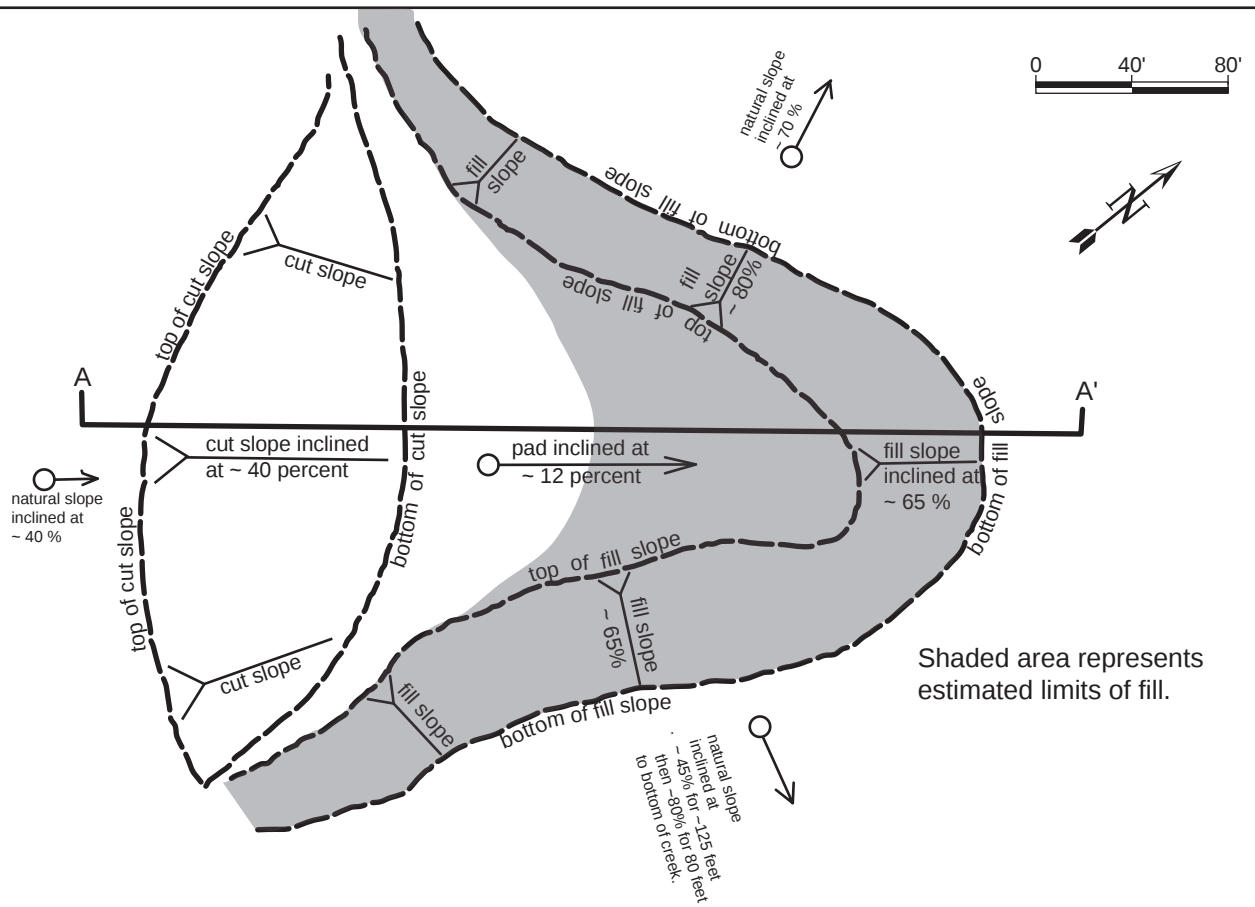
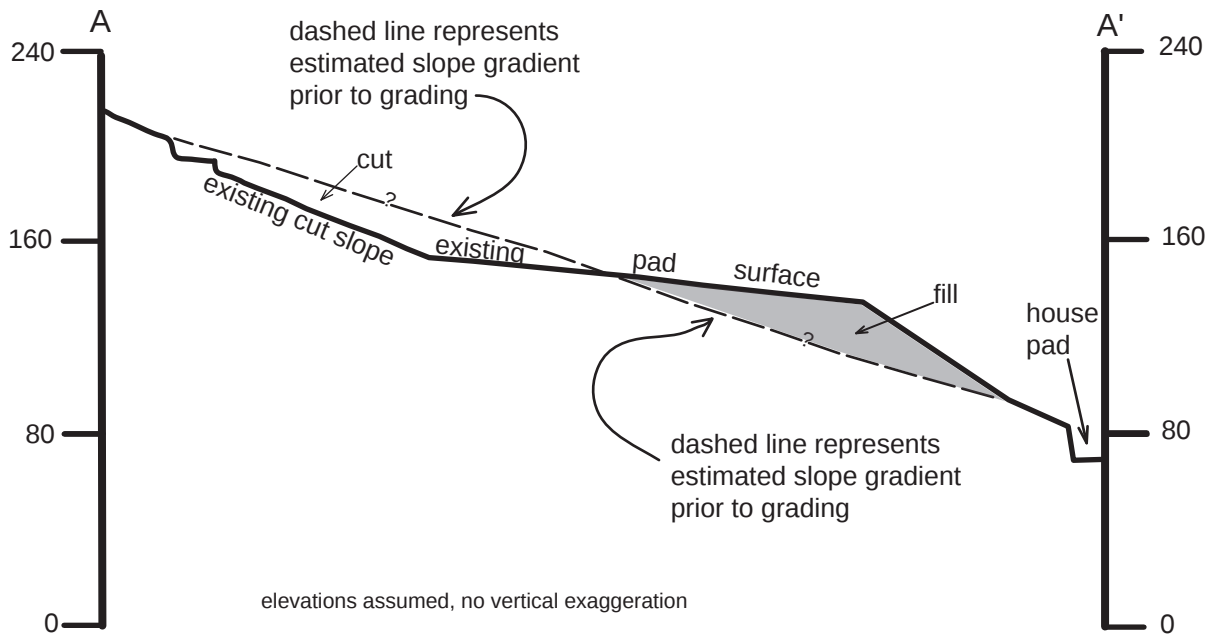
Figure: 4

Pad Area #1. The southern approximately 1.8 acre pad was constructed on a northeast trending spur ridge (Figures 4 and 5). Materials cut from the ridge nose were side cast on the ridge flanks. The fill is estimated to be a maximum of about 20 to 25 feet thick and it is estimated to be on the order of about 15,000 cubic yards of materials. Organic debris (for example tree stumps, brush, and logs) were observed protruding out of the fill. In many places the organic debris was observed to be in positions that appeared to be supporting the fill materials. The fills do not appear to have been founded, keyed into, or placed on firm soils or bedrock. The fills appear very loose and uncompacted. Fills are perched on 80 percent slopes that descend to watercourses that flow to Highway 101. Review of aerial photographs (sets 1947 through 2000) indicate that while roads or skid trails were constructed in the area of the pad in the 1980s, no pad area was present prior to the 2000 aerial photographs.

- A CEG and Geotechnical Engineering shall evaluate the adequacy of grading techniques and the stability of on-site cuts and fill, including an evaluation of potential impacts resulting from failure of slopes to the house pad immediately below Pad #1. The evaluation shall also address potential impacts related to the reconstructed driveway, and potential impacts to downslope drainages, watercourse, and Highway 101. The mitigation plan shall include a map that identifies the locations of unstable fills and slopes and shall include a finding by the project CEG regarding the stability of existing fill slopes.
- The geotechnical engineer shall provide mitigations and designs that include remediation of unstable fills that includes but is not limited to a grading plan that outlines

corrective grading designs. The corrective grading plan and designs will likely require the removal and possible re-compaction of unstable fills and shall be designed by the geotechnical engineer in such a way to minimize potential adverse impacts to slope stability identified by the CEG.

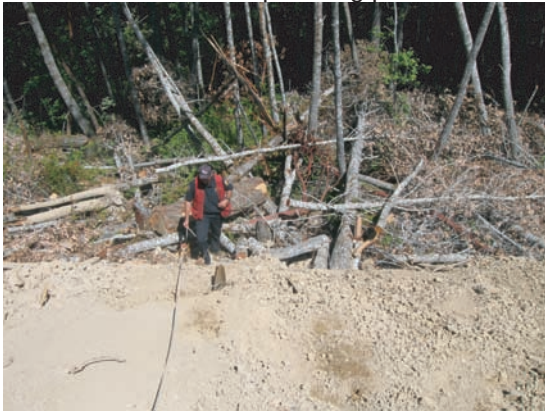
Bottom of fill slope along pad 1.

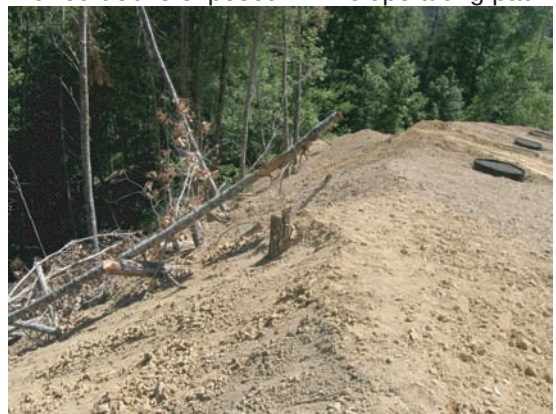
Buried debris exposed in fill slope along pad 1

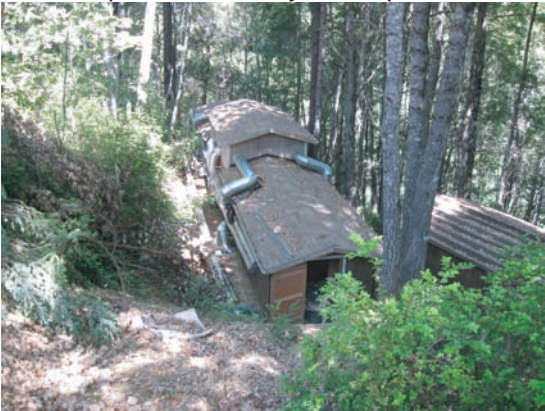
House pad immediately below pad 1.

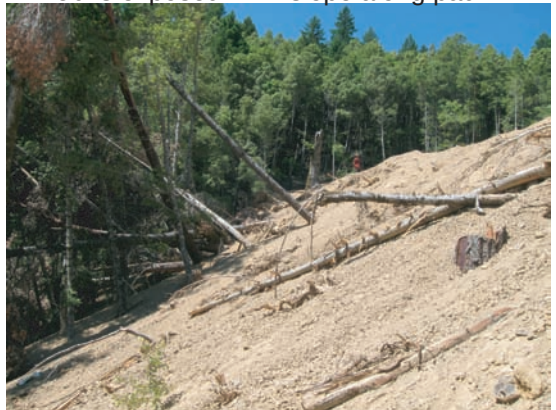
Debris exposed in fill slope along pad 1.

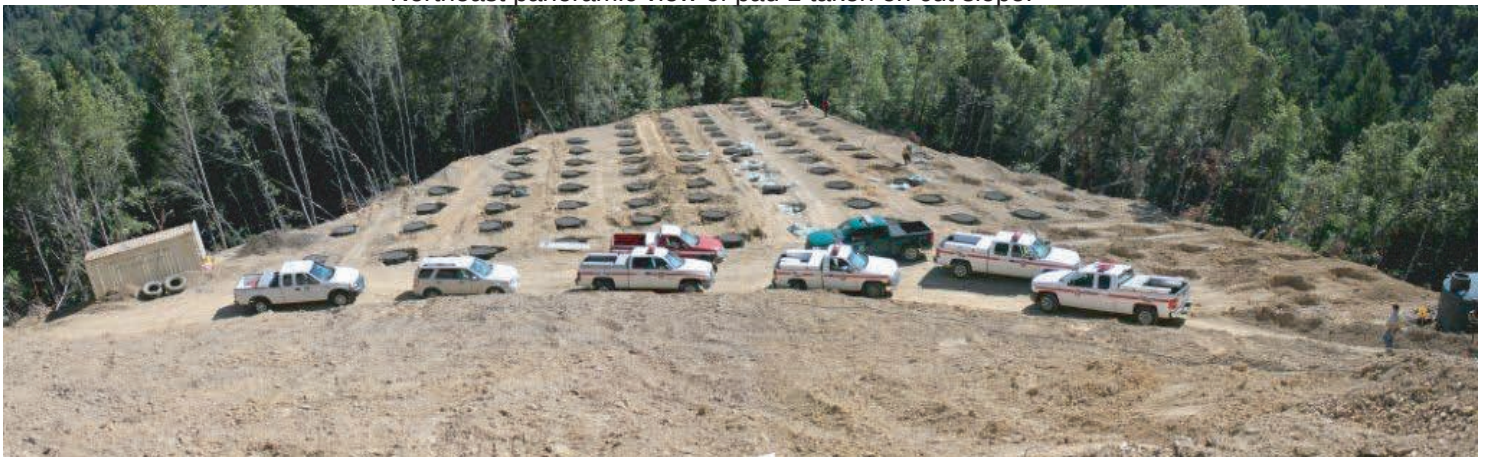
Northeast panoramic view of pad 1 taken on cut slope.

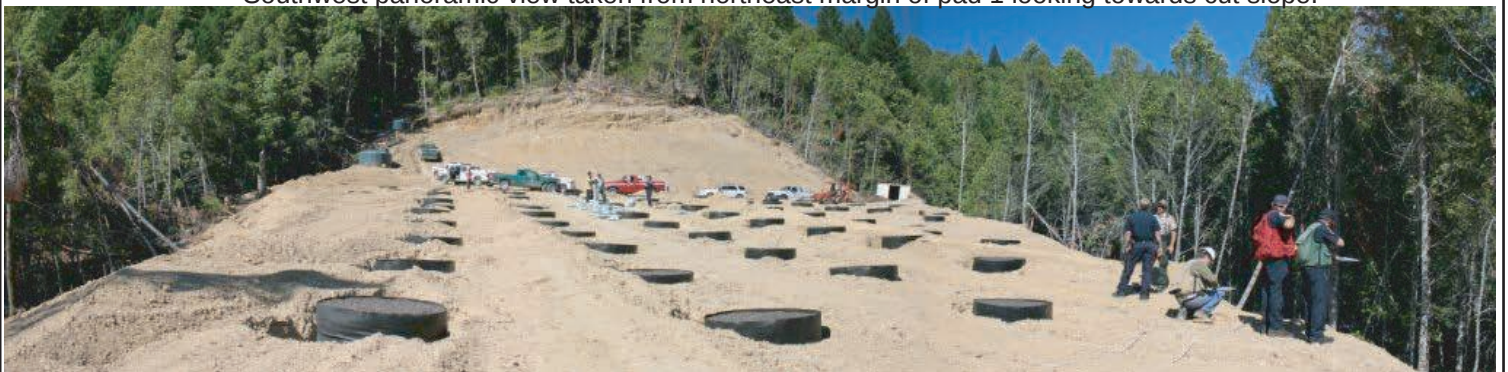
Southwest panoramic view taken from northeast margin of pad 1 looking towards cut slope.

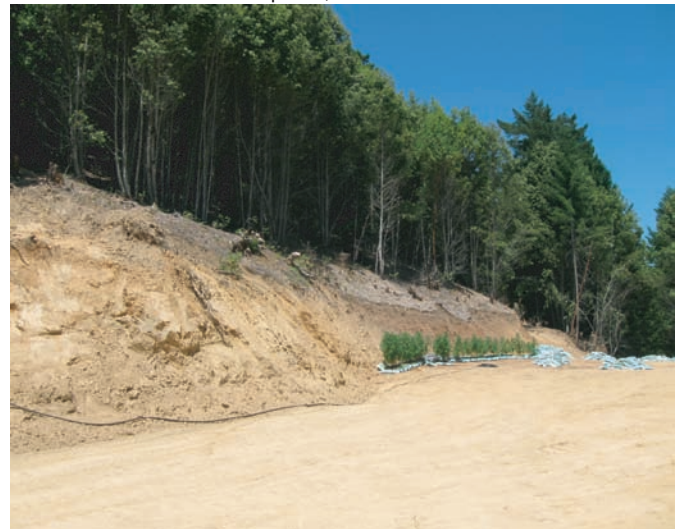
Northwest view of pad 2, cut bank excavation

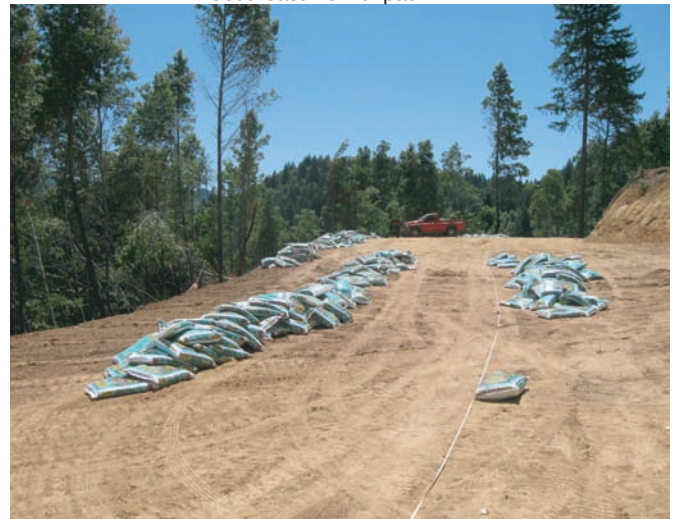
Southeast view of pad 2

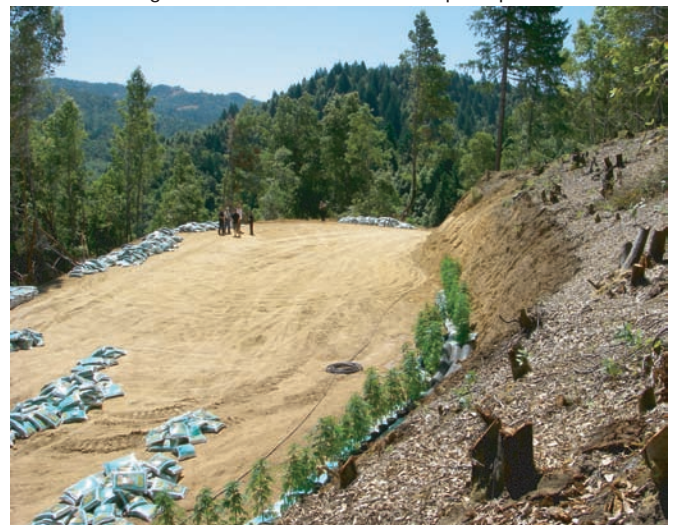
Facing east taken from above cut slope at pad 2.

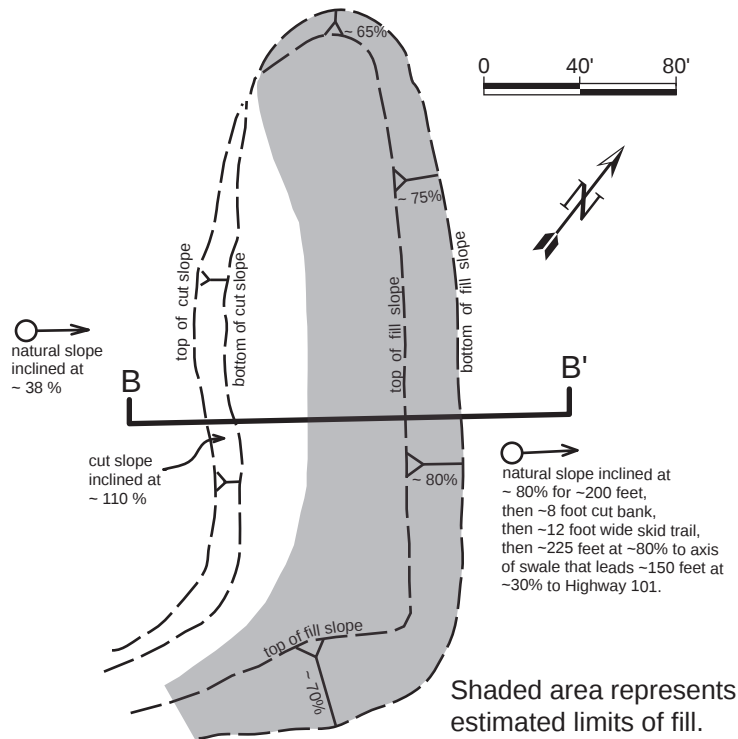
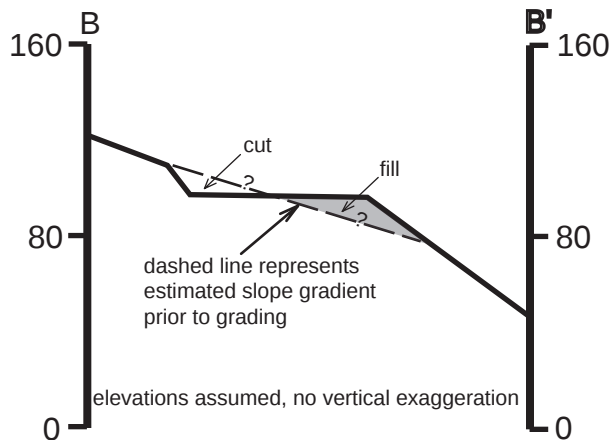
Figure: 6

Pad Area 2. The northern 0.6± acres pad was constructed on a northeast facing slope (Figure 6). Fills estimated to range from from about 10 to 20 feet thick appear to have been side cast on the slope. It is estimated that roughly 2500 cubic yards of fill materials were generated. Organic debris (for example tree stumps, brush, and logs) was observed protruding out of the fill. In many places the organic debris was observed to be in positions that appeared to be supporting the fill materials. The fills do not appear to have been founded, keyed into, or placed on firm soils or bedrock. The fills appear very loose and uncompacted. The fills are perched on 80 percent slopes that descend to Highway 101. Review of aerial photographs (sets 1947 through 2000) indicates that a smaller pad area was constructed in this area in the 1980s and was enlarged sometime after the 2000 photographs were taken.

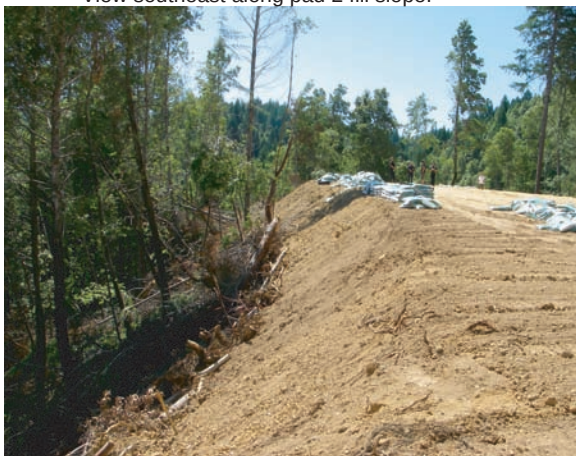
View southeast along pad 2 fill slope.

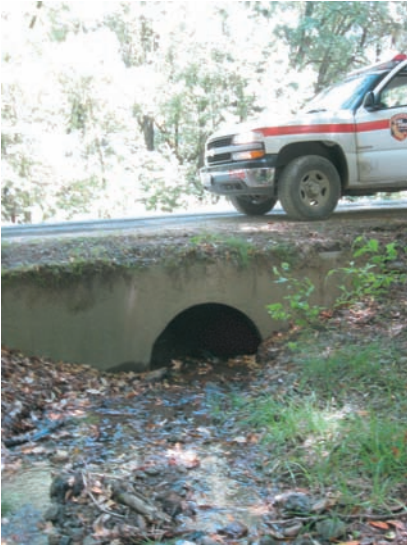
- 3). Highway 101 Culvert. The approximately 42-inch diameter culvert that flows under Highway 101 could become plugged if fills that have been side cast into the watercourse channel at the top of the driveway are not removed from the channel. If the culvert plugs, water will likely pond along fills used to construct Highway 101 and eventually flow across the highway. This could adversely impact stability of Highway 101 and the safety of the motorists that use it.

Half plugged ~ 42" culvert under Highway 101

- Cal Trans shall be notified of potential impacts to Highway 101 and the 42-inch diameter culvert that runs under the highway and have the opportunity to comment or participate in any mitigations to Highway 101.

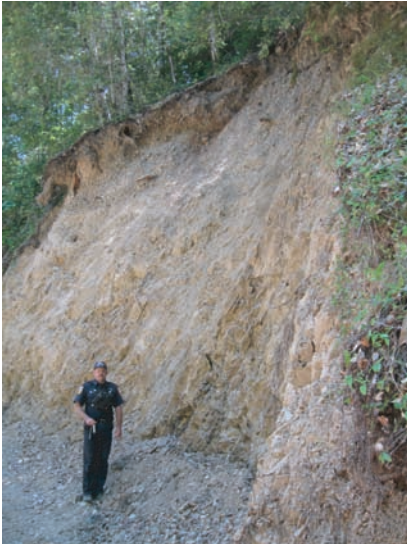
Cutting and filling appears to have recently occurred at the top of the driveway. What appears to be approximately 300 to 400 cubic yards of side cast materials were placed onto 90 percent slopes that descend to a watercourse channel. The side cast fills extend from the driveway all the way to the channel (approximately 100 feet) and have resulted in sediment in the watercourse. The watercourse flows to an on-site domestic water supply and eventually to an approximately 42-inch diameter culvert that flows under Highway 101 (Figure 7). The culvert was observed to be about half filled with sediment at the time of the inspection.

Excavation at top of driveway from which sidecast fill appear to have been generated.

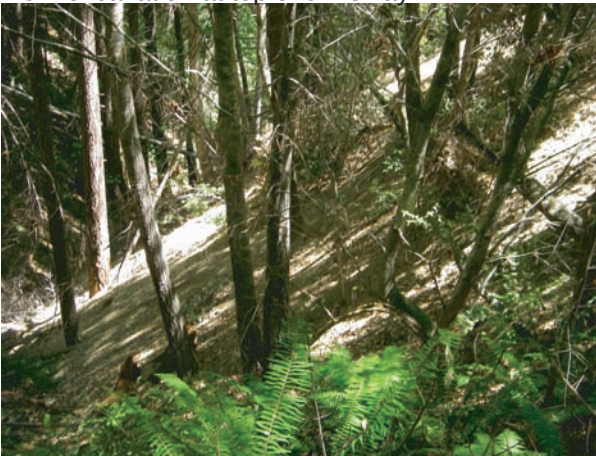
Loose sidecast on ~90% slopes into creek generated from excavation at top of driveway.

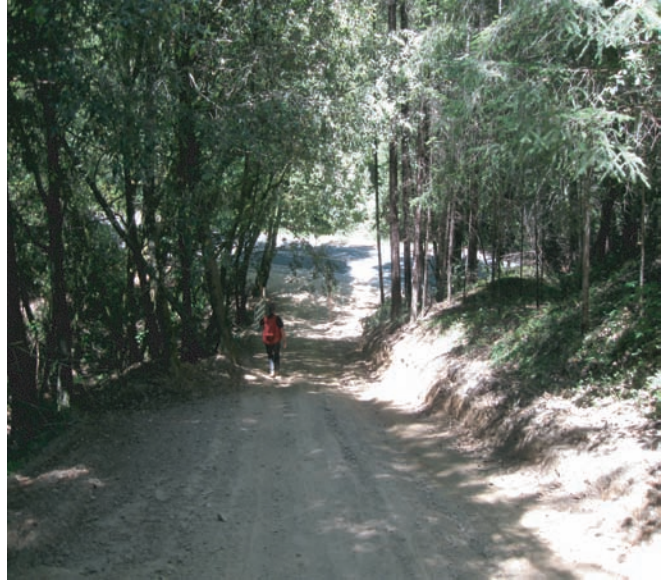
Driveway that descends to Highway 101 (in distance).

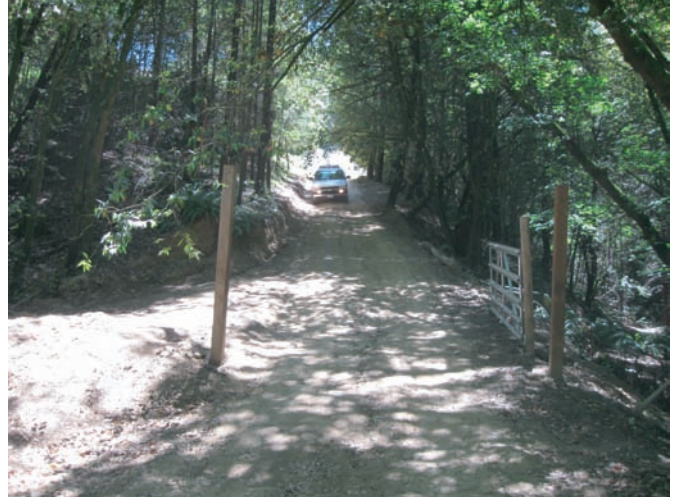
View of driveway ascending from Highway 101.

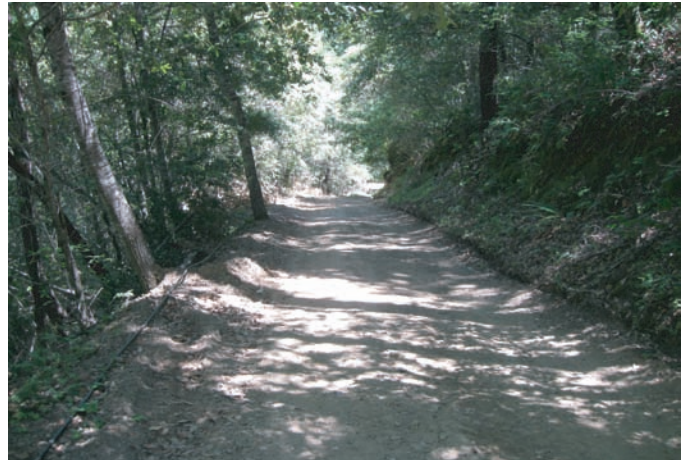
- 2). Driveway Drainage. The existing reconstructed driveway appears undrained and if left in its current condition, runoff from it appears to be in a position to flow onto Highway 101. This could result in sediment deposition onto Highway 101 and could adversely impact the safety of the motorists that use the highway.

Midslope portion of undrained driveway that contains an outside berm.

- A geotechnical engineering or CEG shall provide mitigation and design that de-waters and drains the site driveway. This can be included on the corrective grading plan that is developed for site remediation.
