North Coast Regional Water Quality Control Board

Name and Location of Facility Inspected Dick's Sporting Goods 1975 Cleveland Avenue Santa Rosa, California 95401 APN: 012-490-032		Facility Permit National Pollutant Discharge Elimination System (NPDES) General Permit For Storm Water Discharges Associated With Construction And Land Disturbance Activities Order No. 2009-0009-DWQ as amended by 2010-0014-DWQ & 2012-0006-DWQ (hereinafter CGP) NPDES No. CAS000002 WDID No. 1 47C362461 Notice of Intent (NOI) No. 421700	Inspection Date October 15, 2014 Inspection Time 7:00-8:15 AM
Names & Titles of On-Site Representatives and Consenting Parties	Consent¹ Provided?	Contact Information DanD@codding.com	Notified of Inspection?
Dan Davis, Superintendant	<input checked="" type="checkbox"/> Yes		<input checked="" type="checkbox"/> No
Inspector Names & Titles² Kason Grady, Water Resources Control Engineer			
California Integrated Water Quality System (CIWQS) Inspection ID 2023503

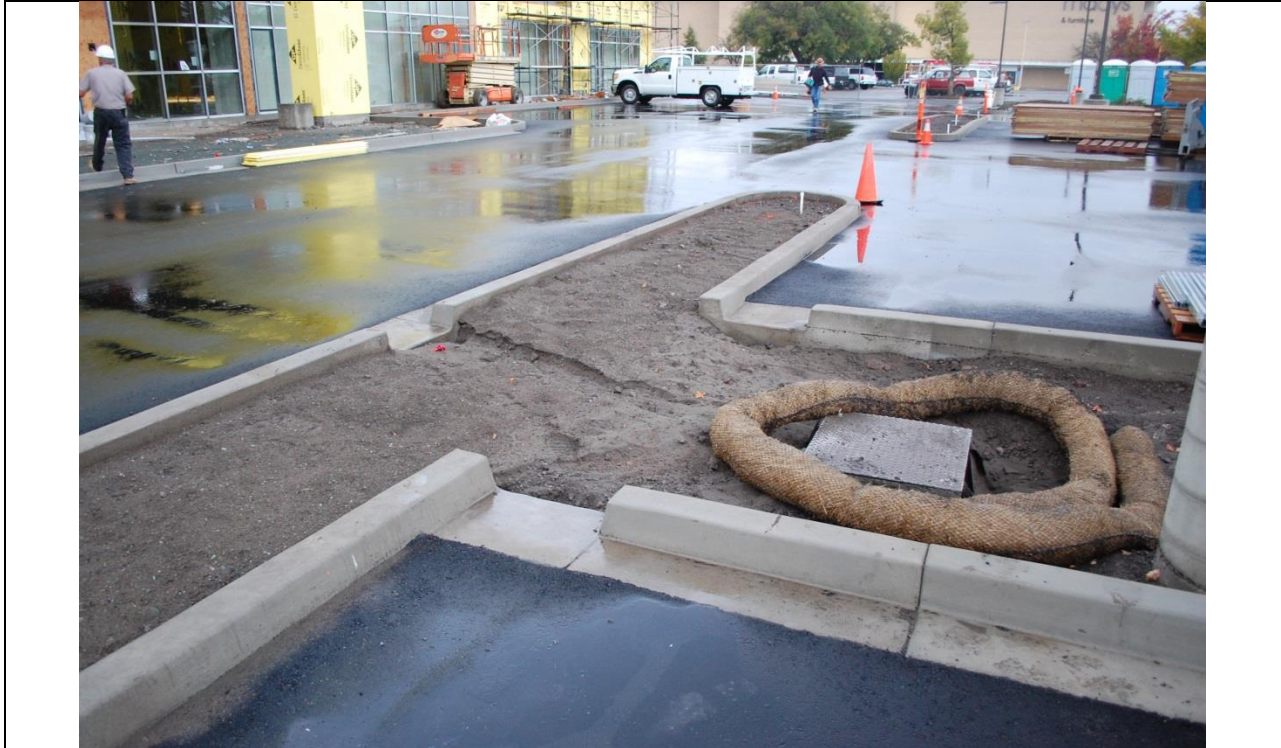
Photo 1: Onsite drop inlet with evidence of erosion and sediment transport. Fiber roll is not installed per specification (not trenched in or staked and is being used in an area of concentrated flow).

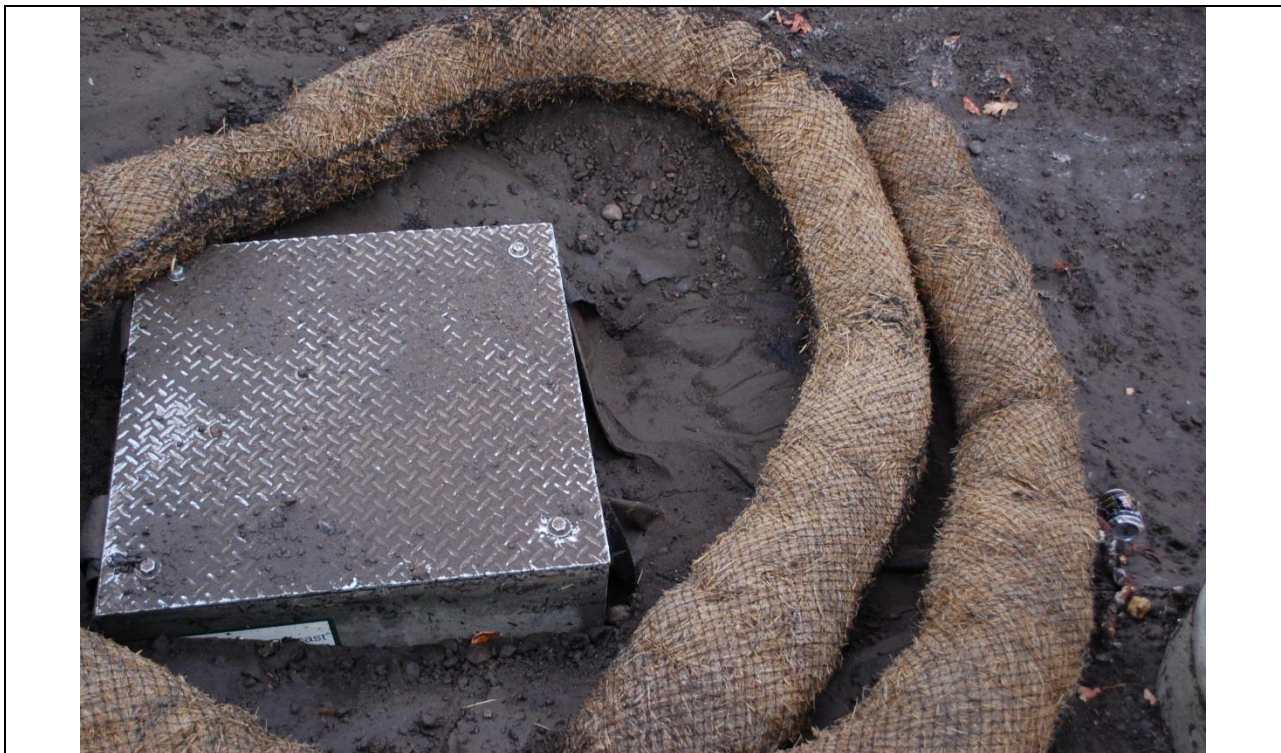
Photo 2: Close-up of drop inlet shown in Photo No. 1

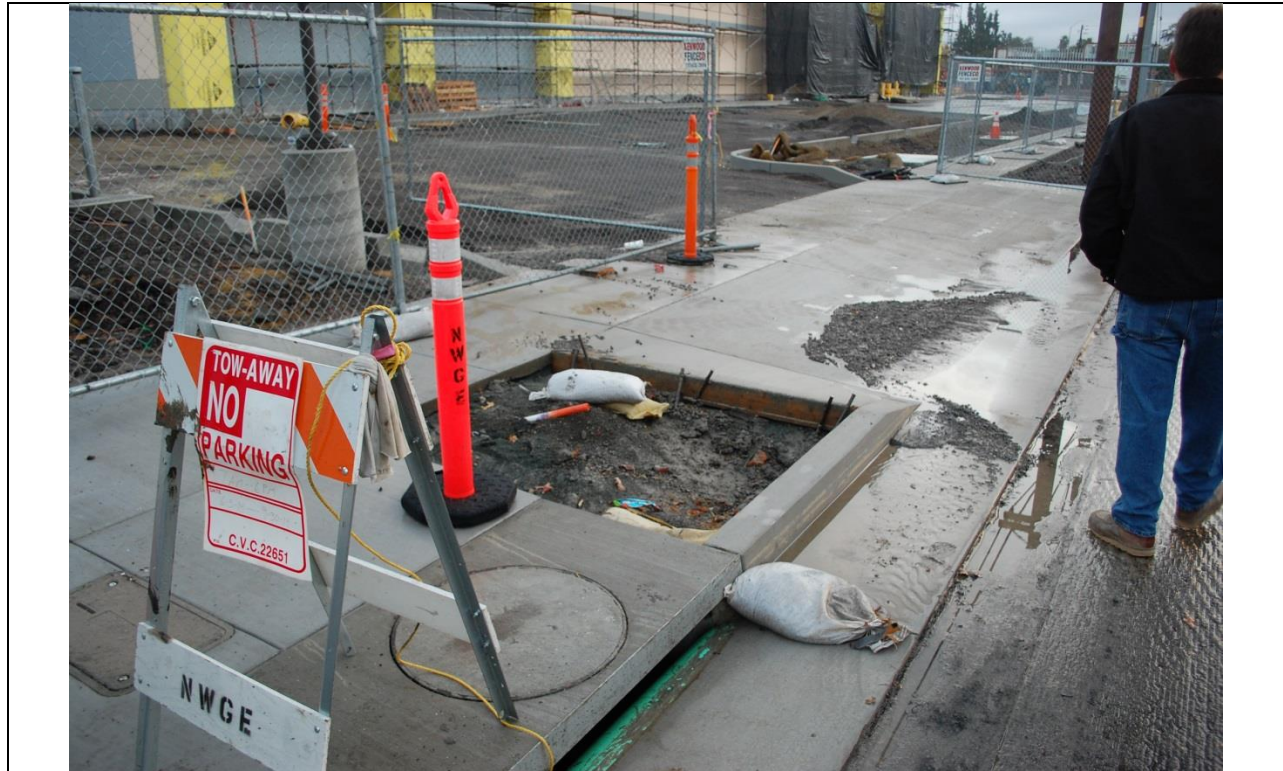
Photo 3: Sediment and high pH water in the gutter.

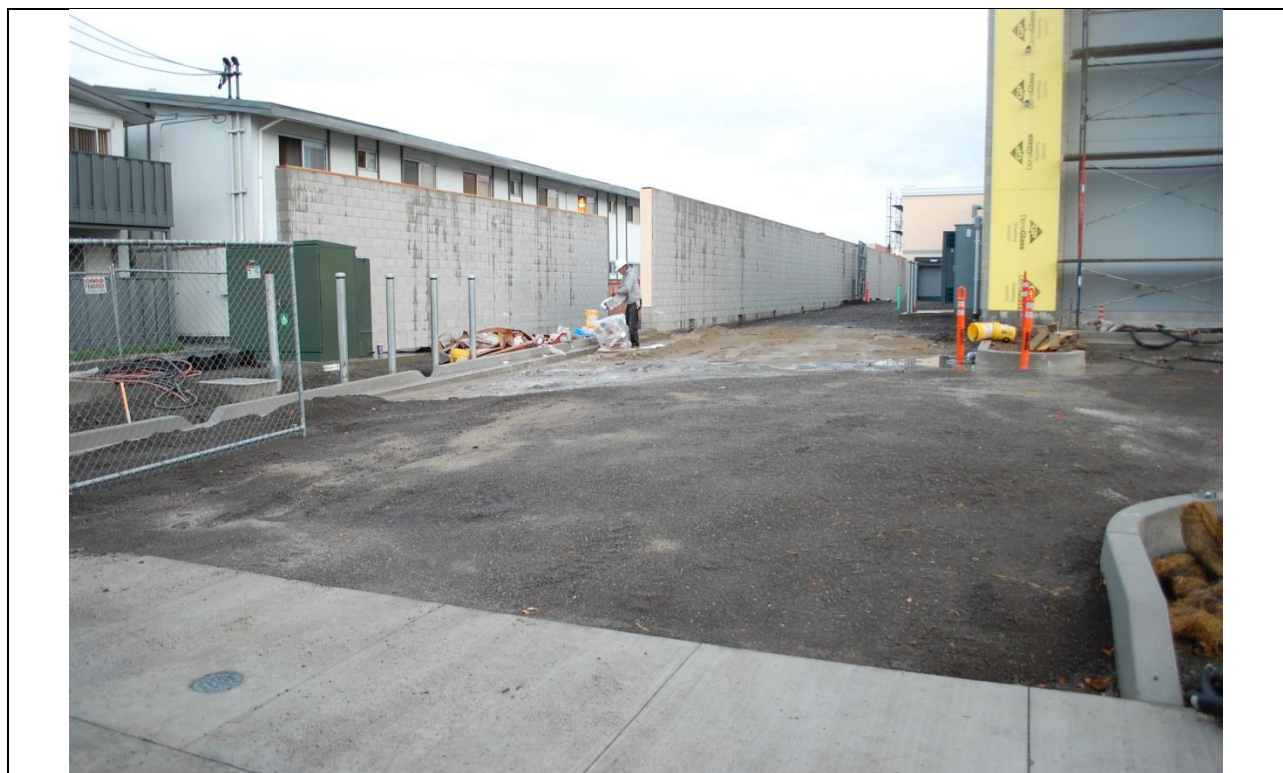
Photo 4: Southwest corner of the Site with insufficient erosion and sediment controls.

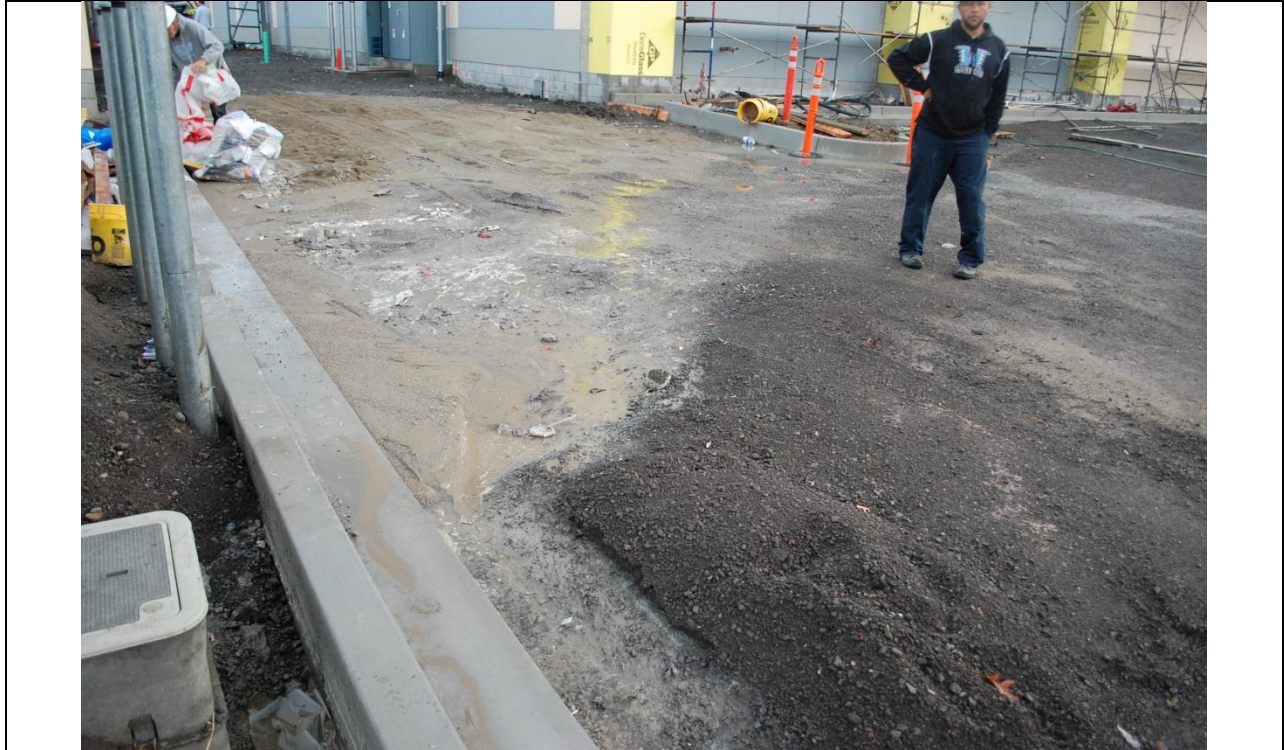
Photo 5: Evidence of erosion and sediment transport with insufficient controls and apparent concrete washout/disposal.

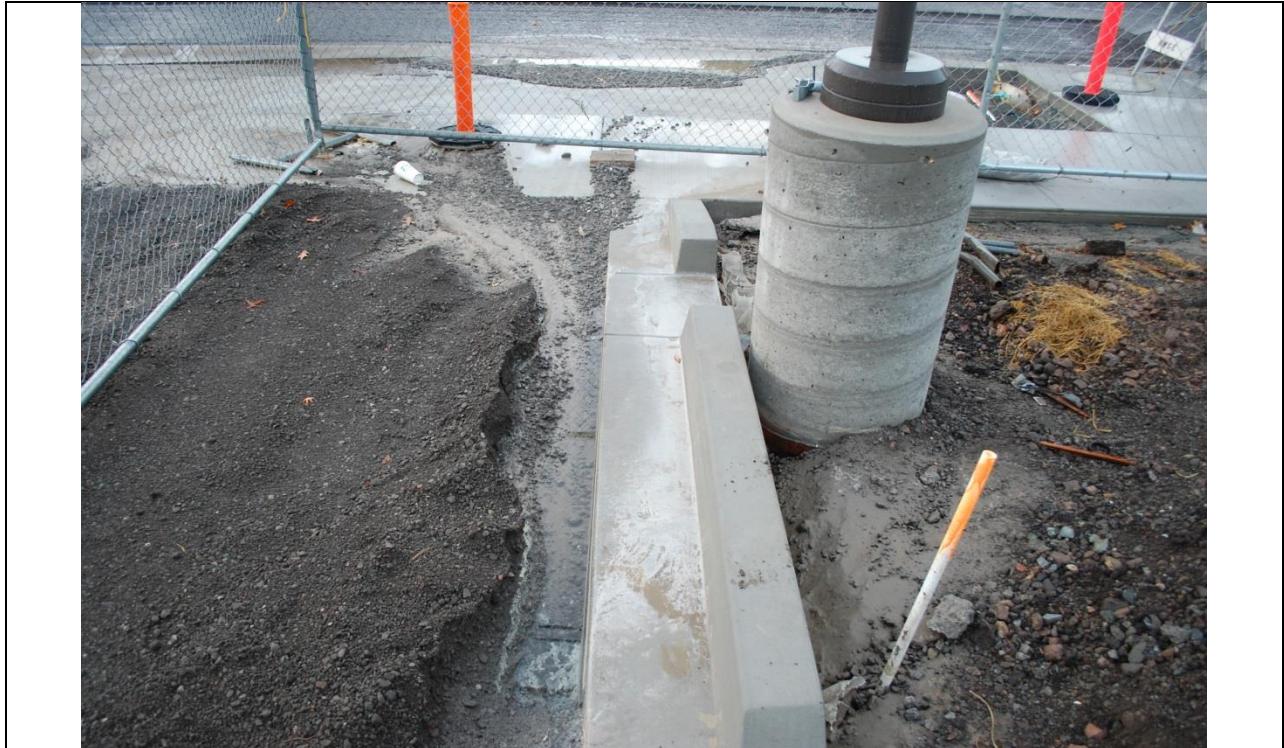
Photo 6: Evidence of erosion and sediment transport with insufficient controls and apparent concrete washout/disposal.

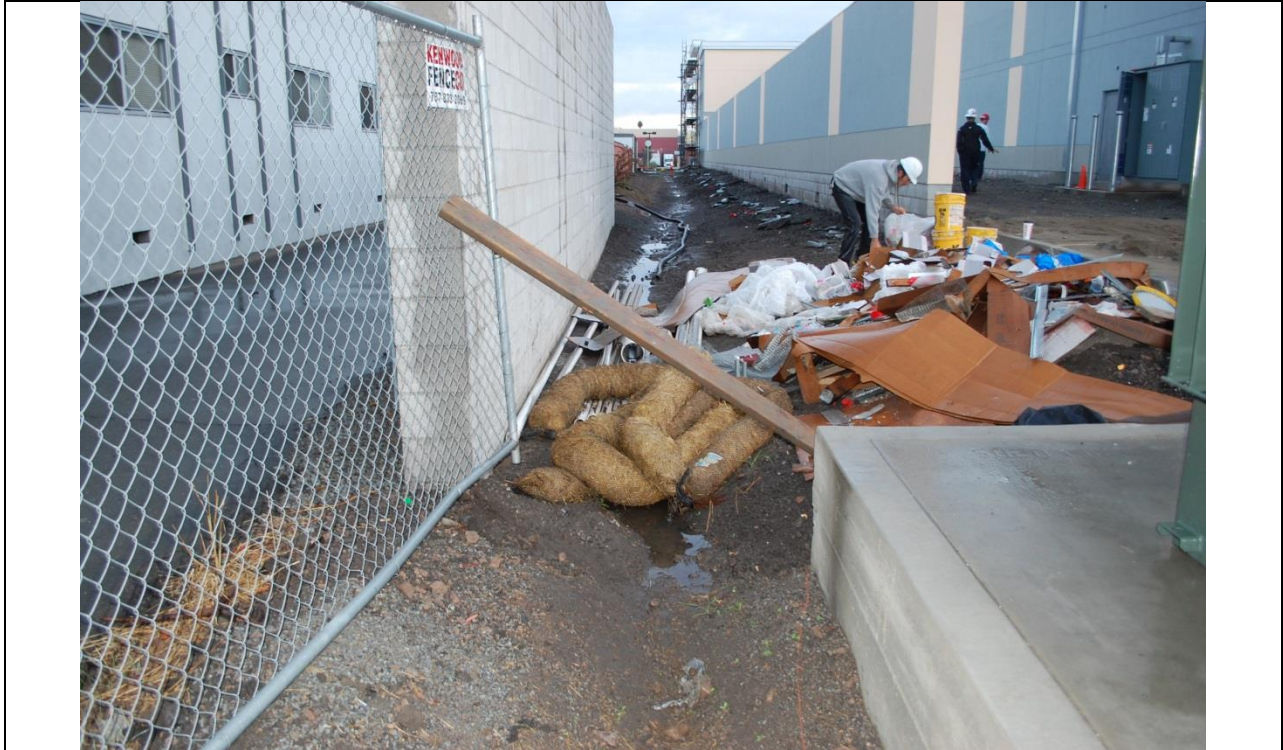
Photo 7: Debris and trash uncontained in a drainage swale with insufficient erosion and sediment controls.

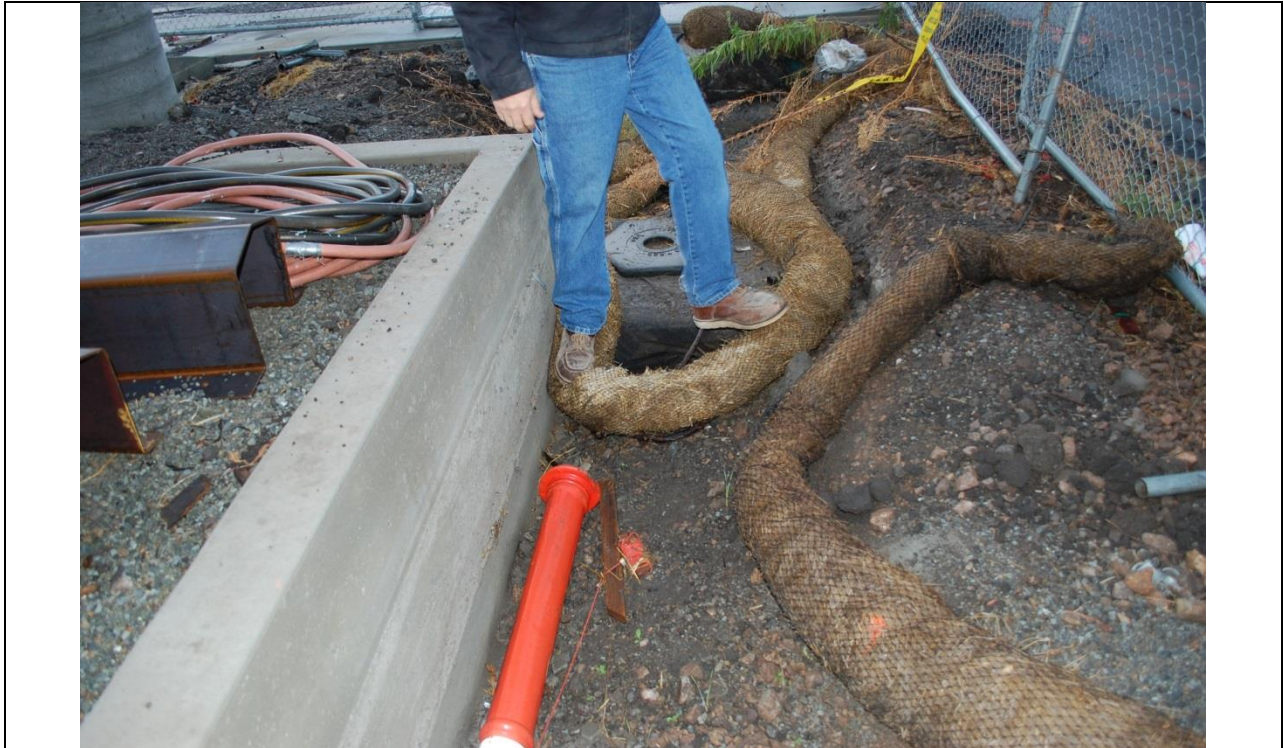
Photo 8: Drop inlet at the southwestern corner of the site. The fiber roll under foot was just placed there by the contractor, but was not in place during the rain event.

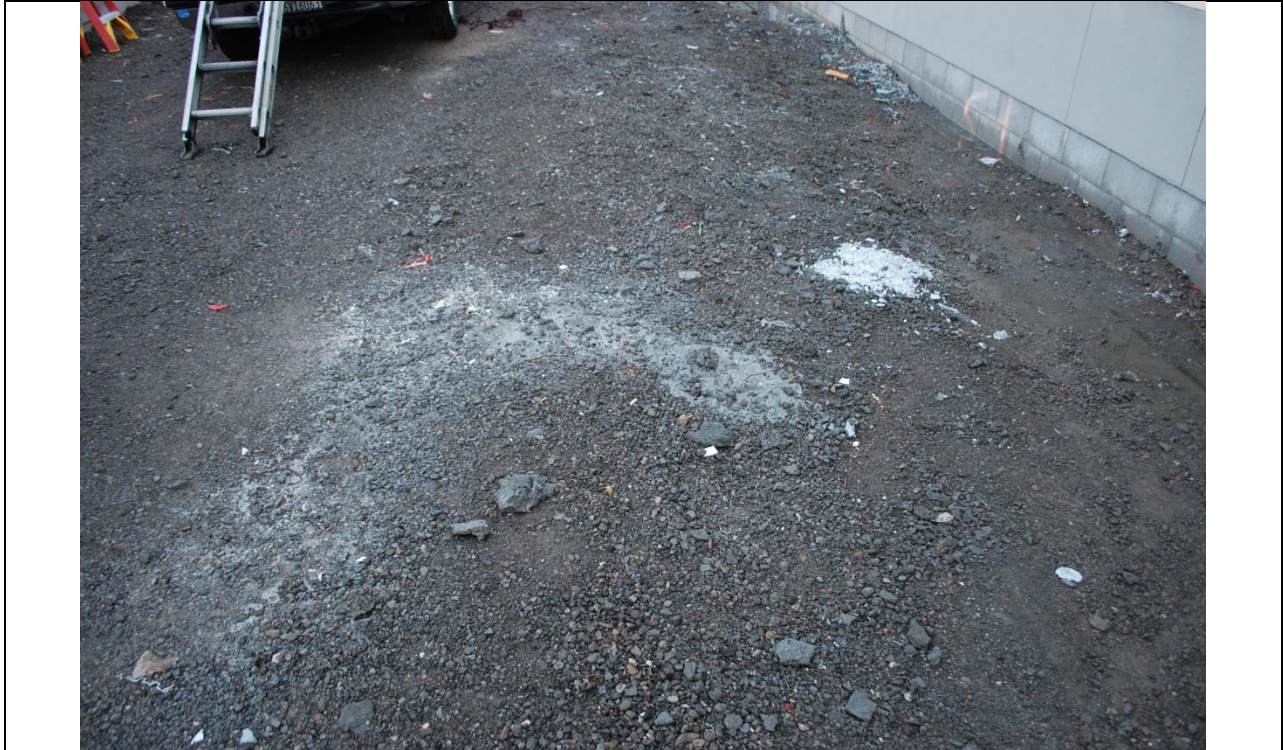
Photo 9: Insufficient containment of residual stucco waste, which was exposed to rain.

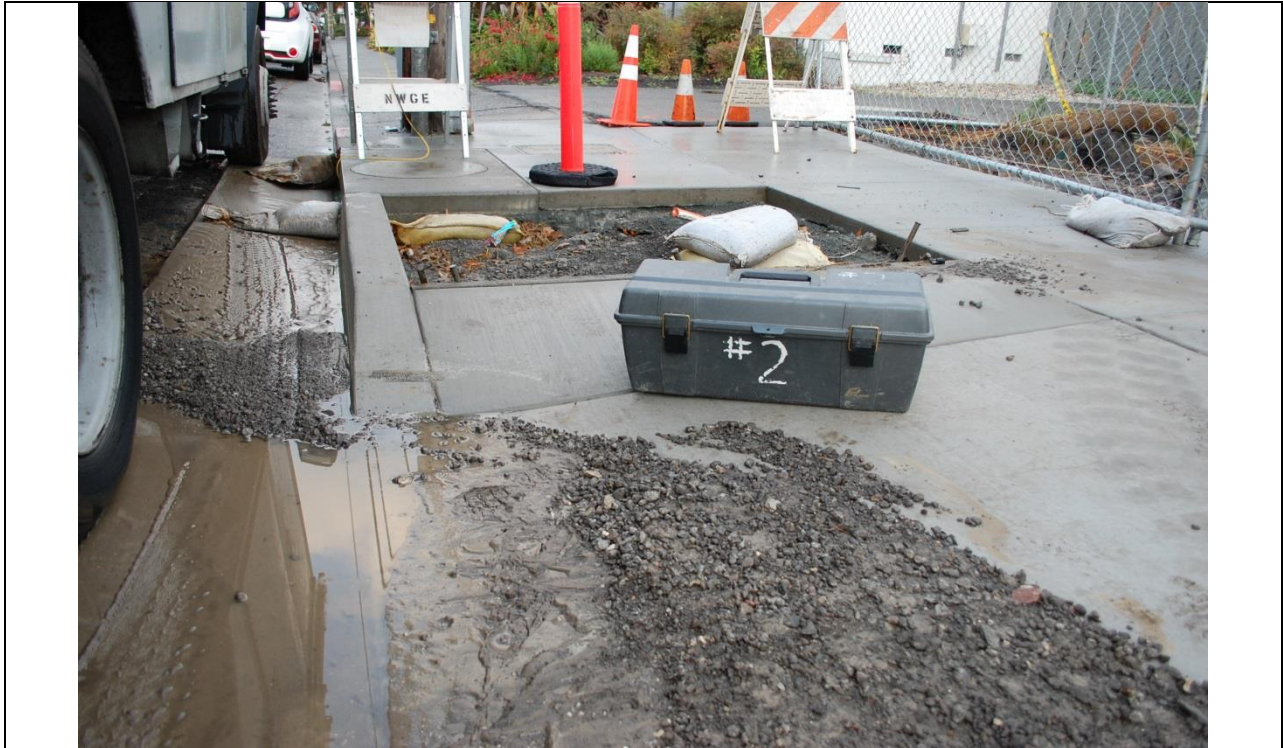
Photo 10: Residual water in the gutter with pH of 10.02.

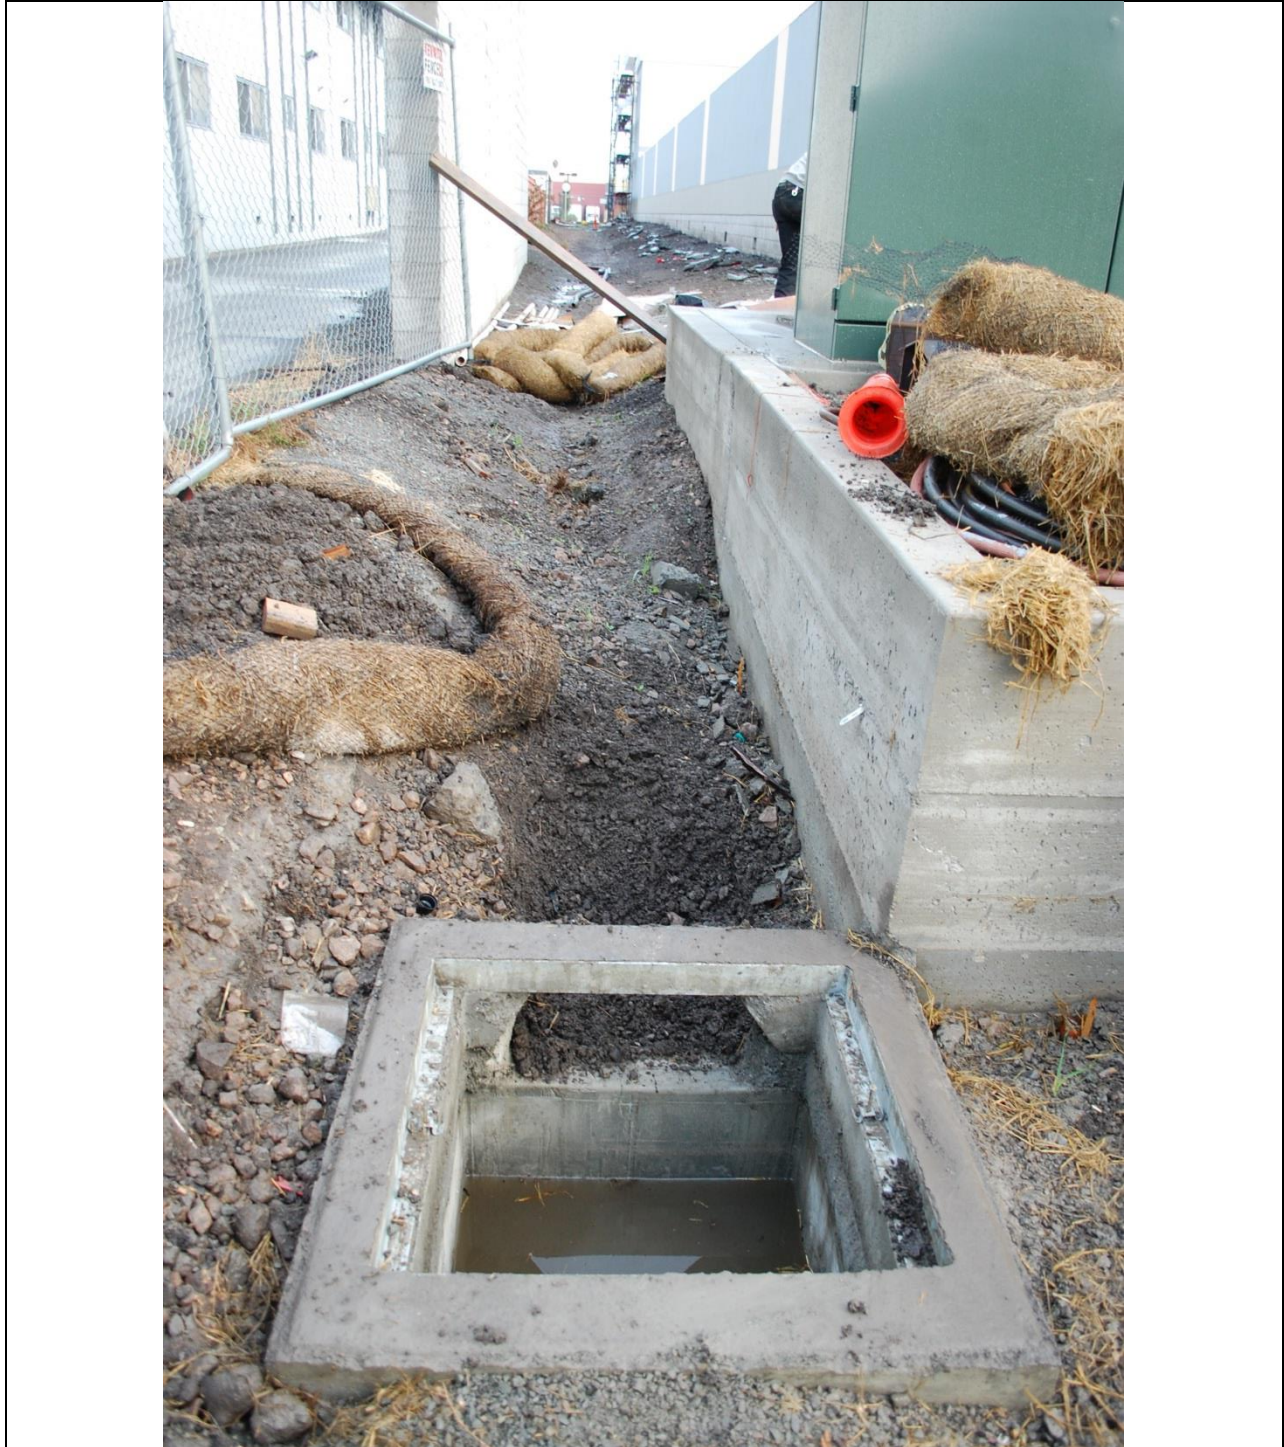
Photo 11: Southwestern drop inlet containing residual storm water with a pH of 9.65 and an undisturbed turbidity of 171 NTU.

10/15/2014	Residual storm water in drop inlet	pH	9.65	std. units	38.45554	-122.72825	3	7:55 AM	8:05 AM	K. Grady
10/15/2014	Residual storm water in drop inlet	Conductivity	75	μS/cm	38.45554	-122.72825	3	7:55 AM	8:05 AM	K. Grady
10/15/2014	Residual storm water in drop inlet	Turbidity	171	NTU	38.45554	-122.72825	3	7:55 AM	9:45 AM	K. Grady
