CALIFORNIA REGIONAL WATER QUALITY CONTROL BOARD  
NORTH COAST REGION

CLEANUP AND ABATEMENT ORDER NO. R1-2015-0048  
FOR  
JENNIFER NIELSEN, ASSESSOR PARCEL NUMBER 210-141-011  
WDID 1B14099CNHU

HUMBOLDT COUNTY

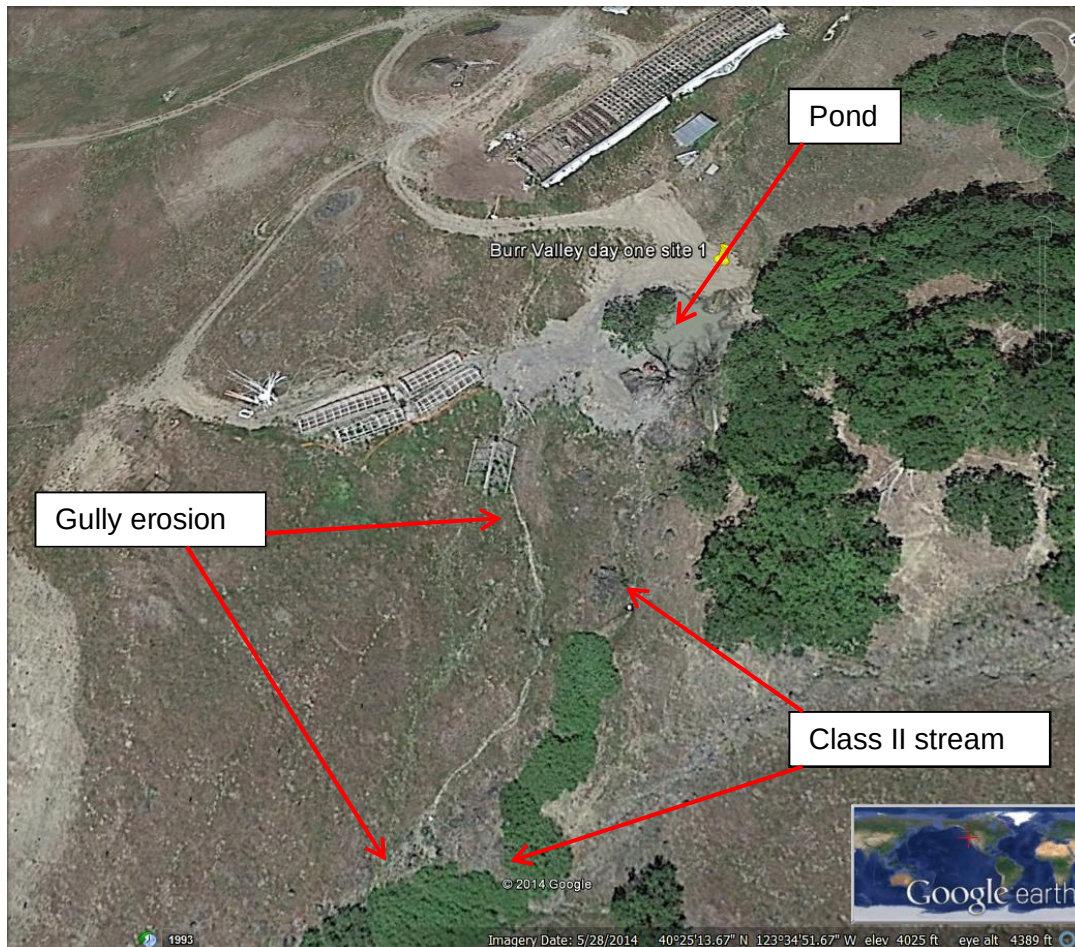
square foot earthen pad. It appears that runoff from this area drains delivers to streams by towards the Class III stream and pond or towards a drainage ditch that runs along the slope on the southwest side of the greenhouse and discharges to the class II stream below the pond. I also observed evidence of rill erosion and sediment delivery to the Class II stream and pond, and evidence of gully formation caused by the drainage ditch runoff from the greenhouse on the slope below the pond and greenhouse. In reviewing Google Earth imagery following the inspection, I observed evidence that gullies had formed and sediment had discharged to the Class II stream below the pond, in 2013.

Image 2- Google Earth image of Site 1. Note the gully running to the Class II stream from the greenhouse and developed road.

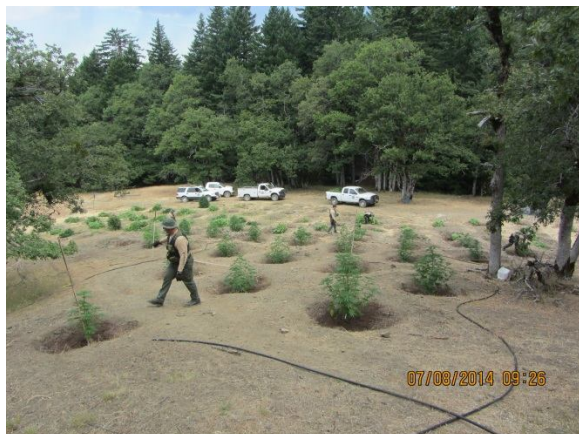
On this parcel, I observed an outdoor cultivation area with approximately 50-75 marijuana plants, 4 approximately 10,000-gallon water bladders/aqua dams, and a 2,500 gallon water tank (refer to Image 2, below, for approximate location of these features). Two of the water bladders were full, one partially full, and one empty; I estimate approximately 27,500 gallons of water were stored in the bladders and tank at the time of the inspection. The cultivation area was on a slope ranging from 3% - 25%.

Image 5- shows the outdoor cultivation area with at least 50 plants (Photo 7001)

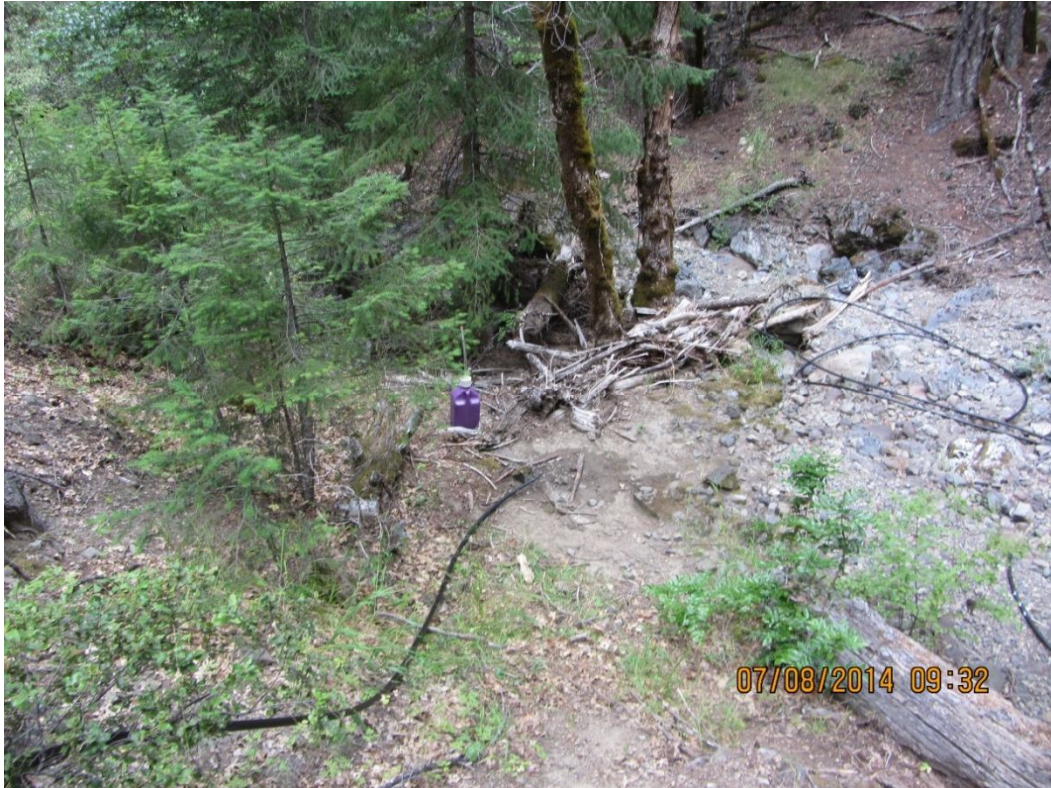
Dairy Creek crosses the parcel approximately 500 feet away from this cultivation area, closer than it appears on the aerial images, and appears to be a water source for irrigation at this location. One of the law enforcement officers participating in the inspection showed me the location adjacent to Dairy Creek where law enforcement officers had removed a gasoline-powered pump just prior to my visit to the site. (Refer to Image 5, below). I observed a gas can at this location, a pipe that had reportedly been connected to the pump, and wet and discolored soils on the ground below the end of the pipe, where the pump had reportedly been sitting. The officer advised me that the pipe led to the water bladders and tank. I did not observe any fuel spill containment or cleanup materials or features at the site where the pump had been placed. Dairy Creek was dry at the time of my inspection.

The manner and method of water diversion and storage at this location may be a violation of the Water Code and Fish and Game Code.

Image 6 – shows the site of apparent water diversion from Dairy Creek. (Photo 7003)

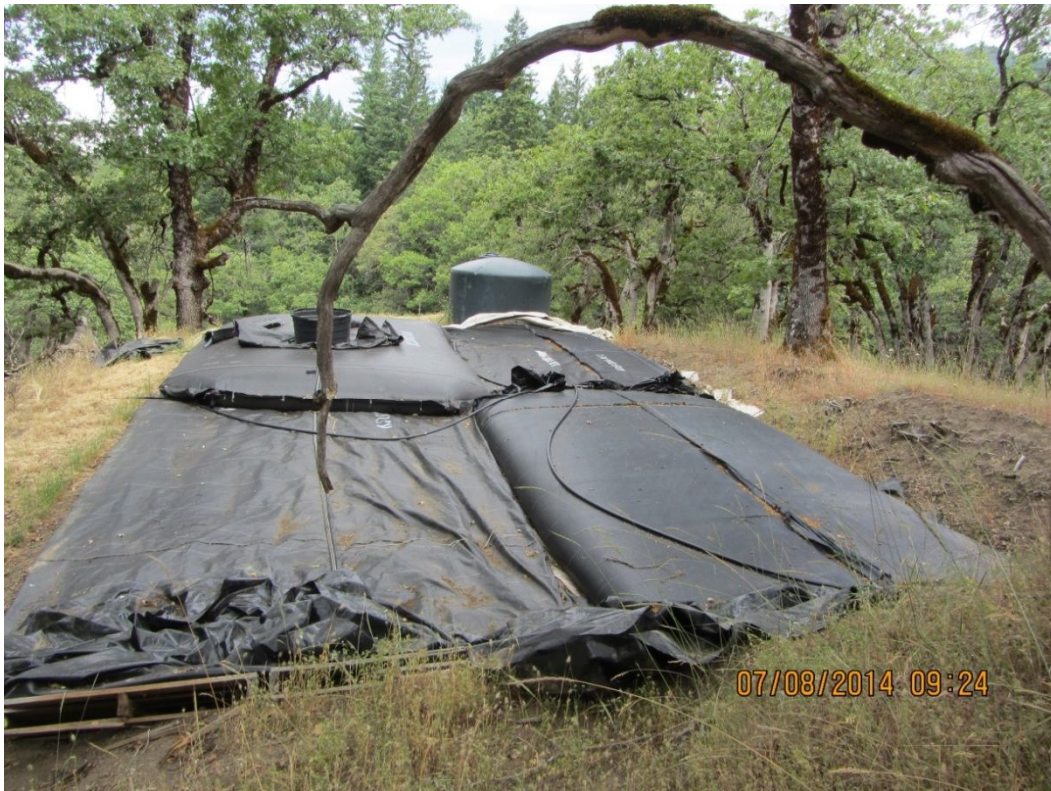
Image 7 – Water bladders and water tank (Photo 6998)

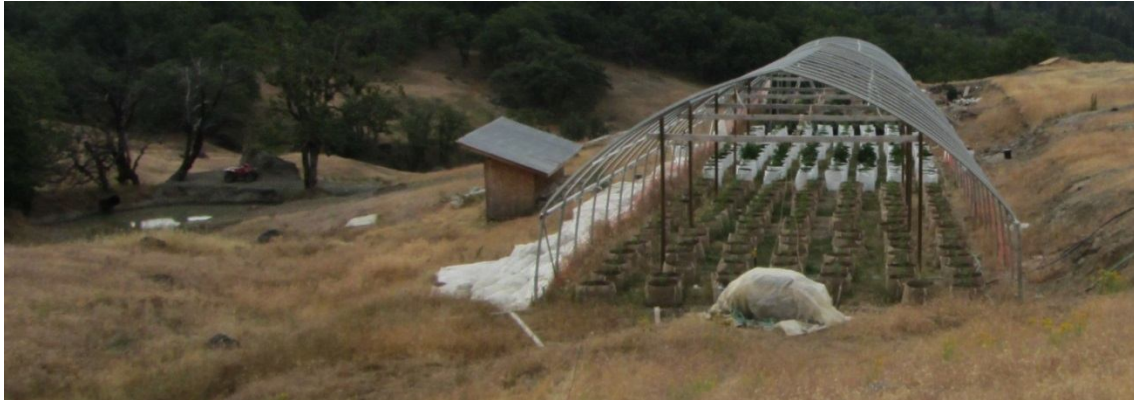
Image 8 – is looking south at the large greenhouse and the pond (Photo 6994 cropped and enlarged)

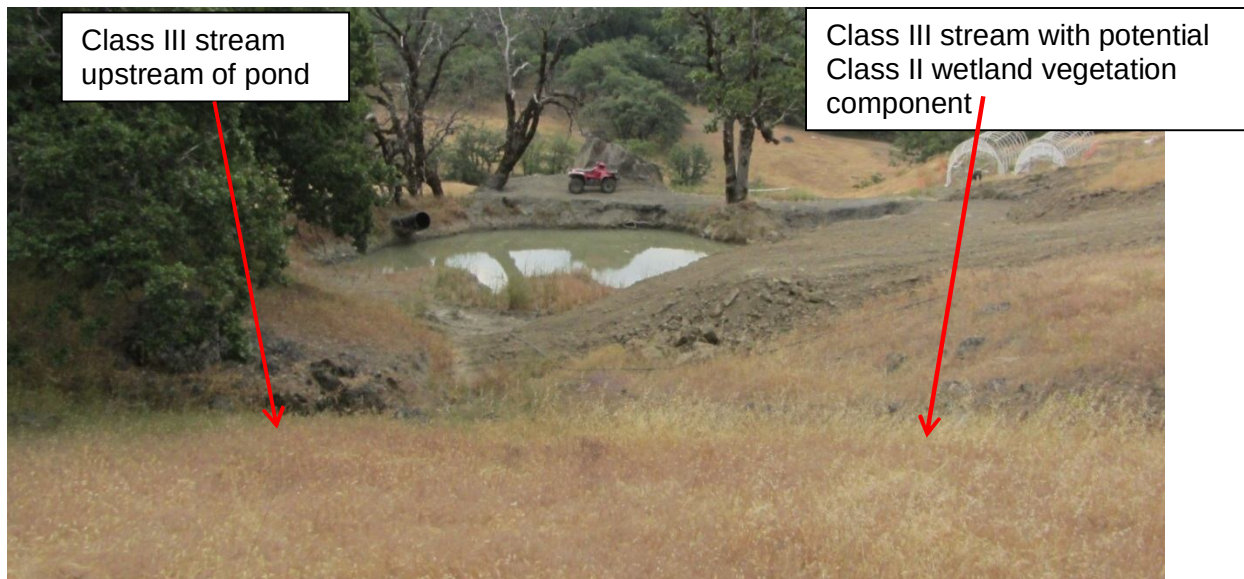
I observed additional loose fill piled adjacent to the pond, in locations where winter rainfall is likely to result in delivery of sediment to the pond and beyond it into the Class II stream channel below. I observed goldfish in the pond.

Image 9 – is looking south at the pond, earthen dam, dead trees, and two Class III streams entering the pond. (Note the perched earthen fill materials piled adjacent to the pond). (Photo 6948 cropped)

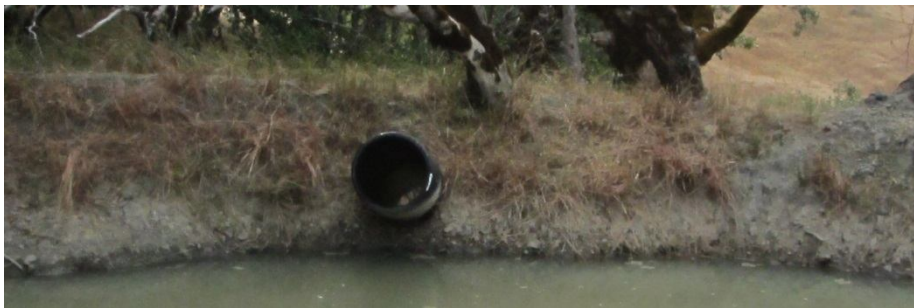
In my opinion, the earthen dam is unstable and likely to fail. Failure of the dam would result in a substantial sediment discharge and the release of a nonnative species into the Van Duzen River watershed. As discussed below, I gathered measurements while in the field, and following the inspection, calculated an estimated volume of fill material comprising the dam and available to be transported downstream in the event of a catastrophic failure.

Image 10 – shows the pond, spillway, culvert, and dam. Note the trees are buried in the fill. (Photo 6963 cropped and zoomed in)

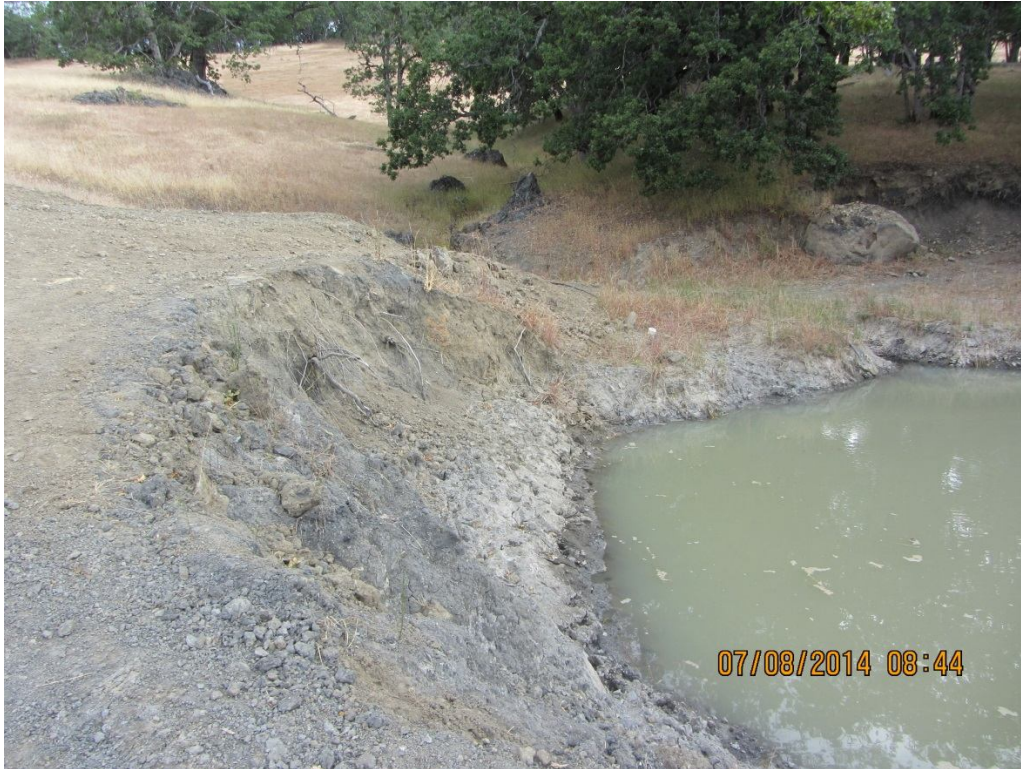
Image 11- shows perched earthen fill materials above the pond, (Photo 6960)

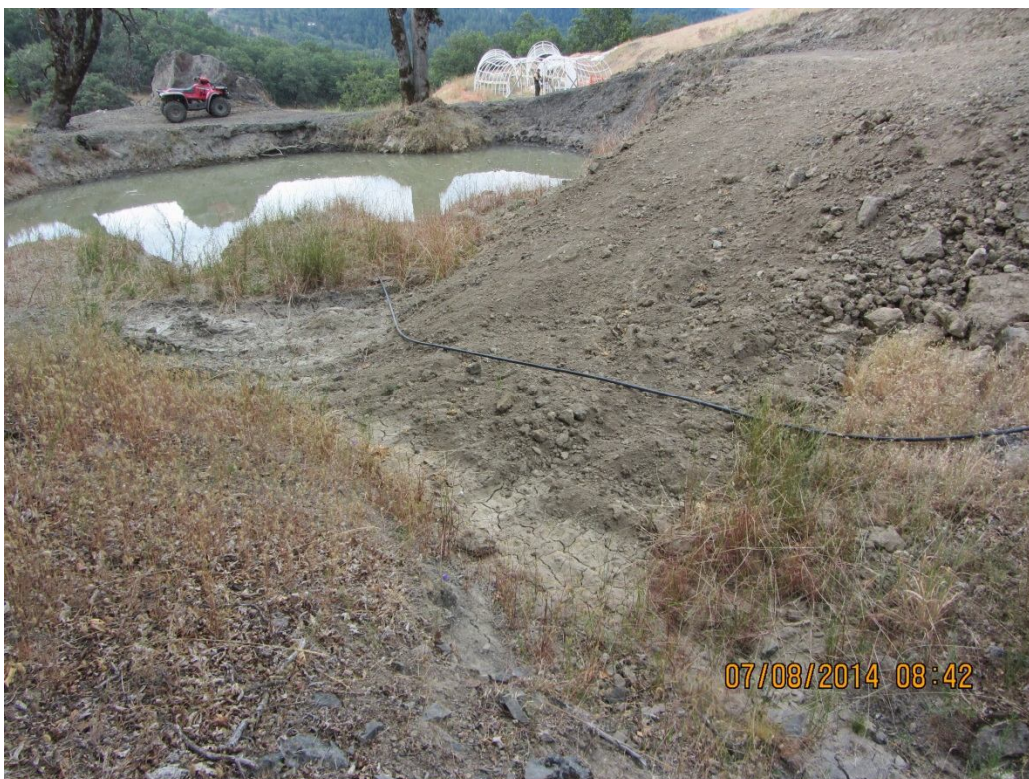
Image 12 – shows perched earthen fill materials adjacent to and deposited in the streams entering the pond. (Photo 6951)

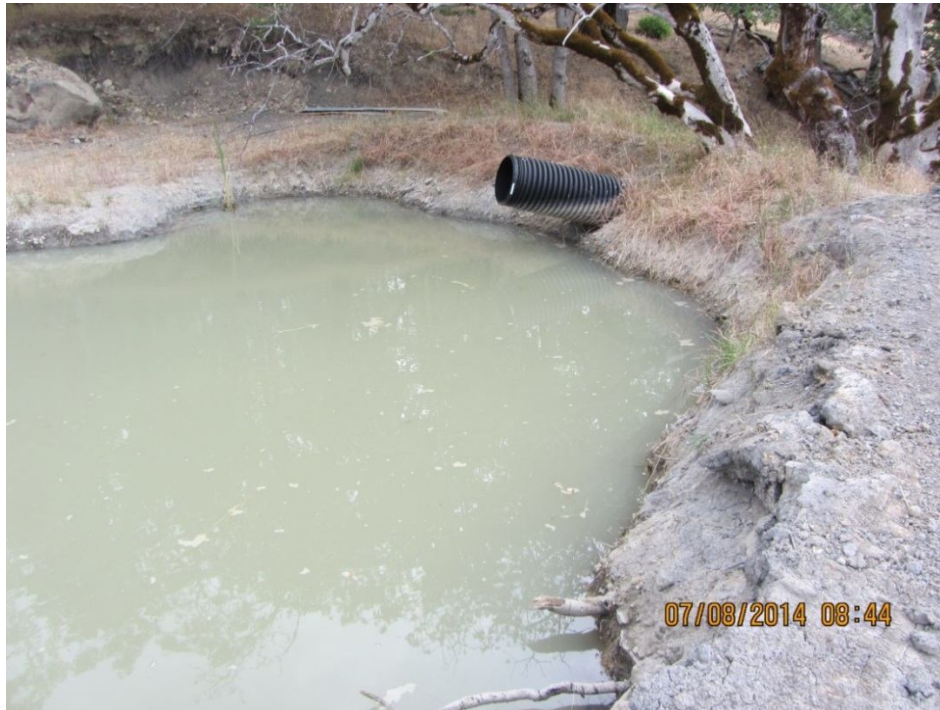
Image 13 – shows the pond spillway culvert. Note the pipe is installed at a steep angle. This is not an orthodox installation, and appears to threaten the dam with overtopping and eroding during heavy rainfall. (Photo 6959)

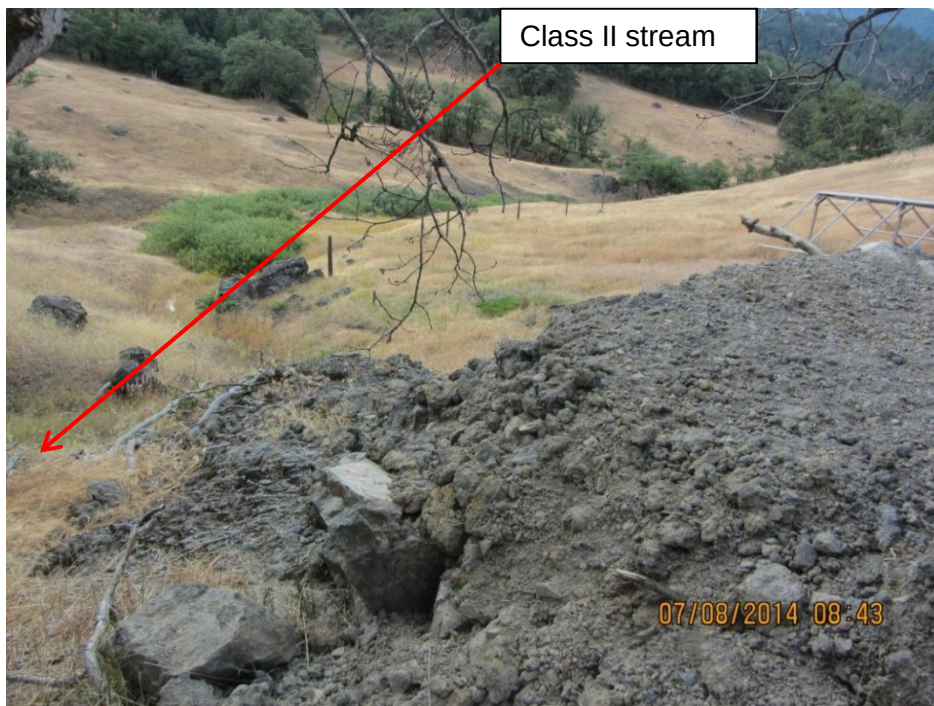
This portion of the dam consists of loose earthen fills placed on a steep slope, and exposed to rainfall and saturation by the pond. Based on my observations, I believe that the potential for failure at this location is above moderate to high.

Image 14 – shows the downhill side of the dam, note the loose unconsolidated fill material used in dam construction perched adjacent to and placed in the Class II stream channel. (Photo 6955)

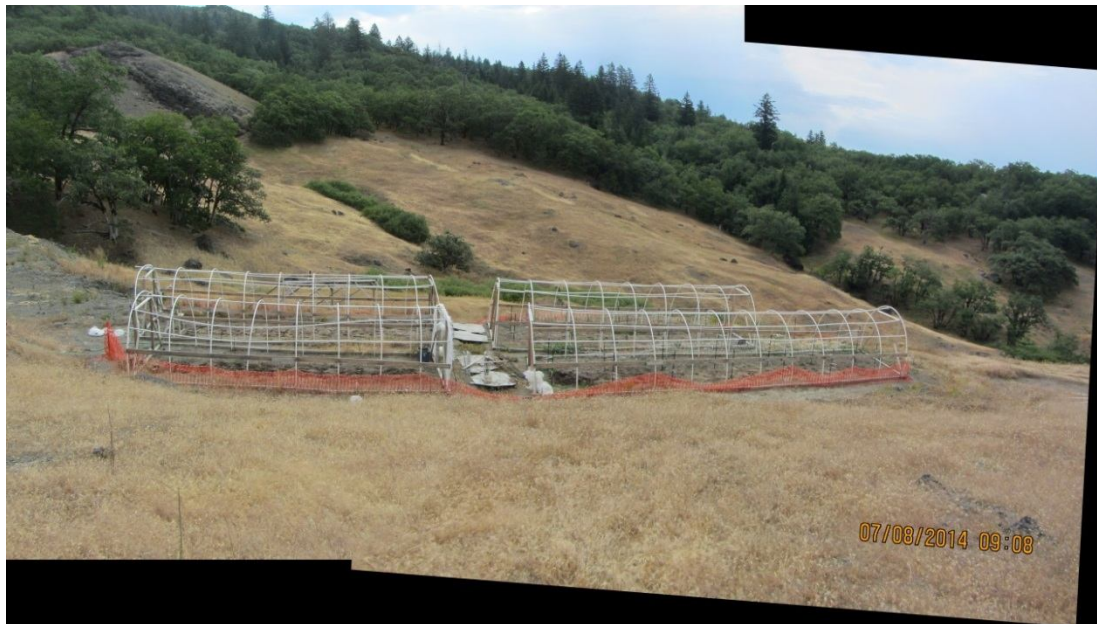
Image 15 – shows the four small greenhouses (photo 6992 and 6993 merged)

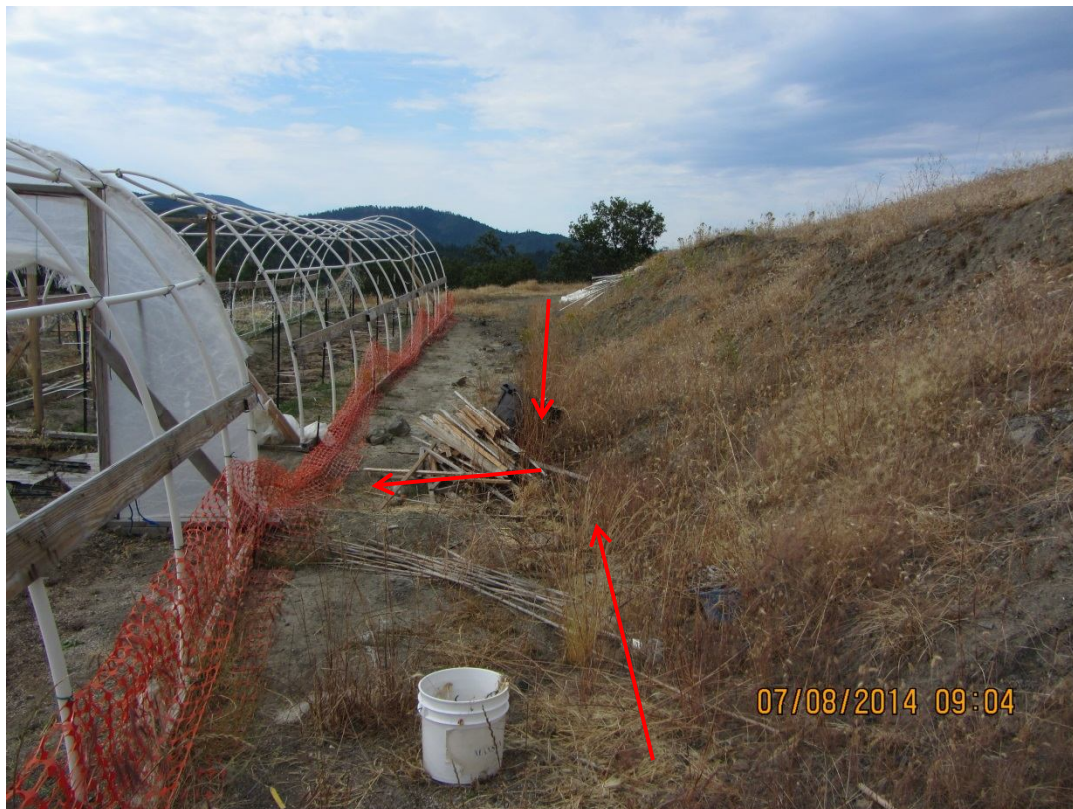
Image 16 – The arrows denote the constructed ditch drainage behind the four small greenhouses; the drainage is designed to carry all flows to the center of the greenhouses where it is then directed to the Class II stream below. This design concentrates flows, and may concentrate nutrients from the grow site potentially delivering these nutrients to the stream down slope. (Photo 6986)

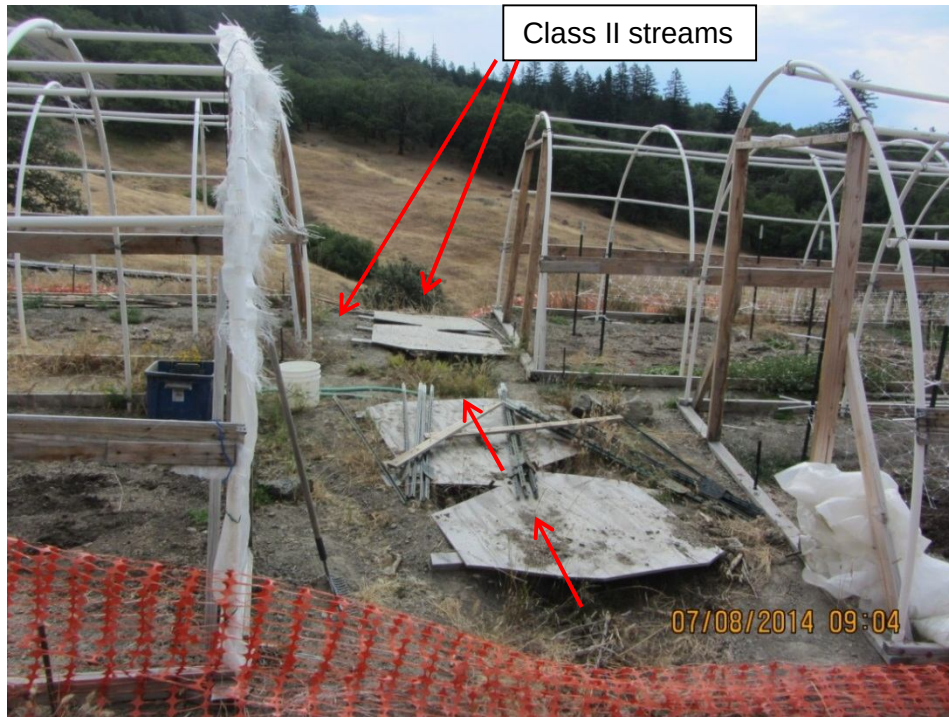
Image 17 – shows the drainage ditch between the four small greenhouses; the arrows denote the flow path of the ditch. (photo 6987)

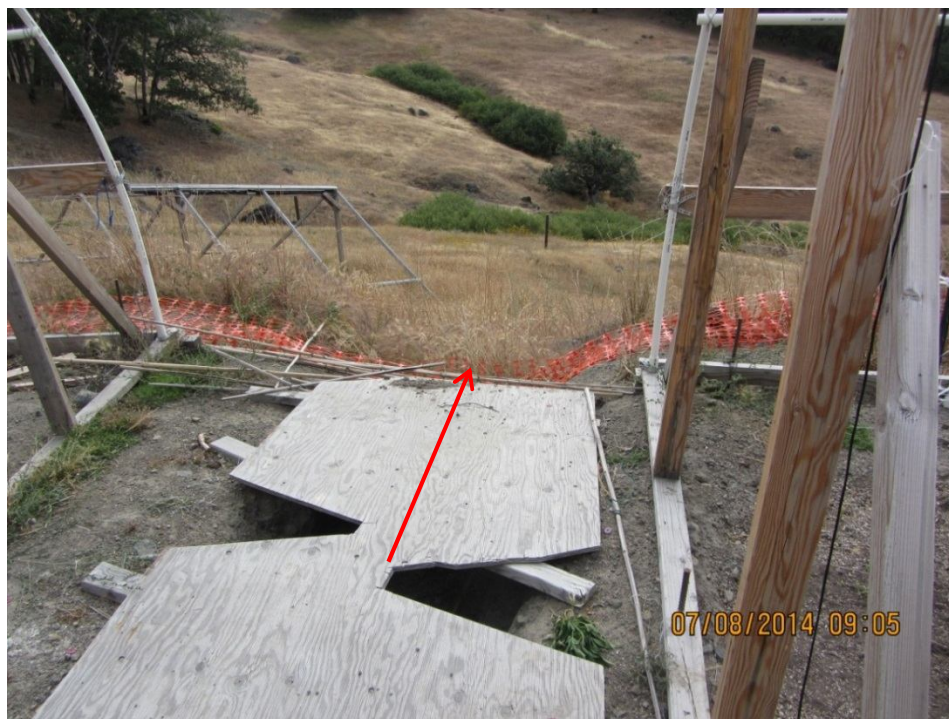
Image 18 – Here the drainage ditch outlets onto the slope below.

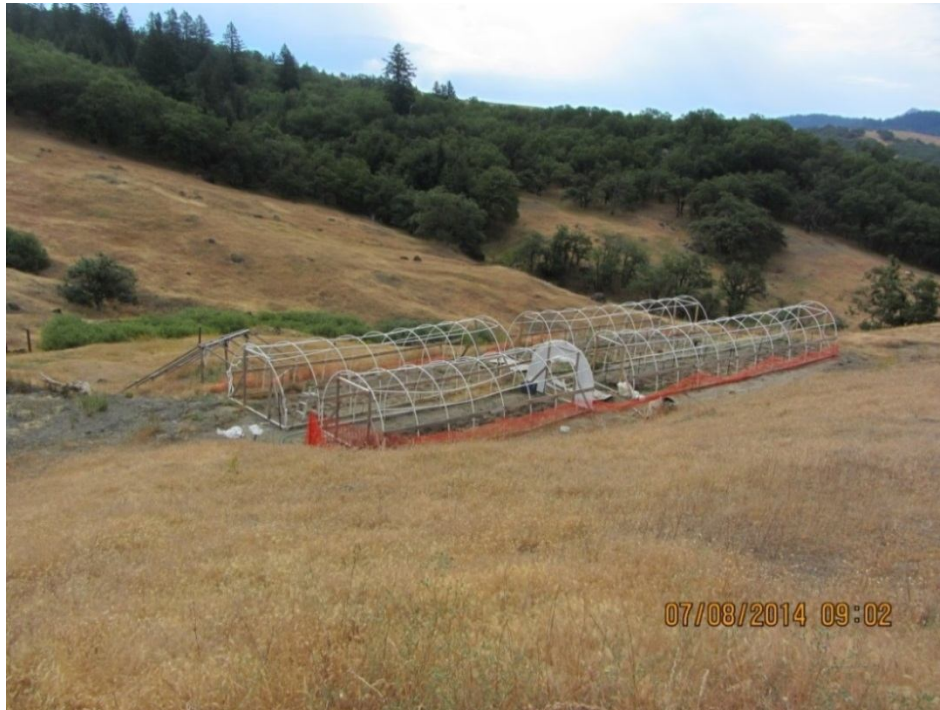
Image 19 – shows the four small greenhouses and the Class II stream in the background (photo 6981)

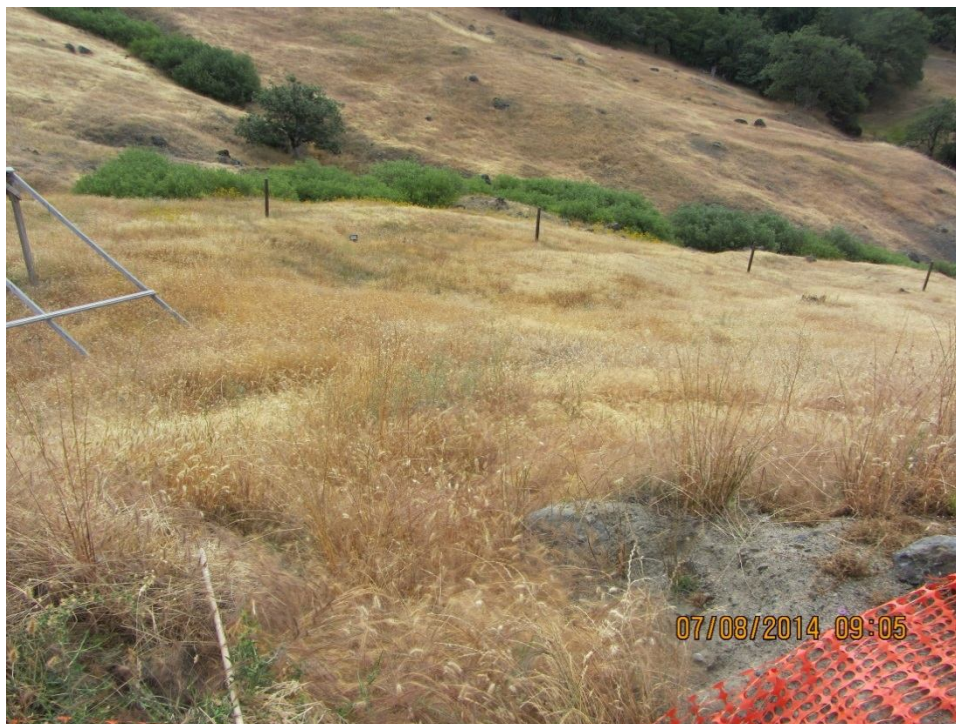
feet upslope of the Class II stream. As the slope gets closer to the Class II stream below, the slope increases to approximately 50%+. I observed that the slope was vegetated with grasses, and consisted of hummocky ground with several old small surficial failures. I observed that the pad had been shaped to drain centrally to a drainage ditch at the center of the pad, which drains to slopes that lead directly to the Class II stream below. In addition to increasing the chance for forming erosional gullies and transporting sediment and other pollutants directly to the downslope watercourse, concentrating the flows on this slope may exacerbate unstable slope conditions and lead to slope failures and potential sediment delivery to the watercourse.

Image 20 – is looking downslope from the four greenhouses to the Class II streams, approximately 200 feet below. Note the hummocky topography, potentially indicating unstable ground. Drainage features and conveyances on the pad for the greenhouse area concentrate runoff from this area onto the slope below. (Photo 6991)

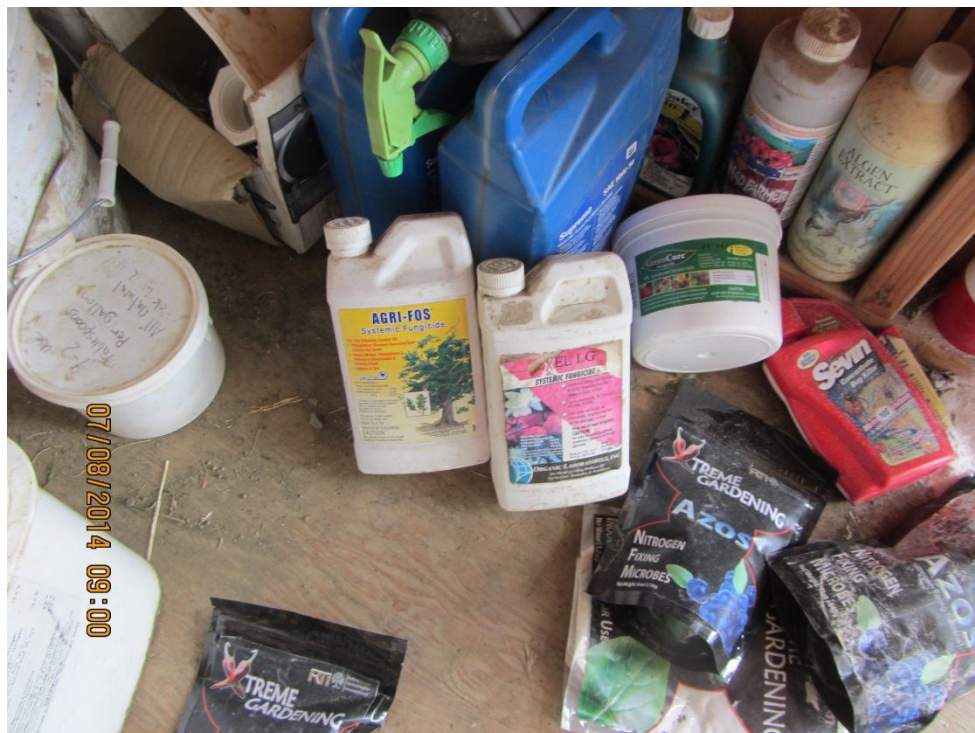
Image 21 – shows some of the pesticides, fertilizers, motor oil, and fertilizers in the shed (photo 6974)

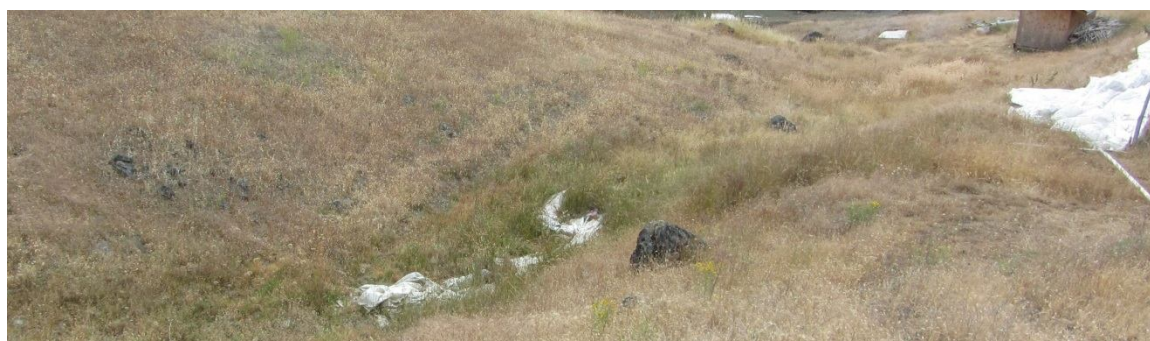
As noted above, I observed plastic sheeting adjacent to and in the channel of the Class II/III stream downslope of the greenhouse.

Image 22 – shows the plastic sheeting in the stream and adjacent to the stream above the pond. (Photo 6946 cropped)
