## North Coast Regional Water Quality Control Board

Date: February 25, 2016

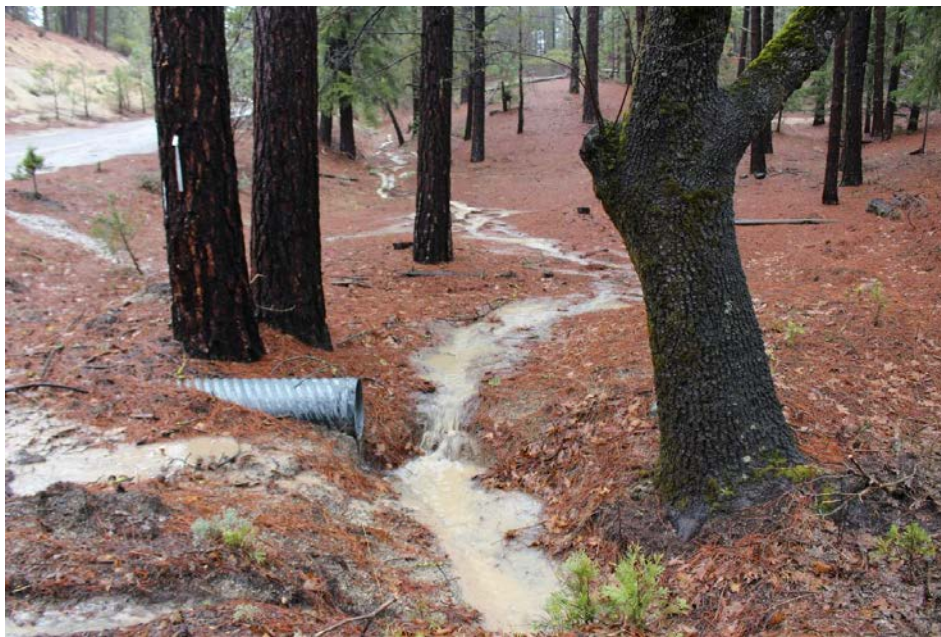
**Photo 1: Picture taken on January 29, 2016 by CAL FIRE staff showing elevated turbidity in an ephemeral channel that drains the Western Clearing identified in Figure 1**

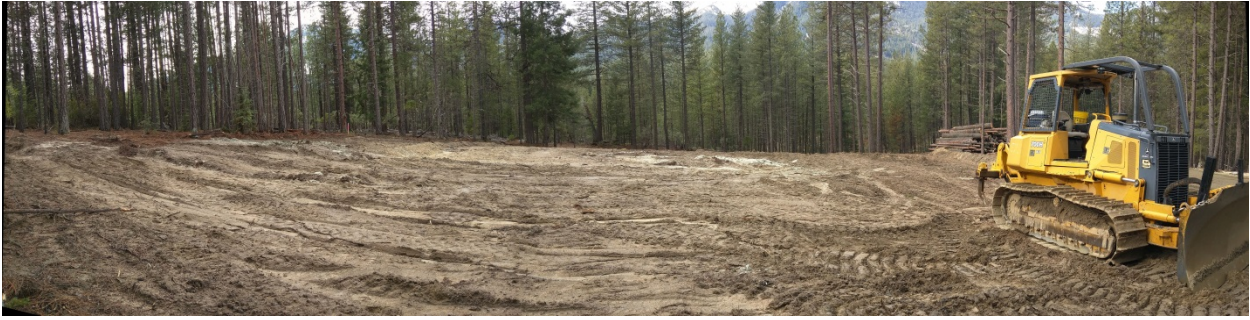
**Photo 3: Panorama of the Western Clearing, view towards the west**

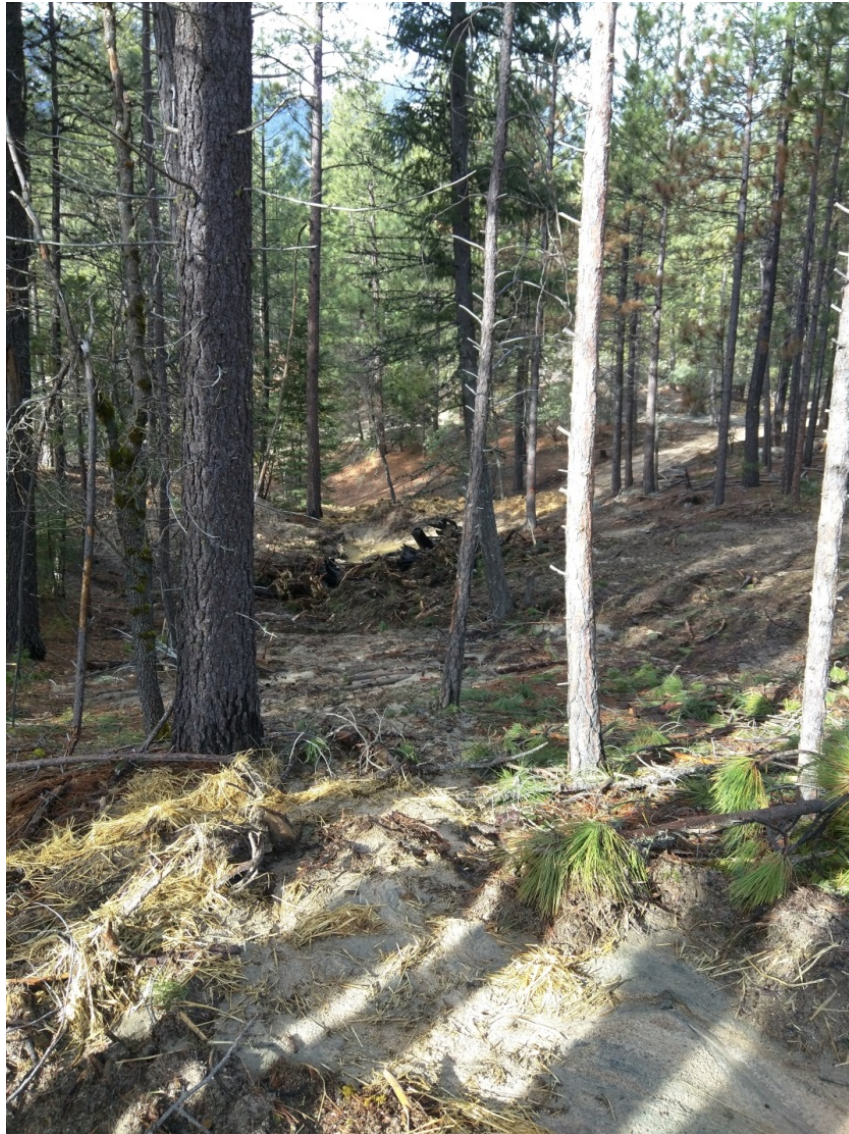
**Photo 4: View looking downstream towards the in-channel detention basin from the Western Clearing. Note sediment deposits passing through the straw and the burned stumps placed in the ephemeral watercourse further downhill**

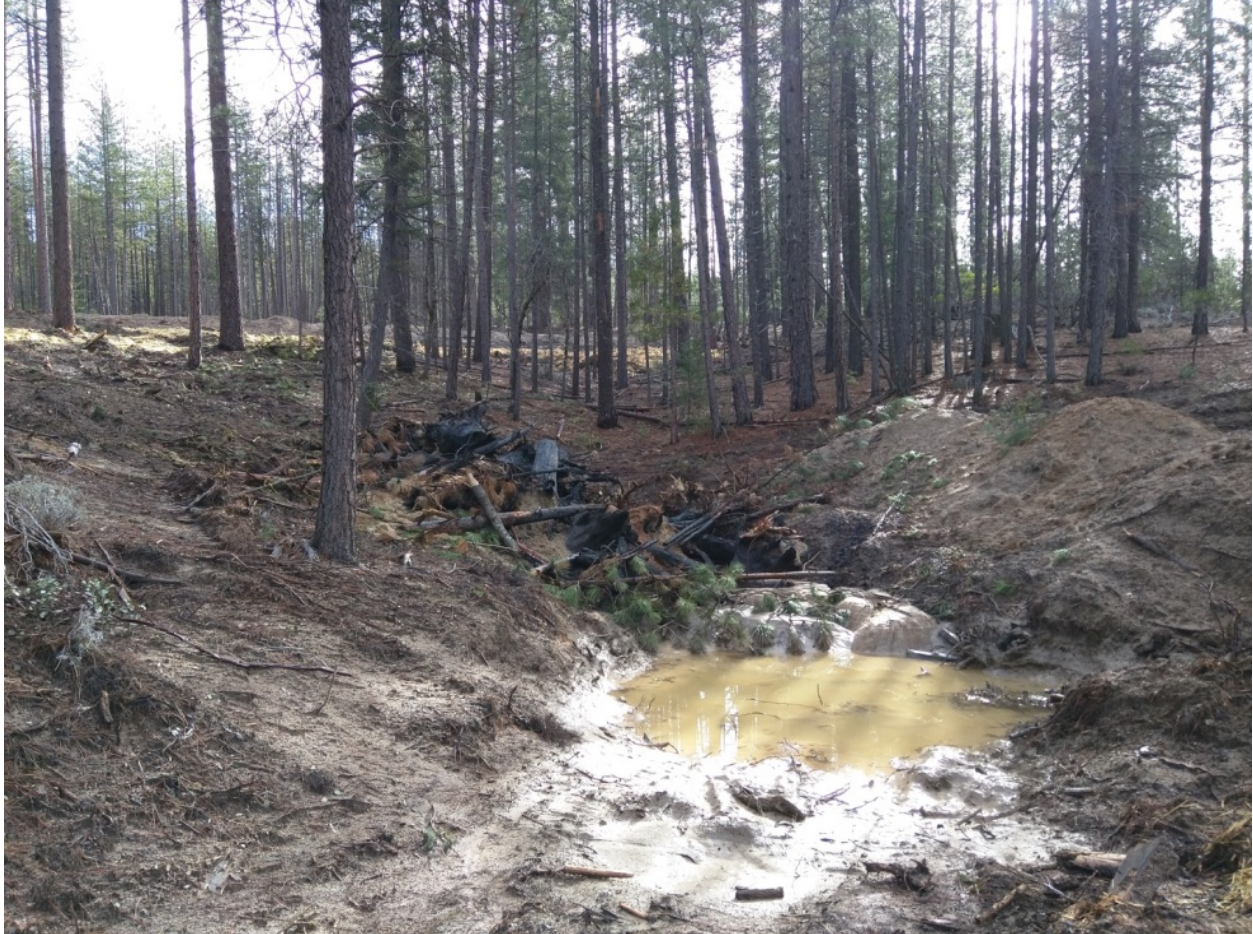
**Photo 5: Constructed detention basin within the ephemeral watercourse. View looking south**

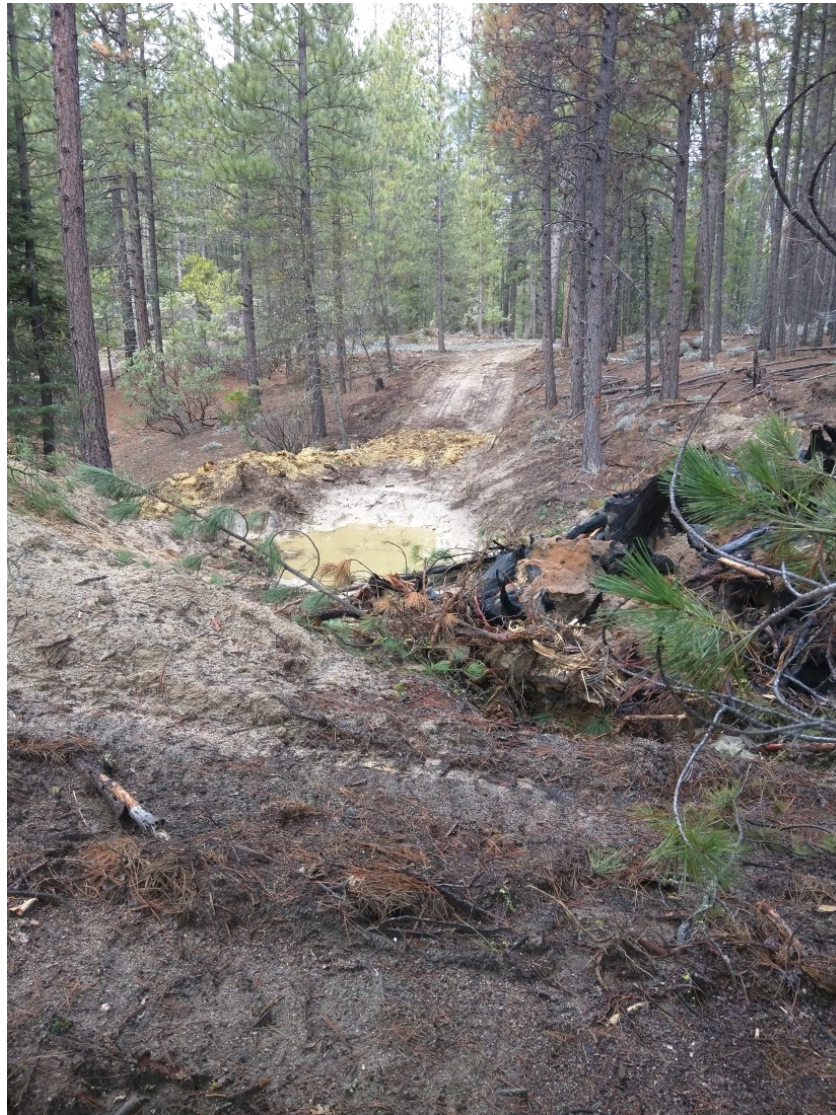
**Photo 6: Another view of the detention basin, looking north. Note the new road spur construction; French Creek Court runs perpendicular to the spur near the top of the picture**

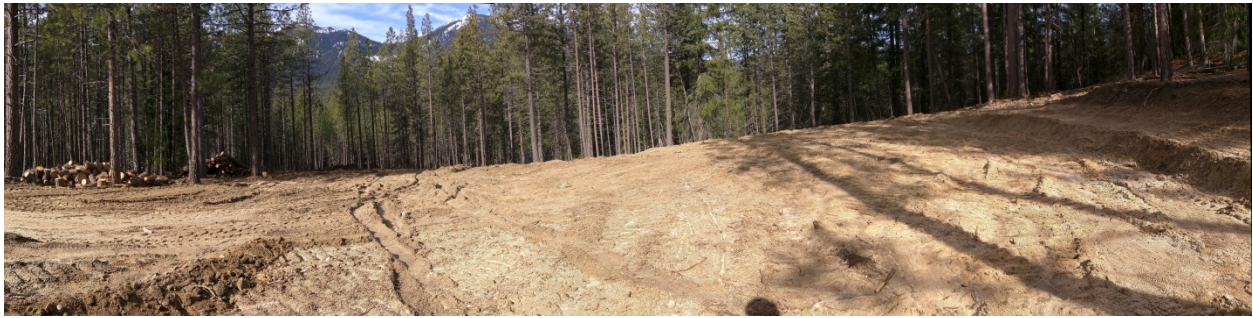
**Photo 7: Panorama of the Eastern Clearing area, view to the north**

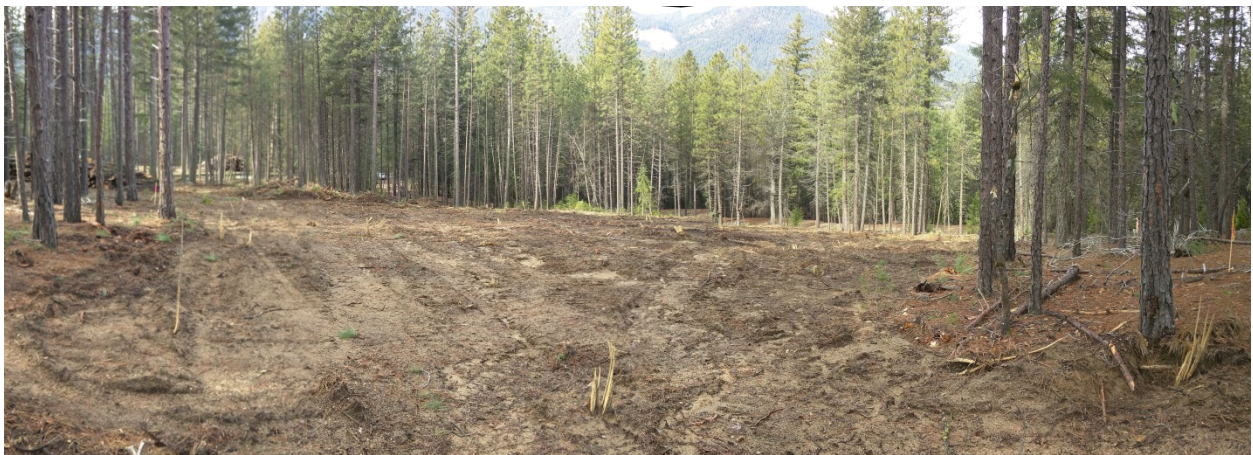
**Photo 8: Panorama of the Central Clearing, view to the northwest. Note the small stumps sticking out of the ground in the foreground**

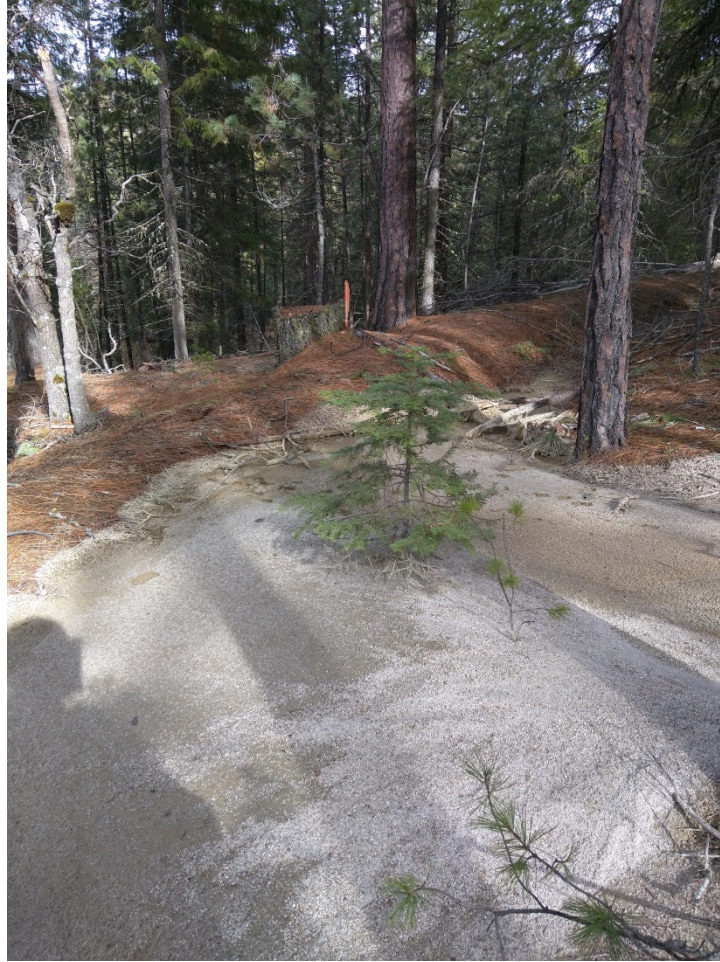
**Photo 9: Earthen material adjacent to water well construction**

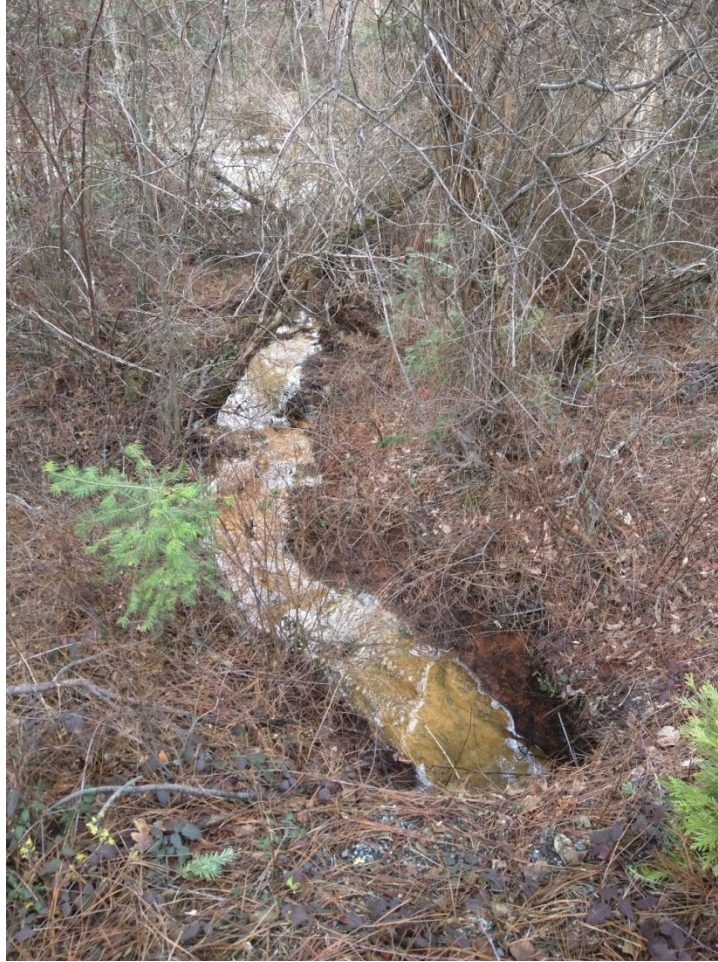
**Photo 10: Discharge from culvert draining alleged landfill area.  
Photo taken from the French Creek Road right of way.**

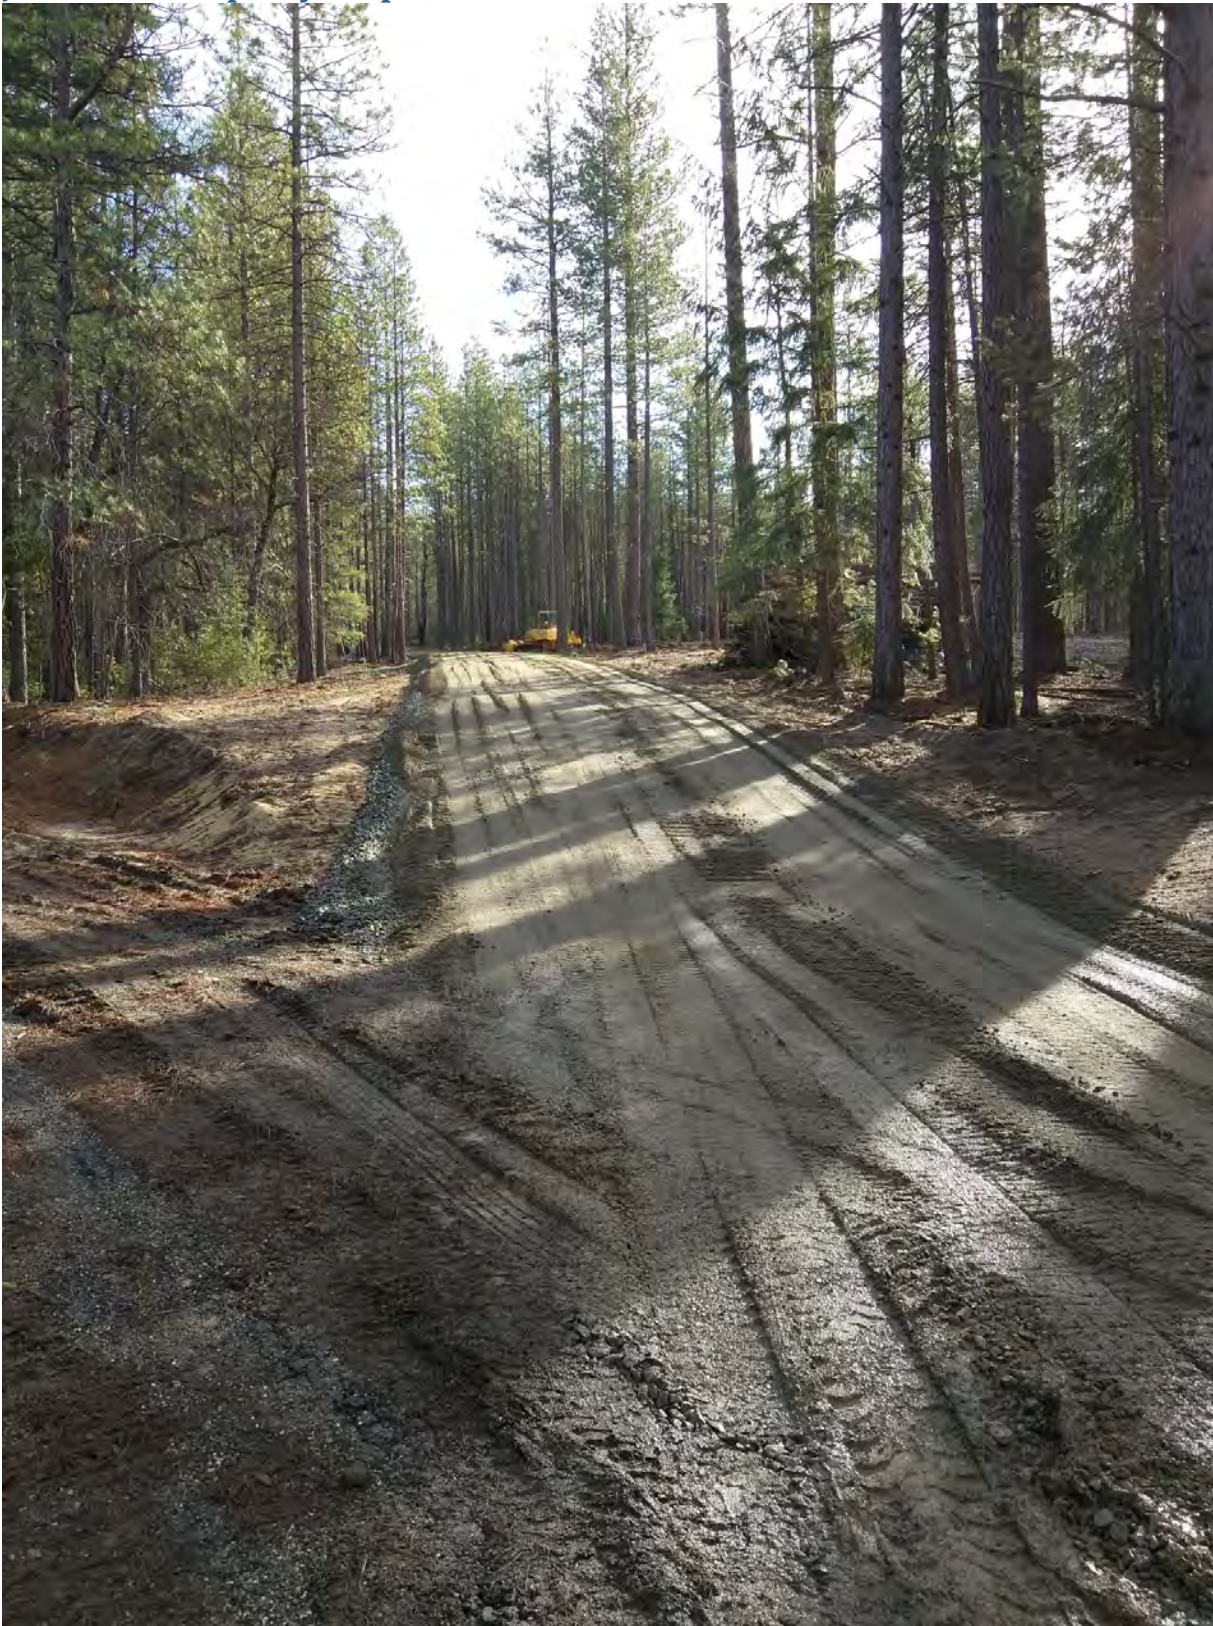
**Photo 1: View from French Creek Court looking east at the newly constructed road**

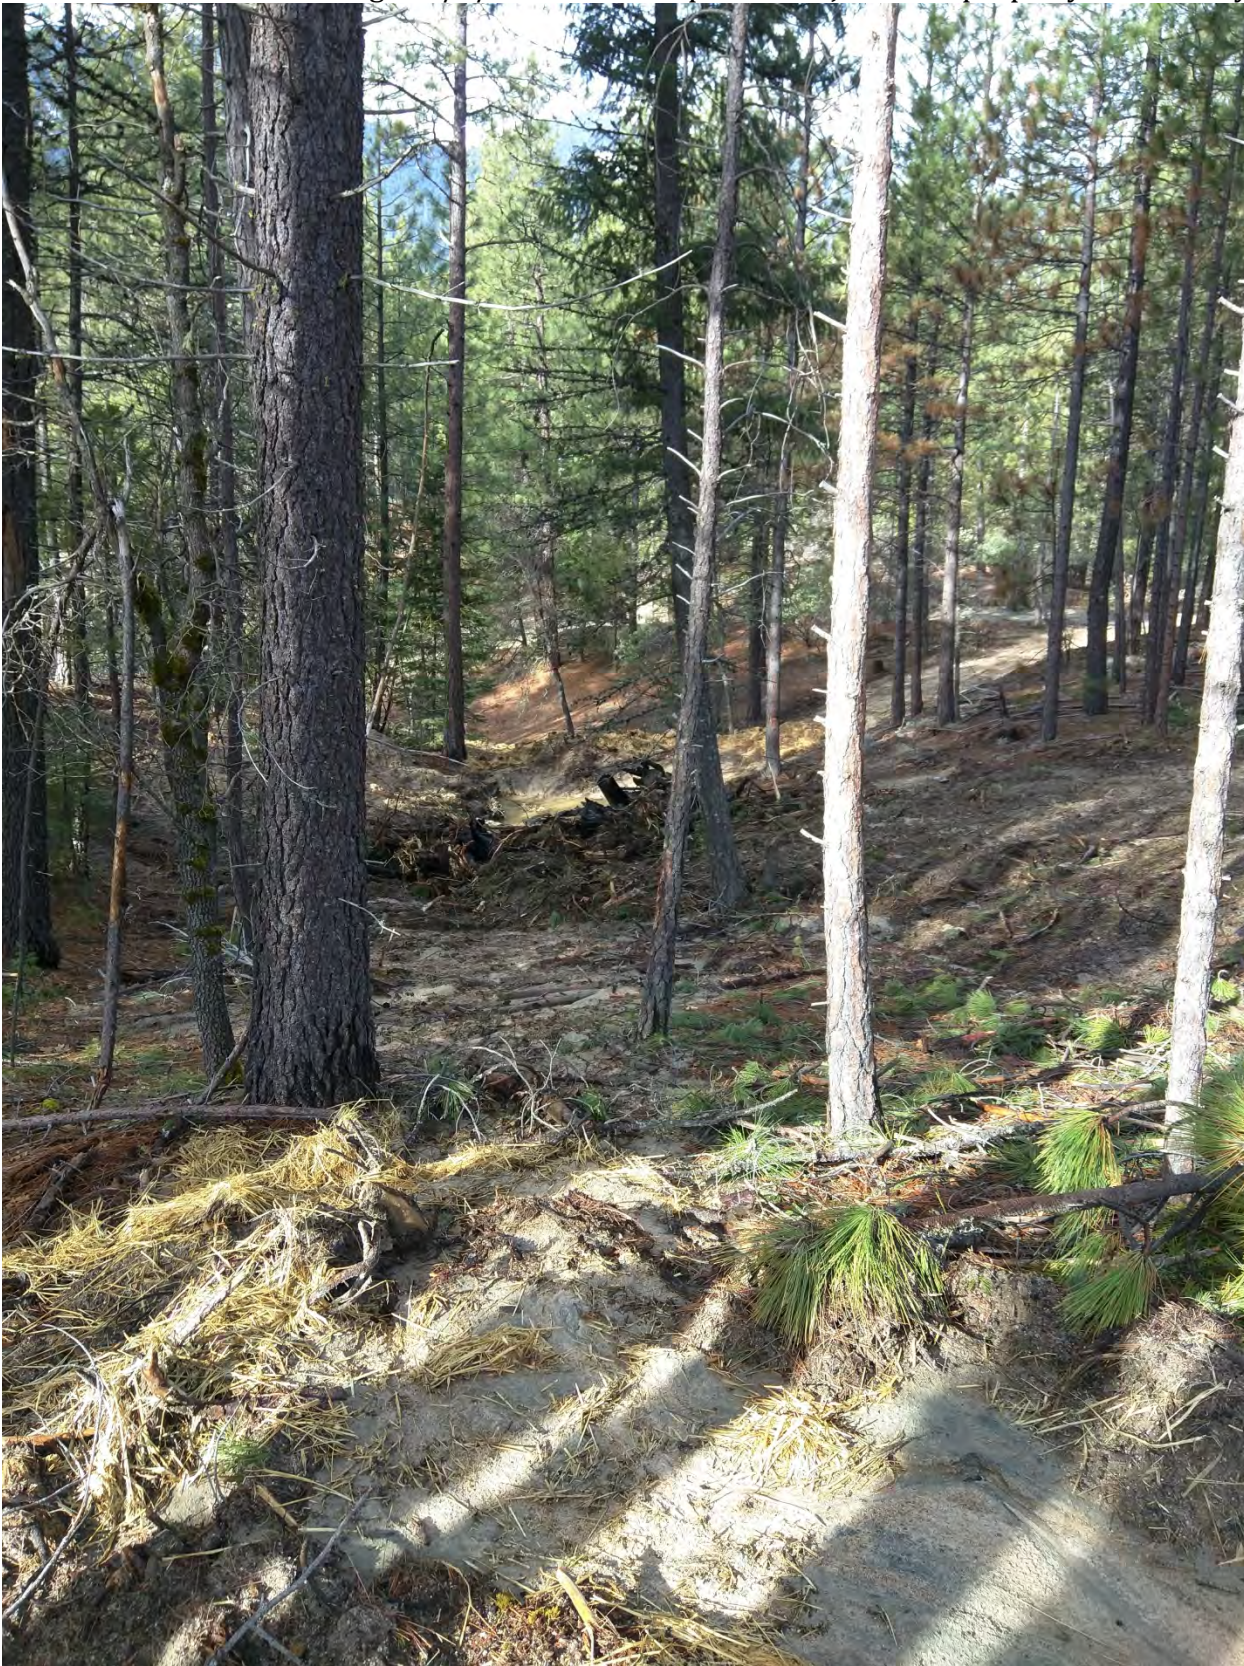
**Photo 6: View looking downstream at the constructed detention basin in the ephemeral watercourse. Note evidence of sediment transport through the straw and burned stumps placed just upstream of the detention basin**

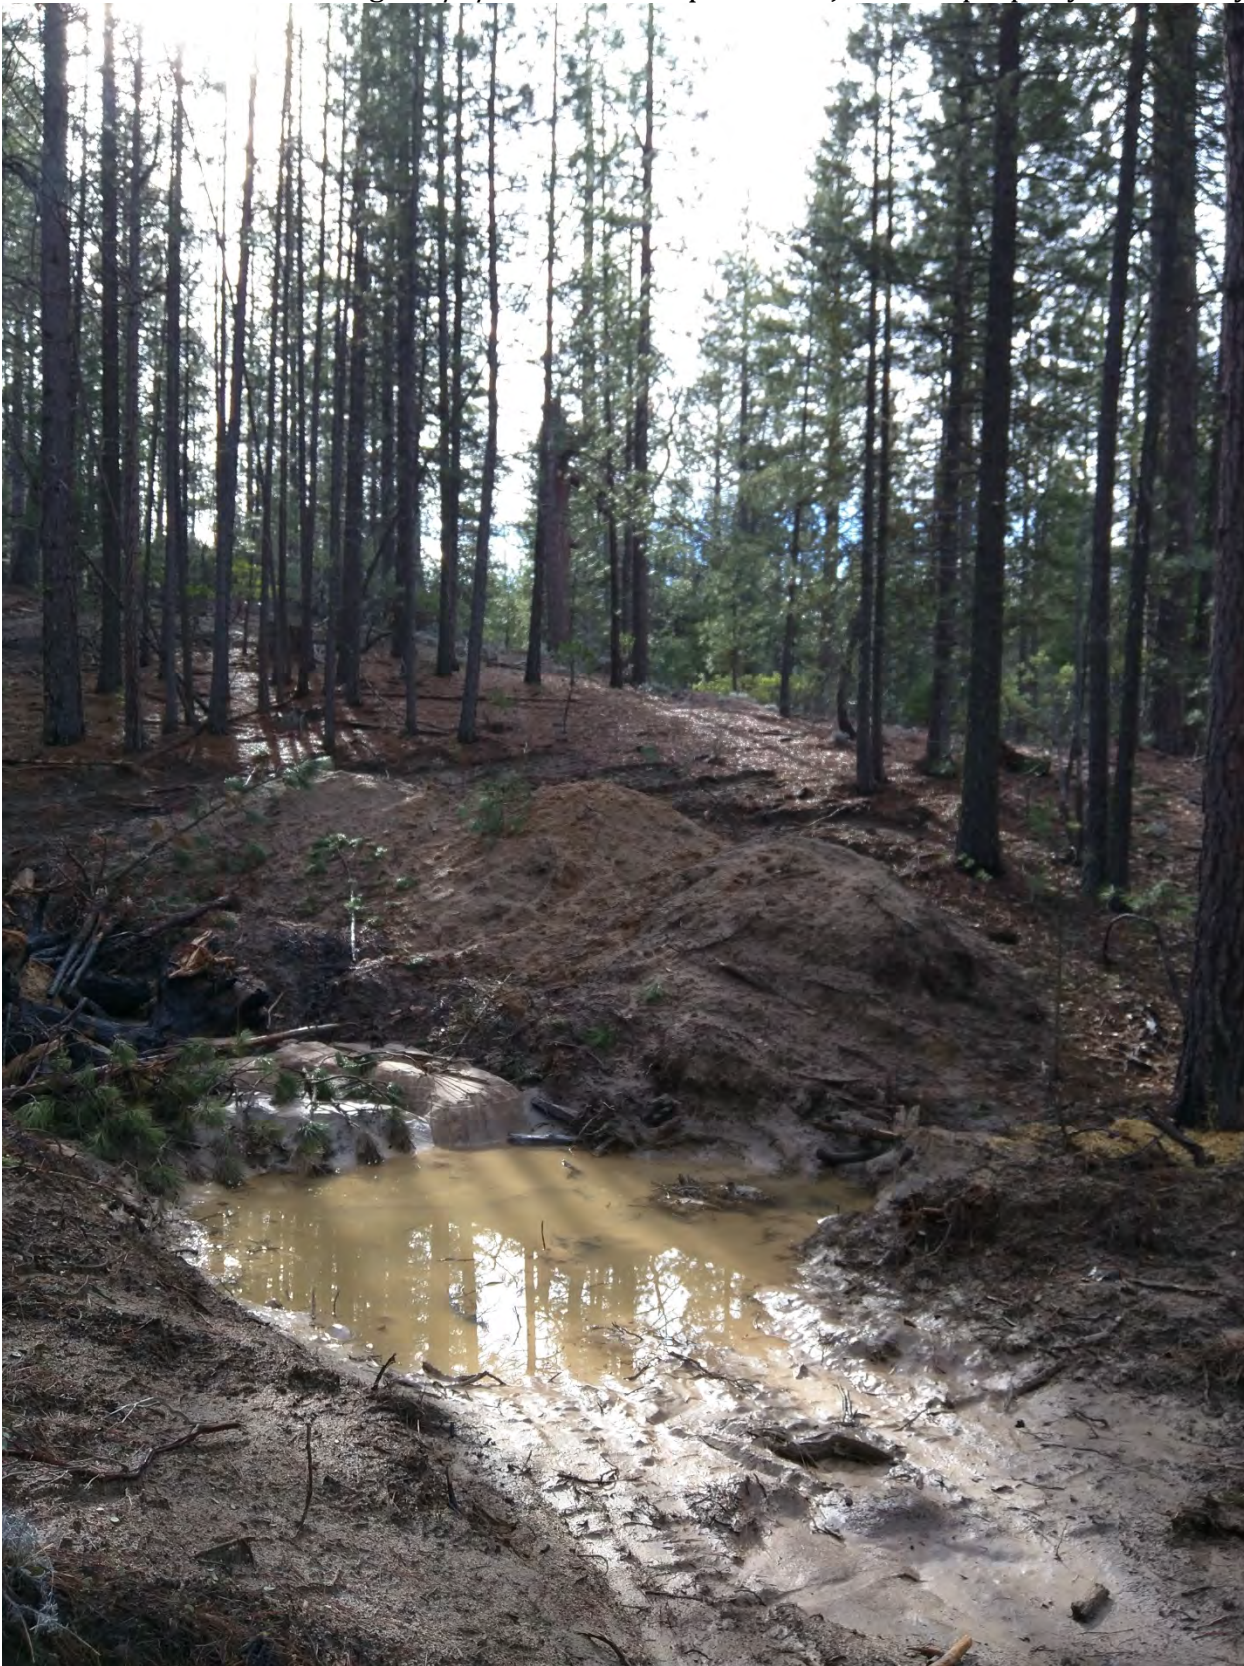
Photo 7: View looking south across the constructed in-channel detention basin. Note burned stumps placed just uphill of the basin

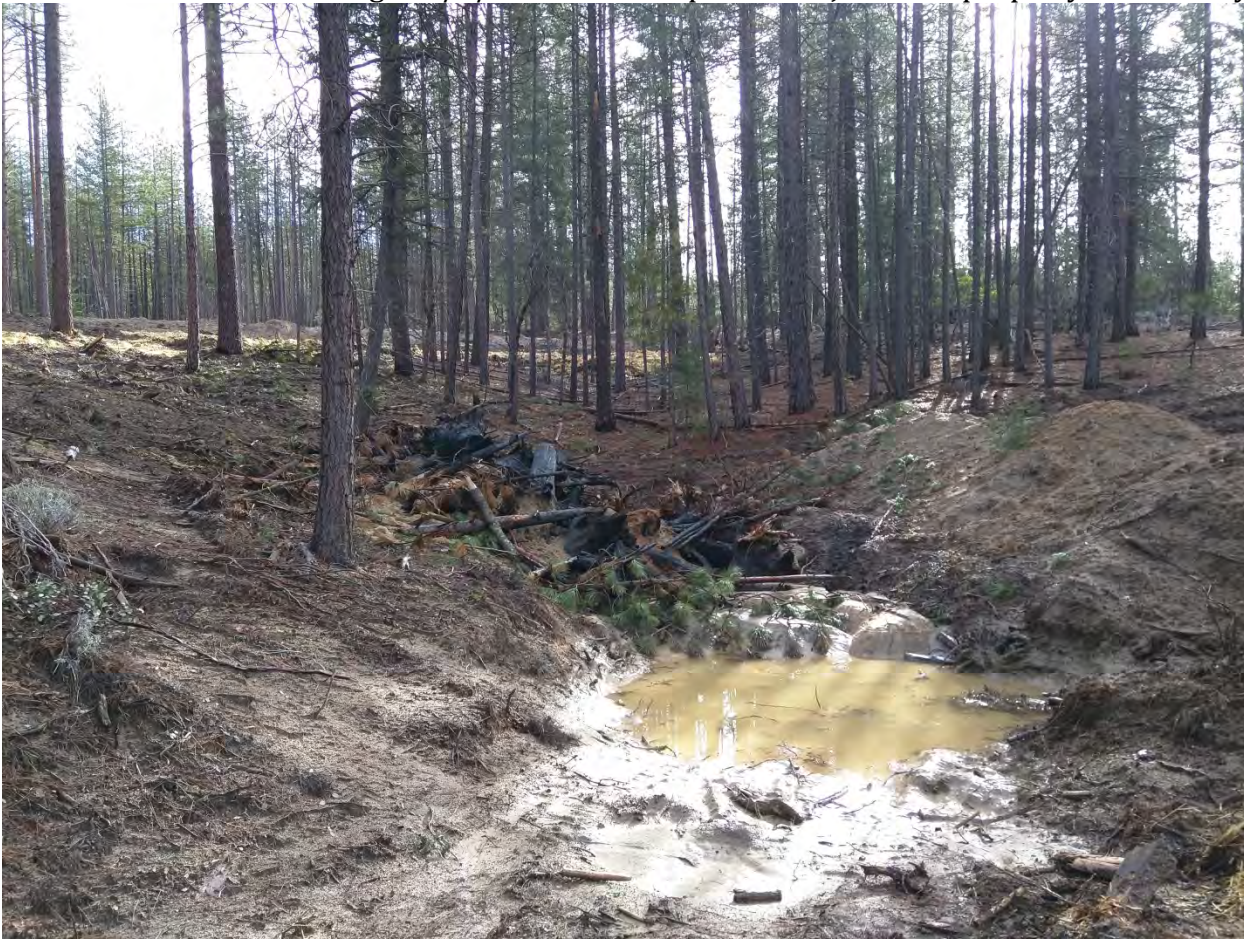
Photo 8: View of the ephemeral watercourse upstream of the basin towards the Western Clearing

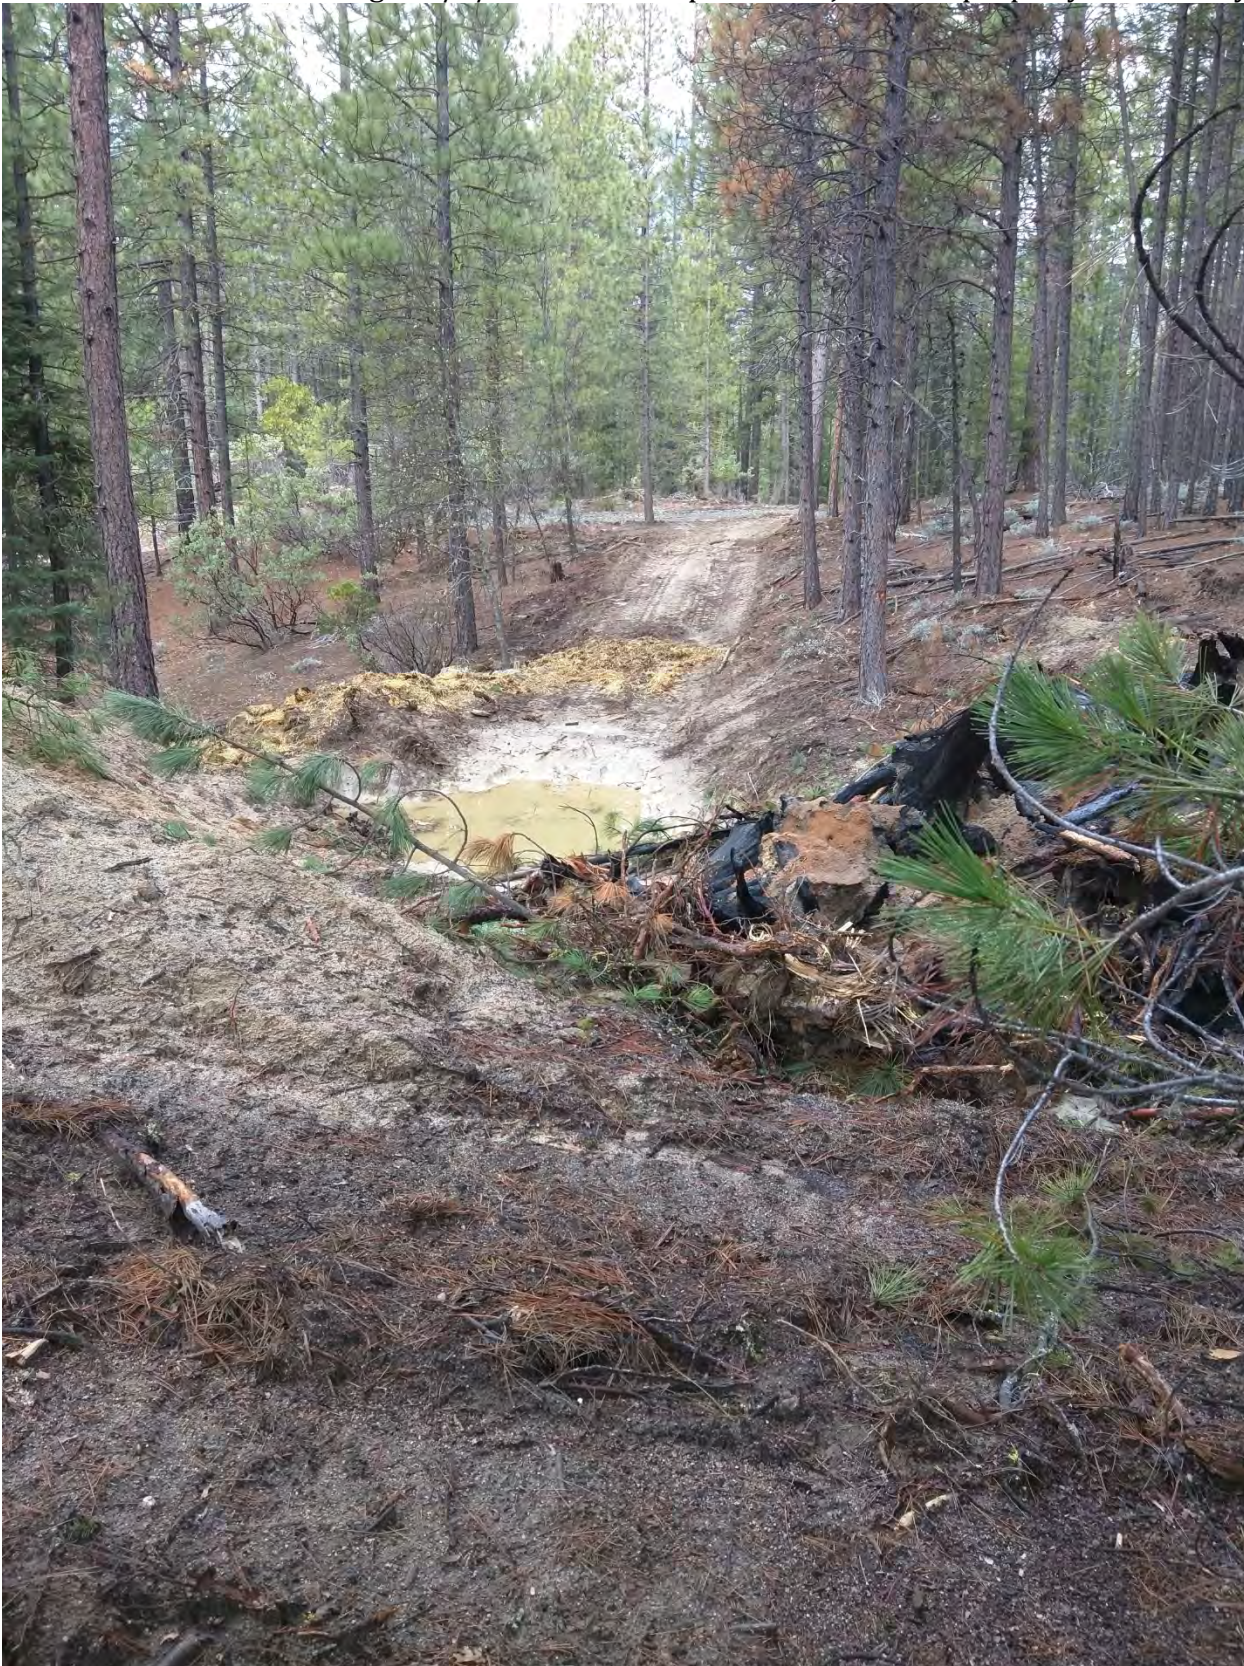
Photo 16: View looking north across the in-channel detention basin. Note the burned stumps and the access construction. French Creek Court is visible running west to east in the upper third of the photo

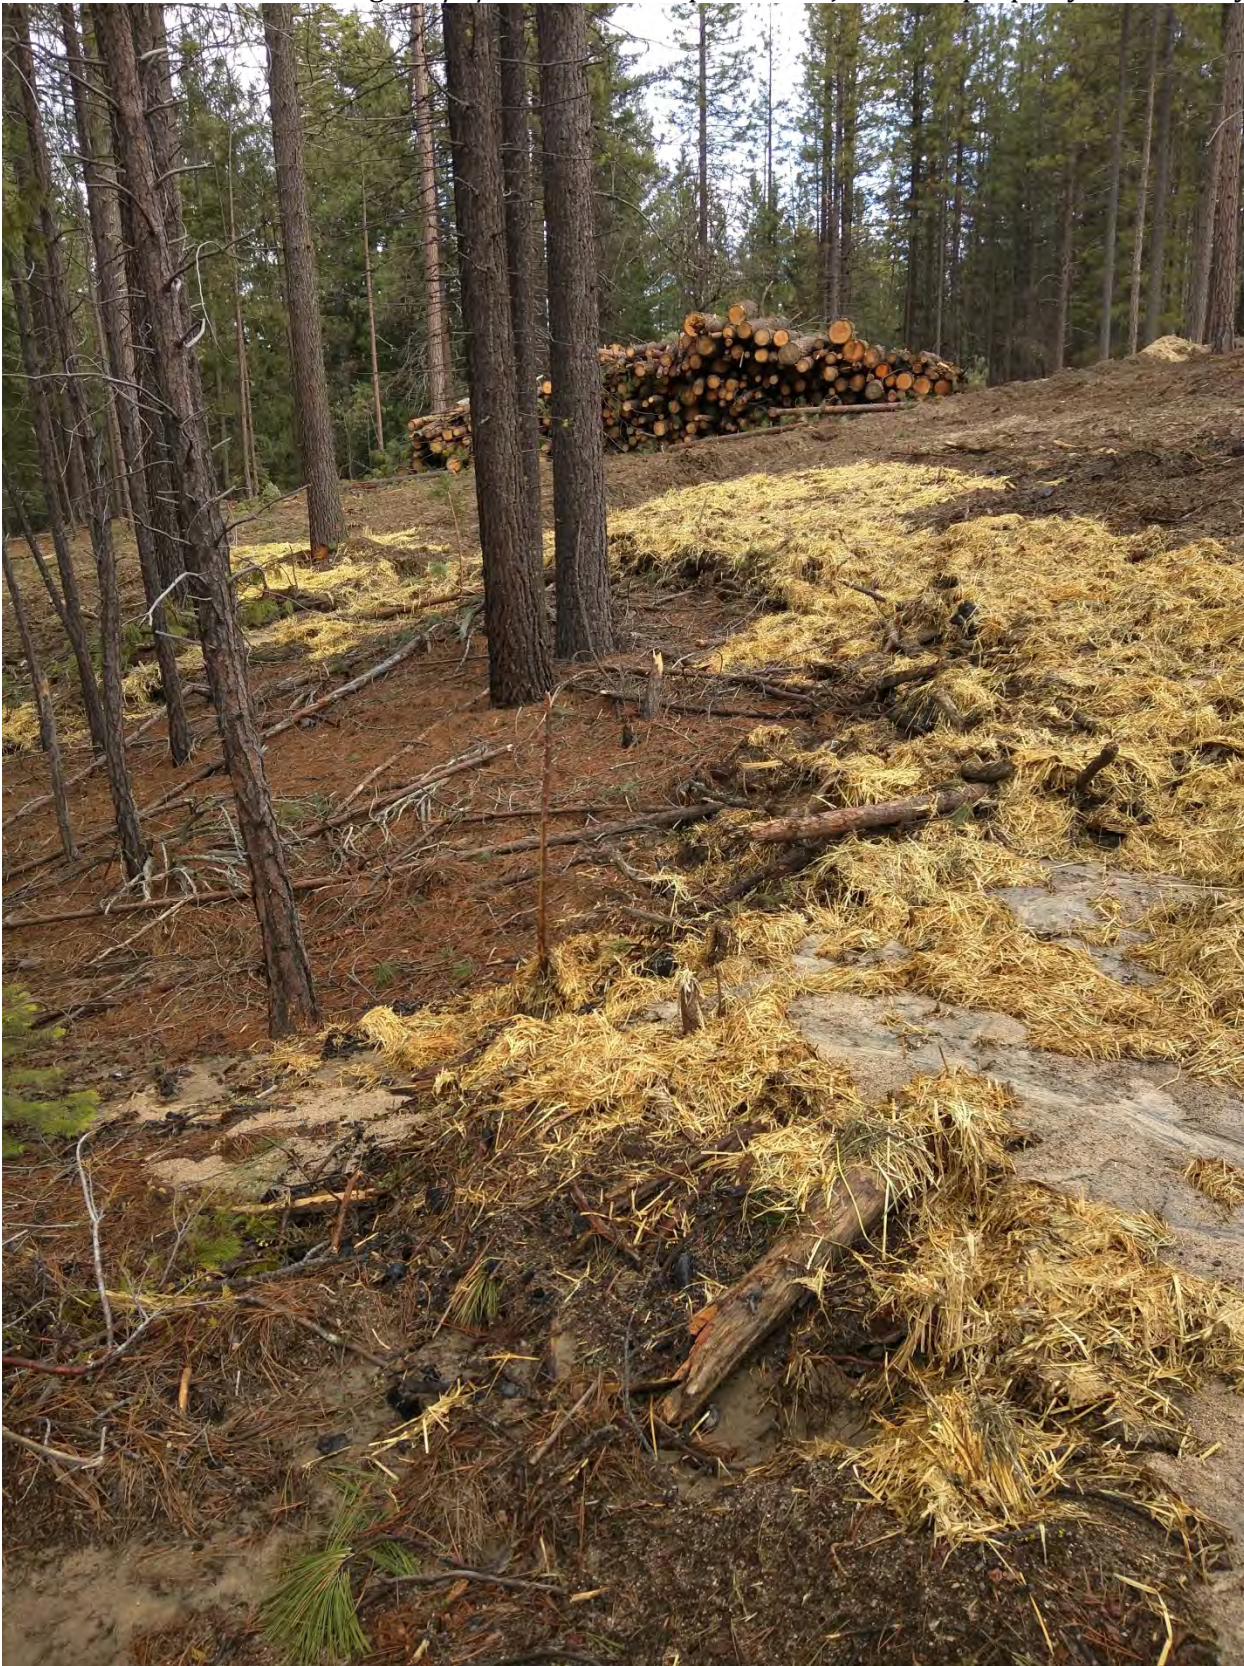
Photo 17: View looking north across the downhill portion of the Western Clearing, showing the application of straw on the slope

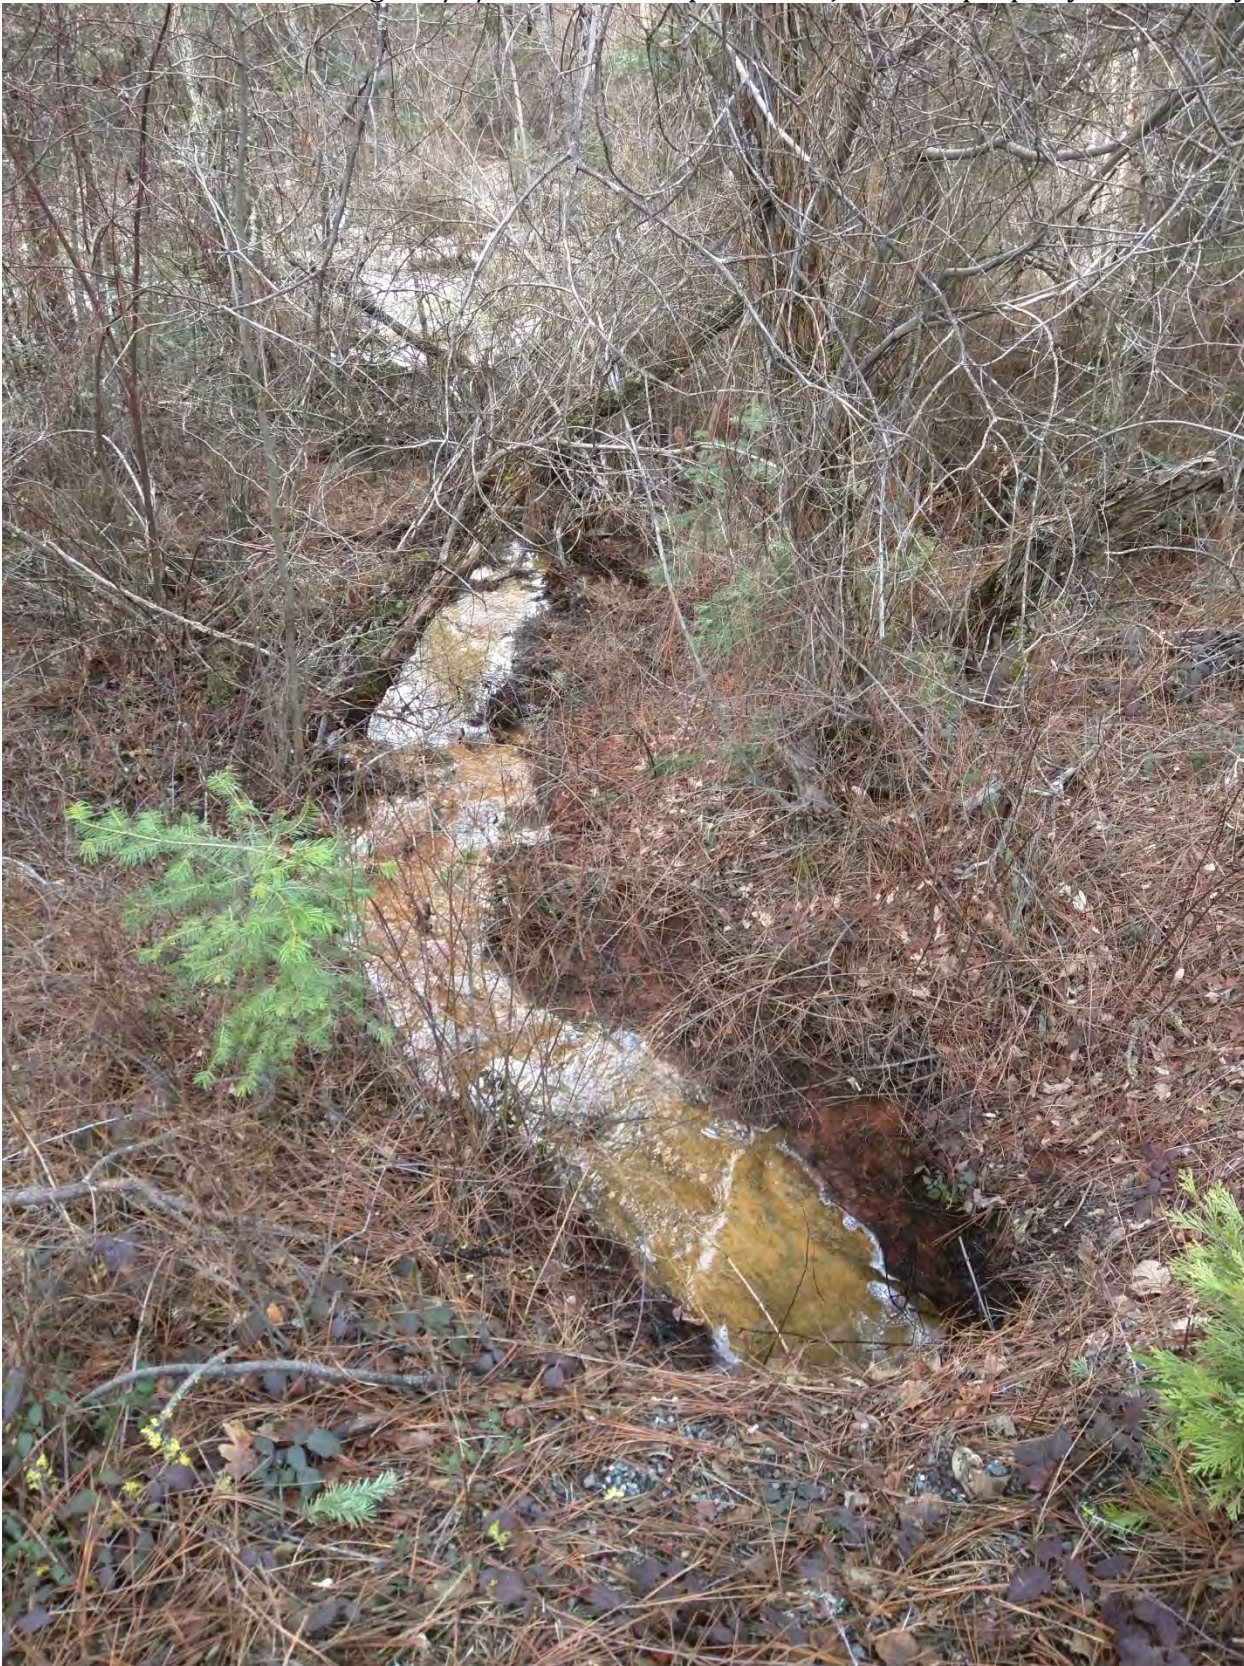
Photo 55: View west from the County Right-of-way at the culvert that drains the alleged JH Ranch landfill location. Flow appeared yellowish and a small amount of foam was observed

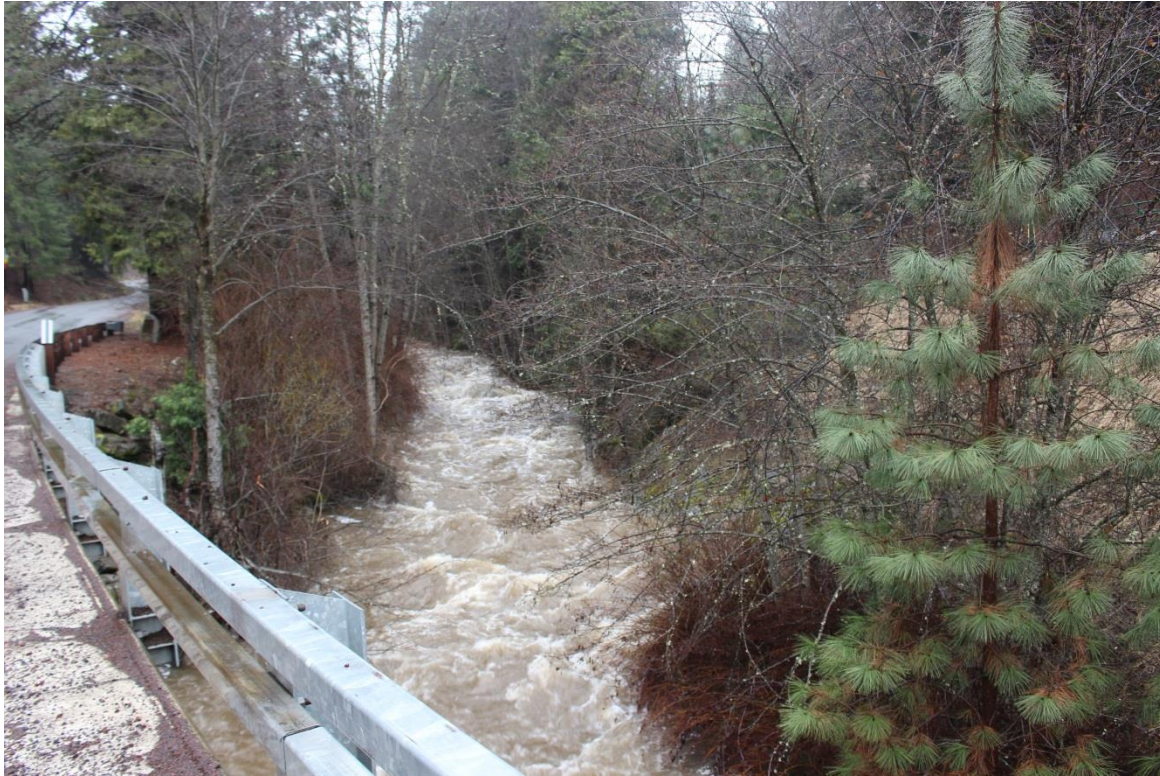
P1 1/29/2016 9:20 AM

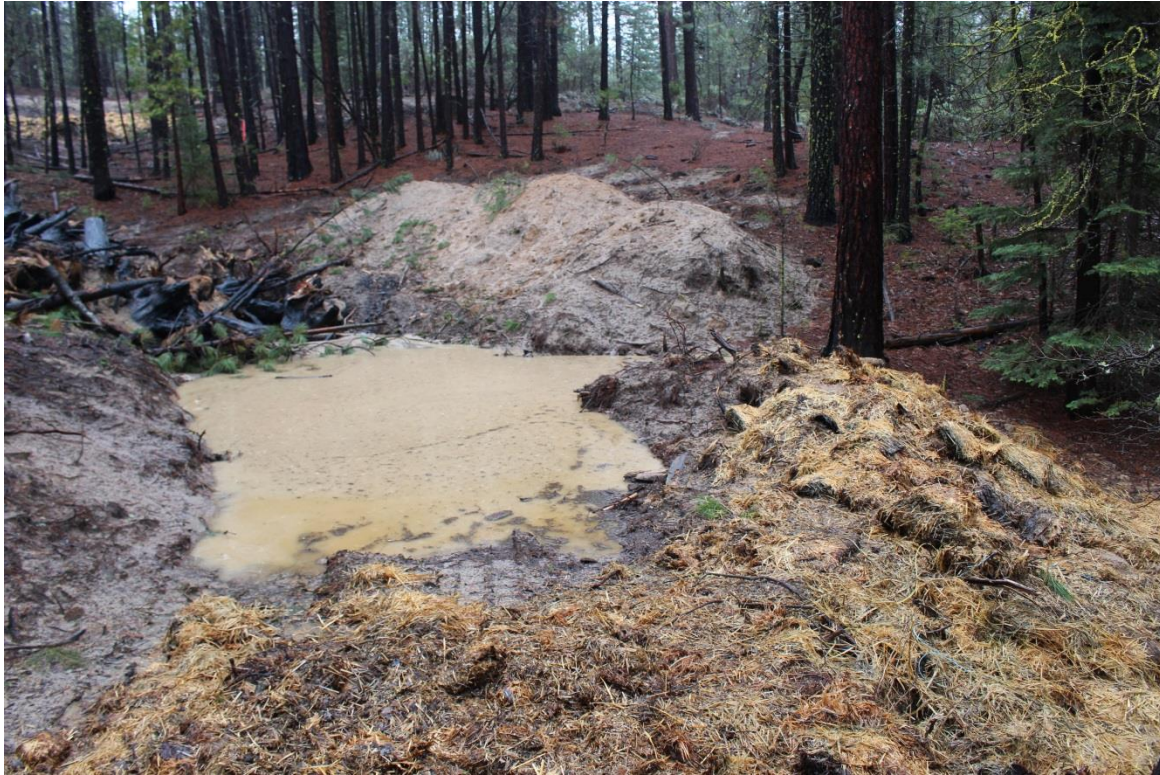
P11 1/29/2016 10:38 AM  
Looking south at turbid water in catch basin, and burn pile.

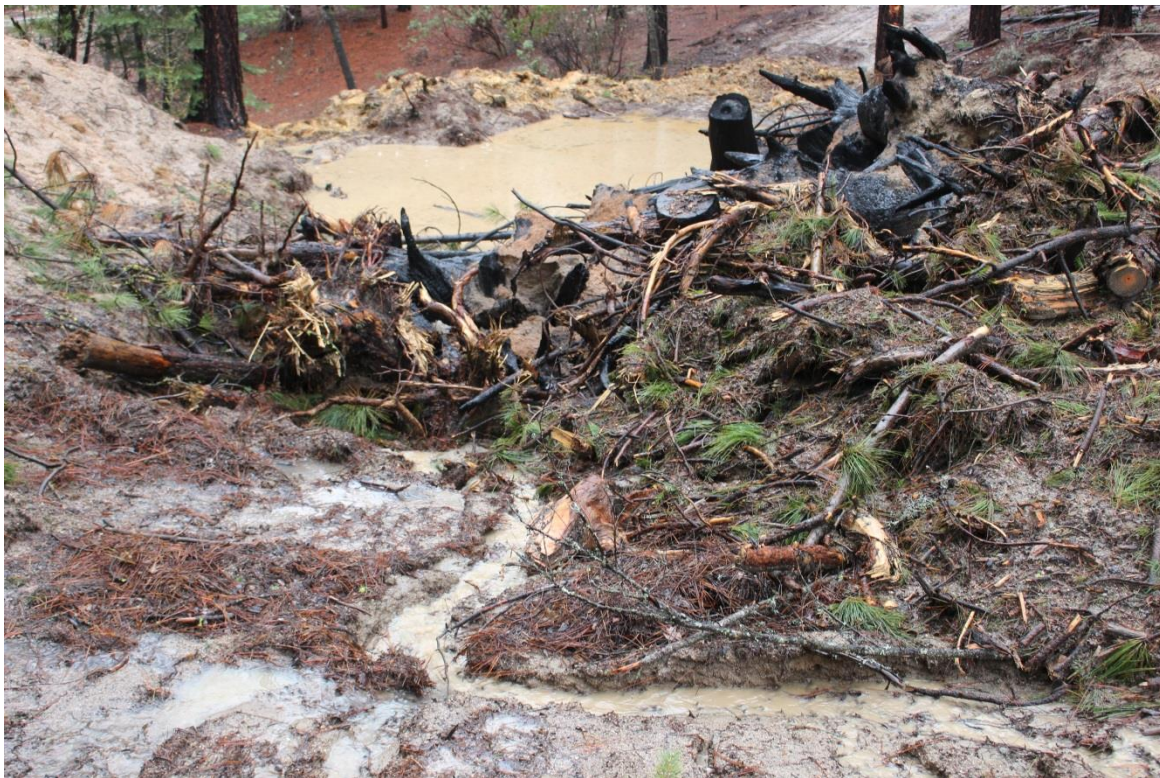
P12 1/29/2016 10:40 AM  
Looking northwest at flowing turbid water from conversion area, catch basin and burn pile.
