## North Coast Regional Water Quality Control Board

Date: February 25, 2016

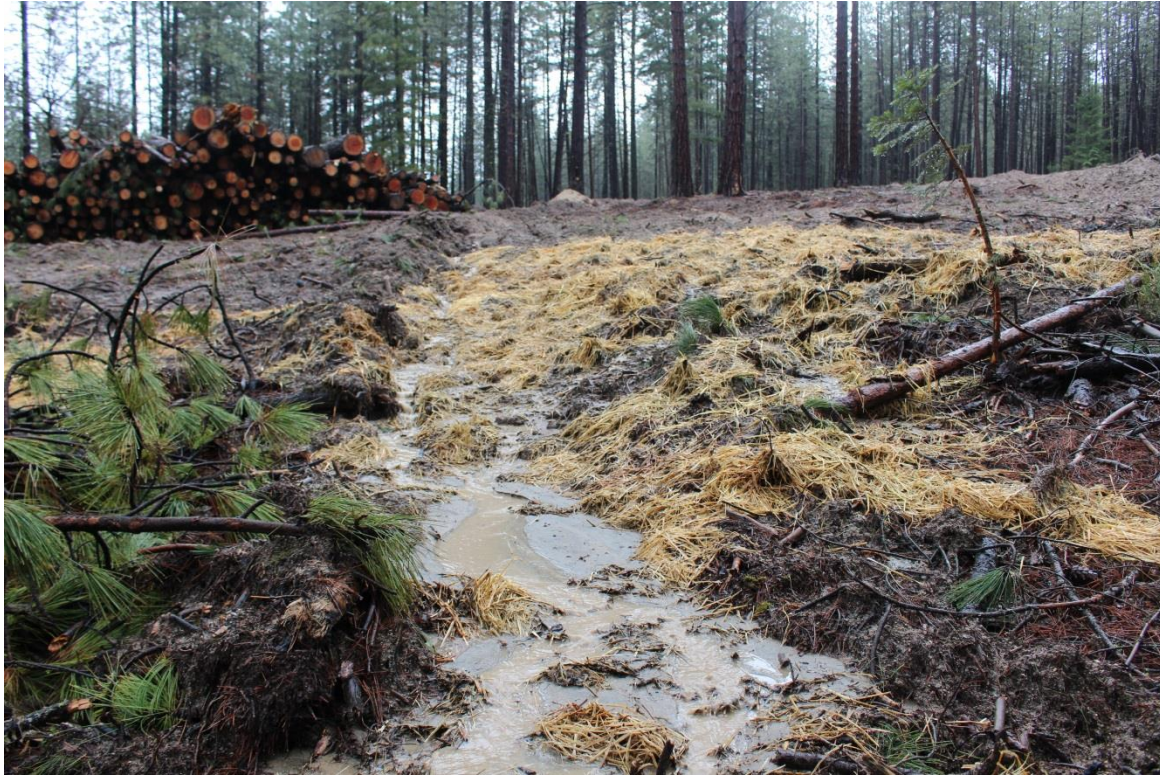
P13 1/29/2016 10:41 AM

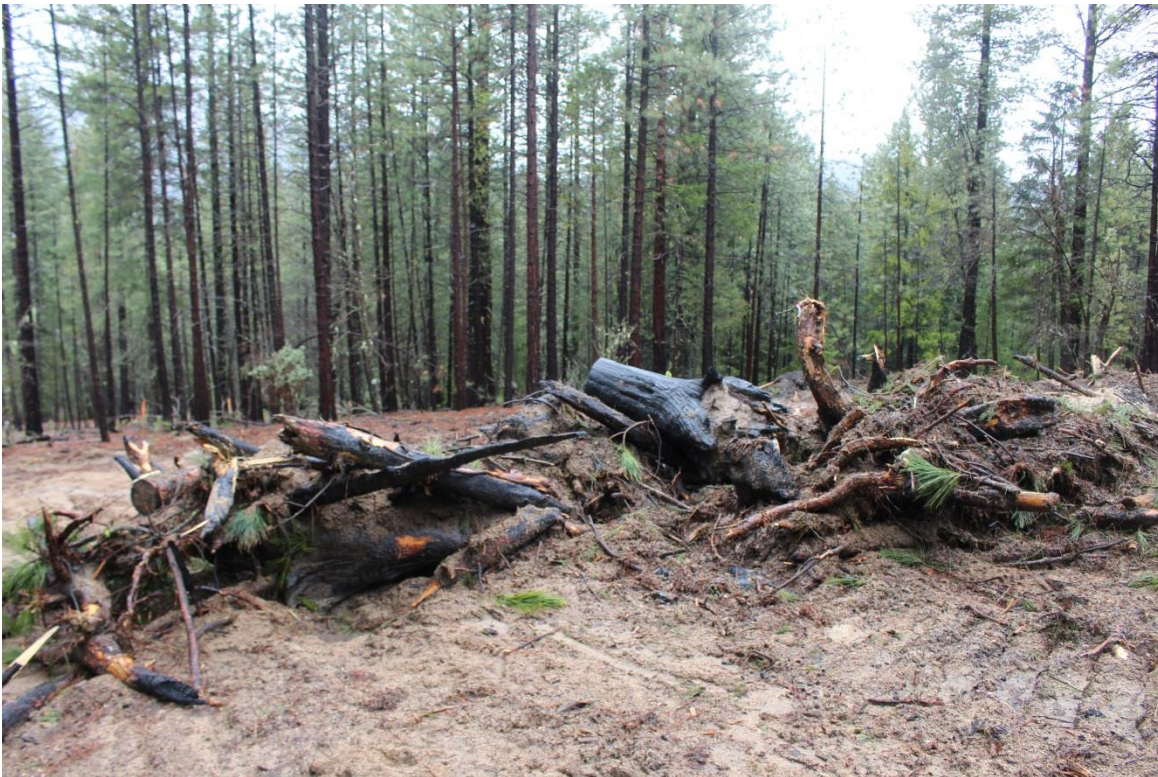
P36            1/29/2016       11:31 AM  
Looking at burn pile and stumps.

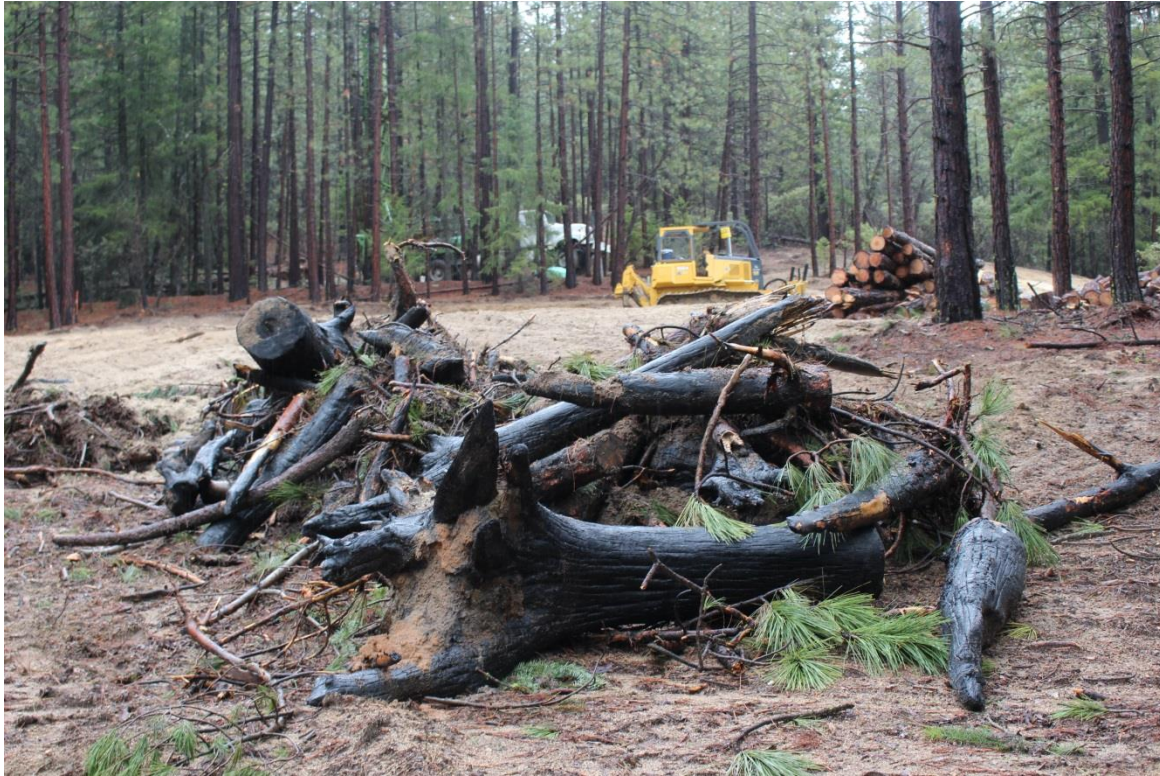
P37 1/29/2016 11:32 AM  
Looking at burn pile and stumps.

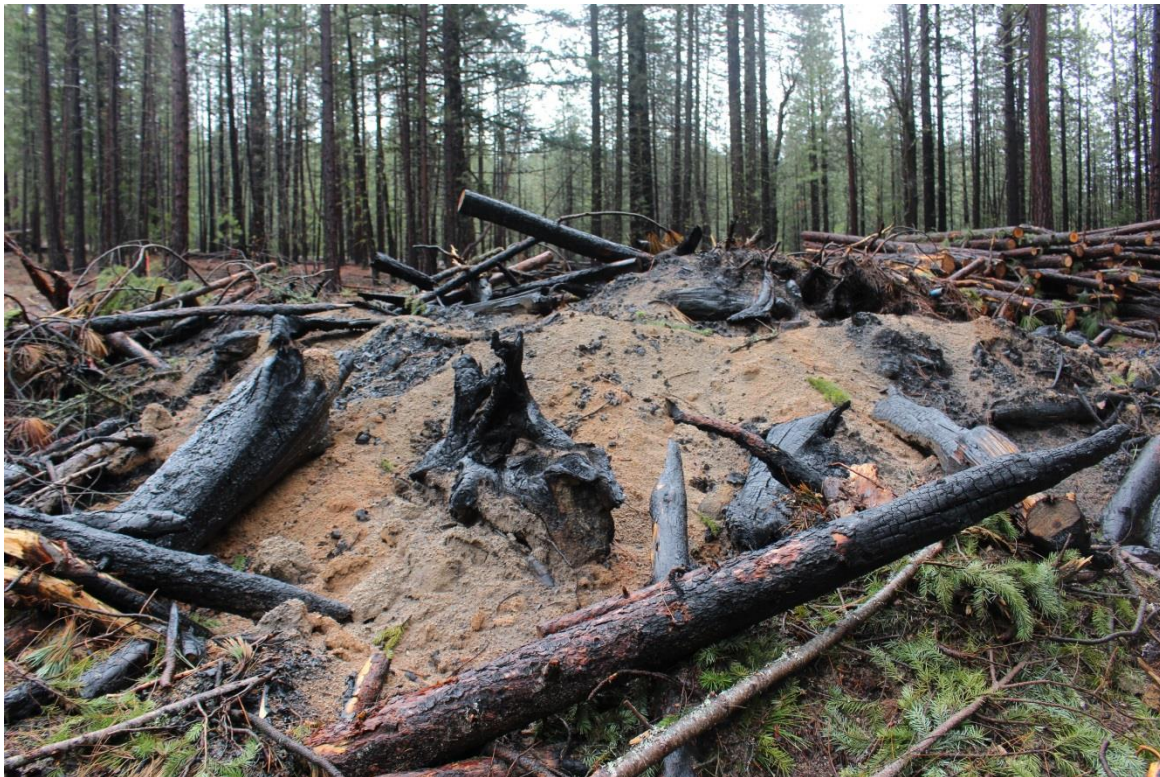
P38 1/289/2016 11:34 AM  
Looking southeast at burn pile and stumps.

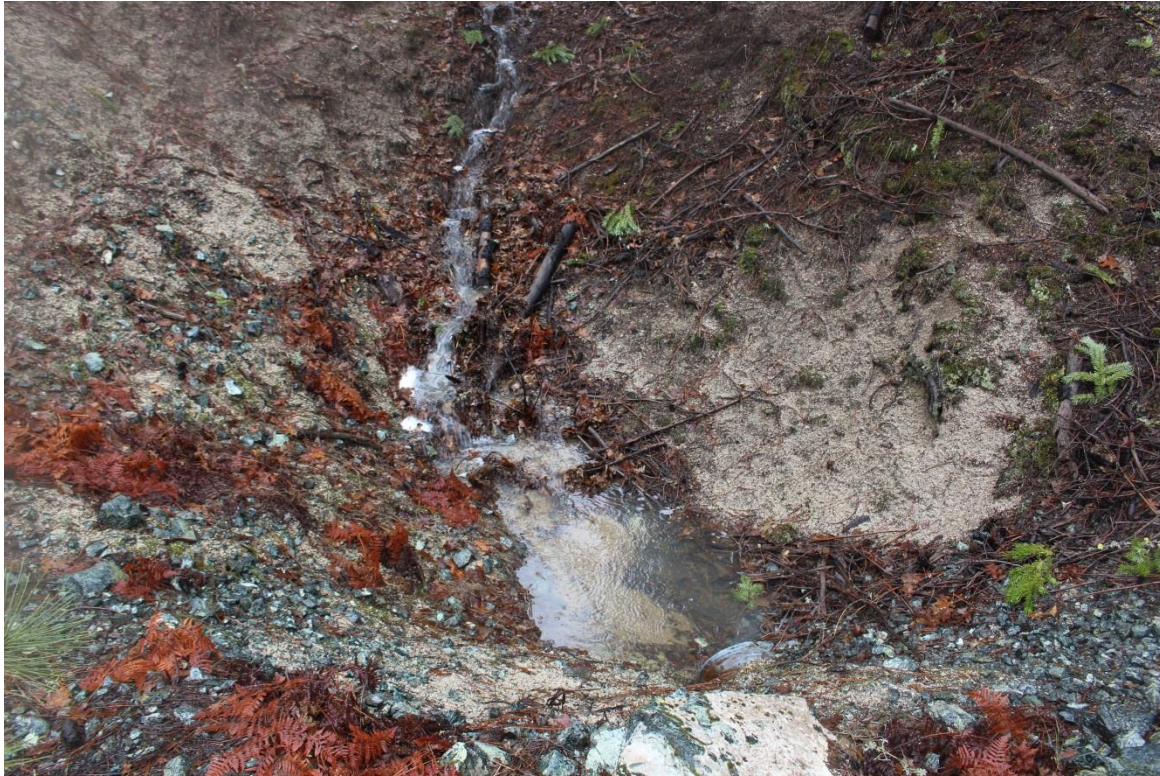
P39 1/29/2016 11:49 AM
