## North Coast Regional Water Quality Control Board

Subject: **Notice of Violation and California Water Code Section 13267 Order for Technical Reports**

File: Reservation Ranch; WDID No. 1B11125DDN

September 21, 2016, Reservation Ranch Inspection Report

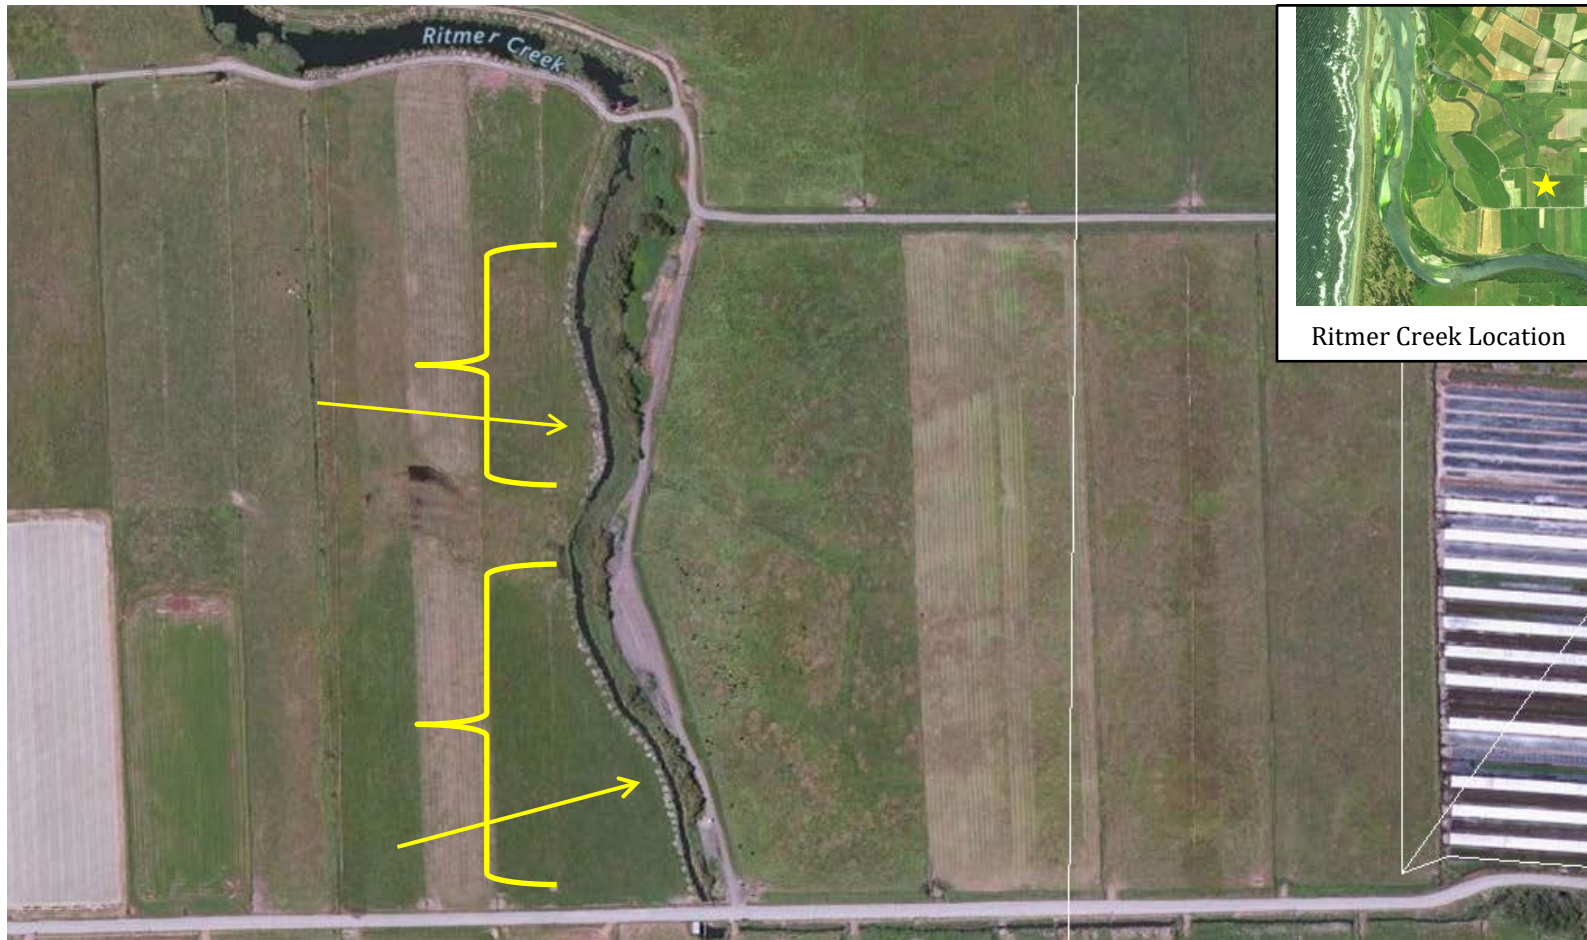
Attachment F—June 2010 Bing Imagery Showing Apparent Dredging of Ritmer Creek

Apparent dredge spoil piles are placed immediately adjacent the left bank of Ritmer Creek, in the two areas designated by the arrows and brackets.

Provide the following information related to the dredging of Ritmer Creek, as shown in Attachment F:

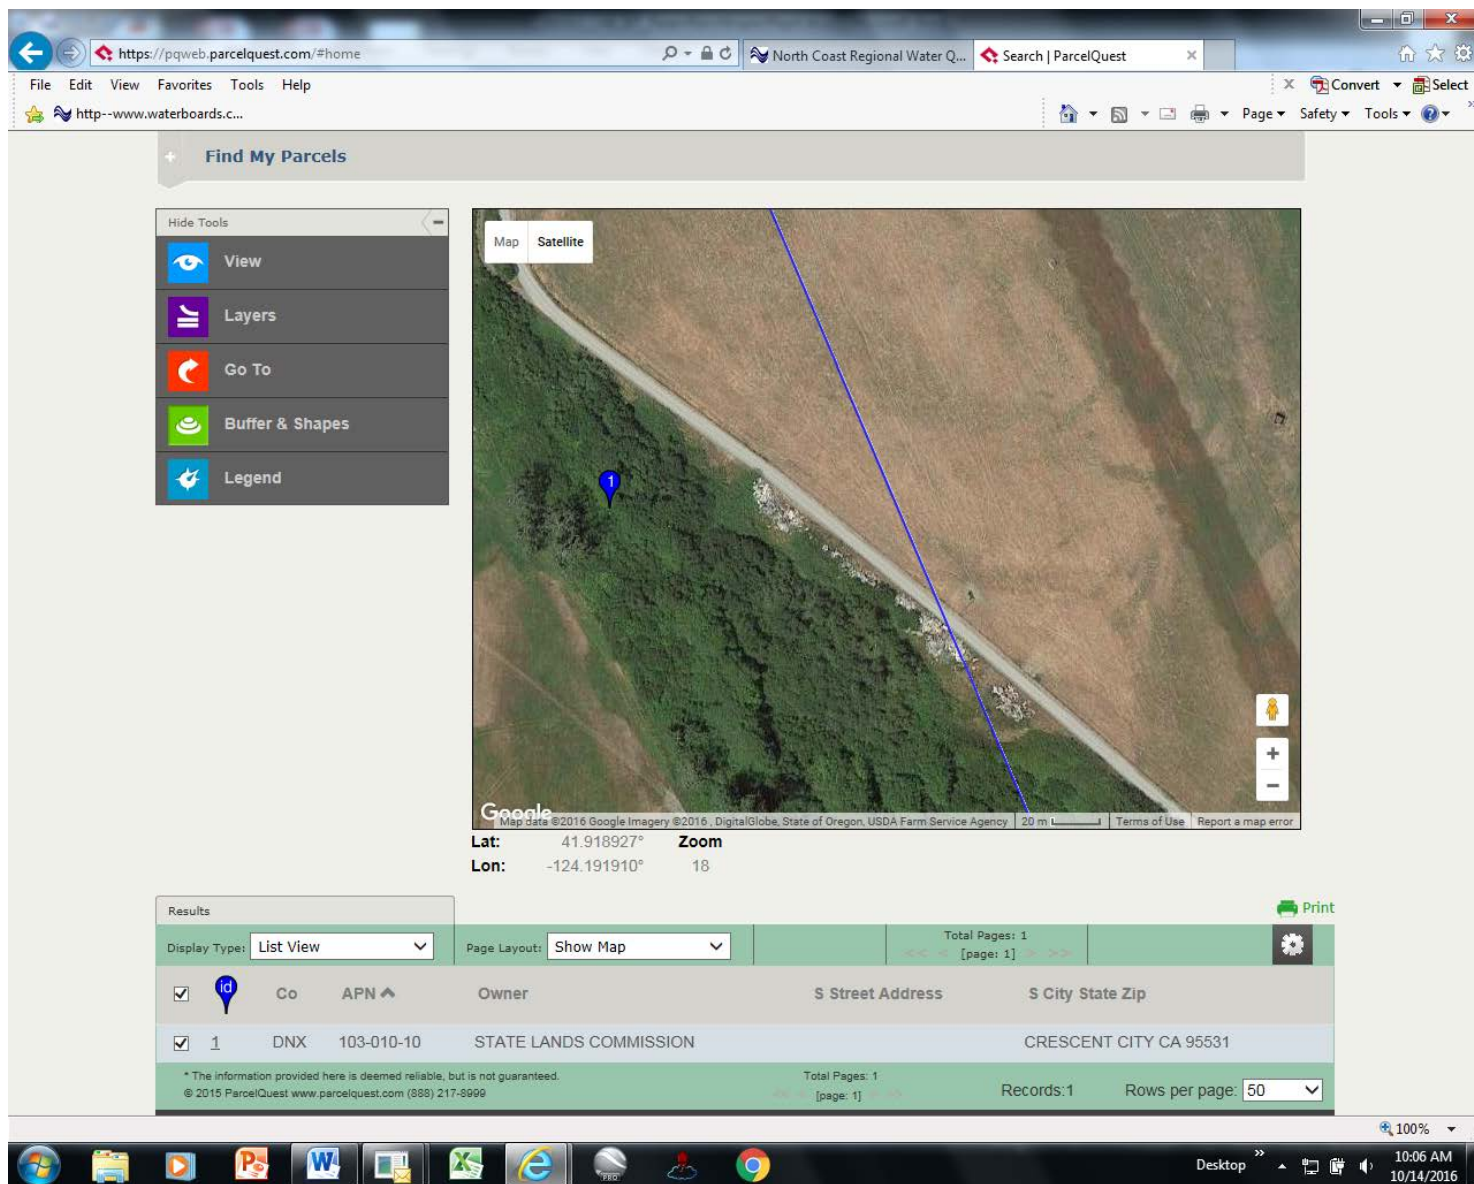
**Figure 4b. Screenshot from ParcelQuest showing closer view of east boundary of Del Norte APN 103-010-10 overlain on 2016 photo imagery. Waste material is clearly visible along the road.**

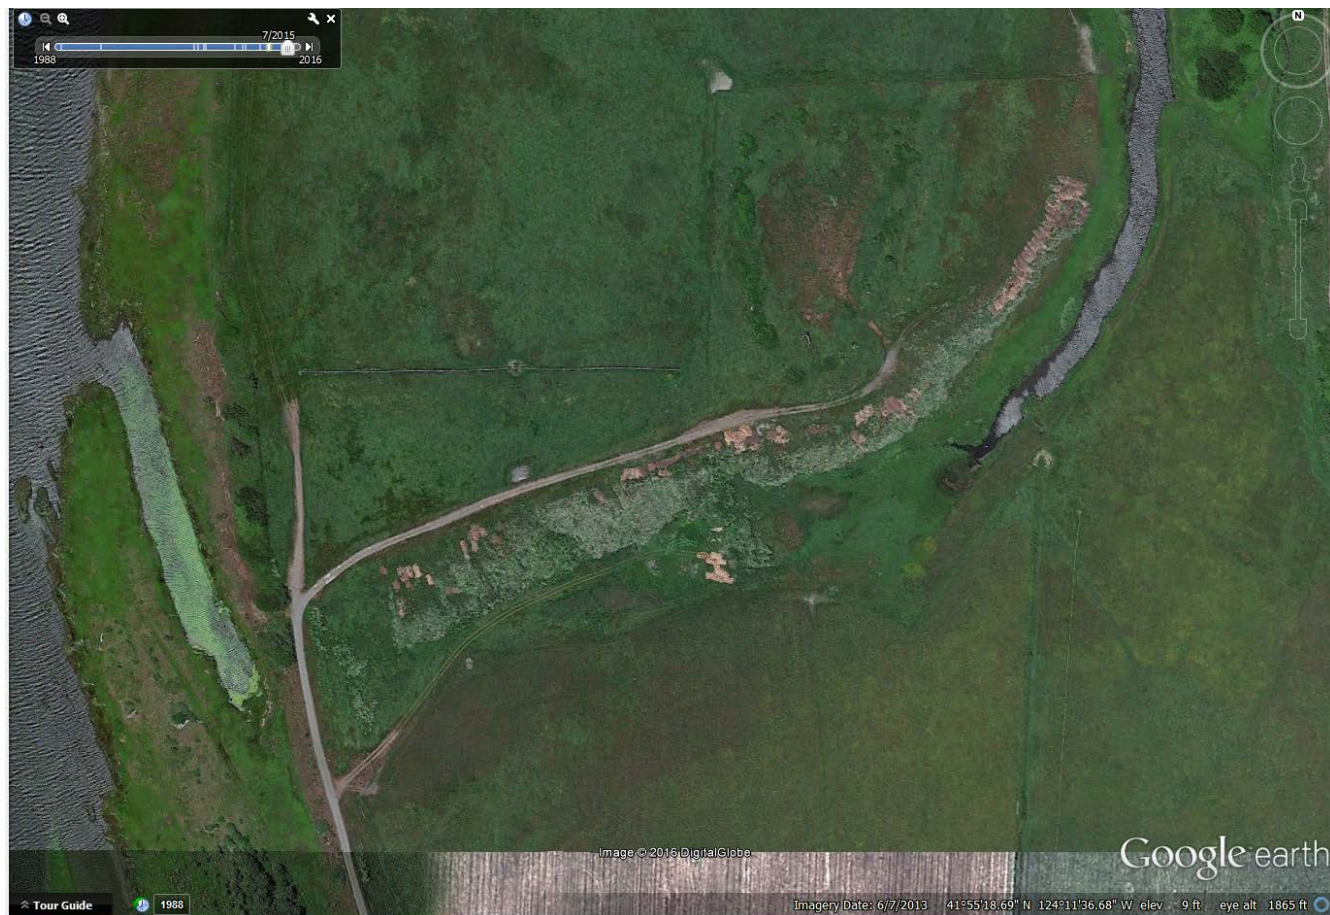
**Figure 5: June 7, 2013, Google Earth imagery indicating potential fill discharge to waters of the state**

The Inspection Team visited Area C because potential discharges of fill material to waters of the state were observed previously on Google Earth aerial photo imagery (for example, see Figure 5). Historical aerial images also provide evidence that Islas Slough was a side channel of the Smith River until the upstream extent was blocked from the main stem by a levee constructed likely sometime between 1972 and 1974. At the time of the site inspection, Regional Water Board staff observed that the open water portion of Islas Slough terminated approximately 1,100 feet from the inboard side of the Smith River

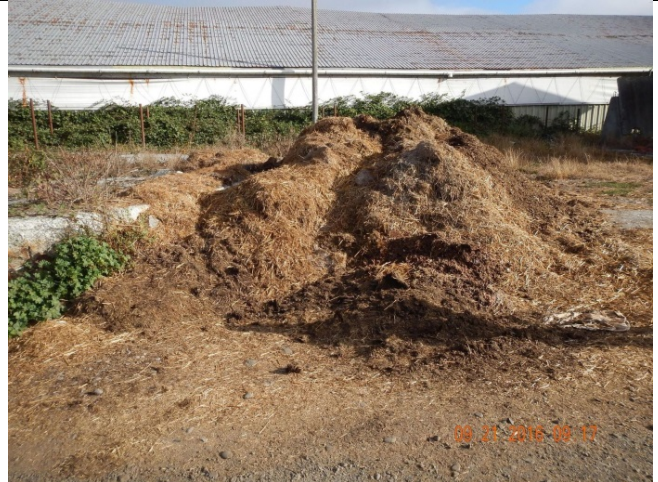
Photo 2: Manure/straw bedding from Stall Barn at ranch.

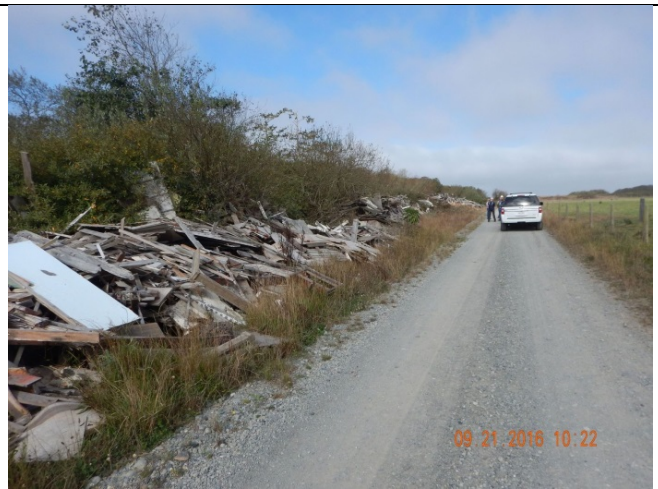
The Inspection Team asked Ranch Representatives about the origin of the waste shown in Photo 4. The Ranch Representatives stated that the fencing waste was from the dairy, and that other debris was from Ship Ashore Resort, associated recreational vehicle sheds (which are owned by Reservation Ranch), and employee housing. Ranch Representatives stated that other waste was dumped by people because the gate is kept open during daytime hours and gate access is not monitored. Ranch Representatives also explained that they burned wood piles for about 30 years, but no longer do so because current regulations do not allow it; Steven Westbrook stated that the burning of manufactured lumber is a

Inspection Team members Cherie Blatt, Pat Veasart, and Brendan Thompson measured the approximate height and length of the visible waste piles with a tape measure and stadia rod. The piles collectively measured approximately 430 feet long along the west side of the ranch dirt road, 25-30 feet wide, and up to 7.5 feet high for an estimated volume of 2,400 cubic yards of waste above grade. It is important to note that Josh Levine, Brendan Thompson, Gordon Leppig, and Mike Van Hattem observed more waste below ground level and to the west of the waste piles. Josh Levine photographed the partially buried waste. Mike Van Hattem and Gordon Leppig inspected the area and stated that they found living obligate wetland plants among the buried and piled debris.

Photo 4: Area A: Waste pile.

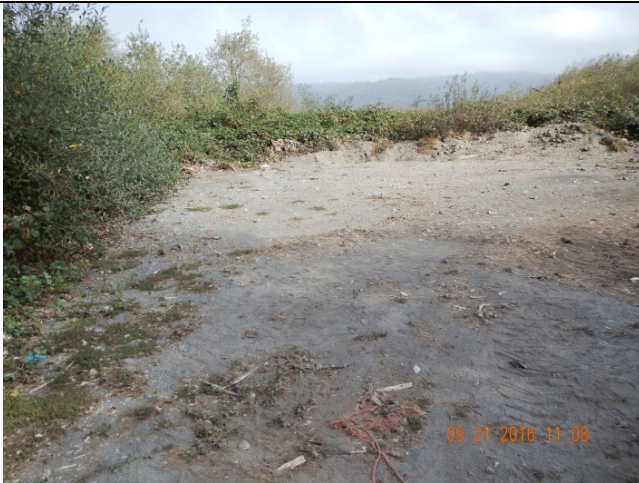
- B. Dead Cattle Disposal (Area B)** – As shown in Figure 1 and 2, Area B appears to be entirely located on the State Lands Commission-owned parcel, APN 103-010-10, approximately 70 yards southwest of the southern extent of the waste pile at Area A. Area B's approximate latitude/longitude is 41.919758, -124.189268. Regional Water Board staff observed a clearing surrounded by dense stands of willow and Himalayan blackberry and containing loose soil spread over cattle carcasses (see Photo 5). The Inspection Team concluded that the area had been recently graded with heavy equipment based on the presence of machinery track

Photo 5: Area B--Soil graded over dead cattle. Thick layer of willow and Himalayan blackberry.

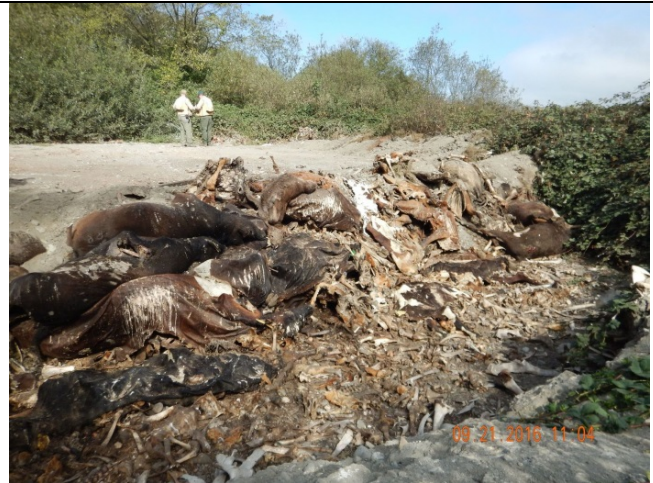
marks, the appearance of the soil, and the lack of vegetation starts. Regional Water Board staff observed an approximately 5 to 6-foot-deep, 6-foot-wide, 25-foot-long trench adjacent to the recently graded area. The trench bottom was densely covered with bones and the wall of the trench consisted of dead cattle on one side and a matrix of dirt and bones on the other side (see Photo 6 and Photo 7).

Photo 6: Area B—Trench wall of dead cattle below top soil layer.

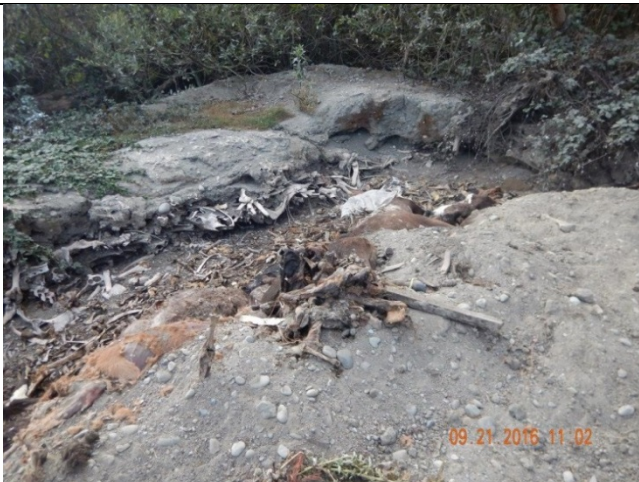
Photo 7: Area B--opposite trench bank from previous photo.

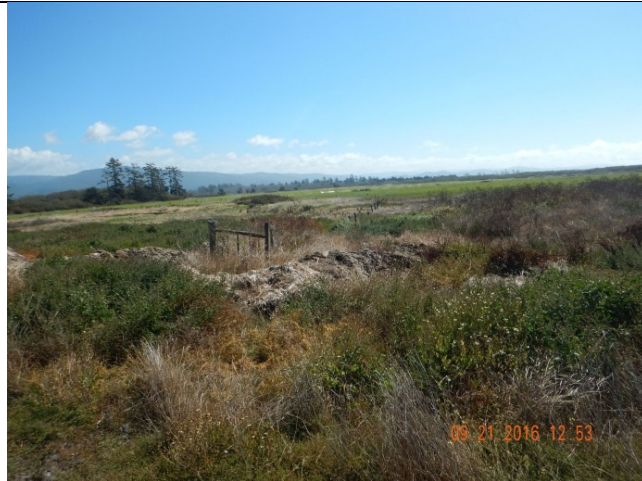
West of the fence shown in Figure 3 and Photo 14, the Inspection Team observed numerous piles of earthen and organic material throughout the remnant river/slough channel. The Inspection Team observed a large continuous area of deposited fill material at approximate latitude/longitude 41.921092, - 124.195179, immediately on the west side of the fence (see dashed black lines in Figure 3. This area of fill extended across the width of the remnant channel and consisted of a non-uniform distribution of several piles. Wetland vegetation was evident between the piles and the fence in low-elevation areas where little or no material had been placed. The continuous area of wetland vegetation on the east side of the fence continued across the fence into the western area, but the Inspection Team observed “fingers” of wetland vegetation reaching into the area of deposited fill material that ended abruptly at the margins of the mounds of fill material. It appeared that the fill material prevents wetland hydrology from

Photo 14: Area C. Standing on the road looking southeast at the fence line. Dumped material in the foreground.

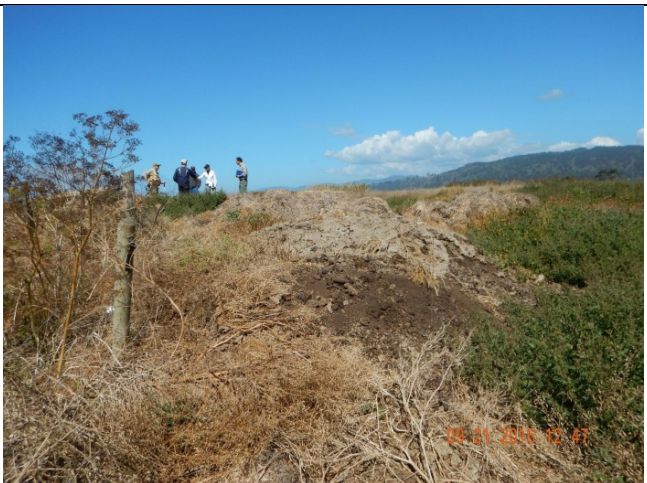
Photo 15: Area C. Looking northwest from the fence line up to the vantage point of Photo 14.

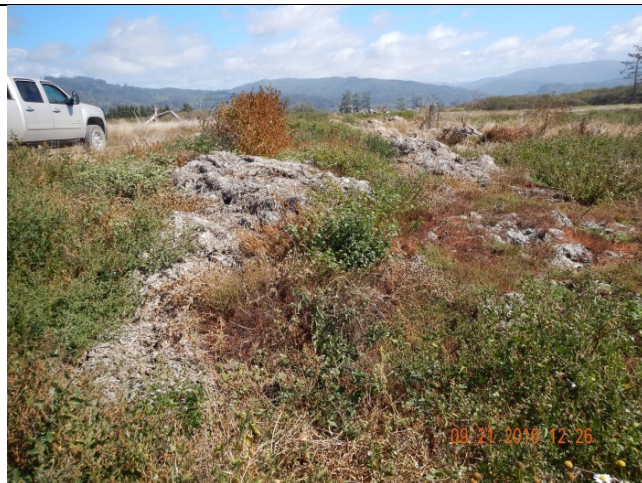
Photo 16: Area C. Dumped organic material on the bank between ranch road (left) and Islas Slough (far right), as looking northeast.

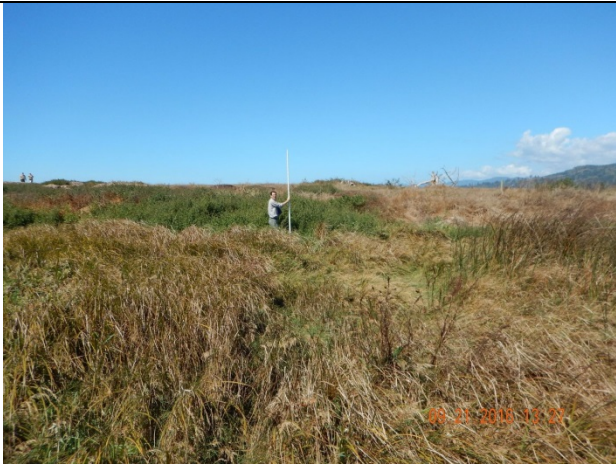
Photo 17: Area C. Measuring the height of accumulated material at left bank of Islas Slough.

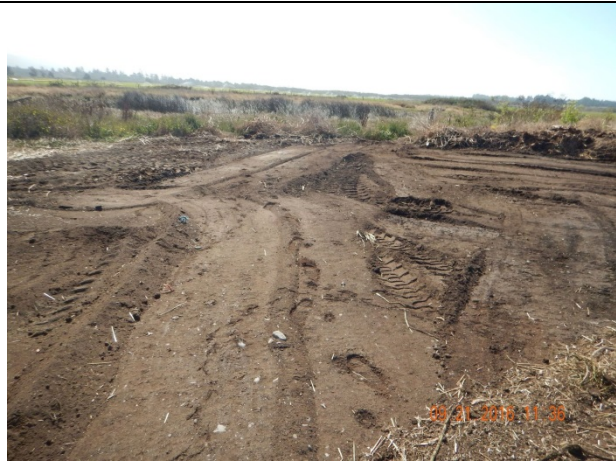
Photo 18: Area C. Recent grading on bank between ranch road and Islas Slough as looking southeast.

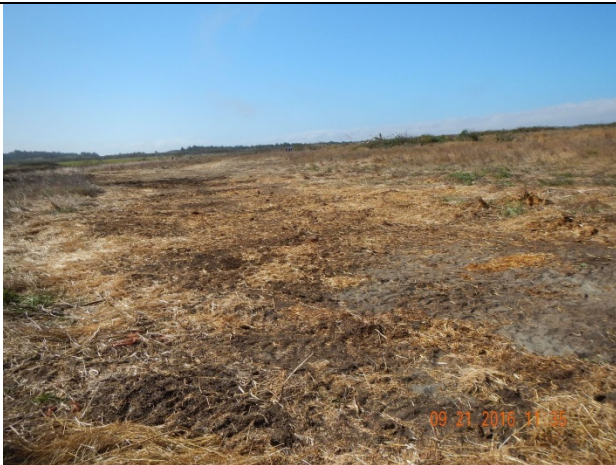
Photo 19: Area C. Tractor track marks on flat area between ranch road and Islas Slough.

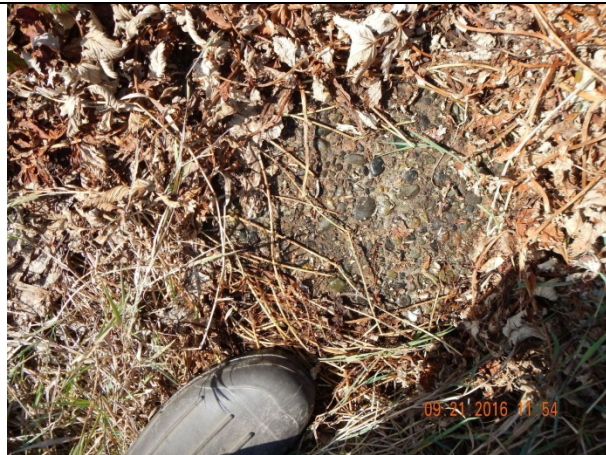
Photo 20: Area C. Concrete debris in Islas Slough channel at approximate latitude/longitude 41.921795, -124.193744.

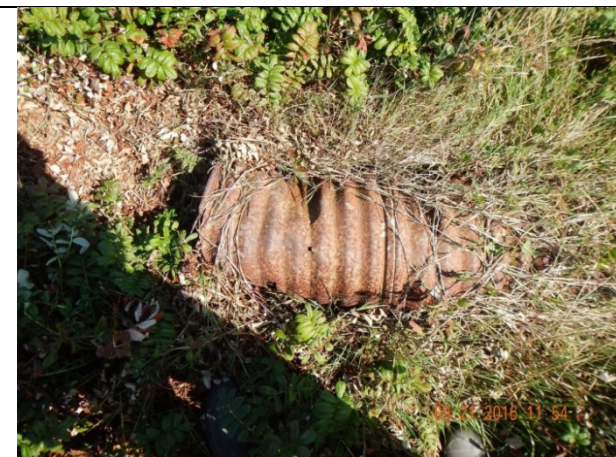
Photo 21: Area C. Old culvert debris in Islas Slough channel at approximate latitude/longitude 41.921795, -124.193744.

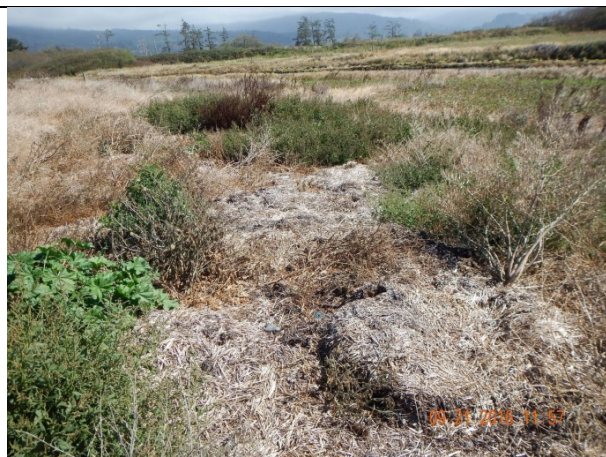
Photo 22: Area C. Manure/straw piles between ranch road and Islas Slough.

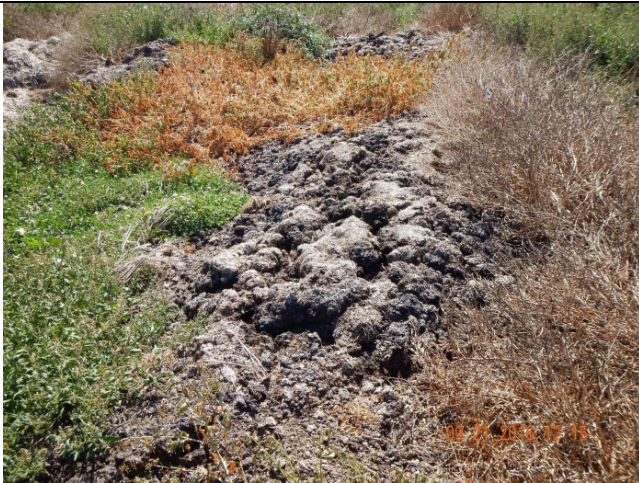
Photo 23: Area C. Manure/straw piles between ranch road and Islas Slough.

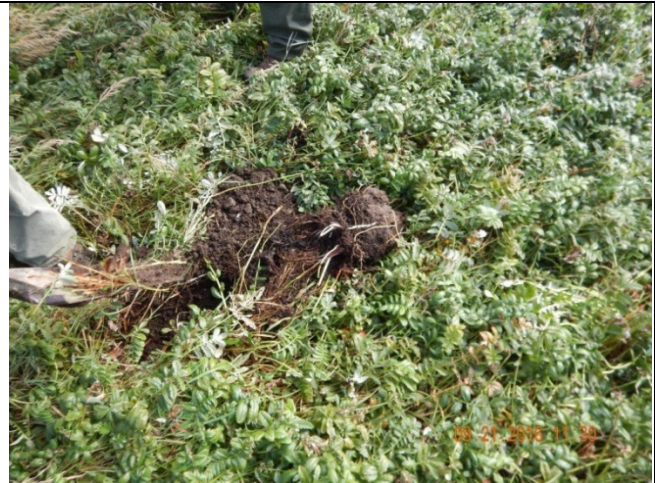
Photo 24: Area C. Inspector dug a hole in the lower elevation of the remnant slough channel, which showed a high concentration of river gravel.

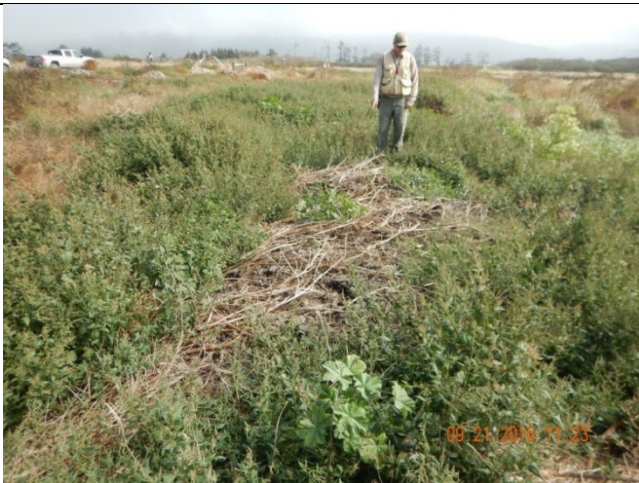
extending as far up the remnant slough channel as it would naturally or possibly did in the past. On the western side of this deposited material, wetland vegetation was present in low-lying elevations that appeared to be unaffected by fill material. Mike Van Hattem dug a hole in one of these areas, and found that the material had a high concentration of river gravel, indicating that a side channel of the Smith River was likely present at that location at some time in the past (see Photo 24). A pile of dirt covered by thatch was observed in this vicinity at approximate latitude/longitude 41.921009, -124.195769 (see Photo 25).

Photo 25: Area C. Dirt material deposited in remnant slough channel covered by thatch.

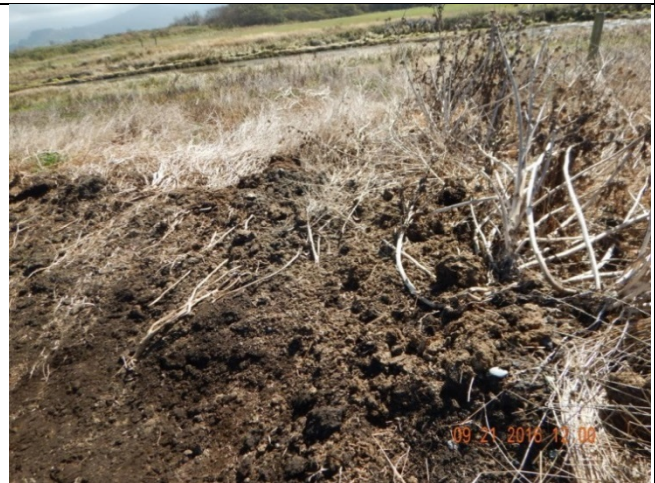
Photo 26: Area C. Recently disturbed organic material pushed up against wetland vegetation at approximate latitude/longitude 41.921658, -124.194131.
