**North Coast Regional Water Quality Control Board**

DATE: December 29, 2016

SUBJECT: FOX HOLLOW CONSTRUCTION SITE INSPECTION SUMMARY

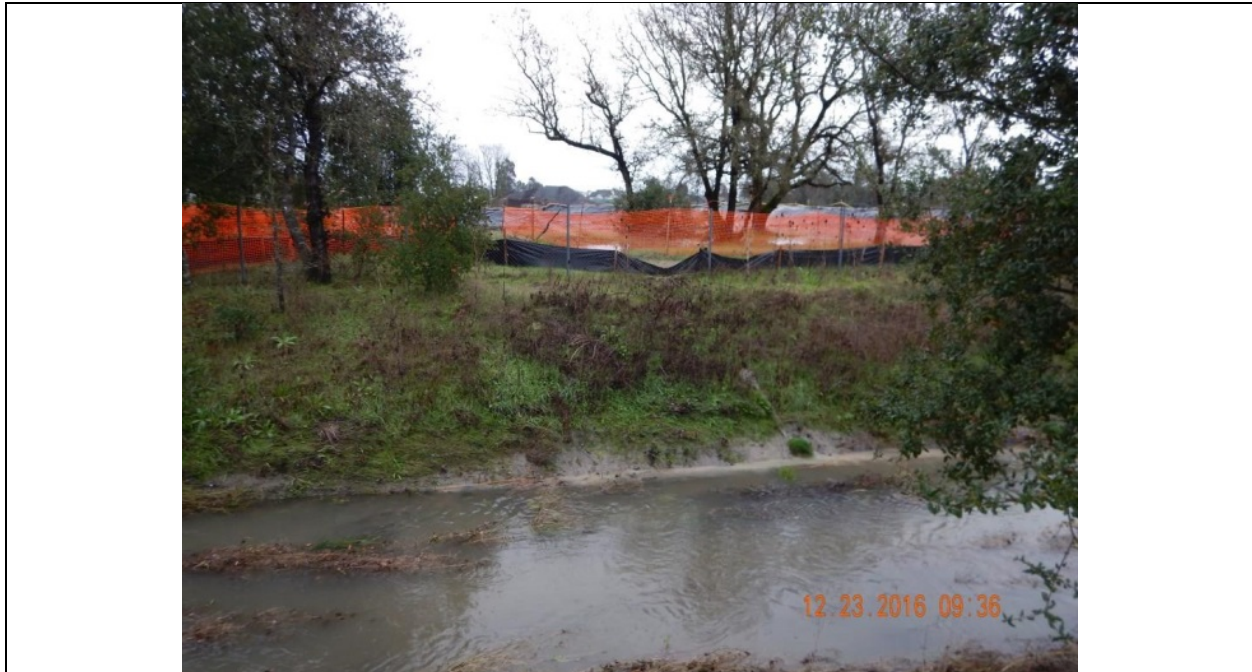
Photo 1: Peterson Creek discharge location 1. Photo was taken at 8:36 a.m. The camera time stamp was corrected after this photo was taken. Water was running down the stream bank and causing turbidity along the left bank channel margin as shown in the photo.

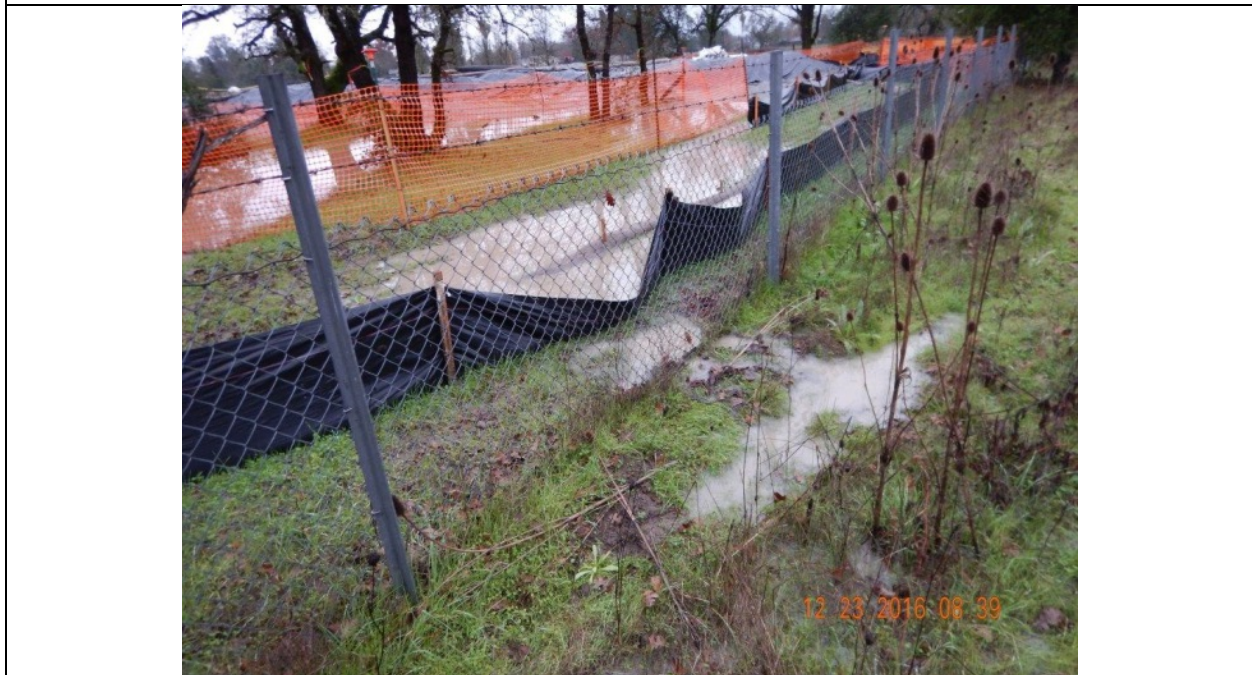
Photo 2: Peterson Creek discharge location 1. It appeared that storm water was passing underneath the silt fence. This discharge location appears to correspond with discharge sampling location #1 as provided in the 12/23/16 Sampling Field Log sheet.

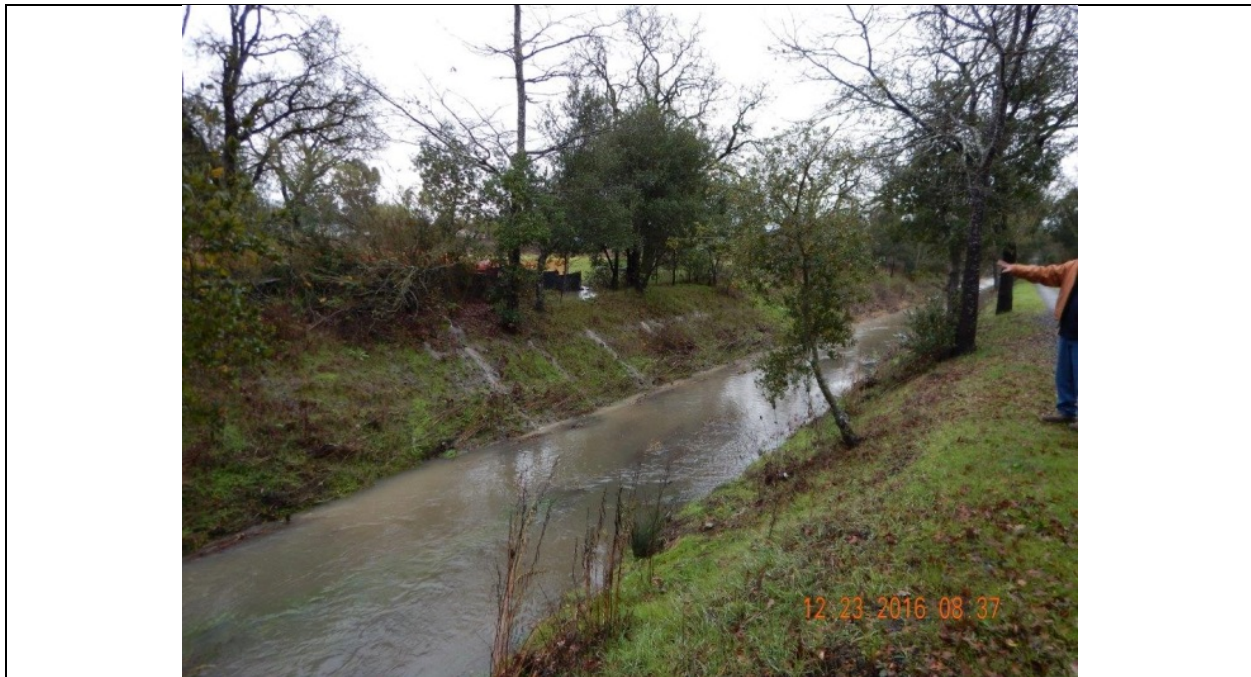
along the Project boundary. The purpose of the impoundments was to slow down and store water to prevent discharges of sediment-laden water to Peterson Creek. The impoundment perimeters were either constructed from silt fence (see Photo 14) or earthen berms covered in filter fabric (see Photo 6 and 7). The impounded water was discharging to the creek by either overwhelming the perimeter sediment controls (see Photo 2) or, by infiltrating at the top of bank, piping through the creek bank (see Photo 3 and 4), running down the creek bank and discharging into the active channel.

Photo 3: Peterson Creek discharge location 2. This discharge location appears to correspond with discharge sampling location #5 as provided in the 12/23/16 Sampling Field Log sheet. As shown in Photo 4, storm water was either passing beneath the silt fence or infiltrating and discharging at a uniform elevation on the bank of Peterson Creek. Storm water may have infiltrated and forced to emerge from the bank after hitting an impervious soil layer.

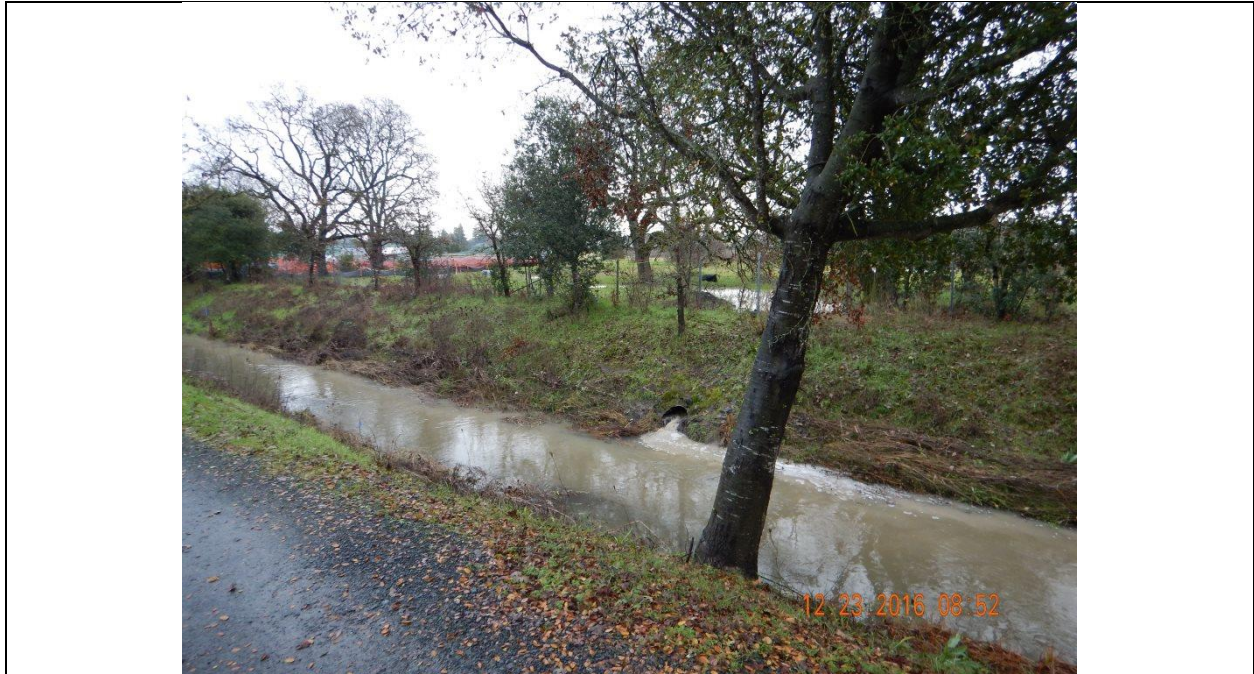
Photo 5: Peterson Creek discharge location 3. It was unclear where or whether this discharge originated from the Project site. This outfall does not appear to be listed as a discharge location on the 12/23/16 Sampling Field Log sheet, though sampling location #4 may be in the background at the silt fence, where runoff leaves the southwest Project boundary.

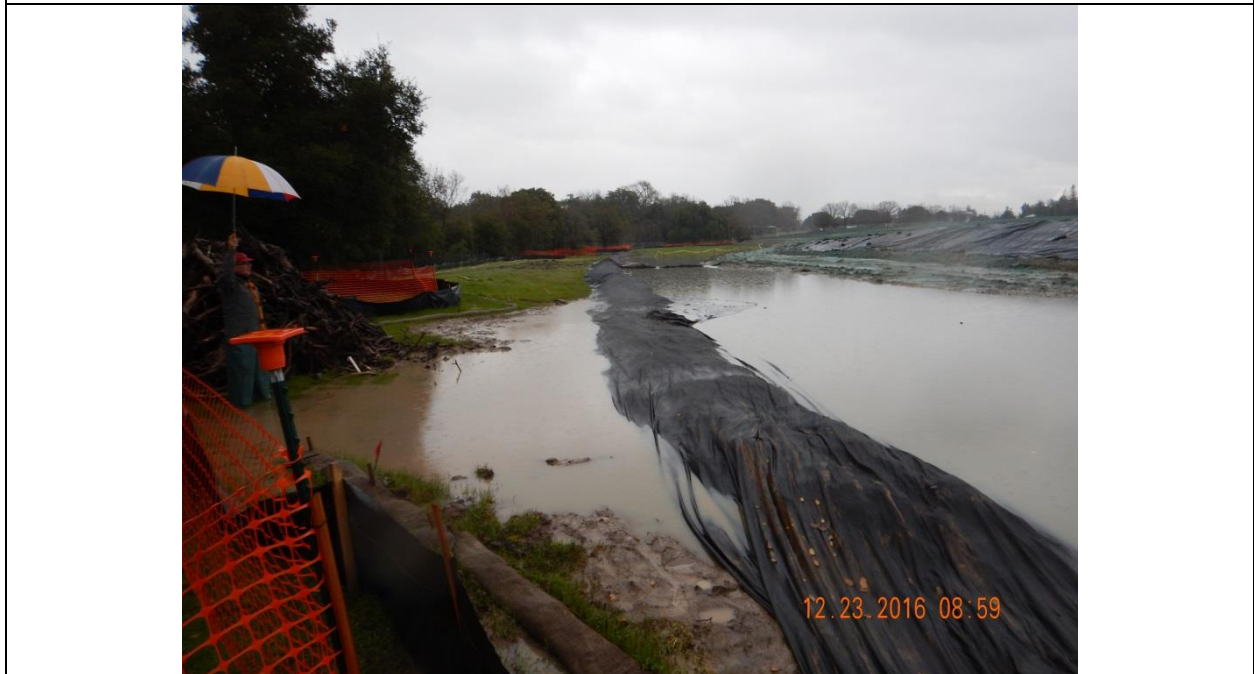
Photo 6: Earthen berm covered with filter fabric. Looking north. Peterson Creek is approximately 40 feet to the left.

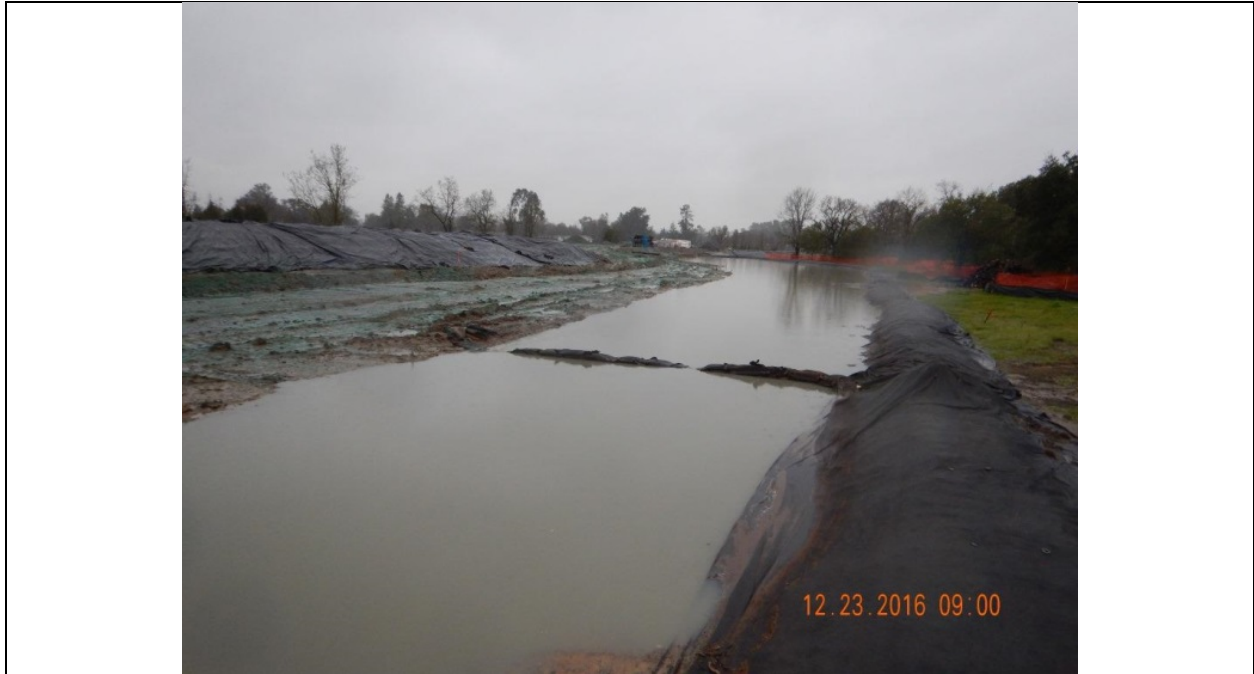
Photo 7: Another earthen berm covered with filter fabric, looking south. Peterson Creek is approximately 60-70 feet to the right.

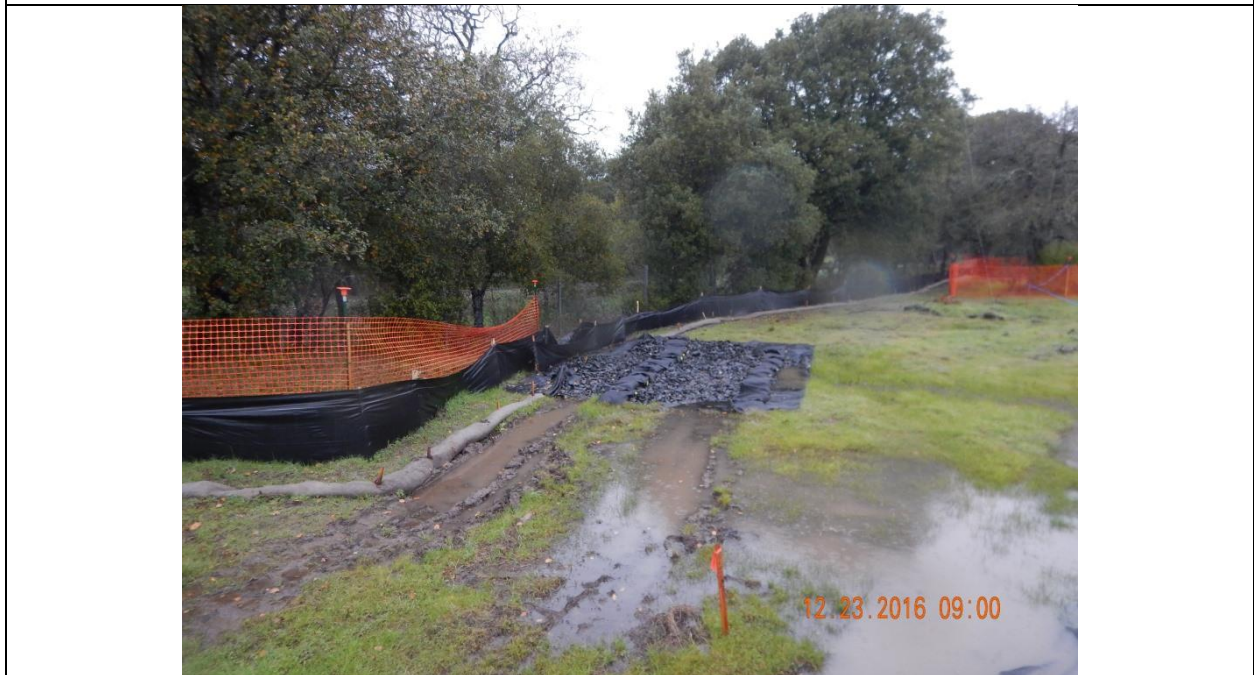
Photo 8: An armored discharge point along the western project boundary, in the northwest corner. There was no discharge to Peterson Creek occurring at the time of our visit.

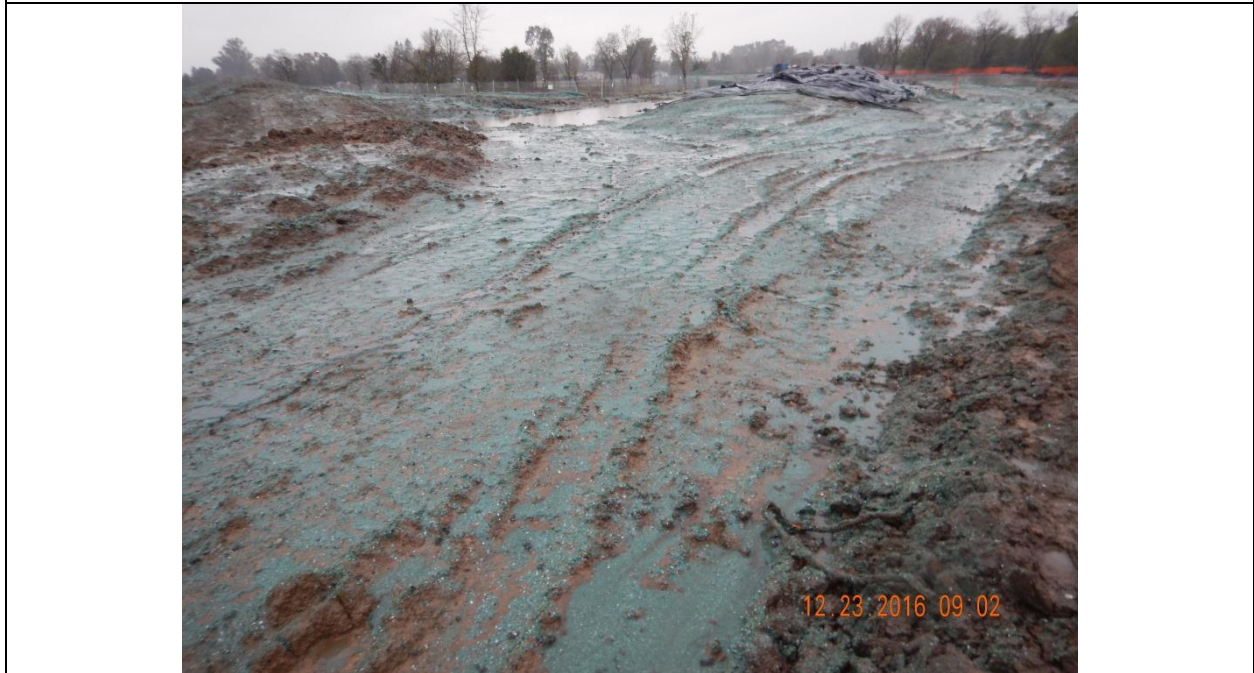
The entire site had been recently sprayed with a fiber matrix/Earthguard combination (hydromulch). Mr. Fortney said that the hydromulch application rate was 1500 pounds/acre, and that the Earthguard was used in a concentration of 7 gallons/acre (see Photo 10 and 11). Earthguard is a soil binder—according to the manufacturer, Earthguard is as effective applied in a water solution as it is mixed into a fiber matrix slurry. It was evident that the hydromulch had been recently applied, because pools of runoff from hydromulch-treated areas had a green tint to them as a result of the green dye used by the fiber matrix manufacturer (see Photo 16).

Photo 10: Disturbed area with hydromulch after rainfall.

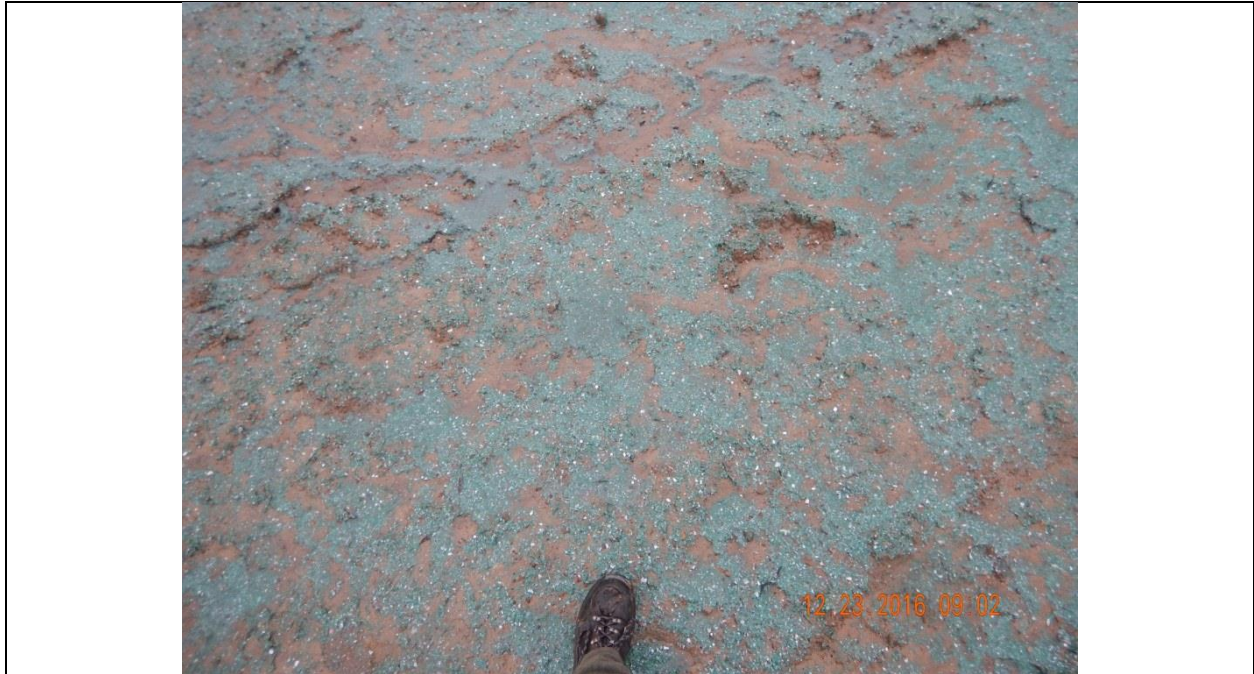
Photo 11: Close-up of area shown in Photo 10. Mr. Fortney said the hydromulch was sprayed at 1,500 pounds per acre.

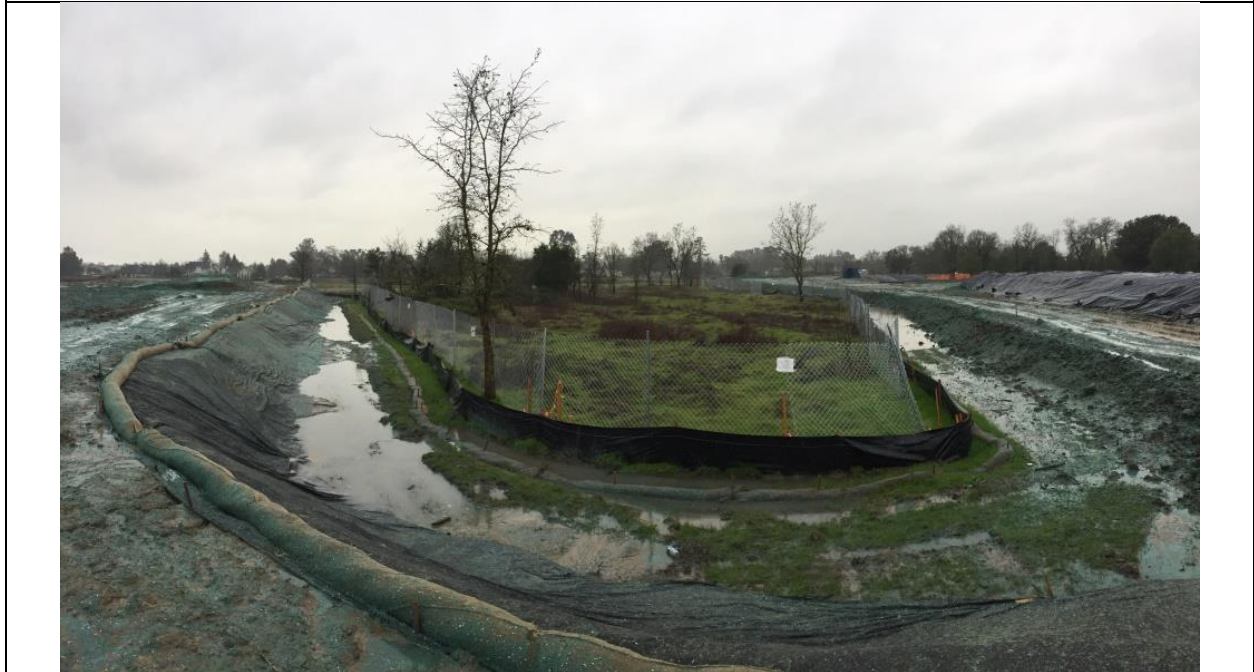
had been impacted by construction runoff. We did not see any indication that the wetland had been damaged by turbid runoff (see Photo 12). However, we did observe turbid runoff from the construction site in a wetland immediately adjacent the southern Project site boundary, at the base of a constructed retaining wall (see Photo 13). This wetland appeared to be a wetland identified as "W2" in the 401 certification application materials (see Figure 1). Impacts to this wetland are not permitted by the 401 certification.

Photo 12: Looking south, jurisdictional wetland area required to be preserved as a condition of the 401 certification.

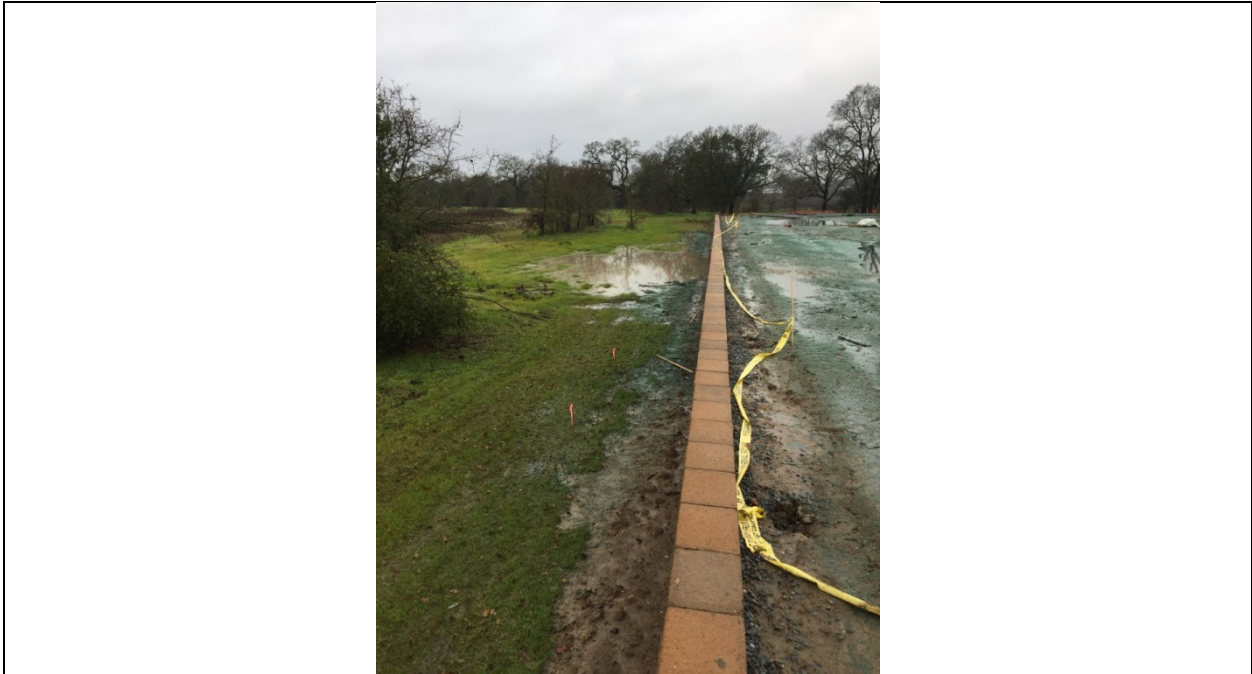
Photo 13: Retaining wall along southern Project boundary, looking west. The puddle consists of muddy runoff from the Project site and may be a jurisdictional wetland as identified in Project 401 certification application documents. Runoff from disturbed Project areas reached this depression area by passing below the western end of the wall, whereupon it flowed east into this area.

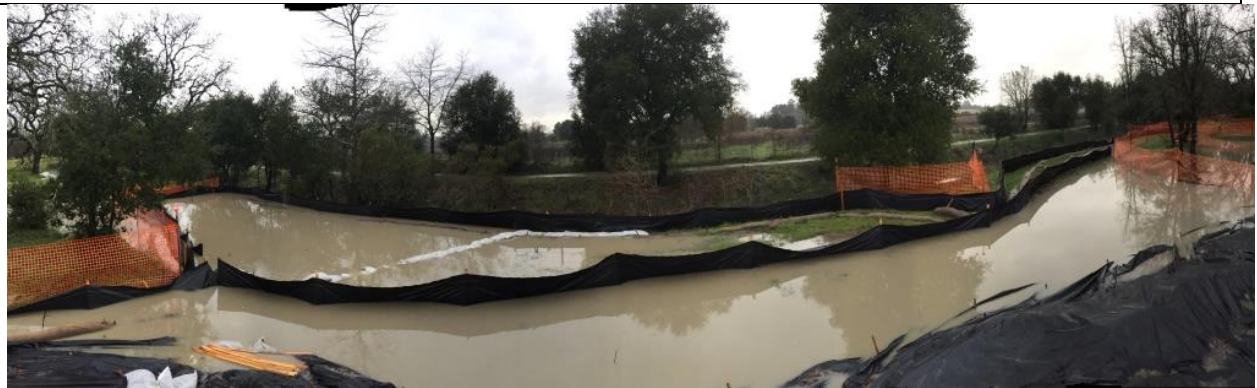
Photo 14: A view of improvised detention basins along western Project boundary, looking west.

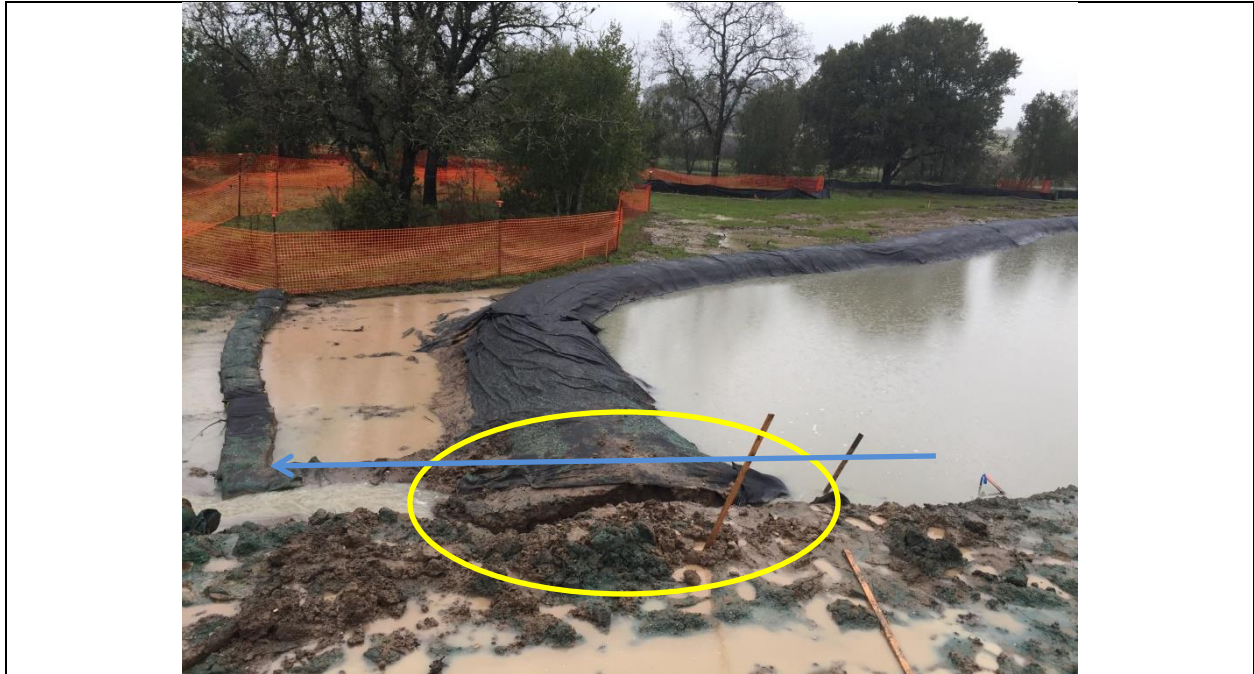
Photo 15. One of the earthen basins failed and storm water was flowing into the next downstream basin. The blue line shows flow direction.

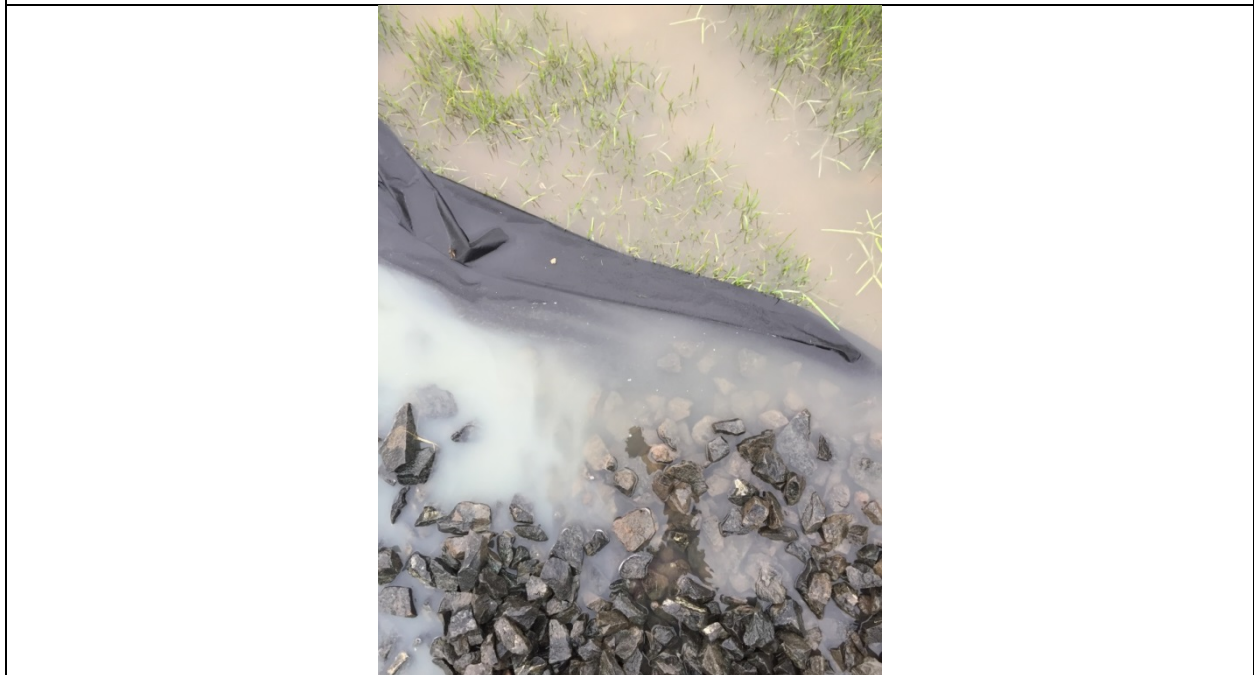
Photo 16. Photo taken within the eastern catchment. The storm water runoff on the bottom half of the photo is from areas treated with hydraulic mulch and has a green hue, unlike the water in the top of the photo, which is from areas largely not treated with hydraulic mulch. Ponded water throughout the Project area, in areas where hydromulch had been applied, had a green hue.

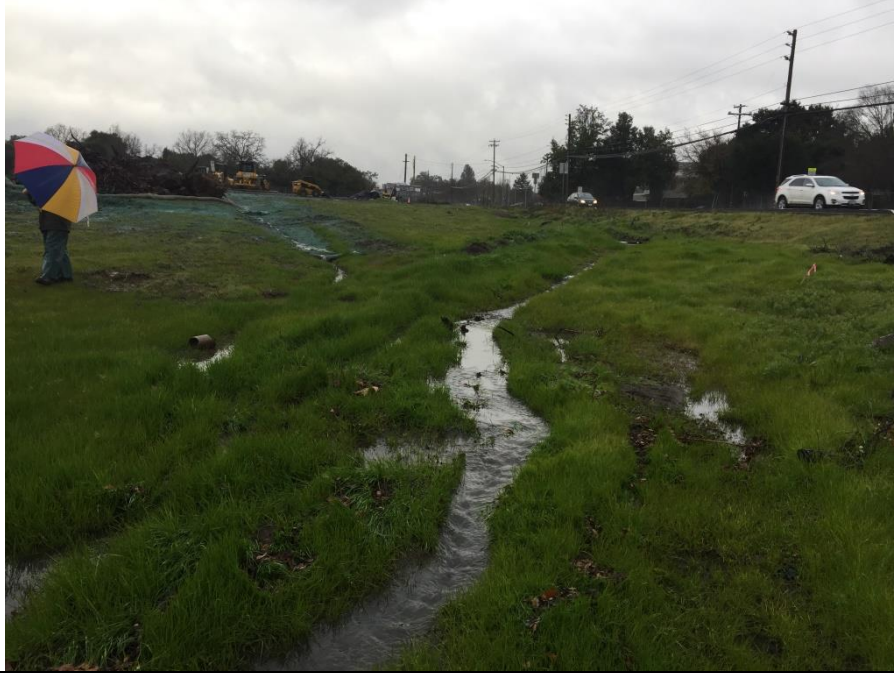
After inspecting the western Project boundary, we walked along the northern Project boundary, where no discharges from the Project were observed, to the eastern project boundary where storm water accumulated to discharge to a drain inlet in the southwest corner of the Project area. One drainage entered this Project catchment from a Fulton Road cross culvert (see Photo 17).

Photo 17: Looking north on the southeast portion of the Project site. Run-on from Fulton Rd. cross-culvert shown coming from the right side of photo to the foreground. A confluence with the drainage from the equipment staging area is in the lower left corner of the photo.

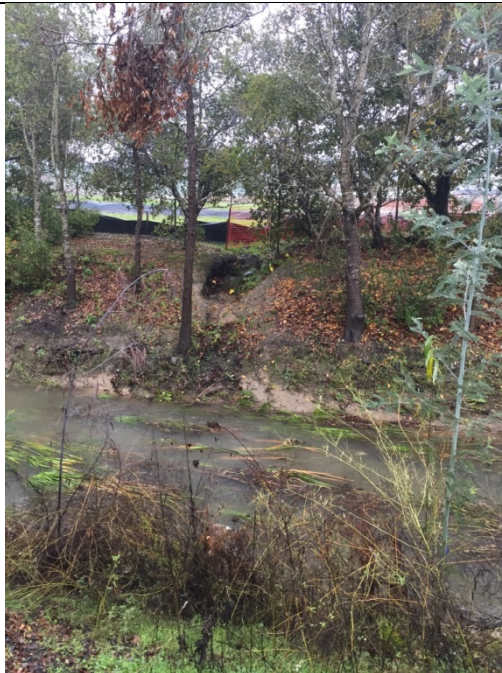
Photo 18: Existing outfall channel on the left bank of Peterson Creek where future drainage from the western side of the Project is proposed for discharge.

Mr. Fortney mentioned that when conditions were suitable (i.e., drier), he intended to work with the Project consulting engineer to revise the drainage pattern so that all runoff would discharge at one discrete location (see Photo 18). I cautioned him that the engineer should perform the necessary calculations to ensure that the outlet to Peterson Creek could handle this introduced flow and not cause erosion in response to the changed hydrology. I mentioned that they may need to distribute the drainage to more than one outlet to prevent erosion, depending upon the engineering calculations.

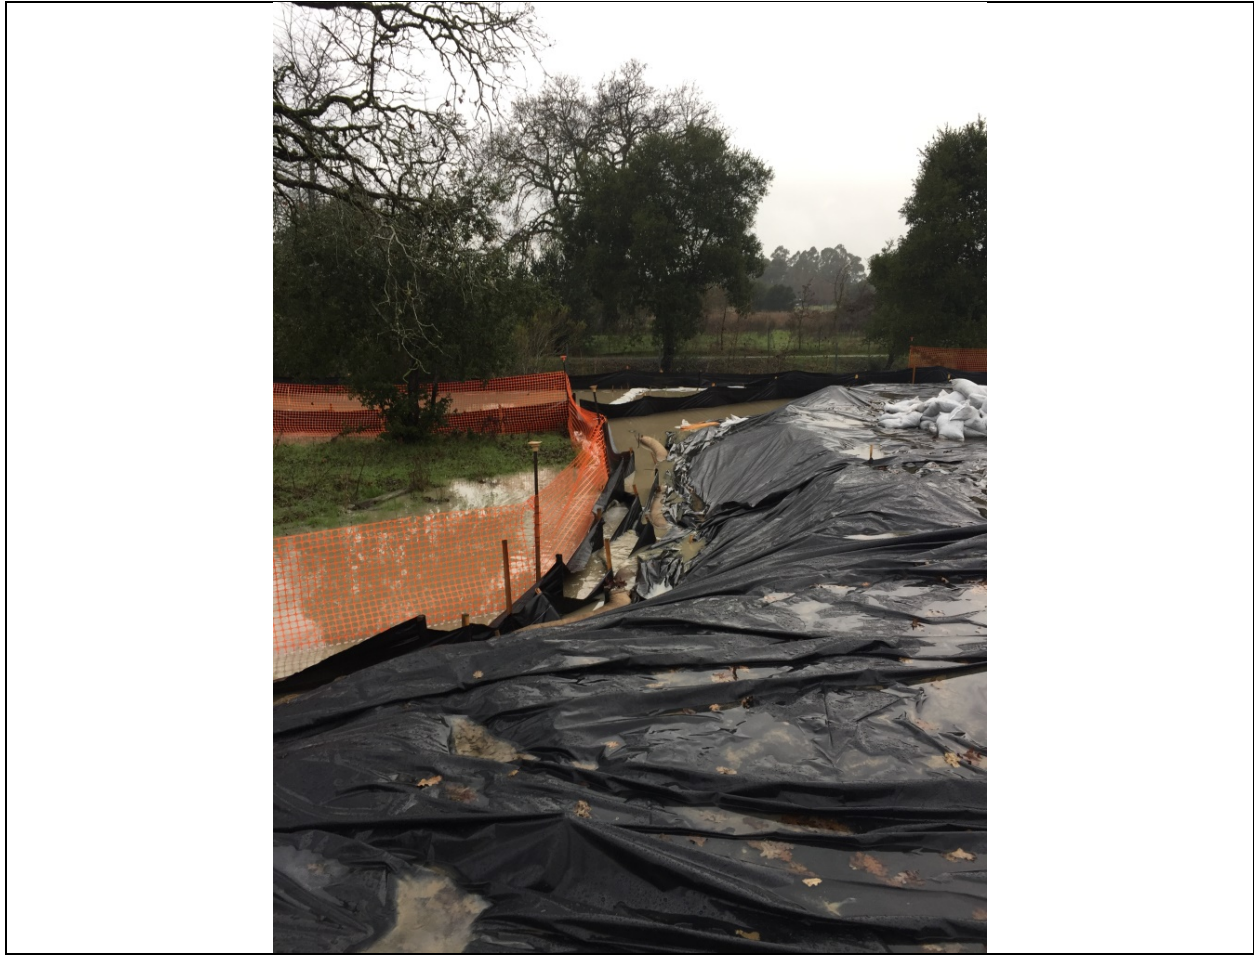
It was apparent that the implemented BMPs were the result of a reactive pollution prevention strategy; because proper wet weather site planning was not completed prior to the wet season, site conditions necessitated construction of several improvised detention basins and in some places, multiple layers of sediment control (see Photo 9, 14, 15, 19). Measures that could have been performed earlier in the season to make the site runoff more manageable appeared to not have been performed; for instance, breaking the project into smaller catchments so that runoff could be more easily managed, construction of sediment/detention basins engineered per the CASQA manual, and Project-wide, series of check dams to slow runoff and allow sediment to settle.

Photo 19: Looking west, at multiple layers of sediment control near southwestern Project boundary.
