Attachment A

Field Inspection Report

Name and Location of Facility Inspected	Rhys Vineyard, Clarke Ranch, 6501 Branscomb Road, Laytonville, CA		
Inspection Date & Time:	September 29, 2015 0830-1700 Travel time included	Mendocino County Assessor Parcel Numbers (APN)	015-050-061 015-050-057 015-050-056 015-050-055 015-050-050 015, 050-051 014-300-019

Report Prepared By:
Stormer Feiler, Environmental Scientist (ES), North Coast Regional Water Board (RWB)

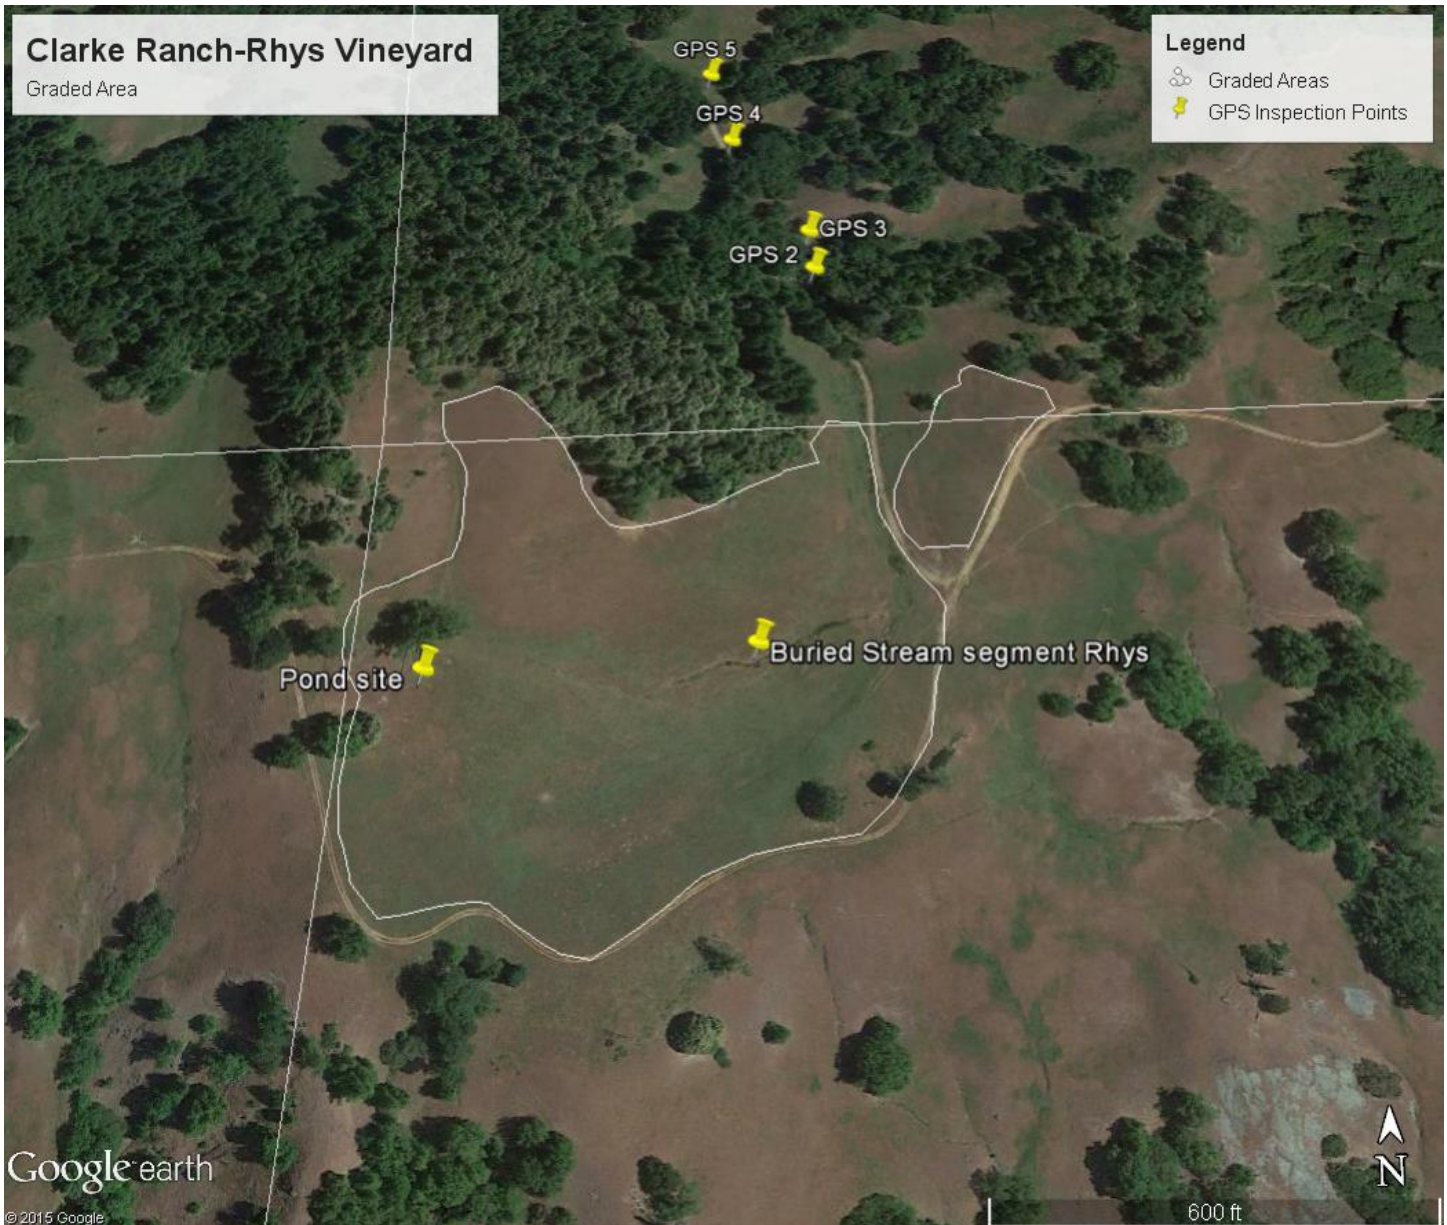
Image 4 – location of large graded area and recently constructed pond, prior to grading and excavation. (Google Earth Pro imagery, image date May 25, 2014)

Image 4, above, shows the recently graded area, prior to grading. In order to estimate the extent of ground disturbance, based upon site observations, I have outlined on this image the approximate areas affected by grading. Using mapping tools to measure the outlined polygon, I measured the graded area delineated on the west side of the access road to comprise approximately 14 acres and the graded area

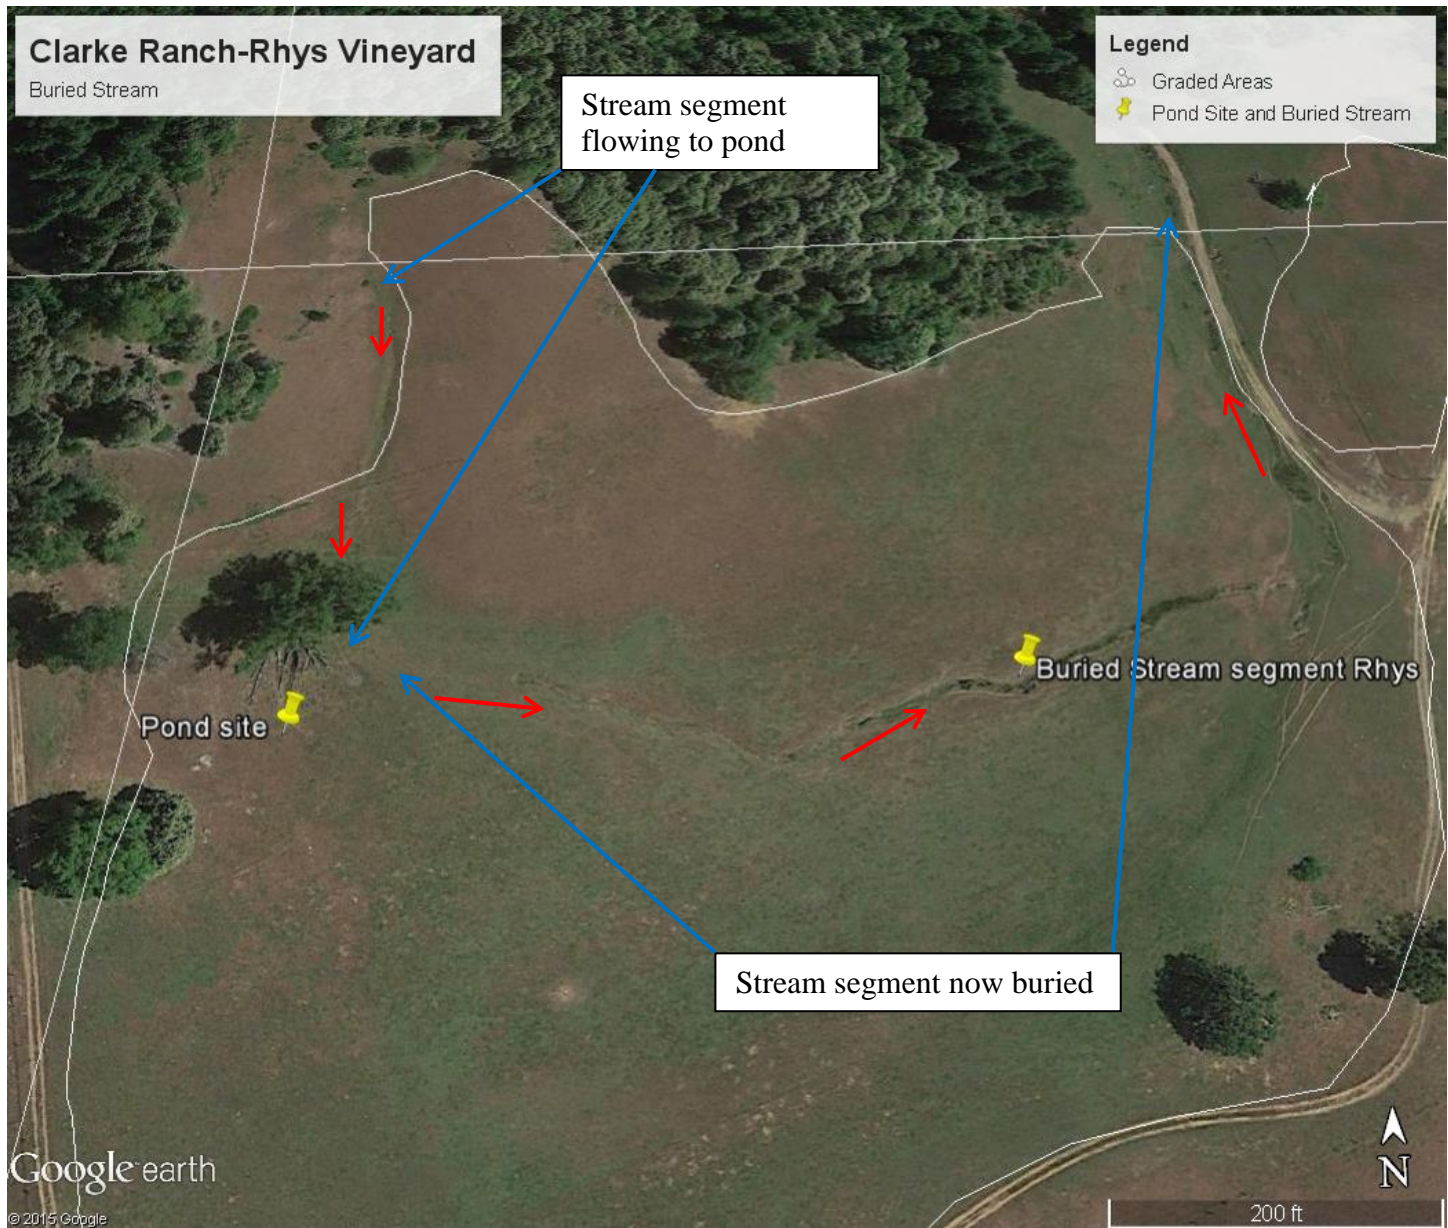
I observed that the grading and excavation to clear and contour slopes and to create the pond had resulted in the burial of the stream that was visible on 2014 Google Earth images. The length of stream channel buried by the grading is approximately 1480-1650 feet.

Image 5 - graded area prior to development and pond excavation, showing the affected stream length and area. The red arrows denote flow direction. (Google Earth 5/28/2014 imagery)

During the inspection, I observed that the entire portion of the site delineated in image 5 above had been graded and covered with earthen material excavated to create the new pond. No surface stream was visible leading from the upper slope to the lower slope. The hinge line of the grading above the pond site followed the existing slope contour and created a drainage ditch to the pond along the flow path of the former stream as shown in image 5 above. This flow path was interrupted at the pond and I

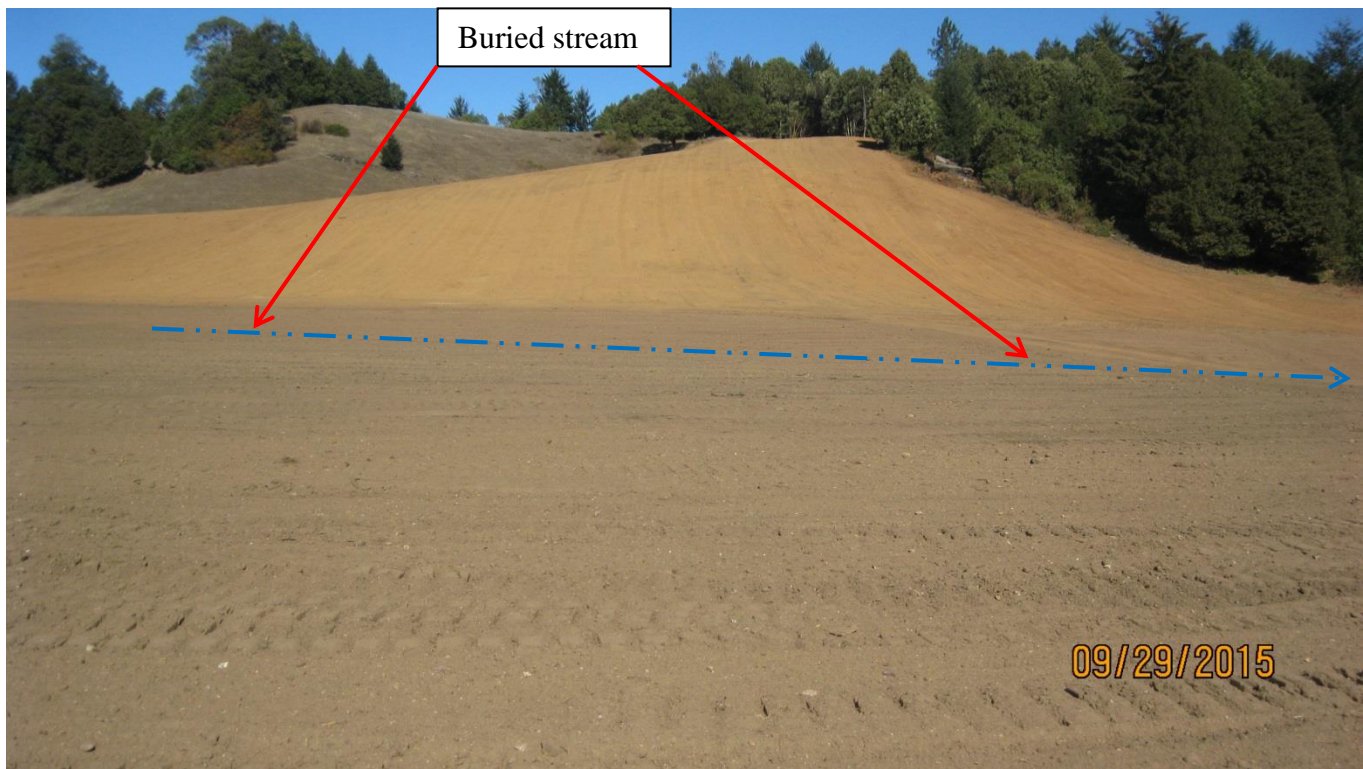
Image 6 shows graded slope to the west of the pond excavation site. Note the two different colors of soils, which is likely a result of spreading the spoils excavated from the pond across the slope and burying the existing stream. (Division of Water Rights inspection photo 0585)

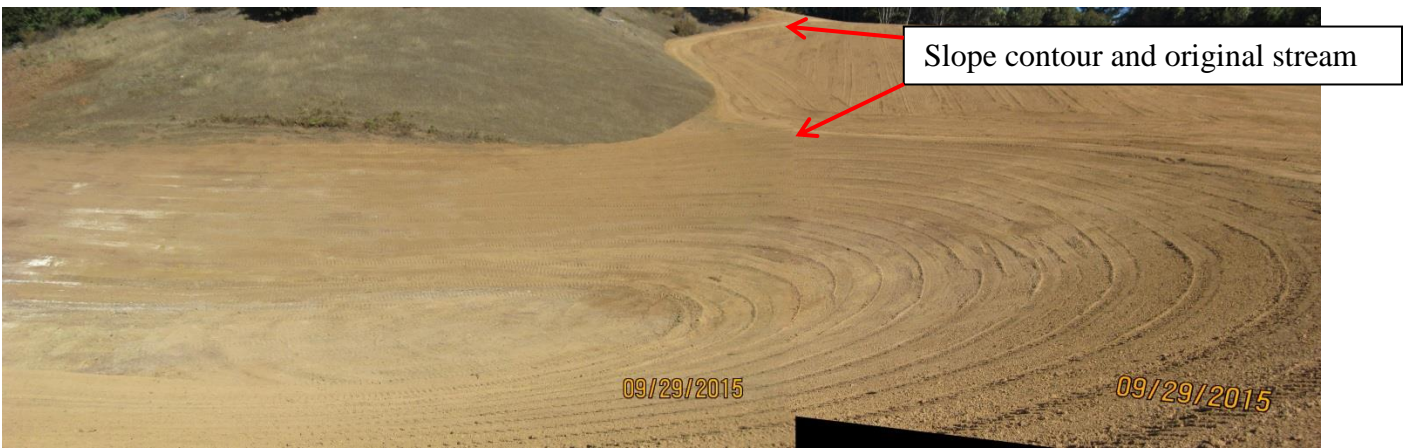
observed no stream channel below the pond. During the inspection, Mr. Seckora stated that the pond was not a pond, but had been dug out to get at a chert formation to use as road rock on the access road surface. He stated he had decided to leave the hole as a sediment trap to catch rainfall runoff and sediment from the slope and stream above. I observed that the pond did not have a constructed outfall or overflow channel. Upon returning to the office I used mapping tools to estimate the length of filled in channel in order to calculate the approximate volume of fill placed in the channel. Utilizing Google Earth I came up with a Channel length of 1480 -1650². Based on my calculations, I conservatively estimate that 1480-1650 feet of stream channel was filled, with approximately 109 cubic yards of earthen fill placed in the stream channel, as part of the grading and development of this vineyard area.

Image 7 shows the hole excavated to extract rock or to develop a pond. Note the stream originally followed the slope contour and flowed down to the meadow area below the pond. Here the drainage has been interrupted and directed to the pond. In addition, the original stream channel has been filled with loose earthen material because of the grading. (Division of Water Rights inspection photos 0587 and 0589 stitched together.)

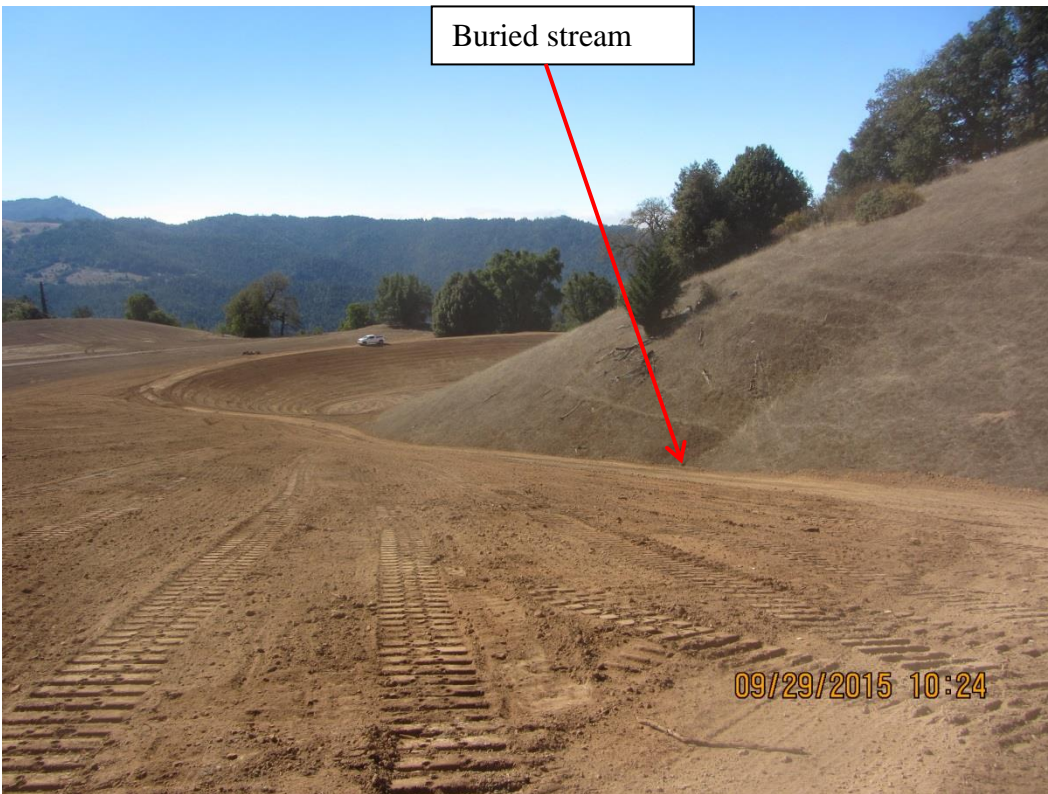
Image 8 shows the pond and the slope contour filled with loose soils leading to the pond from above. (IMG 0208)

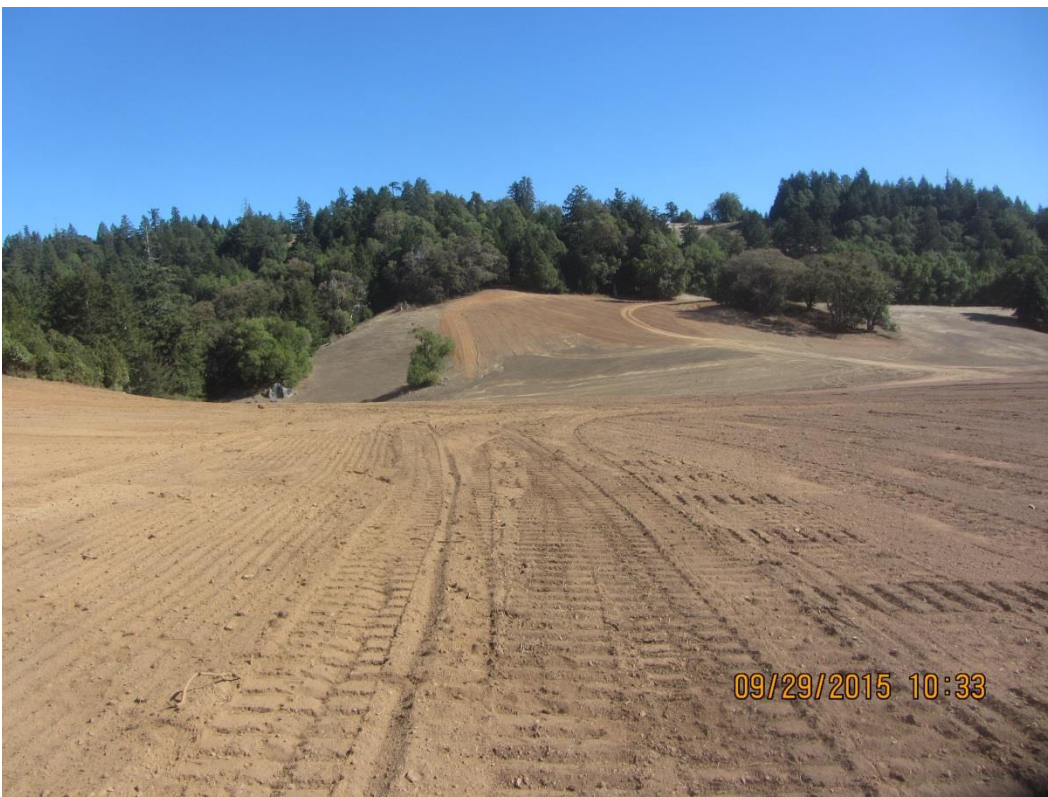
Image 9 shows the slope below the pond looking south at approximately the location where I would expect to see the stream visible in images 4 and 5 flowing to the east across the slope and down to the main stream to the north. (IMG 0219)

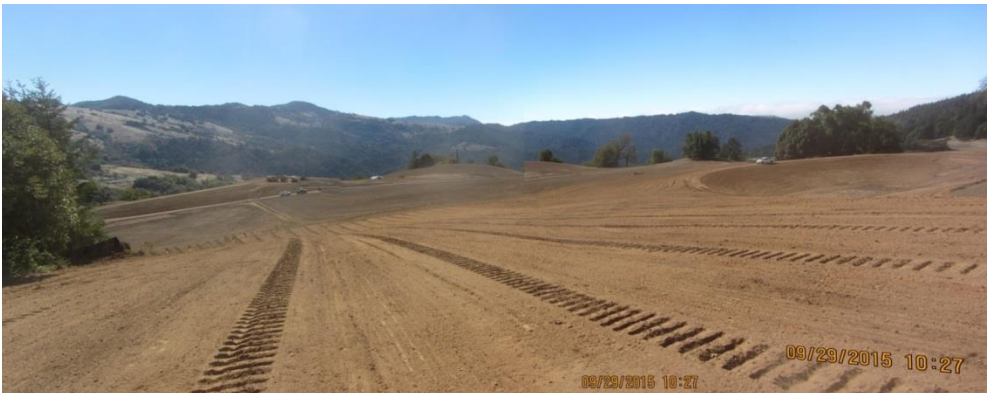
Image 10 shows an overview of the grading; the pond is visible to the far right. (IMG 0209-0212 and 0214 stitch).

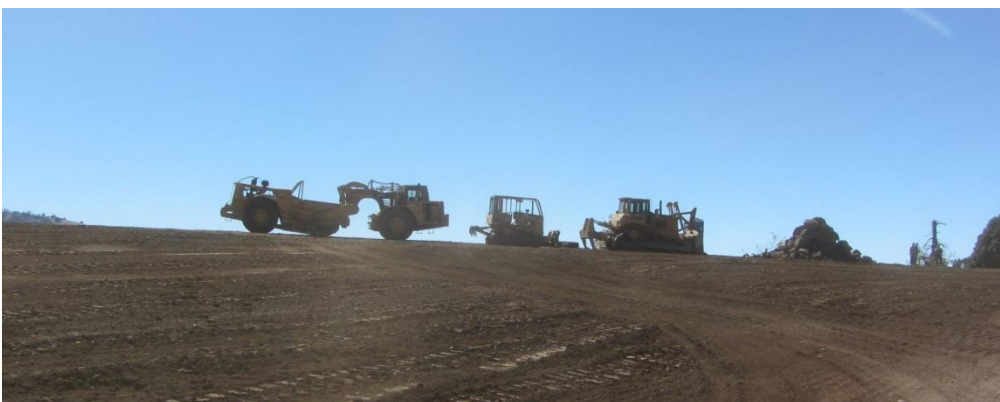
Image 11 shows the equipment observed on site. (IMG 0244 cropped))

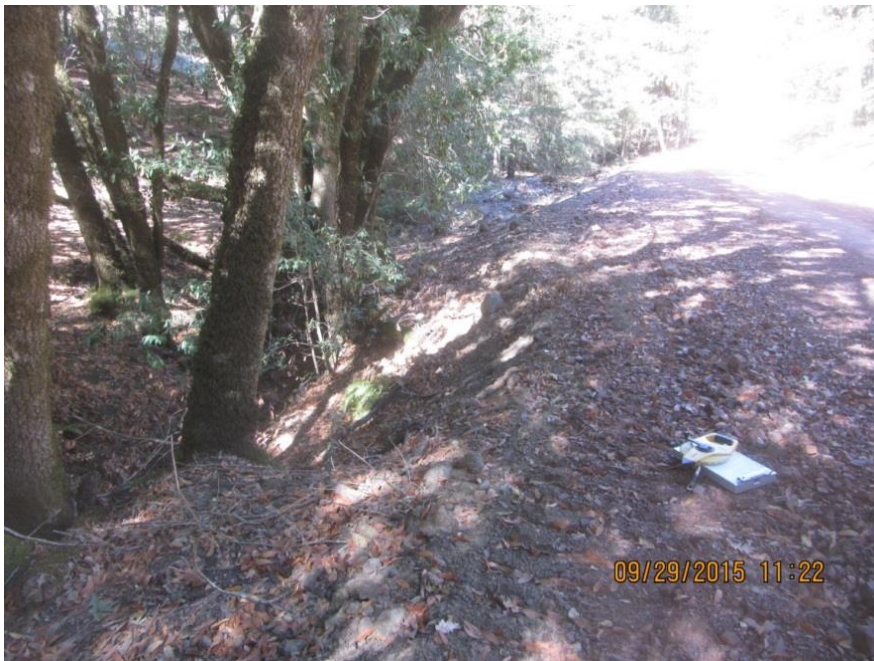
Inspection Feature GPS 2 (39°36'33.84"N and 123°33'8.01"W)

GPS 2 is an approximately 142 foot road segment that has an outboard edge of earthen materials perched above the stream channel. The road surface drains towards these earthen materials and Regional Water Board staff consider the potential threat of delivery of this material to the stream to be high for 100' of the road length and low for the other 42'.

Image 12 shows the road segment at GPS 2. Note the loose earthen material along the road edge adjacent to the stream. (IMG 0252.)

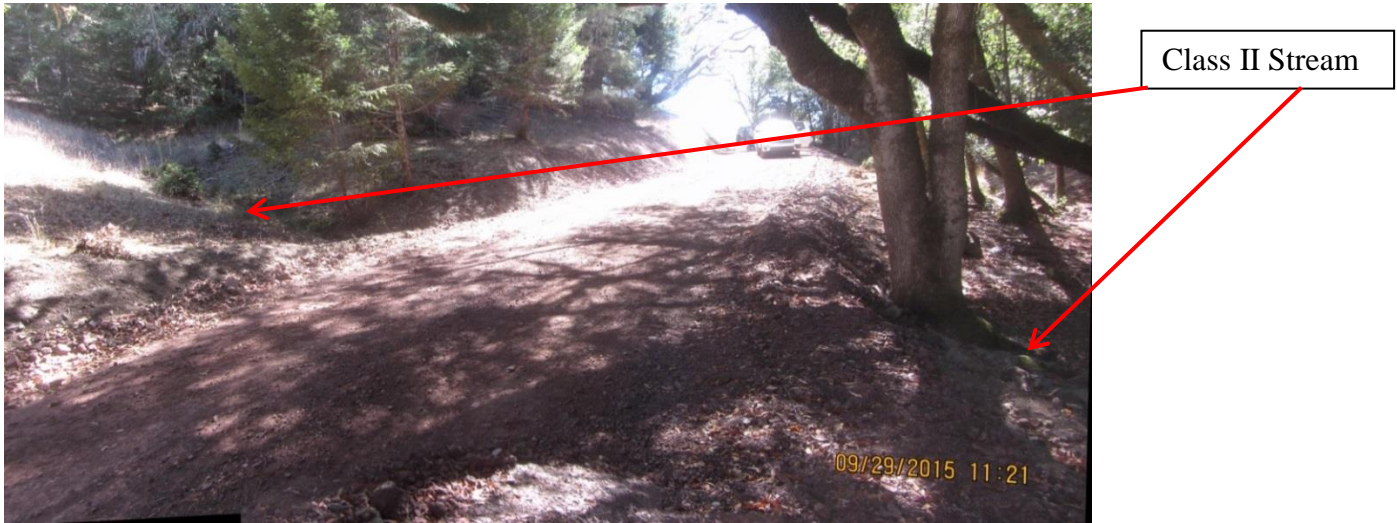
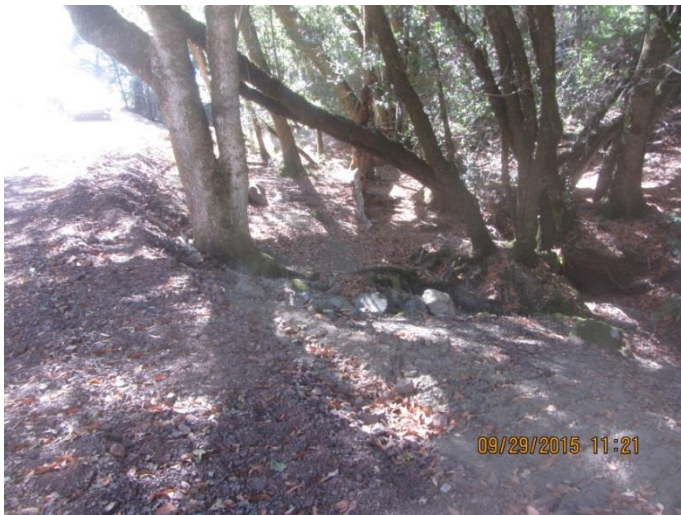
Inspection Feature GPS 3 (39°36'34.75"N and 123°33'8.05"W)

Based on field measurements and subsequent calculations, I estimate that approximately 18.4 yds.³ or 3717.73 gallons of fill material was placed in the stream channel at GP3.

Image 13 shows the stream crossing at GPS 3. (IMG 0247-0251)

Image 14 shows the stream crossing at the downstream road edge at GPS 3. (IMG 0249)

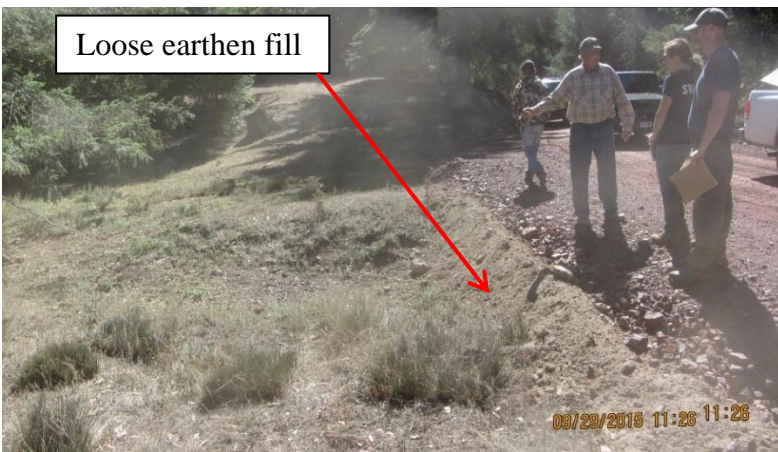
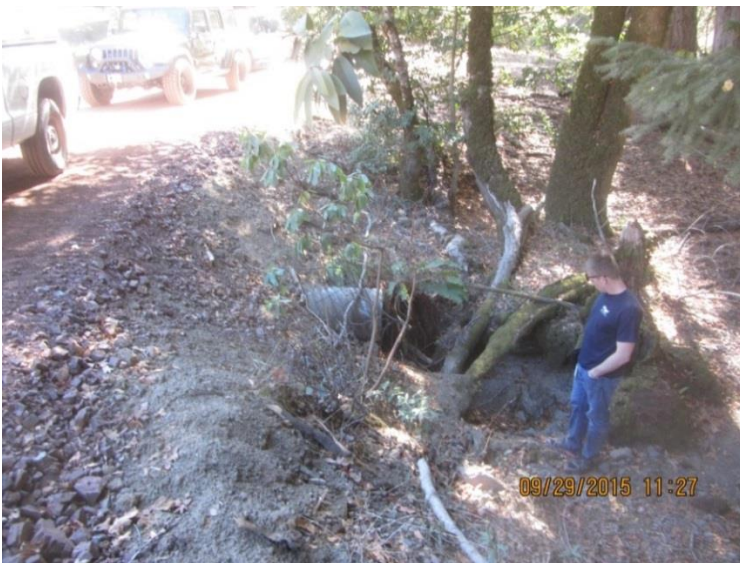
Inspection Feature GPS 4 (39°36'37.19"N and 123°33'9.84"W)

GPS 4 (stream crossing 2) is a location where the road prism was constructed through a large Class II or Class I watercourse. The road fill completely filled the stream channel. I observed a partially visible culvert on the downstream (west) side of the stream crossing but I was unable to find the culvert on the upstream (east) side. Earthen material placed in the stream at this location represents a discharge of waste to receiving waters. Based on my measurements and subsequent calculations, I estimate that approximately 28.45 cubic yards, or 5746.16 gallons of fill material was placed in the stream channel at this location.

Image 15 shows the road fill in the stream channel on the east (upstream) side of the road at GPS 4. Note there is no culvert visible in the road fills placed into the stream channel on this side of the road. A culvert was visible on the downstream side of the crossing. (Stitch of 0253 and 0254)

Image 16 shows the downstream side of the stream crossing at GPS 4. Note the erosion below the culvert outlet, possibly as a result of the drop at the culvert outlet and/or as a result of the culvert being undersized and forcing high flows through at increased velocities. (IMG 0257)

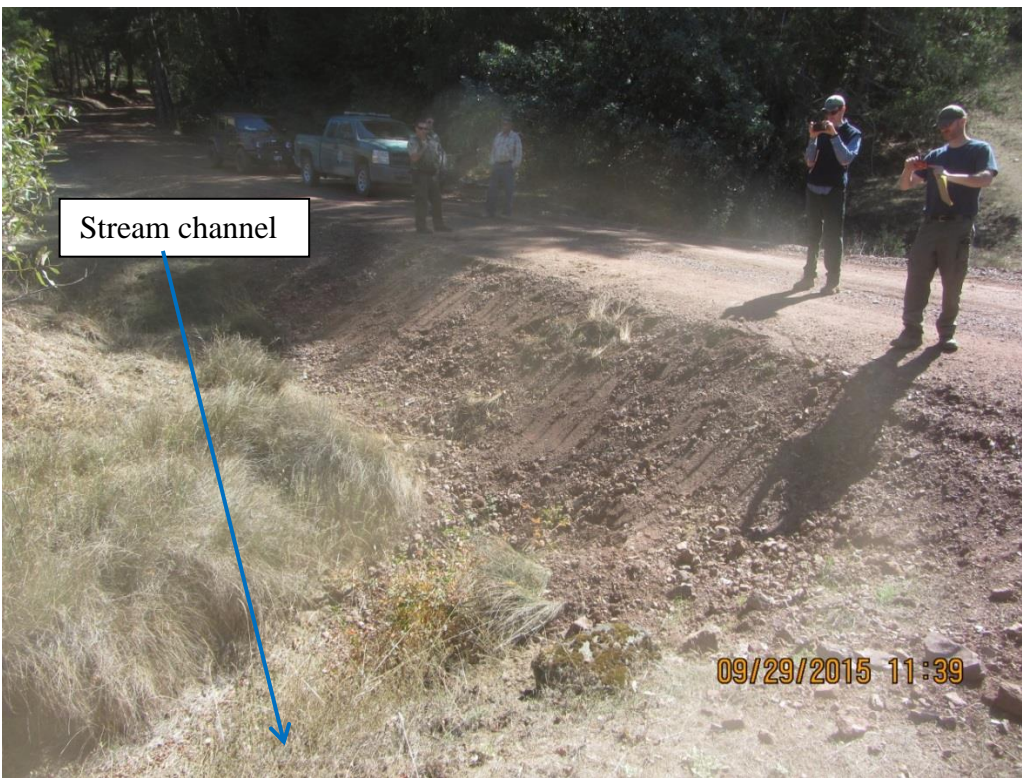
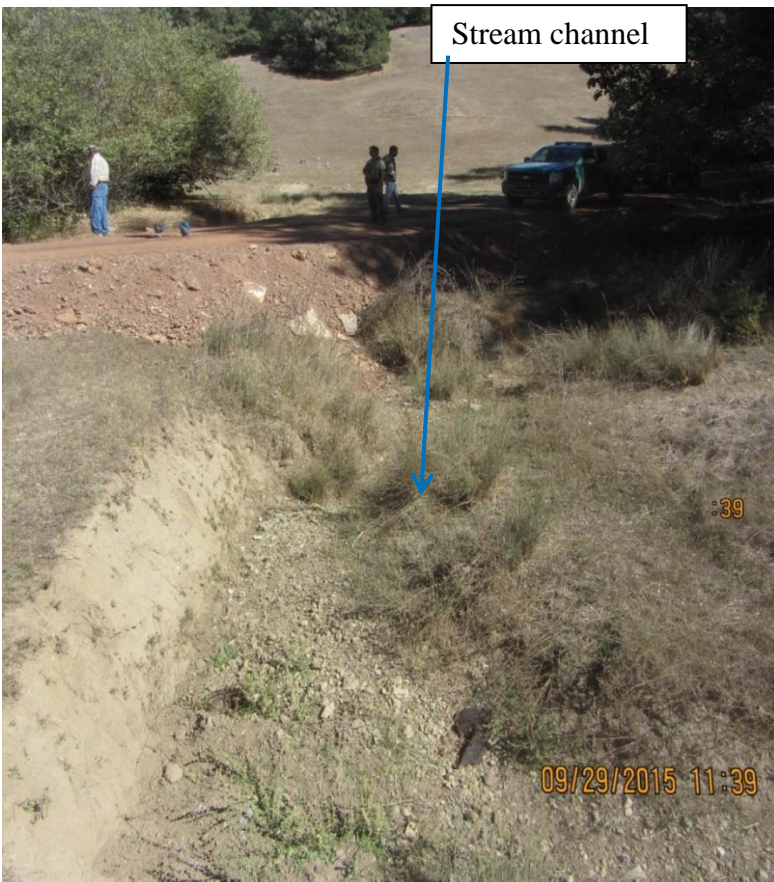
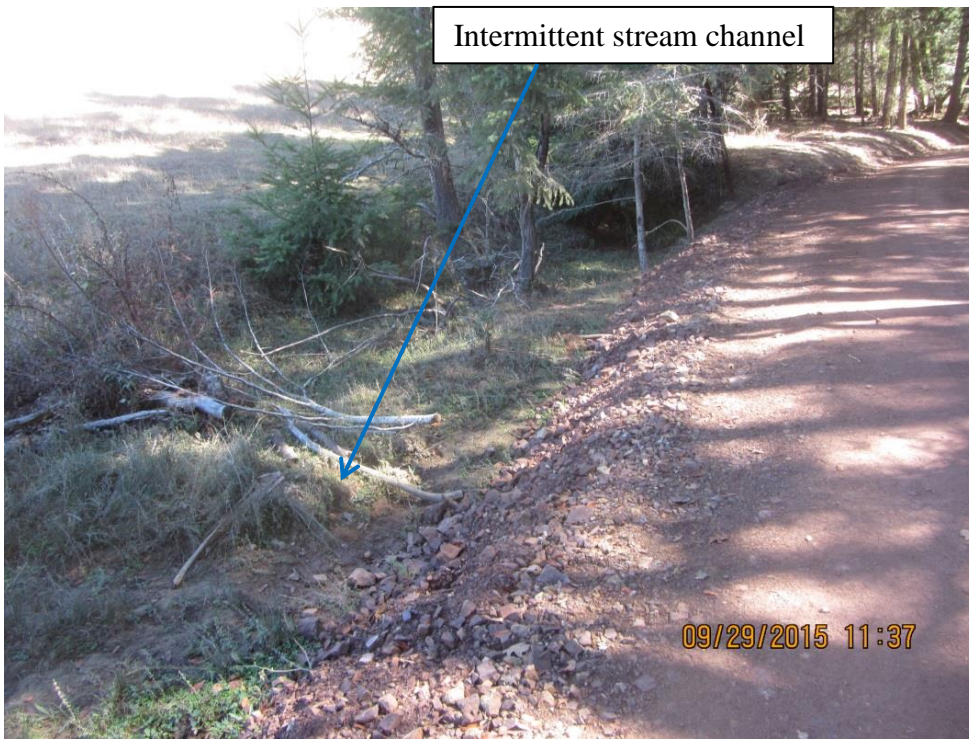
Inspection Feature GPS 5 (39°36'39.05"N and 123°33'10.29"W)

Based on field measurements and subsequent calculations, I estimate that approximately 65.69 cubic yards or 13,268.57 gallons of fill material was placed in the stream at GPS 5.

A Class III watercourse flows from the south along the east side of the road and meets up with the larger watercourse near the crossing. The road is located directly adjacent to a segment of this Class III watercourse and it is likely that sediment from the road surface may discharge into this watercourse during rainfall sufficient to cause overland flows.

Image 17 shows the upstream east side of the filled stream channel at GPS 5. (IMG 0263)

Image 18 shows the downstream west side of the filled stream channel at GPS 5. (IMG 0260_0261 stitch)

Image 19 shows the Class III stream channel along the edge of the road south of GPS 5. (IMG 0259)

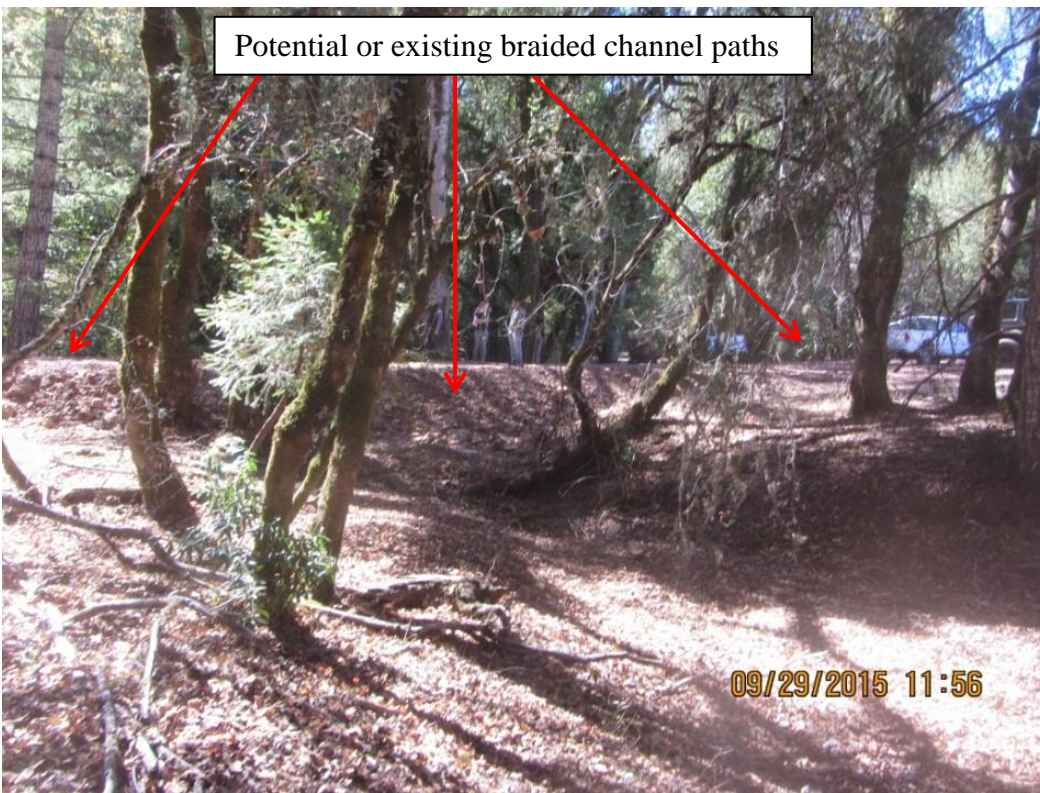
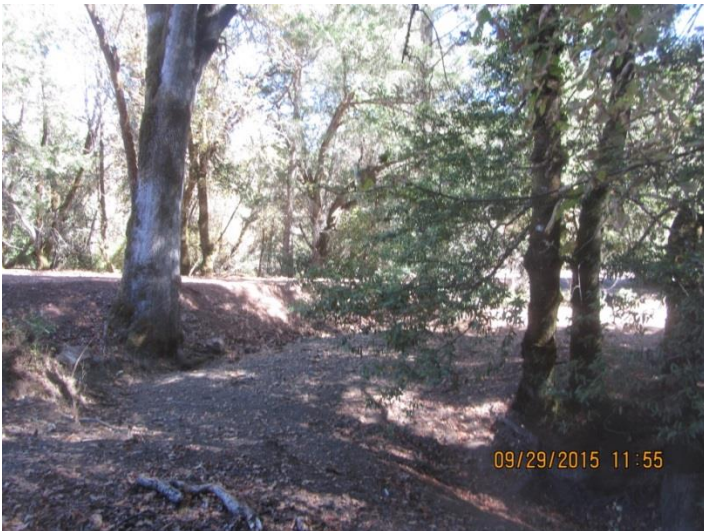
Inspection Feature GPS 6 (39°36'43.89"N and 123°33'20.99"W)

GPS 6 (stream crossing 4) is a location where the road was constructed/reconstructed through a seasonal Class I or Large Class II stream. There was no culvert or other constructed drainage structure to allow for stable conveyance of stream flows through the earthen fills placed in the channel during construction. The upstream channel form is a conventional stream channel 14 feet wide; however, at the road/stream intersection, the channel is braided and divides into two streams. For the purposes of conservatively calculating the fill volume placed into the channel, I only calculated the volume of fill in the portion of the braided channel that appeared to be most recently active. Earthen material placed in the stream channel at this location represents a discharge of waste to receiving waters. On the upstream side of the road stream flows run up to the placed fill and then flow south along the fill material. Based on field measurements and subsequent calculations, I conservatively estimate that approximately 104.3 yds.³ or 21,065.89 gallons of earthen material was placed in the watercourse channel at GPS 6.

Image 20 shows the road fill in the braided stream channel at GPS 6. The arrows roughly delineate where the channel appears to have flowed in the past. (IMG 0275)

Image 21 shows stream crossing 4 (GPS 6) looking downstream at the roadway crossing through and blocking the stream channel. (IMG 0271)

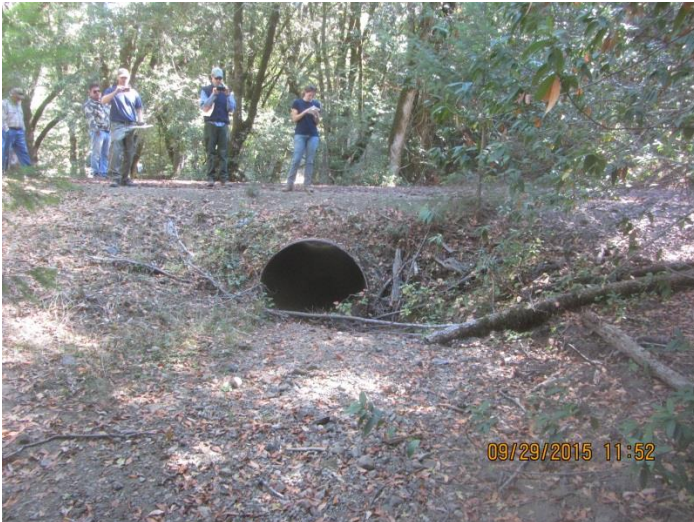
Inspection Feature GPS 7 (39°33'25.16"N and 123°33'25.66"W)

GPS 7 (stream crossing 5) is an existing 54-inch culvert crossing upstream of GPS 6. The culvert is likely undersized to allow for the unimpeded passage of the expected 100 year flow and debris. I observed that the stream channel was wider than the culvert, an indication that the culvert may be undersized. The inside ditch along the road upstream of the culvert is uninterrupted and appears to function as a stream likely carrying eroded materials from the road surface into the stream at the stream crossing. As I recommend below, the Discharger should engage appropriately licensed/qualified professional(s) to evaluate this stream crossing and inside ditch to determine if the culvert is adequately sized to pass the 100 year flow and debris and to identify appropriate locations to redirect flows from the inside ditch to

Image 22- upstream of the culvert at crossing 5 (GPS 7) looking downstream at the mouth of the culvert. Note the width of the stream channel as compared with the diameter of the culvert inlet. (IMG 0266)

reduce the volume of road runoff draining to the stream crossing.

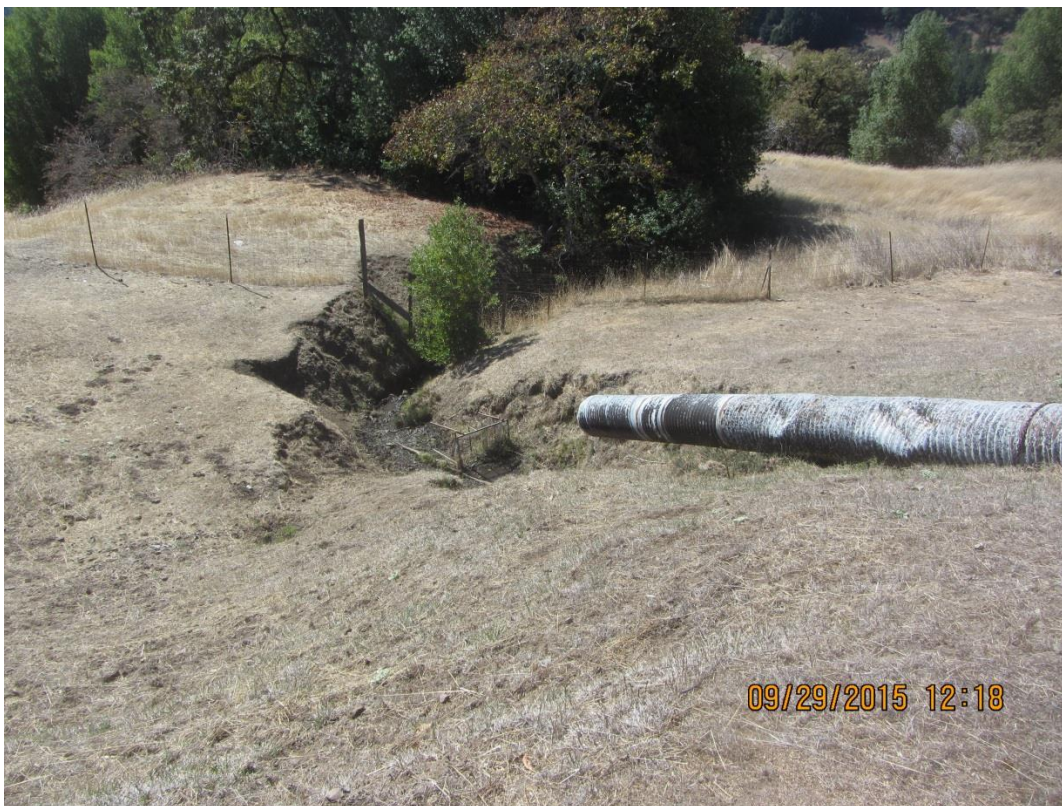
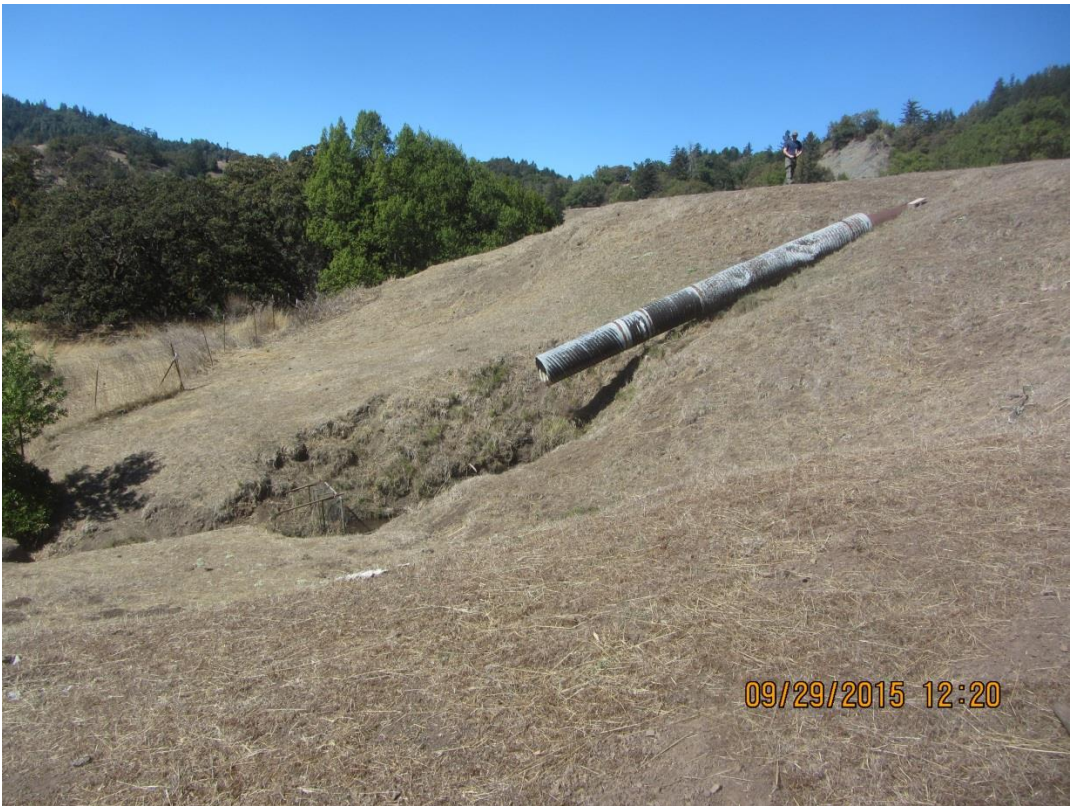
Outflows from the larger of the two ponds (GPS 8) pass through a culvert into a Class II perennial stream channel below the pond. The culvert outlet is exposed and shotgunned. Staff observed signs of significant erosion around and downstream of the culvert outlet, likely on the order of hundreds of cubic yards of soil have eroded while this culvert has served as the pond outlet. The erosion of the dam's fill face is potentially compromising the integrity of the downstream berm/dam.

Image 24 shows the overflow culvert from the larger pond (GPS 8). Note the shot-gunned culvert outlet and gully formation in the stream channel below the culvert outlet. The landscape also appears to be heavily grazed; note the difference between vegetation in the foreground and on the other side of the fence. (IMG 0276)

Image 25 provides another view of the shot-gunned spillway culvert outlet for GPS 8. (IMG 0282).

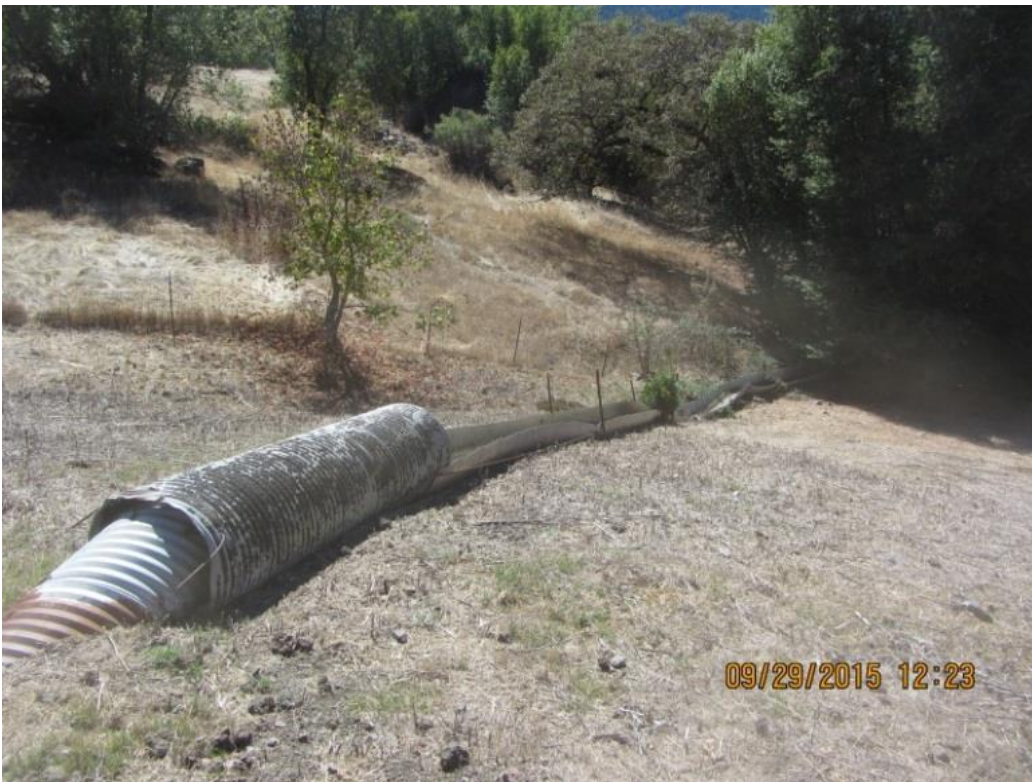
The smaller of the two ponds, GPS 9, also intercepts a Class II perennial stream. The pond outlet flows into a Class II stream. I observed minor evidence of erosion in the stream below the pond; this erosion may be a result of increased winter flows from the pond or may be associated with wild hogs and/or use by grazing animals.

Image 28 shows the outfall from the smaller pond (GPS 9). Note the culvert and half pipe do not appear to be structurally sound; however, the half pipe was carrying flows during the inspection. (IMG_0284)

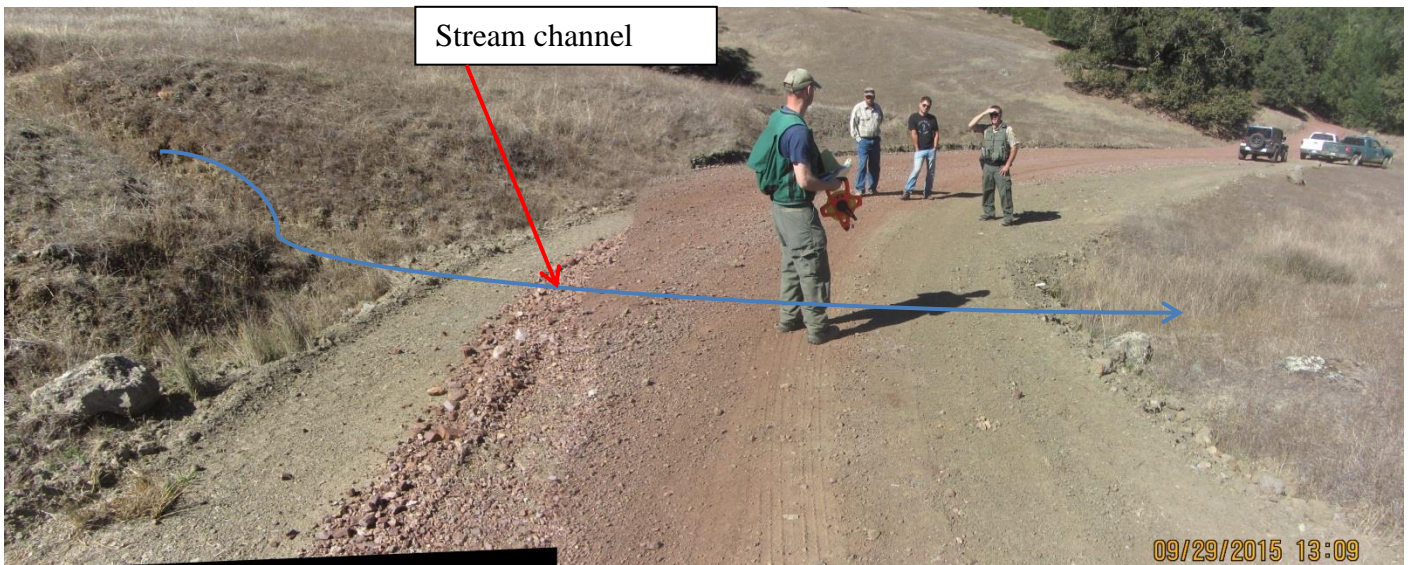
Inspection Feature GPS 10 (N. 39°36'50.4"-W. 123°33'42.7")

GPS 10 (stream crossing 6) is a location where the road was constructed/reconstructed through the headwaters of a small Class III stream. Staff noted juncus growing in the channel. There was no apparent culvert or other constructed drainage structure to allow for stable conveyance of stream flows. Earthen material placed in the stream channel at this location represents a discharge of waste to receiving waters. Based on field measurements and subsequent calculations, I estimate that approximately 4.88 cubic yards, or 987.4 gallons of earthen material was placed in the stream channel at GPS 10.

Image 31 shows GPS 10. (IMG 0290-0291 stitch).

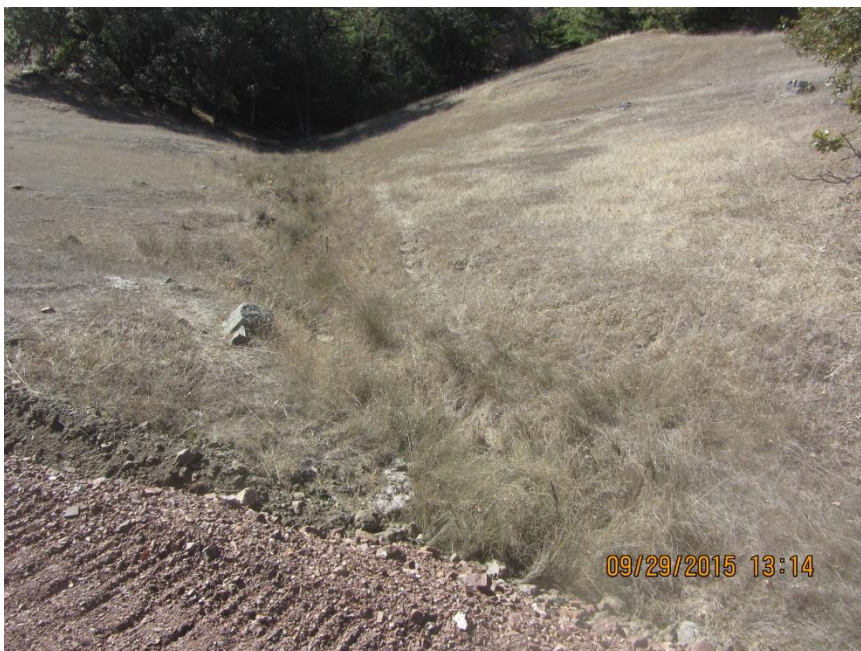
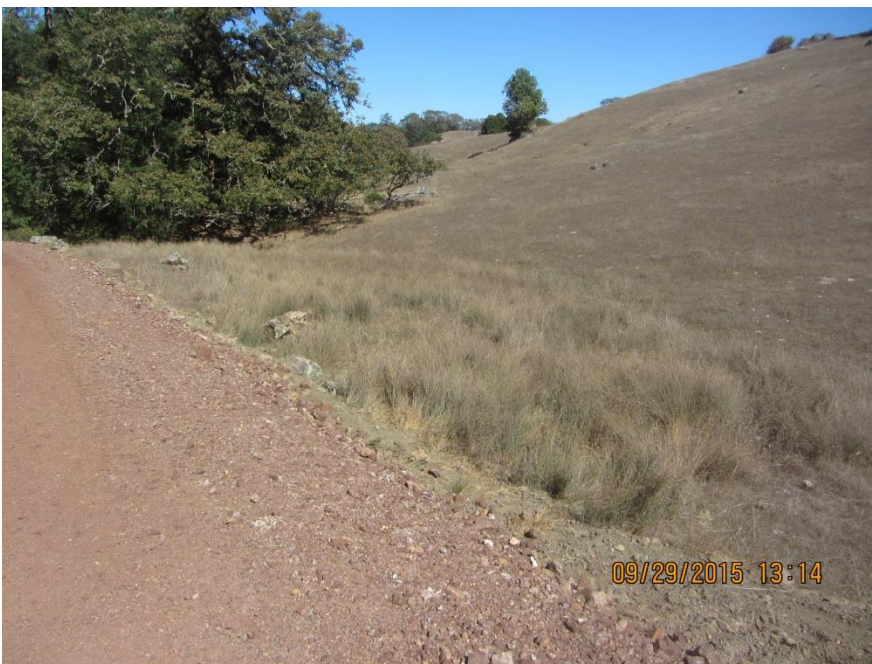
Inspection Feature GPS 11 (N. 39°36'52.4"-W. 123°33'42.4") (Stormer Feiler photo 0292)

GPS 11 (stream crossing 7) is a location where the road was constructed/reconstructed through the headwaters of a small Class II/III stream. Staff noted juncus growing in the channel, often an indicator of sufficient annual saturation to support non-fish aquatic species and Class II habitat. There was no apparent culvert or other constructed drainage structure to allow for stable conveyance of stream flows. Earthen material placed in the stream channel at this location represents a discharge of waste to receiving waters. Based on field measurements and subsequent calculations, I estimate that approximately 12.2 cubic yards, or 2,468.57 gallons of earthen material was placed in the watercourse channel at this location.

Image 32 shows the upstream channel at GPS 11 as it intersects the constructed/reconstructed road. (IMG_0294)

Image 33 shows the downstream channel at GPS 11. (IMG 0296)
