Attachment A

Field Inspection Report

Name and Location of Facility Inspected	Rhys Vineyard, Clarke Ranch, 6501 Branscomb Road, Laytonville, CA		
Inspection Date & Time:	September 29, 2015 0830-1700 Travel time included	Mendocino County Assessor Parcel Numbers (APN)	015-050-061 015-050-057 015-050-056 015-050-055 015-050-050 015, 050-051 014-300-019

Report Prepared By:
Stormer Feiler, Environmental Scientist (ES), North Coast Regional Water Board (RWB)

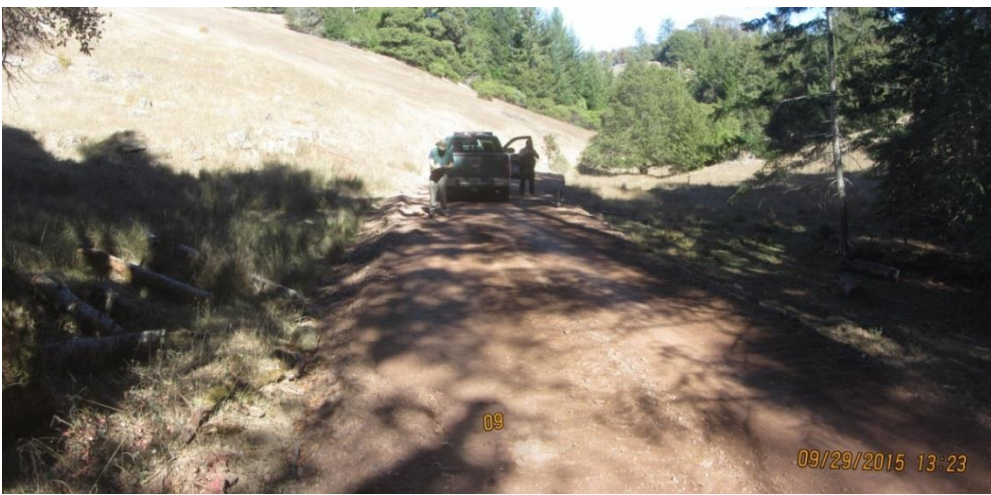
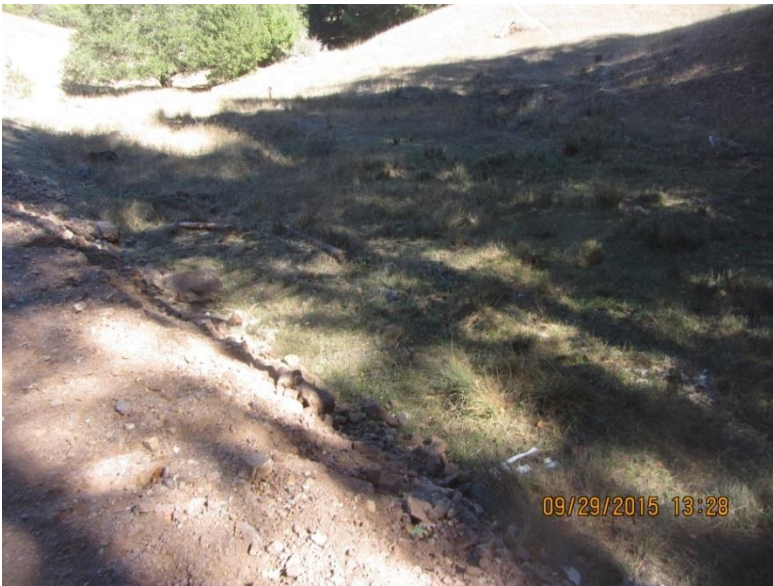
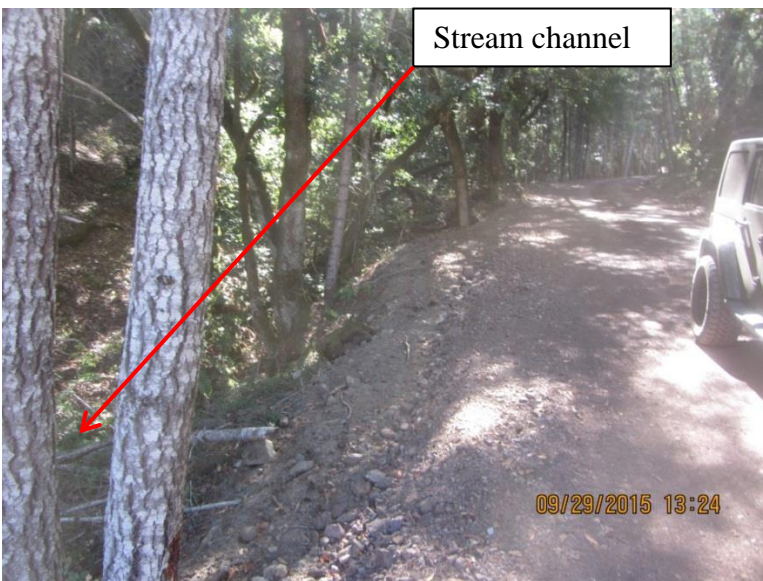
GPS 12 (stream crossing 8) is a location where the road was constructed/reconstructed through the headwaters of a small Class III stream and Class II wetland. Staff noted juncus growing in the channel and downstream of the road crossing filling the channel. Staff observed evidence of recent grazing sufficient to crop most grasses and other vegetation at the stream crossing. There was no apparent culvert or other constructed drainage structure to allow for stable conveyance of stream flows. Earthen material placed in the stream channel at this location represents a discharge of waste to receiving waters 52 cubic yards, or 10,502.64 gallons of earthen material was placed in the stream and wetland at location GPS 12.

Upstream of the wetland stream crossing staff observed perched fill along the road edge directly above the stream channel, at a location where it is likely to fall into or be transported via runoff into the stream. Roadwork to eliminate/prevent impacts to water quality and beneficial uses should include removal of perched fills along this road segment, modifying/reshaping the road as necessary to avoid concentrating surface flows into the adjacent stream channel.

Image 34 shows stream crossing 8 (GPS 12). (IMG 0301_0302stitch).

Image 35 shows the grazed wetland area at stream crossing 8 (GPS 12). (IMG_304)

Image 36 shows the perched fills directly above the stream channel south of stream crossing 8 (GPS 12). (IMG_0303)

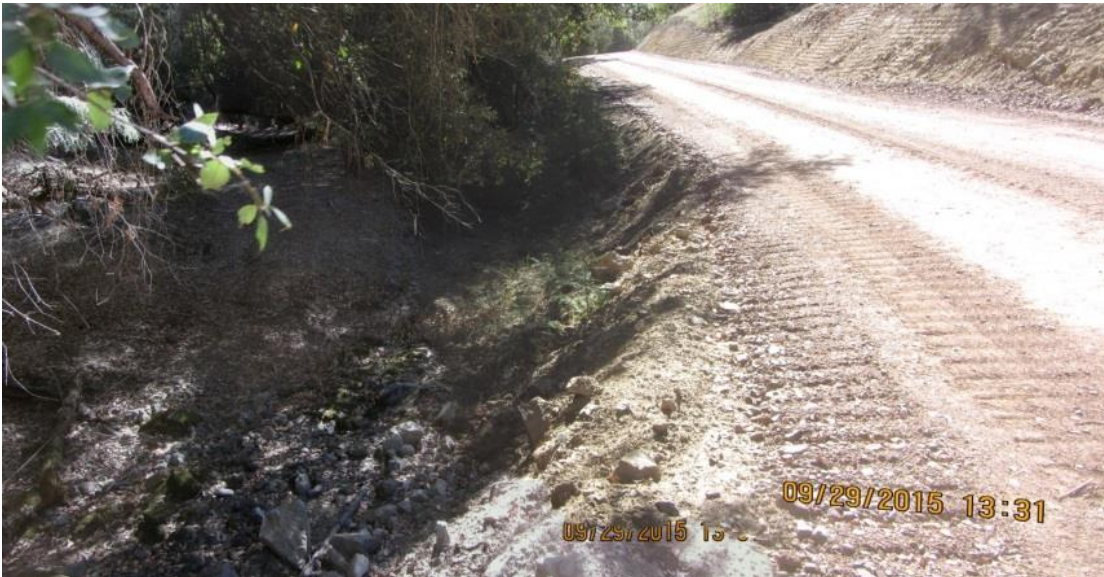
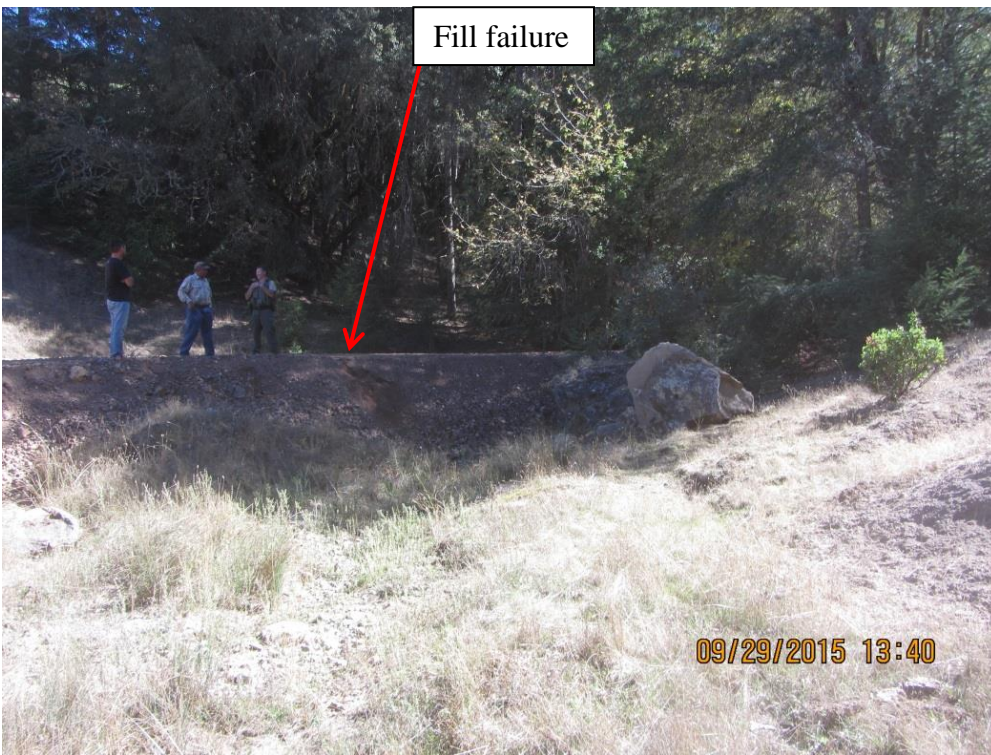
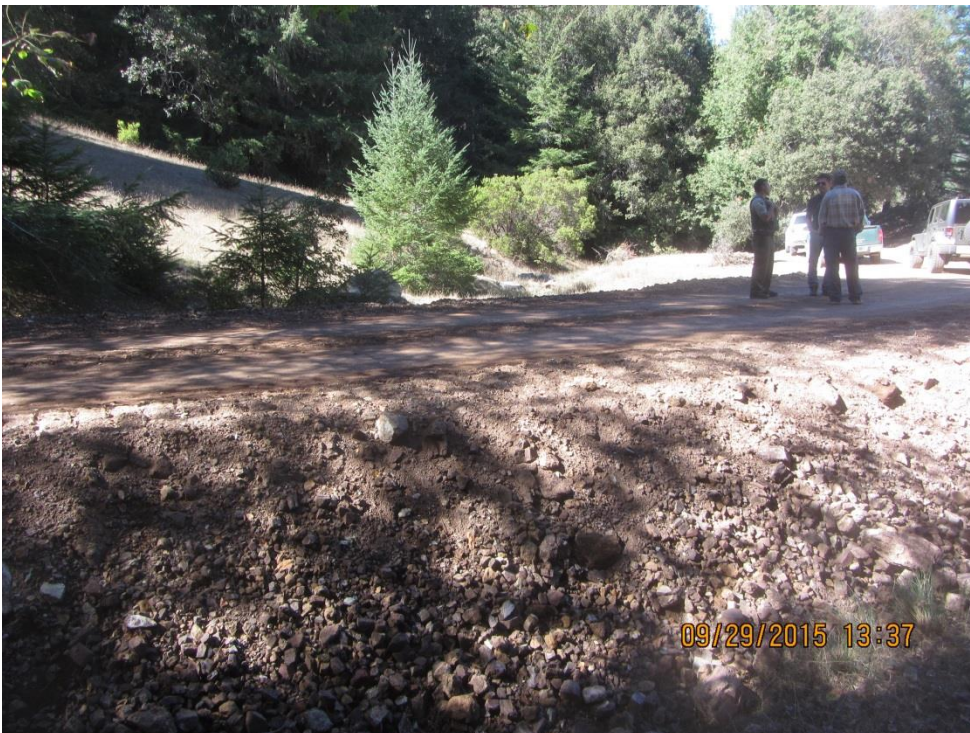
Image 37 shows the recent road construction/reconstruction in and adjacent to the stream that resulted in the placement of earthen fill materials in the stream and in locations where such materials can pass into the stream in the event of rainfall at GPS 13. (IMG 0306_0307stitch)

Image 38 looking upstream shows the earthen fills in the stream channel cross sectional area; note the fill failure visible on the road fills and no evidence of a culvert in place to pass stream flows through the earthen fills at GPS 13. (IMG 0316)

Image 39, looking downstream over the top of the earthen material placed in the stream channel at GPS 13; note the looseness of the materials. (IMG_0314).

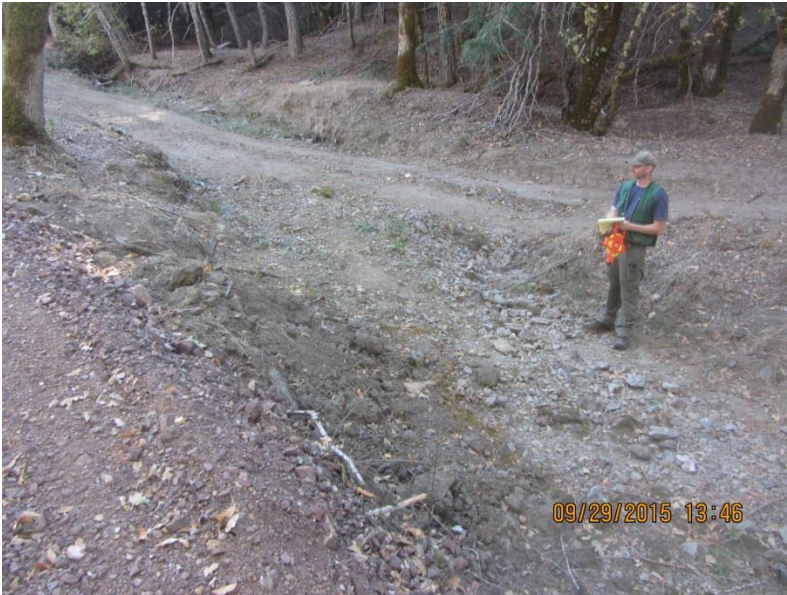
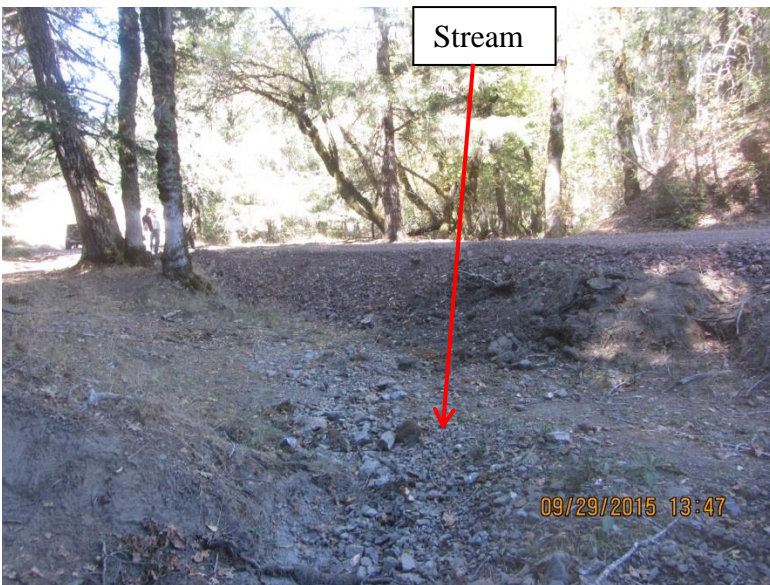
Image 40 shows the secondary road in the stream channel and the road fill in and adjacent to the upstream channel placed during the recent road construction at GPS 14. (IMG 0321).

Image 41 shows the road fills in the stream looking upstream at the crossing at GPS 14. (IMG 0323).

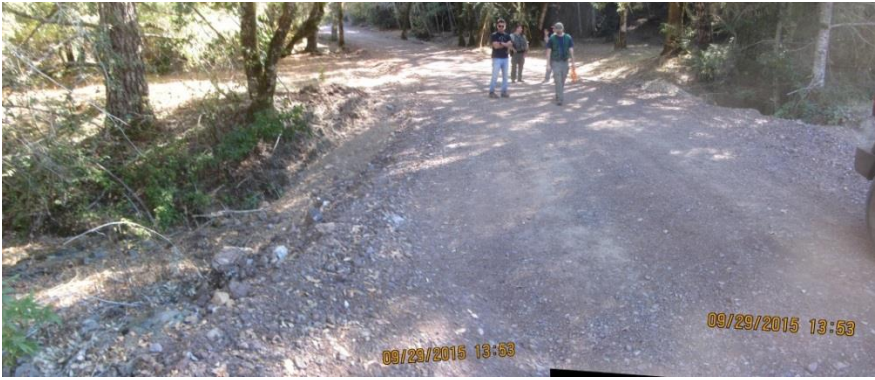
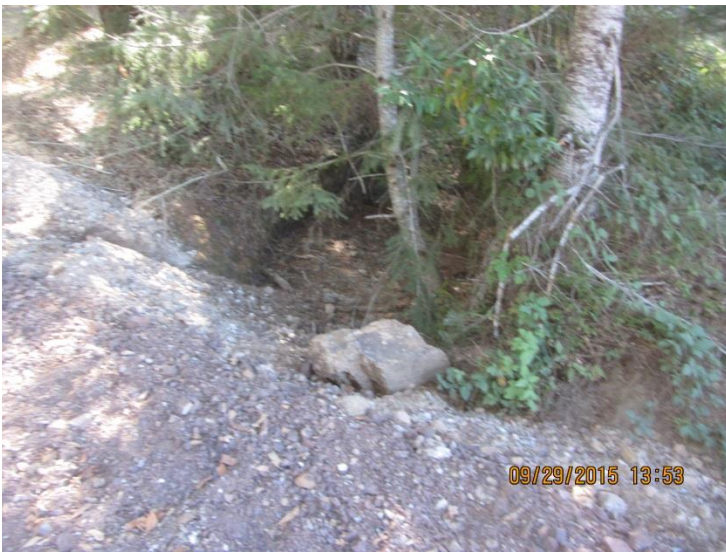
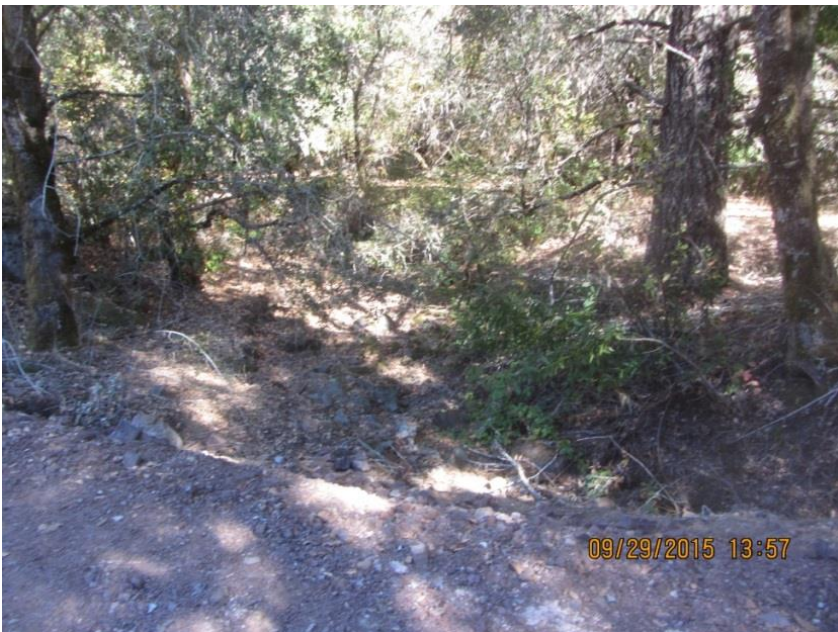
GPS 15 (stream crossing 11) is a location where the road was constructed/reconstructed through a large Class II stream. There was no apparent culvert or other constructed drainage structure to allow for stable conveyance of stream flows. Earthen material placed in the stream channel at this location represents a discharge of waste to receiving waters. In addition, I observed evidence of rill erosion off the road surface into the stream, resulting from concentrated road surface runoff. Based on my

measurements and subsequent calculations, I estimate that approximately 58.9 cubic yards, or 11,896.26 gallons of fill material have been placed in the stream channel at location GPS 15.

Image 42 shows stream crossing 11 (GPS 15). (IMG 0324_0325 stitch).

Image 43 shows the upstream channel as it reaches the earthen fills in the road at GPS 15. (IMG 0326)

Image 44 shows the downstream channel at stream crossing 11 (GPS 15). (IMG 330)

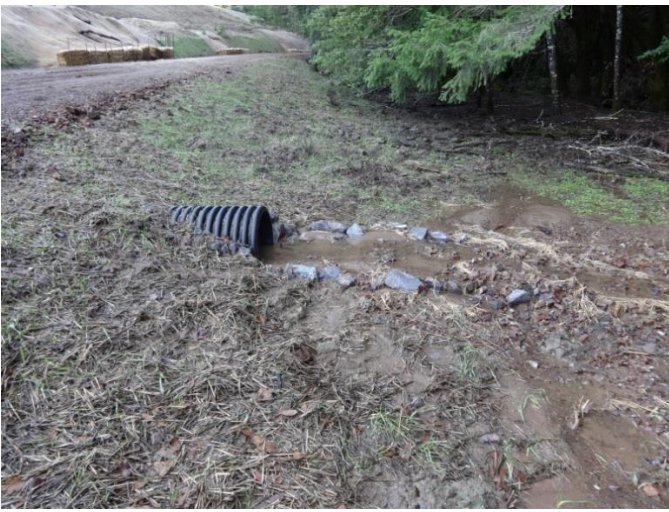
Image 46 shows a recently installed culvert and the sediment deposits at the outlet of the culvert; also note the evidence of possible erosion from slopes above and behind the culvert. (Brandon Rose photo 016).

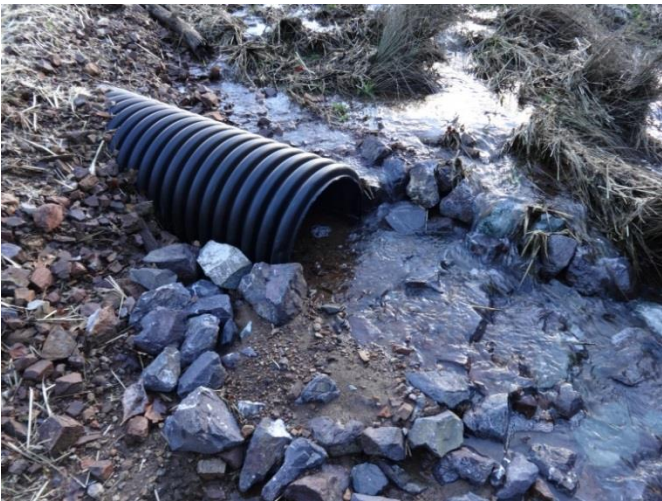
Image 47 shows the outlet of a recently installed culvert delivering into a stream. Note the sediment deposits in the culvert reducing carrying capacity and providing evidence of upstream erosion, sediment delivery and transport. (Brandon Rose photo 118).

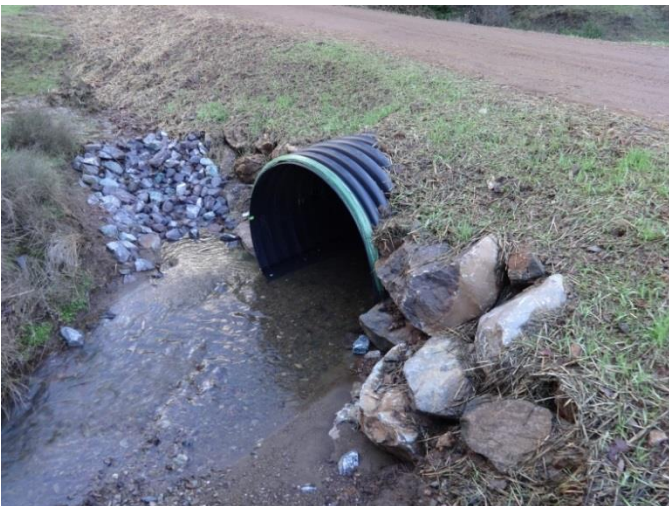
Image 48 shows a recently installed culvert. Note the sediment deposited along stream banks and on the culvert bottom. (Brandon Rose photo 093).
