**+Attachment C**

**Fox Hollow NOV/13267 Order**

**Photo Log**

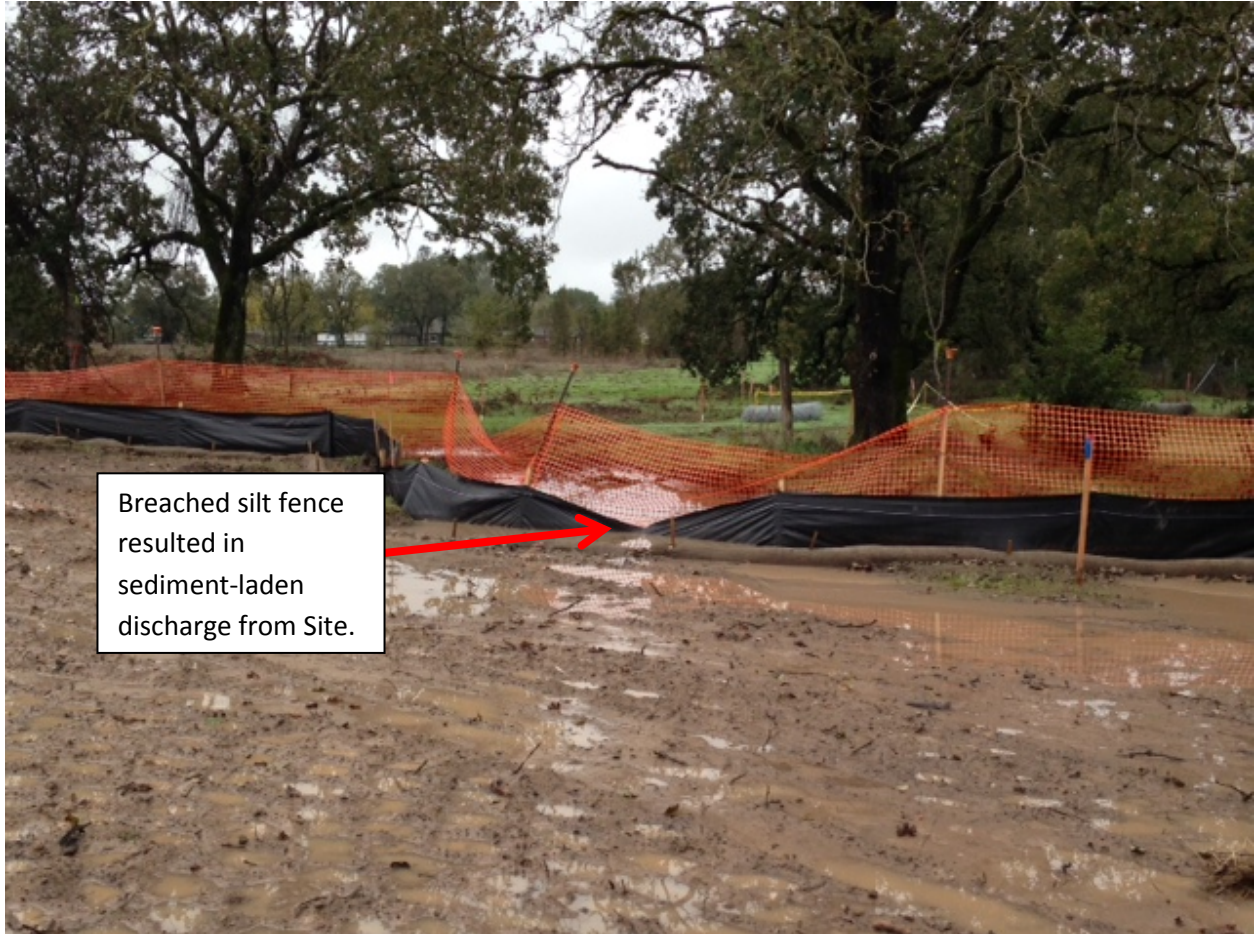
Breached silt fence  
resulted in  
sediment-laden  
discharge from Site.

**Photo 1.** Sediment-laden water discharged from the southwestern corner of the Site. Clayton Jones of the City of Santa Rosa observed five discharges of sediment-laden water from the Site during his October 31, 2016, inspection. Photo was taken by Clayton Jones on October 31, 2016, facing southwest.

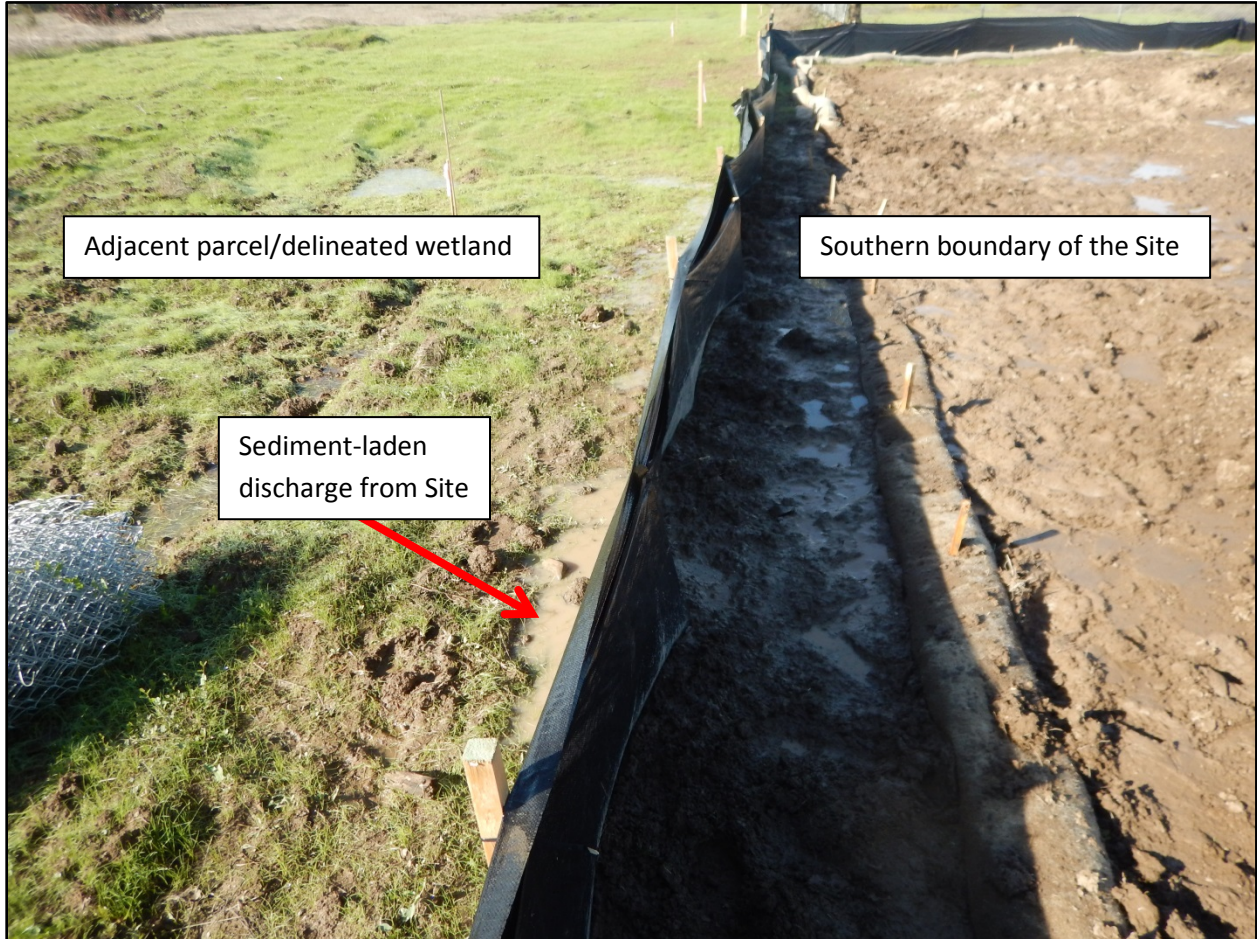
**Photo 2.** This photo depicts one of the discharges locations from the Site that Staff observed during the inspection. Staff observed a lack of erosion controls on the twenty-plus acres of disturbed soil onsite, plus inadequate sediment controls that were overwhelmed during the rain event that occurred in late October, 2016. Photo was taken facing roughly west at 10:48 on November 3, 2016.

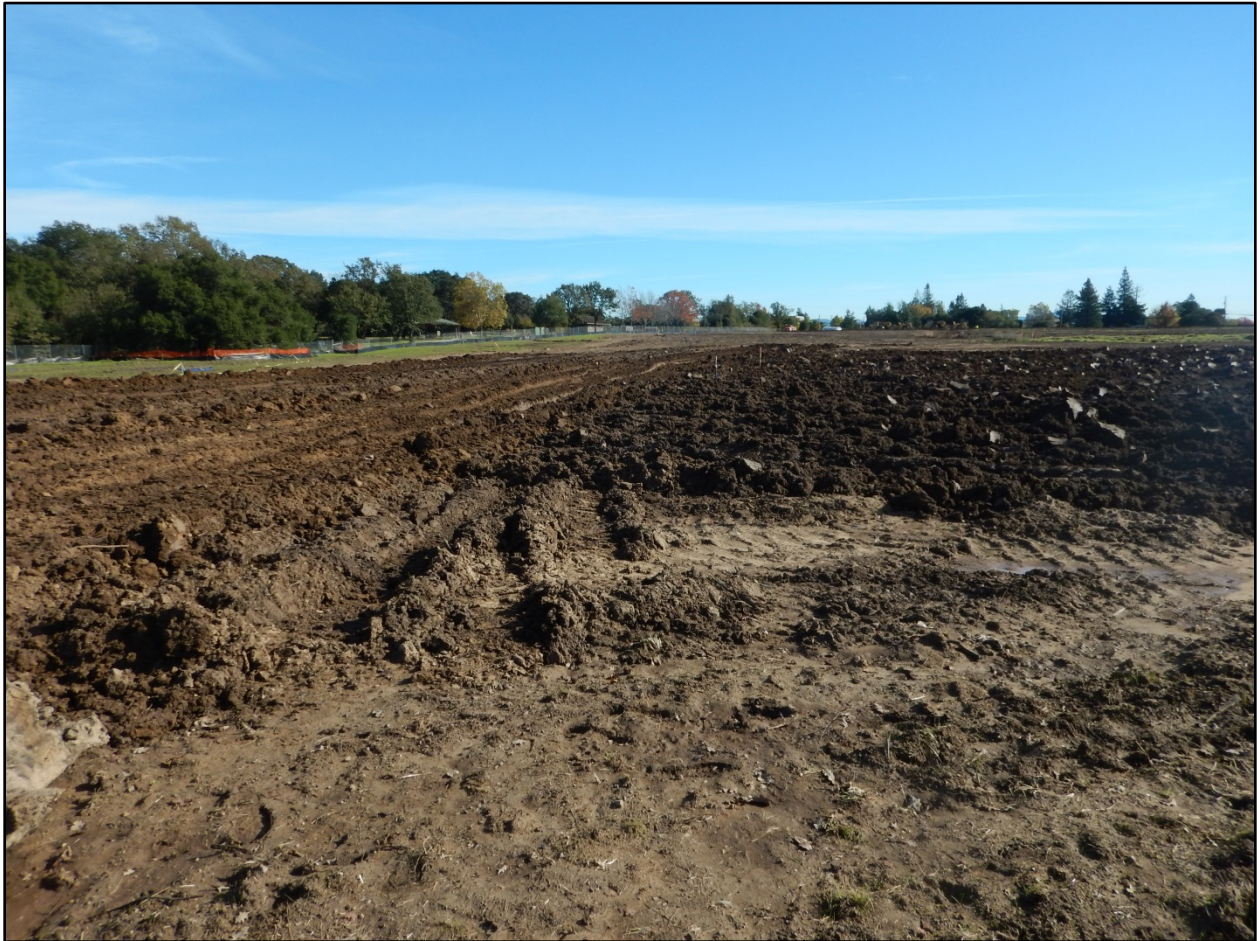
**Photo 3.** Conditions of the Site during the inspection. Photo depicts around one third of the Site. Staff did not observe any erosion controls in place to prevent sediment from being dislodged and discharged in storm water runoff. Sediment controls that were in place were overwhelmed and ineffective during late October, 2016, rains. Photo was taken standing adjacent and east of the preserved wetlands, facing northeast at 11:01 on November 3, 2016.

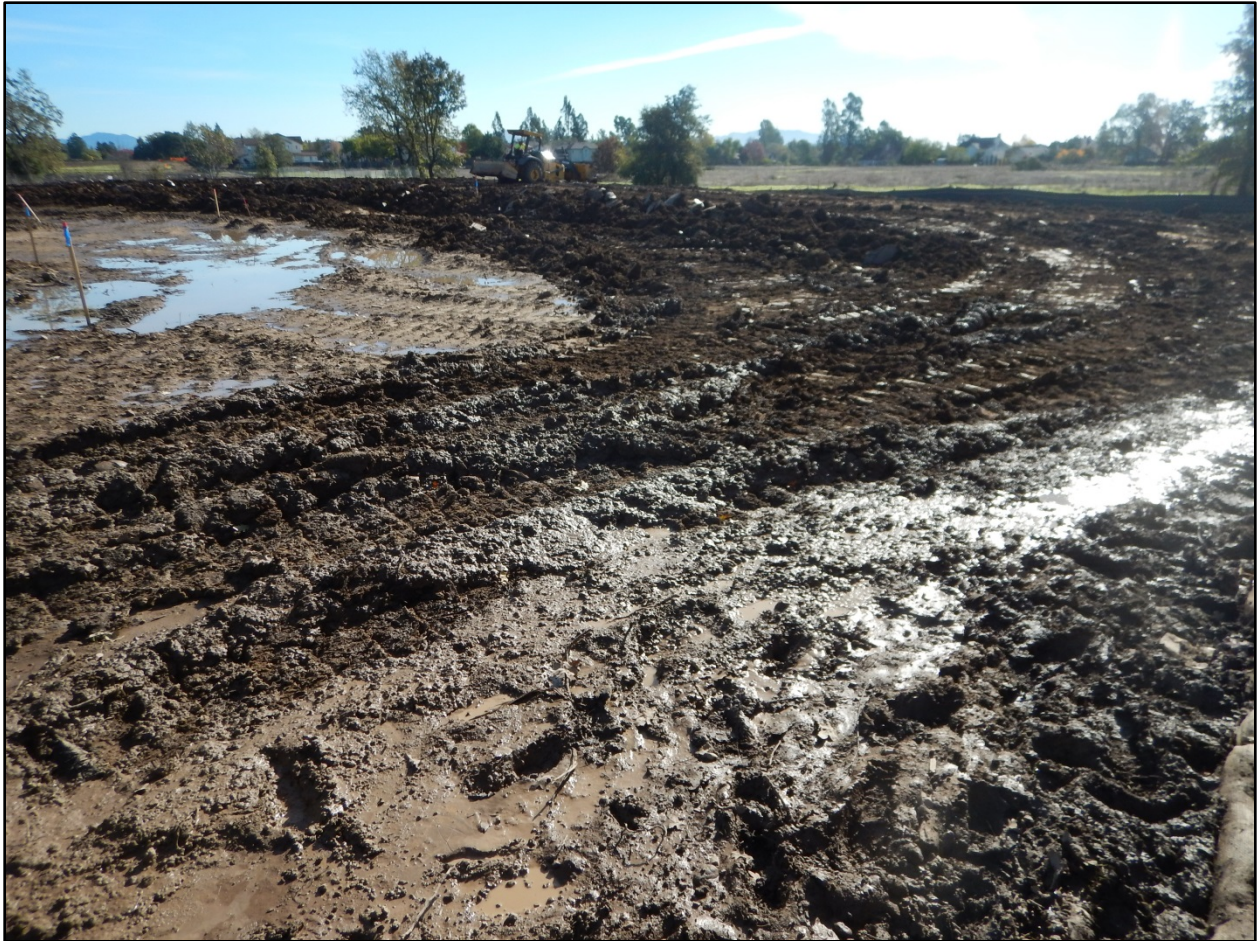
**Photo 4.** Conditions of the Site near the western boundary. Staff did not observe any erosion controls in place to prevent discharges of sediment. Soil was highly saturated and sediment-laden puddles of water remained on most of the Site after a couple of days of dry weather. Photo was taken facing southeast at 11:05 on November 3, 2016.

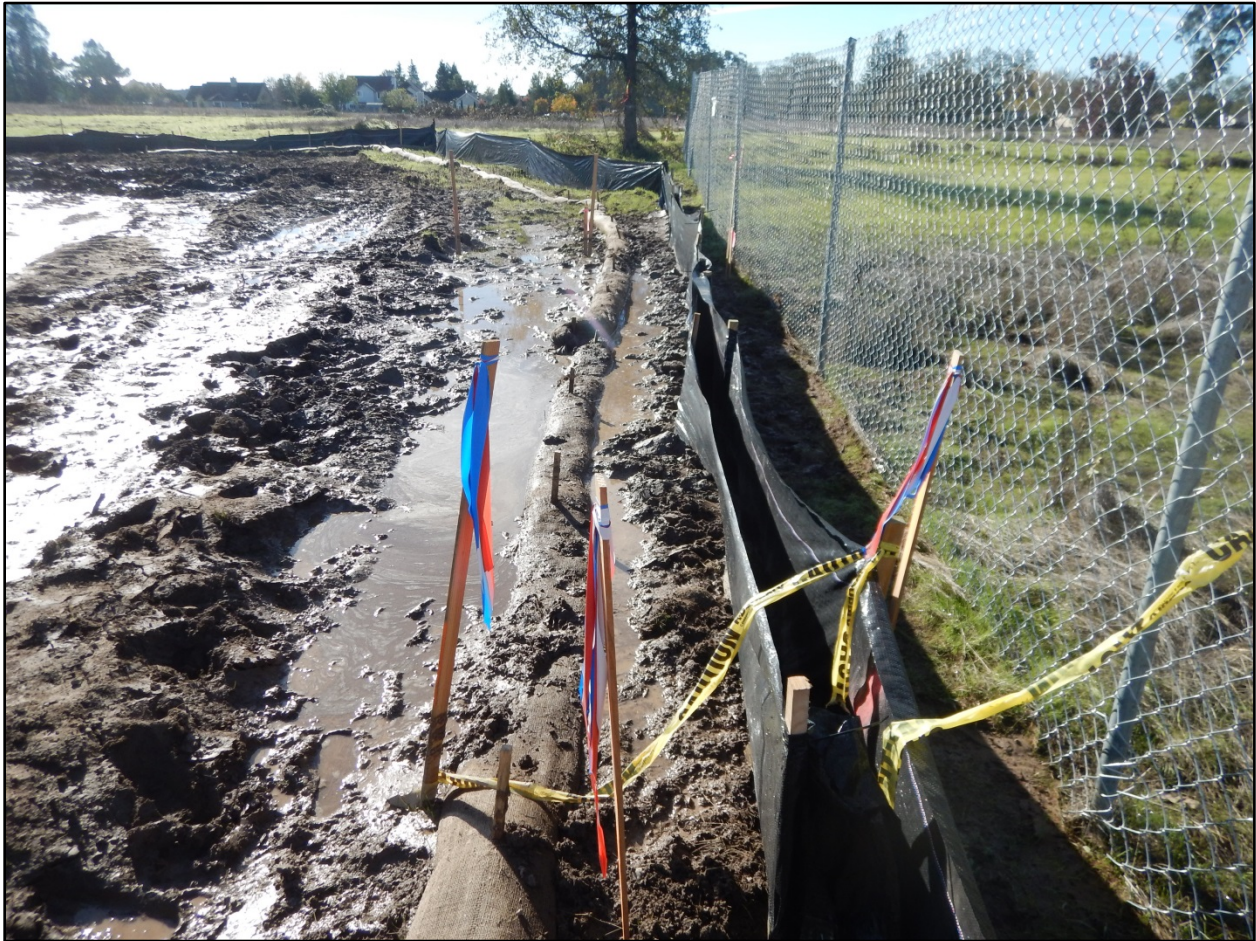
**Photo 5.** Conditions of the Site adjacent to the east side of the persevered wetland. In order to prevent discharges of sediment into the wetland in future rain events, the sediment controls needed to be maintained immediately. Photo was taken facing roughly south at 10:49 on November 3, 2016.

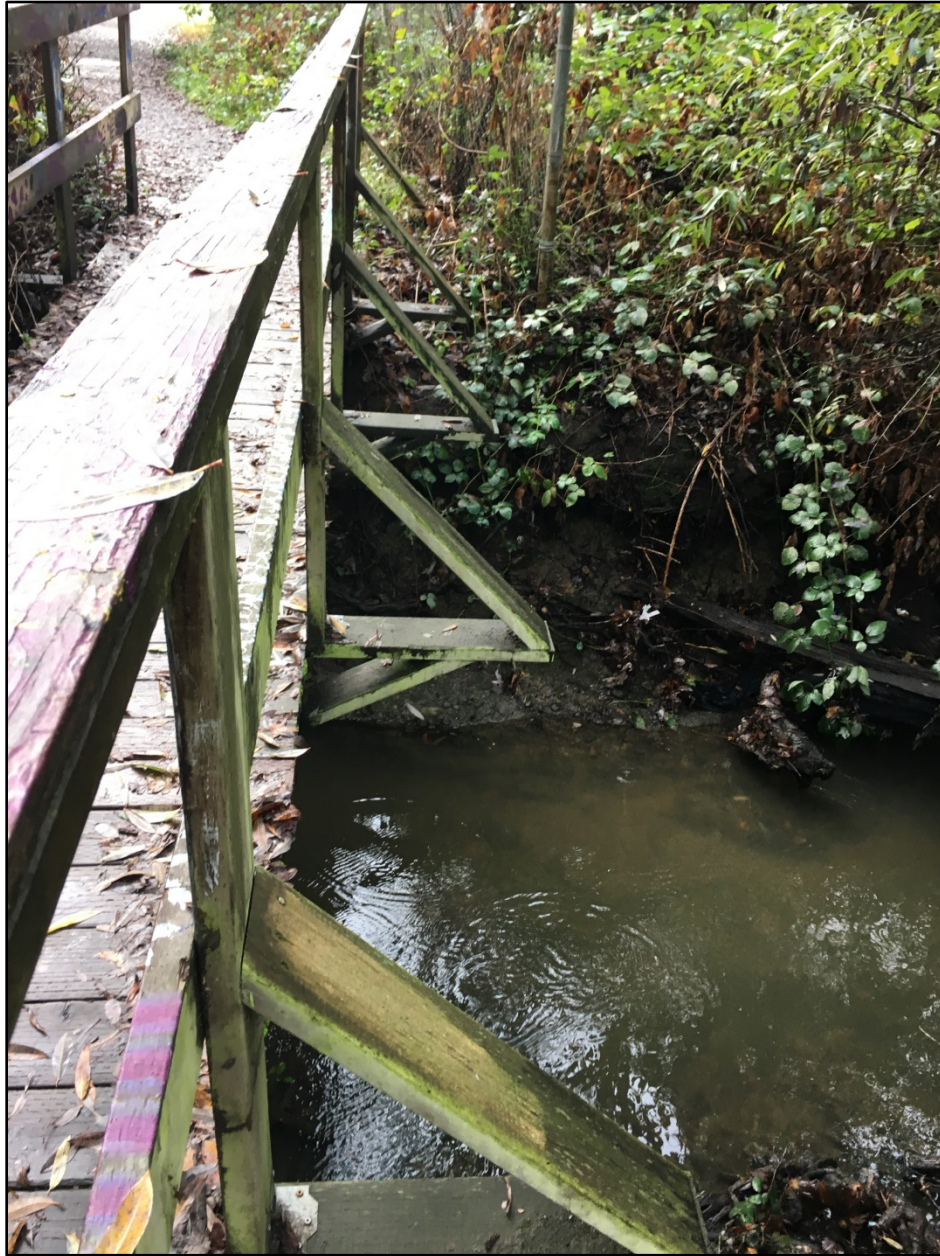
**Photo 6.** Background condition of Peterson Creek upstream of Site. Photo was taken at bridge over Peterson Creek just east of the Community Park to the north of the Site, facing northwest, at 09:02 on November 20, 2016.

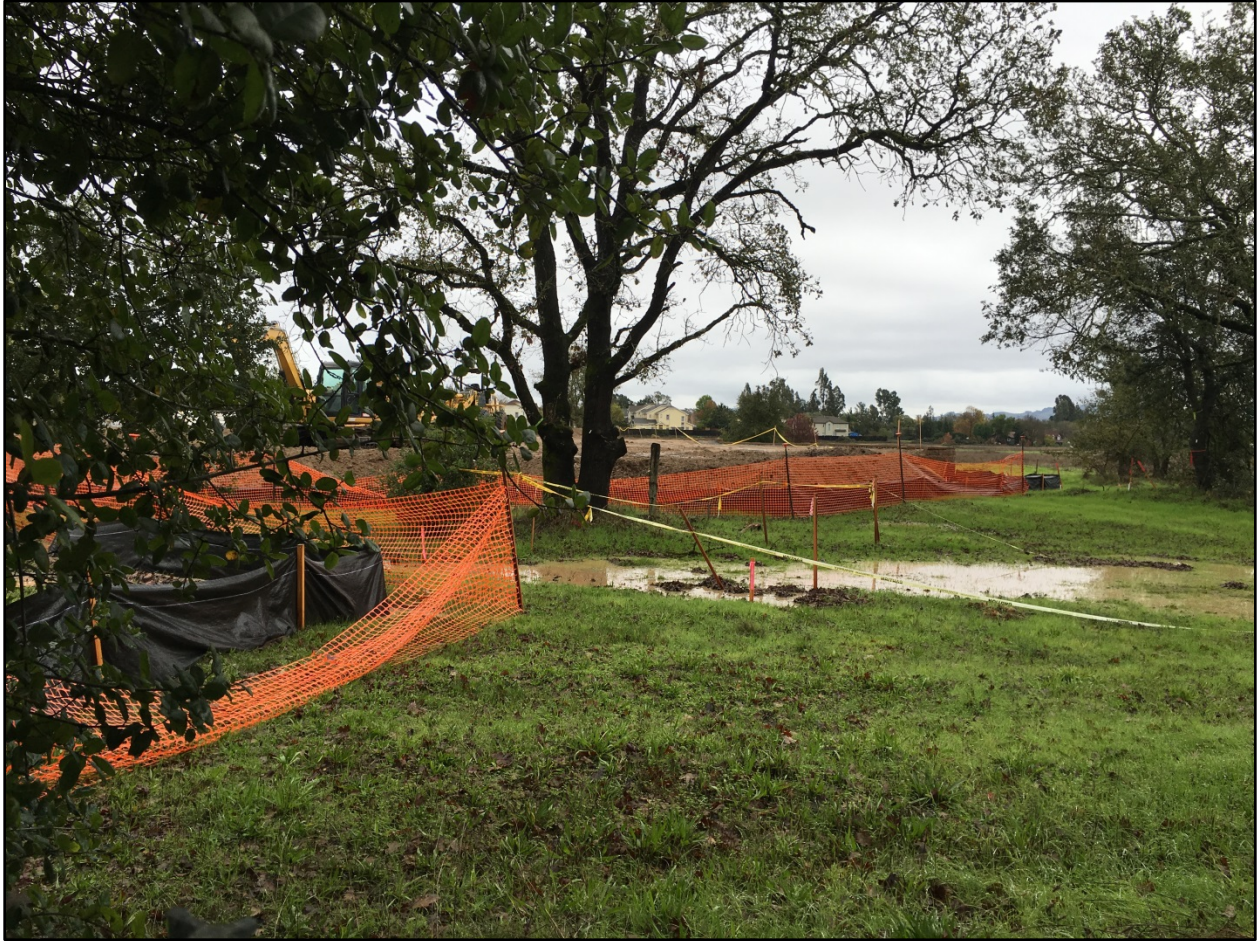
**Photo 7.** Sediment-laden water discharged through BMPs on the western boundary of the site adjacent to Peterson Creek. Photo was taken facing southeast on November 20, 2016, at 09:25.

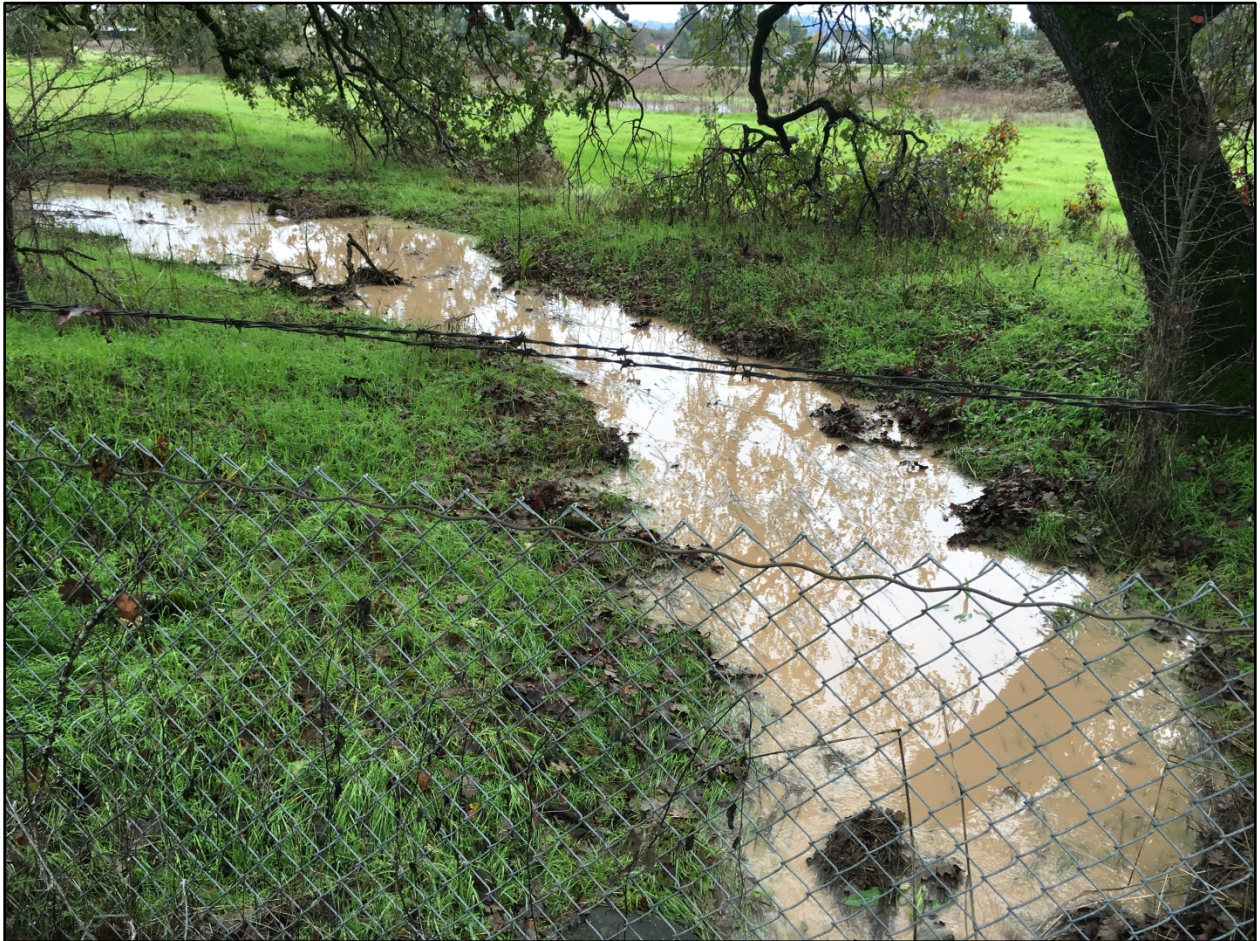
**Photo 8.** Sediment-laden water discharged offsite into a swale on the adjacent property and into a drop inlet beneath the fence in the foreground of the photo. The adjacent property is well-vegetated and was not the source of sediment in the discharge. Photo was taken facing southeast on November 20, 2016, at 09:28.

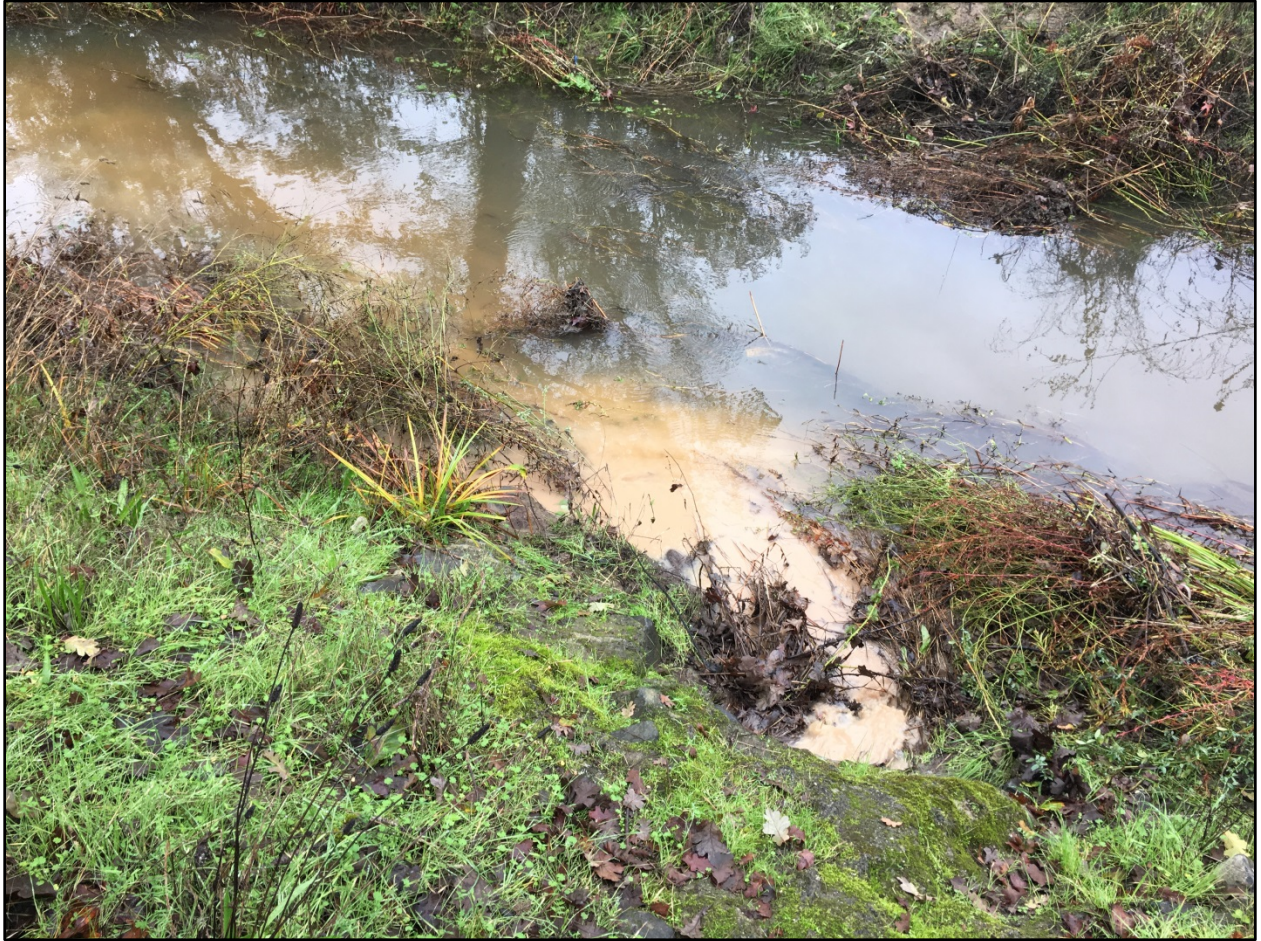
**Photo 9.** Sediment-laden water discharged into the drop inlet to a culvert and into Peterson Creek.  
Photo was taken facing west on November 20, 2016, at 09:28.

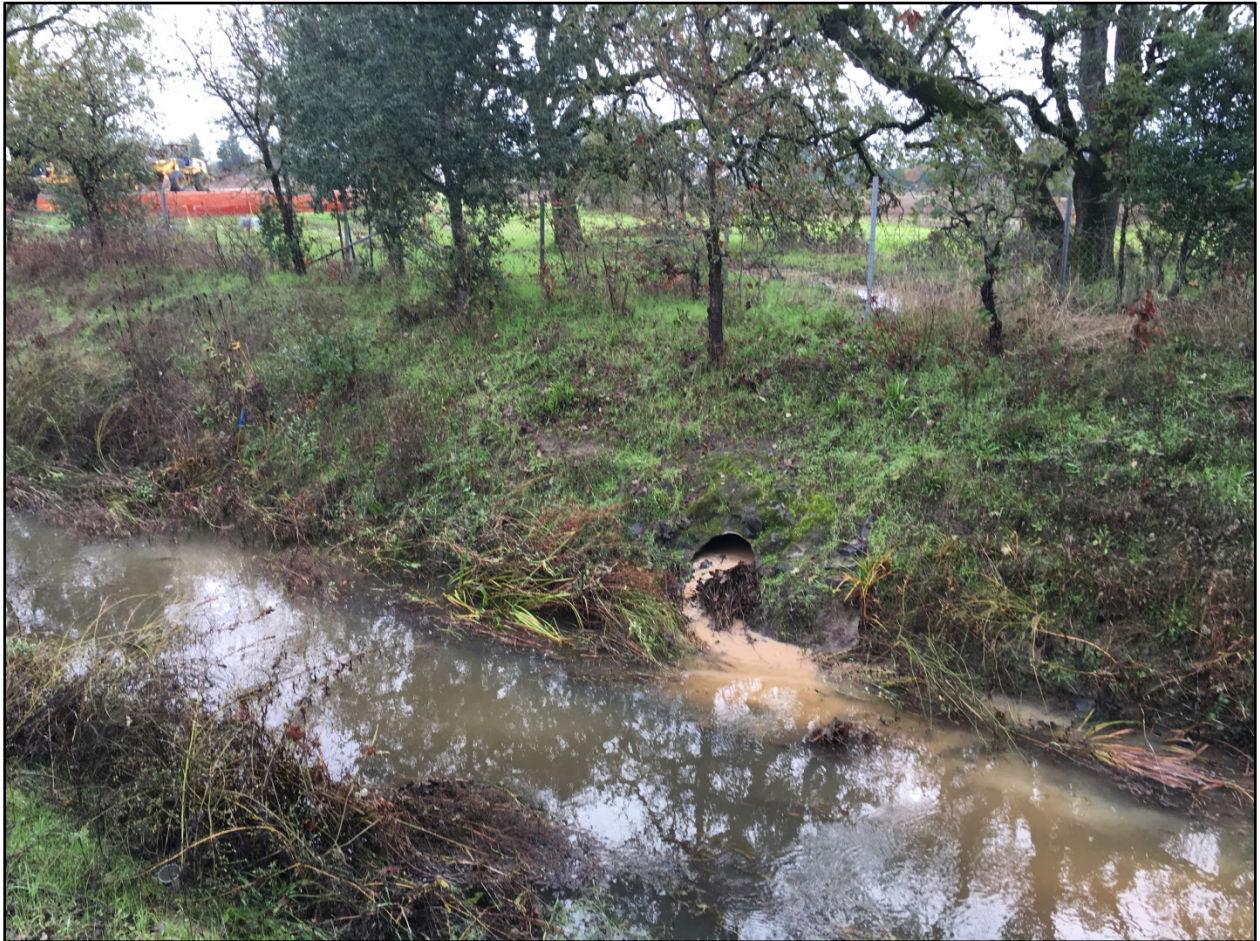
**Photo 10.** Sediment-laden water discharged from the southwestern boundary of the site (see orange fencing in background) to a swale on the adjacent property to the south, and into a culvert to Peterson Creek. Photo was taken facing east on November 20, 2016, at 09:13.

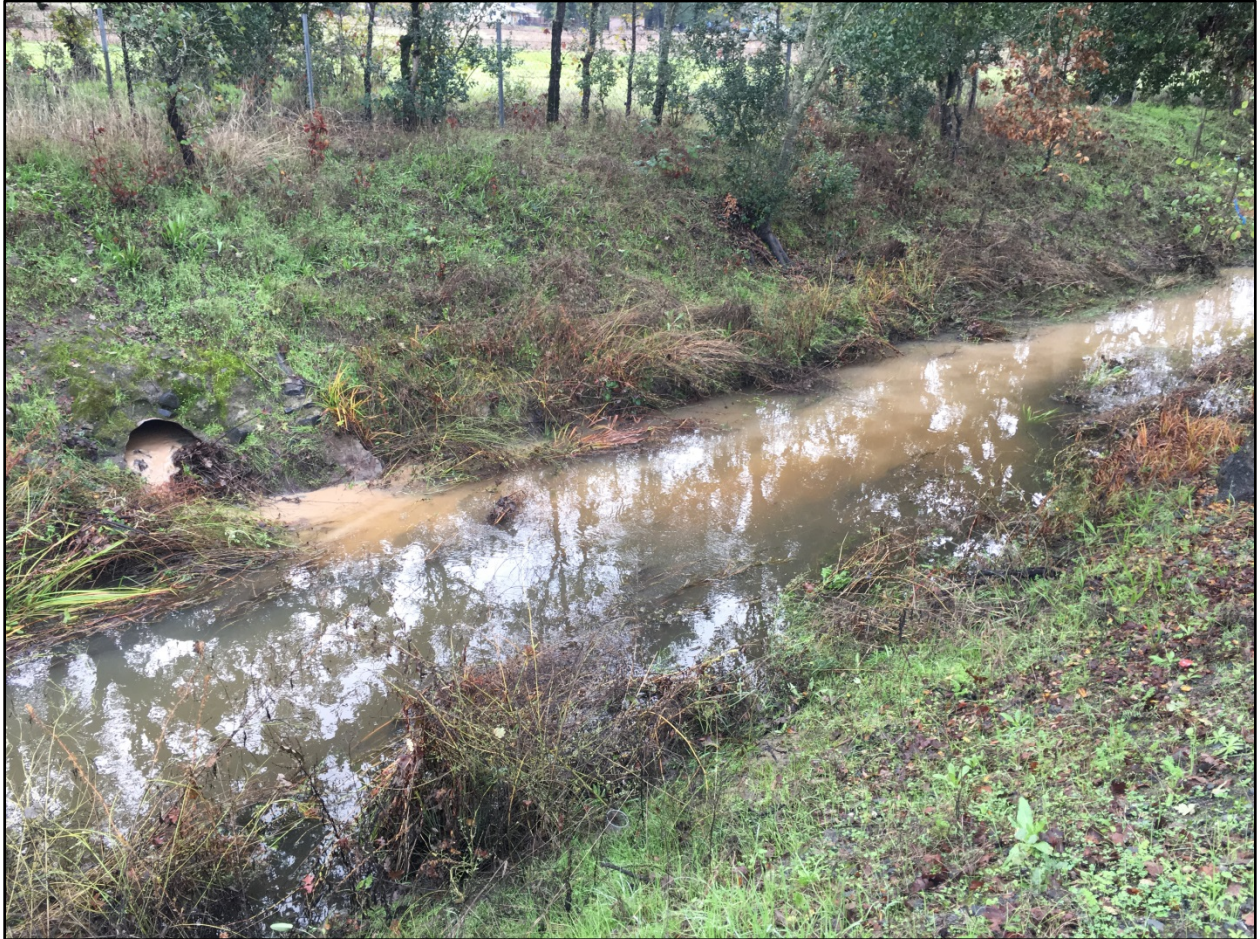
**Photo 11.** Sediment-laden water discharged from the site to Peterson Creek. Photo was taken facing southeast on November 20, 2016, at 09:13.

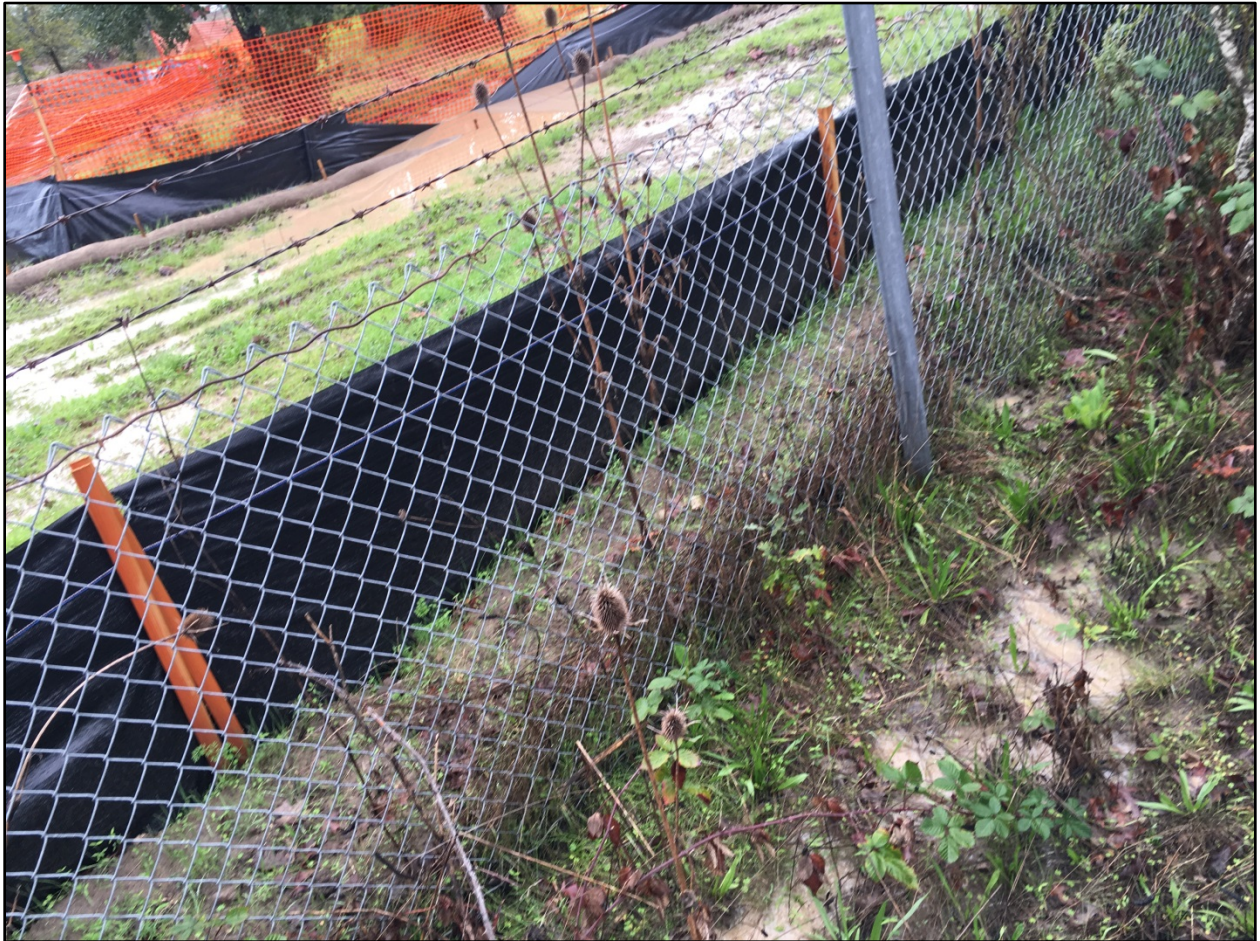
**Photo 12.** Sediment-laden water seeped through silt fencing on the western boundary of the Site as a result of highly-saturated exposed soil. Silt fencing (in the background of the photo) was breached by a large volume of sediment-laden water. Photo was taken facing southeast on November 20, 2016, at 09:22.

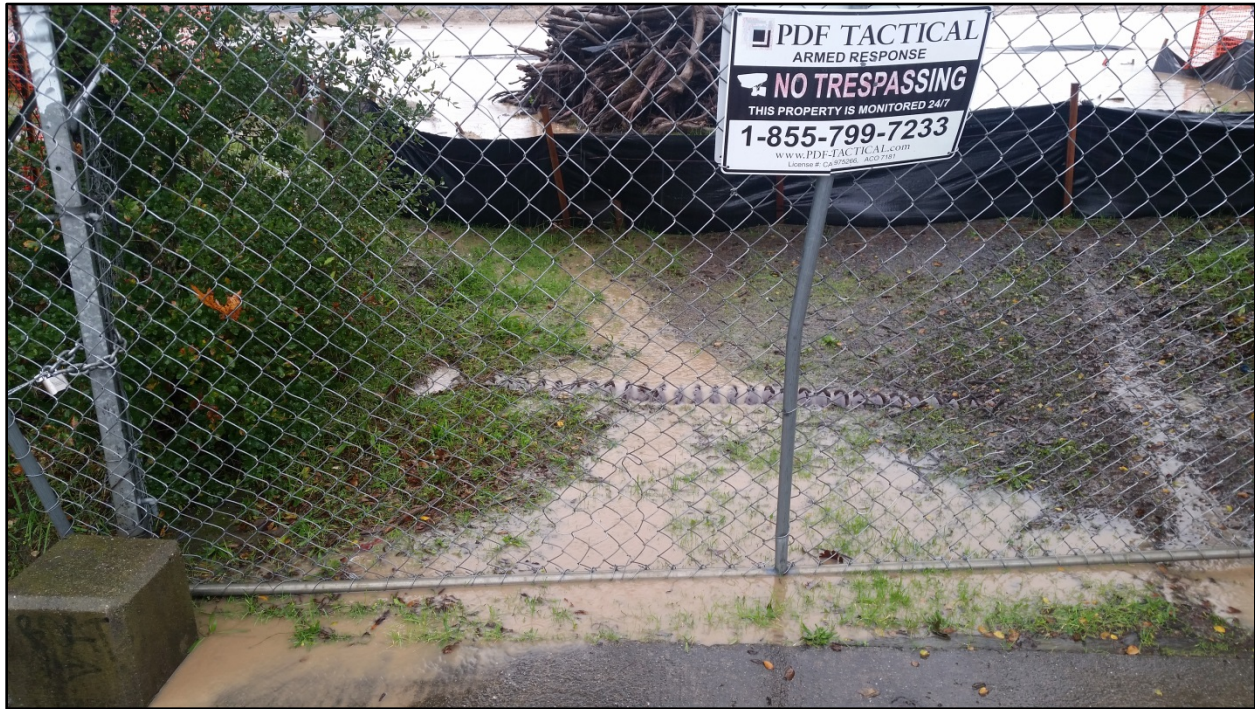
**Photo 13.** Sediment-laden storm water runoff discharged from the Site along the western boundary at the bridge over Peterson Creek as a result of the lack of adequate best management practices (BMPs). The runoff flowed under the bridge and into Peterson Creek. Photo was taken facing southeast at 13:24.

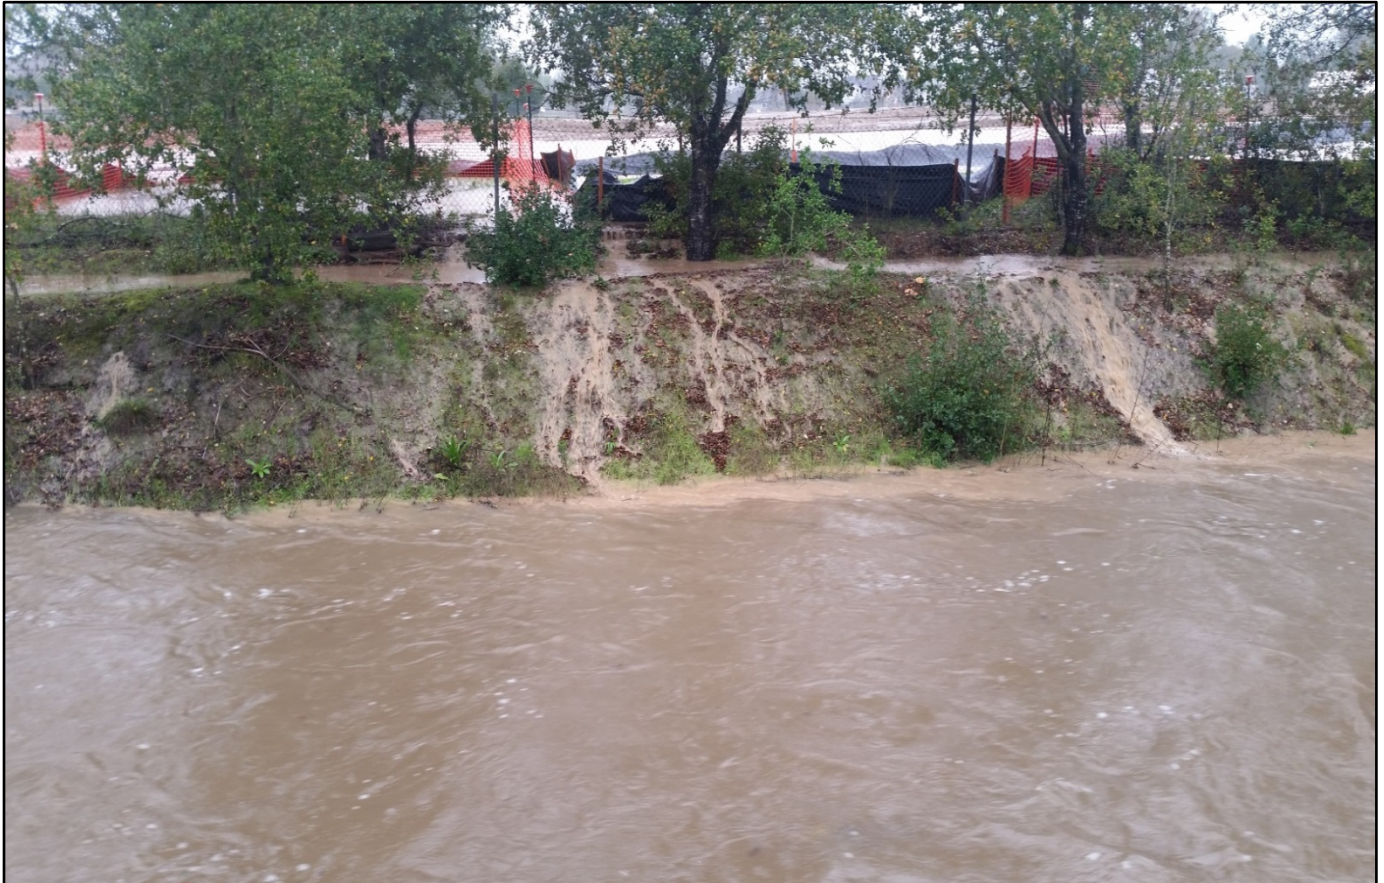
**Photo 14.** Sediment-laden storm water runoff discharged from the Site along the western boundary and into Peterson Creek. The containment area was overwhelmed by the volume of water, causing it to flow over the berm and over the silt fences and into the creek. Photo was taken facing southeast at 13:25.

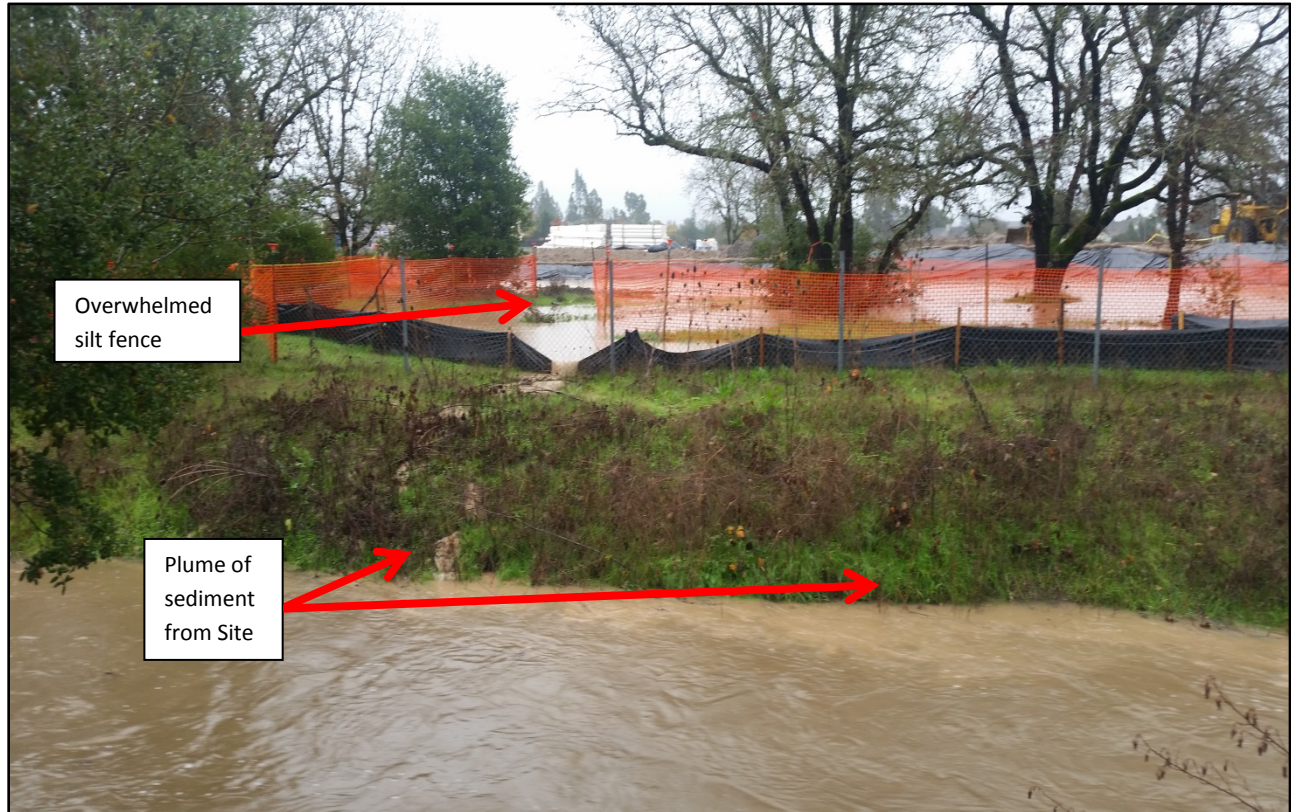
**Photo 15.** Sediment-laden storm water runoff from Site discharged into Peterson Creek. This area was also overwhelmed by the overflow of water in the containment area. Photo was taken facing southeast at 13:27.

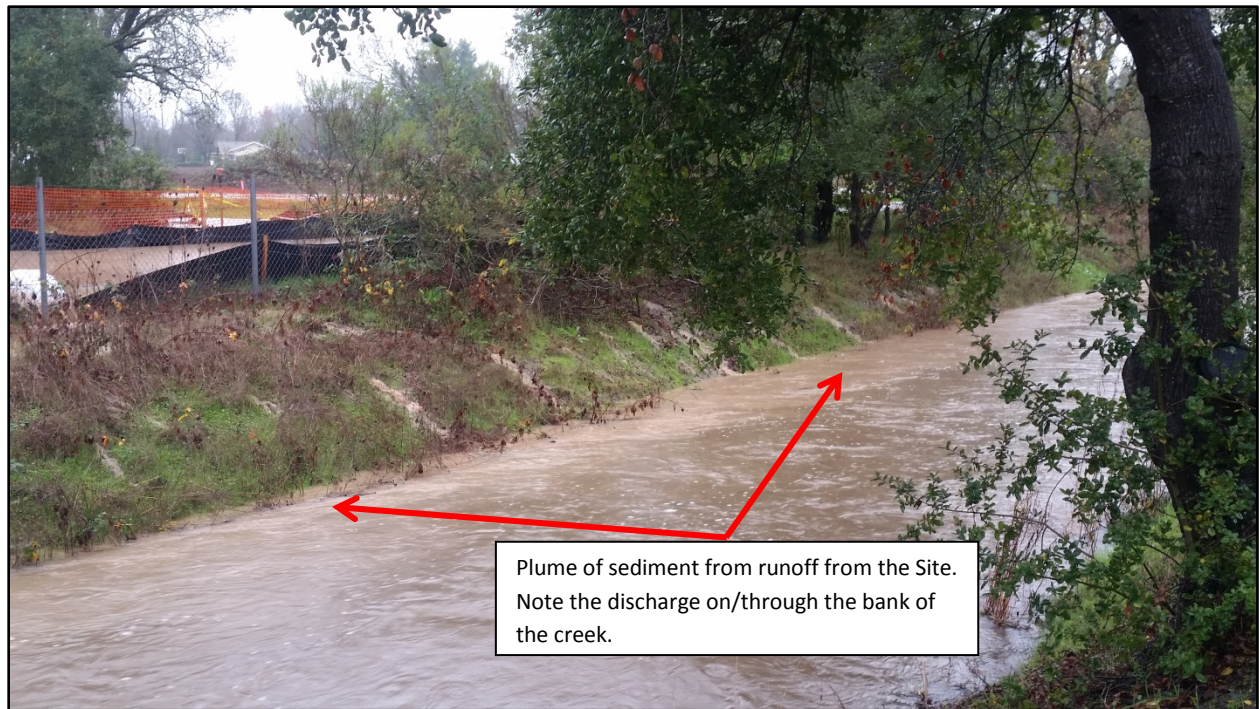
**Photo 16.** Sediment-laden storm water runoff discharged from the Site into Peterson Creek along western boundary. Discharges were a result of overwhelmed BMPs and highly-saturated, unprotected soils, which allowed the water to seep under BMPs and through the bank of the creek. Photo was taken facing southeast at 13:28.

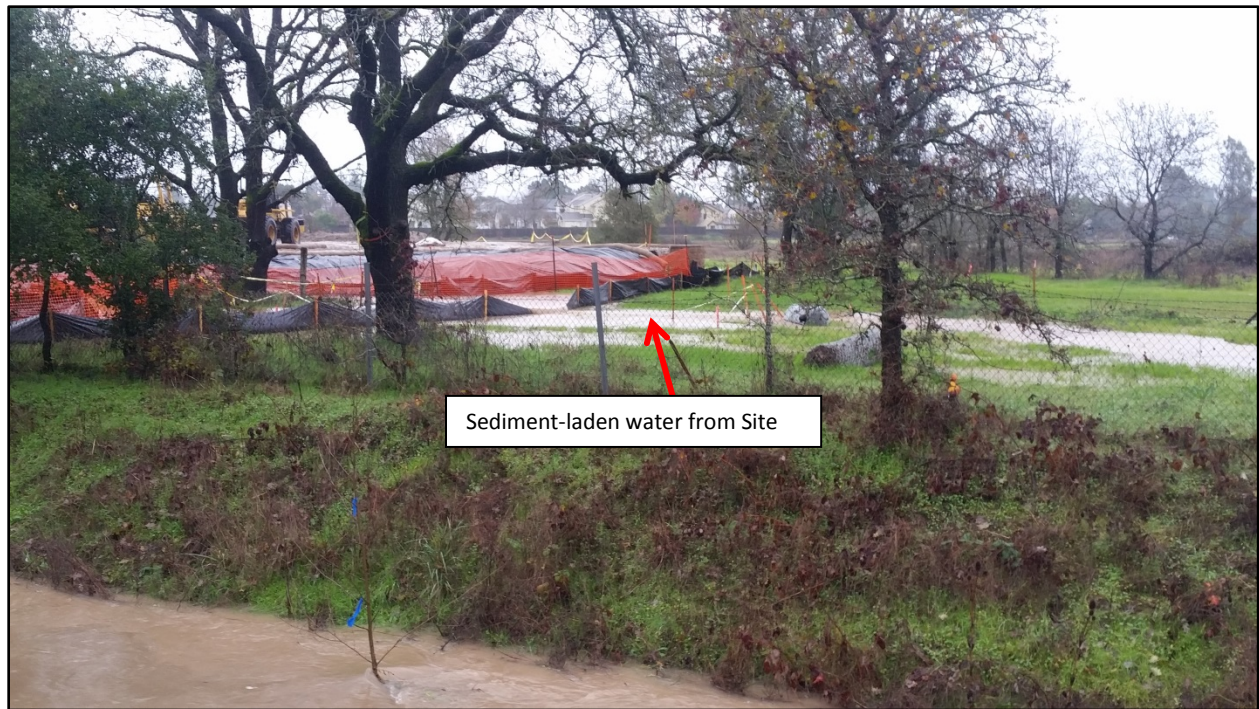
**Photo 17.** Sediment-laden storm water runoff overwhelmed a silt fence near the southwest corner of Site where the November 20, 2016, discharge was documented. This water flows to a swale on the adjacent property and into a drop inlet into Peterson Creek. Photo was taken facing southeast at 13:30.

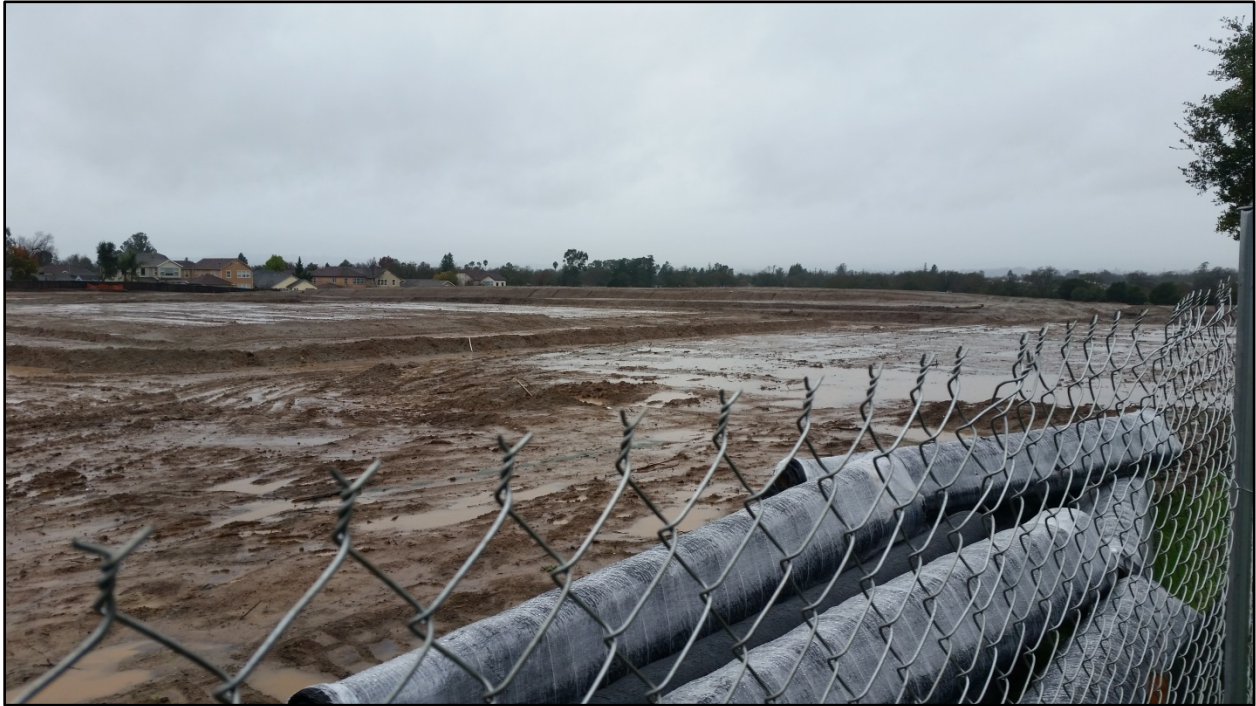
**Photo 18.** Conditions of the Site at the time of the discharge. Note the lack of erosion controls. Photo was taken at the northern boundary of the Site facing southwest at 14:02.

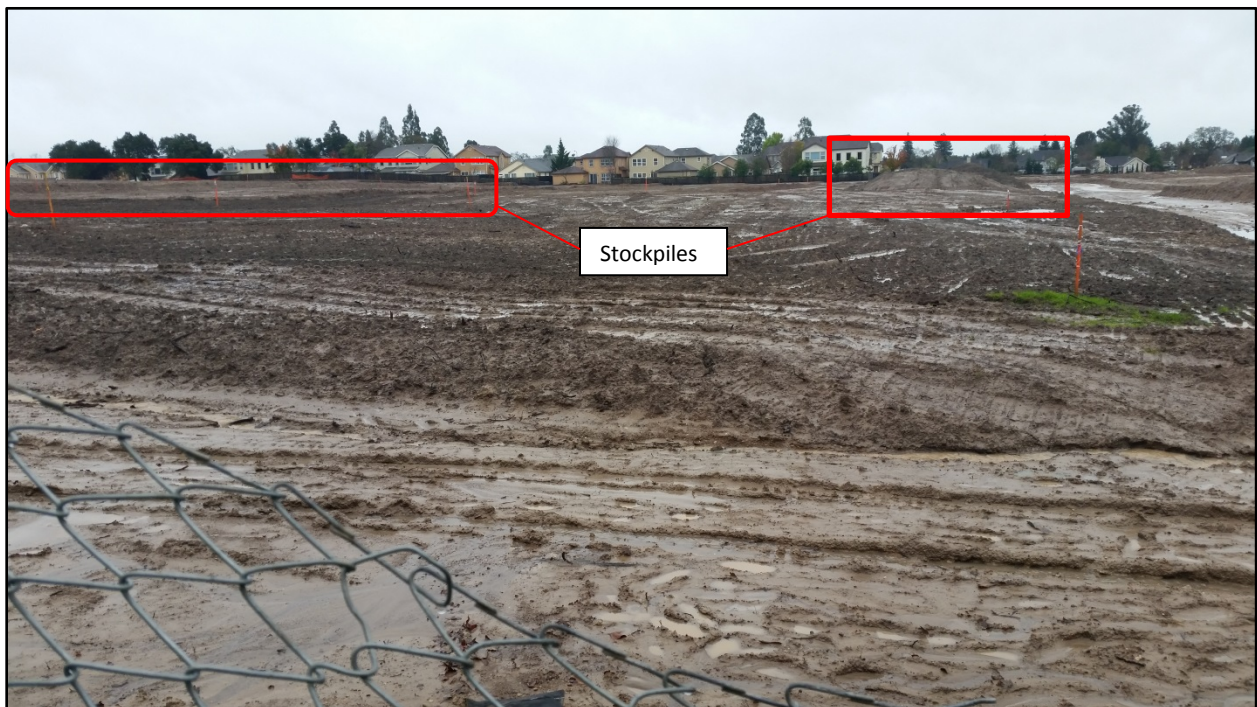
**Photo 19.** Conditions of the Site at the time of the discharge. Note the lack of erosion controls and the stockpiles lacking coverage and berms/perimeter controls (Construction General Permit, Attachment D.B.1.b.) Photo was taken at northern boundary of project facing roughly south at 13:54.
