**+Attachment C**

**Fox Hollow NOV/13267 Order**

**Photo Log**

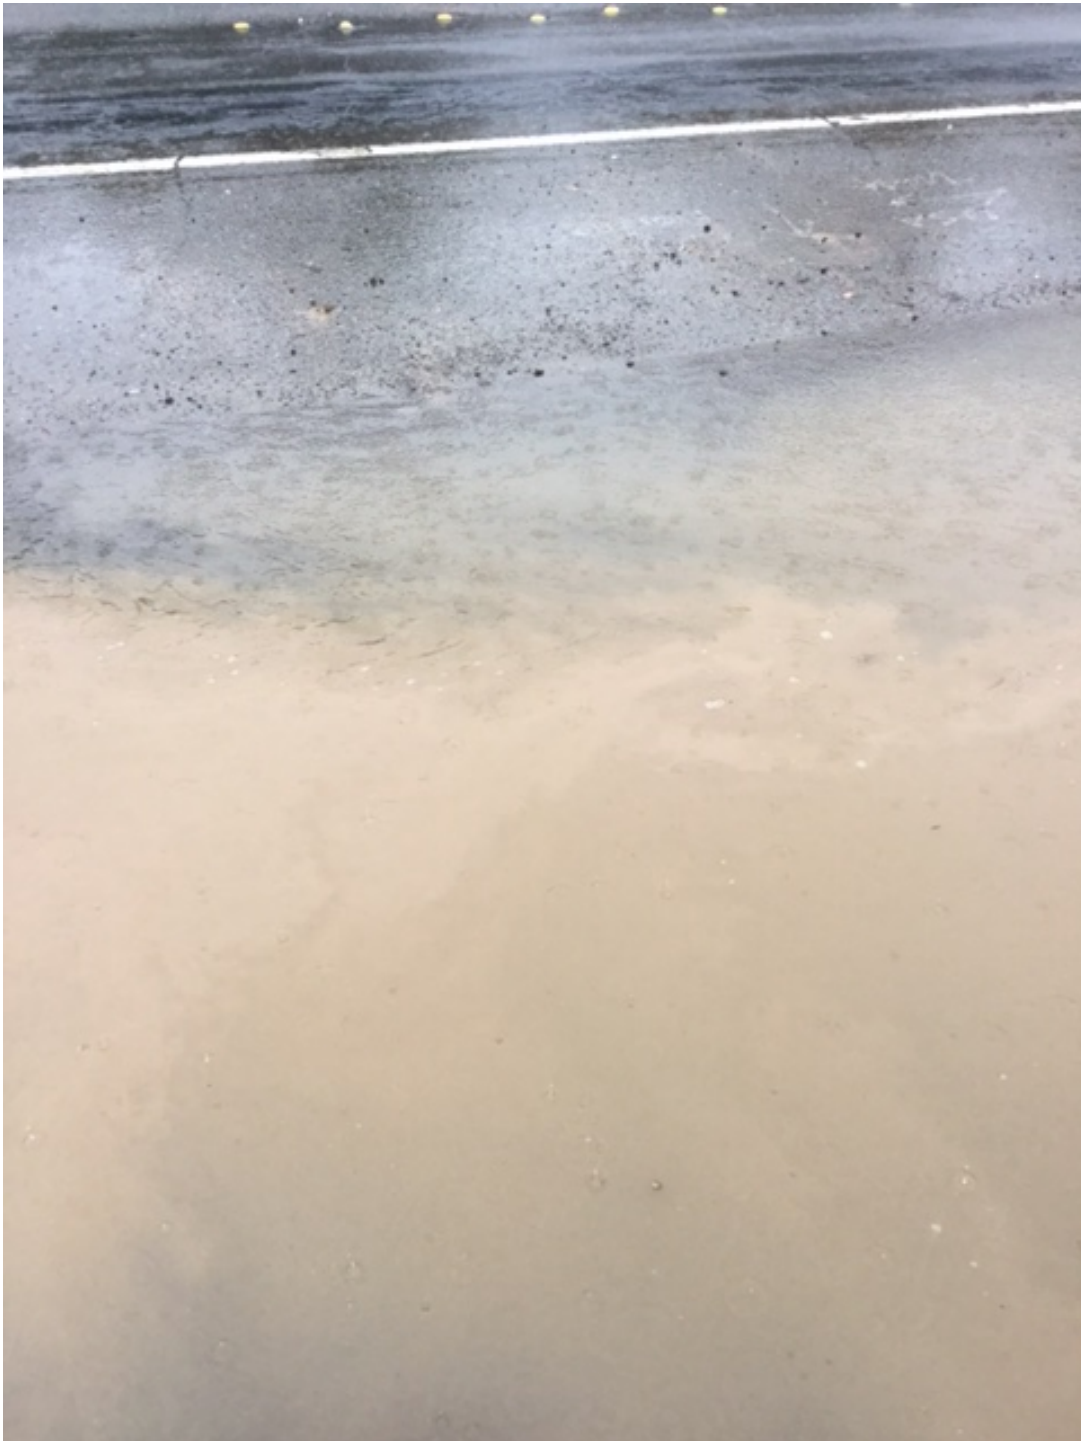
**Photo 20.** Sediment-laden discharge from Site's entrance to Fulton Road. Discharge occurred due to lack of adequate BMPs on construction entrance. Photo was taken by Mr. Gary Morris of LJP Construction Services during his inspection on December 15, 2016.

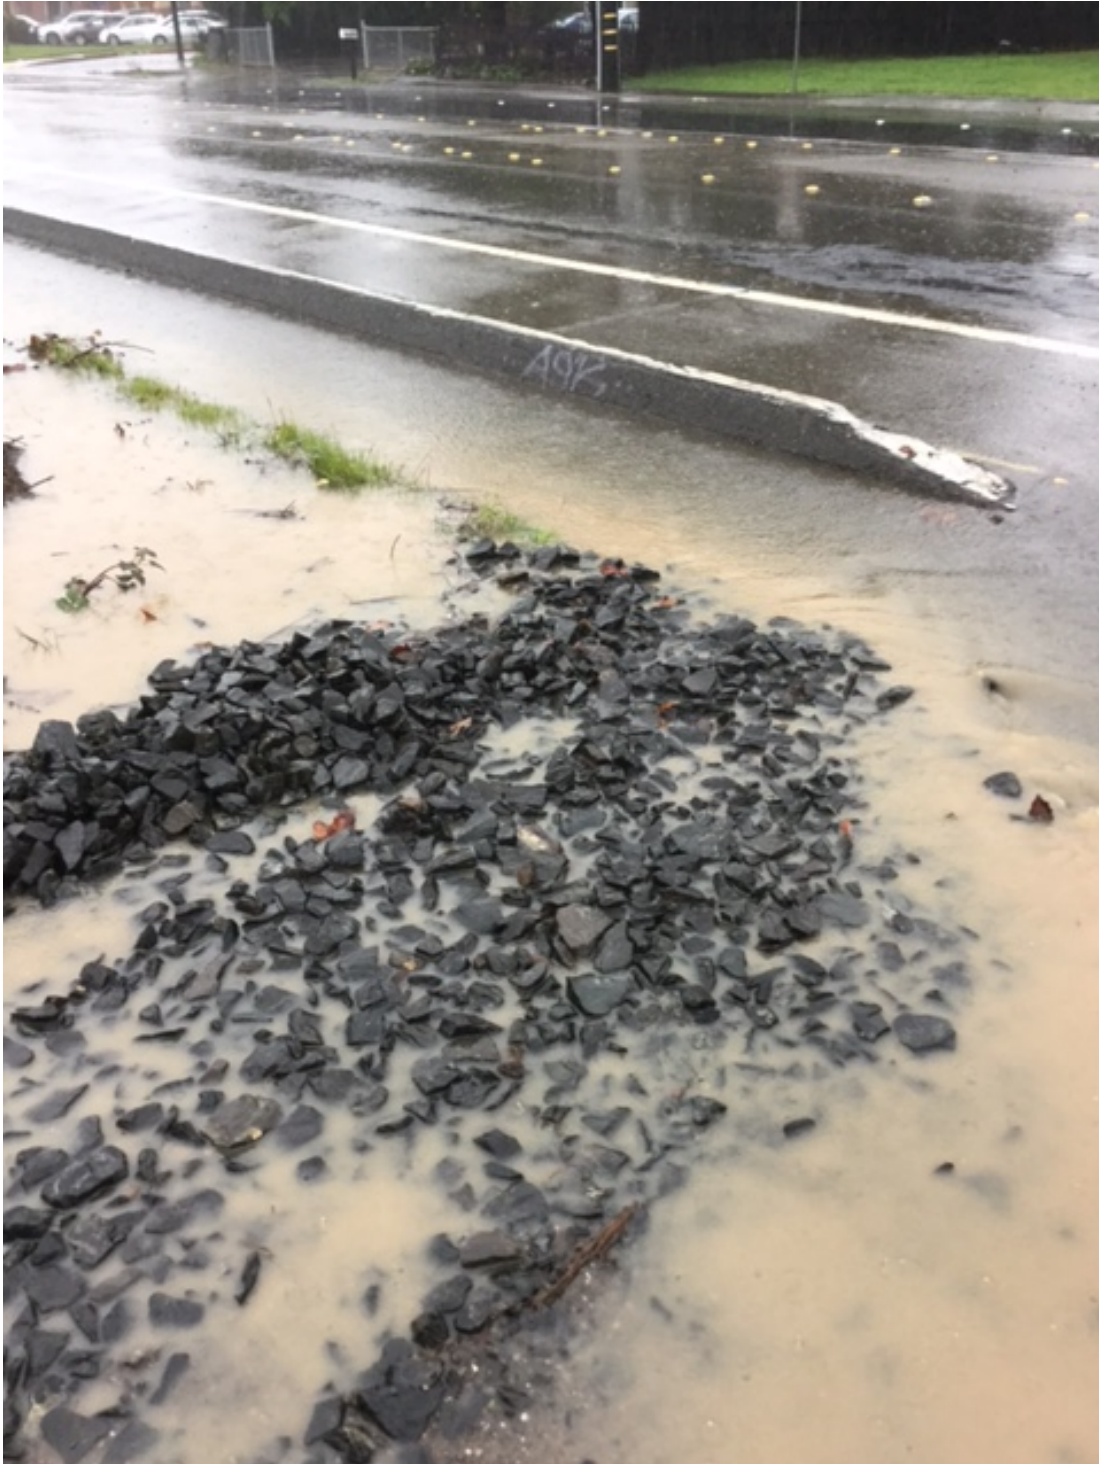
**Photo 21.** Sediment-laden discharge from Site's entrance to Fulton Road. Discharge occurred due to lack of adequate BMPs on construction entrance. Photo was taken by Mr. Gary Morris of LJP Construction Services during his inspection on December 15, 2016.

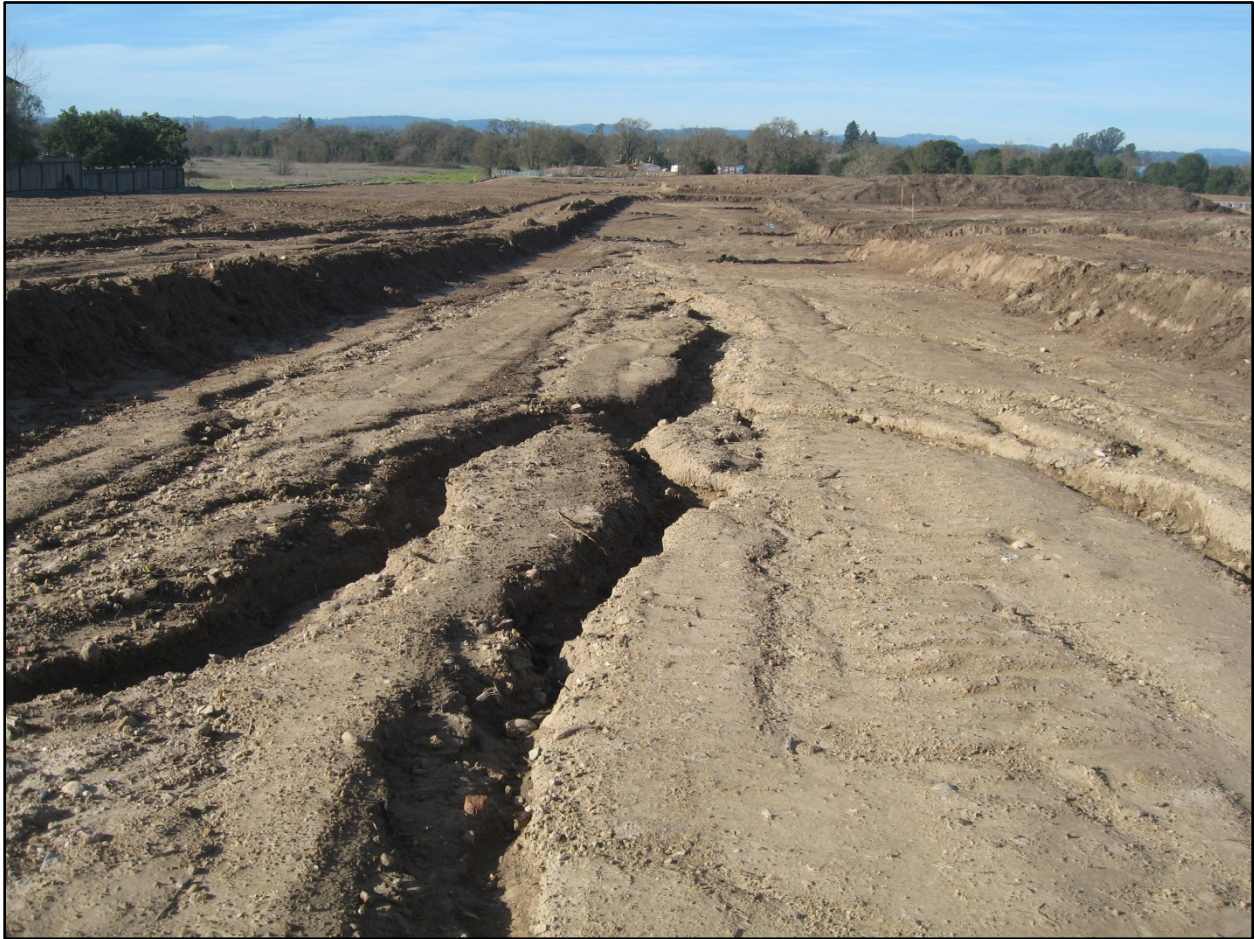
**Photo 22.** Gullies formed along the one of the roads on the southern portion of the project. The gullies ranged from one to two feet wide and deep along this and other roads. The gullies formed as a result of concentrated flow on the exposed soil lacking erosion and adequate sediment controls. Photo was taken facing west at 11:48.

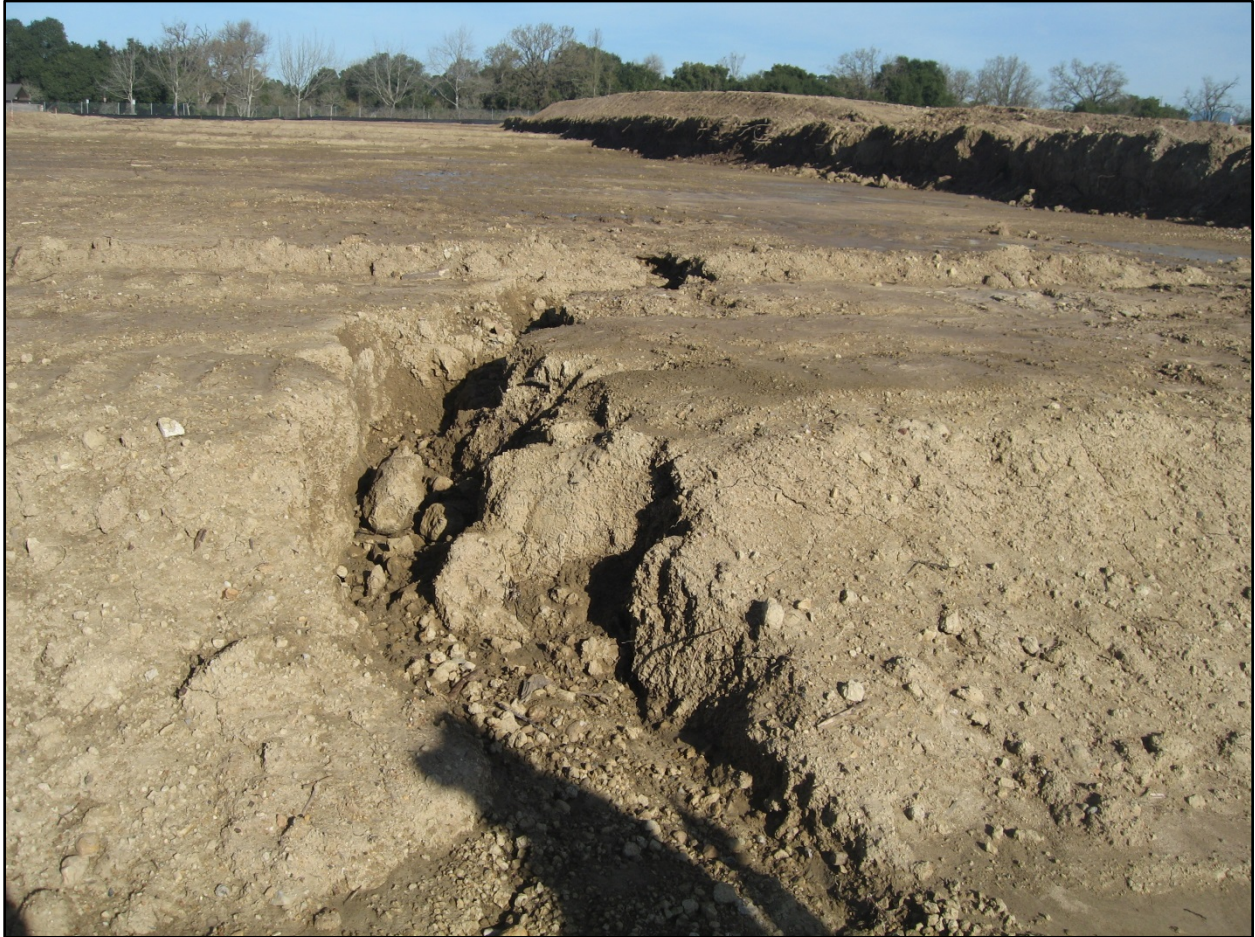
**Photo 23.** Gullies formed on the slopes of the housing pads as a result of concentrated flow on the soil lacking erosion and sediment controls. Gully depicted in photo ranged from one to three feet wide and one to feet deep. Photo was taken facing roughly north at 11:47.

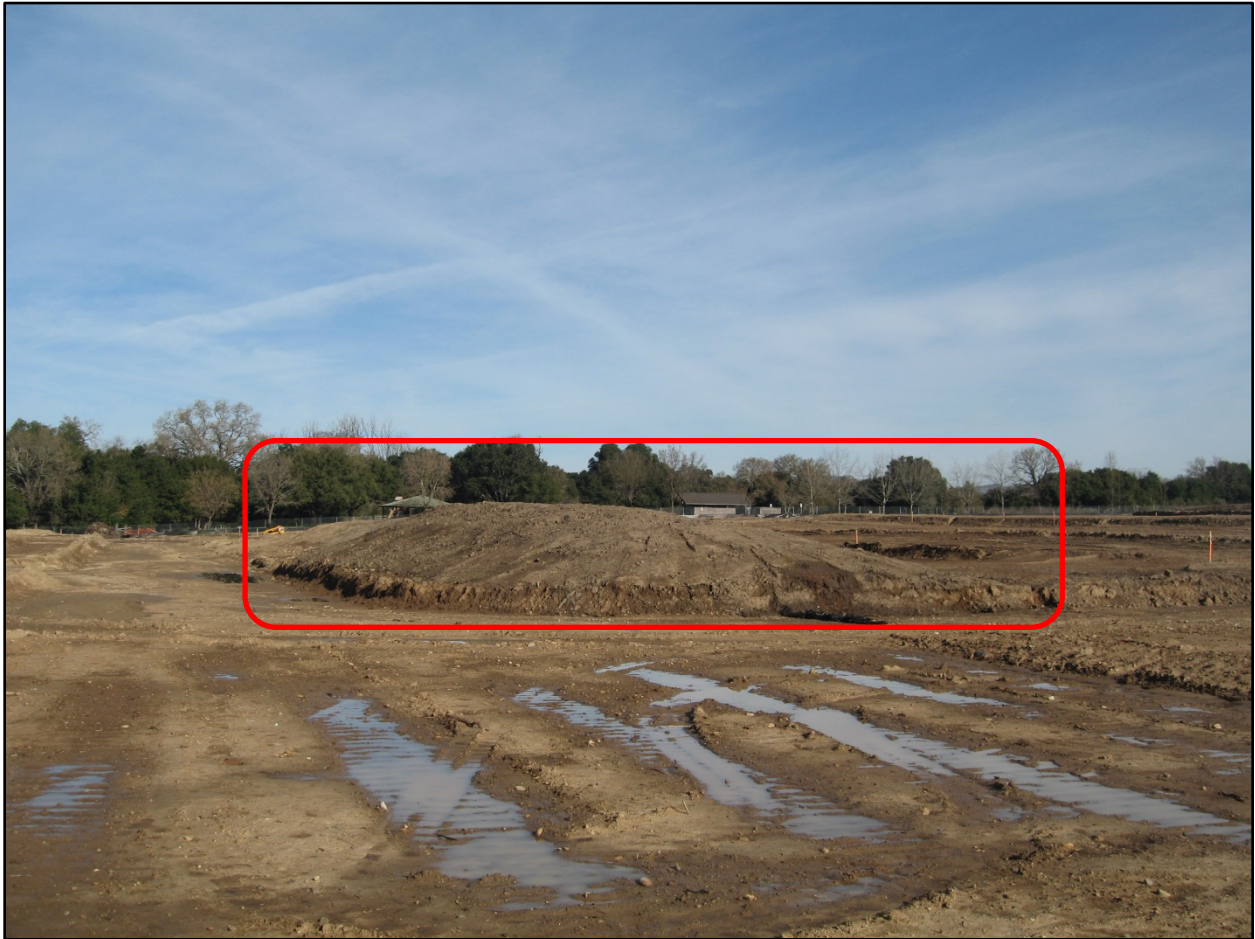
**Photo 24.** Stockpiled sediment lacked cover and a berm for perimeter control (red rectangle). As a result, the stockpile exhibited rilling. Photo was taken facing roughly north at 11:57.

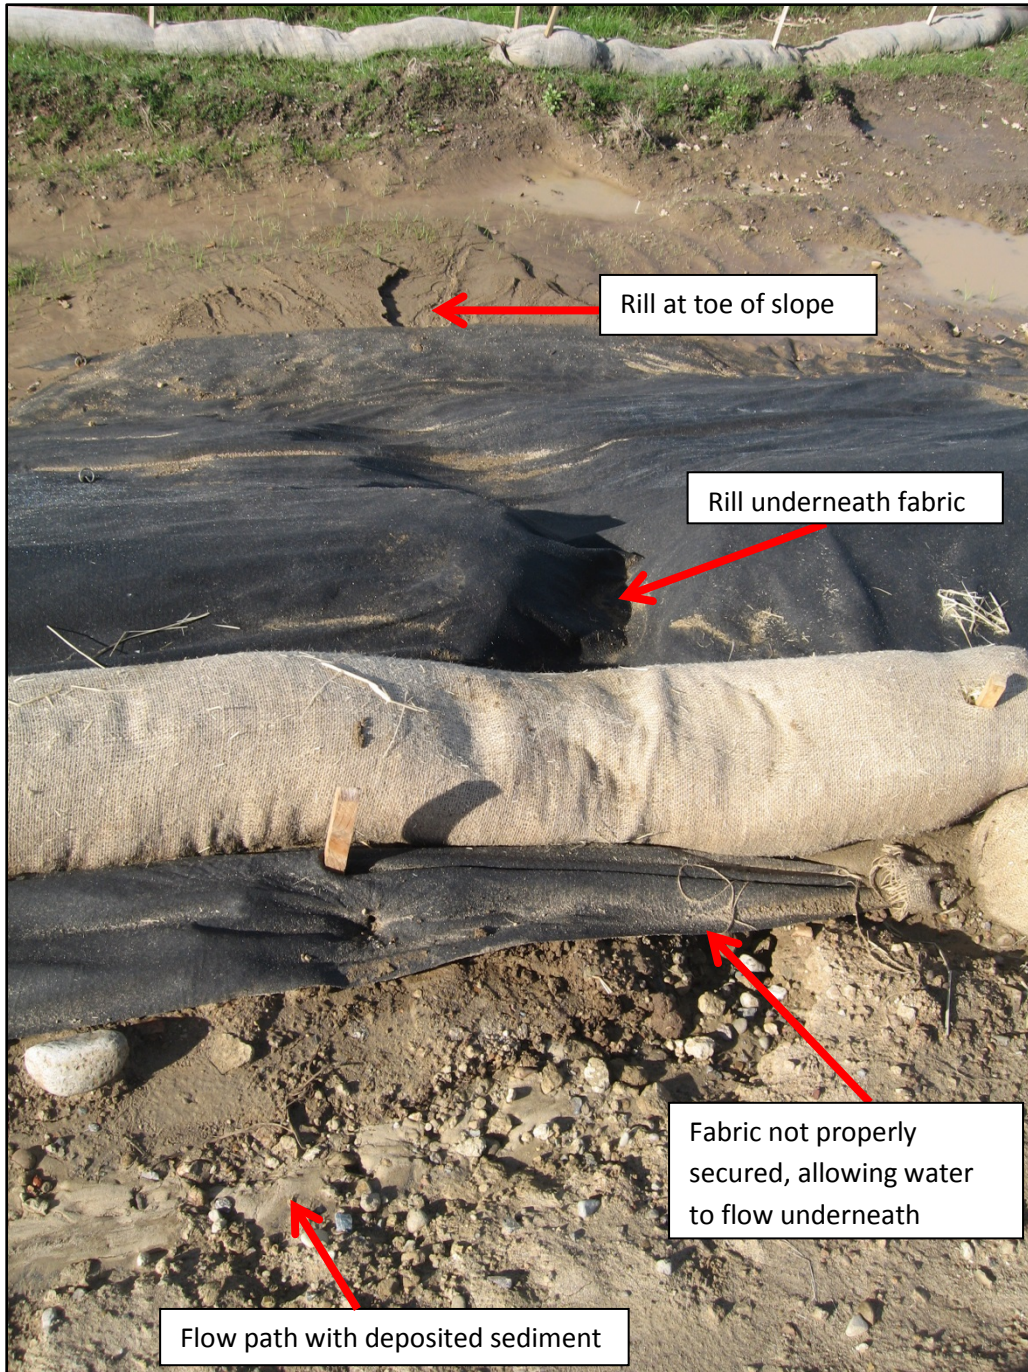
**Photo 25.** Inadequately secured fabric on slopes of the perimeter of disturbed area allowed for rilling and sediment transport during rain events. If fabric was properly secured, water would not be allowed to flow underneath the fabric, preventing erosion and sediment transport. Photo was taken east of the preserved wetland's eastern boundary at 12:04.

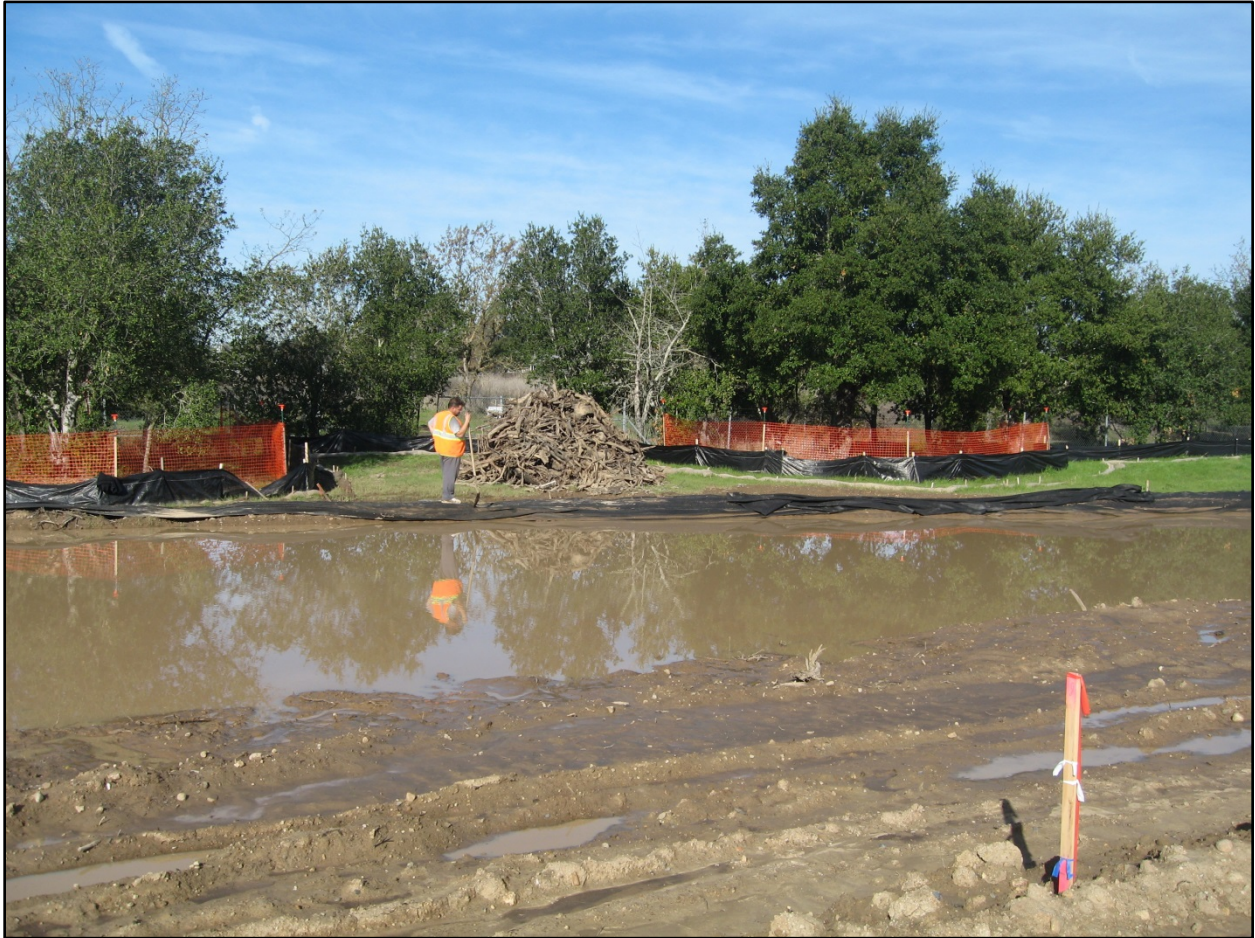
**Photo 26.** Storm water containment area along western boundary of Site adjacent to Peterson Creek (on the other side of the orange fencing). During the inspection, the containment area was filled near capacity with sediment-laden water. During the previous rain event, the containment area was overwhelmed by the volume of storm water runoff, and water flowed onto the adjacent vegetated area and into the creek. The containment area is not properly designed per the California Storm Water Quality Association's (CASQA) BMP standards, and therefore is not sized adequately to detain the volume of runoff expected from its drainage area, and poses a threat to discharge in future rain events. Photo was taken facing northwest at 12:07.

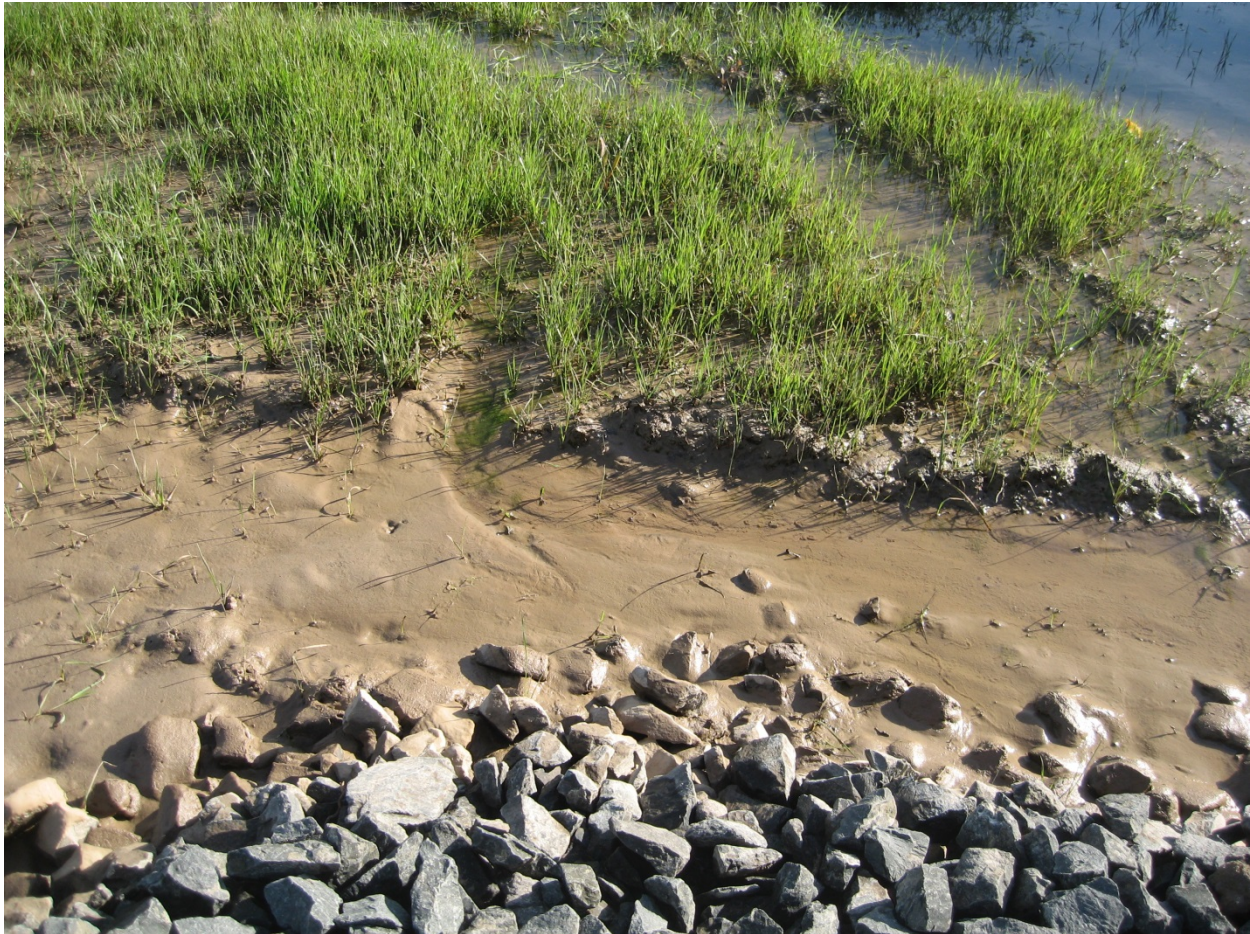
**Photo 27.** Deposits of fine sediment in the flow path to the MS4 inlet represent evidence of a previous discharge. The inlet is located around 10 feet to the right of the photo. Deposited sediment and debris was observed closer to the inlet, but the lighting at the time of the photograph did not allow for a clear image. Photo was taken at 11:44.

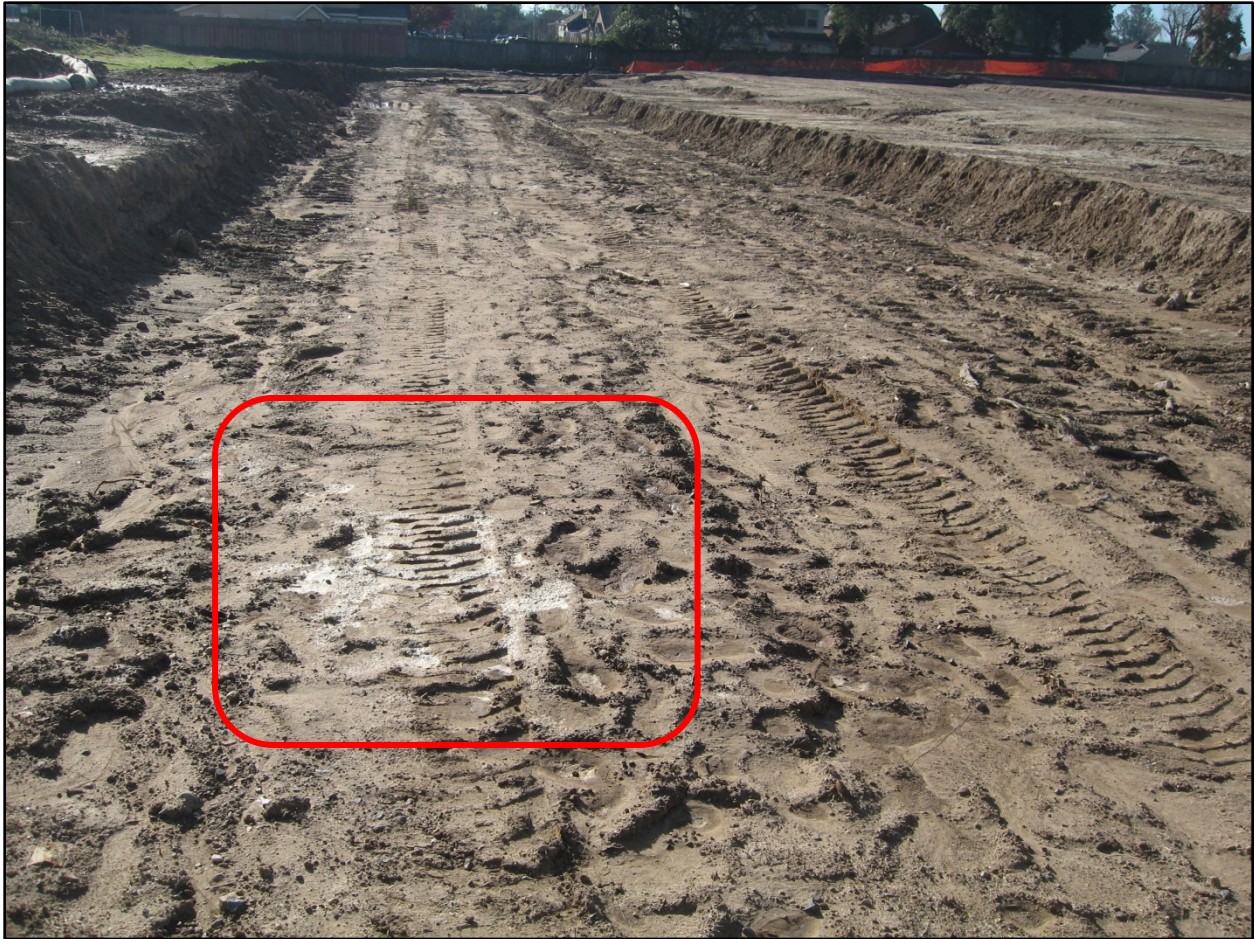
**Photo 28.** The red rectangle outlines remnants of the bonded fiber matrix (BFM) that Mr. Fortney said was applied prior to the December 15, 2016, rain event. Photo was taken on the eastern-most road on the Site. Note the lack of erosion and sediment controls. Photo was taken facing south at 11:36.

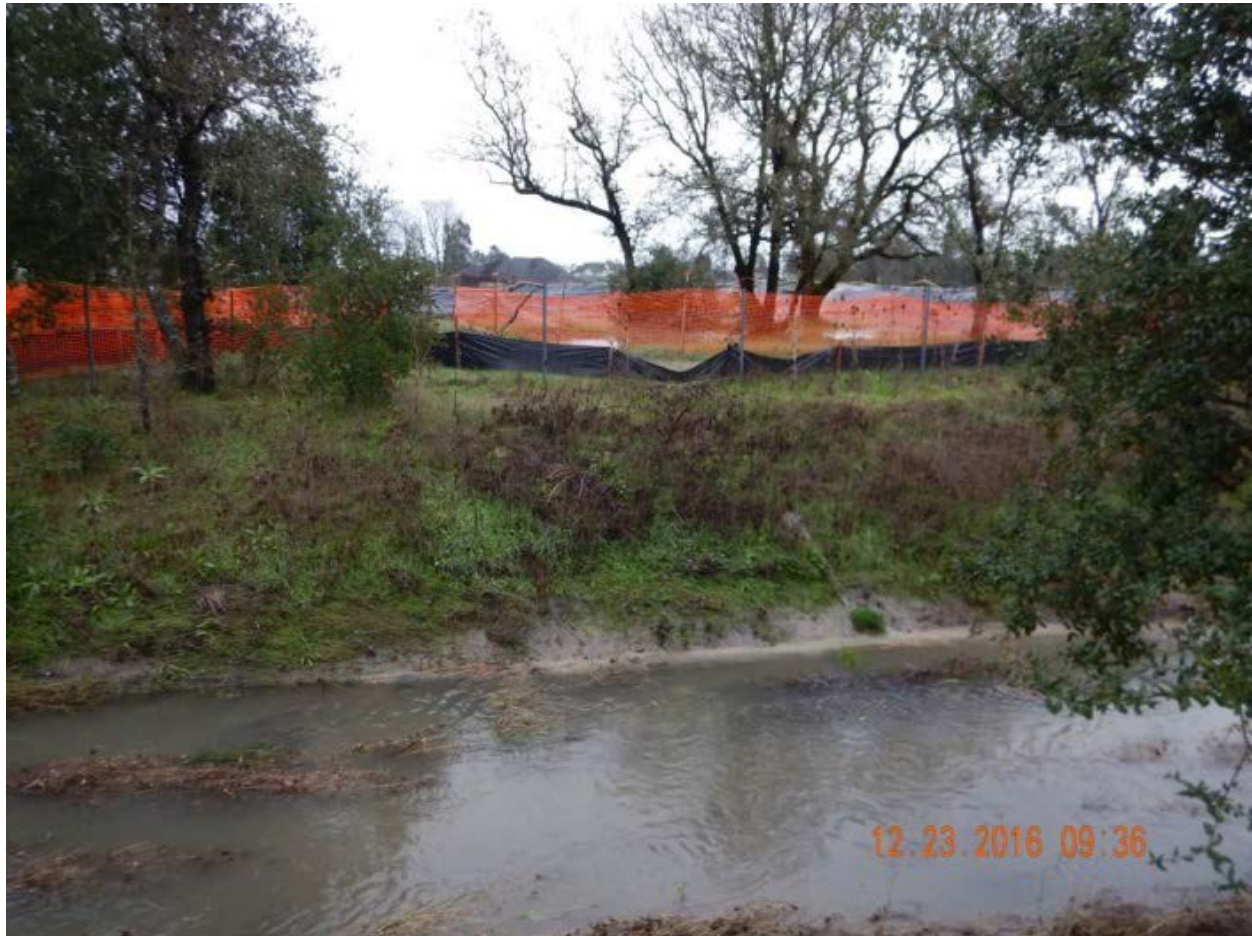
**Photo 29.** Peterson Creek discharge location 1. Photo was taken at 8:36 a.m. The camera time stamp was corrected after this photo was taken. Water was running down the stream bank and causing turbidity along the left bank channel margin as shown in the photo.

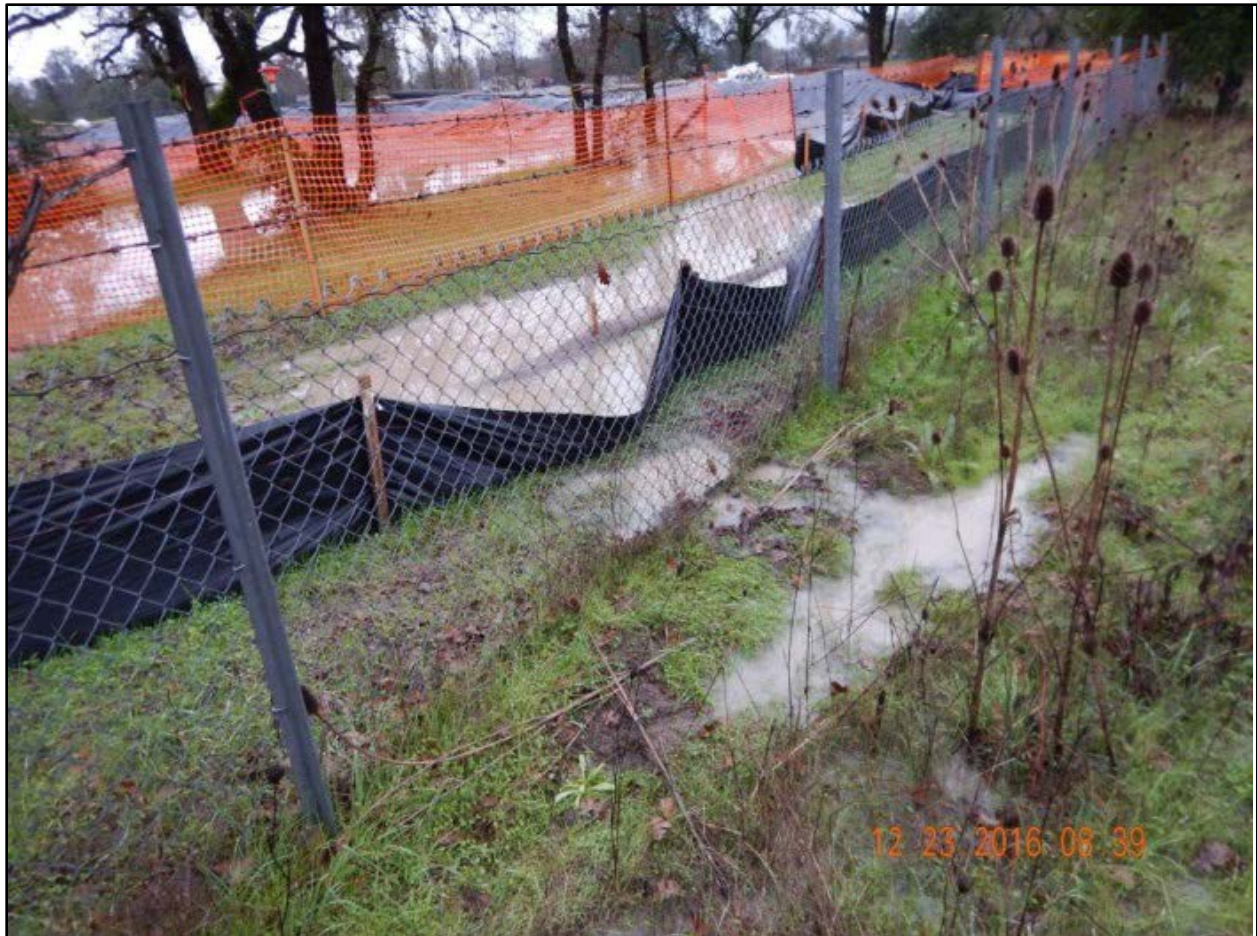
**Photo 30.** Peterson Creek discharge location 1. It appeared that storm water was passing underneath the silt fence. This discharge location appears to correspond with discharge sampling location #1 as provided in the 12/23/16 Sampling Field Log sheet.

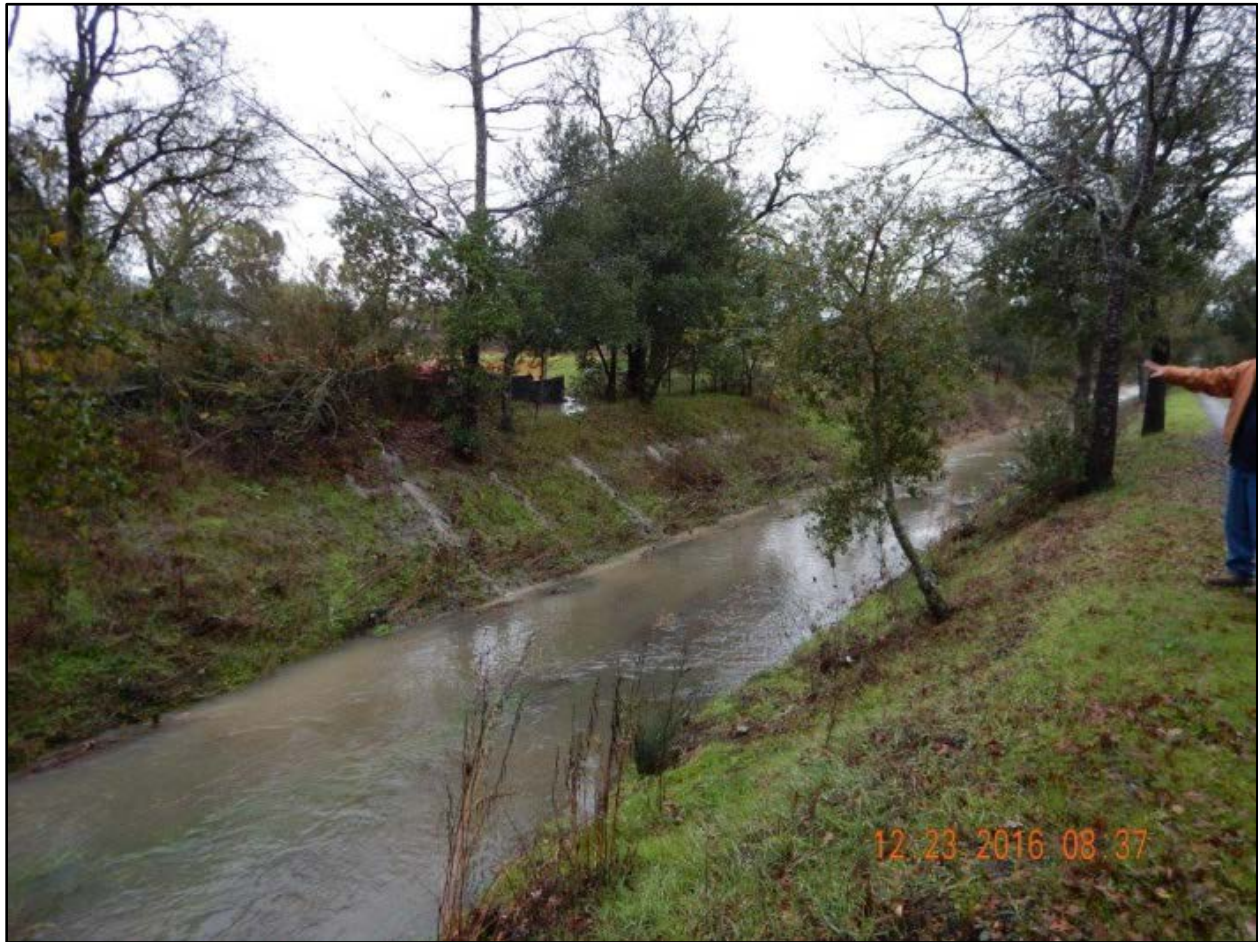
**Photo 31.** Peterson Creek discharge location 2. This discharge location appears to correspond with discharge sampling location #5 as provided in the 12/23/16 Sampling Field Log sheet. As shown in Photo 4, storm water was either passing beneath the silt fence or infiltrating and discharging at a uniform elevation on the bank of Peterson Creek. Storm water may have infiltrated and forced to emerge from the bank after hitting an impervious soil layer.

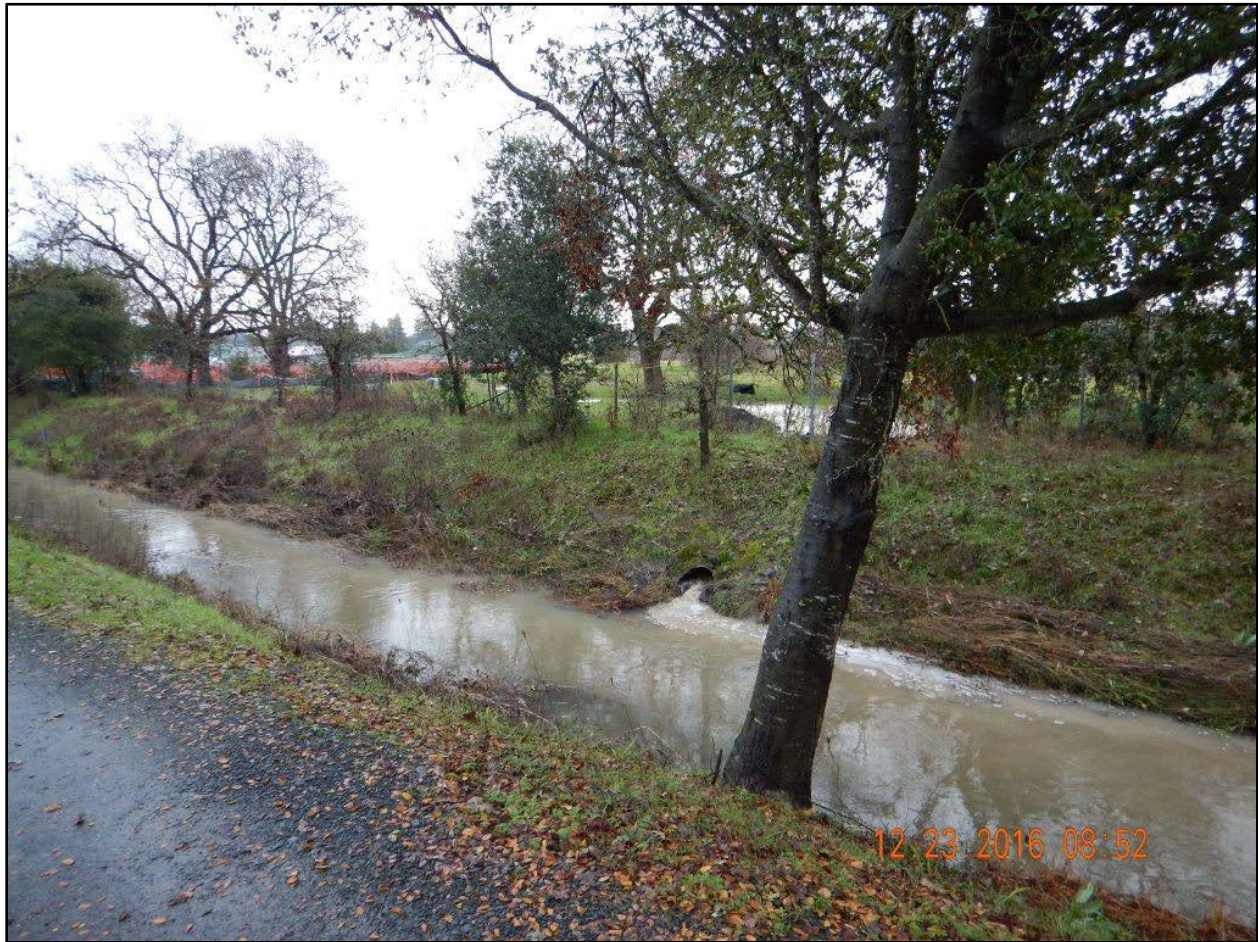
**Photo 33.** Peterson Creek discharge location 3. It was unclear where or whether this discharge originated from the Project site. This outfall does not appear to be listed as a discharge location on the 12/23/16 Sampling Field Log sheet, though sampling location #4 may be in the background at the silt fence, where runoff leaves the southwest Project boundary.

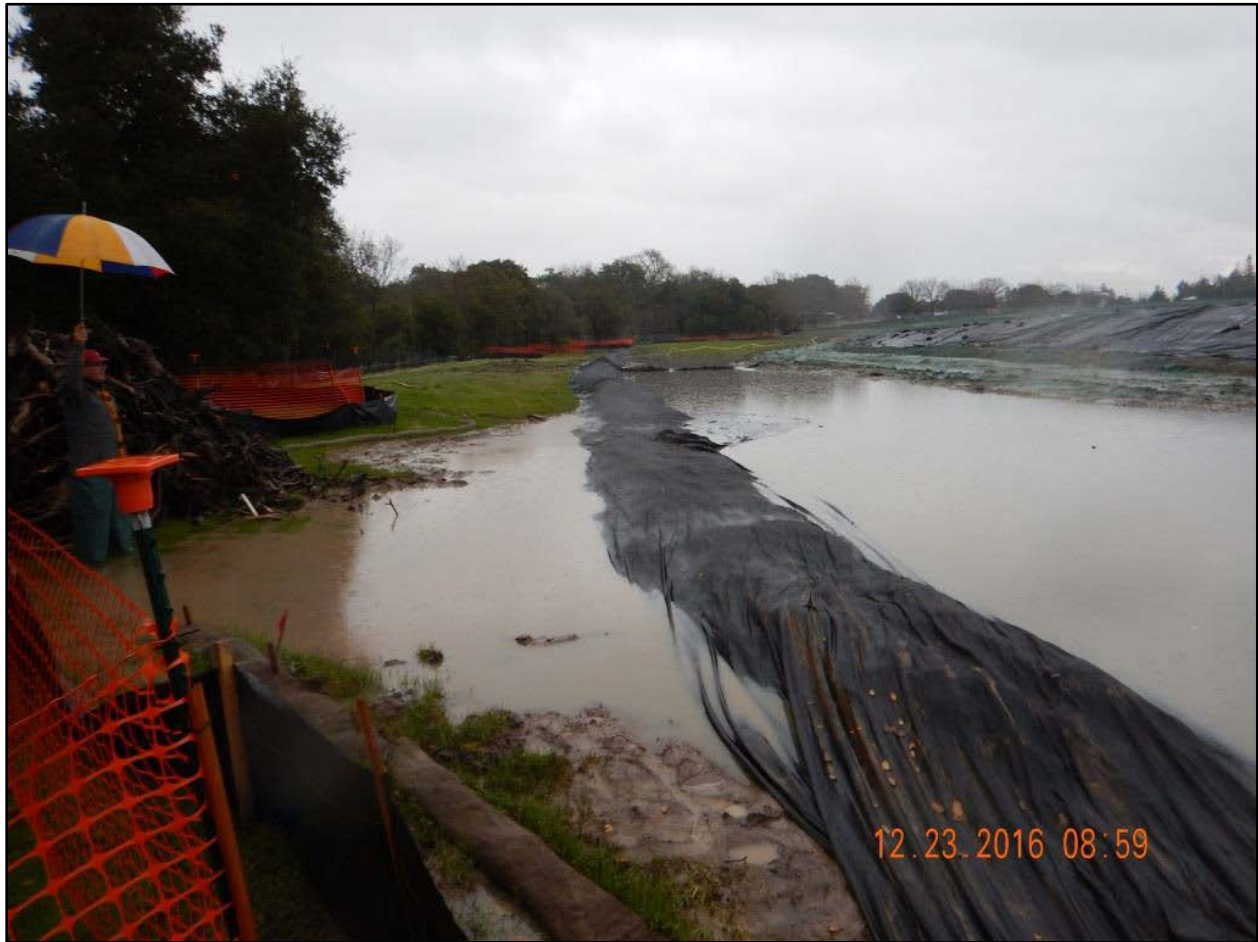
**Photo 34.** Earthen berm covered with filter fabric. Looking north. Peterson Creek is approximately 40 feet to the left.

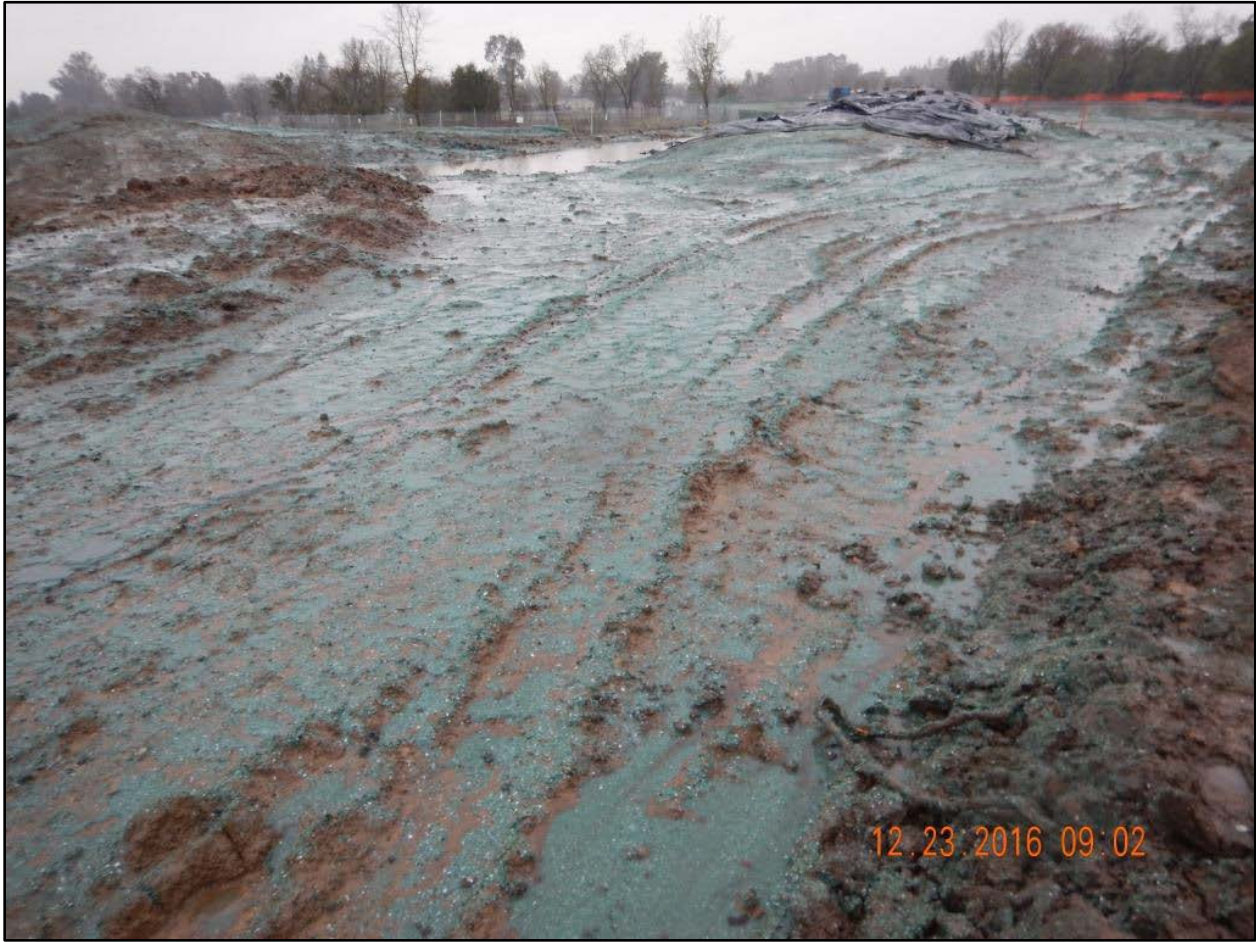
**Photo 35.** Disturbed area with hydromulch after rainfall.

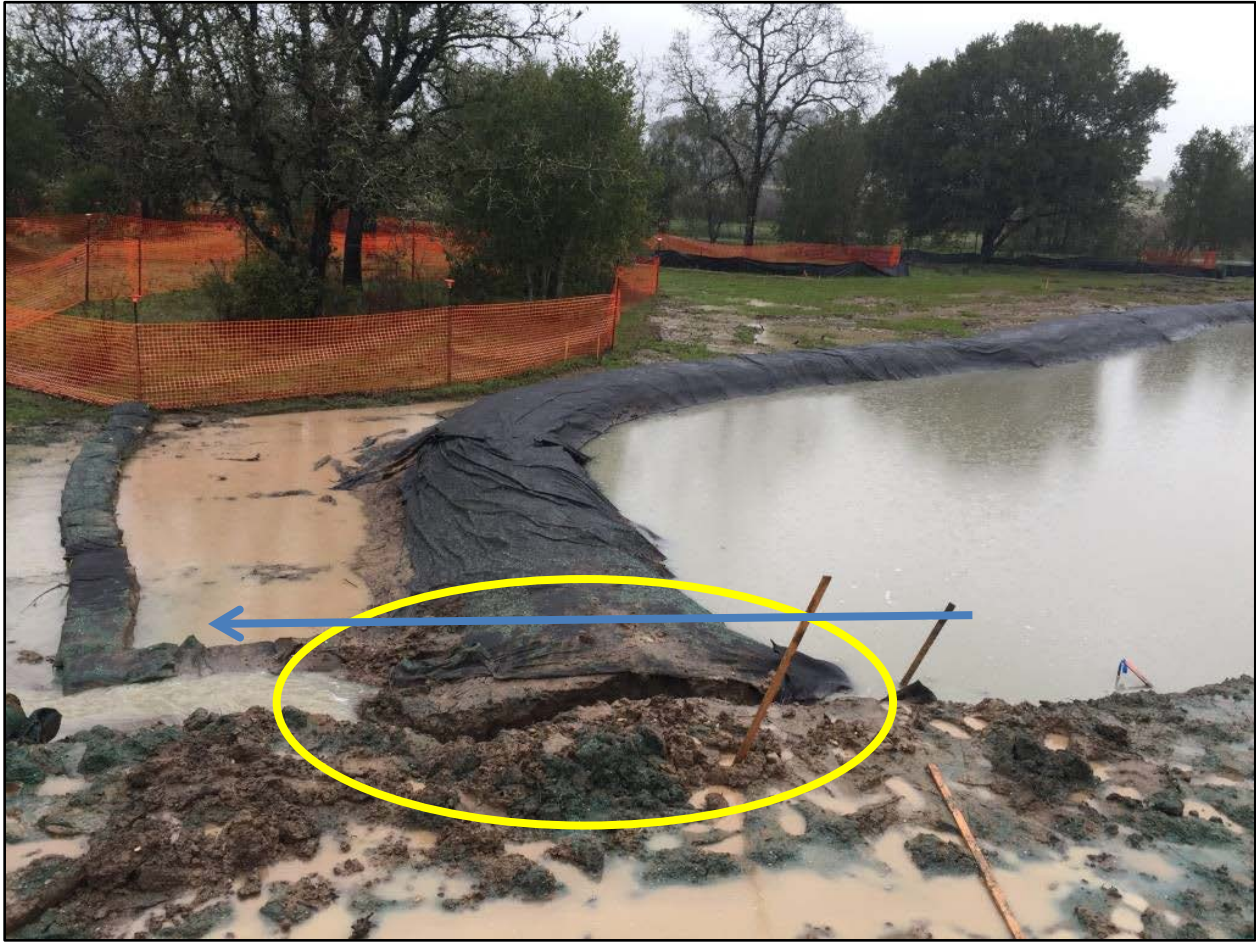
**Photo 36.** One of the earthen basins failed and storm water was flowing into the next downstream basin. The blue line shows flow direction.

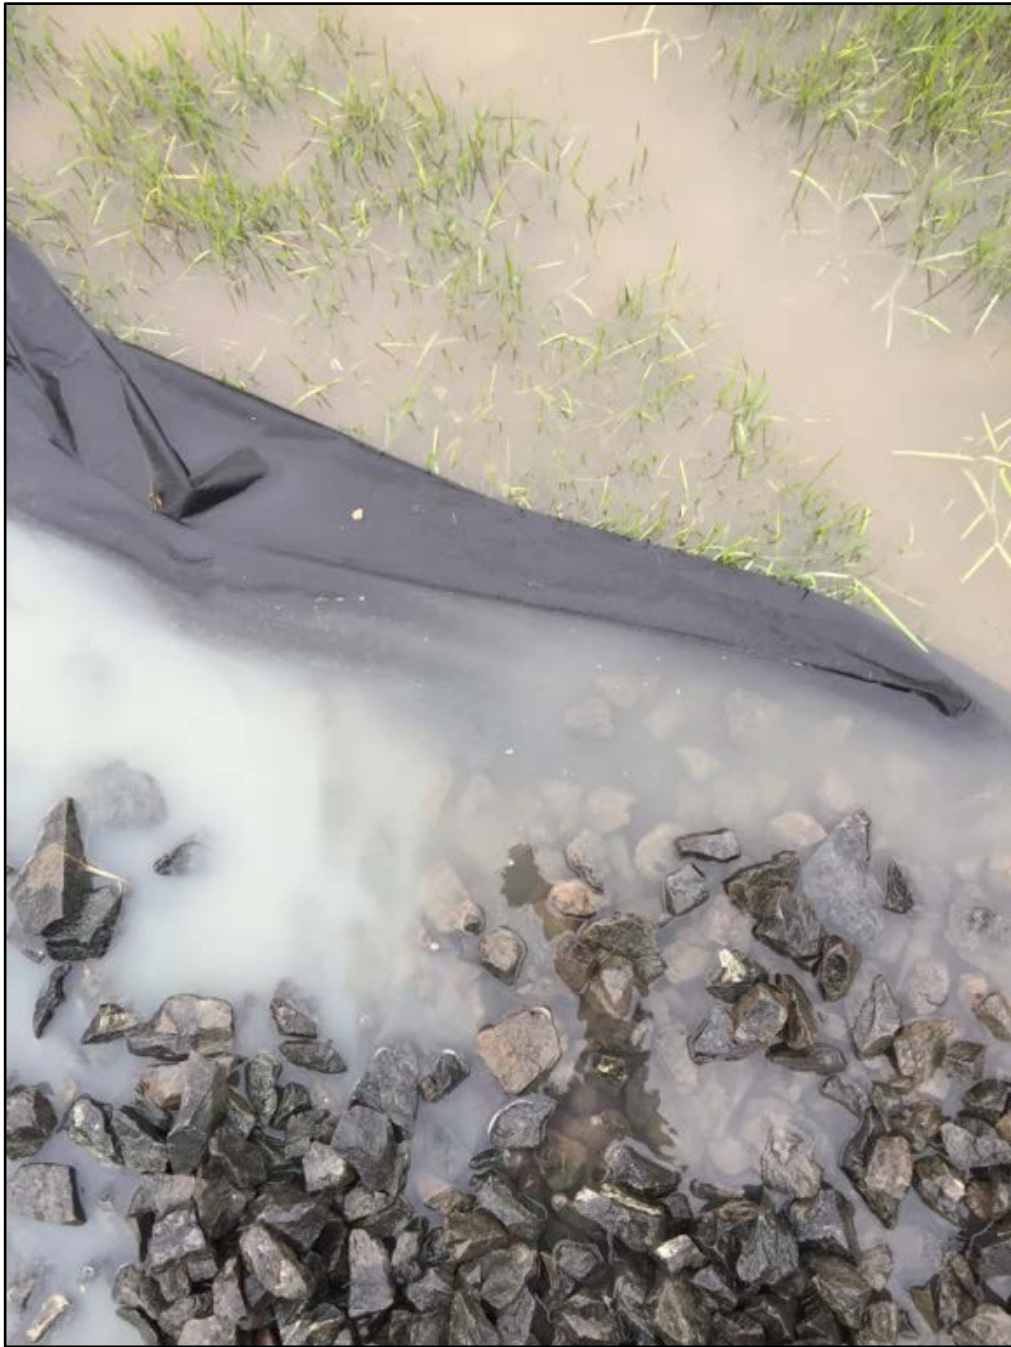
**Photo 37.** Photo taken within the eastern catchment. The storm water runoff on the bottom half of the photo is from areas treated with hydraulic mulch and has a green hue, unlike the water in the top of the photo, which is from areas largely not treated with hydraulic mulch. Ponded water throughout the Project area, in areas where hydromulch had been applied, had a green hue.
