Attachment B
Areas of Concern
Mt. Jackson Mercury Mine 13267 Order

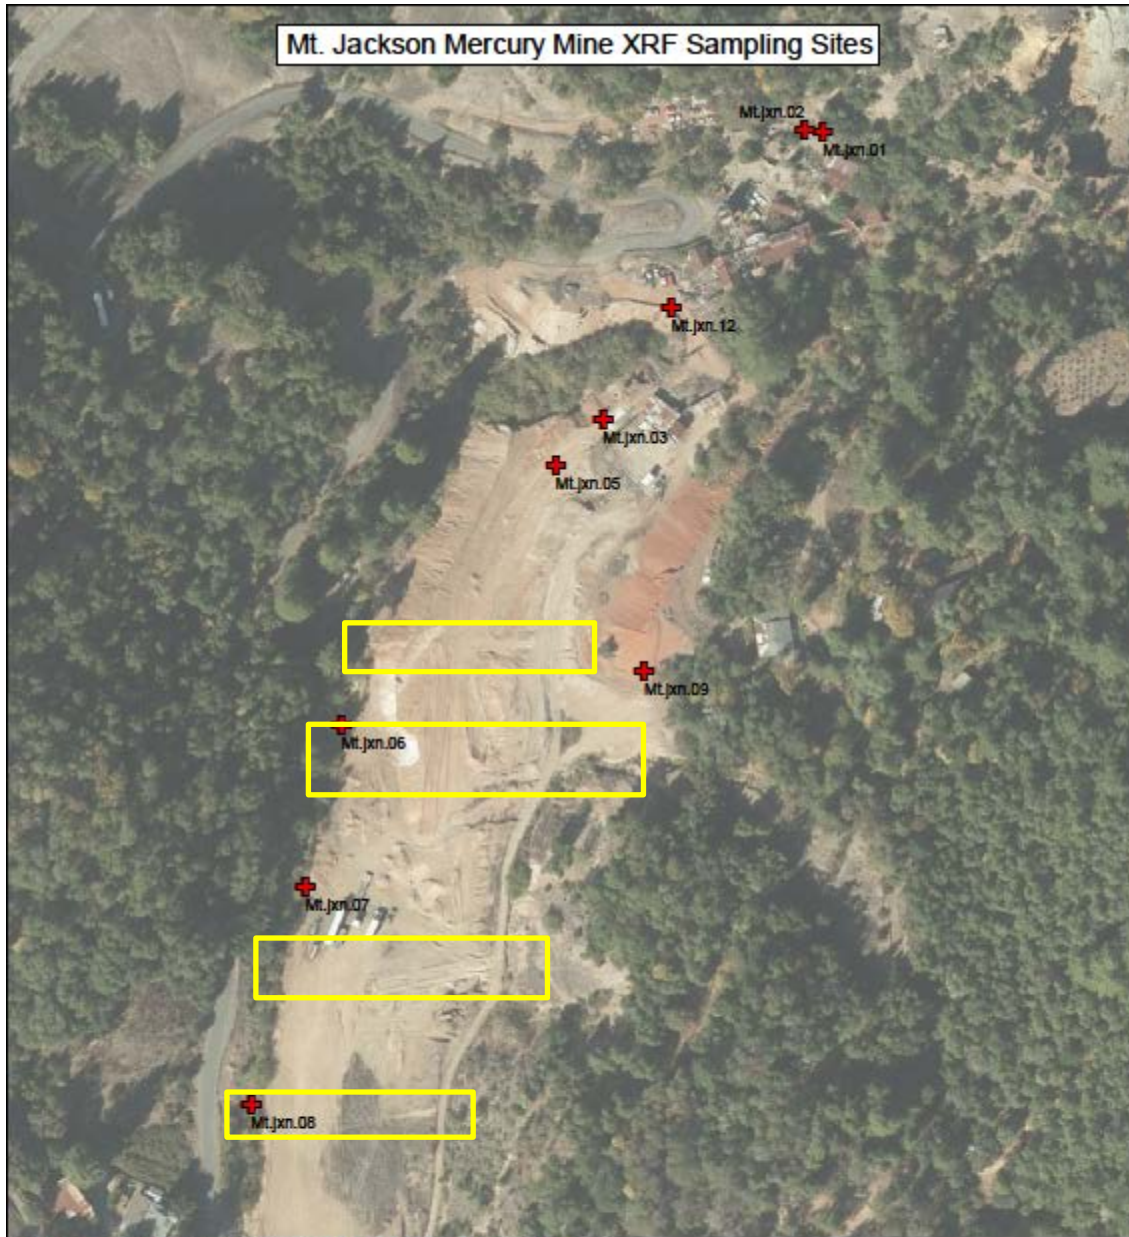
XRF sampling locations and results from the June 3, 2016, inspection. The yellow rectangles provide a rough outline of the Areas of Concern referenced in the Order. The Areas of Concern lie within the drainages onsite.
