North Coast Regional Water Quality Control Board

Subject: **Notice of Violation** of Waste Discharge Requirements Order No. R1-2001-61, Construction Specification No. 3; and Provision Nos. 14 and 18; and **Threatened Violation** of Discharge Prohibitions No. 8 and 15; and **Requirement for Information** Pursuant to California Water Code section 13267, for Tank Gulch Waste Pile, Humboldt County

File: Tank Gulch Waste Pile, Humboldt County, WDID No. 1B92019RHUM

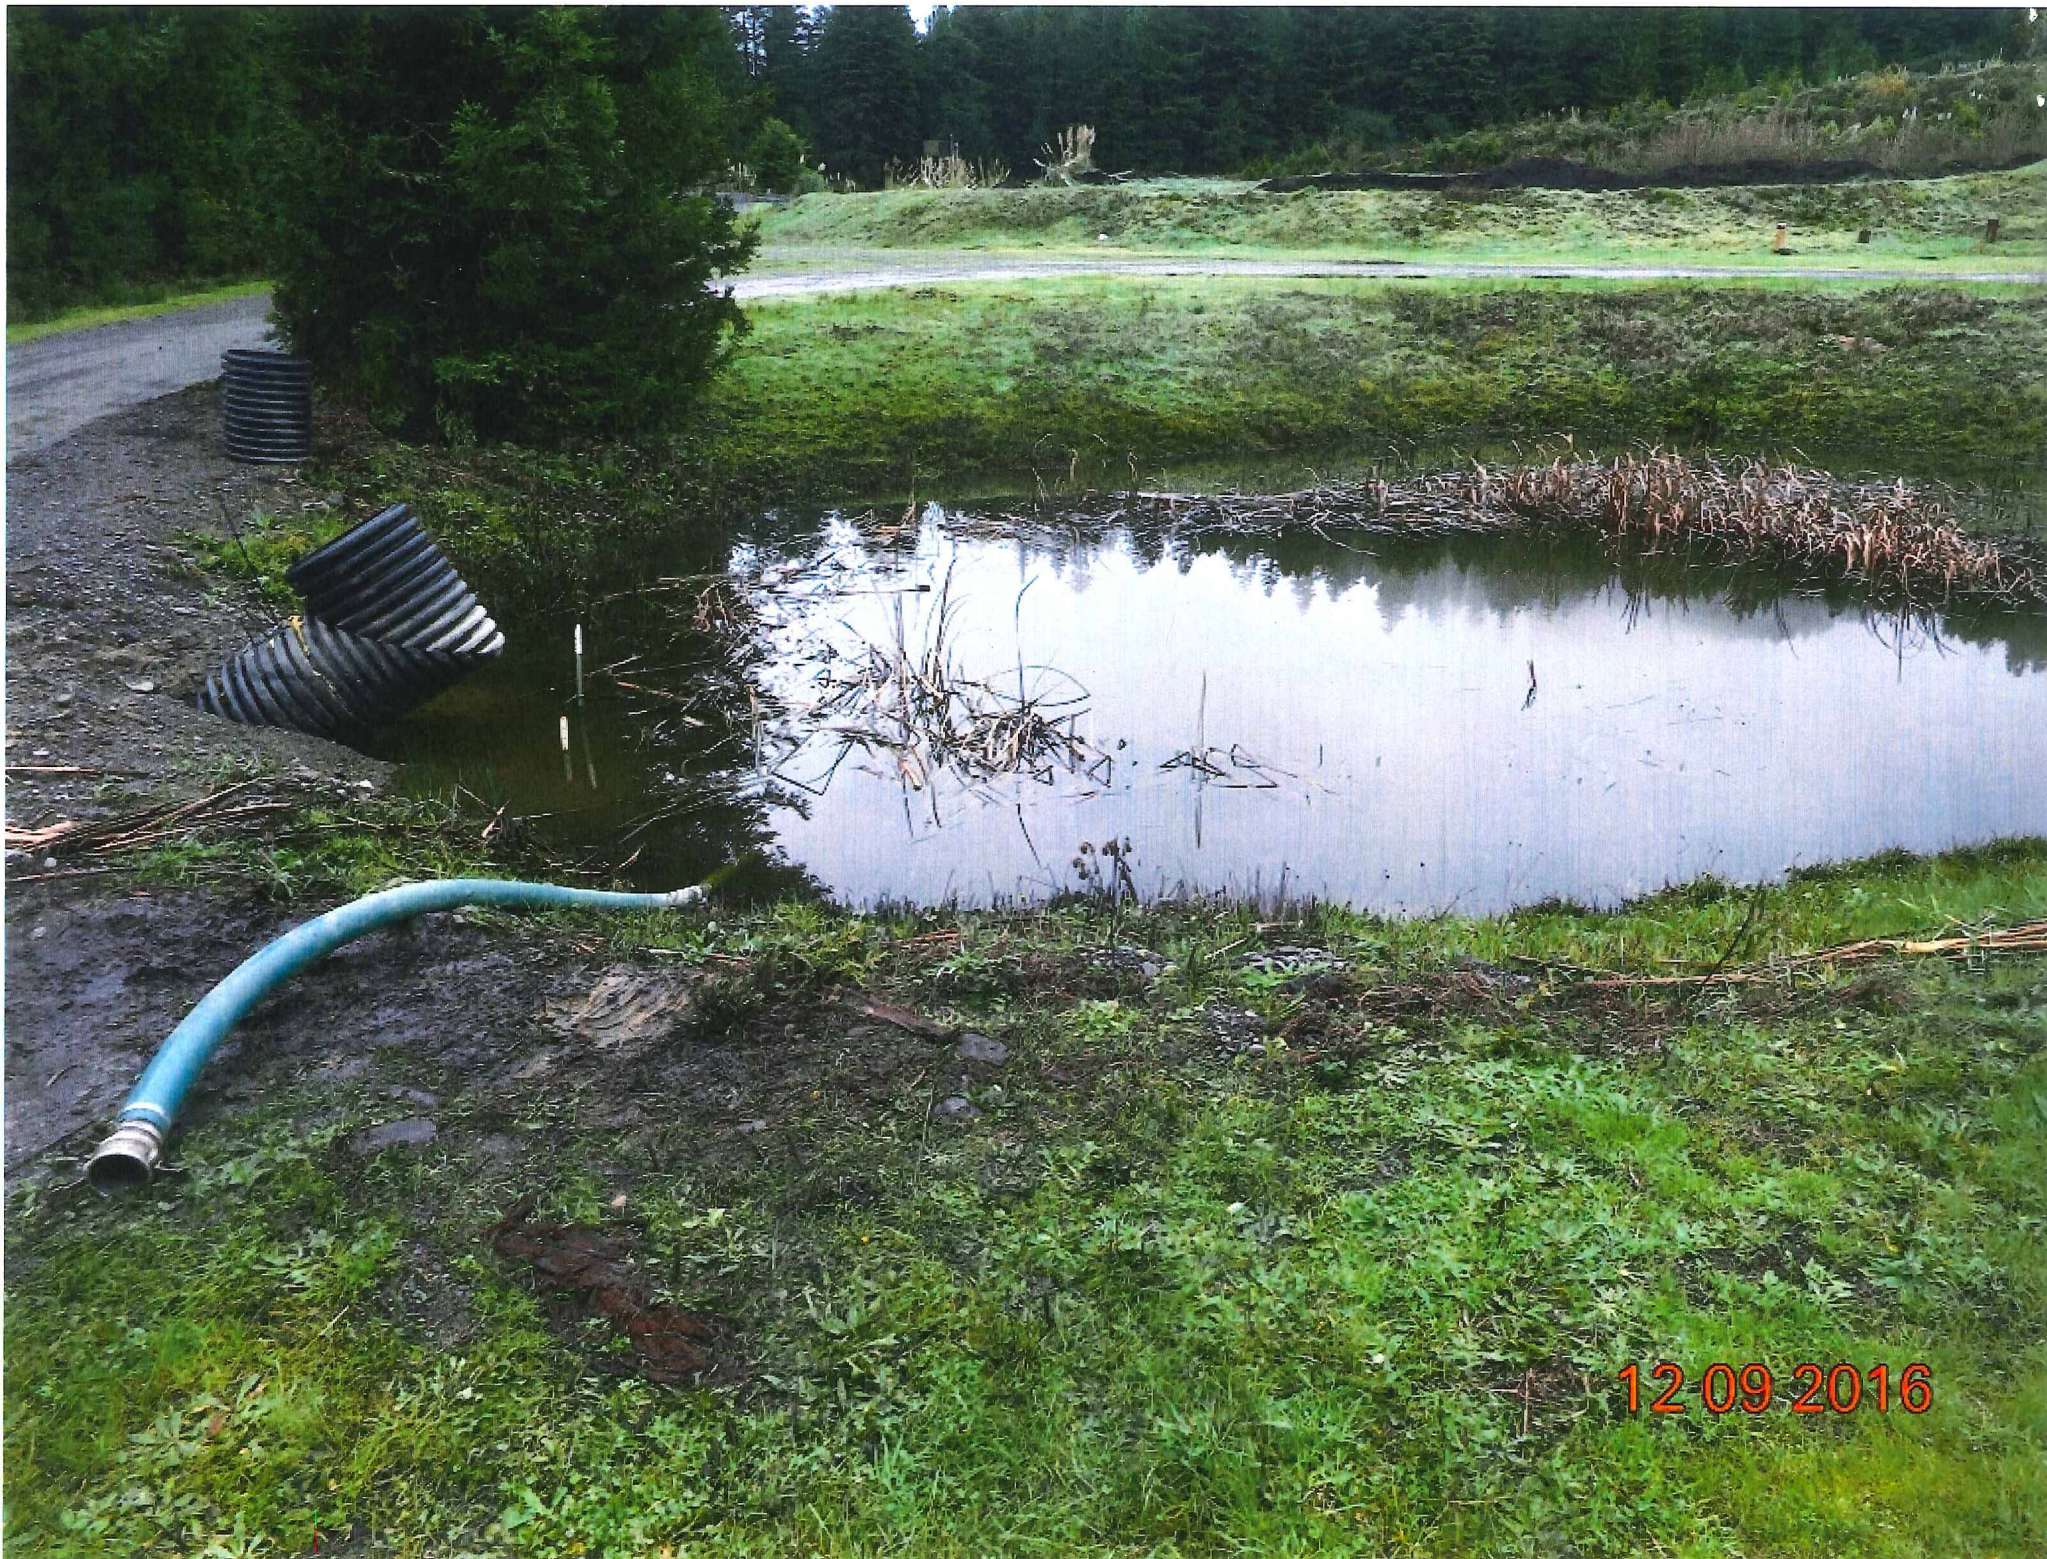
12 09 2016

- F. On December 9, 2016, LEA staff inspected the Site and noted that the PVC effluent pipe of the lower pond had been altered by the HRC roads crew and angled upward which raised the pipe inlet above the road level. Evidence of recent pumping from the lower pond was noted (see Attachment B).

| <p>The LEA's contact person for the site, Suzanne McClurkin-Nelson, from Humboldt Redwood Company, accompanied me during the inspection.</p> <p>The end of the effluent pipe inside of the lower sedimentation pond had been altered by the operator's roads crew since the last inspection. An additional piece of pipe had been inserted at an ascending angle between the horizontal portion of pipe that runs underneath the access road, and the vertical portion of pipe where overflow first enters (see photo: Tank Gulch 12-9-16, P1 and P2). This appears to have raised the inlet of the pipe above the top of the pond; if the pond overflows water may cross the road instead of entering the pipe.</p> <p>The lower sedimentation pond was approximately 40% full. Influent was trickling in at a very slow rate. Based upon the presence of truck tire tracks and a hose at the edge of the pond it appeared that the pond had recently been pumped. During my inspection the water truck arrived and proceeded to pump from the leachate collection tank. The gauge on the leachate collection tank indicated 4.5 feet of liquid.</p> <p>The partial washout of the access road at the 1.5 mile marker appeared essentially the same as it was during last month's inspection; the road was passable and remained covered with gravel, logs lined the top edge of the slope along the road, and the slope remained mostly covered with straw.</p> <p>The upper sedimentation pond was approximately 25% full, and influent was entering at about one gallon per minute. It appeared that no change had been made to the effluent pipe which has what appears to be a small corrosion hole at the bottom of the pipe just behind the 90 degree elbow. The drainage ditch that feeds the upper sedimentation pond contained a small amount of slow moving water. There had been no apparent changes to the waste footprint.</p> <p>Weather: Overcast.</p> <p>e: Suzanne McClurkin-Nelson, Humboldt Redwood Company, LLC Howard Hughes, Mendocino Forest Products Company, LLC (HHughes@mendoco.com) Frank Bacik, Town of Scotia, LLC Gina Morrison, NCRWQCB</p> |

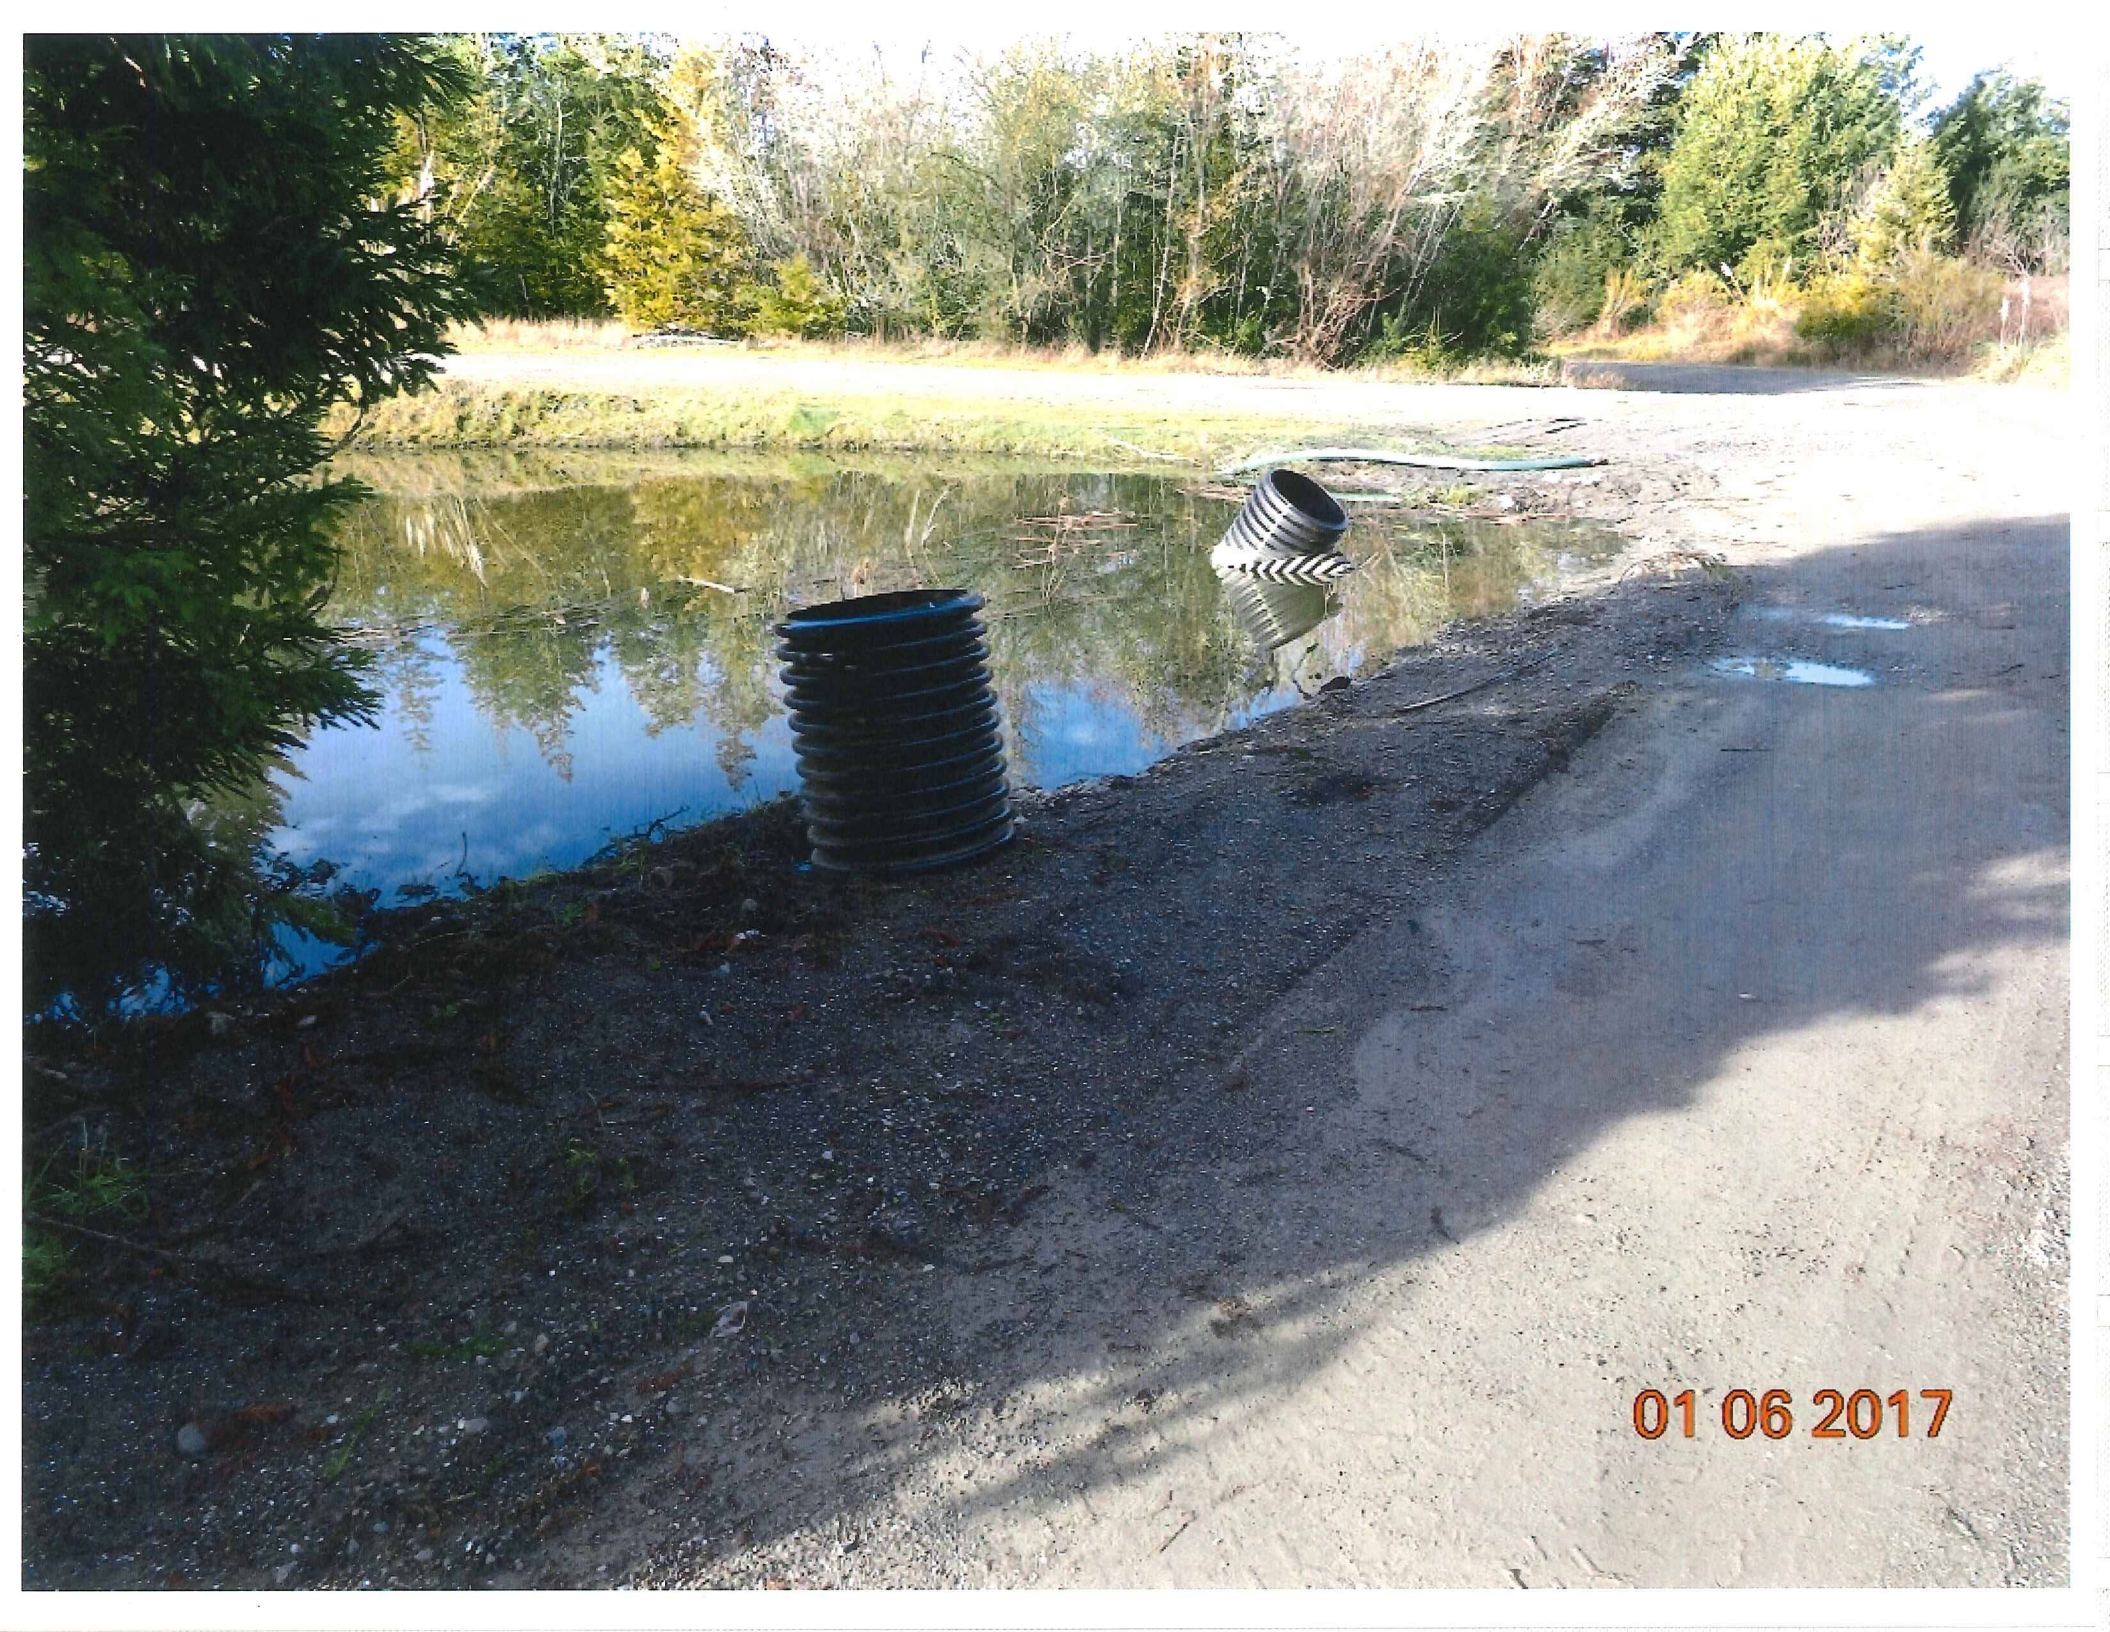
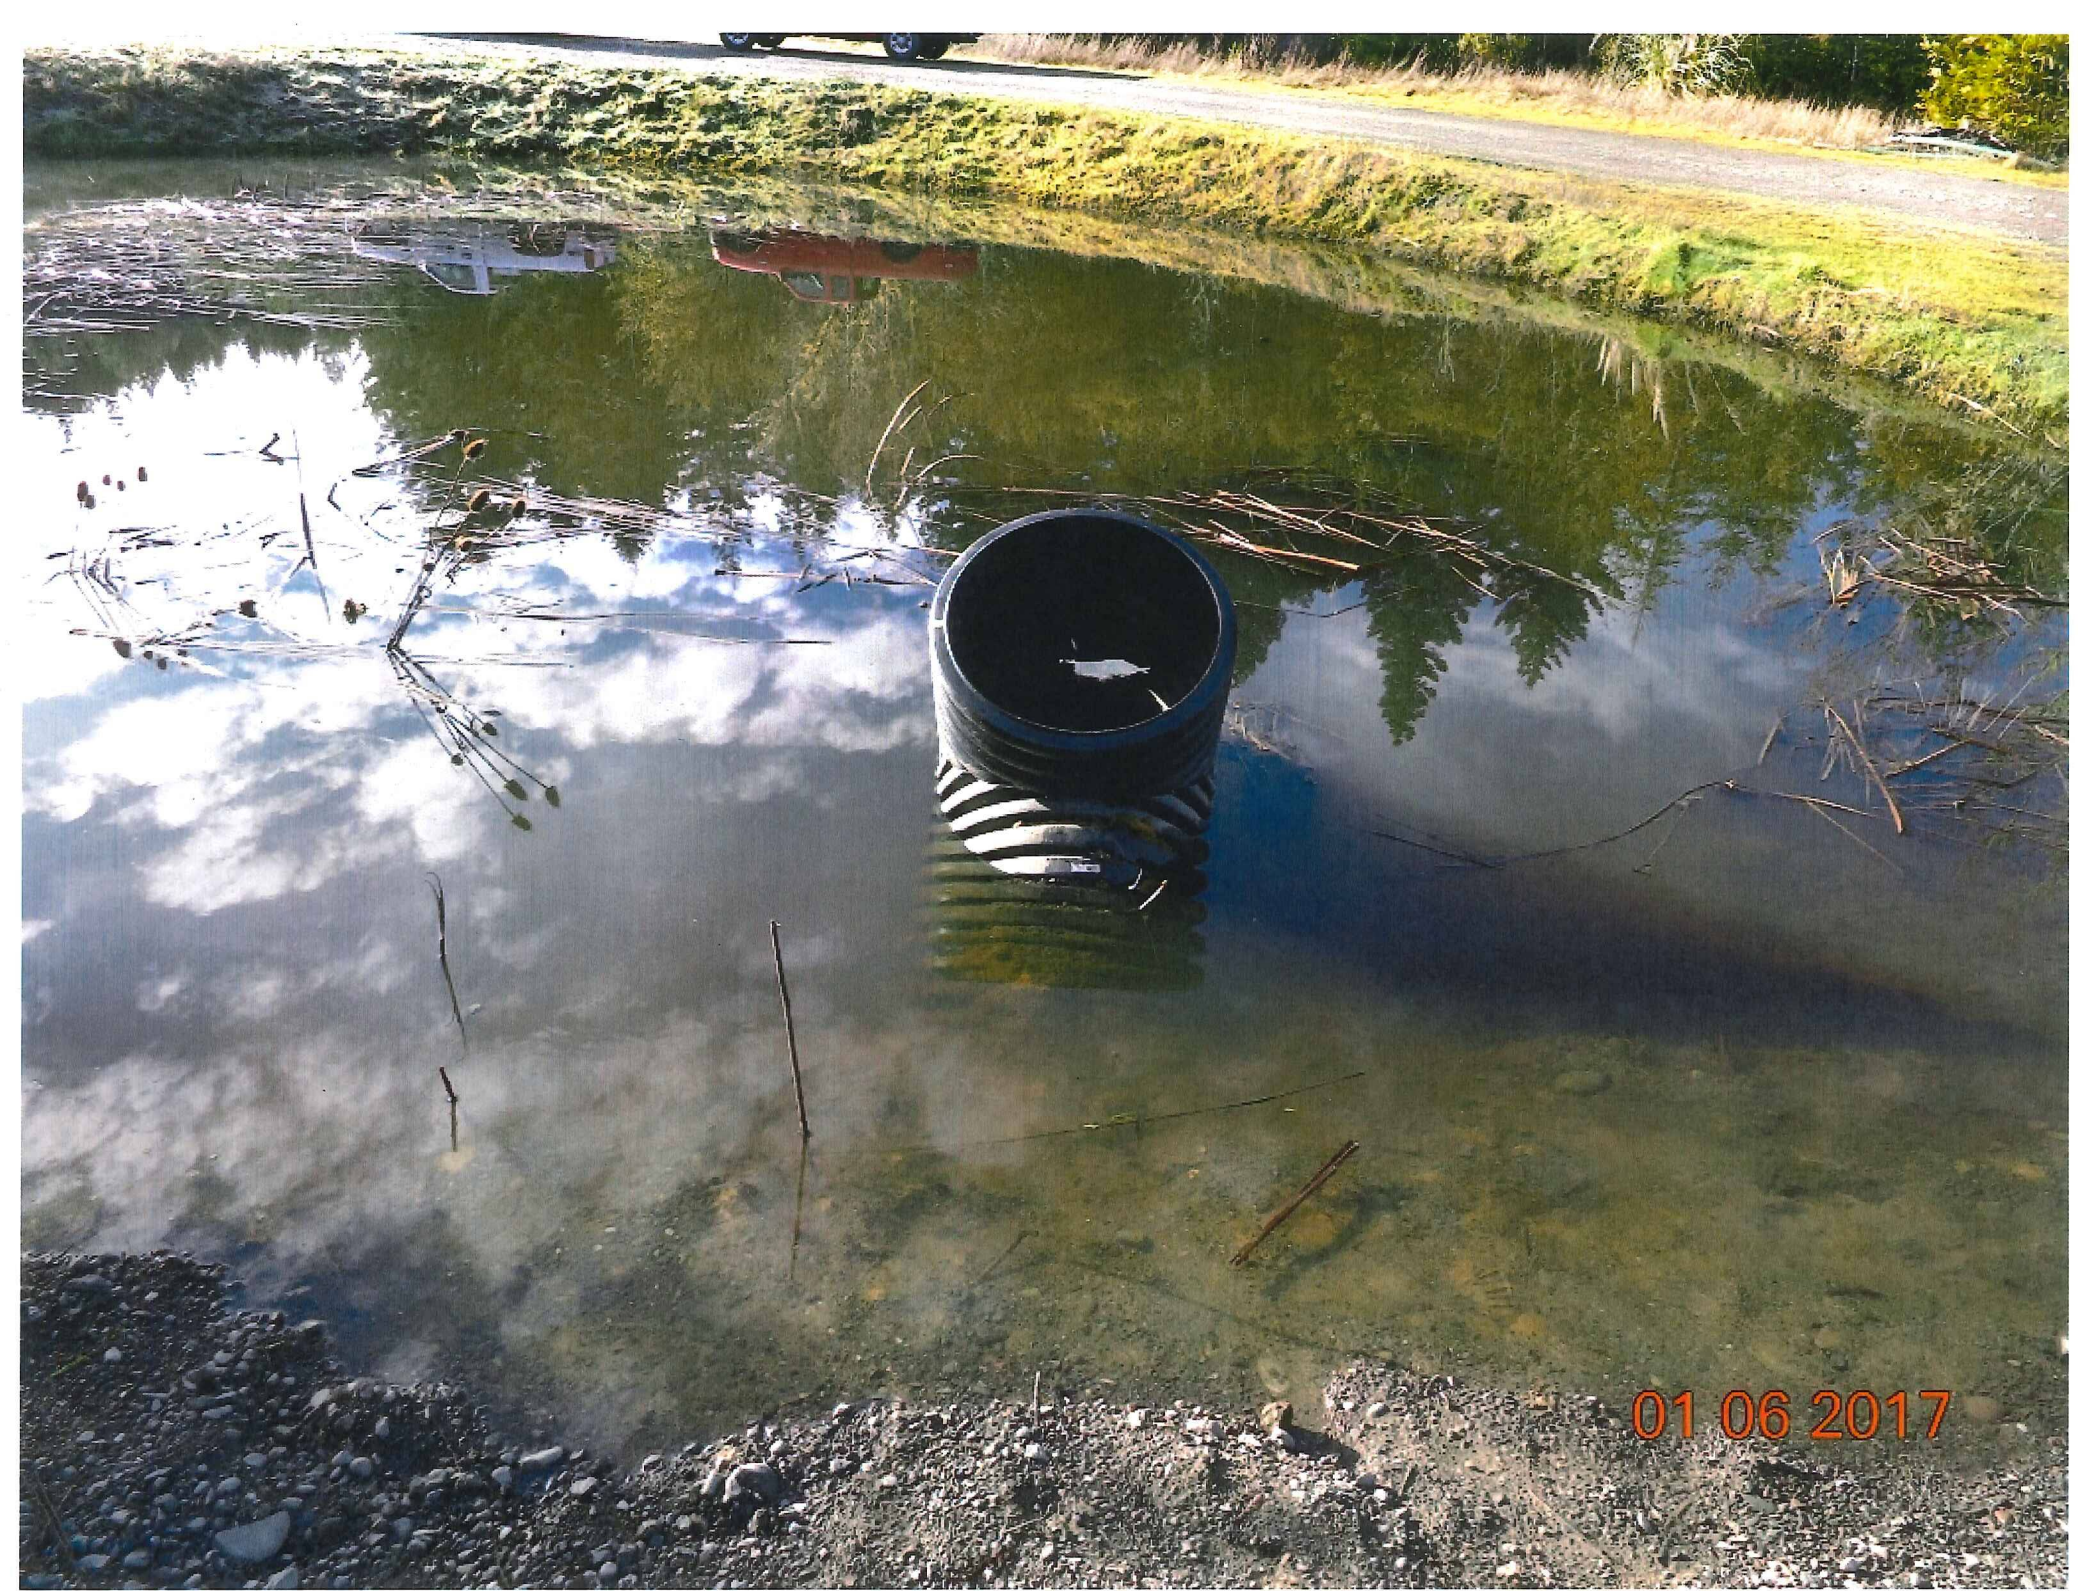
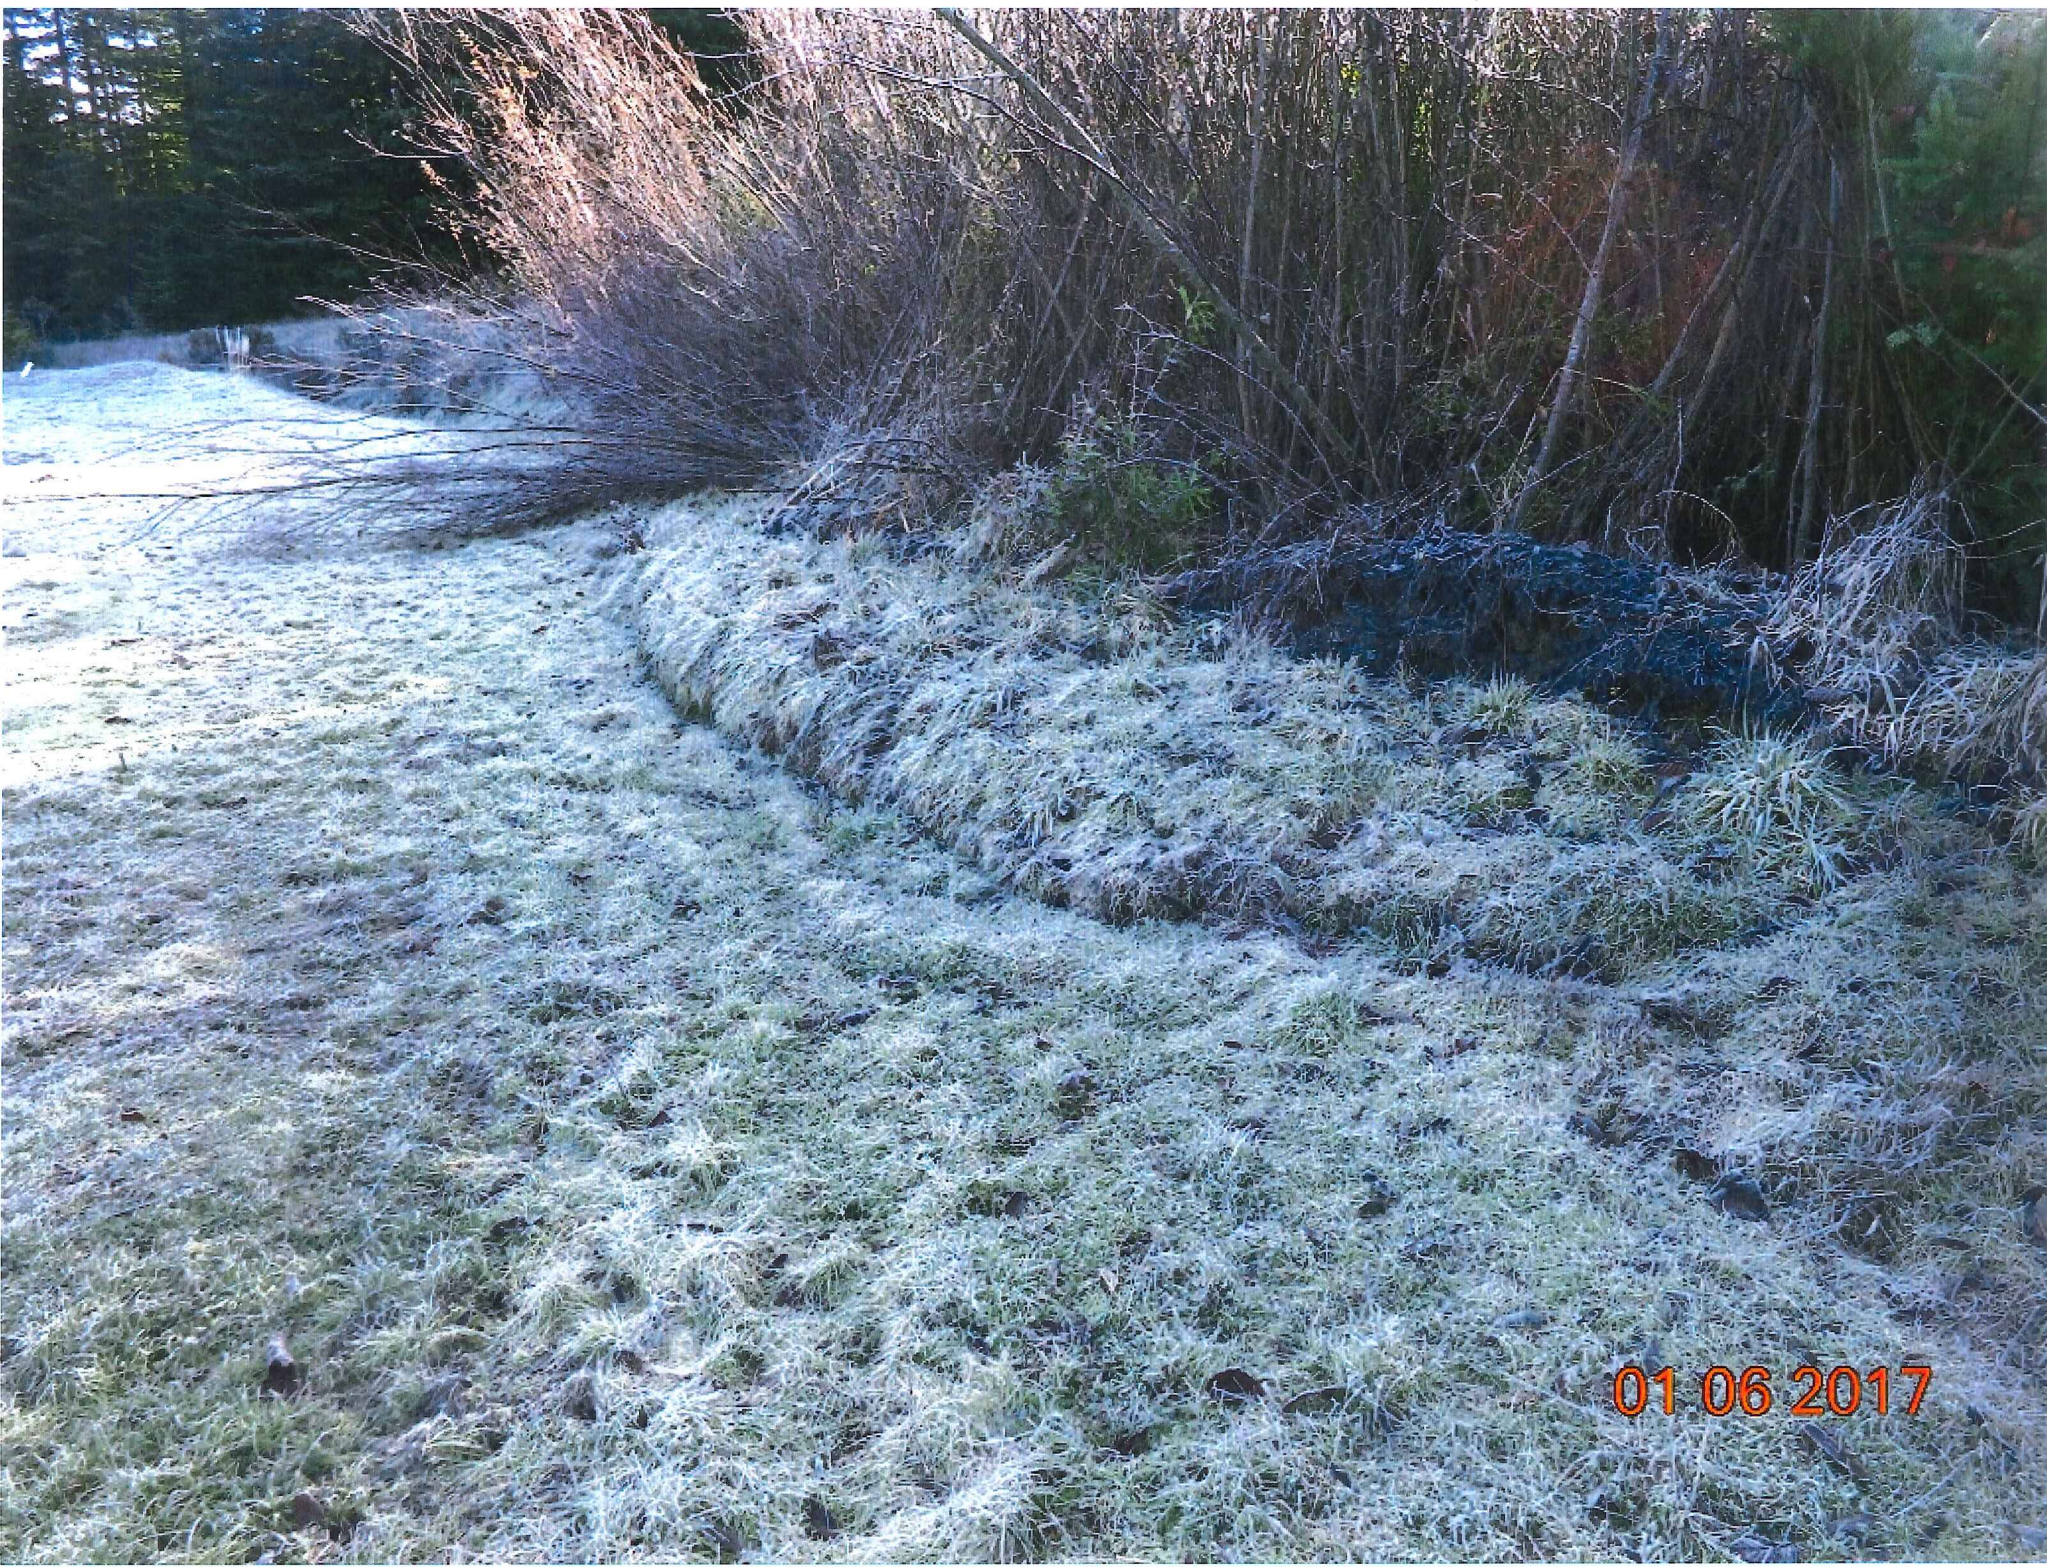
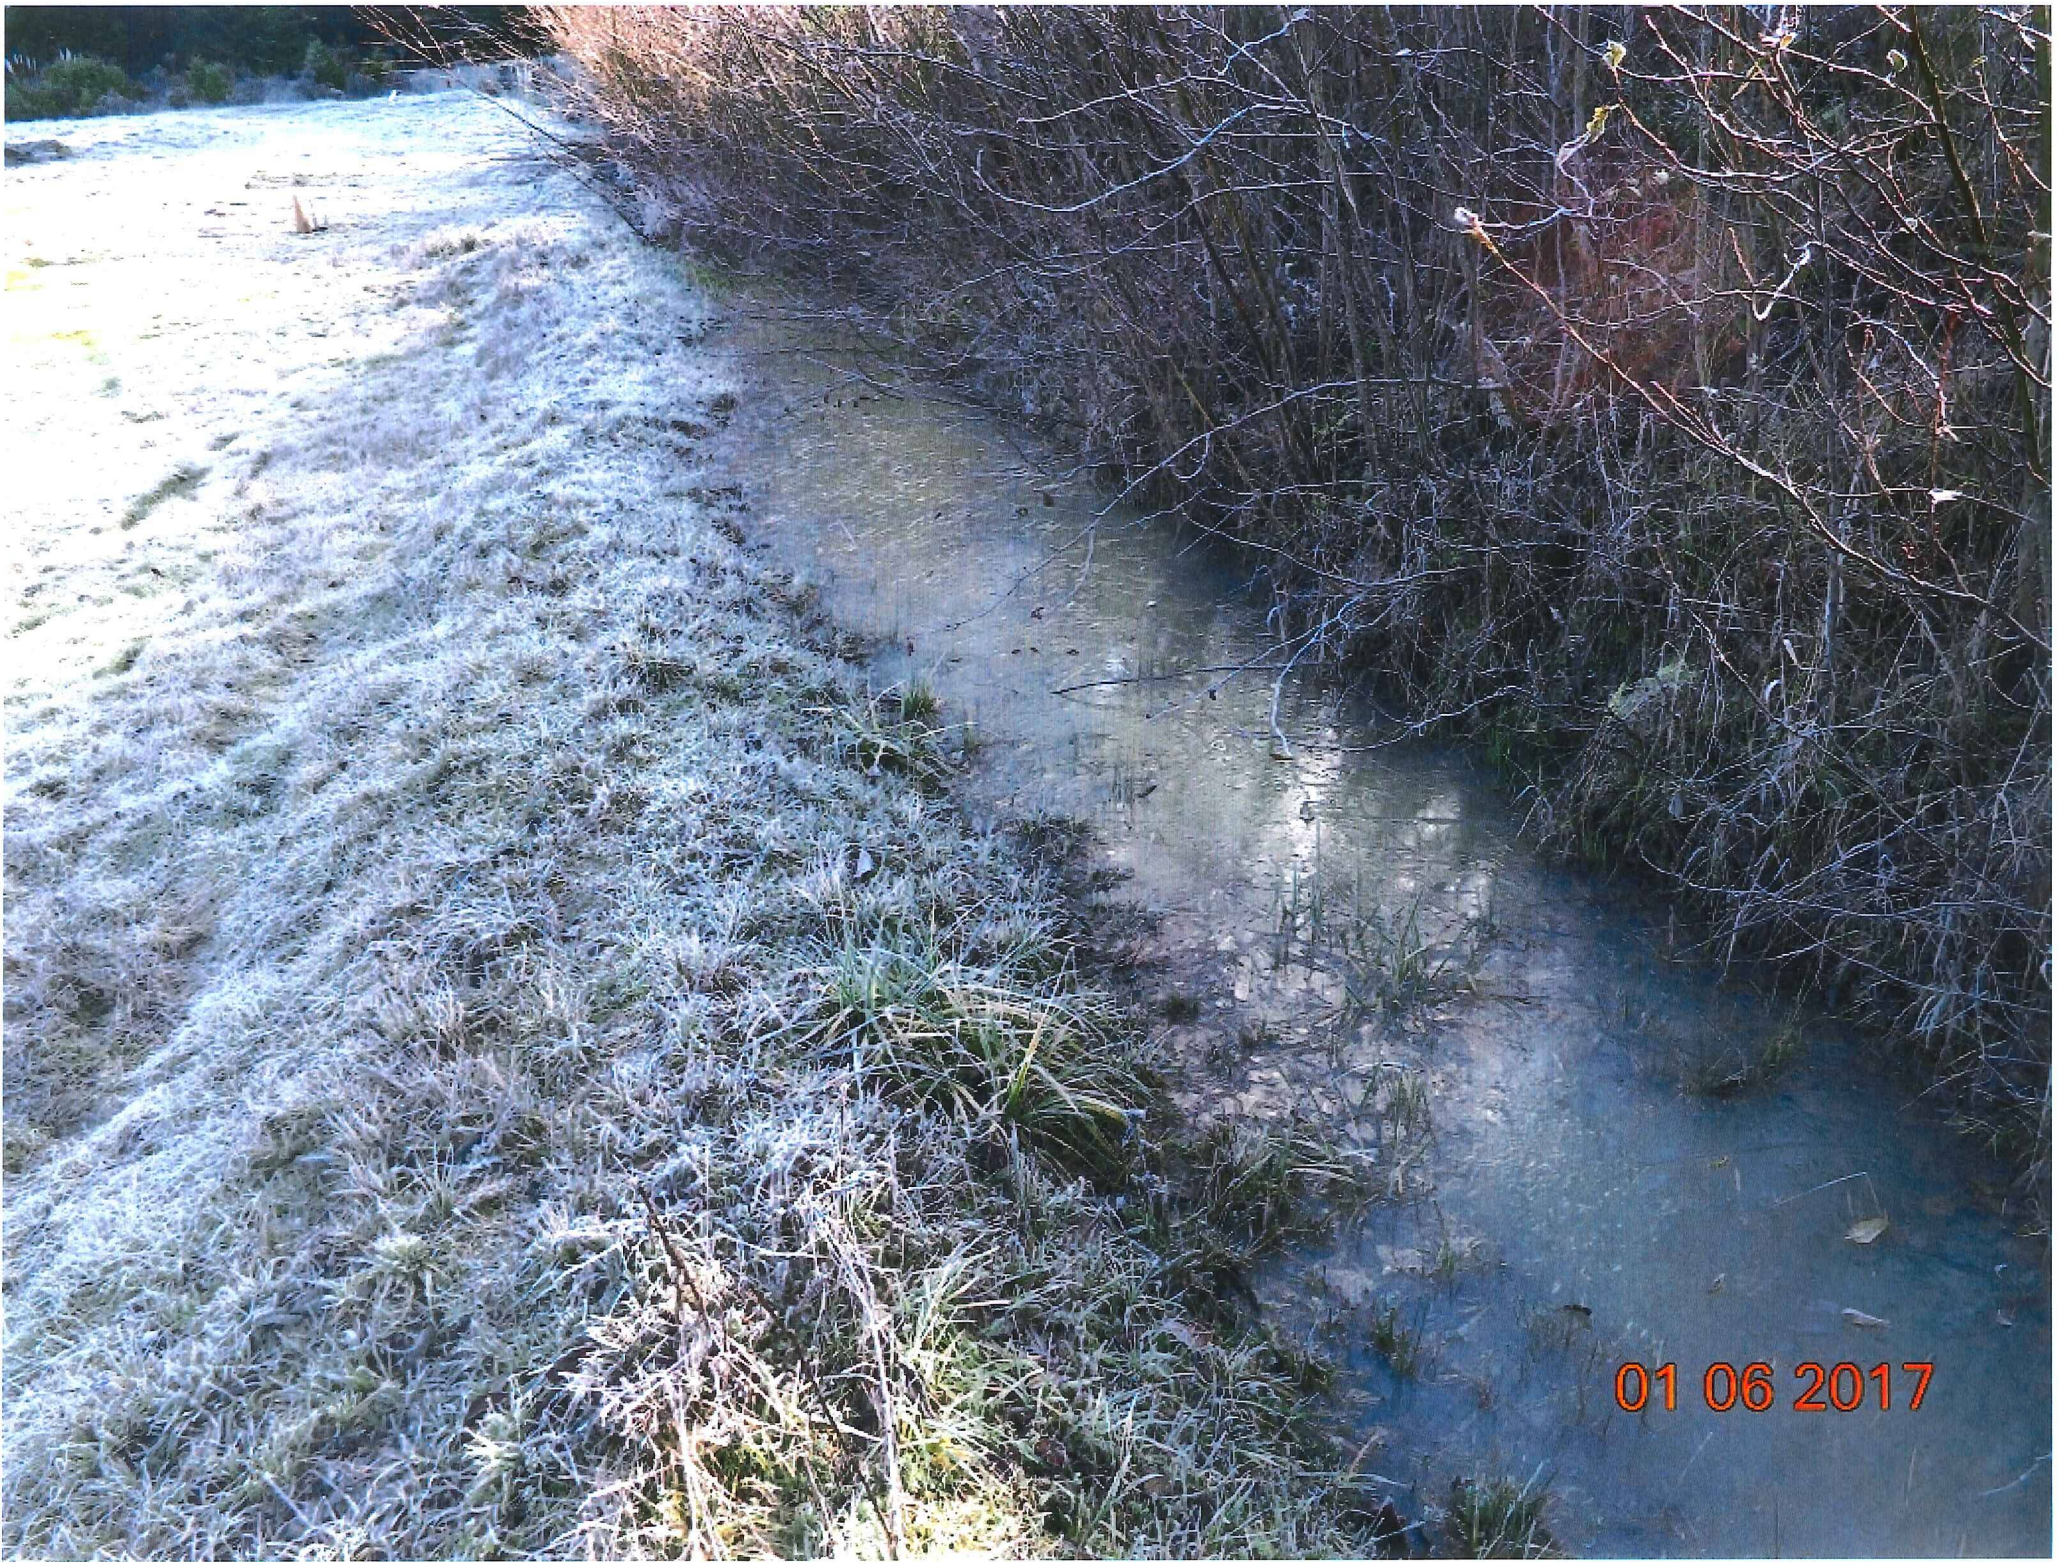
- G. On January 6, 2017, LEA staff inspected the Site and noted that a hole had been cut in the PVC effluent pipe of the lower pond and that the pond was nearing full capacity. During the inspection, Suzanne McClurkin-Nelson of HRC made telephone calls to arrange pumping from the pond and leachate tanks. LEA staff also noted that earth movement had blocked a portion of the west side perimeter drainage ditch (run-on control ditch) and that Ms. McClurkin-Nelson was to inform the roads crew that the slide material needs to be cleared (see Attachment C).

| V | A | Regulations |
|---|---|---|
| <p>Comments: Issue #1: The effluent pipe in the lower sedimentation pond had been altered since the last inspection so that the top of the pipe was at a higher elevation than the lowest edge of the pond (see photo: Tank Gulch 1-6-17, P1). A hole approximately 8 X 3 inches had been cut into the pipe near the bend in the elbow that would allow some water to enter the pipe (see photo: Tank Gulch 1-6-17, P2) It appeared that if the pond were to exceed capacity water may run onto the road before entering the pipe. The pond was nearing its full capacity.</p> <p>Title 27 California Code of Regulations Section 20820 states, "(a) The drainage system shall be designed and maintained to: (1) ensure integrity of roads, structures, and gas monitoring and control systems; (2) prevent safety hazards; and (3) prevent exposure of waste."</p> <p>During the inspection Suzanne McClurkin-Nelson made phone calls and arranged for two water trucks to pump water from the pond and the leachate collection tank that same day. She stated that arrangements would be made to pump water from the pond as necessary until the pipe could be corrected.</p> <p>Issue #2: A section of the hillside on the west side of the site had slid down into the waste footprint and was obstructing the perimeter drainage ditch (see photo: Tank Gulch 1-6-17, P3). The obstruction was causing the water in the ditch to back up (see photo: Tank Gulch 1-6-17, P4), and the ground immediately down gradient (inside the footprint) was very soggy. S.McClurkin-Nelson stated that she would inform the roads crew that the slide material needs to be cleared.</p> | | |
