North Coast Regional Water Quality Control Board

Subject: **Notice of Violation** of Waste Discharge Requirements Order No. R1-2001-61, Construction Specification No. 3; and Provision Nos. 14 and 18; and **Threatened Violation** of Discharge Prohibitions No. 8 and 15; and **Requirement for Information** Pursuant to California Water Code section 13267, for Tank Gulch Waste Pile, Humboldt County

File: Tank Gulch Waste Pile, Humboldt County, WDID No. 1B92019RHUM

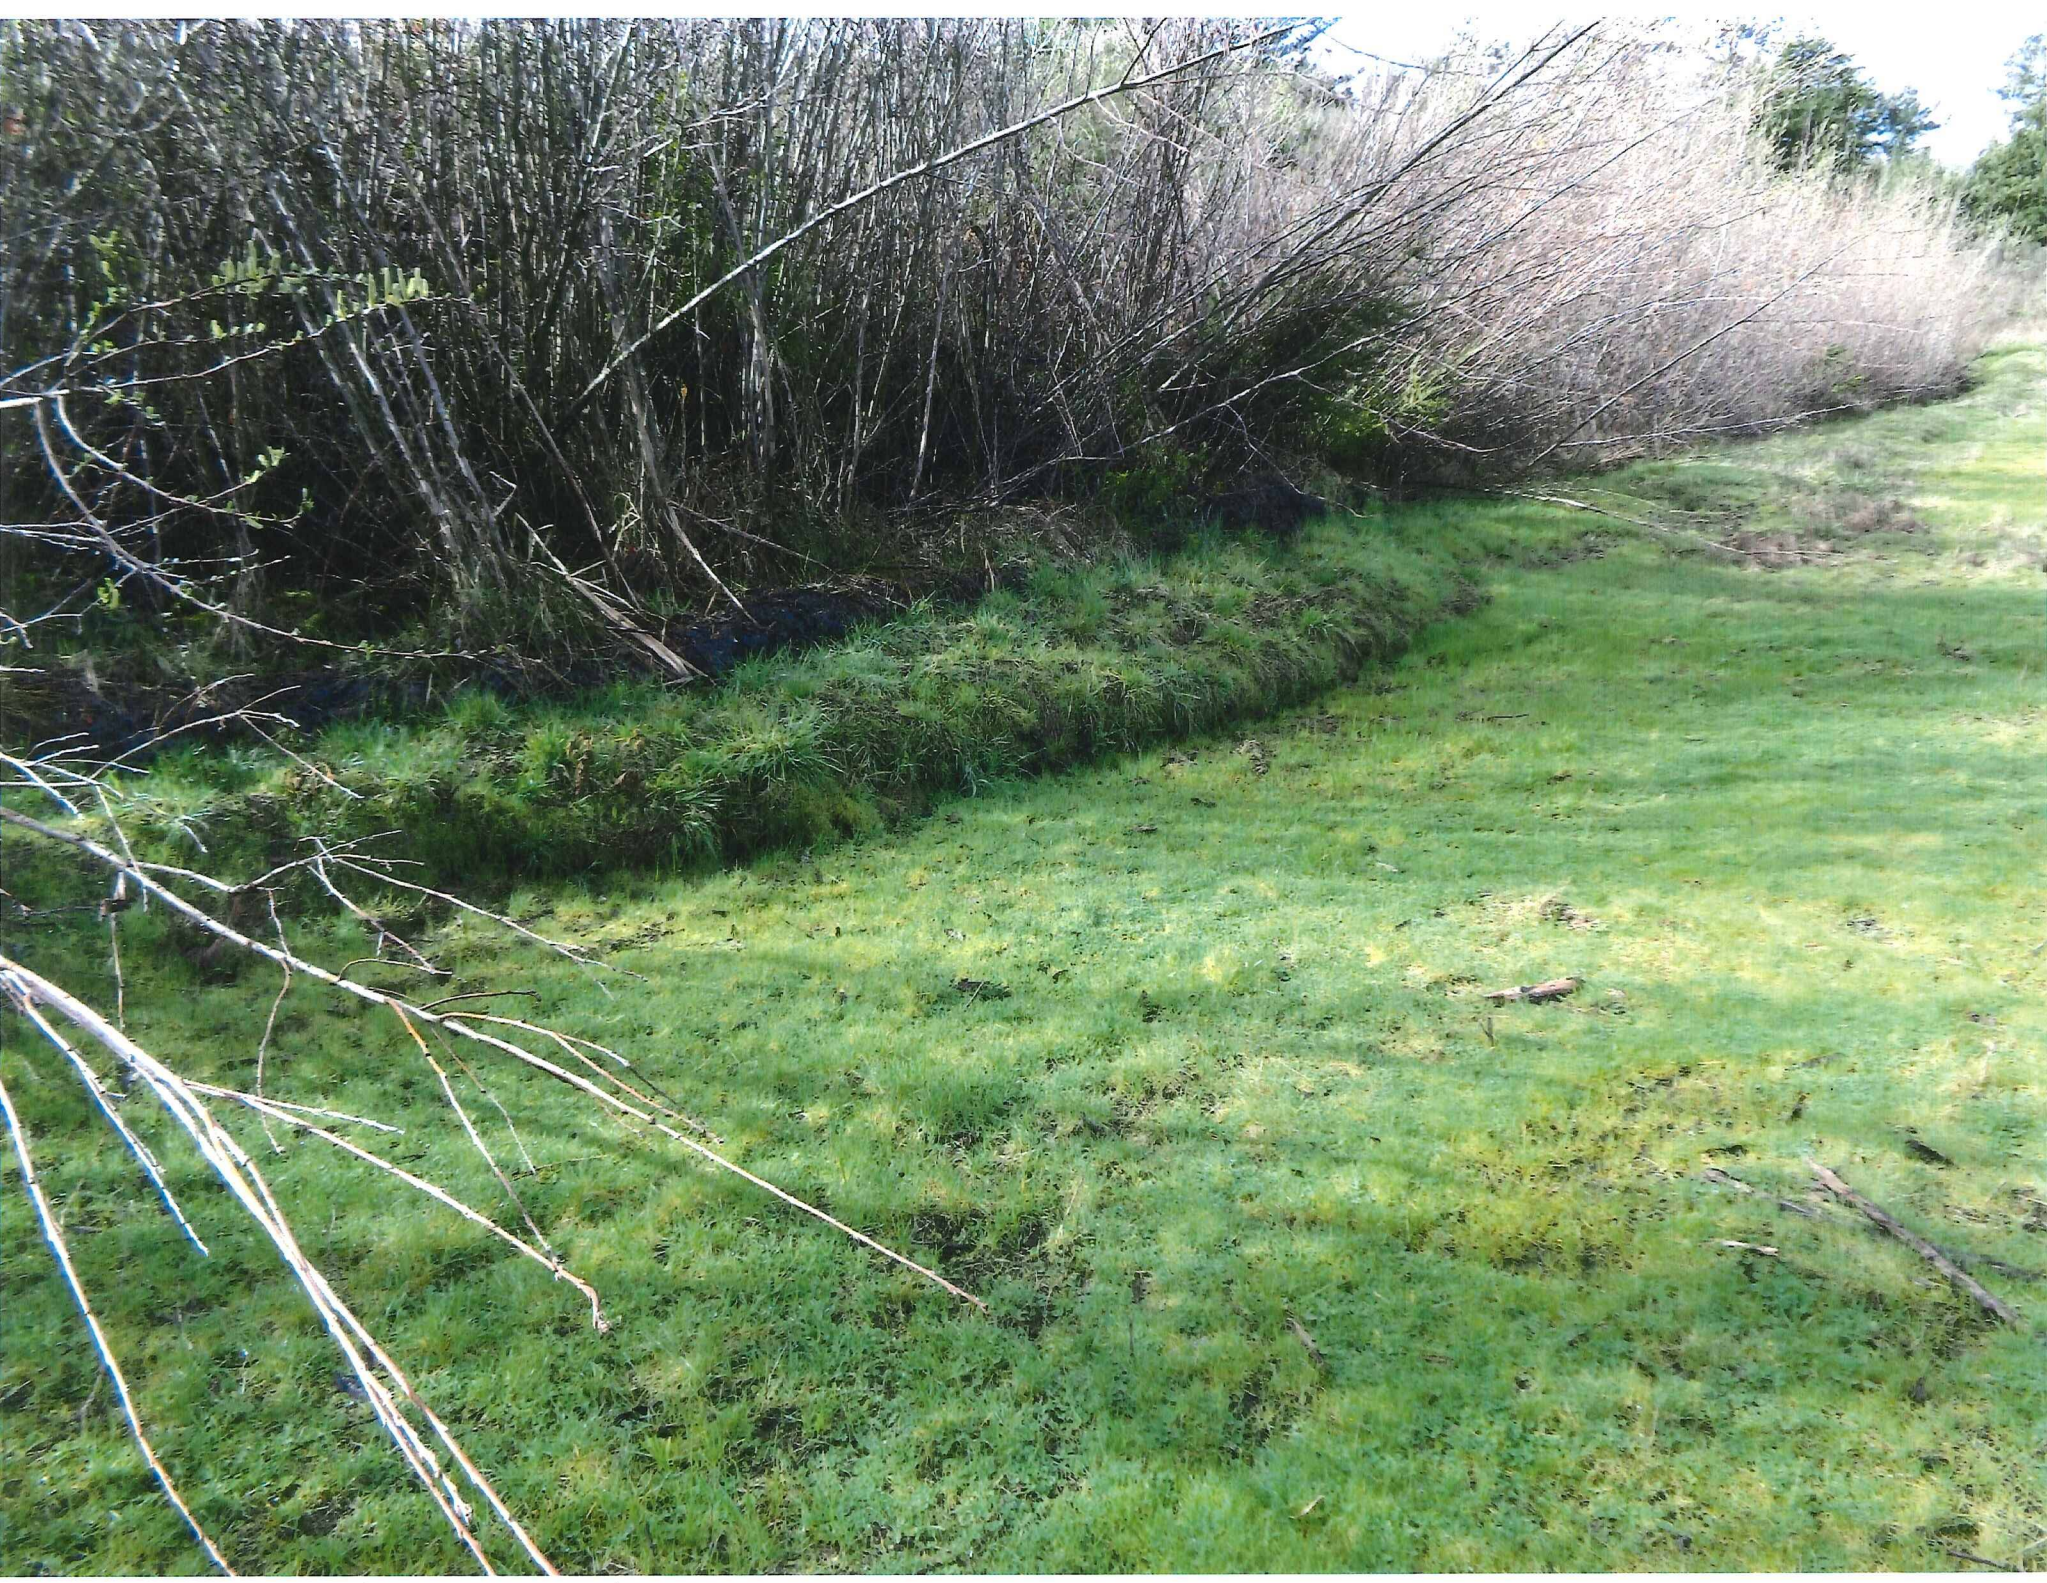
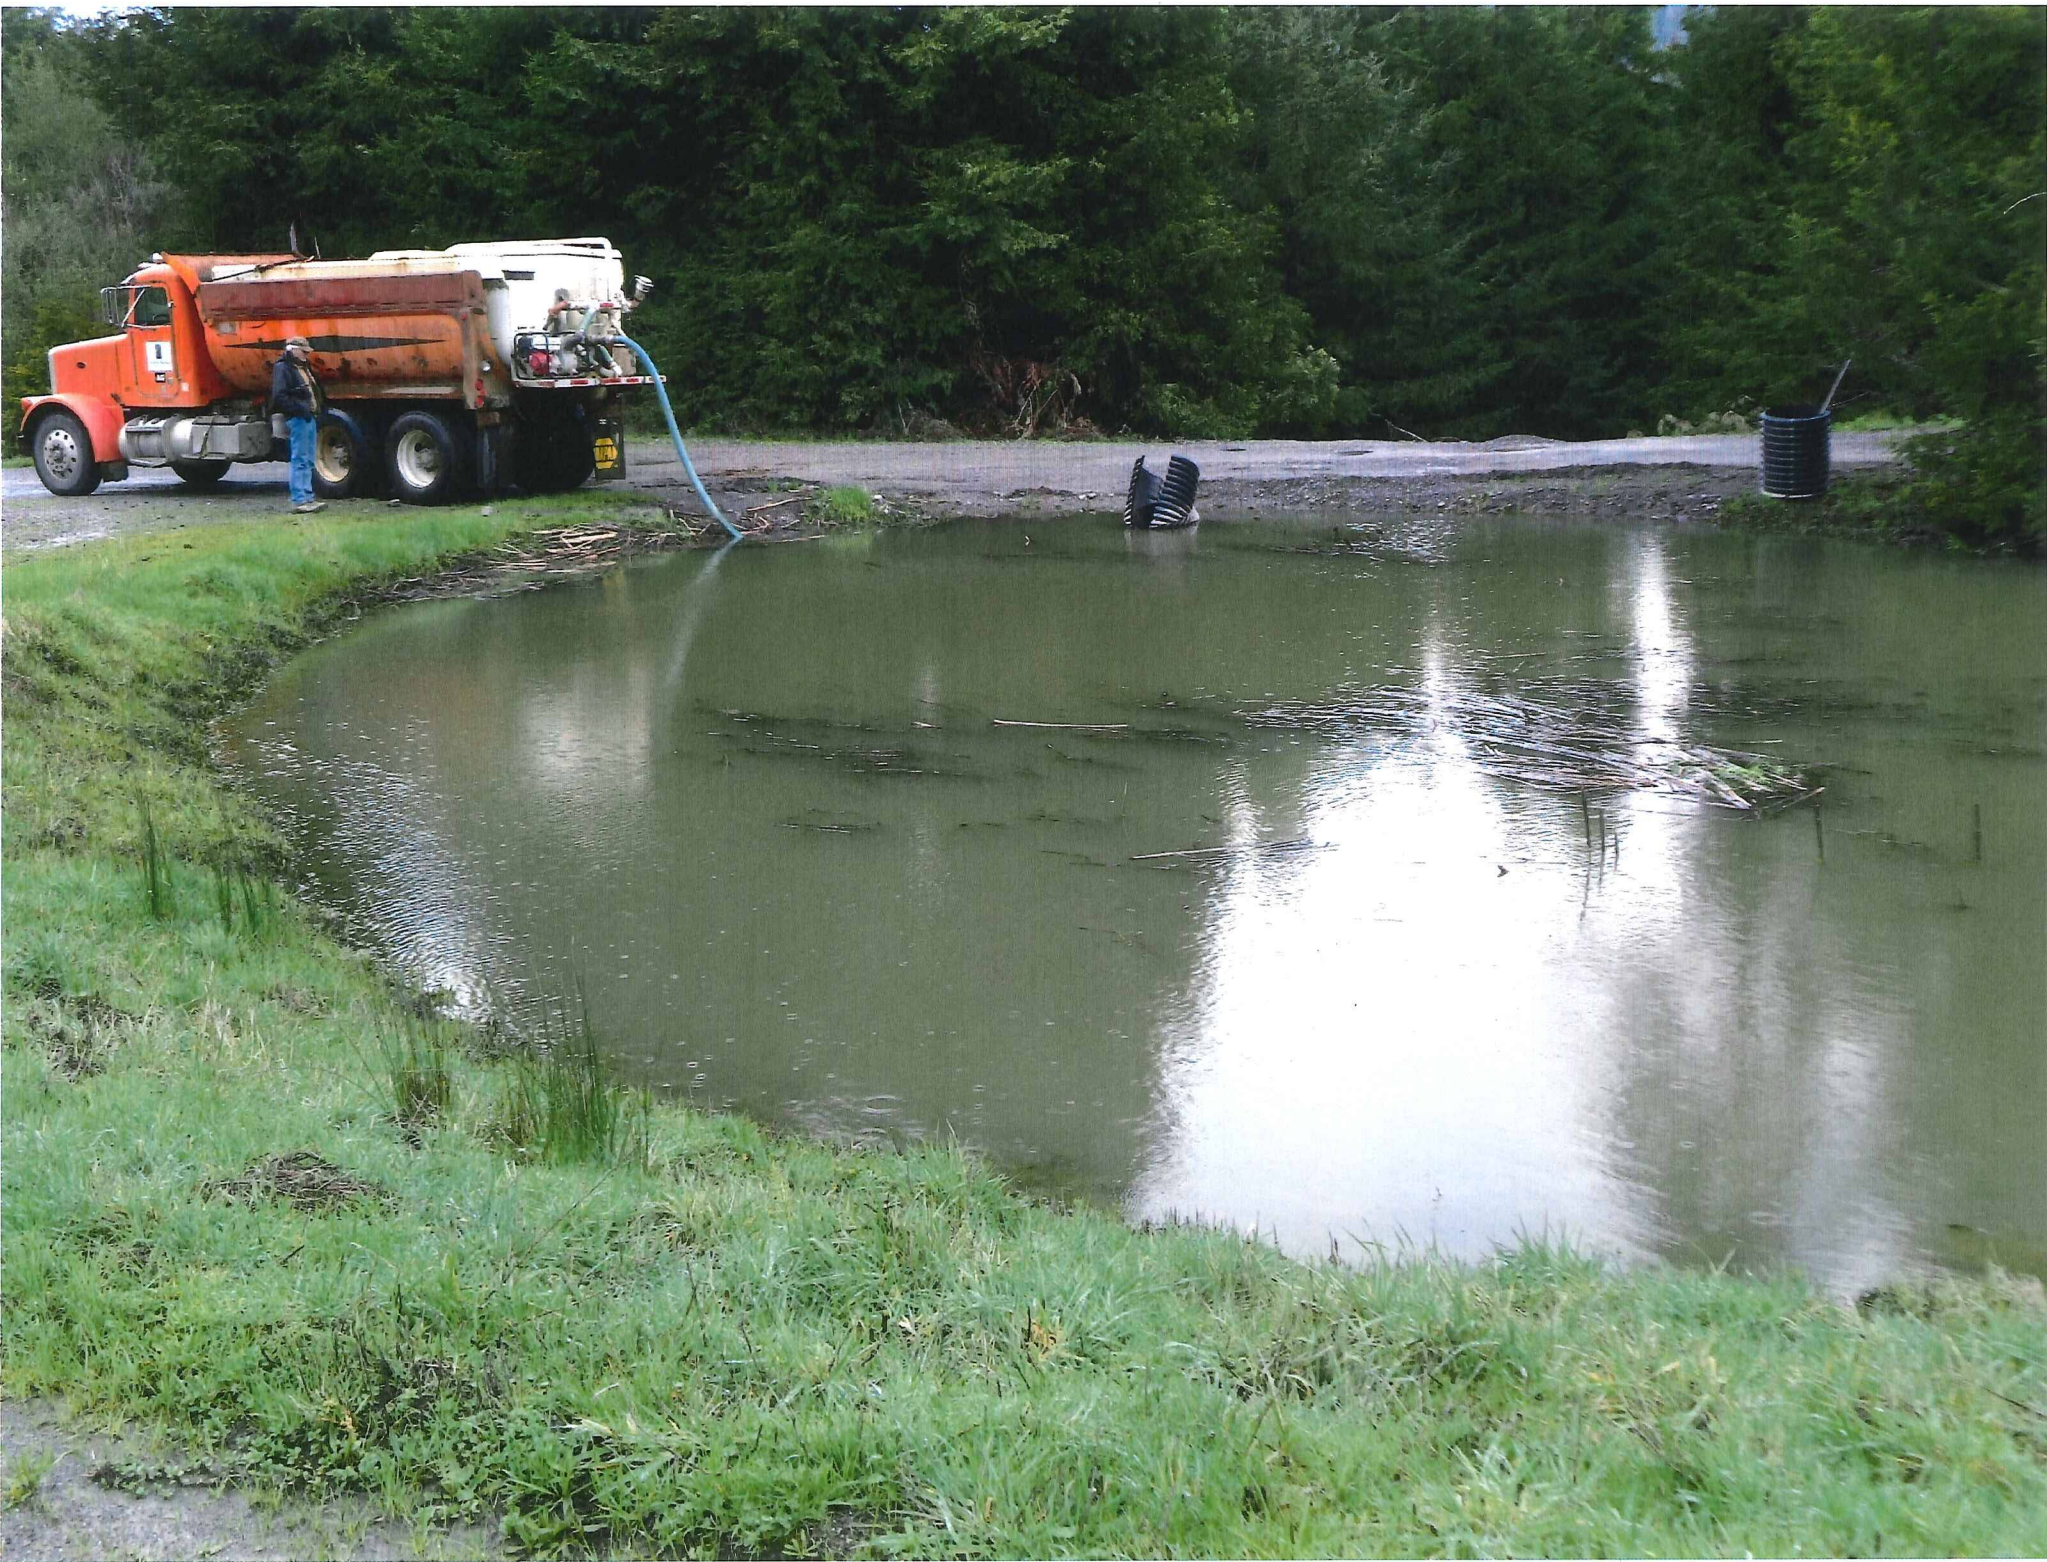
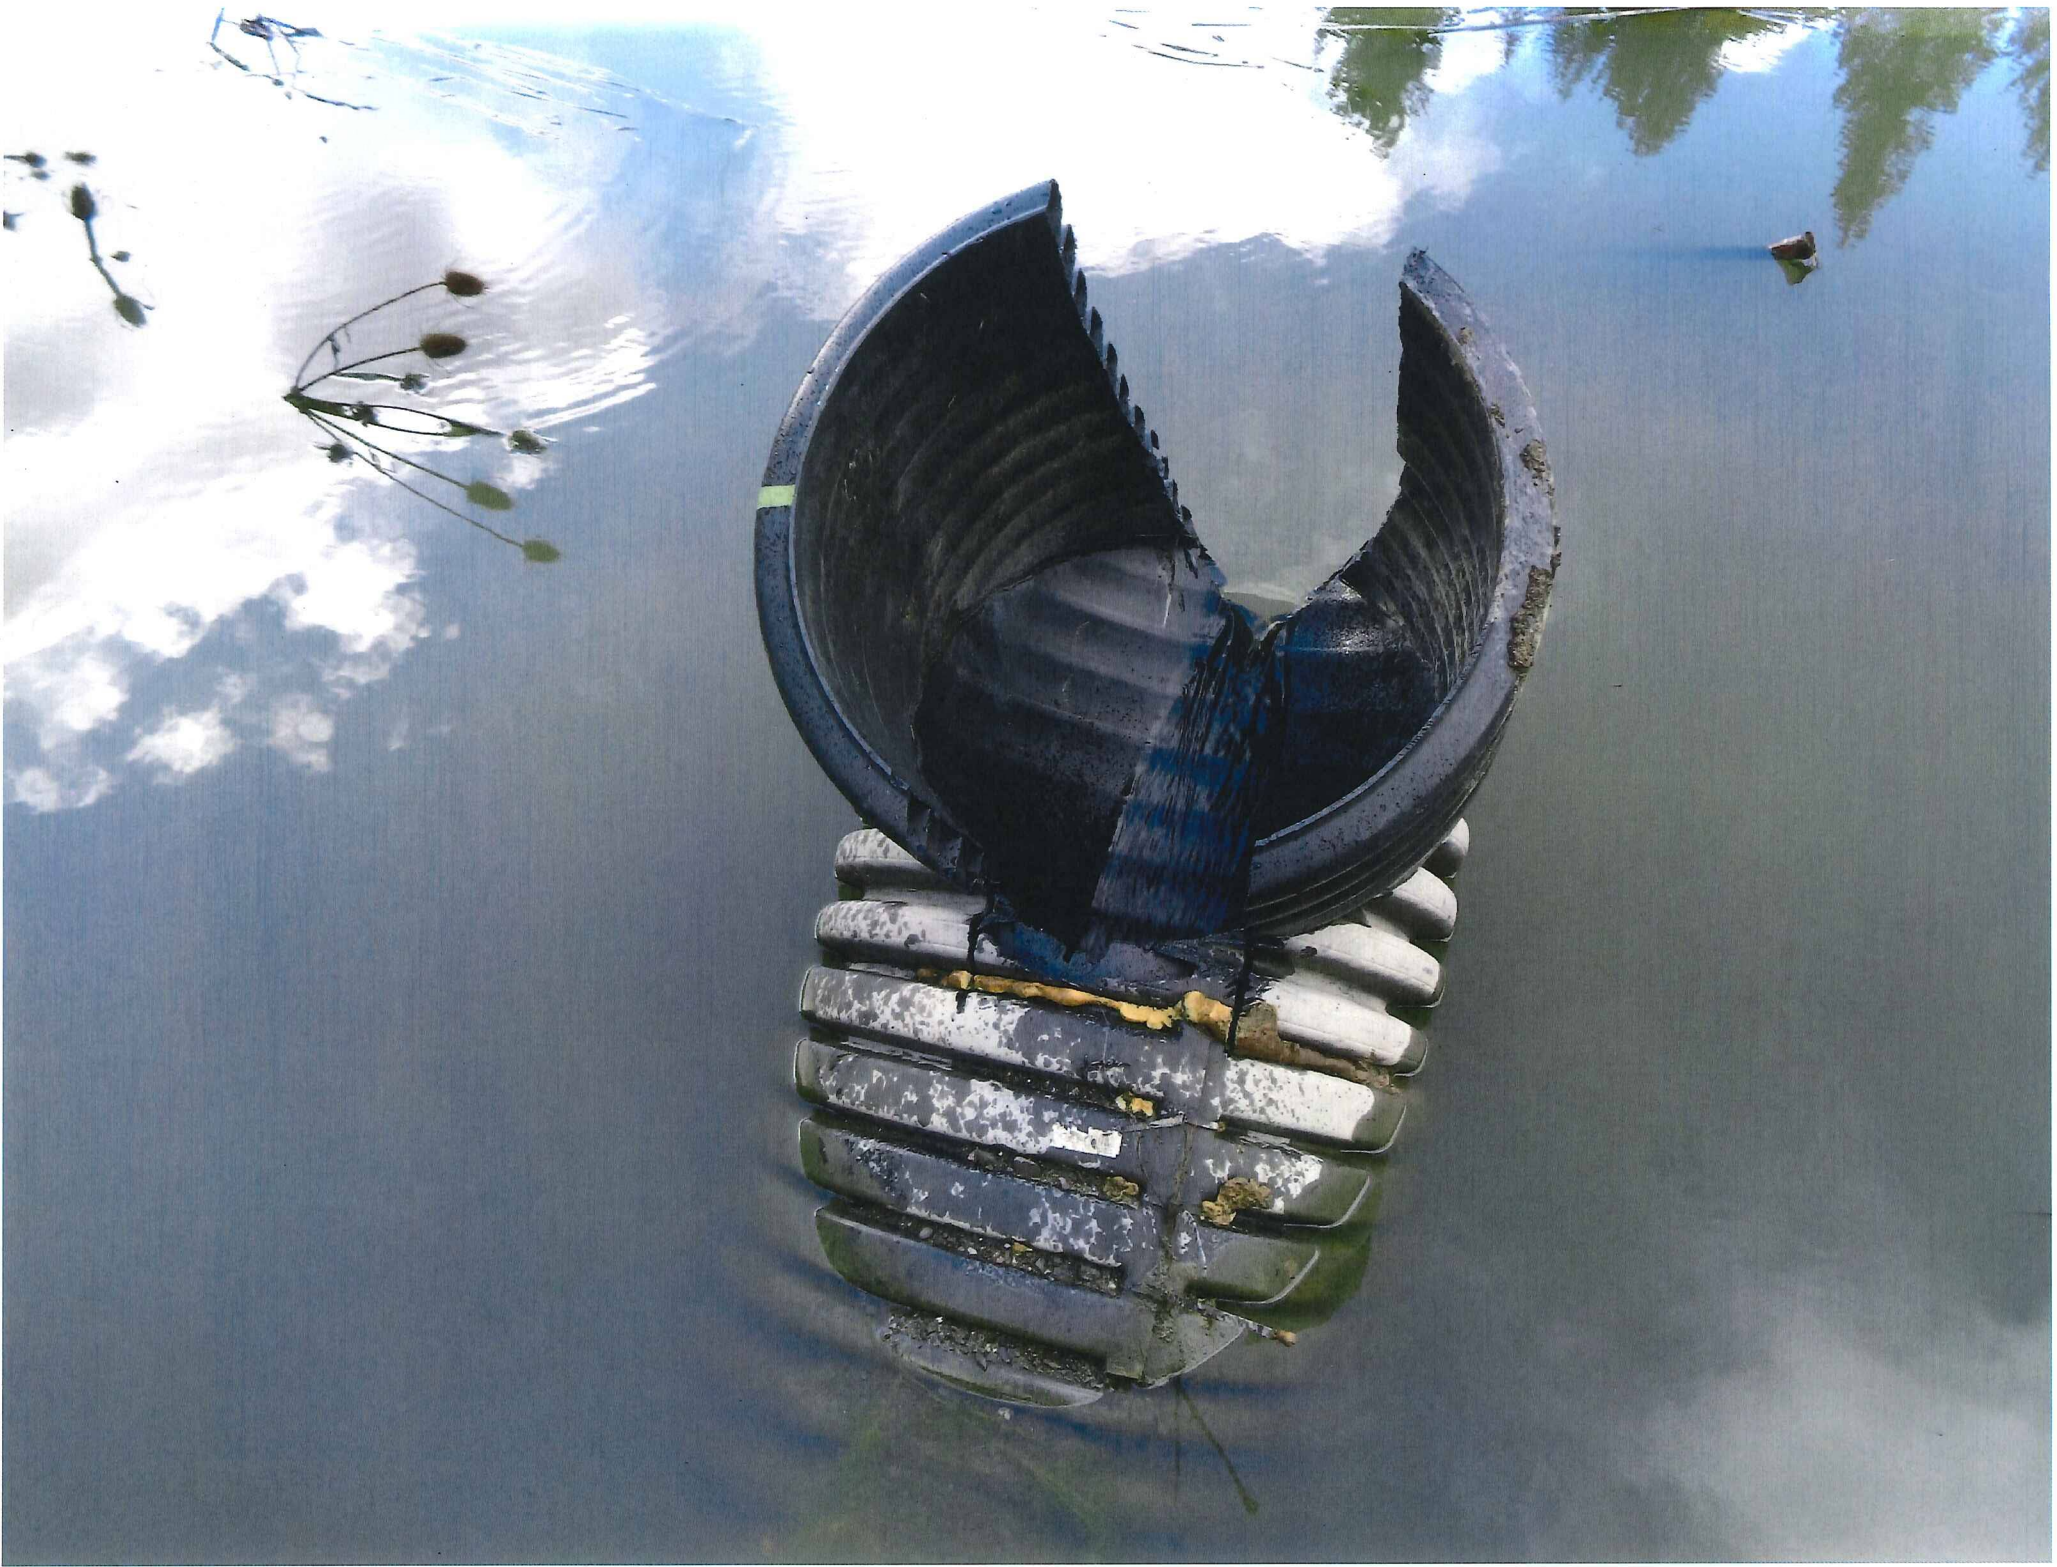
- I. On February 21, 2017, LEA staff inspected the Site and noted that the PVC effluent pipe of the lower pond had been cut and that water was draining into the PVC effluent pipe and discharging to the ground surface on the north side of Ash Dump Road (see Attachment D).

| V | A | Regulations |
|---|---|---|
| <p>Comments: The section of the hillside on the west side of the site that had slid down into the waste footprint and was obstructing the perimeter drainage ditch (see photo: Tank Gulch 2-21-17, P1), and was cited in the 1/6/17 inspection report, appears unchanged. The obstruction continues to cause water to back up in the ditch, and apparently some water to seep into the lined waste footprint. I observed a small amount of water in the drainage ditch immediately down-gradient of the slide. It appears that some water contained in the ditch may be seeping past the slide, but due to the vegetation growing out of the slide material this could not be confirmed. S.McClurkin-Nelson stated that it was unlikely the slide material could be cleared until the rainy season ends and the roads crew has addressed other priority maintenance issues.</p> | | |

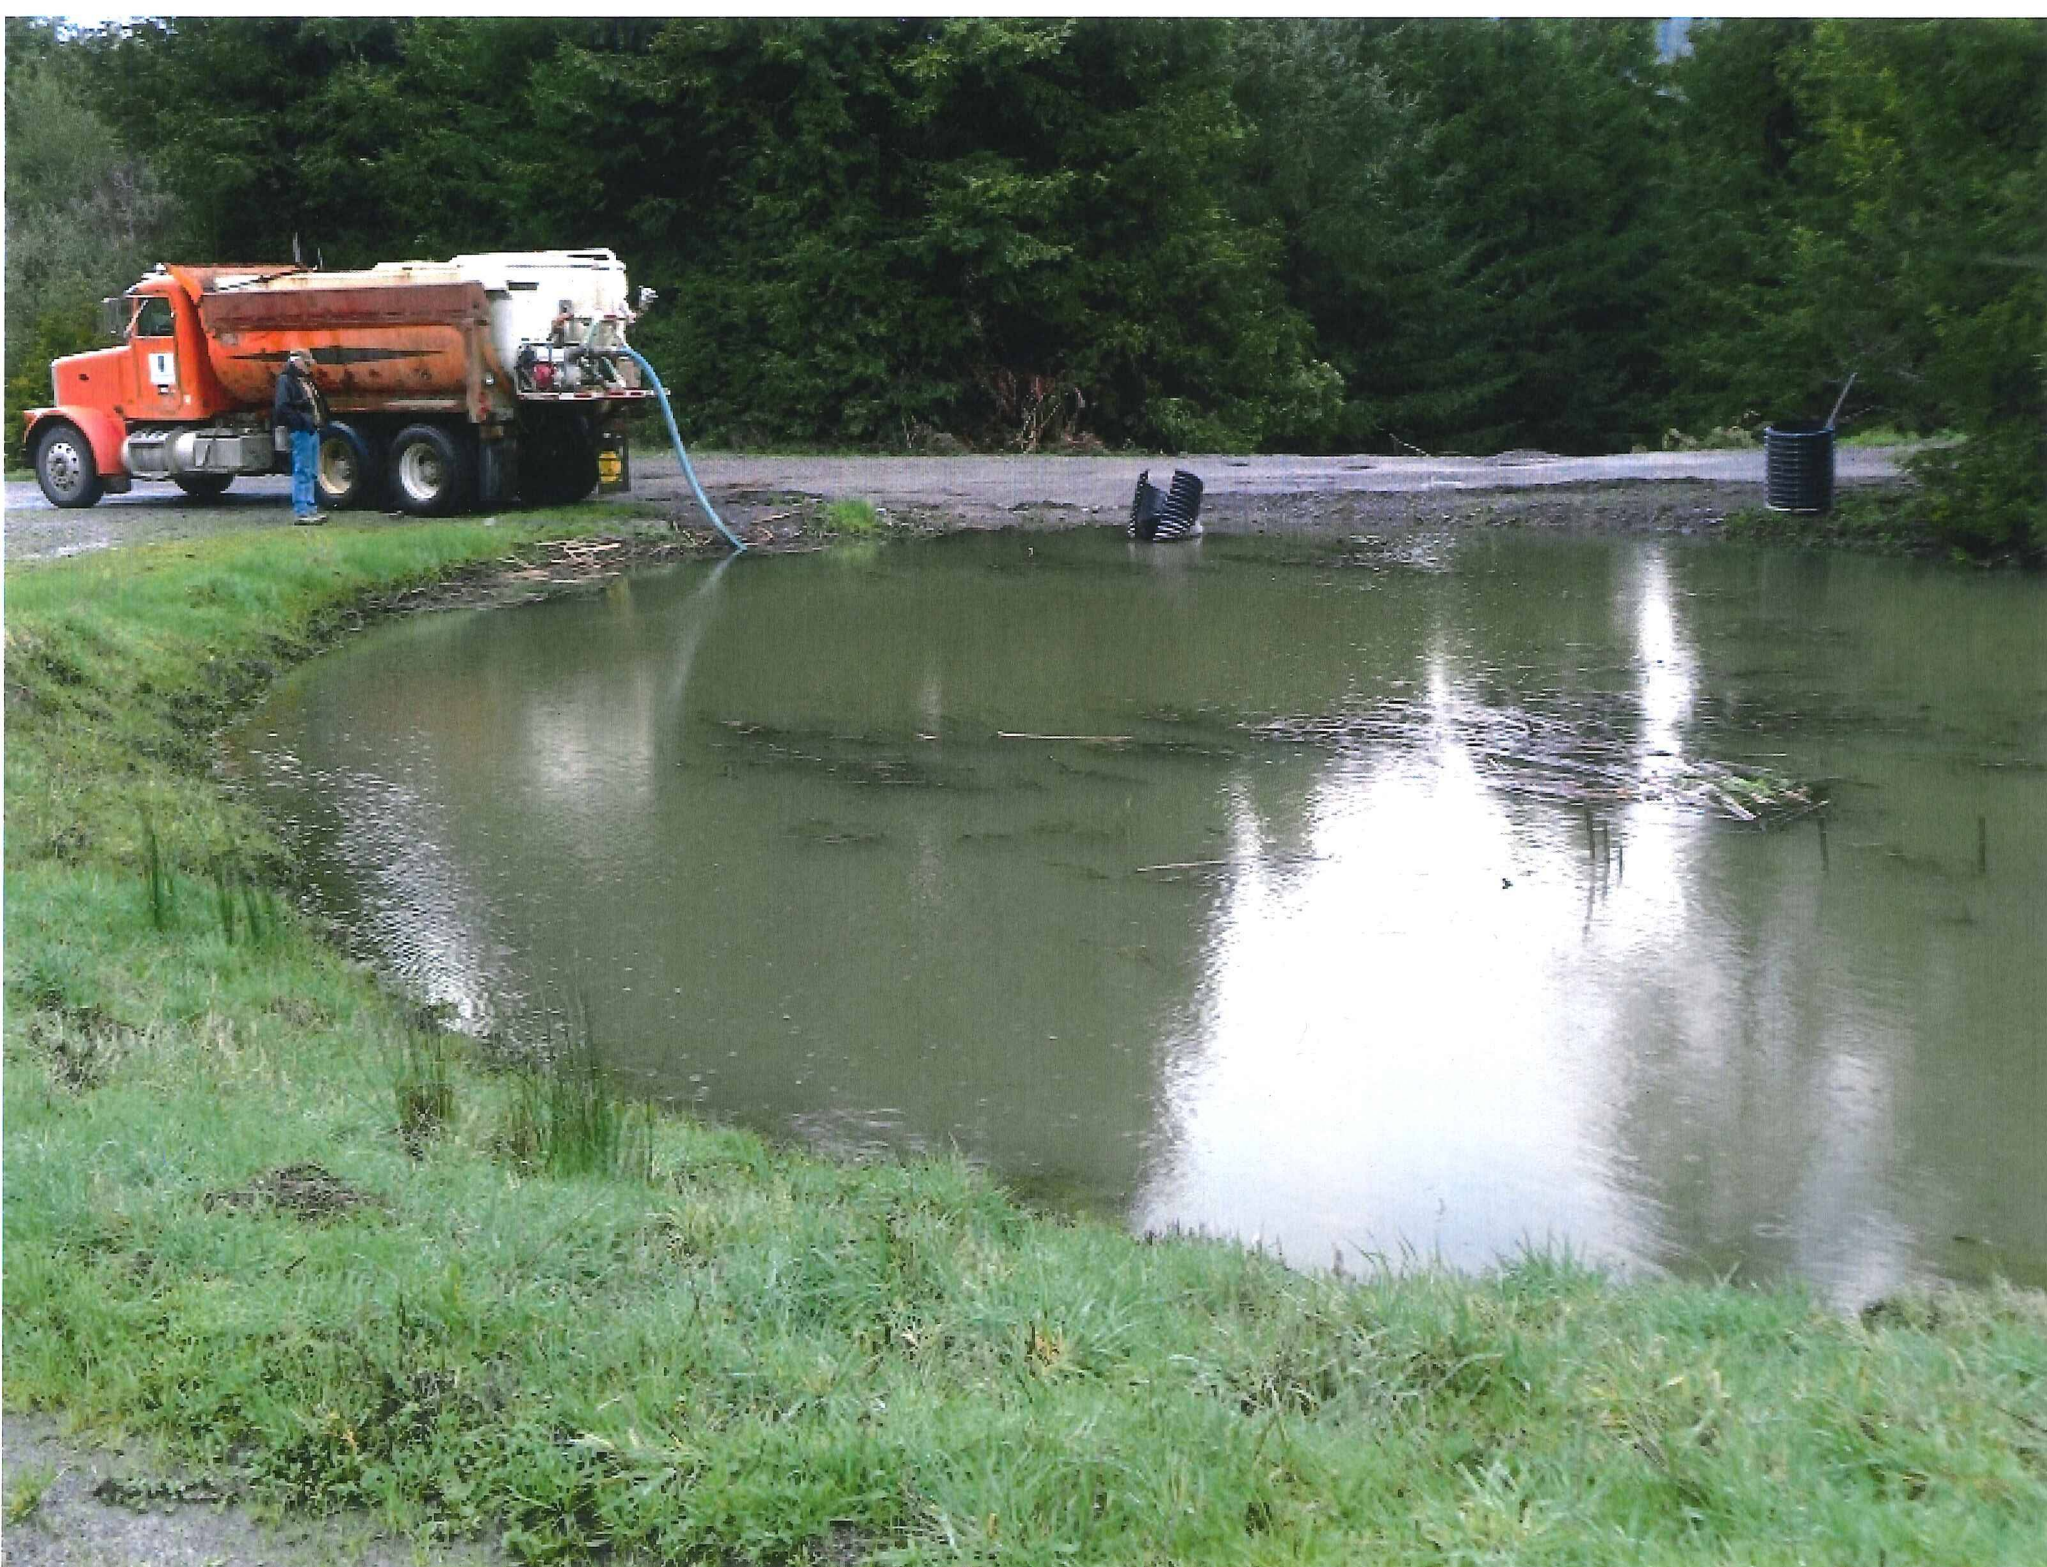
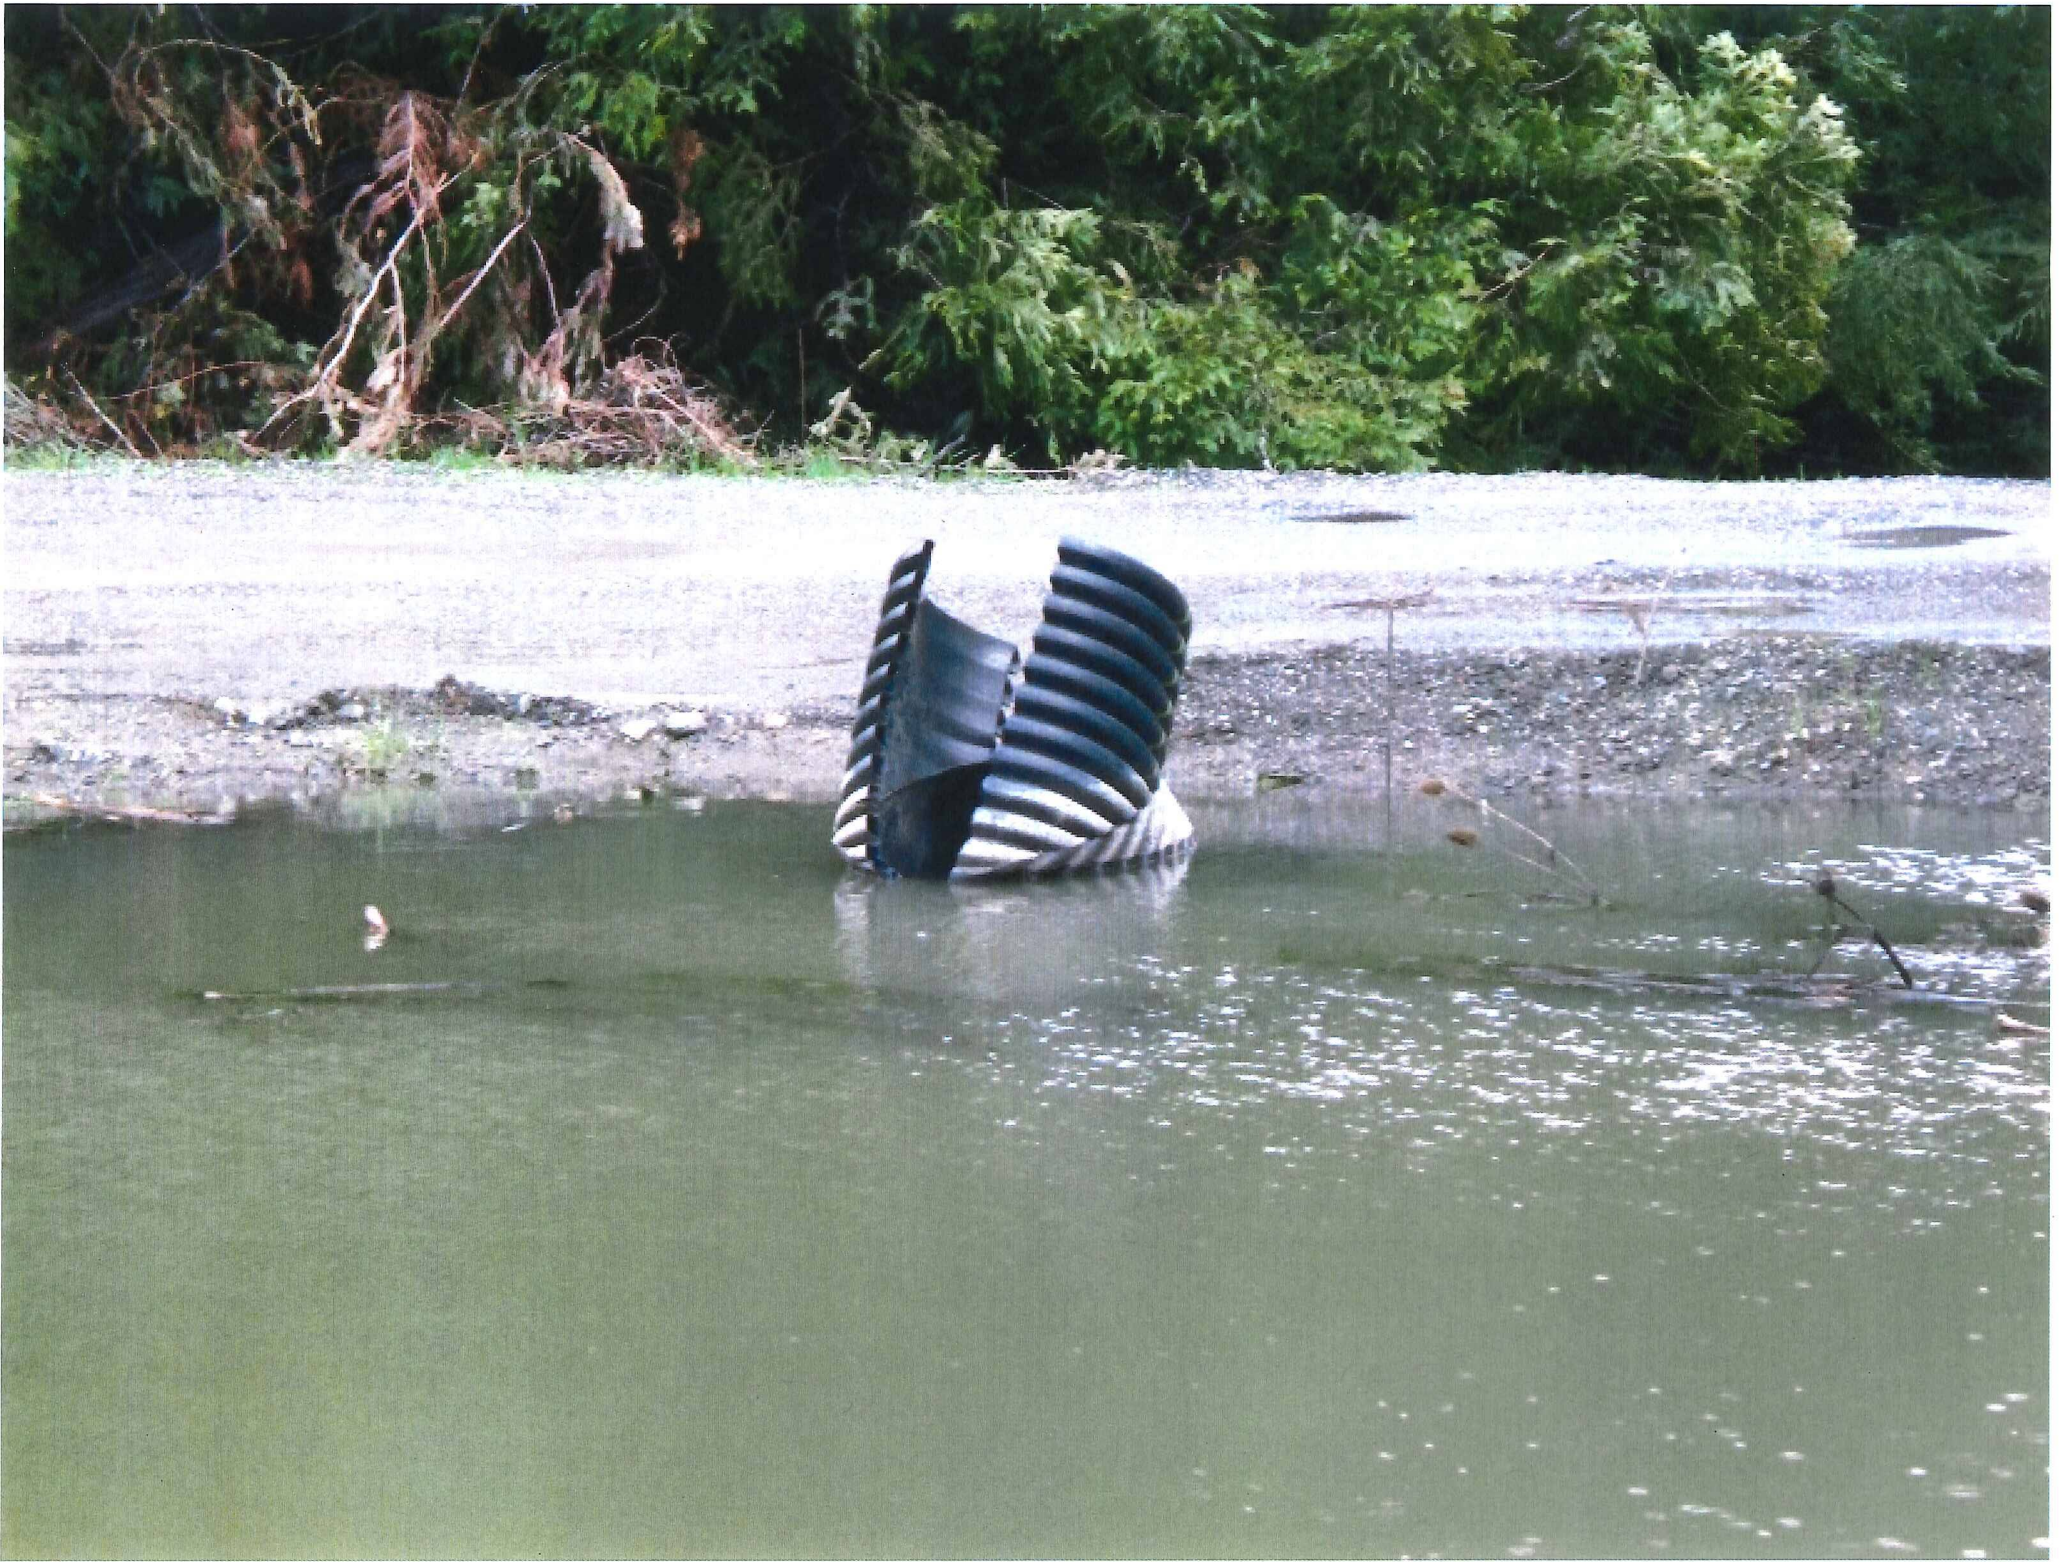
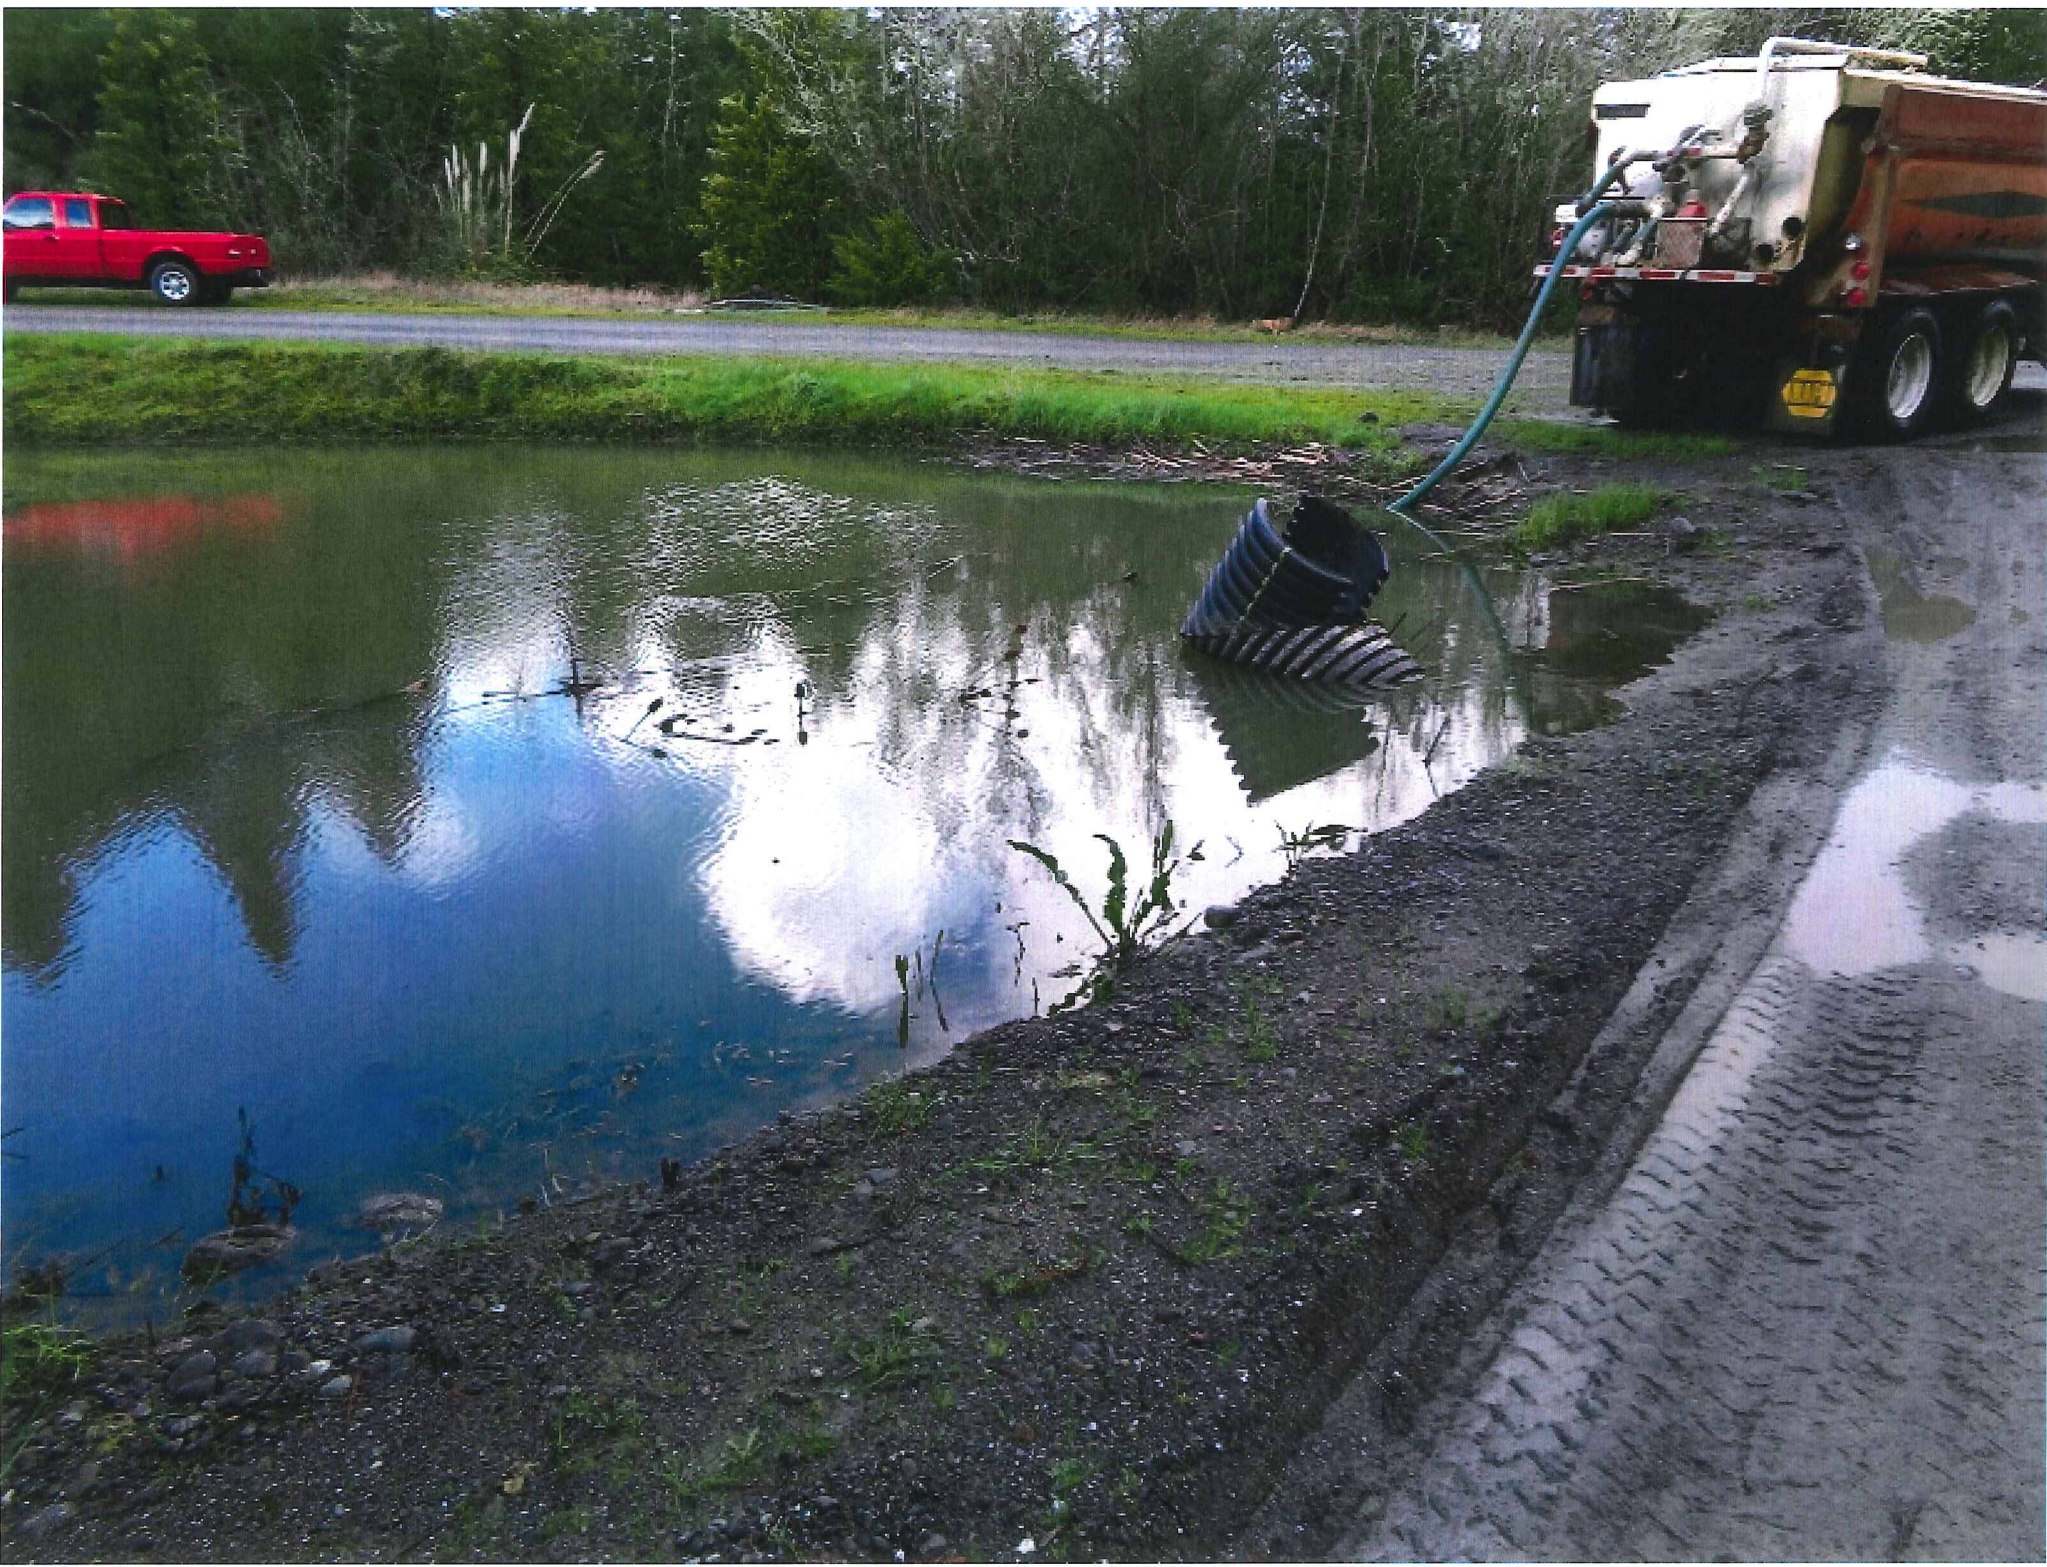
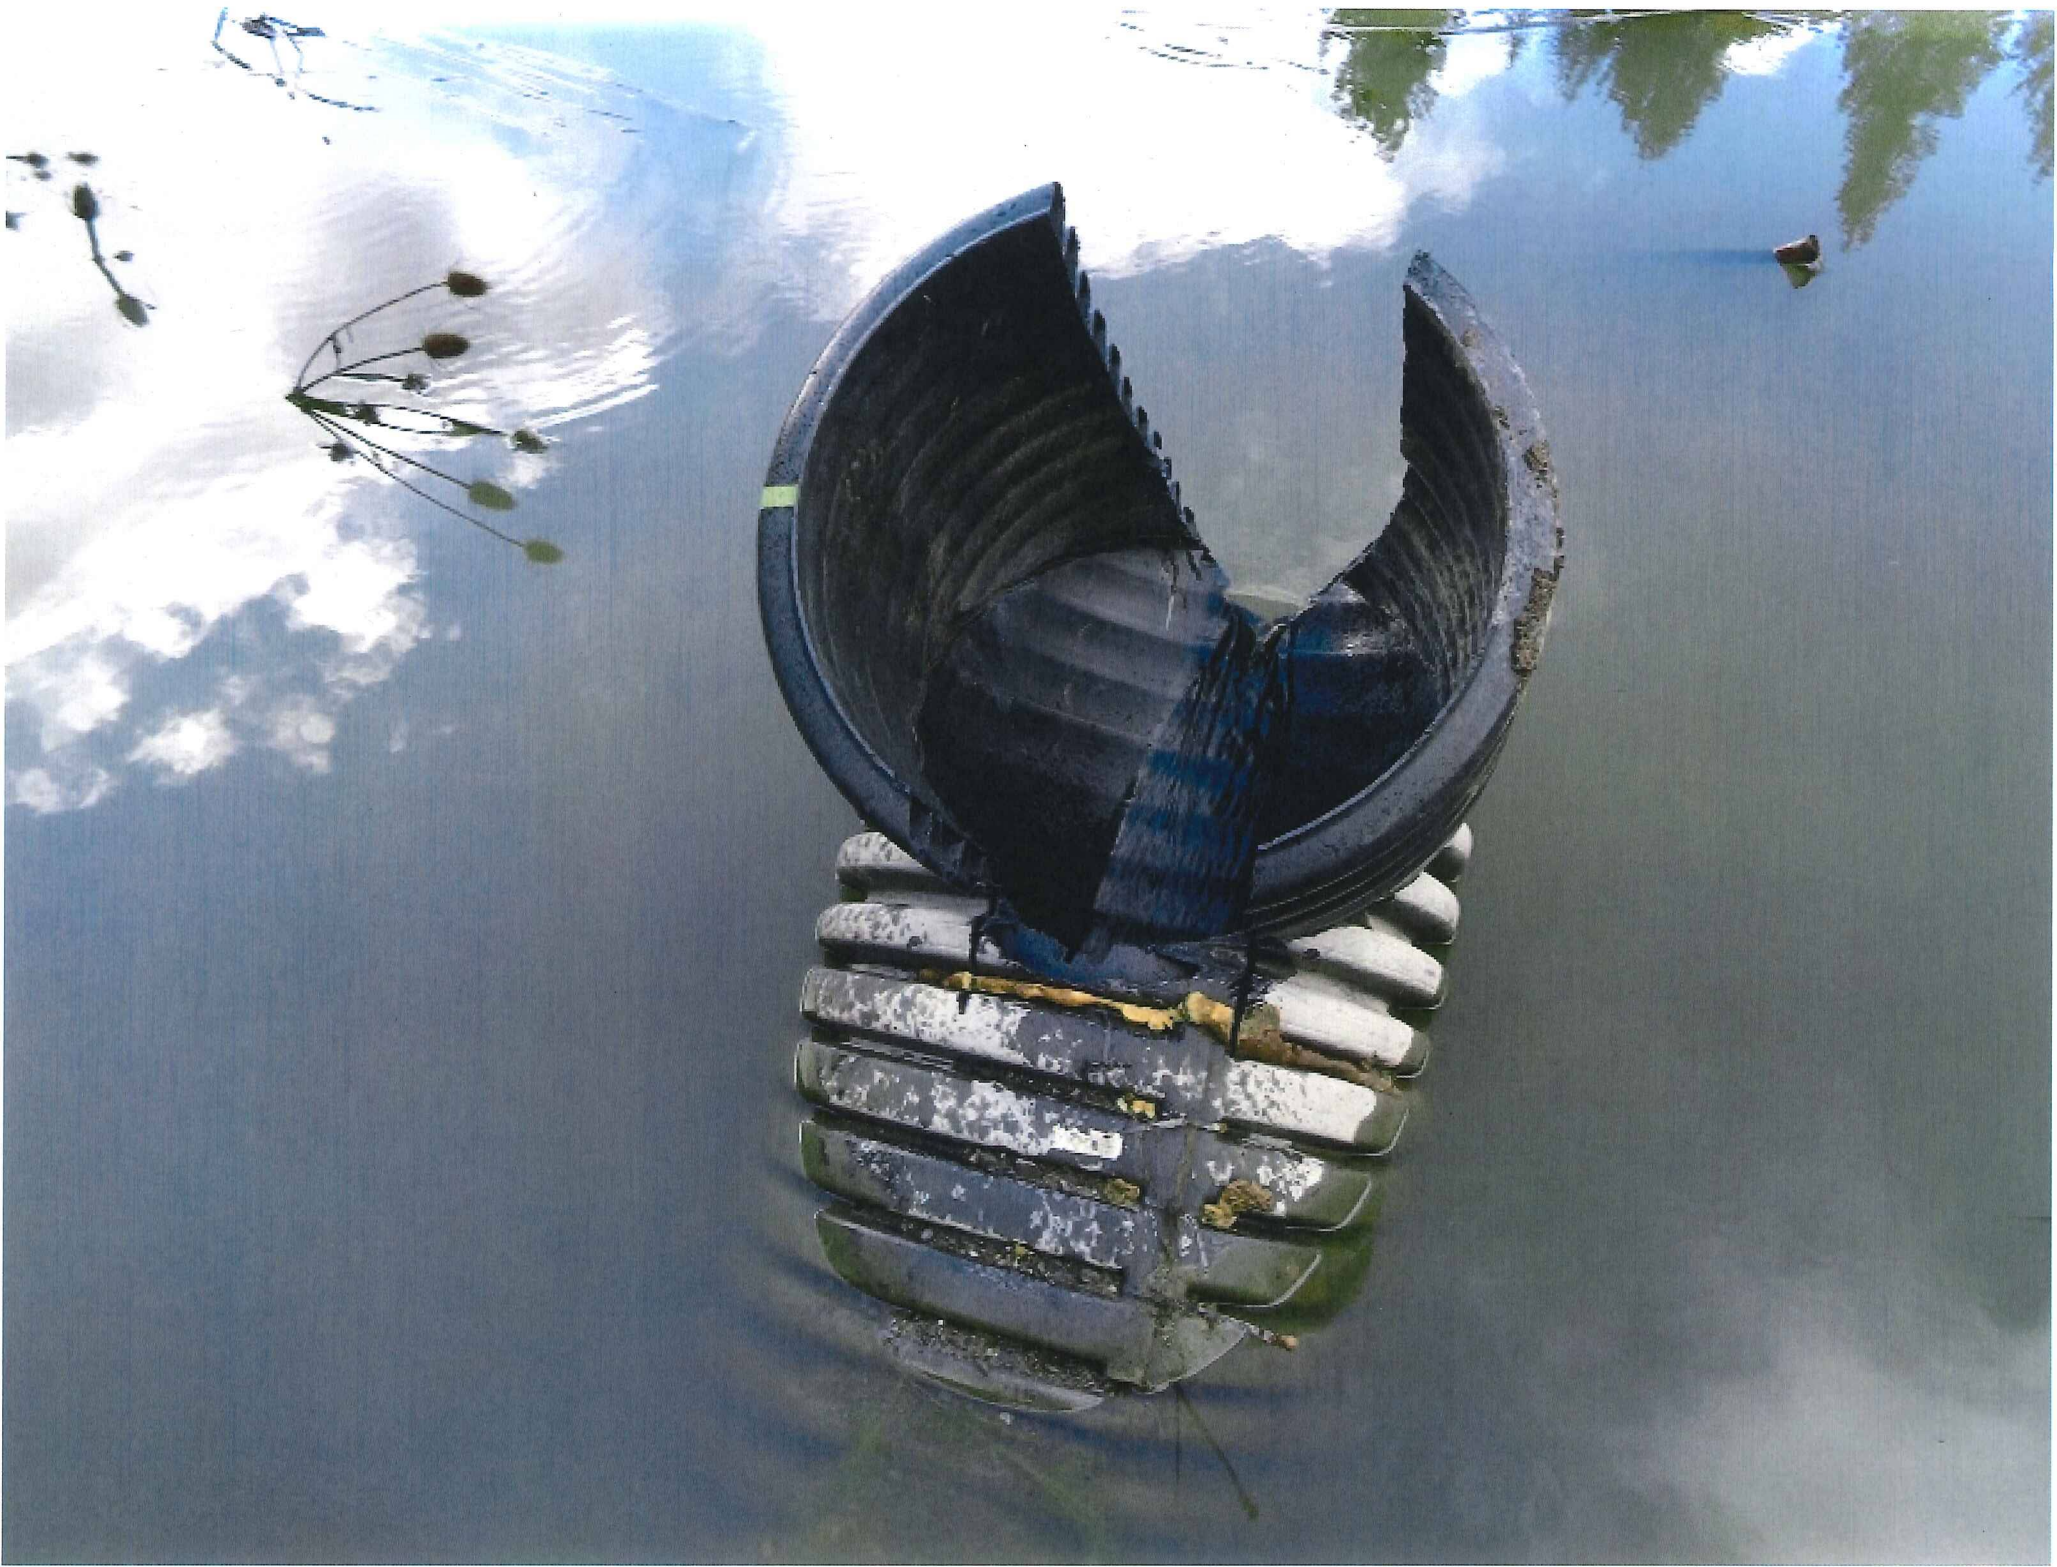
- J. On February 23, 2017, LEA staff sent email regarding the February 21, 2017, inspection, including photographs showing the cut at the top of the PVC effluent pipe (Attachment E).

I contacted Suzanne today about the pipe – she said the road crew was just supposed to repair the pipe, but replaced without contacting her and then made the “adjustment” without consulting her. She is going to be working on getting it repaired or replaced again when weather permits. She thinks they may have busted the pipe bending it like that. I

agree and think it is likely that the water is now leaking into the pipe trench beneath the pipe too (notice the water level is right at the bottom of the pipe).

I did let her know that the sed pond should not be allowed to discharge – they must pump the water as often as it takes. Also that repairs/changes must be verified and documented and those documents sent to me and that if they are going to substantially change the design of a landfill system we need a work plan to review before the work is done. She said she would work with SHN for the documentation requirements going forward.
