**North Coast Regional Water Quality Control Board**

**Shadow Light Ranch LLC Property**  
**CIWQS Place ID No. 825542**  
**Inspection Date November 2, 2017**  
**WDID No. 1B16868CHUM**

Attachment A:  
Photographic Record of November 2, 2017, Inspection of  
Shadow Light Ranch, LLC (formerly Joshua Sweet) Property including Humboldt County  
Assessor's Parcel Numbers 223-073-004-000, 223-073-005-000, 223-061-003-000, 223-  
061-038-000, 223-061-039-000, 223-061-043-000, 223-061-046-000 (All pictures taken  
by Shannon Utley during November 2, 2017, inspection unless otherwise noted)

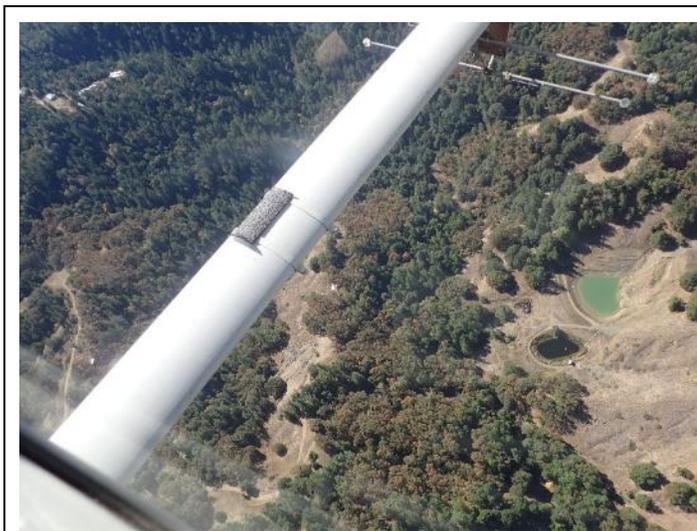
**Site Development:** The large upper pond (POND1 on Site Map) is not visible on available Google Earth images through May 28, 2014, and is not visible on 2016 NAIP imagery. The smaller lower pond (POND2) is first visible in the 10/12/2006 Google Earth imagery. In the next available Google Earth image (5/24/2009), POND2 appears to be full of water. The smallest pond (POND3) is visible in all available Google Earth images (6/12/1993 through 5/28/2014) and NAIP imagery (2005 through 2016). Following the inspection, CDFW staff provided images taken October 27, 2017, of POND1 and POND2 (Photo 1).

Photo 1: Image taken on October 25, 2017, by Warden Kyle Shaw provided by California Department of Fish and Wildlife (CDFW) showing large upper pond with landslide and smaller lower pond.

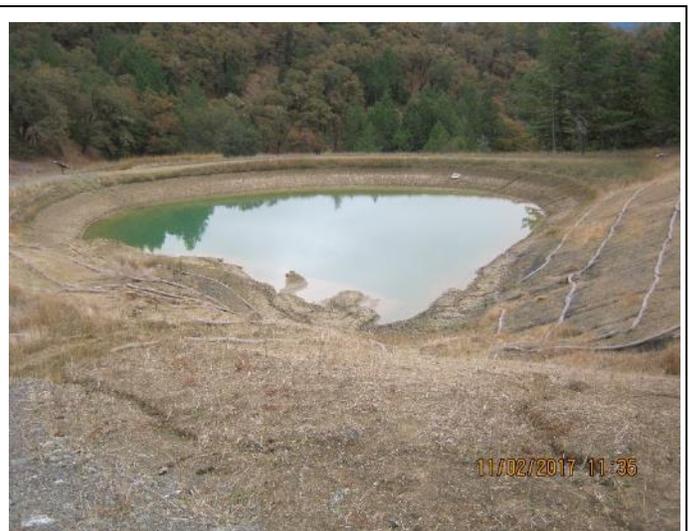
During the inspection, I observed a large newly constructed pond with an earthen berm presumably constructed from material excavated to deepen the pond (POND1 on Figures 1 and 2). DIV staff estimated POND1 to be approximately 24,670 square feet (0.5 acre), up to 18 feet deep, and two thirds full at the time of inspection (Photos 1 through 12). Pond construction resulted in disturbance of approximately 87,000 square feet (2 acres) of possible wetland area based on the 2016 NAIP imagery, which shows the pre-pond area to have been well-vegetated with denser, darker vegetation on the northwest side of the pond (Photo 4 and Figure 2).

Photo 2: Image taken on November 2, 2017 by Chris Van de Wyngard provided by the Division of Water Rights of large upper pond (POND1) looking downhill. Landslide delivery to pond seen on left side of image.

Prepare a restoration and protection plan that includes plans for removal of both POND1 and POND2, delineation of wetland extent prior to pond development, and restoration of natural stream and wetland conditions including mitigation for temporal impacts and an immediate stability analysis of the ponds assessing the threat to water quality from potential failure of POND1 and POND2.

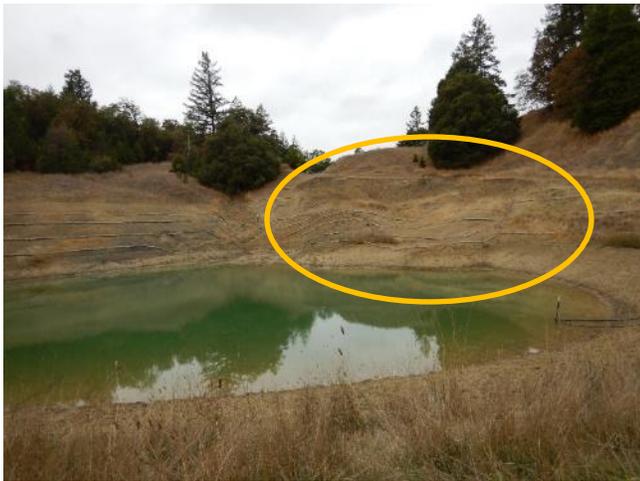
Photo 3: View uphill of upper pond (POND1) from earthen berm. Landslide into pond seen on right side of image (see orange circle).

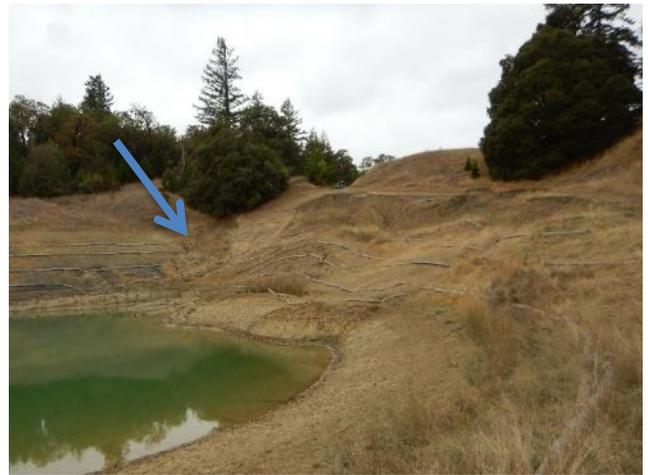
Pond construction reactivated a portion of a historic landslide amphitheater complex of approximately 15,000 square feet (SLIDE1 on Figure 1 and 2), which delivered sediment into POND1, and damaged the access road to the lower pond to make it impassable by any motorized vehicle (Photos 3 and 4). Mr. Sweet indicated that prior to pond construction, there had been a topographic knob-like feature that Mr. Sweet had requested to be removed for aesthetic reasons. Removal of this topographic knob, along with a particularly wet winter, caused this portion of the landslide complex to activate and deliver earthen material into the pond. The slide material in the pond reduced the pond capacity and likely resulted in increased sediment discharges from POND1 into the lower pond (POND2).

Photo 4: Closer view of landslide scarp (SLIDE1) and delivery into POND1. Blue arrow shows location of possible wetland area.

- 12) Remediation, Cleanup, and Restoration Activities: The two landslides near the ponds will require remediation (SLIDE1 and SLIDE2) because onsite development and activities are influencing these features, resulting in adverse impacts to waters of the State (Photos 1 through 4, and 37 through 42). The stream crossings discussed in detail above (C1, C5, C6, and C7) will likely need to be reconstructed or decommissioned.

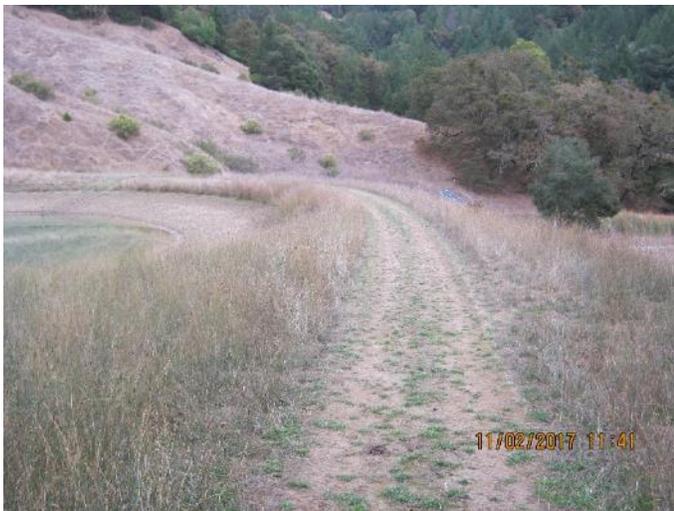
The outflow pipe from POND1 (OUT1) is a 24-inch corrugated metal culvert set into an earthen berm (Photos 5 and 6). Water from POND1 flows through OUT1 (Photos 7 through 10) into the older, lower, on-stream pond (POND2 on Figures 1 and 2), which in turn outflows to a Class II watercourse.

Photo 5: Image taken on November 2, 2017, by Chris Van de Wyngard provided by the Division of Water Rights of earthen berm (BERM) containing upper pond (POND1) on left and lower pond (POND2) on right.

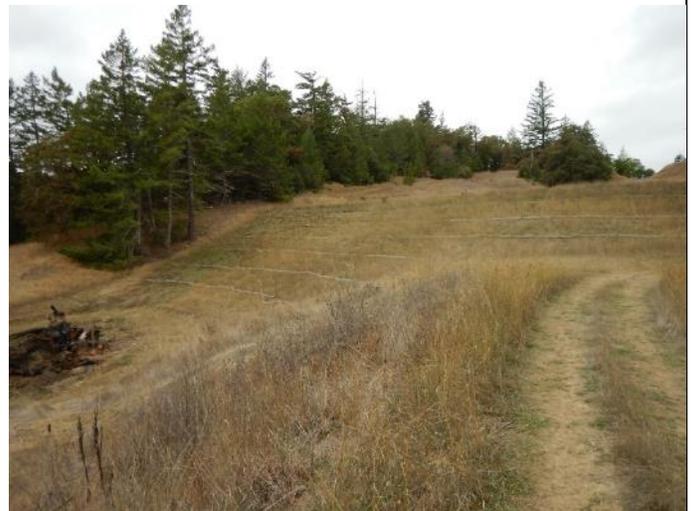
Photo 6: View of POND1 earthen berm (BERM) from western side of POND2.

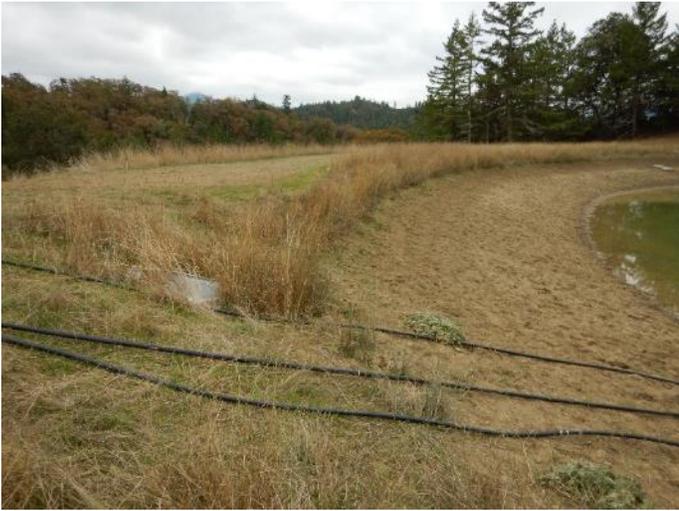
Photo 7: POND1 outflow pipe (OUT1), which delivers into POND2 below.

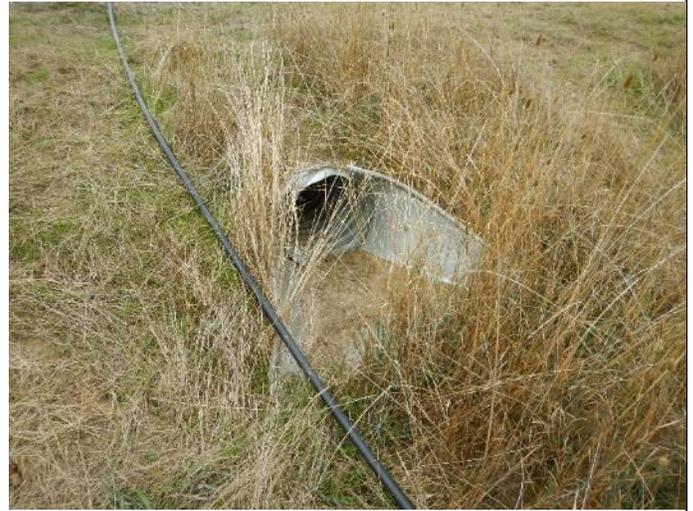
Photo 8: Closer view of POND1 outflow pipe (OUT1) with a layer of sediment covering the bottom of intake.

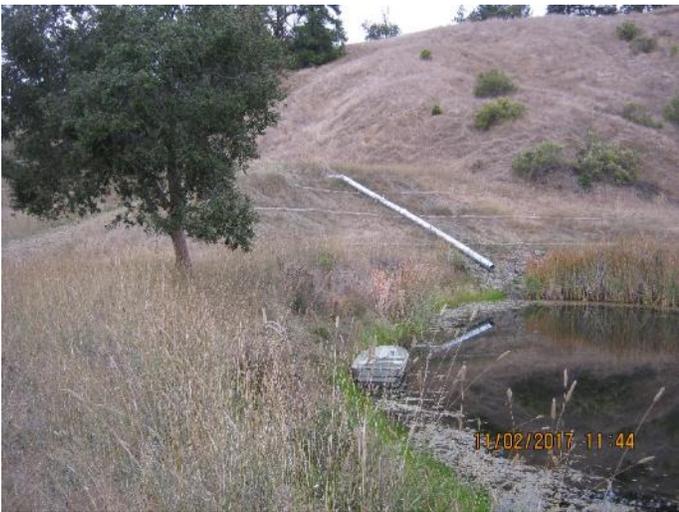
Photo 9: Image taken November 2, 2017, by Chris Van de Wyngard provided by the Division of Water Rights of POND1 outflow pipe (OUT1) into POND2.

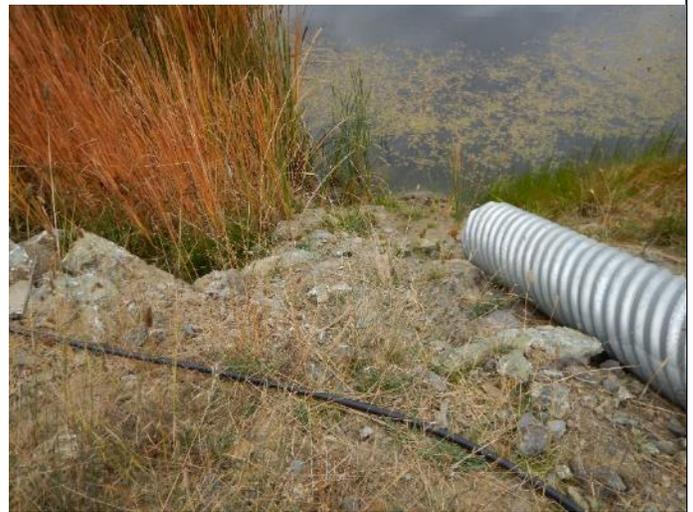
Photo 10: Closer view of POND1 outflow pipe outlet (OUT1) set on rip-rap into POND2.

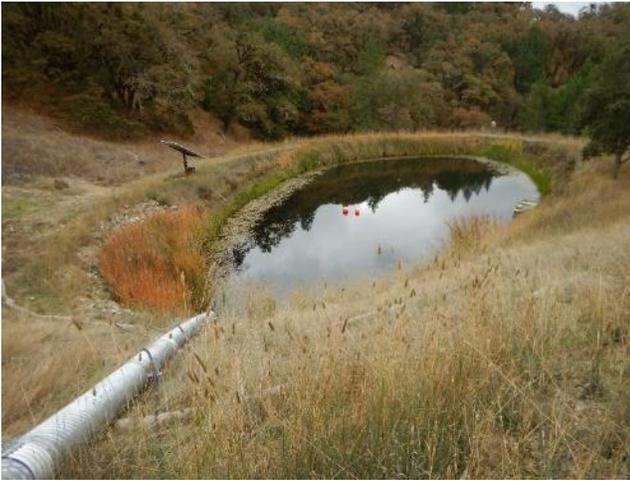
The lower older onstream pond (POND2 on Figures 1 and 2) is first visible in the available aerial imagery in October 2006 and the Regional Water Board has no record of an application for, or issuance of, the required permit(s) for this pond. As noted above, the Responsible Party purchased the Property in November 2006. DIV staff estimated POND2 to be approximately 11,480 square feet (0.25 acres), up to 14 feet deep, three quarters full during the inspection, and fed by a combination of outflow from POND1, a Class III watercourse, rainwater, and stormwater runoff (Photo 1 and Photos 7 through 18). I observed two outflow features for POND2; one was a single 24-inch corrugated plastic pipe (OUT3) that flows to a Class II watercourse (Photos 13 through 16); the other outflow was a set of two 24-inch corrugated plastic pipes (OUT2) that flows to a wetland-type area and then to the Class II watercourse (Photos 17 and 18) and was constructed between June and September 2016.

Photo 11: View downhill at lower pond (POND2) from POND1 berm with outflow (OUT1) from POND1 on left of image.

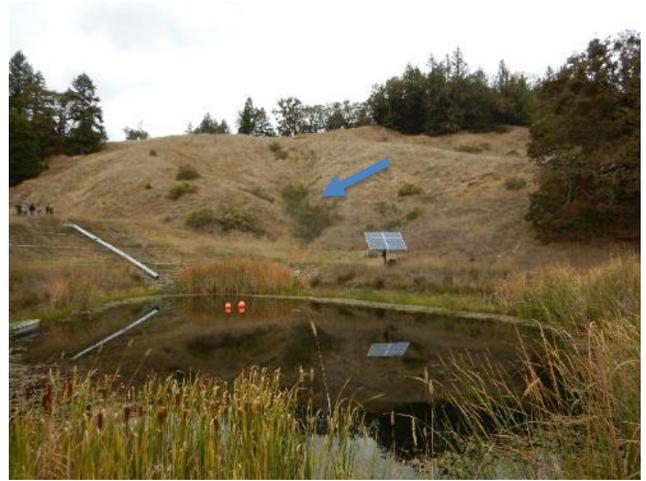
Photo 12: View uphill of POND2 and Class III watercourse (blue arrow shows Class III channel) from downhill side of pond.

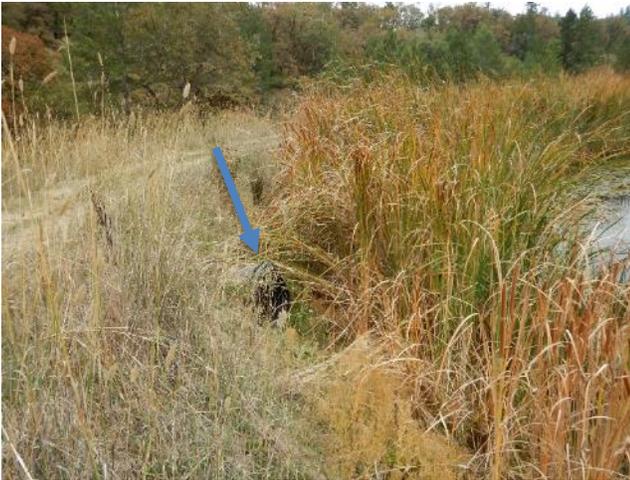
Photo 13: View of single outflow pipe from POND2 (blue arrow shows outflow pipe) (OUT3).

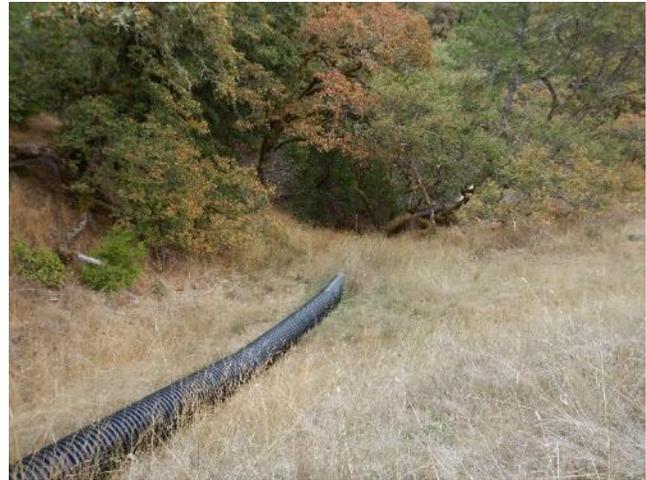
Photo 14: View of single outflow pipe below POND2 (OUT3).

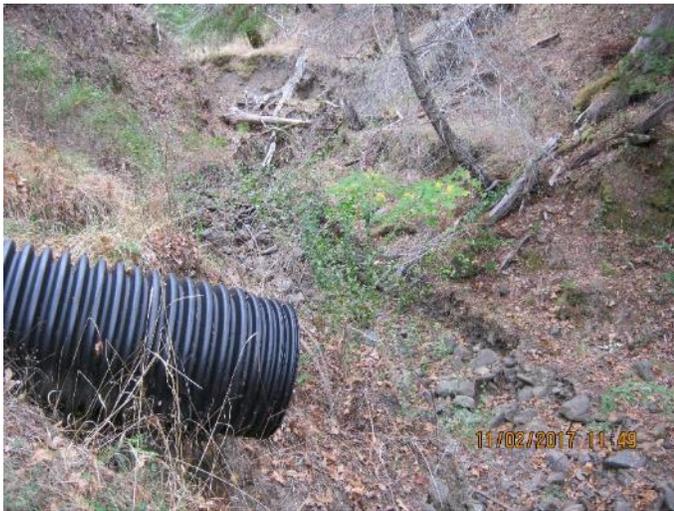
Photo 15: Image taken November 2, 2017, by Chris Van de Wyngard provided by the Division of Water Rights of single outflow pipe set into Class II channel looking upstream (OUT3).

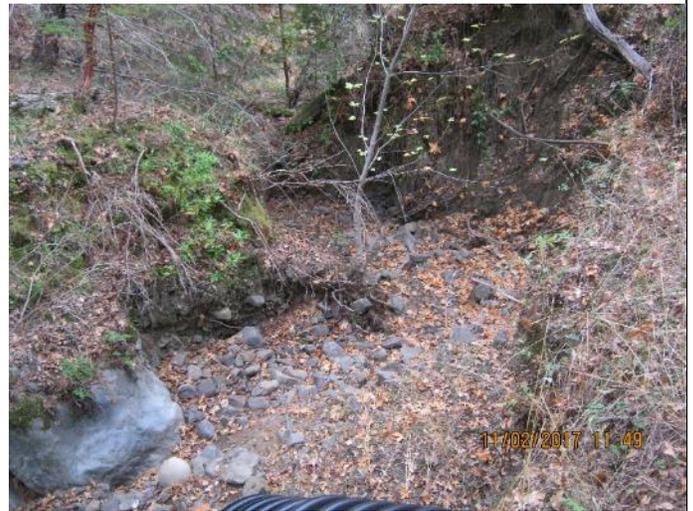
Photo 16: Image taken on November 2, 2017, by Chris Van de Wyngard provided by the Division of Water Rights of single outflow pipe set into Class II channel looking downstream (OUT3).

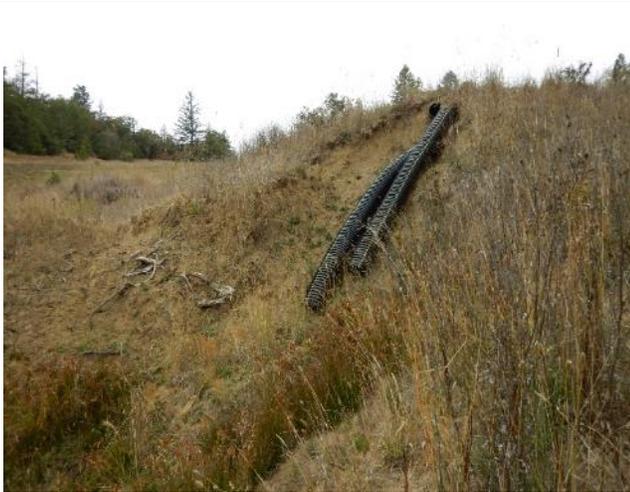
Photo 17: Image of double outflow pipes from POND2 into wetland type area (OUT2).

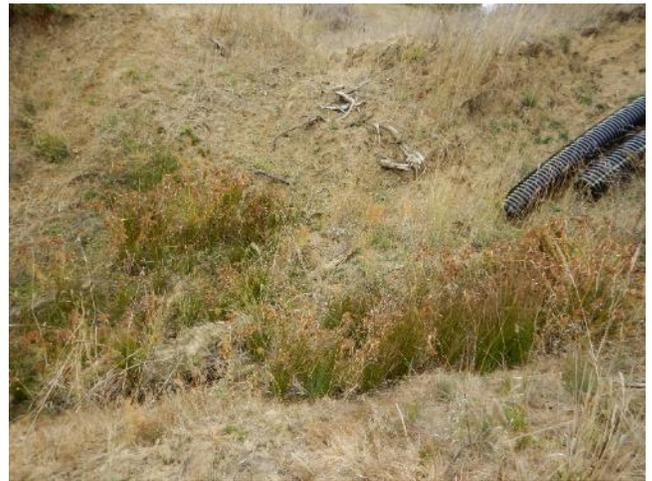
Photo 18: Closer view of wetland area below double outflow pipes from POND2 (OUT2).

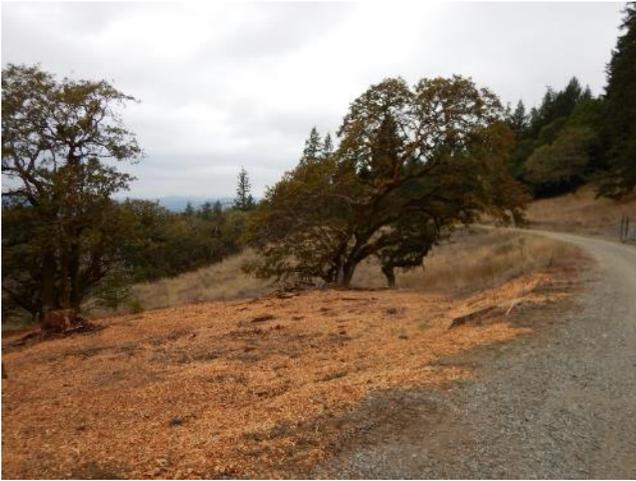
Cultivation area CA1 is a large, graded pad, approximately 150,000 square feet, with approximately 44,100 square feet of cannabis cultivation (Photos 19 through 22, and Figures 1 and 2). I observed several minor erosional areas associated with slope failures along the graded hillside and the constructed drainage ditch to convey irrigation and storm water runoff to a bio-swale (Photo 22).

Photo 19: Image of graded area with timber removal adjacent to large outdoor cultivation area CA1 looking northwest. Disturbed area is shown on Site Map as disturbed area surrounding CA1 (approximately 150,000 square feet of disturbed area).

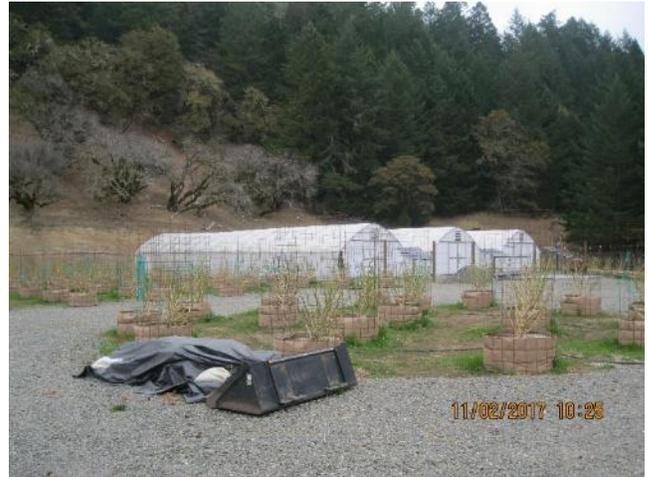
Photo 20: Image taken on November 2, 2017, by Chris Van de Wyngard provided by the Division of Water Rights of cultivation area CA1 (approximately 44,100 square feet).

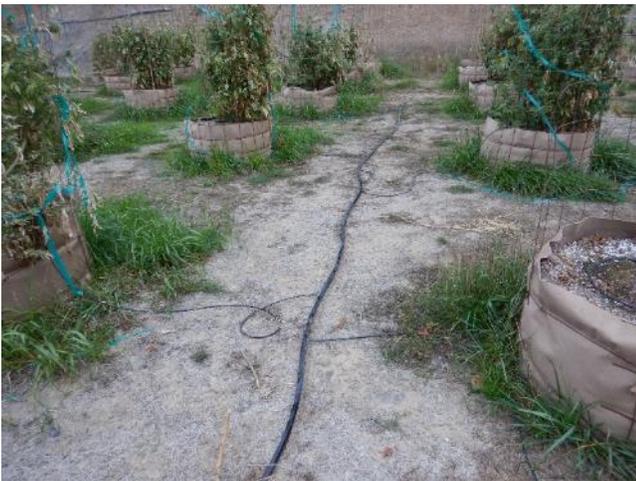
Photo 21: Image of large outdoor cultivation area CA1 grow bags with grass growing around the bases from potential over watering of cannabis plants.

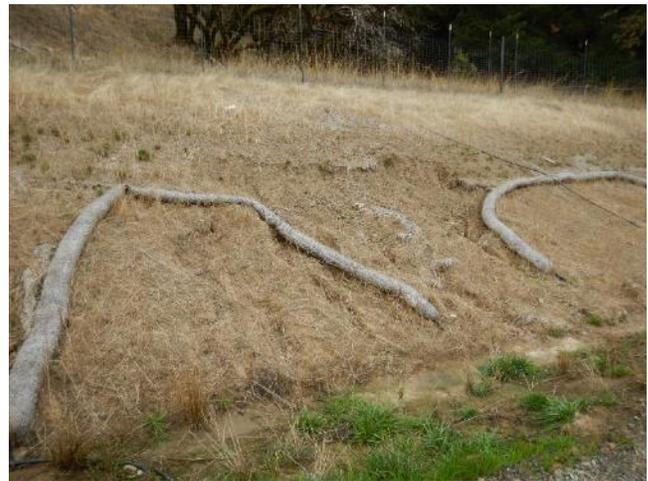
Photo 22: Image of drainage trench at outdoor cultivation area CA1. Image also shows fiber rolls disturbed by soil slumps caused by vegetation removal and erosion of the graded hillside. The fiber rolls were not functioning.

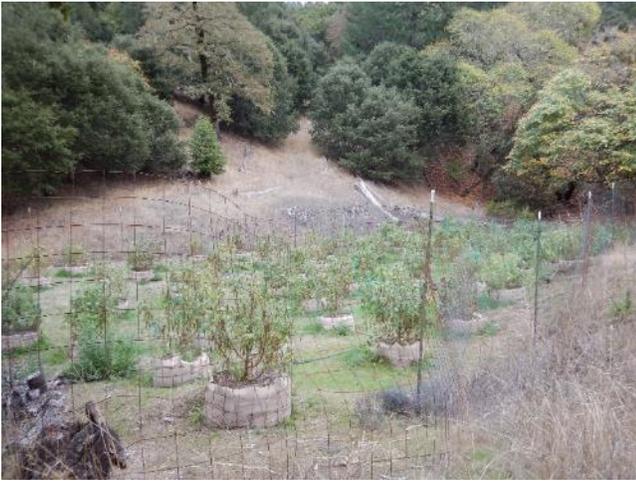
Outdoor cultivation area CA2 is located approximately 28 feet from a Class III watercourse and stream crossing C1 (Photos 23, 33, and 34).

- 3) Riparian and Wetland Protection and Management: Cultivation area CA2 is located 28 feet from a Class III watercourse at C1 (Photos 23, 33, and 34). The Order requires cultivation areas to be located at least 50 feet away from any Class III watercourse or wetland.

Photo 23: Image of outdoor cultivation area CA2 (approximately 7,800 square feet) located 28 feet from Class III watercourse at stream crossing C1.

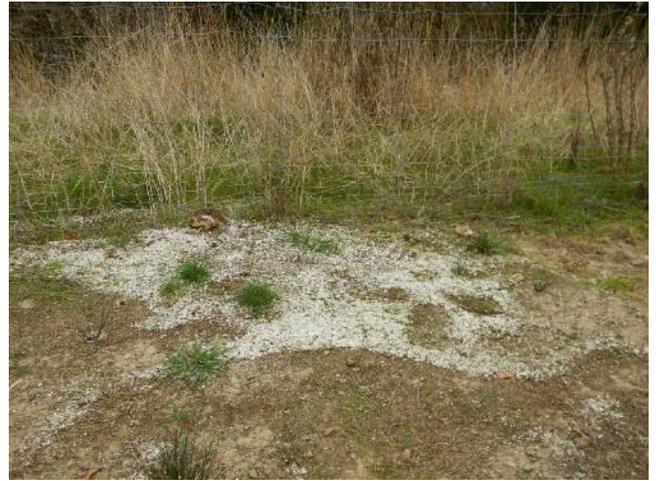
Photo 28: Image of potting soil on the ground at cultivation area CA5 that has been transported across the fence line by runoff.

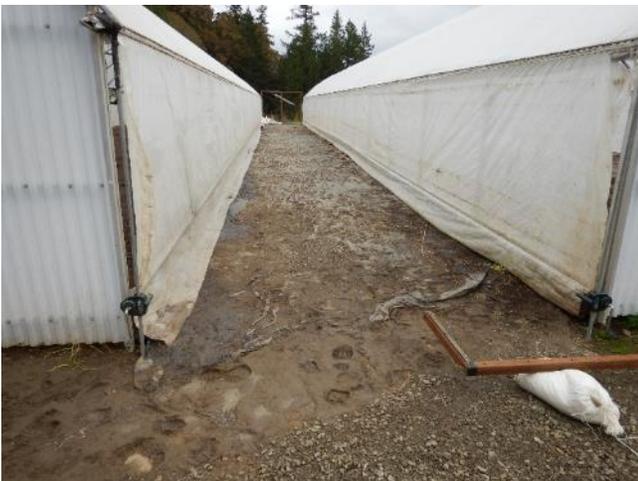
Photo 29: Image of muddy bare soil between greenhouses at cultivation area CA5.

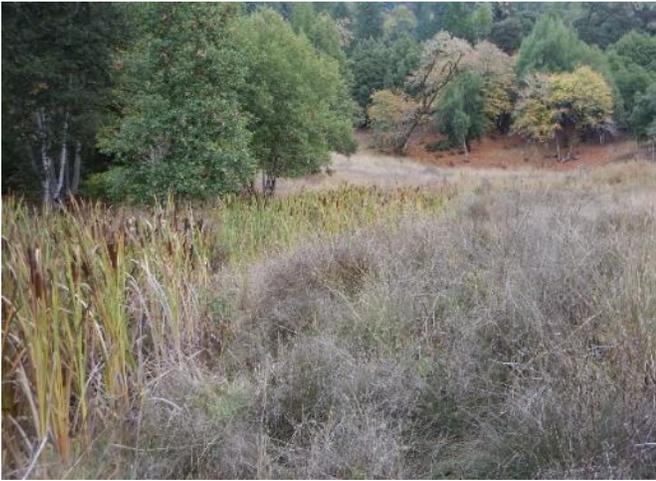
During the inspection, I observed a wetland area (WET on Figures 1 and 2) with standing water, dominated by cattails (Photos 31 and 32). Mr. Sweet indicated that he would like to “clean up” the area by removing the swampy vegetation and re-digging the pond to improve the aesthetics. Any proposed work in this area would require compliance with the California Environmental Quality Act and an authorization through an individual Clean Water Act section 401 water quality certification, which requires avoidance and minimization of impacts and mitigation for any unavoidable impacts. Regional Water Board staff have previously informed Mr. Sweet and Ms. Puno of permitting requirements for dredge/fill in wetlands during a January 2016 site inspection and during a phone call with Ms. Puno in approximately August 2017. Staff again advised Mr. Sweet and Ms. Puno of these permitting requirements during the November 2017 site inspection.

Photo 31: Image of wetland-pond area (WET on Figure 1 and 2) dominated by cattails.

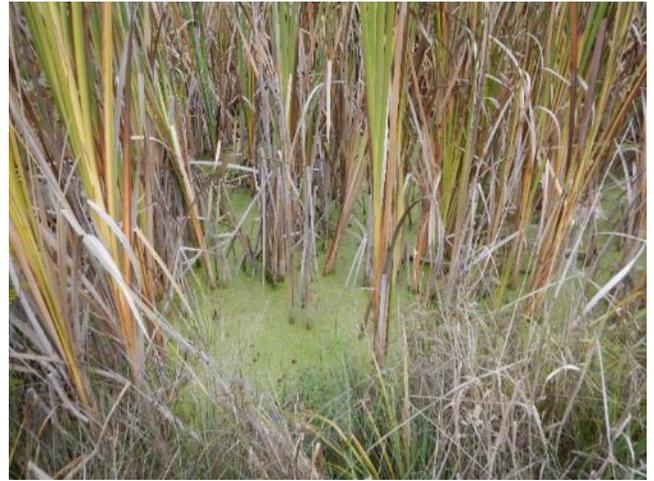
Photo 32: Closer view of wetland-pond area showing standing water and wetland-pond vegetation.

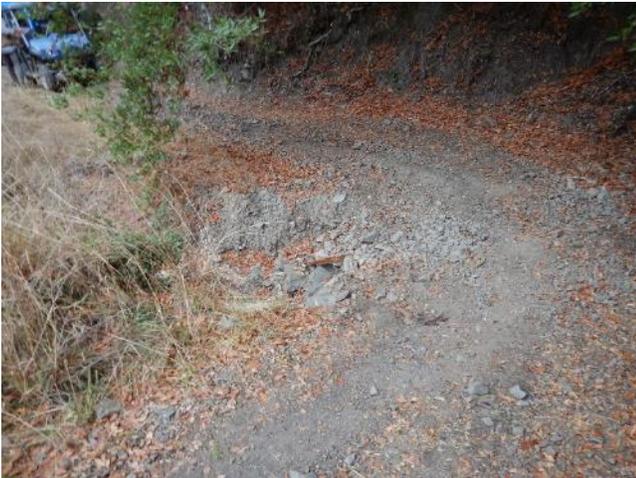
Stream crossing C1 consists of fill placed in the stream channel for an ATV trail approximately 28 feet away from outdoor cultivation area CA2 (Photos 33 and 34). Culverts C5 and C7 are Class III stream crossings, neither installed at the grade of the stream channel of the respective Class III streams (Photos 47, 48, 51, and 52). Stream crossing C6 is on a Class II stream and was not placed in alignment with the natural stream channel, increasing the erosion of the stream channel causing sediment delivery (Photos 49 and 50).

Photo 33: Image of ATV stream crossing C1 blocking Class III watercourse located approximately 28 feet from outdoor cultivation area CA2.

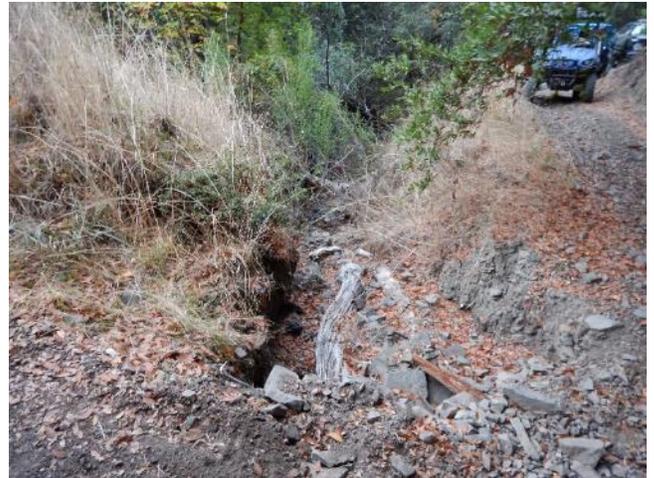
Photo 34: Image of downstream side of stream crossing C1 blocking Class III watercourse and showing erosion of the streambank.

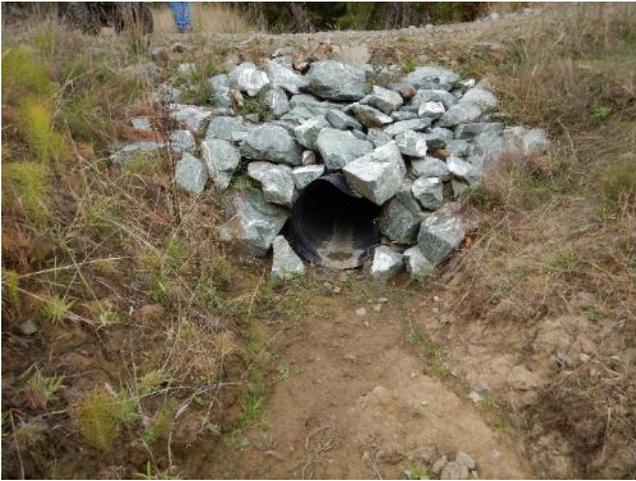
Photo 35: Image of upstream side of stream crossing C2.

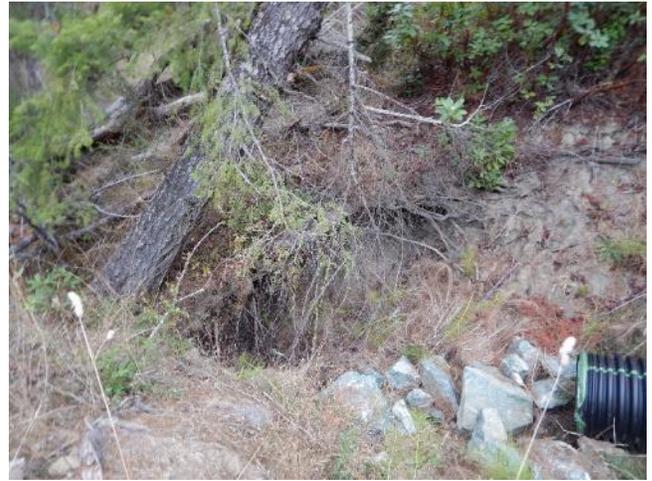
Photo 36: Image of downstream side of stream crossing C2 showing streambank erosion and stream bed armoring.

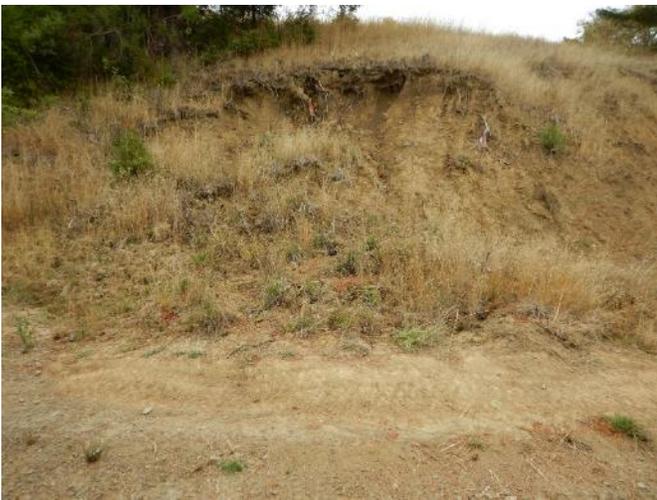
Photo 37: Image of landslide slope failure (SLIDE2) upgradient of the road, located between stream crossing C2 and POND1 caused by road development, grading and surface runoff.

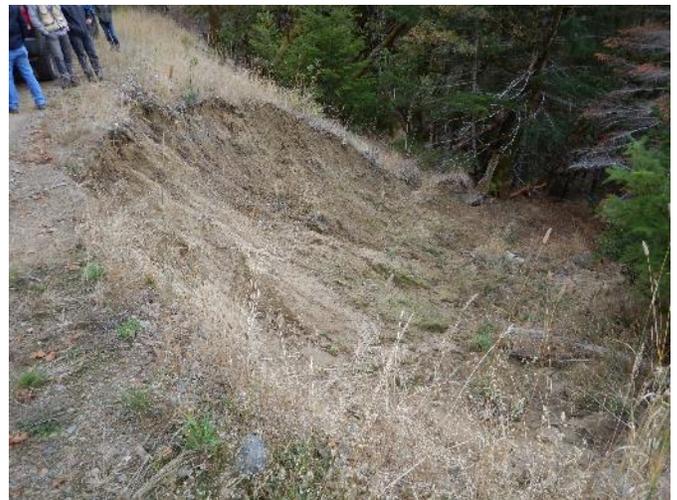
Photo 38: Image of landslide (SLIDE2) downgradient of the road located between stream crossing C2 and POND1 caused by road development, grading and surface runoff.

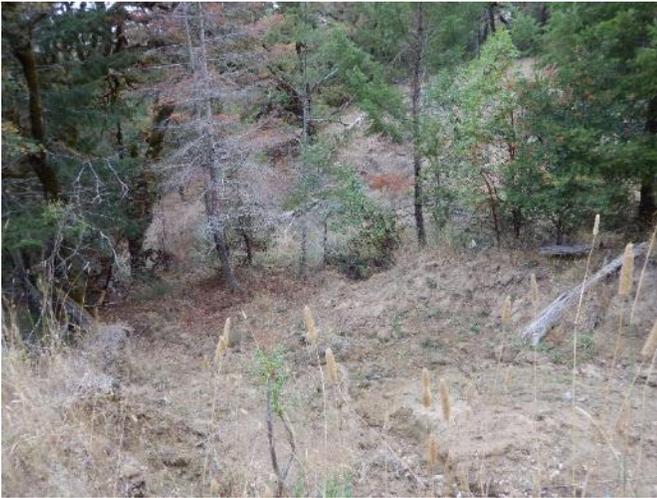
Photo 39: Image of SLIDE2 looking downgradient

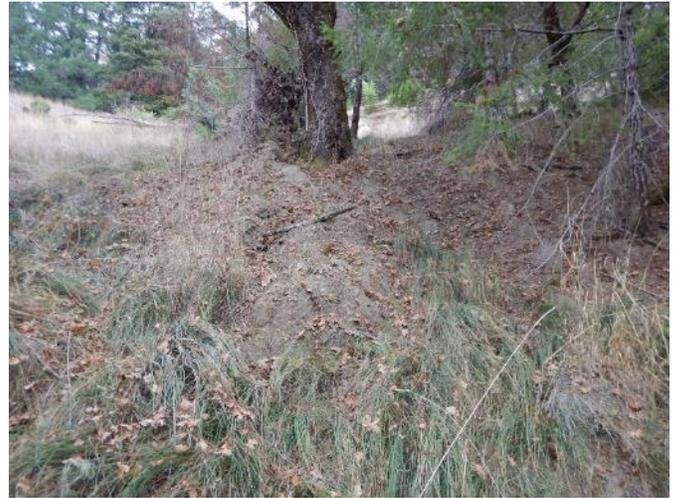
Photo 40: Image of transported sediment downgradient of SLIDE2 looking upgradient.

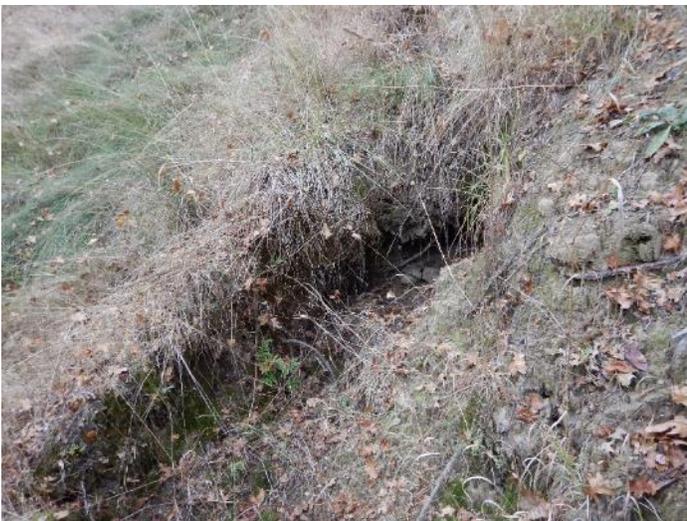
Photo 41: Image of transported sediment from SLIDE2 discharging into a headwaters stream at a headcut.

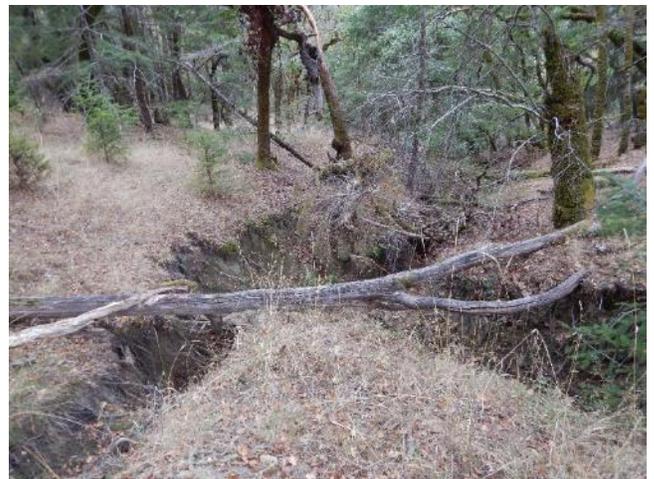
Photo 42: Image downslope of SLIDE2 showing stream channel degradation influenced by the SLIDE2 discharge to the Class III stream channel and hydrologic connectivity of the road network.

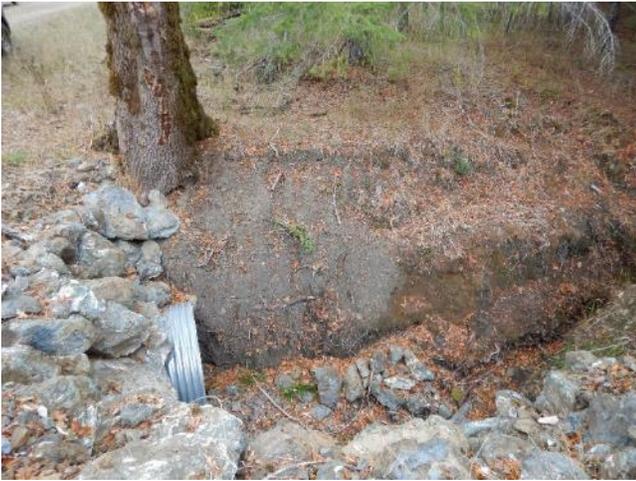
Photo 43: Image of upstream side of stream crossing C3 showing erosion of streambanks and armoring of streambed.

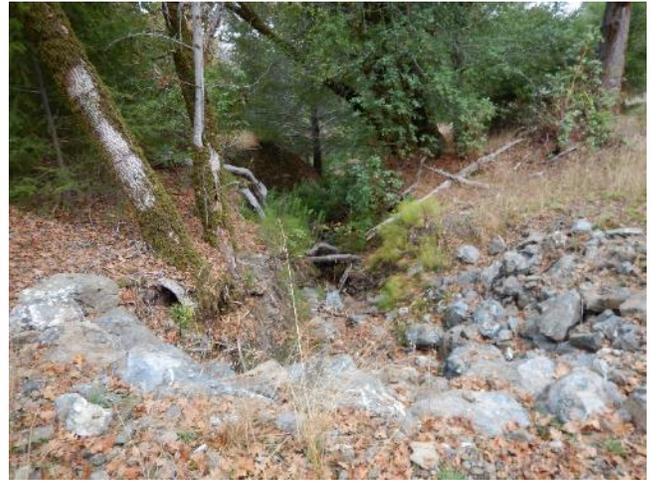
Photo 44: Image of downstream side of stream crossing C3 showing armoring of streambed and streambank.

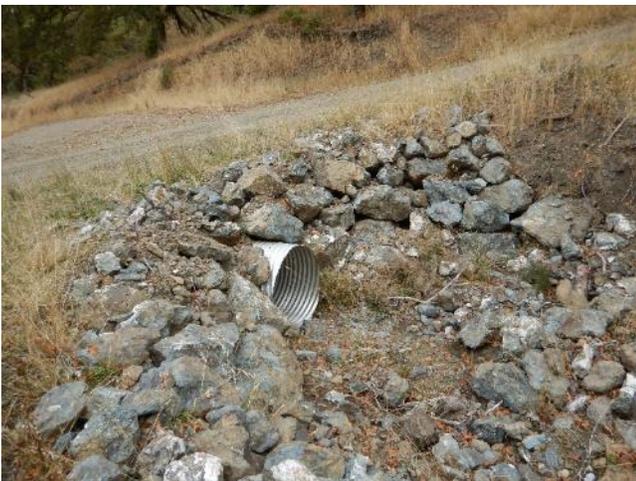
Photo 45: Image of upstream side of stream crossing C4 showing armoring of streambed and banks.

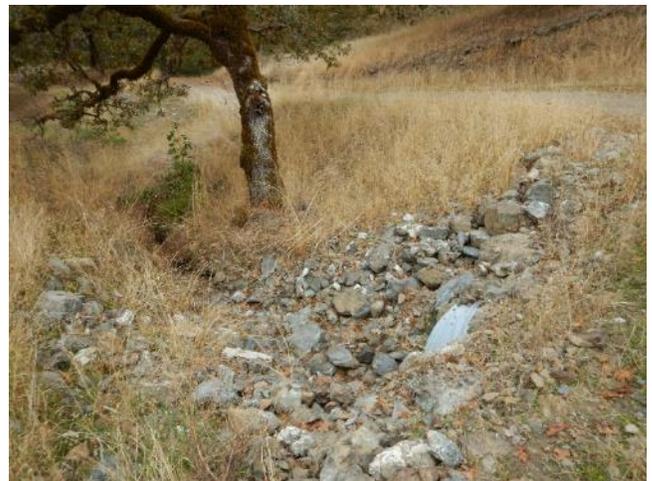
Photo 46: Image of downstream side of stream crossing C4 showing armoring of streambed and banks.

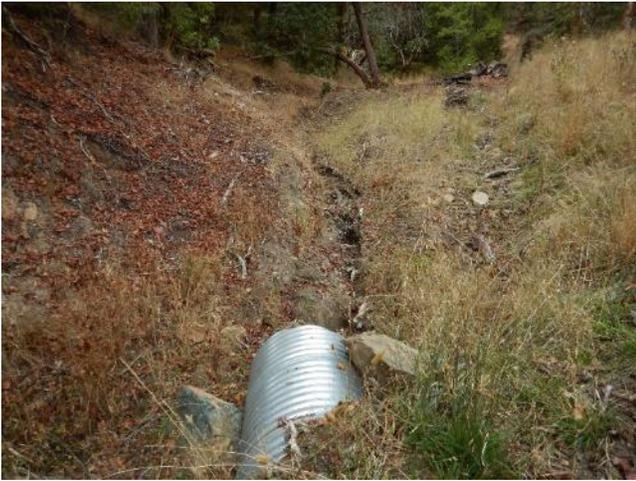
Photo 47: Image of upstream side of stream crossing C5 showing erosion of streambed.

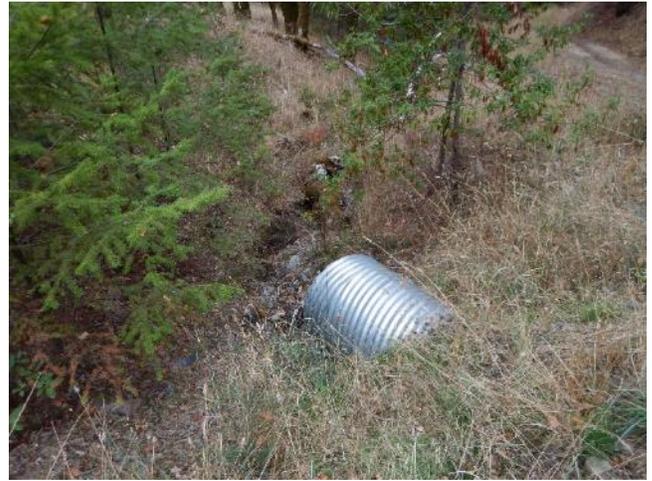
Photo 48: Image of downstream side of stream crossing C5 showing the culvert not set to the grade of the streambed.

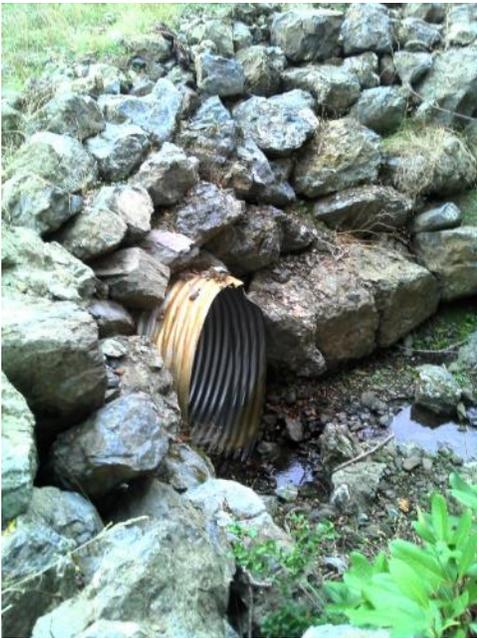
Photo 49: Image of upstream side of stream crossing C6 armoring of streambank of Class II watercourse.

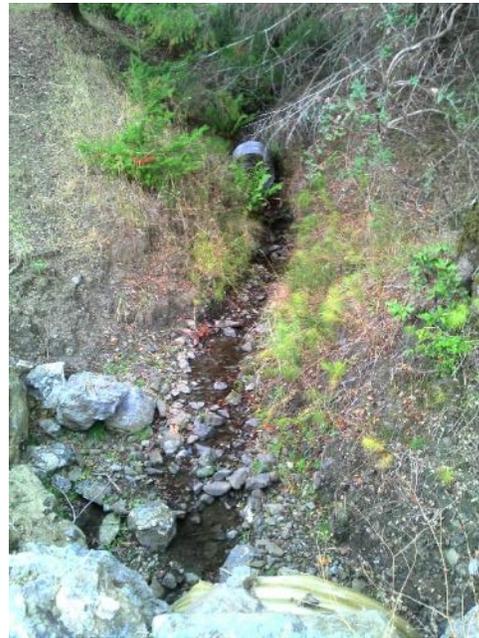
Photo 50: Image of downstream side of stream crossing C6 showing culvert was not placed in alignment with the Class II stream channel.

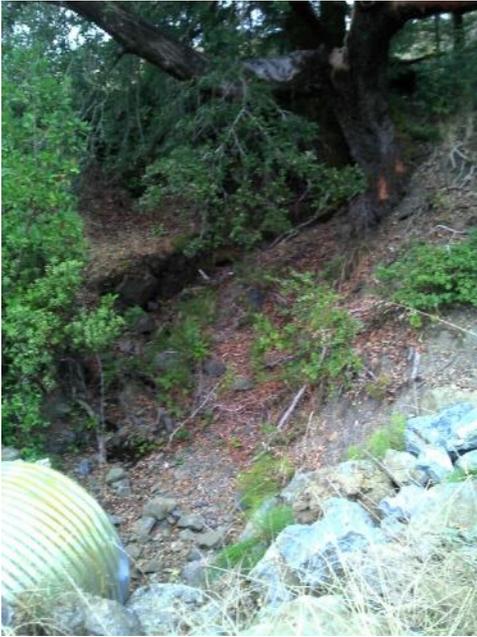
Photo 51: Image of upstream side of stream crossing C7 showing armoring of stream channel.

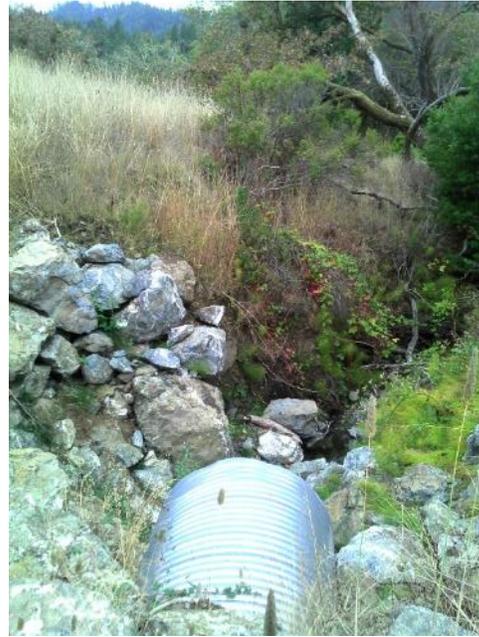
Photo 52: Image of downstream side of stream crossing C7 showing culvert was not set to the grade of the stream channel.

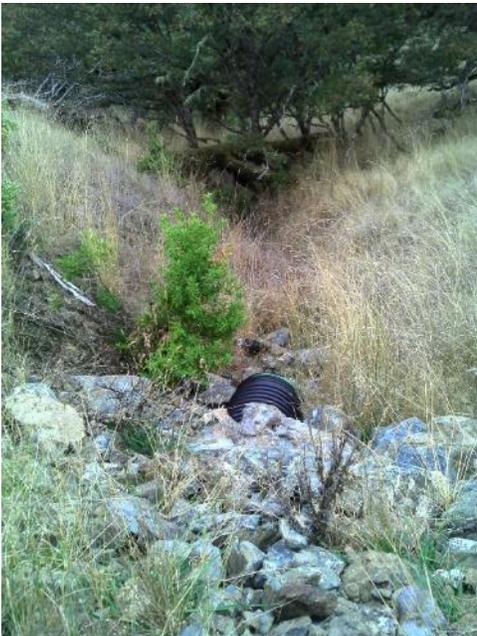
Photo 53: Image of downstream side of stream crossing C8 showing armoring of stream channel.

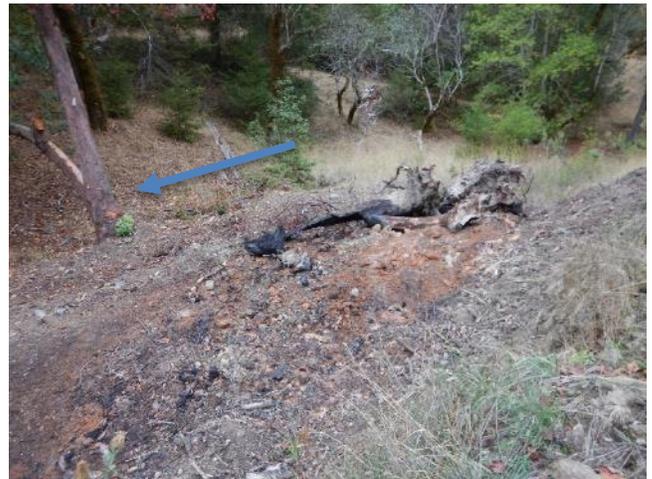
- 4) Spoils Management: I observed one burn pile (BURN on Figure 1 and Figure 3) located adjacent to a Class III watercourse upstream of stream crossing C5, with no containment or cover to prevent it from entering or being transported into the watercourse (Photo 54).

Photo 54: Image showing burn pile (BURN) located adjacent to stream channel upstream of stream crossing C5 (blue arrow is placed above stream channel and shows flow direction).

**Refuse:** Immediately contain and properly dispose of all refuse, including burned refuse/waste consistent with standard conditions 10 and 11 of the Order.

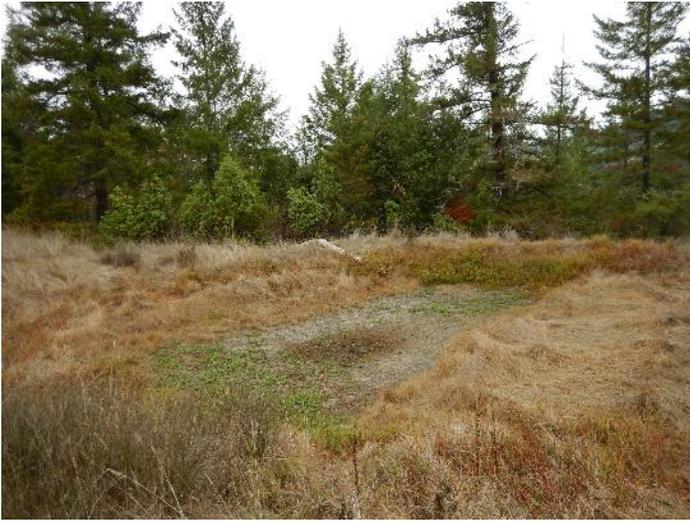
During the inspection I observed a third pond (POND3) located on the opposite side of the ridgeline from POND1 and POND2. This on-stream pond is much smaller (approximately 3,000 square feet) than either POND1 and POND2 and was dry during the inspection (Photo 55). POND3 is visible in all of the available imagery dating back to June 1993 (Google Earth image dated 6/12/1993).

Photo 55: Image of oldest onstream pond (POND3).
