North Coast Regional Water Quality Control Board

Subject: Revised **Notice of Violation** for activities at Assessor's Parcel Number 015-111-09, 2725 Lucas St., Eureka

**Inspection Report Memorandum
2725 Lucas Street, Eureka, Humboldt County**

Date: December 13, 2017

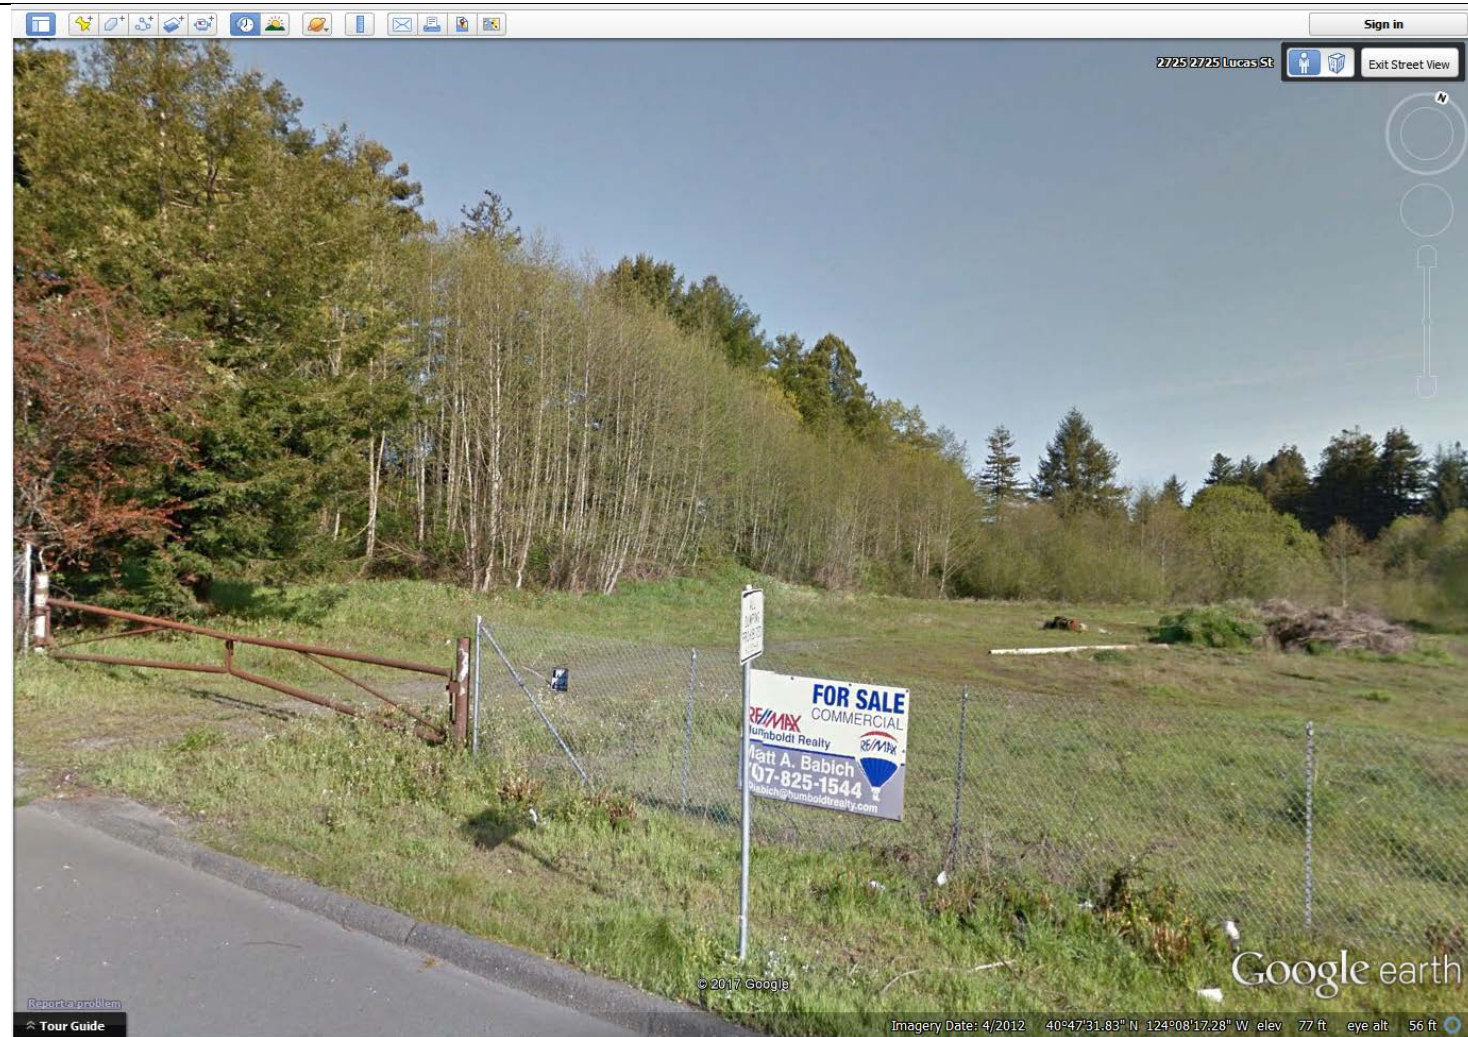
Figure 4: Google Earth street view accessed on 10/16/17. Image date is April 2012, looking north at the parcel entrance. What appear to be a band of alders along the left side of the photo were no longer there at the time of the inspection as shown in Figure 5 and Figure 6.

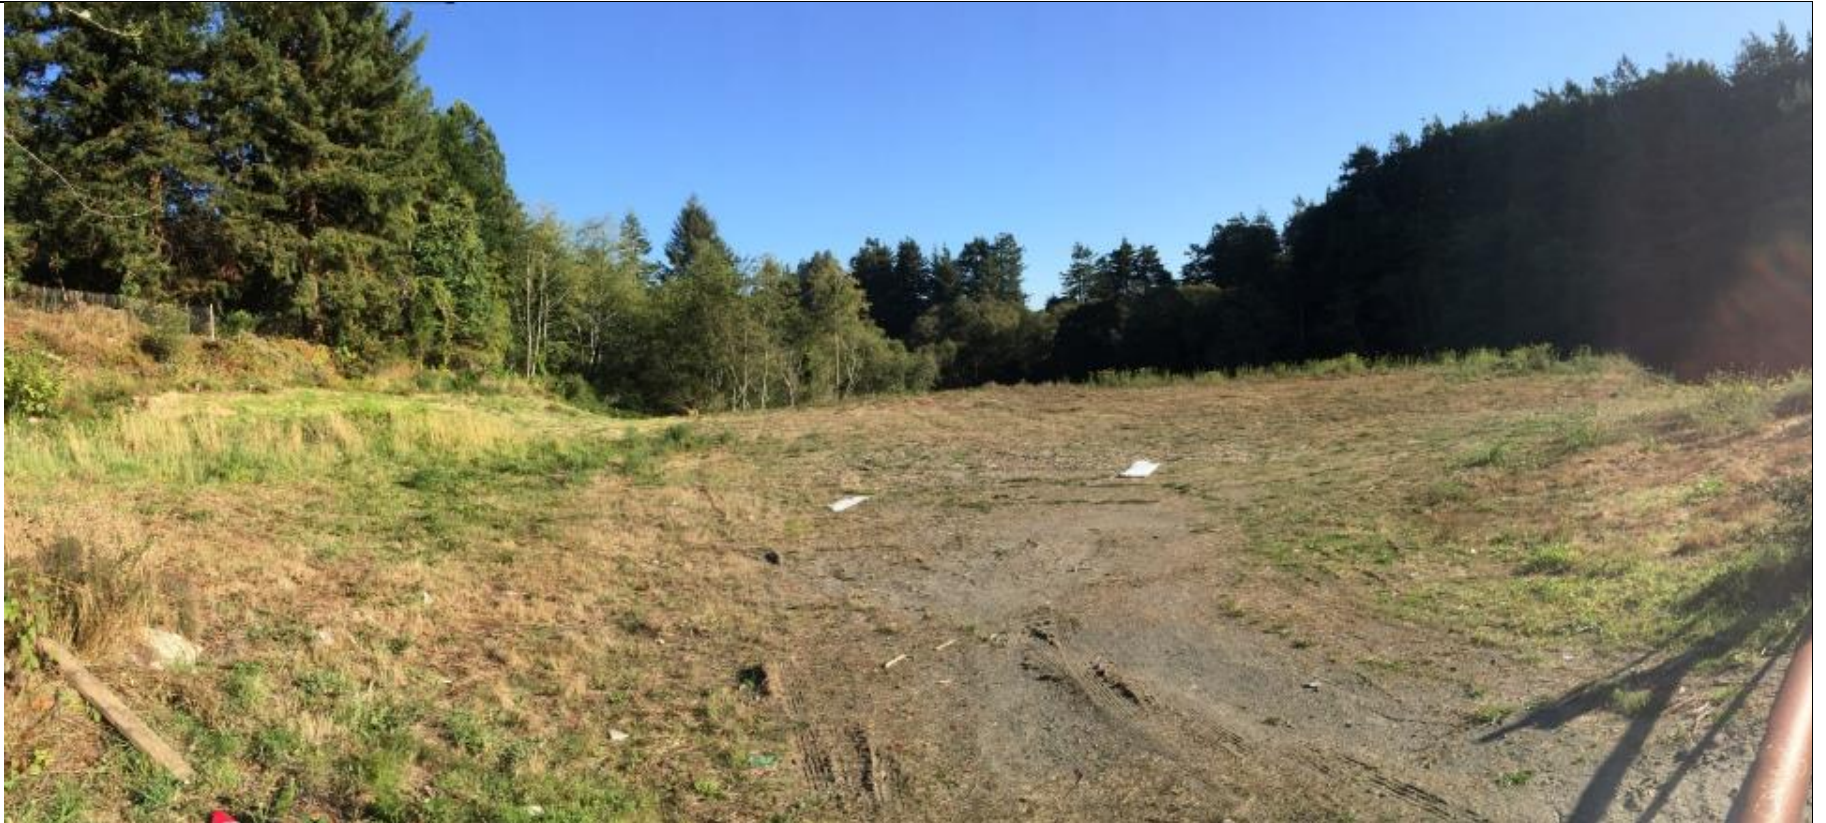
Figure 5: 10/3/17 inspection photo at the entrance looking north.

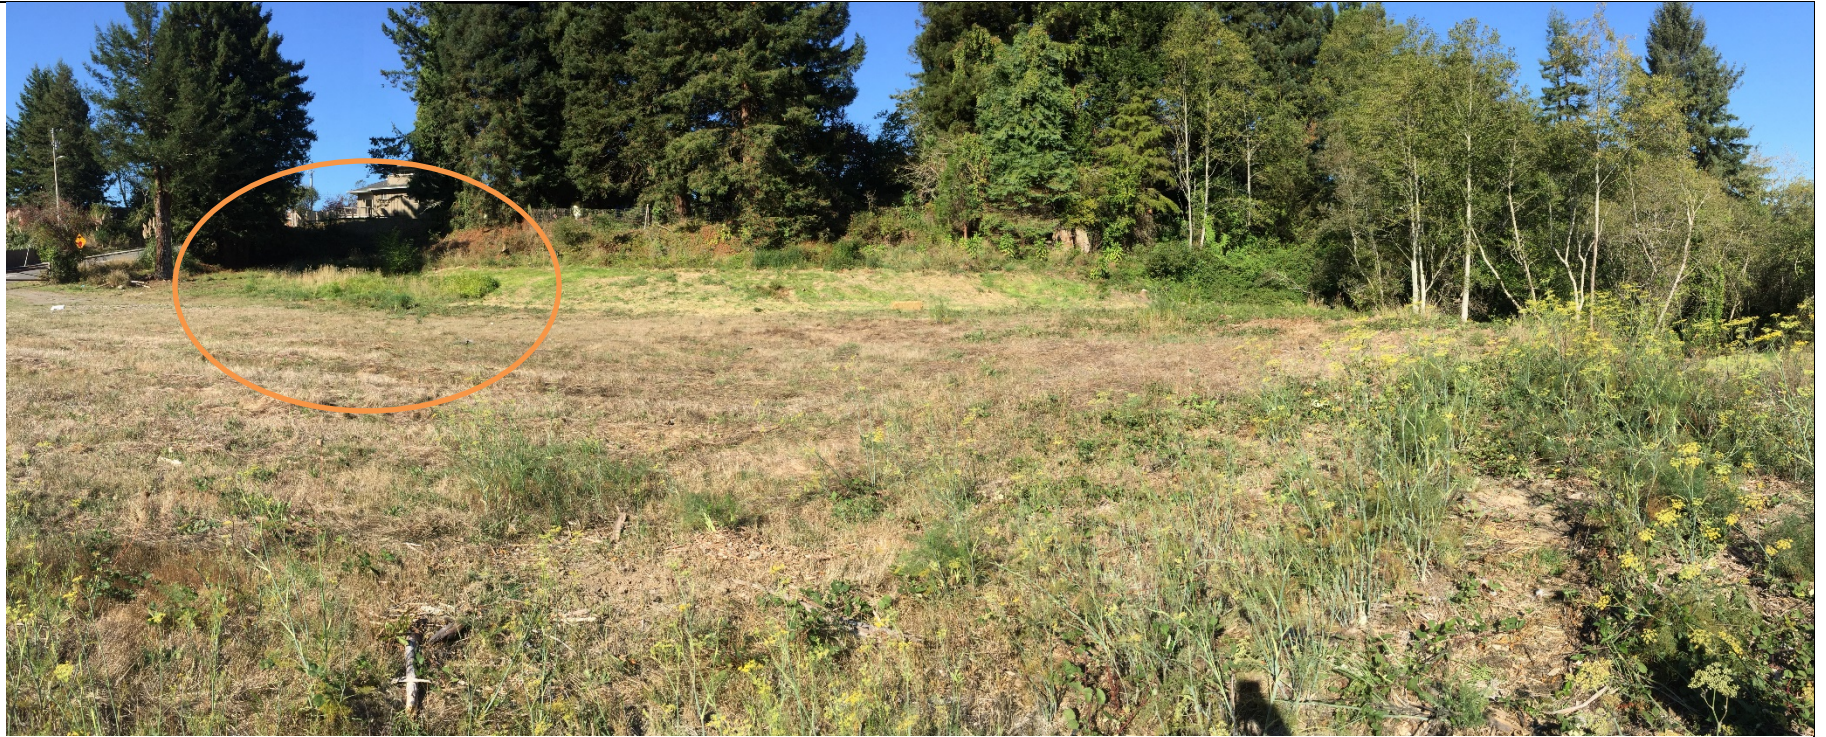
Figure 6: 10/3/17 inspection photo looking west towards southwest corner of the parcel. Hillside seep is circled. Note the abrupt change in vegetation height due to disturbance.

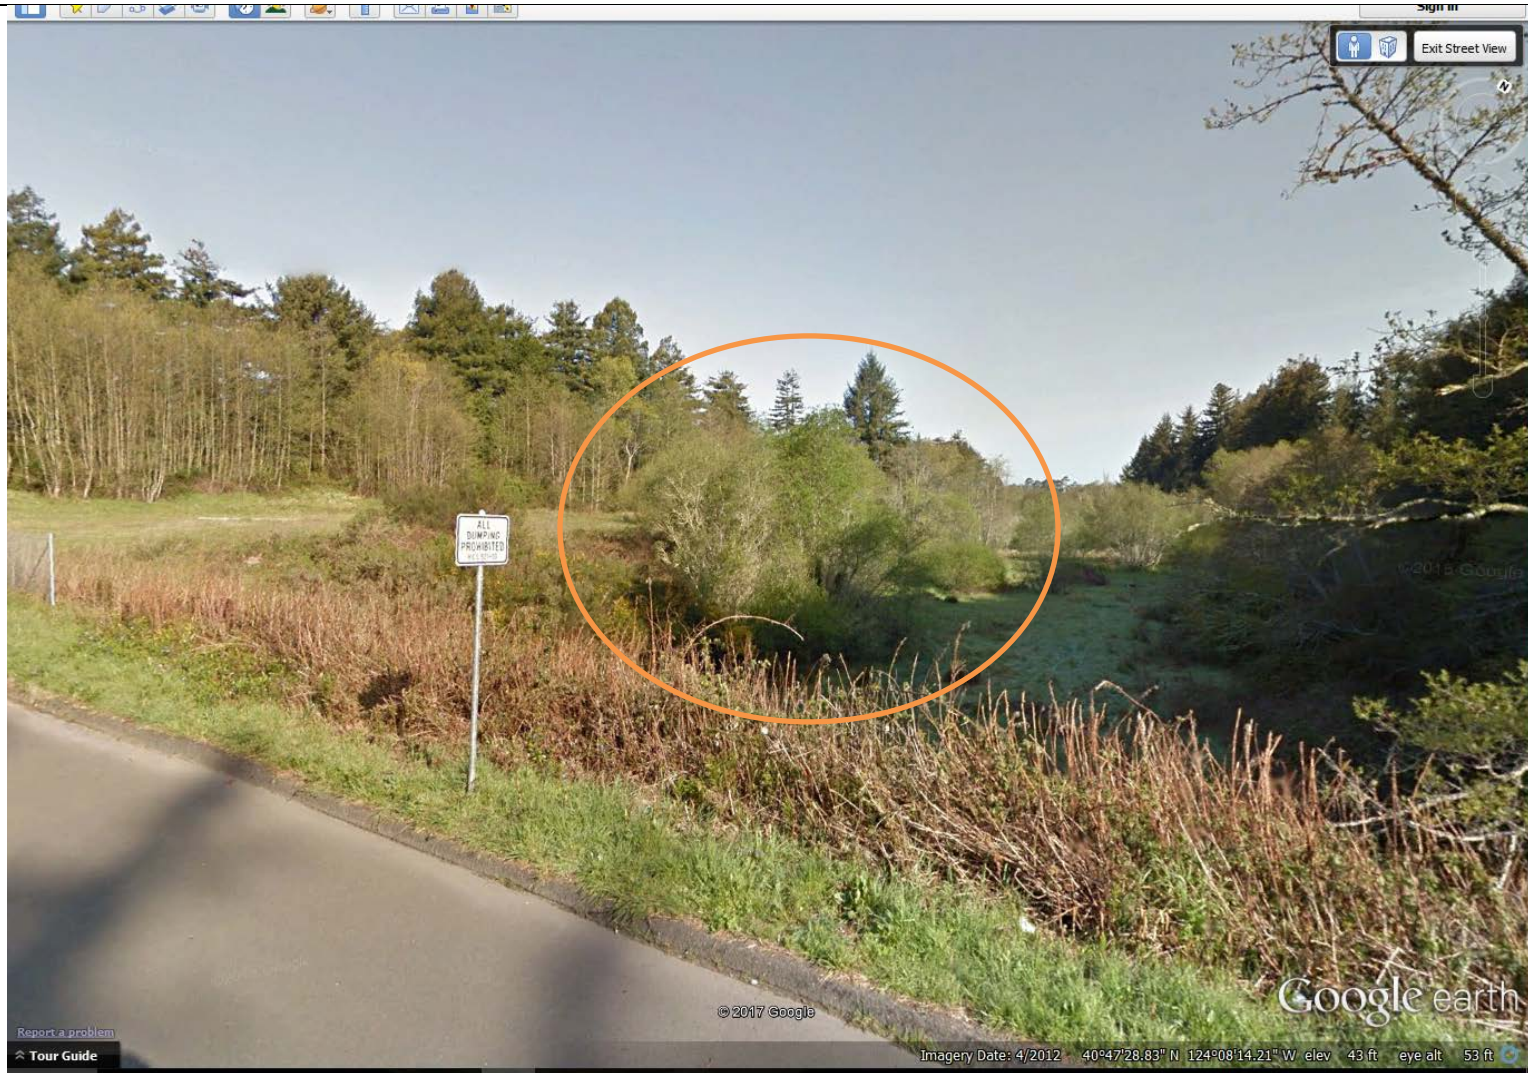
Figure 8: Google Earth street view accessed on 10/16/17. Image date is April 2012. Looking north at the lower floodplain area. This 2012 image shows vegetation on the slope (orange circle) that was not present at the time of the site visit (see Figure 40). Vegetation along the right side of the photo extends further into the floodplain than at the time of the inspection.

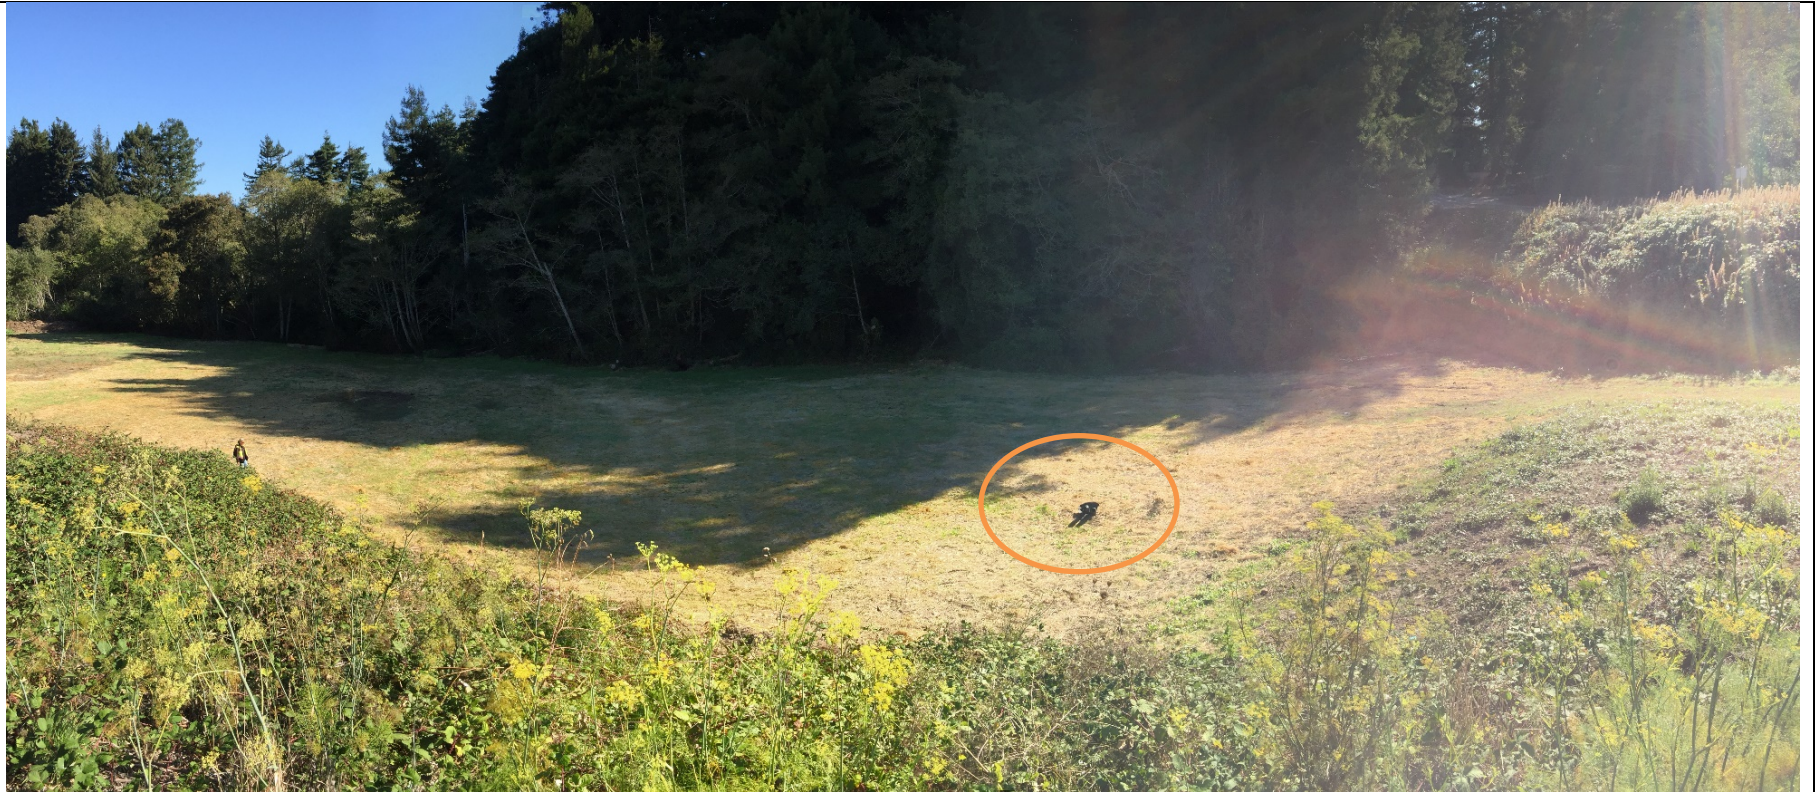
Figure 9: 10/3/17 inspection photo, standing at the edge of the upper area looking northeast toward Third Slough. Drainage feature shown in Figure 26 is circled in orange.

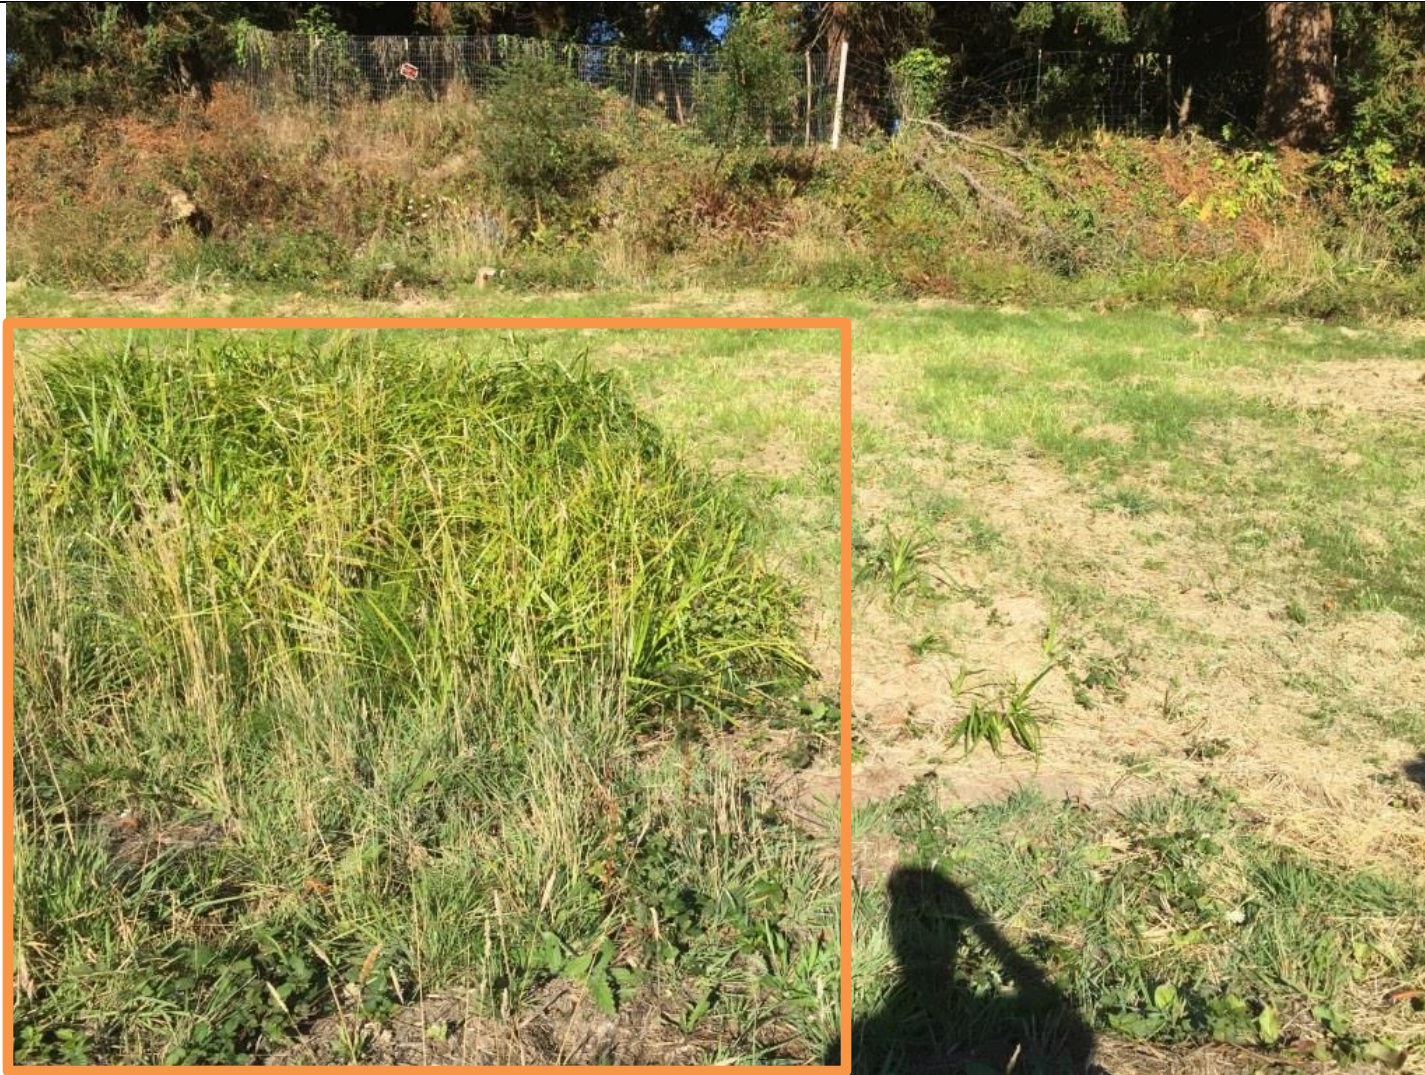
- In the upper area at the southwestern corner of the parcel, there is a hillside seep that appears to have been impacted (see Figures 10-12). The seep includes a small area with un-mowed wetland vegetation present, and wetland hydrology, but the vegetation abruptly ends at one point where wetland vegetation has been disturbed, either by mowing, or by grading; wetland hydrology wasn't observed in the disturbed areas. Much of the area was covered in what appeared to be applied straw.

Figure 10: Hillside seep and vegetation at the southwest corner of the parcel. Abrupt change in vegetation due to disturbance. Ponding (wetland hydrology) was visible in the seep area with tall vegetation (see Figure 11), but not evident to the north of the area where vegetation had been disturbed. Approximate visible seep location is in the orange box.

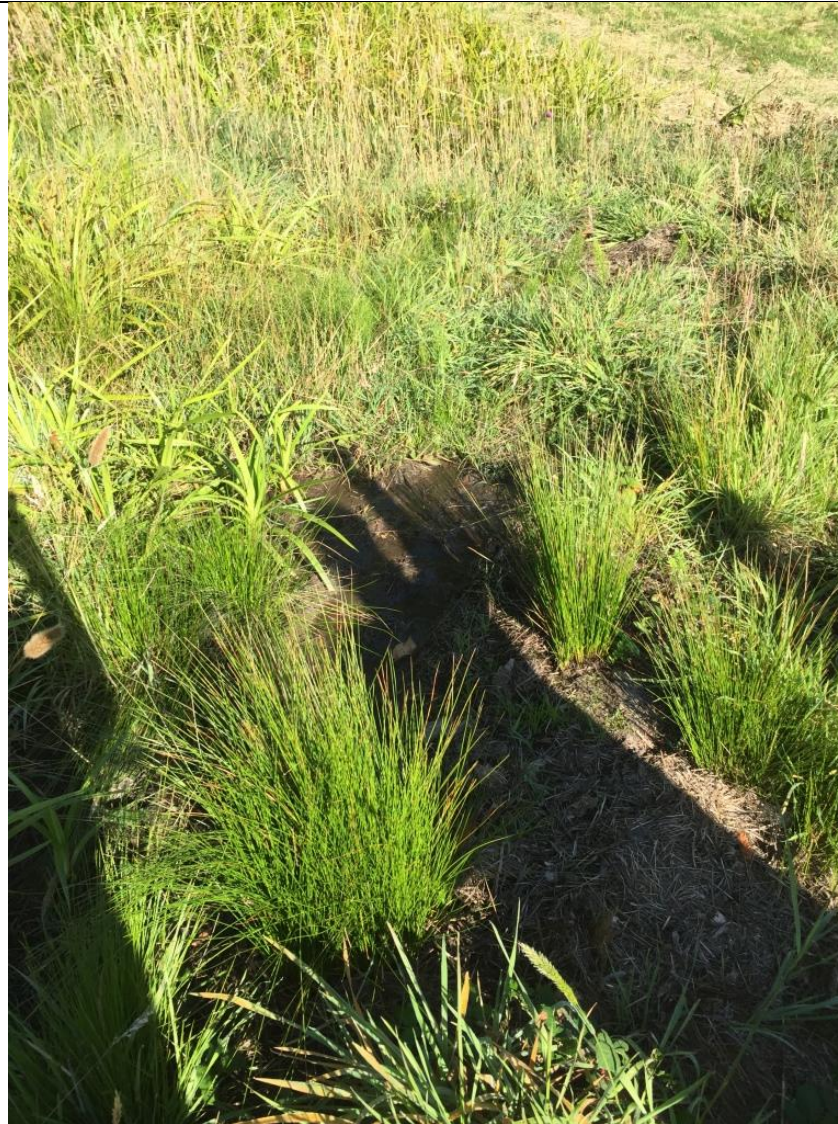
Figure 11: Evidence of ponding amid wetland vegetation within hillside seep area at southwest corner of parcel.

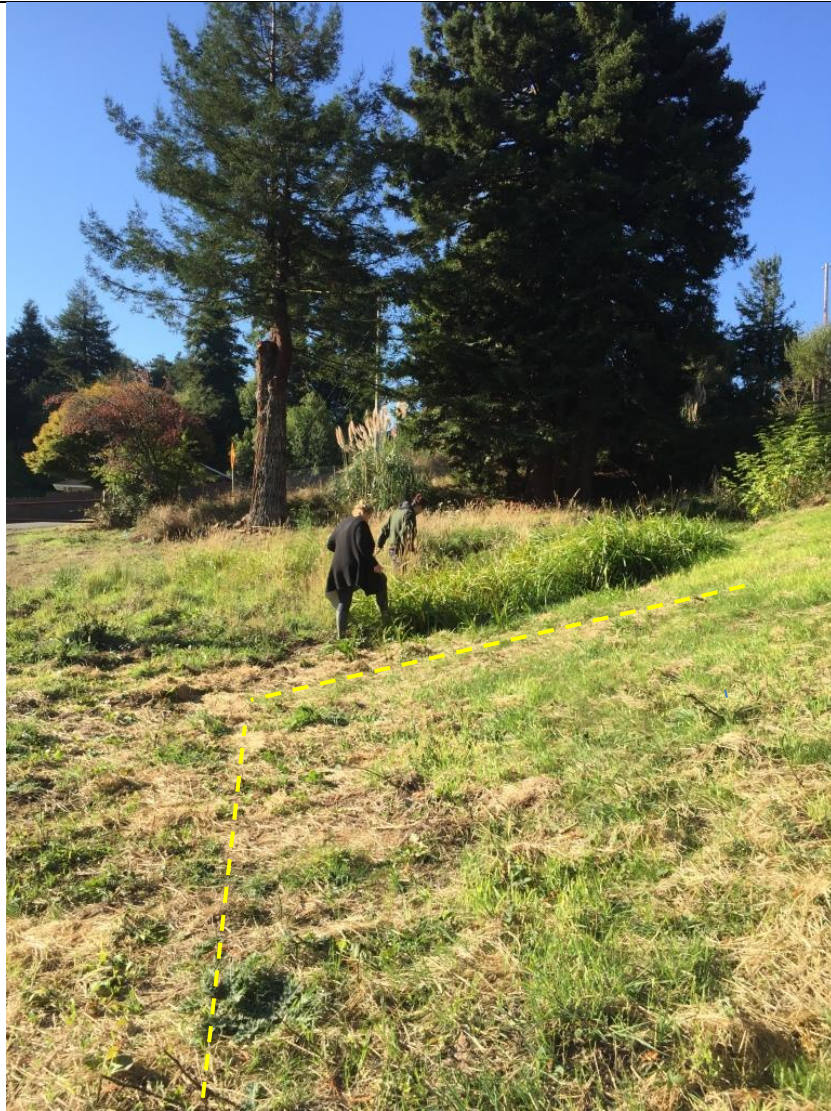
Figure 12: View of hillside seep looking south. The photo was taken down gradient of where the people are standing. Based on ground topography observations, it appeared there may have been a linear excavation in the areas indicated by the dashed yellow line. Further investigation is needed.

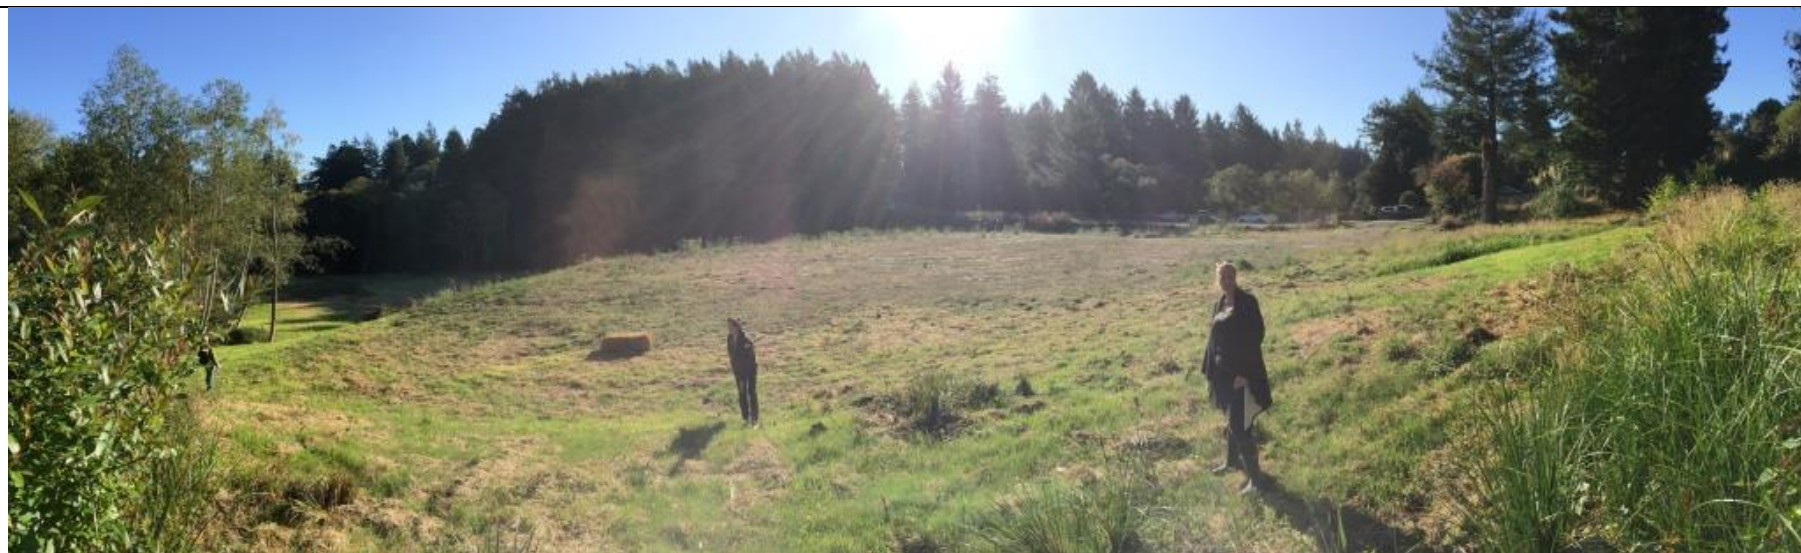
Figure 13: Standing at the hillside seep location and looking east.

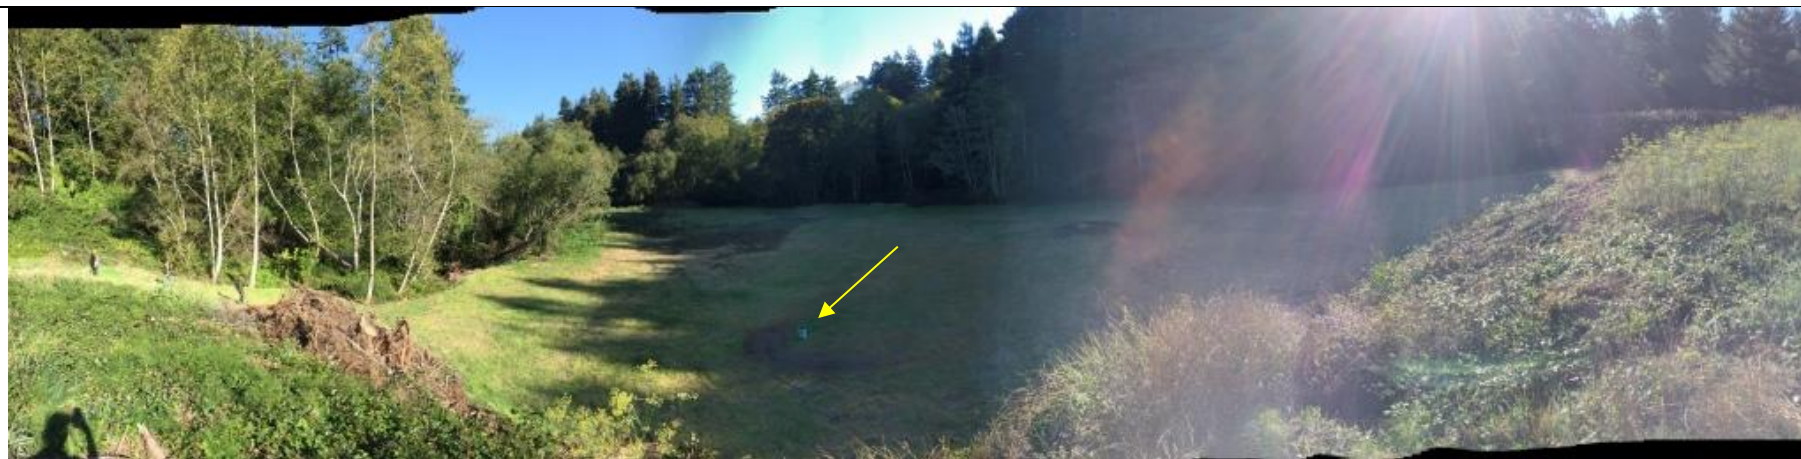
Figure 14: Standing on the edge of the upper area looking northeast. The yellow arrow points to the vertical pipe shown in Figure 15 and Figure 16.

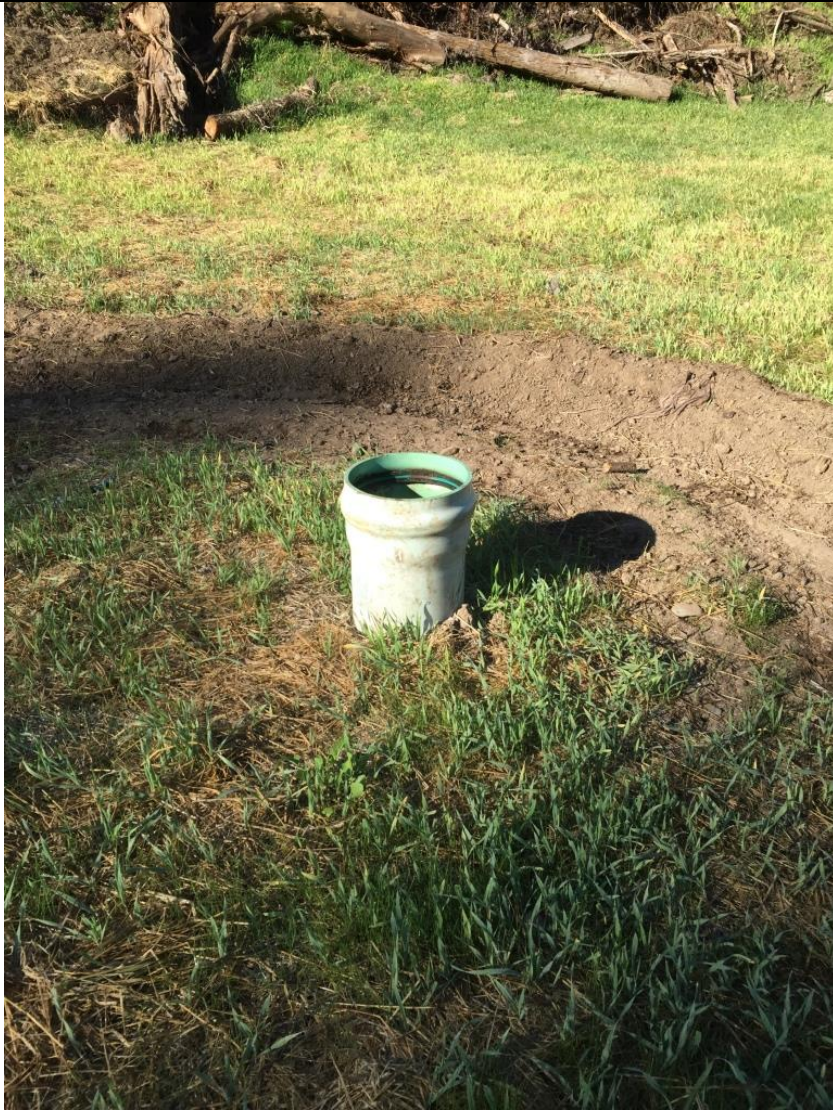
Figure 15: Vertical pipe shown in Figure 14.

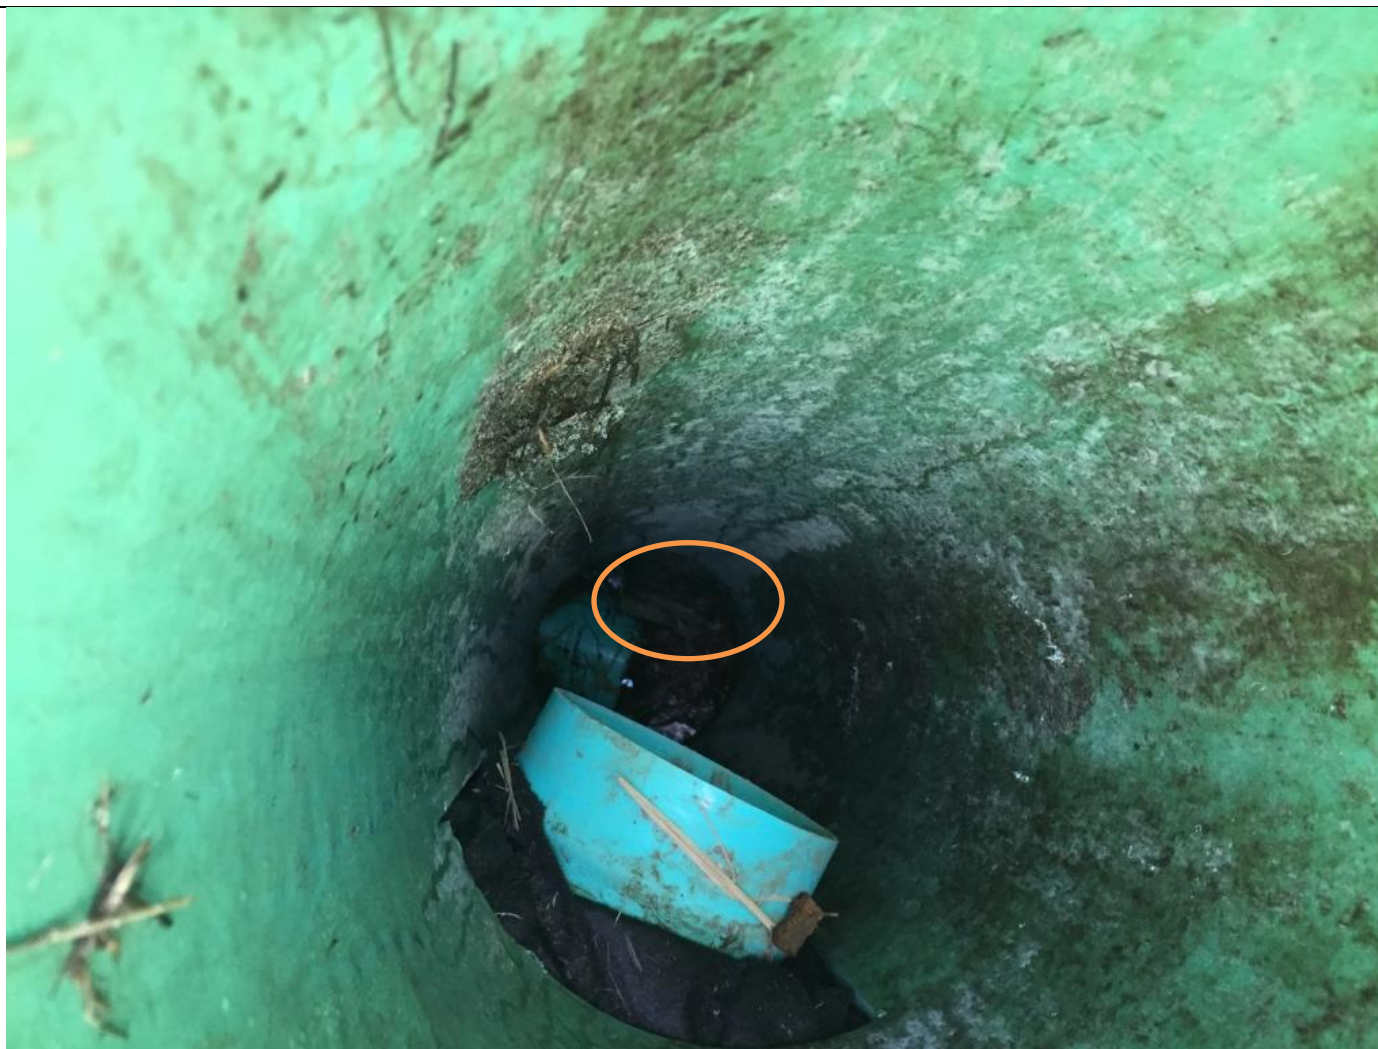
Figure 16: Inside the vertical pipe. There were three pipes protruding into the vertical pipe at differing elevations. At the lowest elevation there was a black, perforated plastic pipe—this pipe is hard to see in the photo and is within the orange circle. Higher in elevation above that pipe were two blue, solid plastic pipes. Figure 17 shows the likely pipe flow paths.

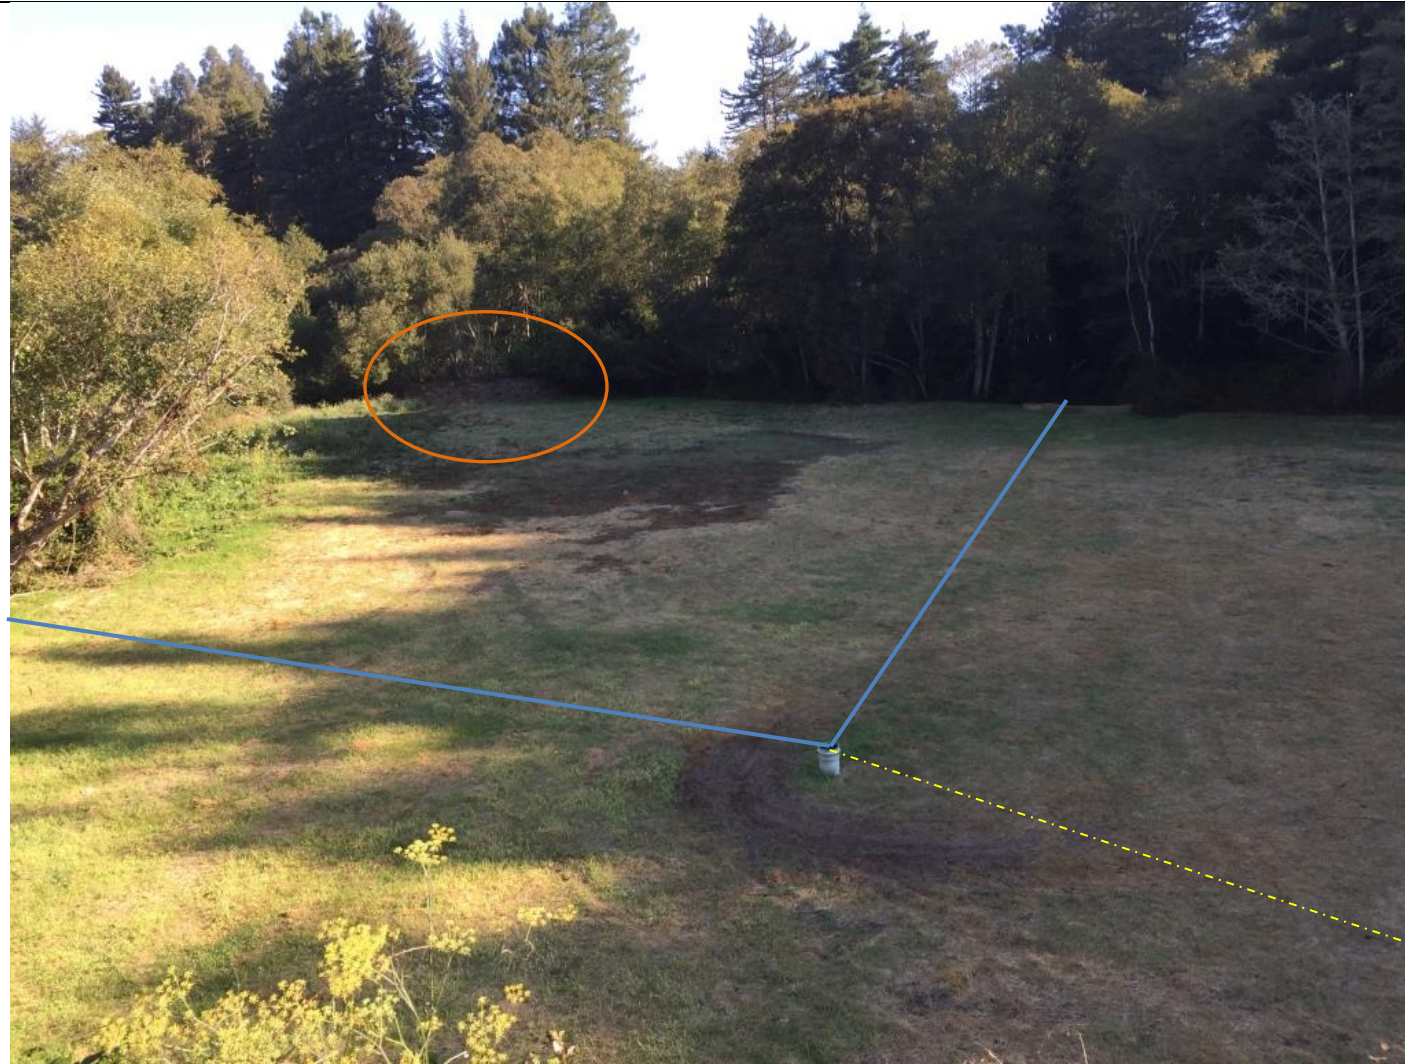
Figure 17: Apparent flow paths of three pipes shown in Figure 16. The dashed yellow line represents the black perforated pipe (see Figure 25 and Figure 26) and the solid blue lines represent the solid, blue plastic pipes--see Figure 22 and Figure 23 for the green flow path, and Figure 27 and Figure 30 for the blue flow path—these pipes appear to drain to the forested wetland and Third Slough, respectively. The debris pile circled in orange is discussed in Figure 36.

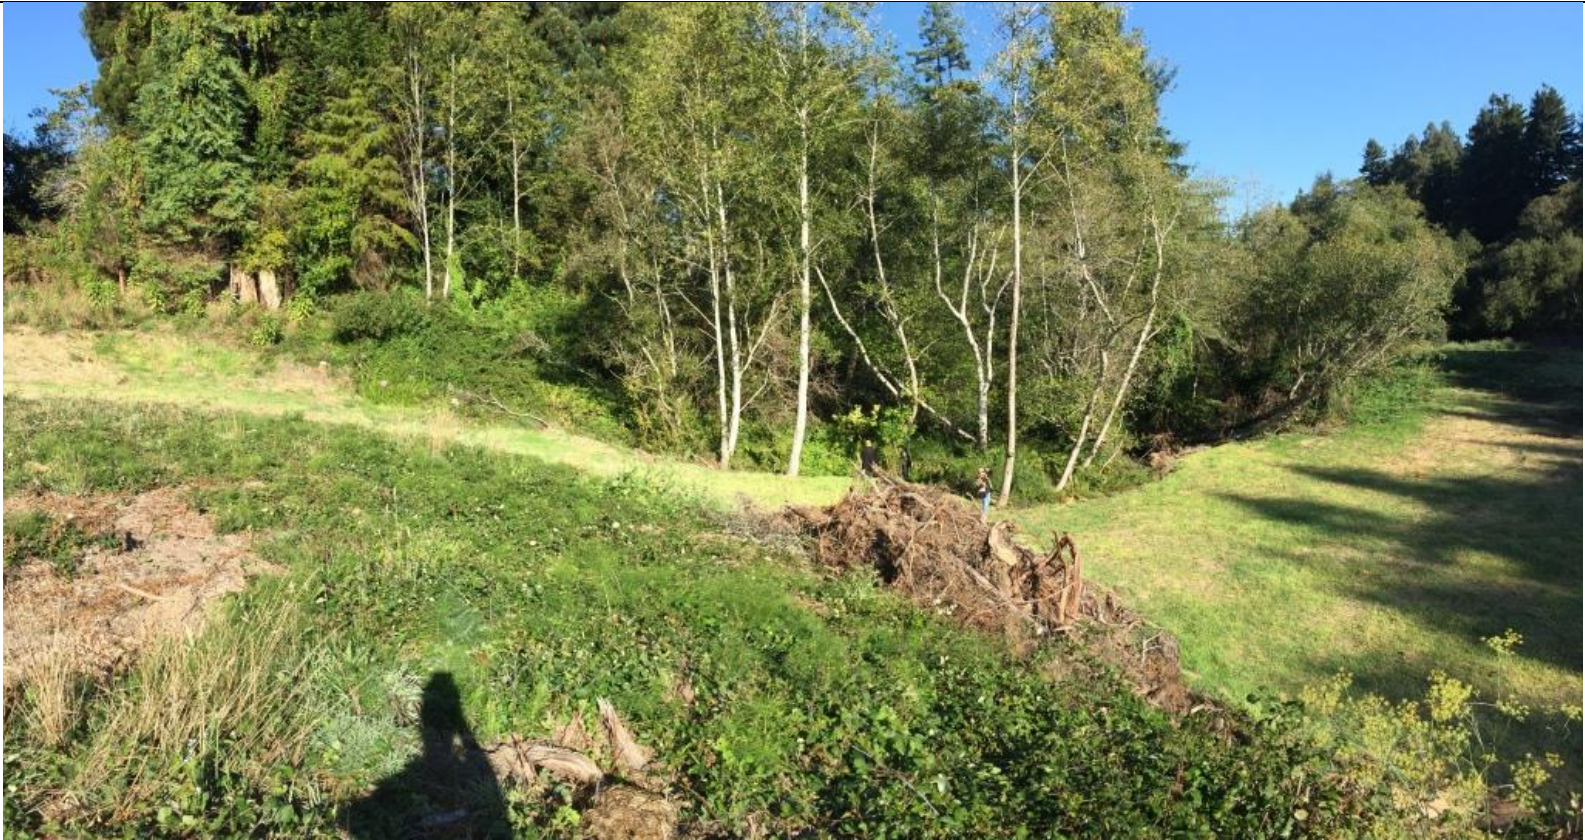
Figure 18: Standing on the upper area looking northwest at the forested wetland area and ramp along the western parcel boundary. Historical aerial imagery accessed on Google Earth shows that the ramp area was formerly vegetated/forested.

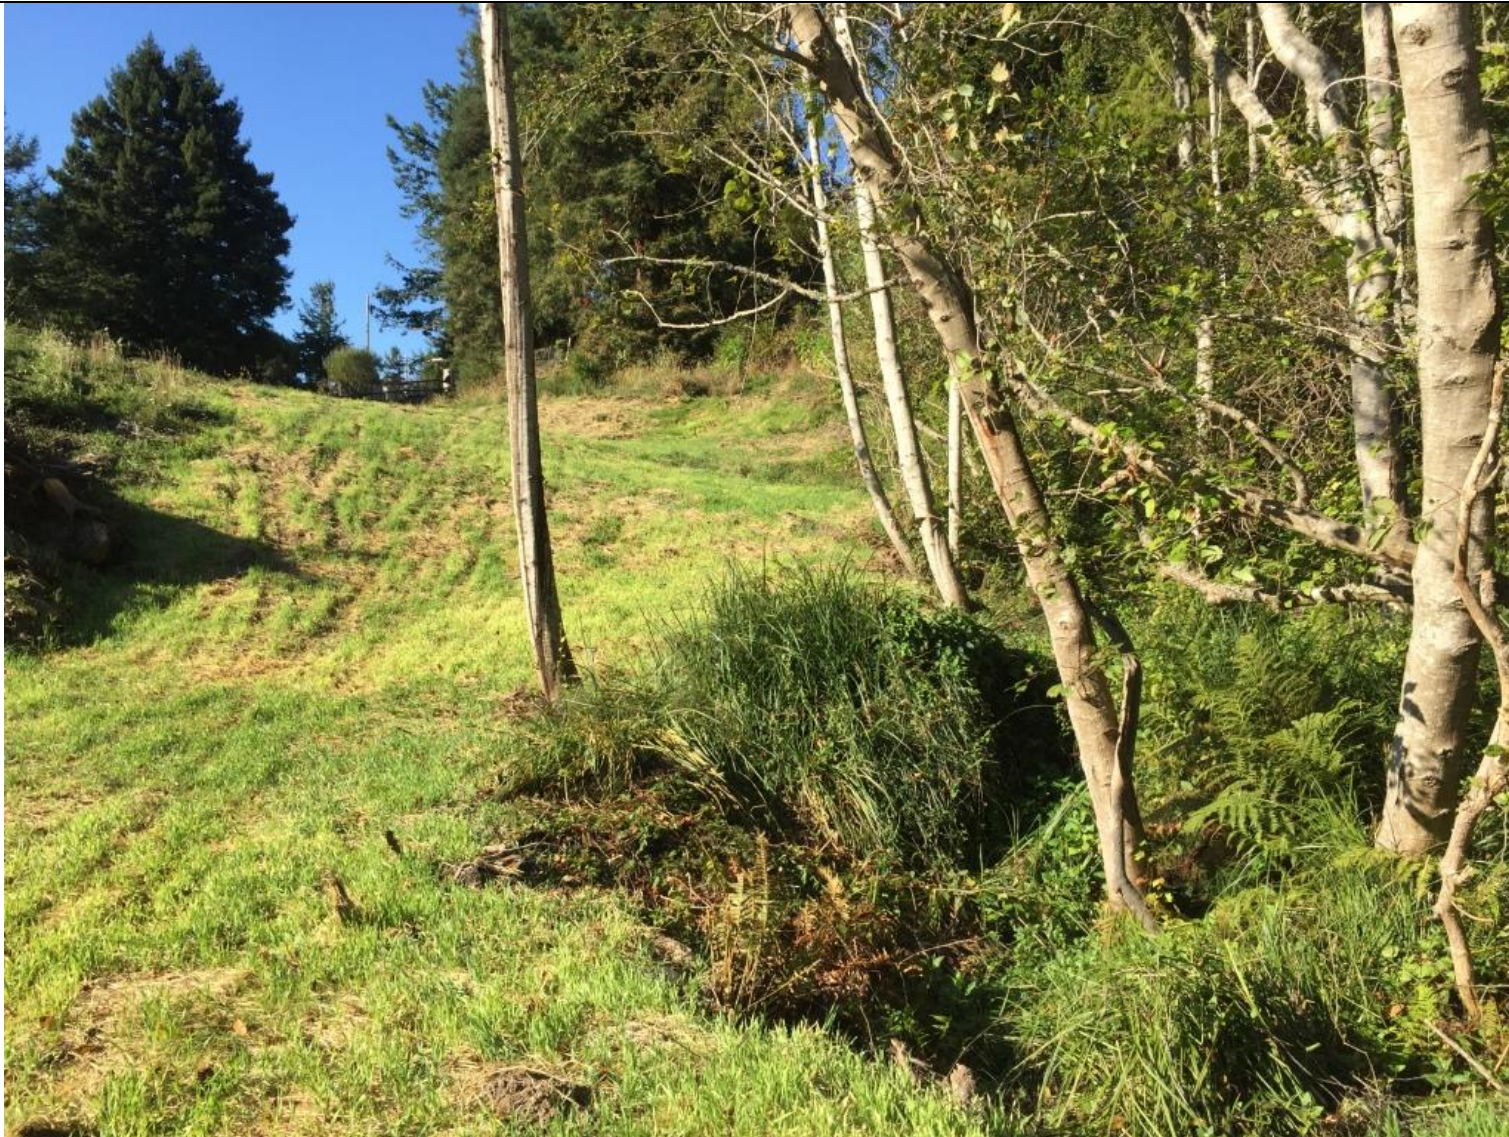
Figure 19: Standing next to the wet forested area shown in Figure 18, looking south. It appears that earth was graded adjacent to and/or into this wet forested area.

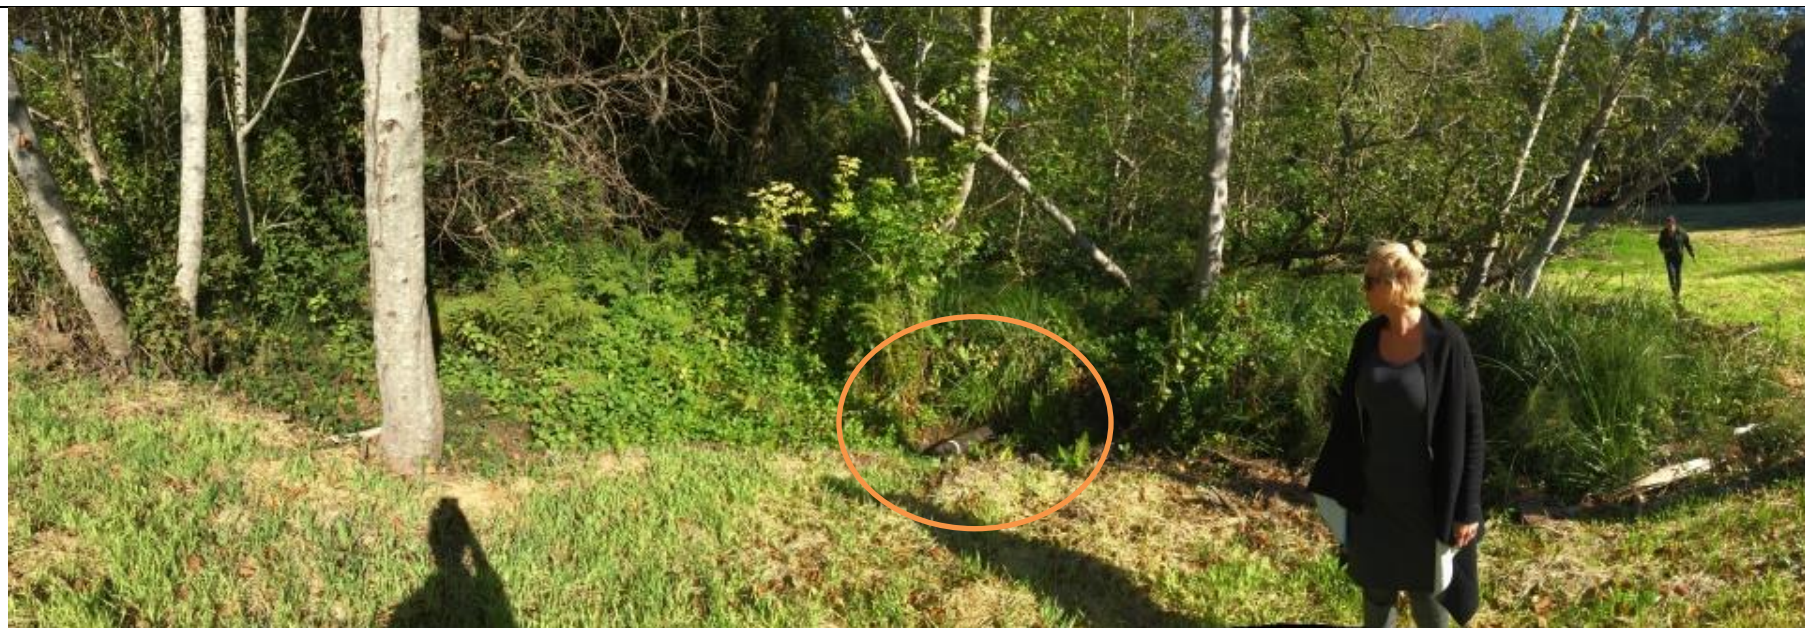
Figure 20: Looking northwest at the wet forested area and standing at approximately the same location shown in Figure 19. In the orange circle is a possible pipe drain (see Figure 21) lying in a very wet area.

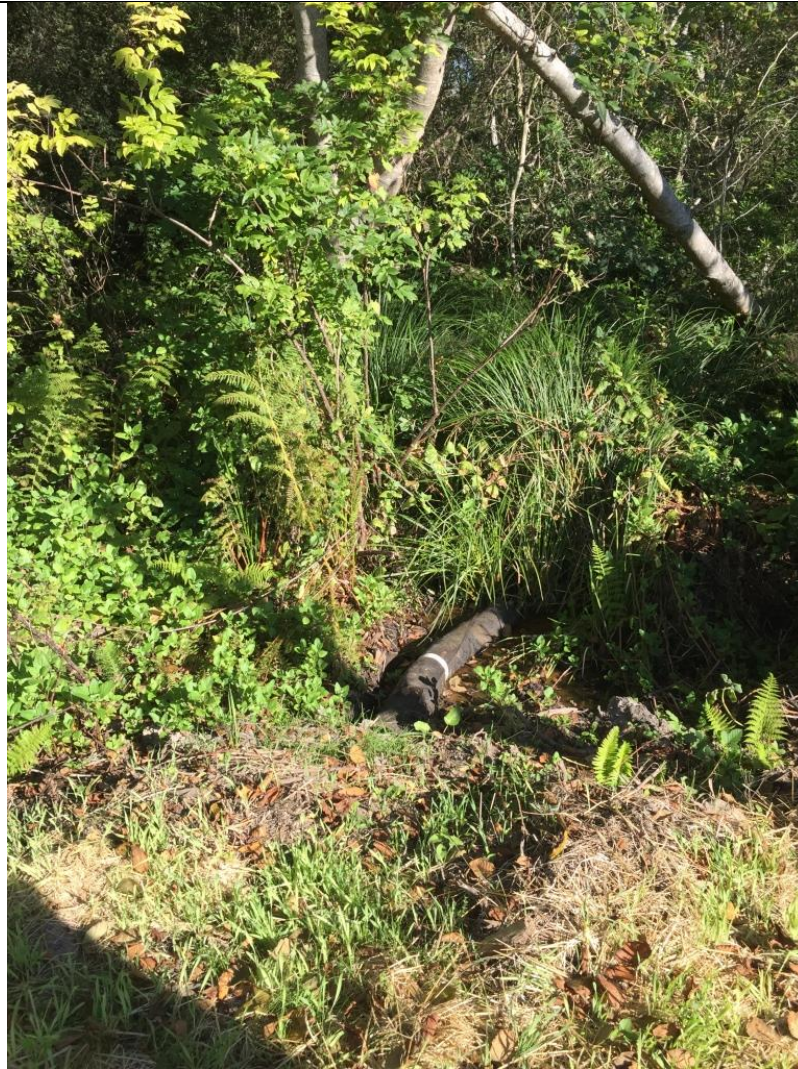
Figure 21: Close up of the possible drain shown in Figure 20. This was coming out of the ground and appeared to be a pipe covered in filter fabric.
