North Coast Regional Water Quality Control Board

Subject: Revised **Notice of Violation** for activities at Assessor's Parcel Number 015-111-09, 2725 Lucas St., Eureka

**Inspection Report Memorandum
2725 Lucas Street, Eureka, Humboldt County**

Date: December 13, 2017

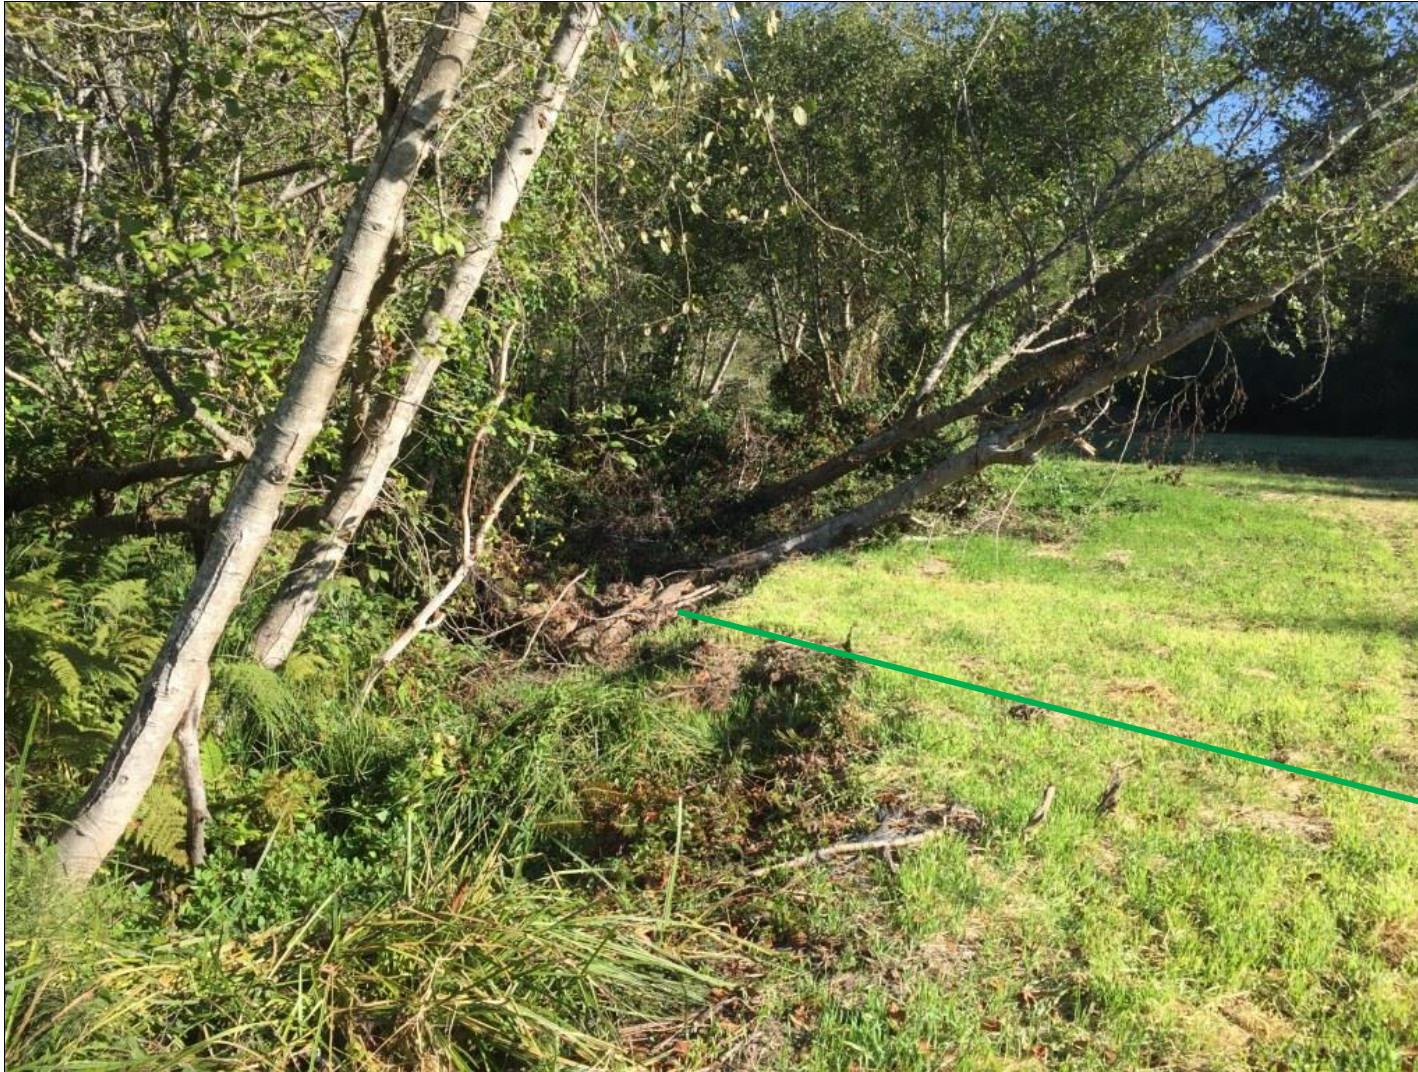
Figure 22: Looking northeast along the margin of the wet forested area. It appears that the upper-most pipe in the vertical pipe would discharge into this area through an outlet buried amongst a pile of wood pushed into the wetland (see Figure 23 and Figure 24). The green line shows the approximate location of the pipe, as extrapolated from the direction of the uppermost pipe in the vertical pipe.

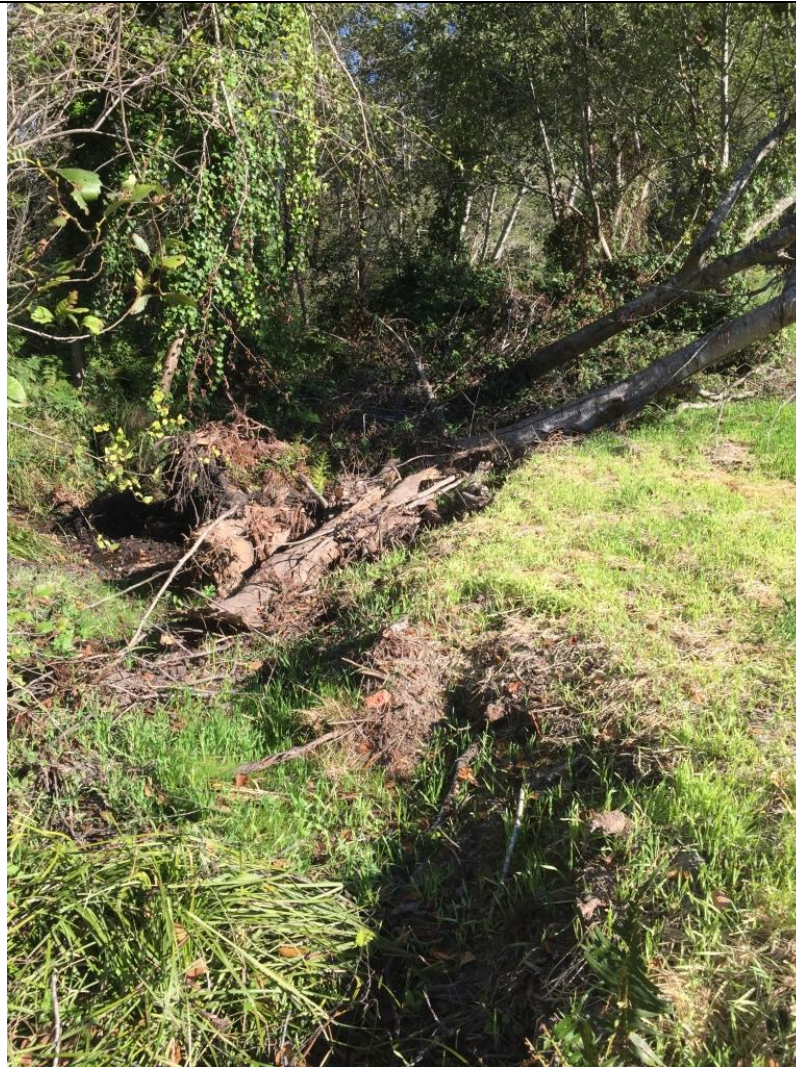
Figure 23: The outlet pipe described in Figure 22 likely discharges somewhere underneath this pile of wood debris. I could not find the outlet, but did not move the wood to try and find it.

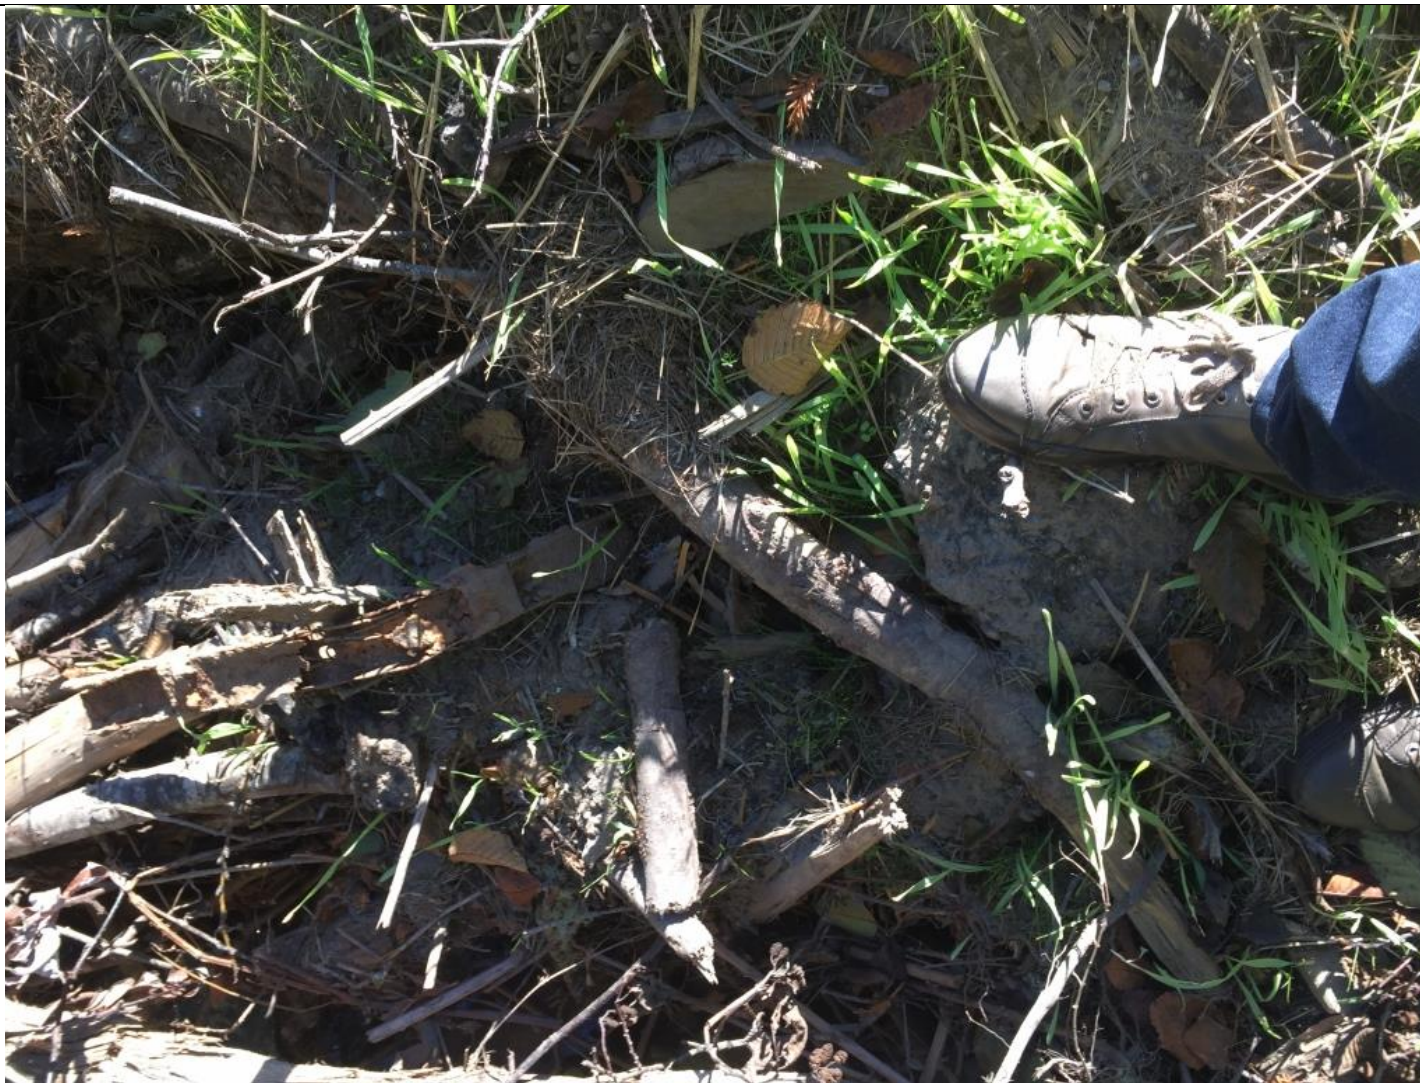
Figure 24: A close-up of the wood debris described in Figure 22 and Figure 23. There appeared to be rubble mixed in with the wood—my foot is on a piece of asphalt—relatively fresh dirt and straw were on top of the wood, suggesting recent disturbance in the area.

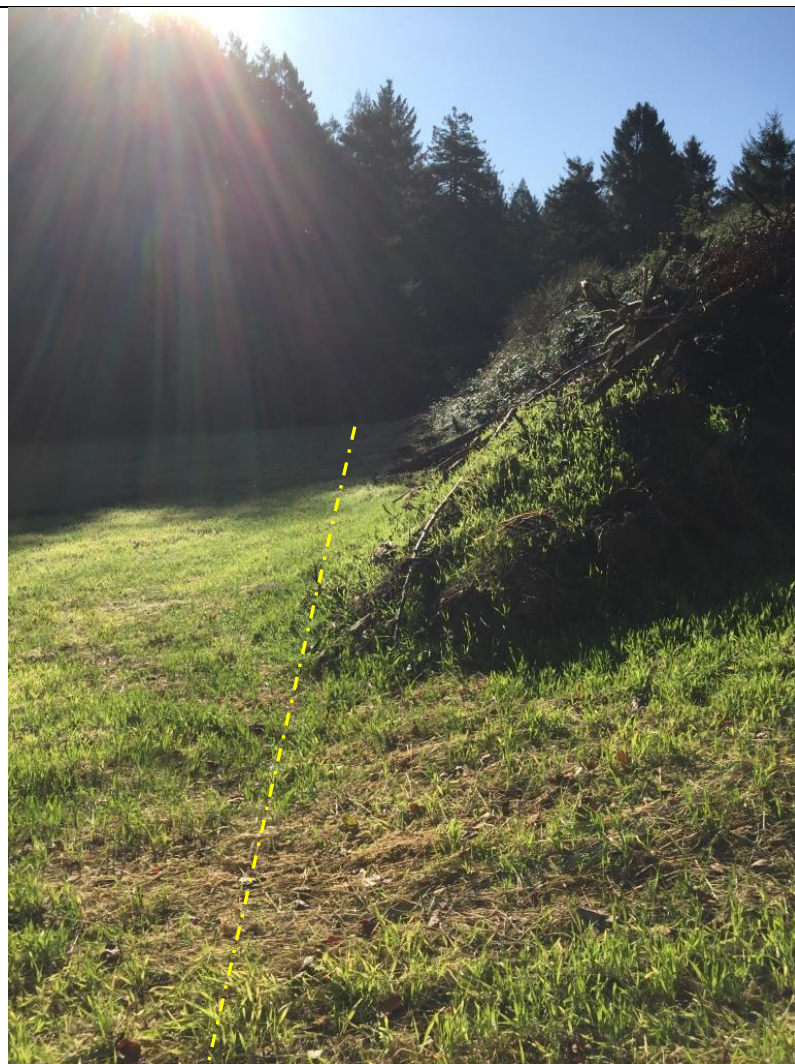
Figure 25: This photo was taken standing at the vertical pipe and looking southeast. The perforated pipe seen at the bottom of the vertical pipe appears to line up with the pipe feature shown in Figure 26. The dashed yellow line approximates the course the pipe would take between these two features, which is along the toe of the slope separating the upper area from the lower floodplain area.

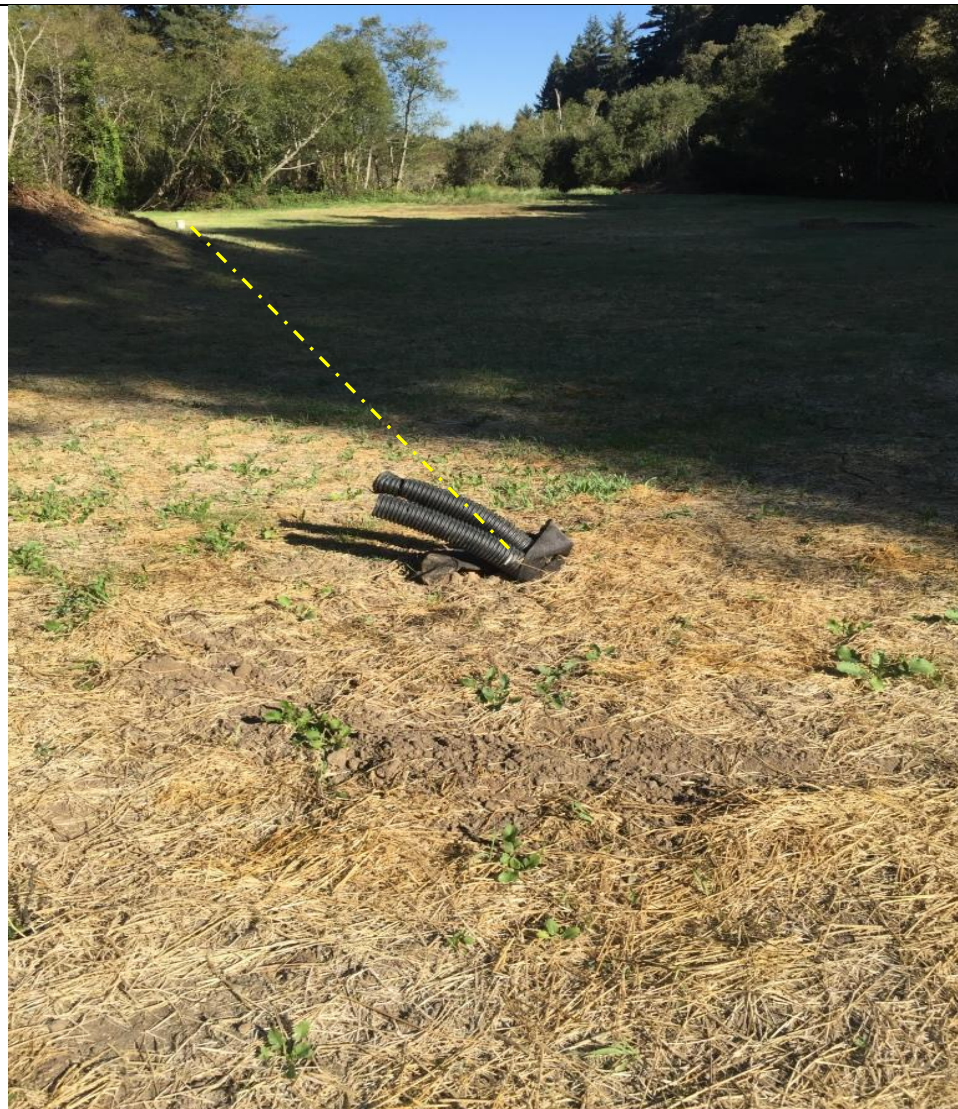
Figure 26: Looking northwest toward the forested wetland and the vertical pipe. There were two black, plastic perforated pipes wrapped in filter fabric sticking out of the ground. It is unknown where each pipe goes, but if one of them goes to the vertical pipe then it may take a path approximated by the dashed yellow line.

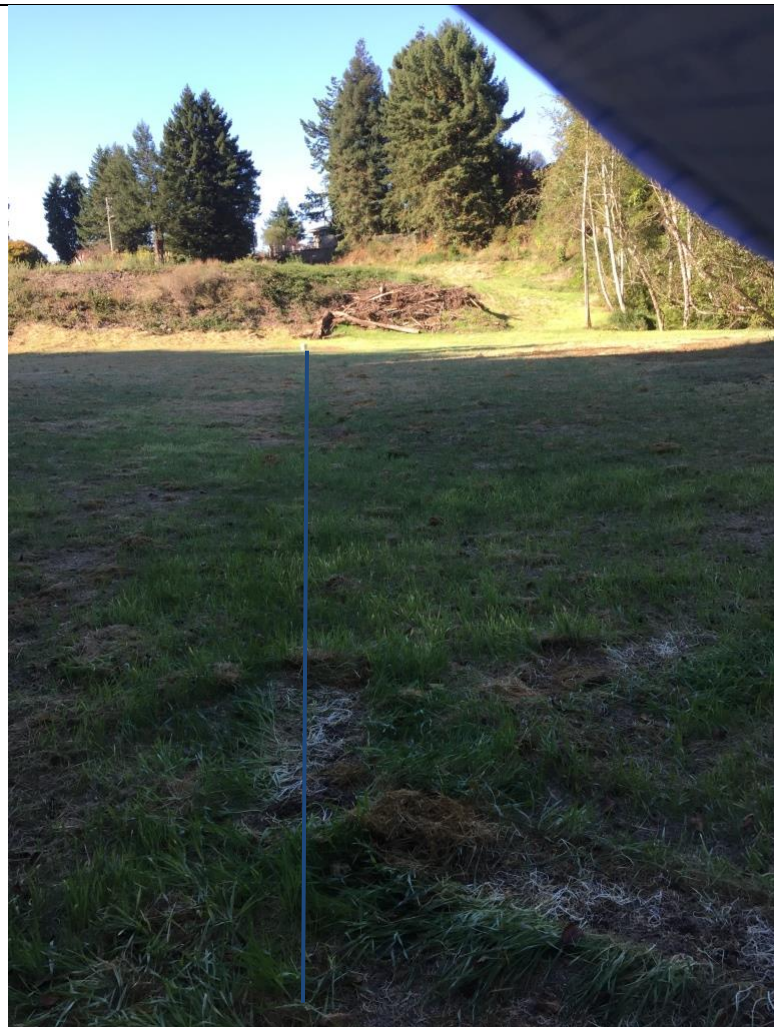
Figure 27: Looking northwest from the upper bank of Third Slough to the vertical pipe. It appeared that the uppermost plastic pipe in the vertical pipe would discharge directly into Third Slough via an outfall immediately behind me—the approximate pipe flow path is represented by the blue line—there was a faint linear ground indentation that appeared to perfectly align the discharge location with the vertical pipe.

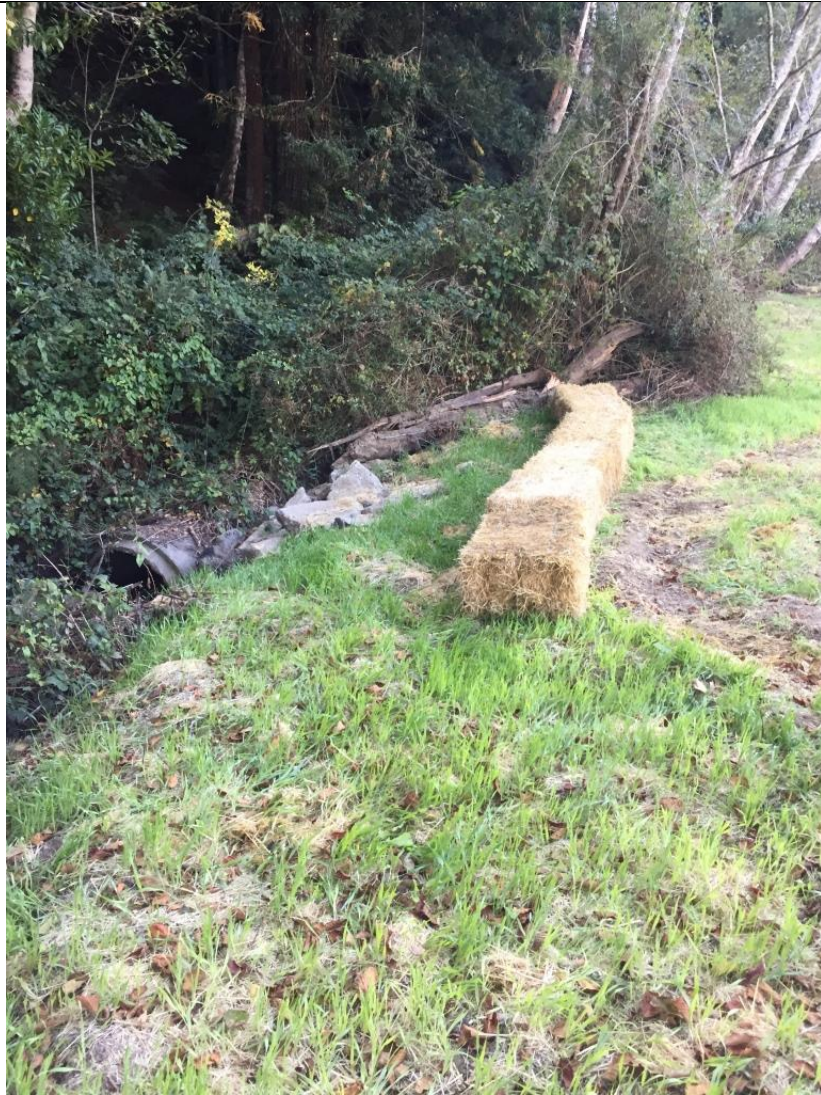
Figure 28: Looking south at the southernmost extent of an un-culverted Third Slough. The photo in Figure 27 was taken at approximately the first straw bale in the foreground. The pipe outfall shown in Figure 30 is in the channel just to the left of the first foreground straw bale.

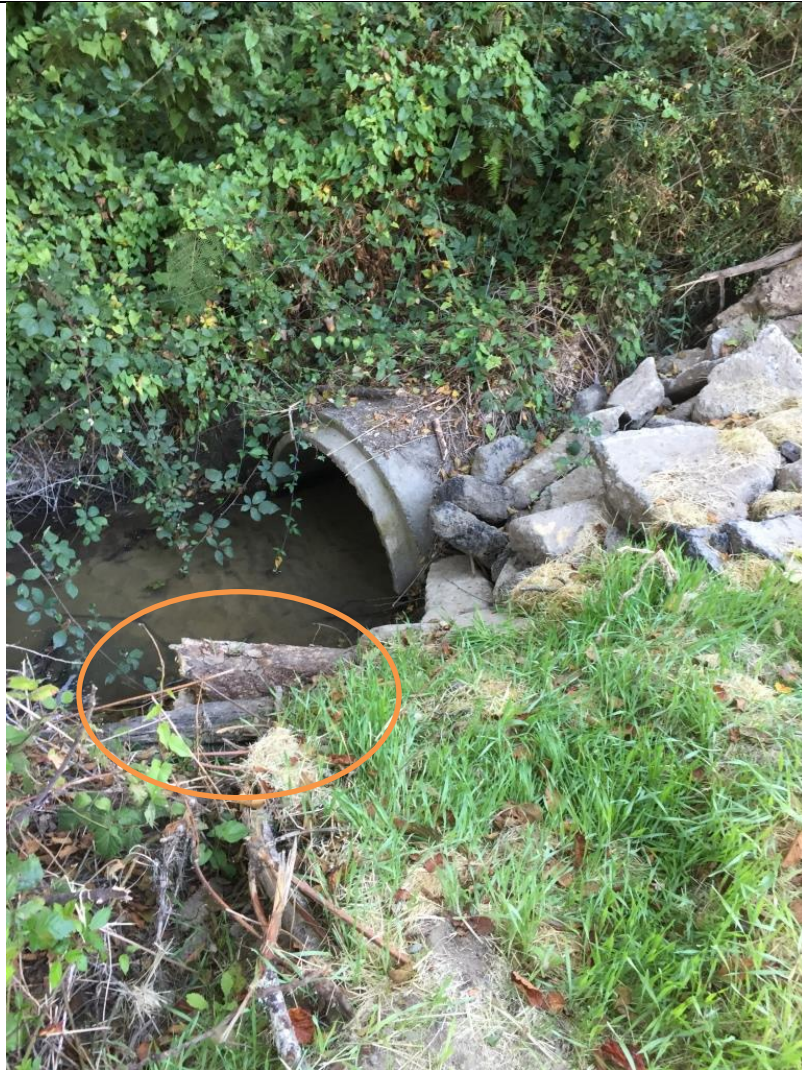
On September 1, CDFW staff reported observing a pipe, wood debris, and concrete that appeared to have been recently placed in the Third Slough channel (see Attachment A, Figures 29 and 30). This material is considered fill material and installation of this material in waters of state would have required a section 404 permit from the U.S. Army Corps of Engineers and a Clean Water Act section 401 certification from the Regional Water Board. You did not apply for or obtain a Clean Water Act section 401 water quality certification.

Placement of the pipe and debris as shown in Attachment A, Figures 29 and 30, would also require Waste Discharge Requirements (WDRs) from the Regional Water Board, pursuant to Water Code sections 13260 and 13376. You did not report this discharge of waste to the Regional Water Board. Failure to report waste discharges and placement of waste in state waters without WDRs is a violation of California Water Code sections 13260 and 13376.

Figure 29: A close-up of Third Slough where it enters a culvert at the eastern parcel boundary. The blue plastic pipe outfall is beneath the wood shown within the orange circle (see Figure 30). The concrete rubble to the right of the culvert appeared recently placed; I suspected there may be another drain outlet beneath the rubble, due to circumstances described in Figure 33 and Figure 34, but could not locate an outlet when peering between the rubble.

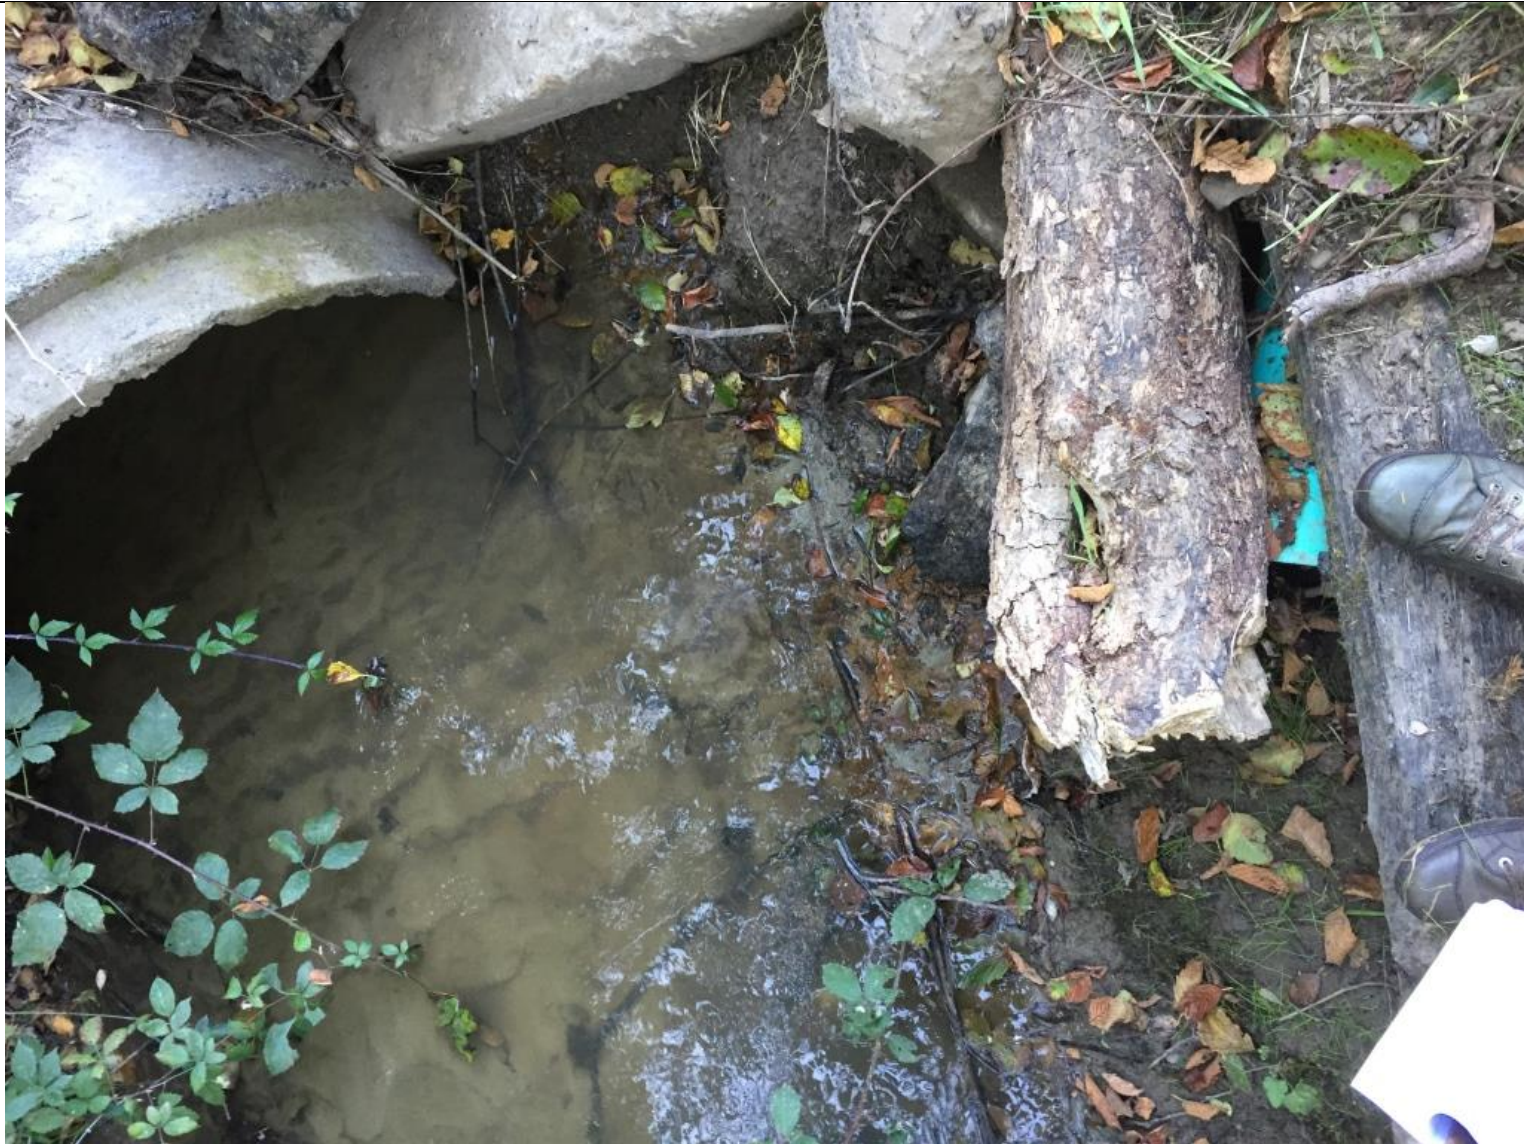
Figure 30: A view of the outfall, ostensibly a continuation of the uppermost pipe in the vertical pipe. It appeared that wood had been deliberately placed over the outfall.

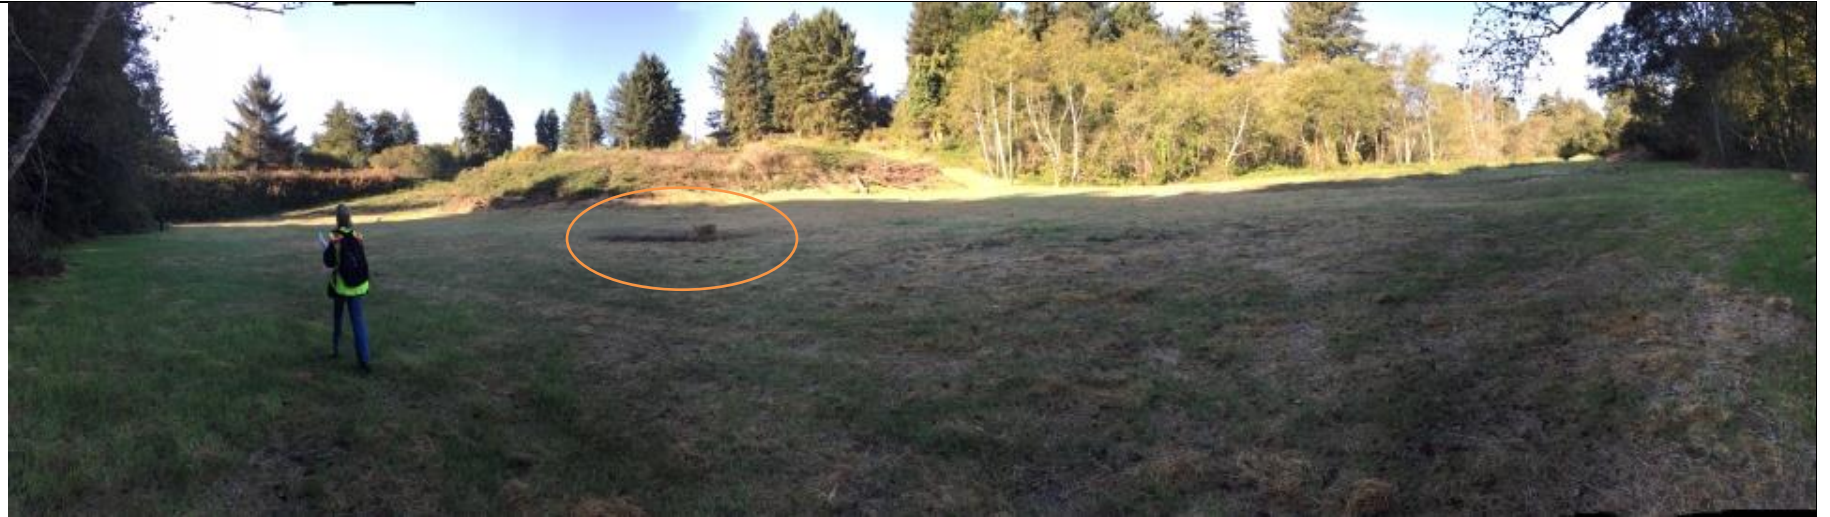
Figure 31: Looking southwest from the straw bales adjacent Third Slough. In the orange circle is a single straw bale as shown in Figure 30.

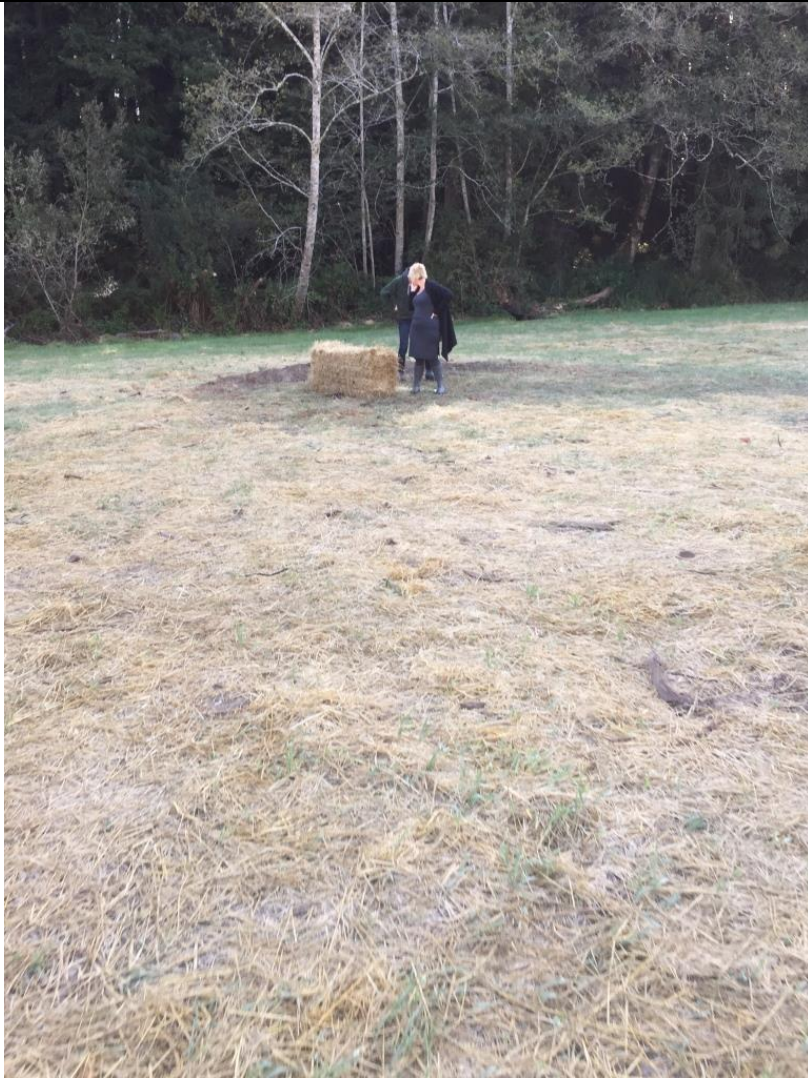
Figure 32: There may have been a filled-in excavation beneath this straw bale, as the ground appeared disturbed and relatively loose.

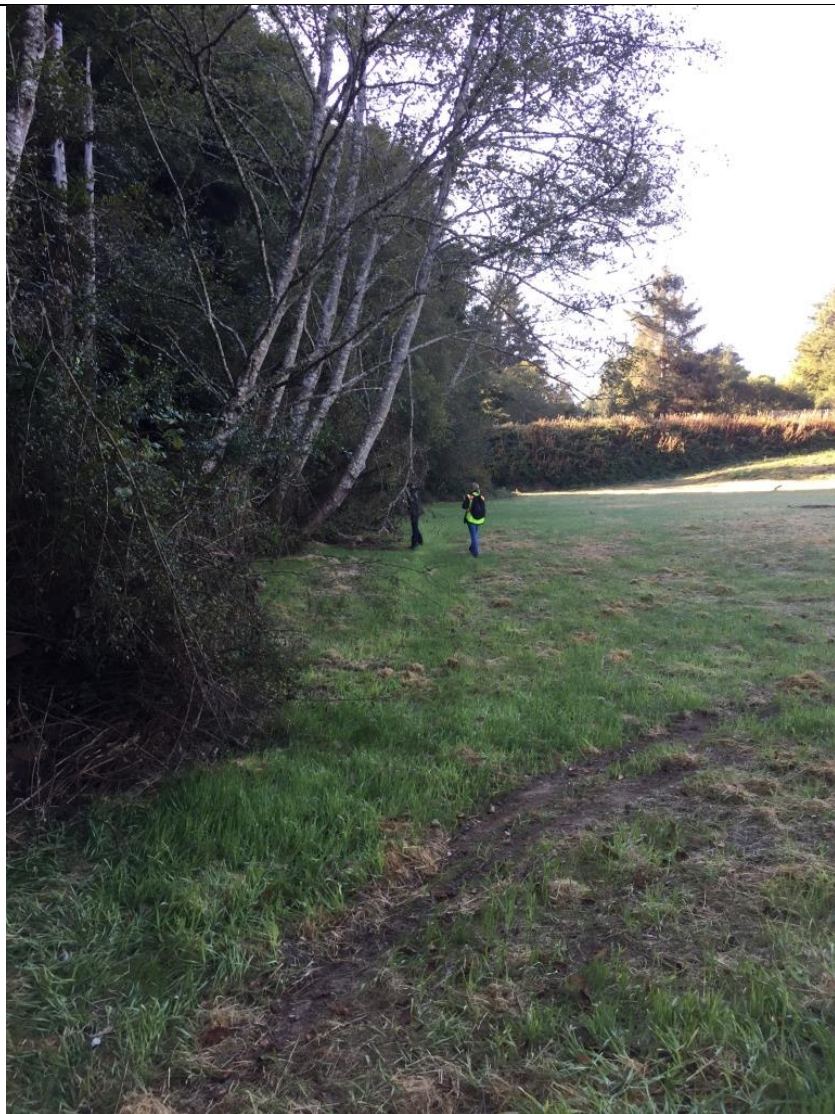
Figure 33: Standing on the upper bank of Third Slough near the culvert entrance looking south along the forested edge. It appeared that there may have been some linear earthwork performed between the people in the distance and the camera vantage point—see Figure 34.

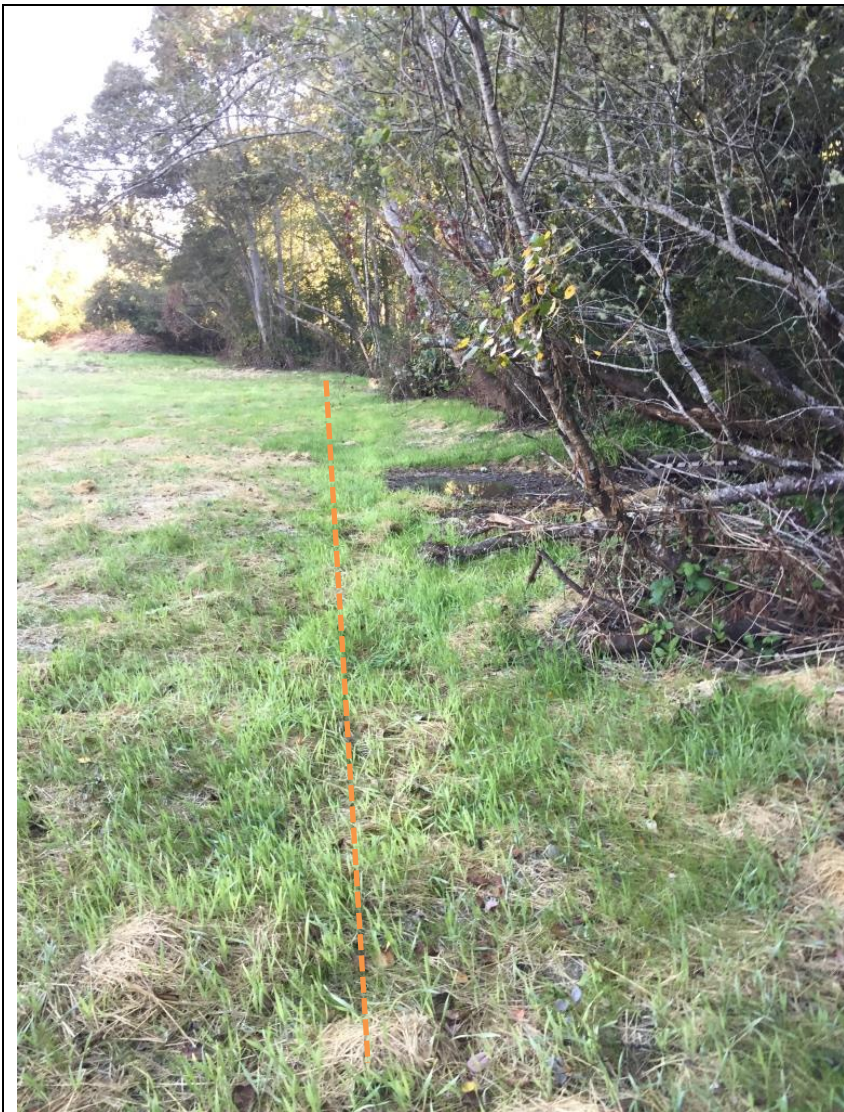
Figure 34: Looking south while standing at the approximate location of the people shown in Figure 33. It appeared that there had been some linear earthwork as made evident by the slight indentation in the ground and unconsolidated gravelly fill (see Figure 35). The orange line represents the approximate location of the likely earthwork. There is likely a pipe or drain at this location.

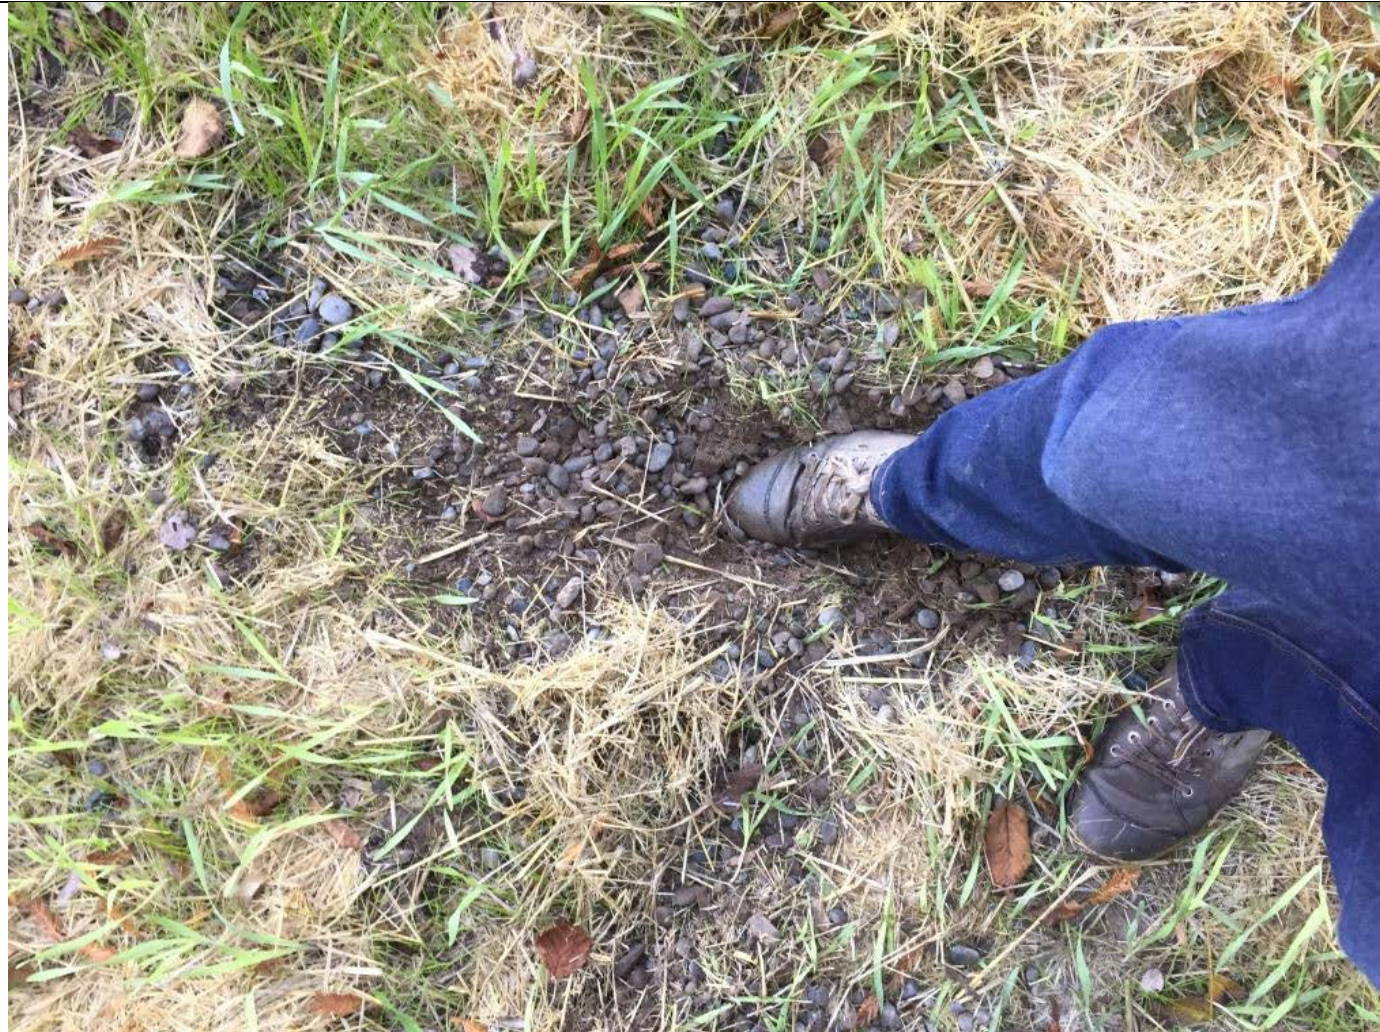
Figure 35: Light scraping of the soil with my shoe in the area represented by the orange line in Figure 34 uncovered a large concentration of rounded gravel. The presence of this rock suggested that it was backfill rather than native material, and the linear nature of the indentation suggests that there may be a pipe buried in this location. There may be an outfall for this pipe adjacent the Third Slough culvert in the area described in Figure 29.

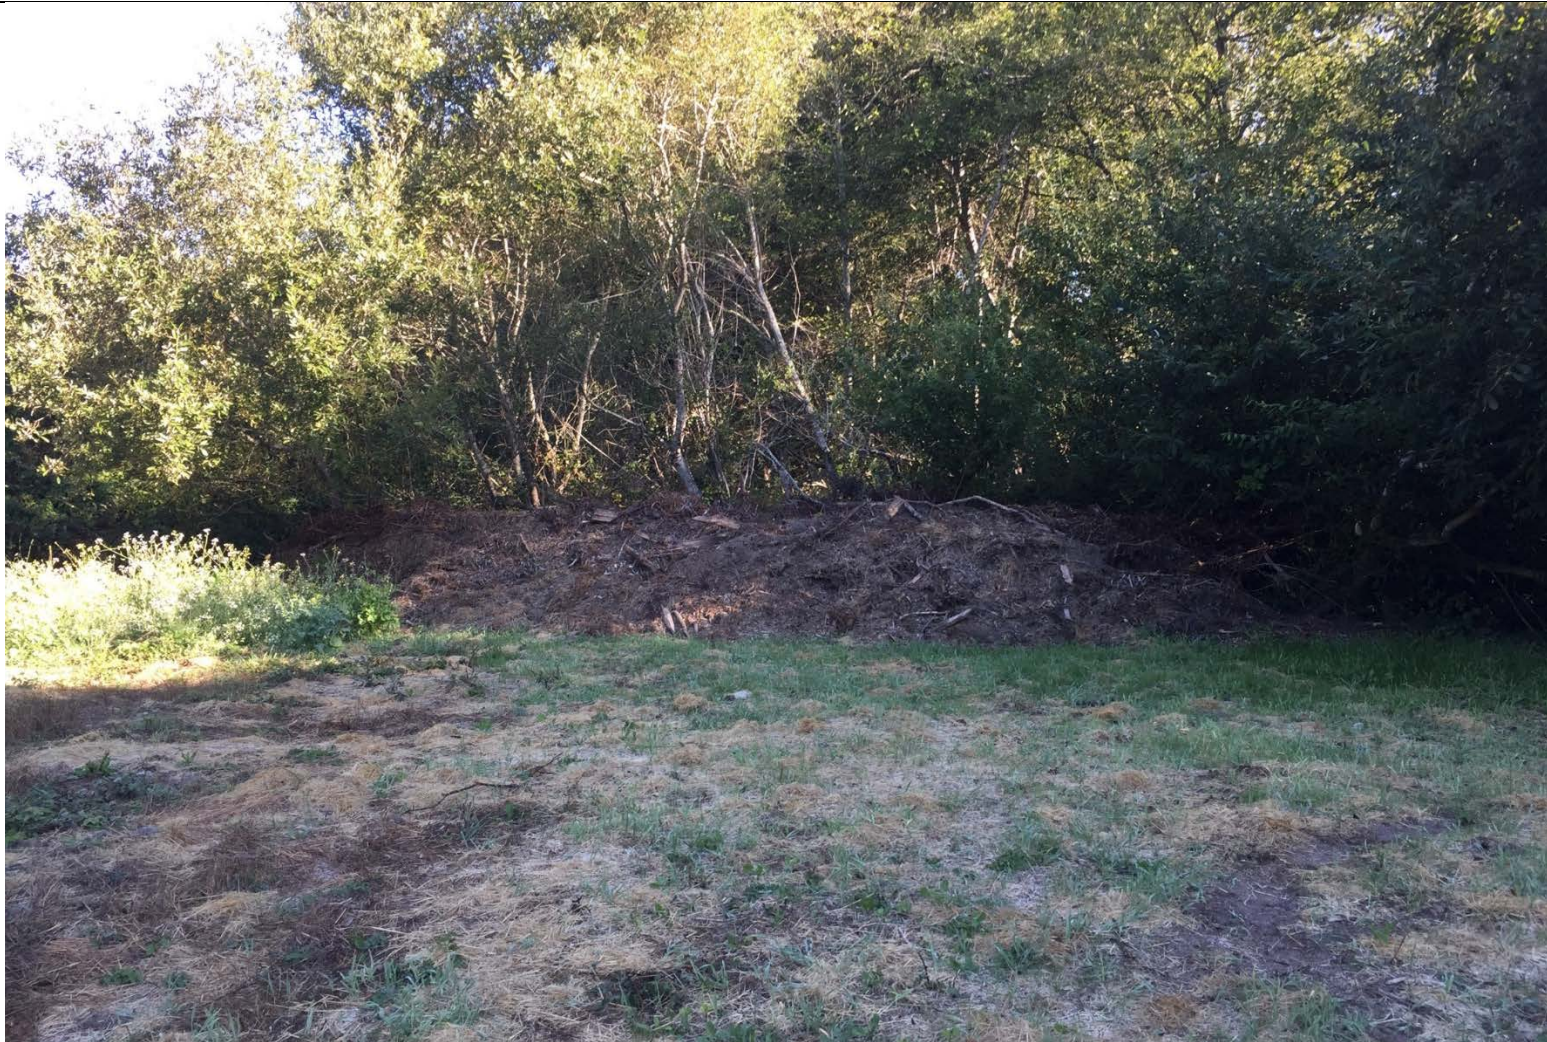
Figure 36: This pile of debris is shown in the orange circle on Figure 17. The debris is along the northern parcel boundary and was pushed into the riparian zone of Third Slough. I estimate the pile to be approximately fifty feet long (21 steps times 28.6" per step) by twenty feet wide, and approximately five feet high.

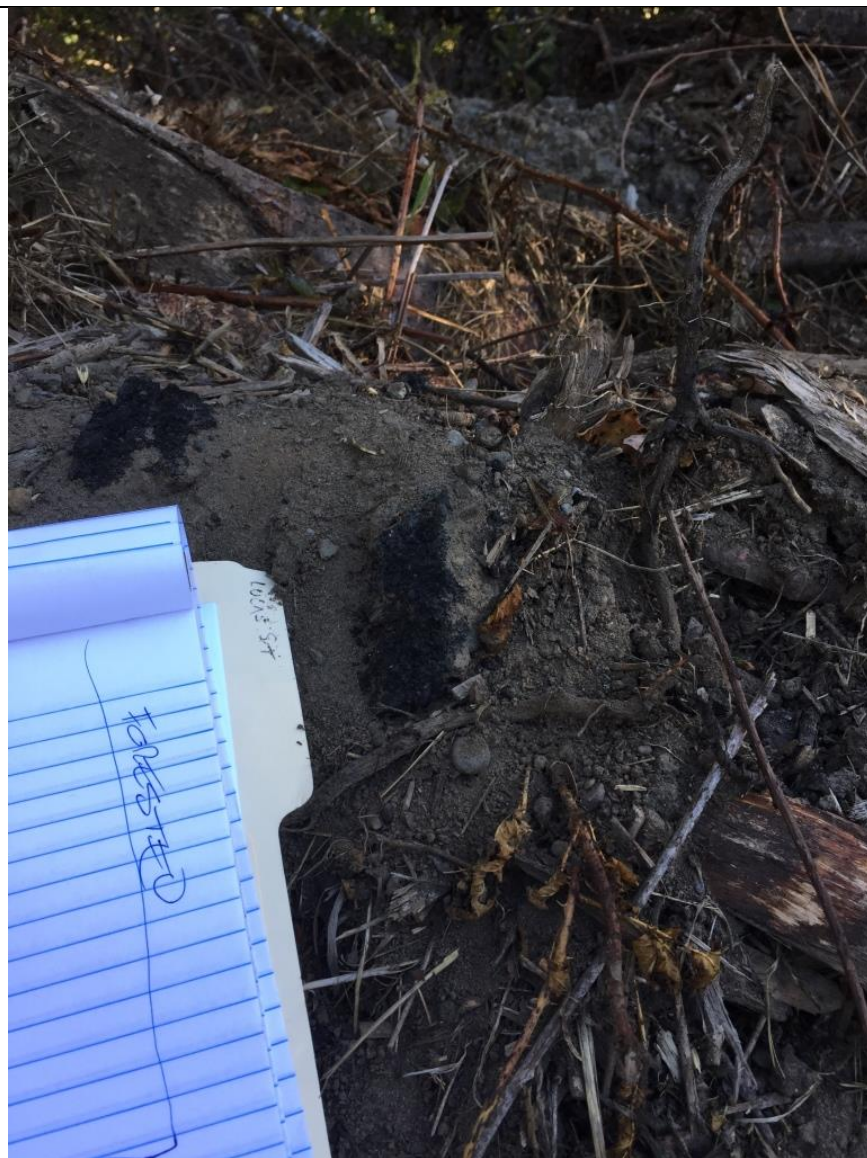
Figure 37: The debris pile consisted largely of woody vegetation and dirt, but debris such as asphalt, concrete, and brick was also within the debris pile. This photo shows two pieces of asphalt mixed in with the other debris.

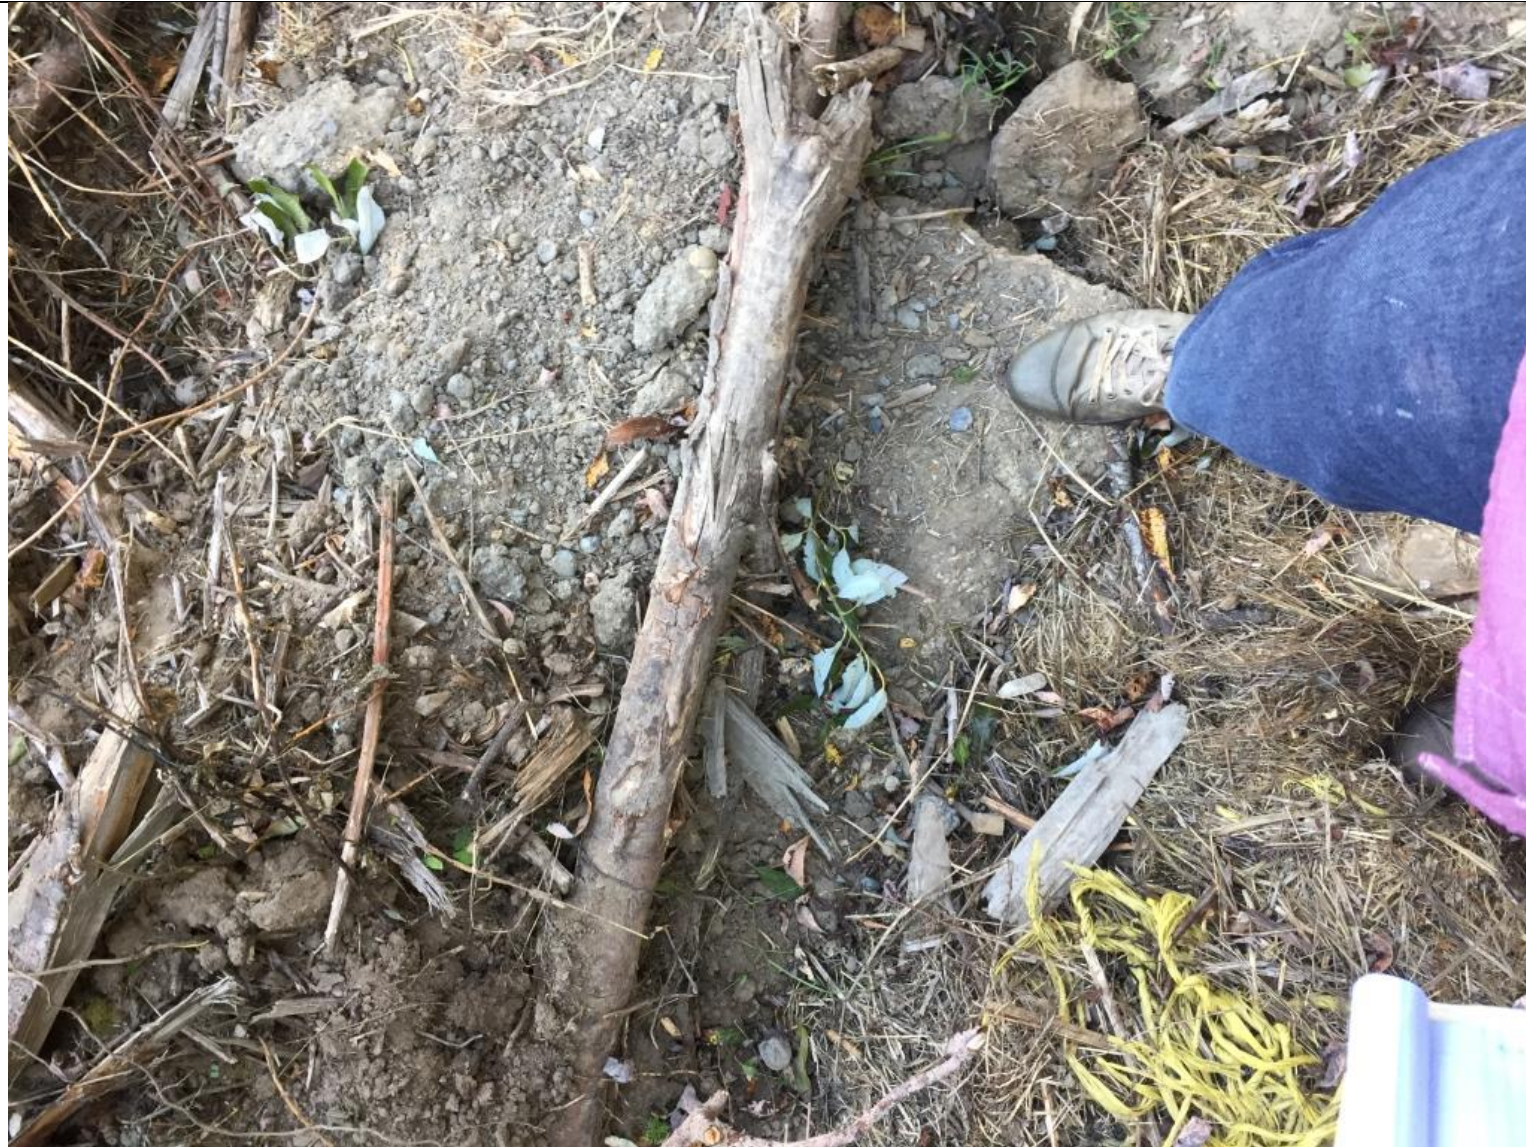
Figure 38: Concrete and nylon twine was in the debris pile. My foot is on a very large piece of partially buried concrete that extends about another 12 inches to the left beyond the overlying branch.

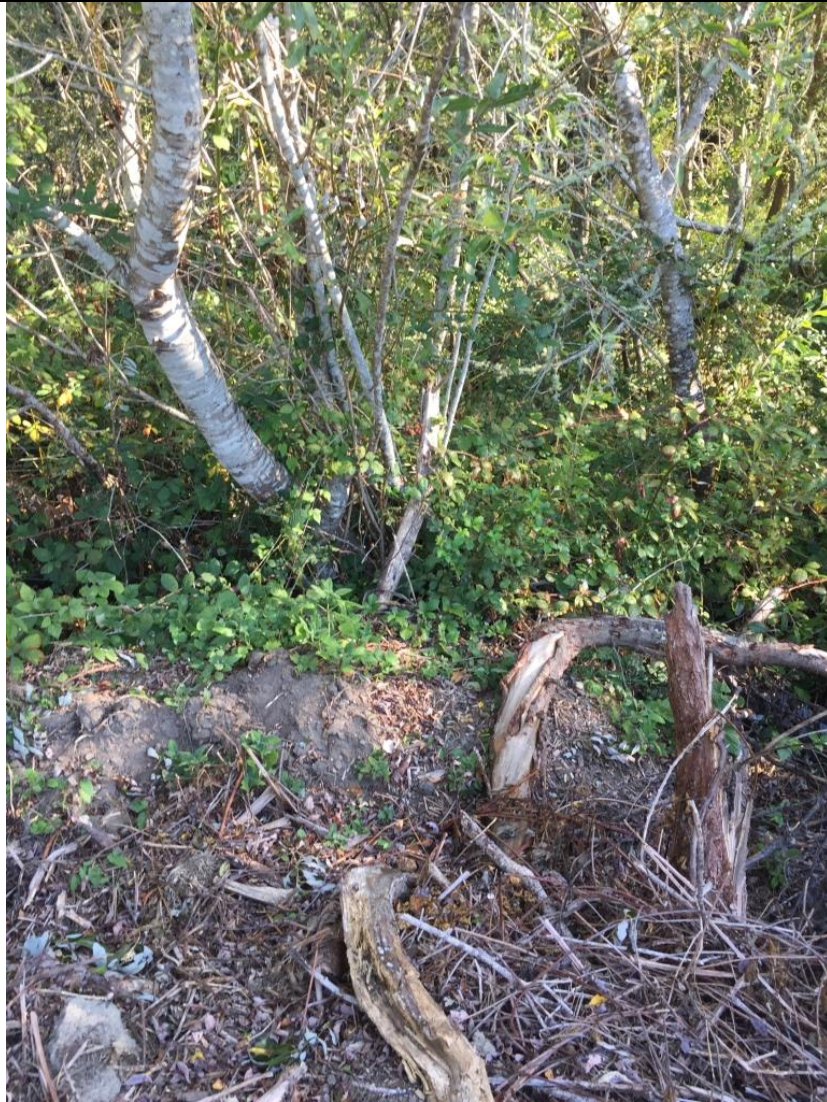
Figure 39: Photo of the debris pile among the riparian vegetation. The pile had been there long enough for some vegetation to start growing over the pile. Because historical photos show a much greater concentration of vegetation on the site, the debris pile contents may have come from the parcel vegetation thinning/removal, particularly from the slope and eastern and western parcel boundaries.
