North Coast Regional Water Quality Control Board

Subject: Revised **Notice of Violation** for activities at Assessor's Parcel Number 015-111-09, 2725 Lucas St., Eureka

**Inspection Report Memorandum
2725 Lucas Street, Eureka, Humboldt County**

Date: December 13, 2017

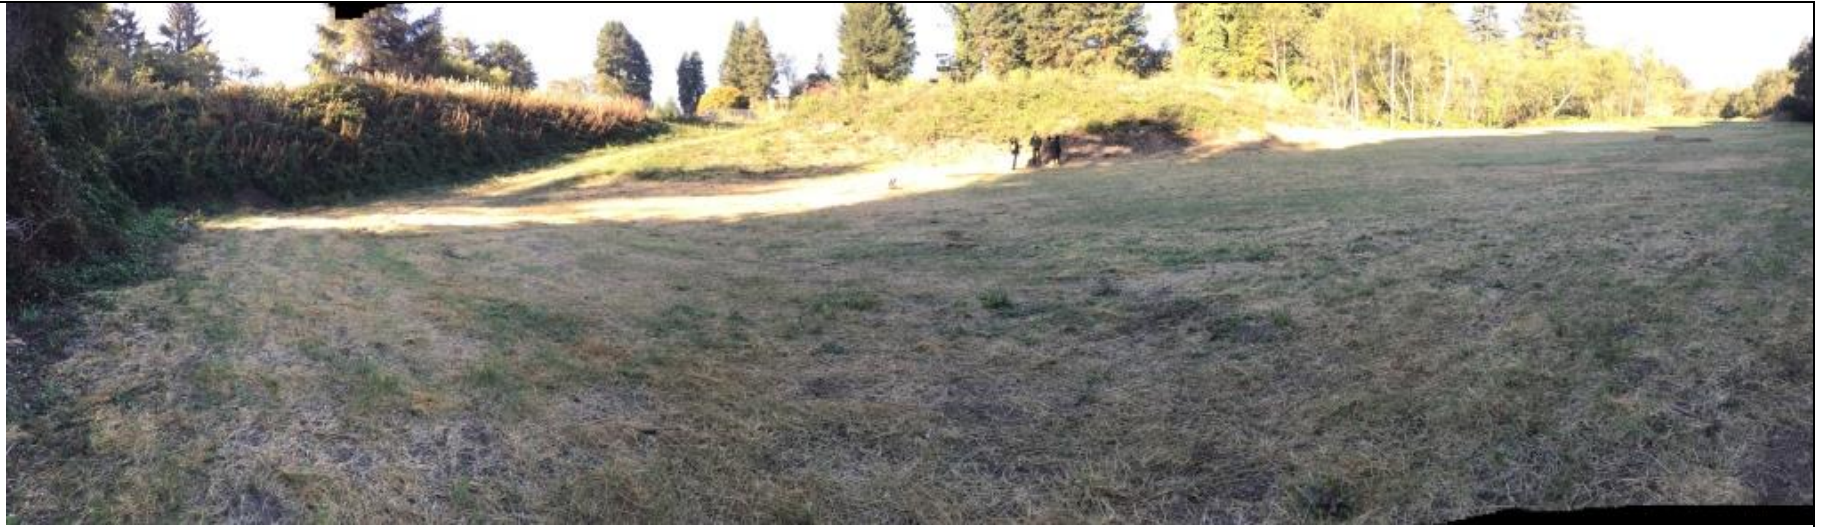
Figure 40: Standing along the eastern parcel boundary looking southwest at the slope area

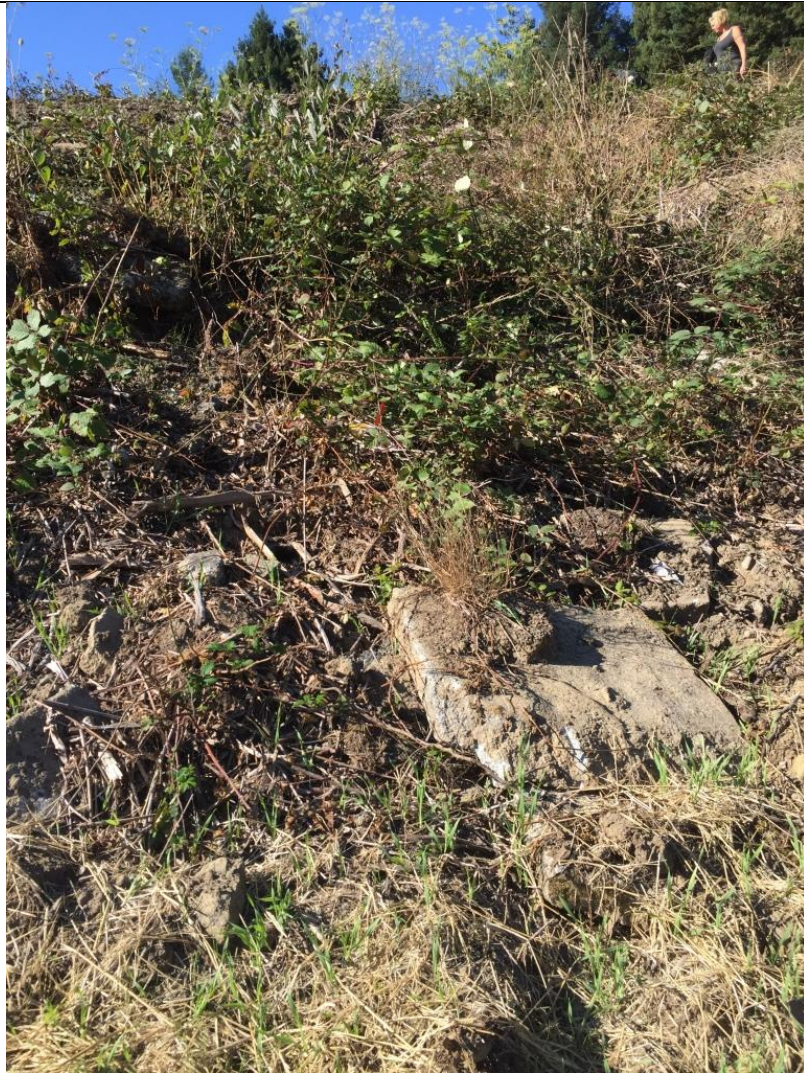
Figure 41: A close-up of the slope shown in Figure 40. The slope had been recently disturbed and was dominated by ruderal vegetation such as Himalayan blackberry and mustard. There was also rubble on the slope, such as the concrete shown in this photo. The debris pile along the northern boundary also included concrete. Incipient wetland plants such as equisetum and pennyroyal were also observed.

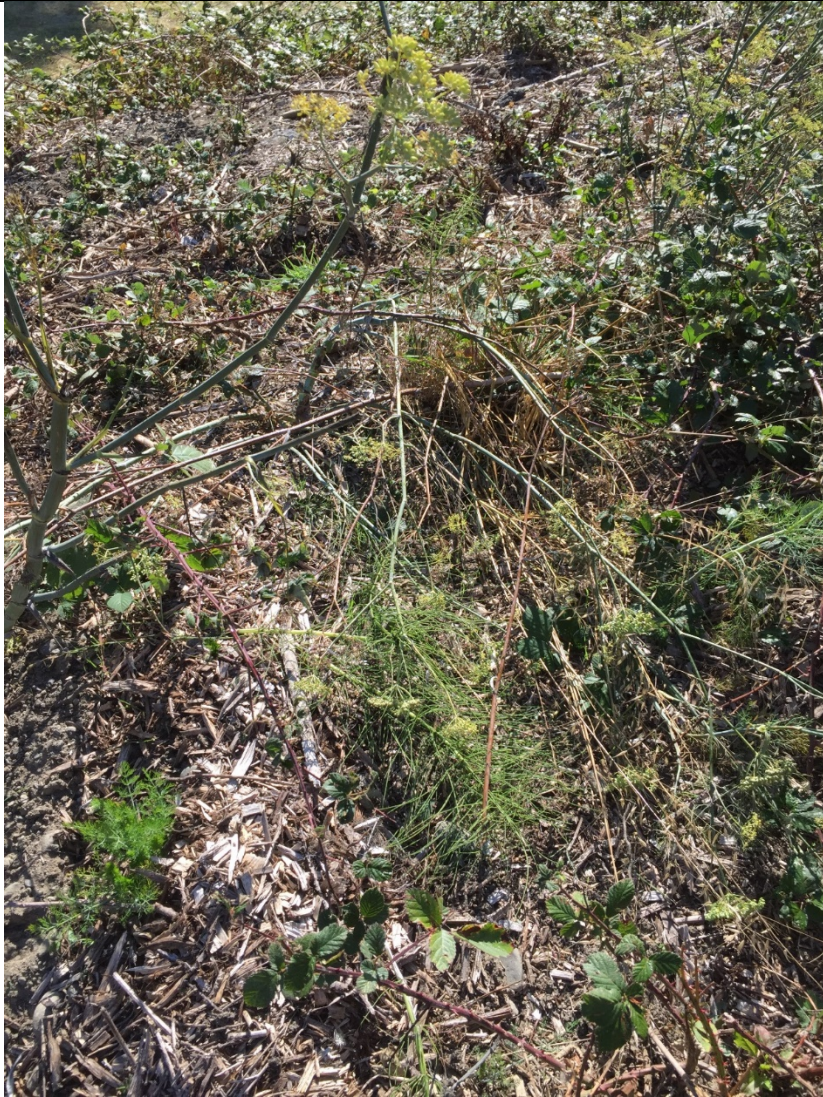
Figure 42: Ruderal vegetation at the top of the slope. There was a significant amount of equisetum amongst the vegetation on the slope and top of slope, suggesting that either wetland conditions exist, or wetland soils were moved to the area from adjacent wetland locations.

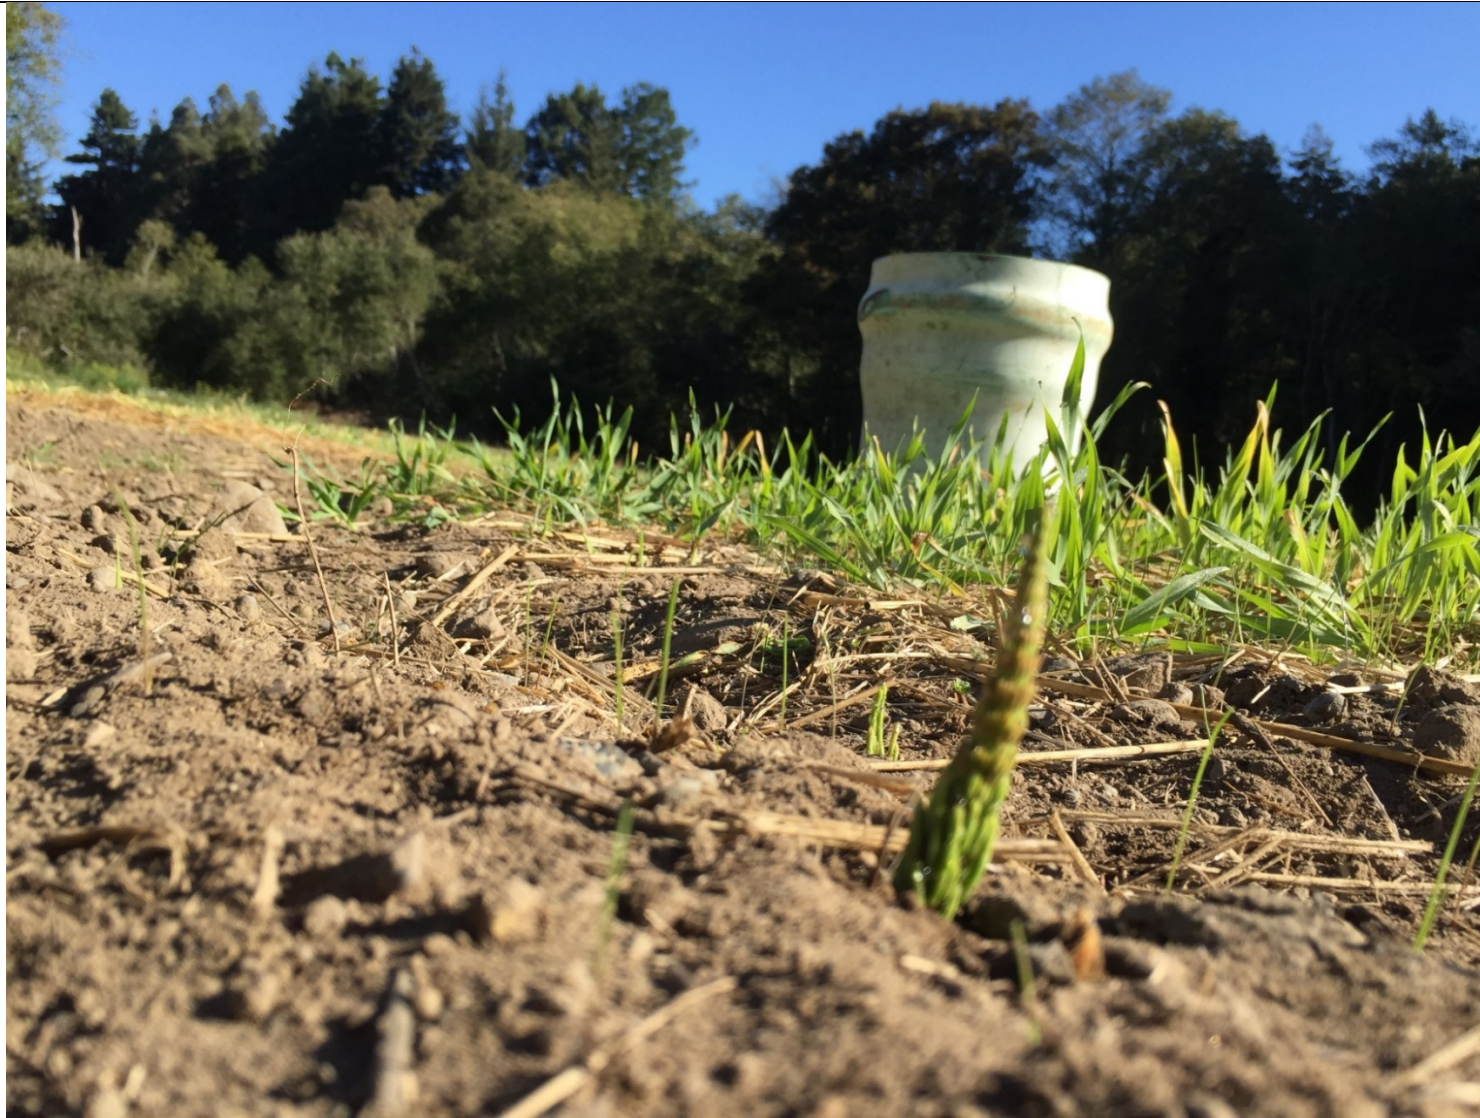
Figure 43: An equisetum start emerging from the disturbed ground adjacent the vertical pipe, suggesting that wetland conditions may exist in this area.

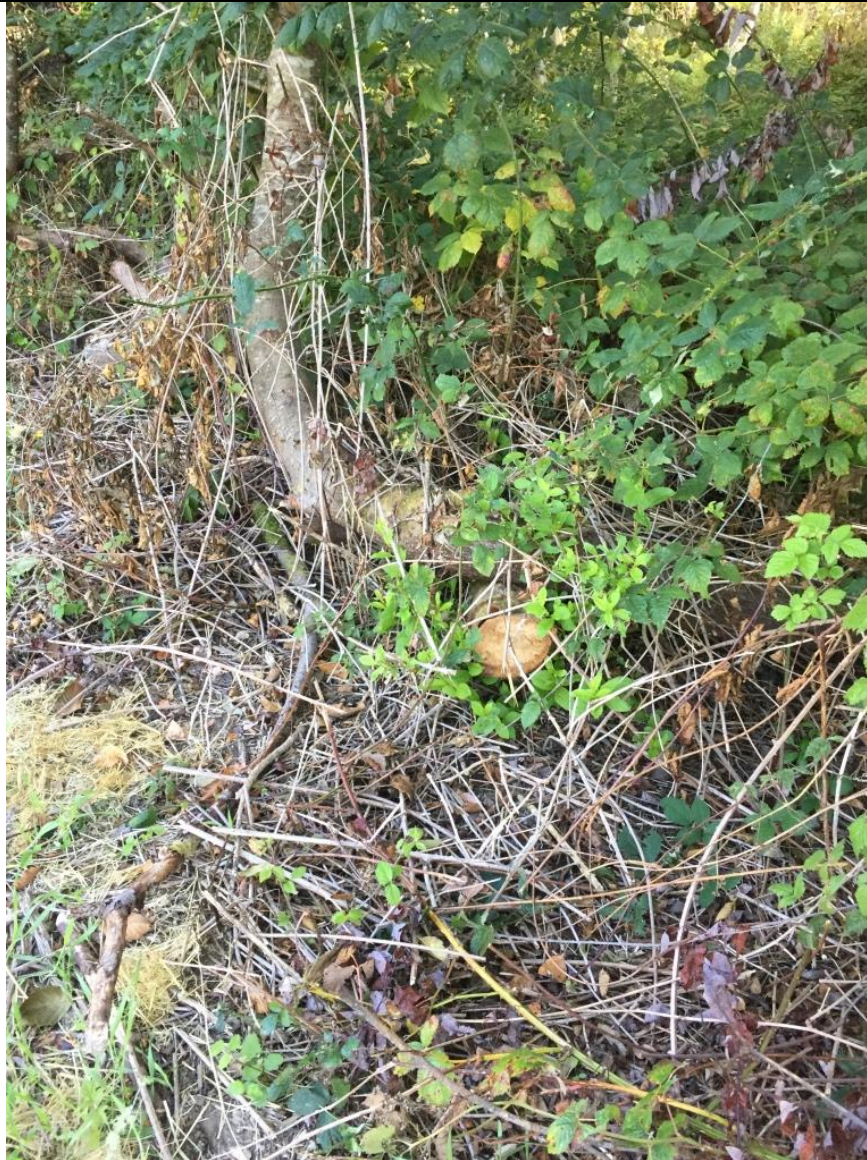
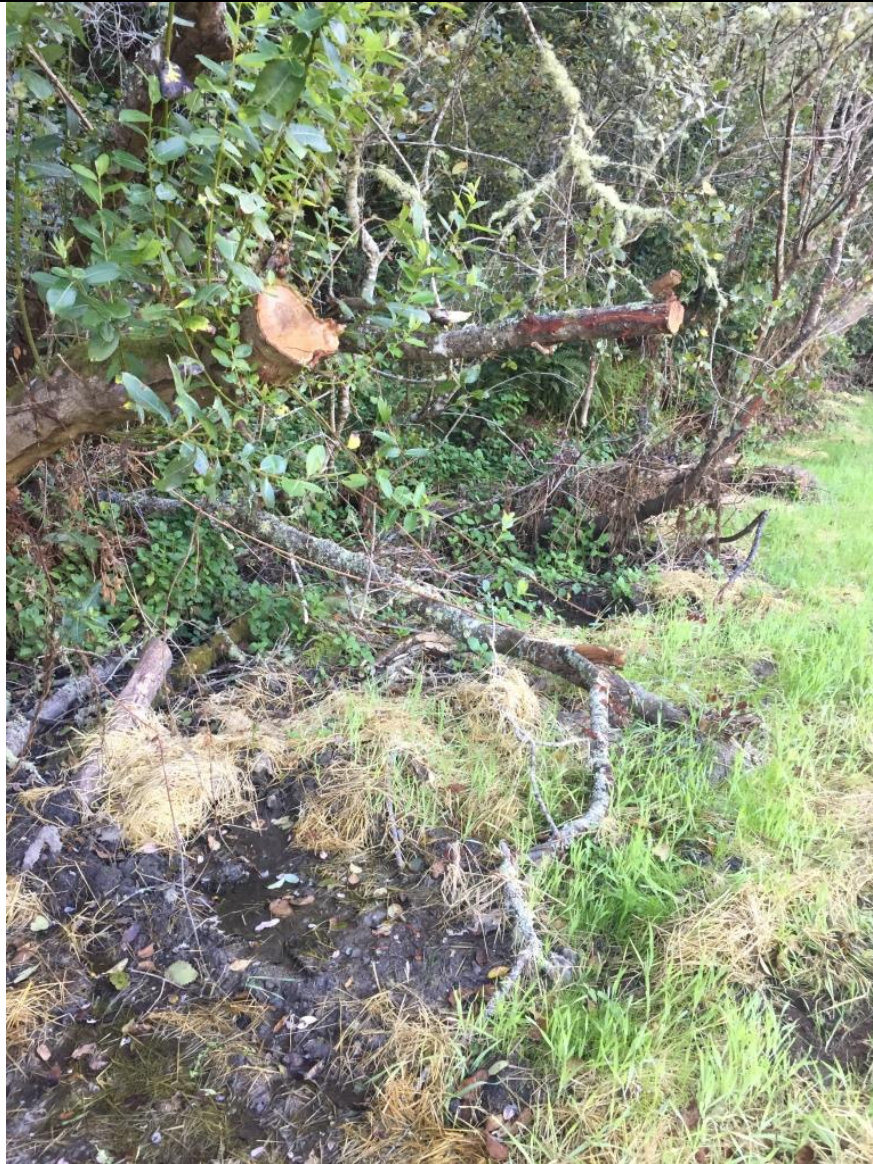
Figure 44: Cut riparian vegetation along the eastern parcel boundary.

Figure 45: Cut riparian vegetation along the eastern parcel boundary.

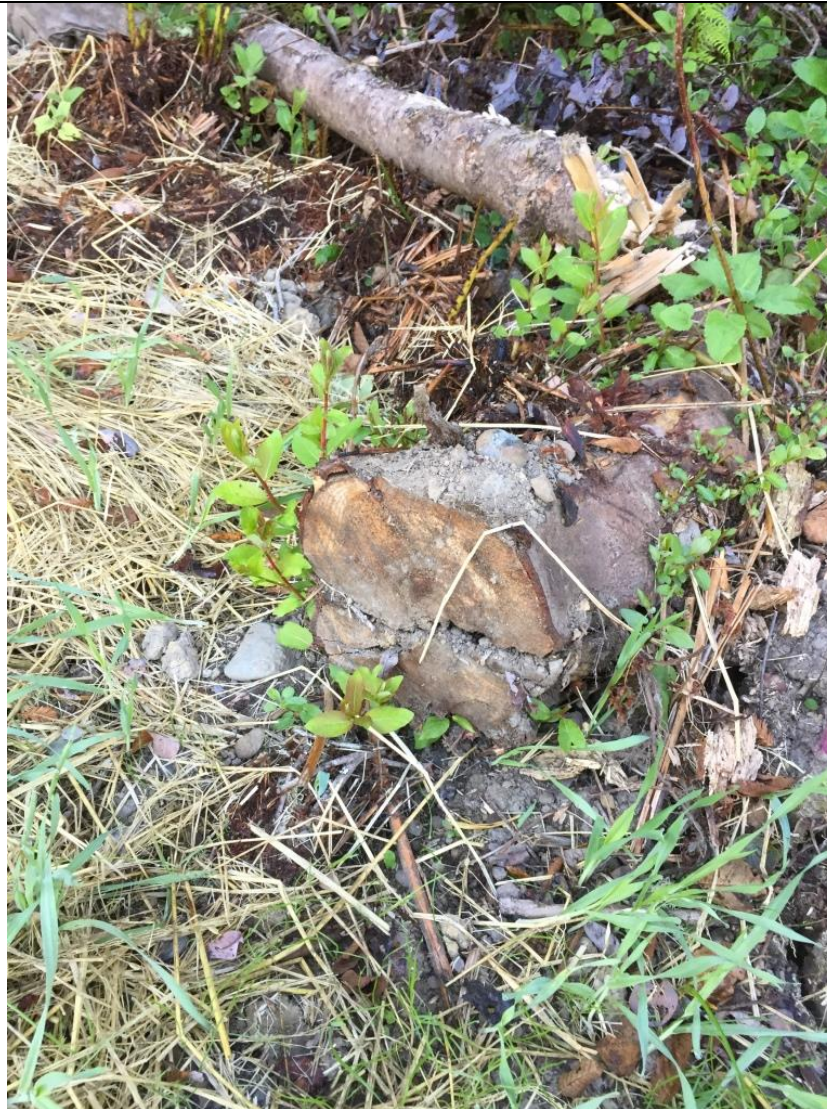
Figure 46: Cut riparian vegetation along the eastern parcel boundary. Fresh dirt perched atop the cut limb indicates recent earth disturbance.

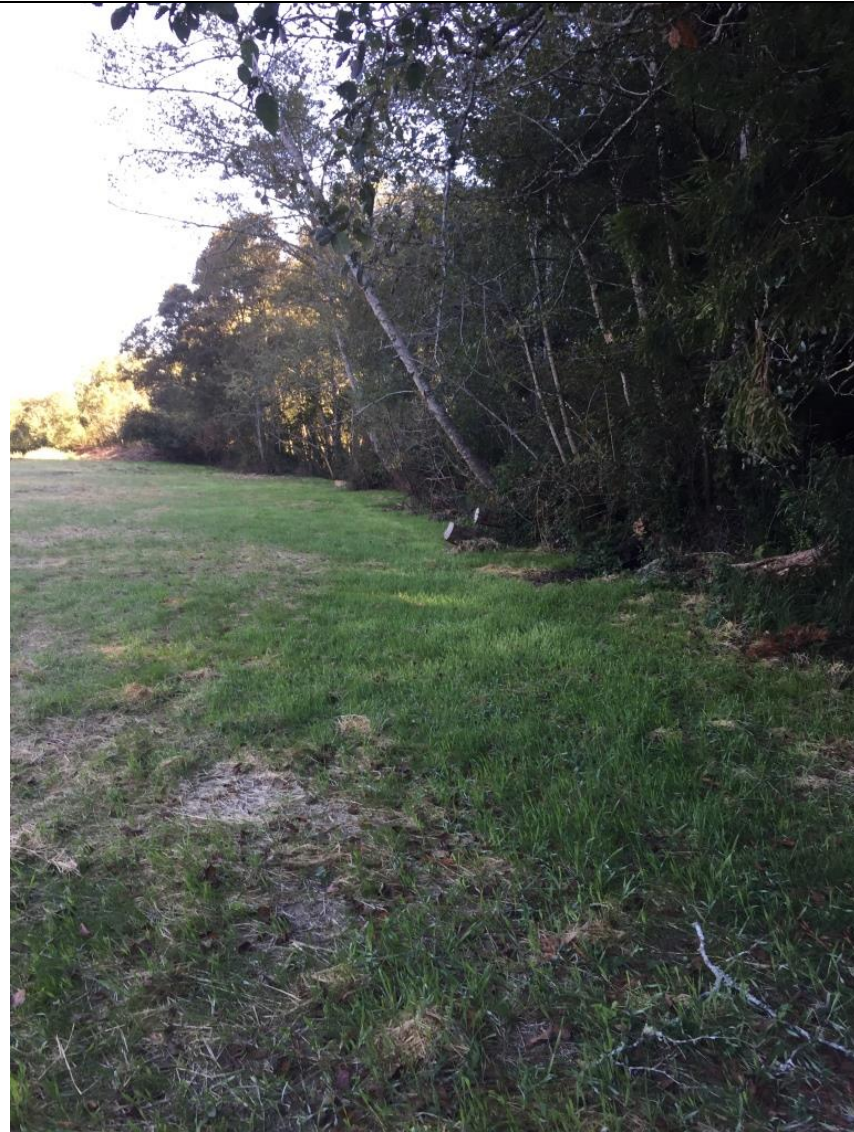
Figure 47: Another view of cut riparian vegetation along the eastern parcel boundary, looking north. It is unclear whether vegetation adjacent and atop the culverted portion of Third Slough is considered riparian vegetation.

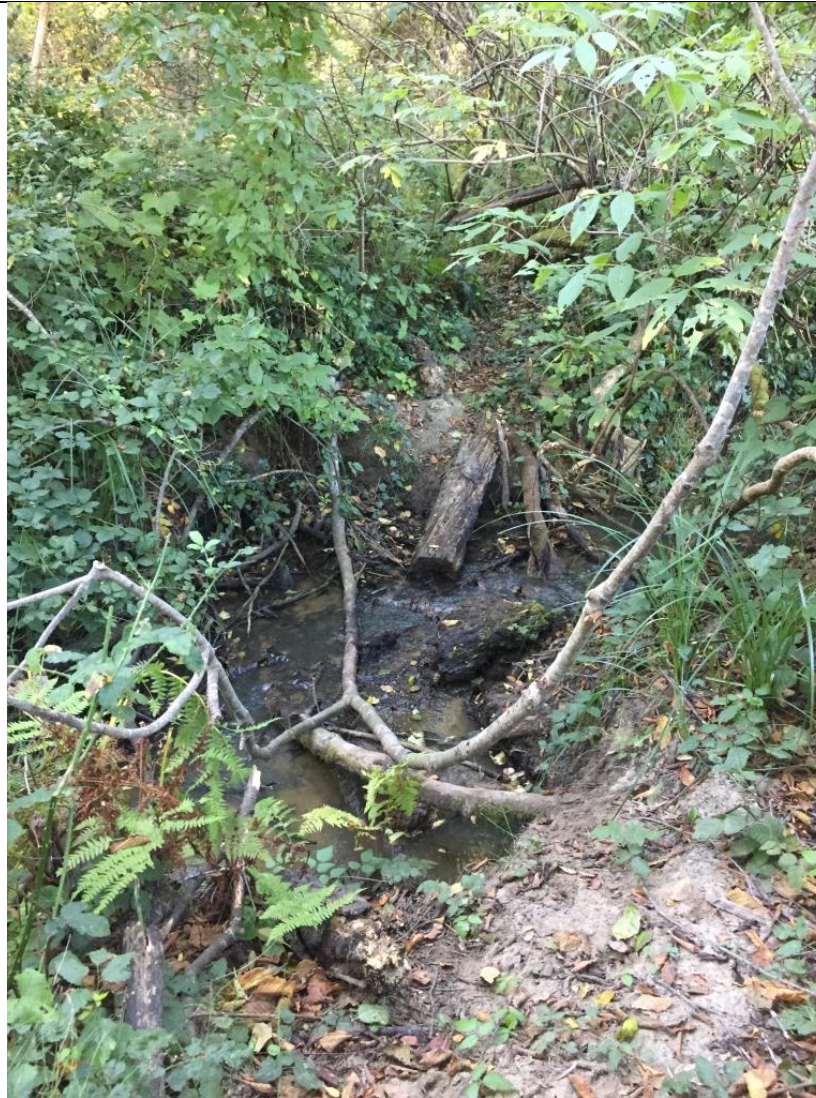
Figure 48: Third Slough, somewhere between the debris pile and Third Slough culvert, containing flowing water.

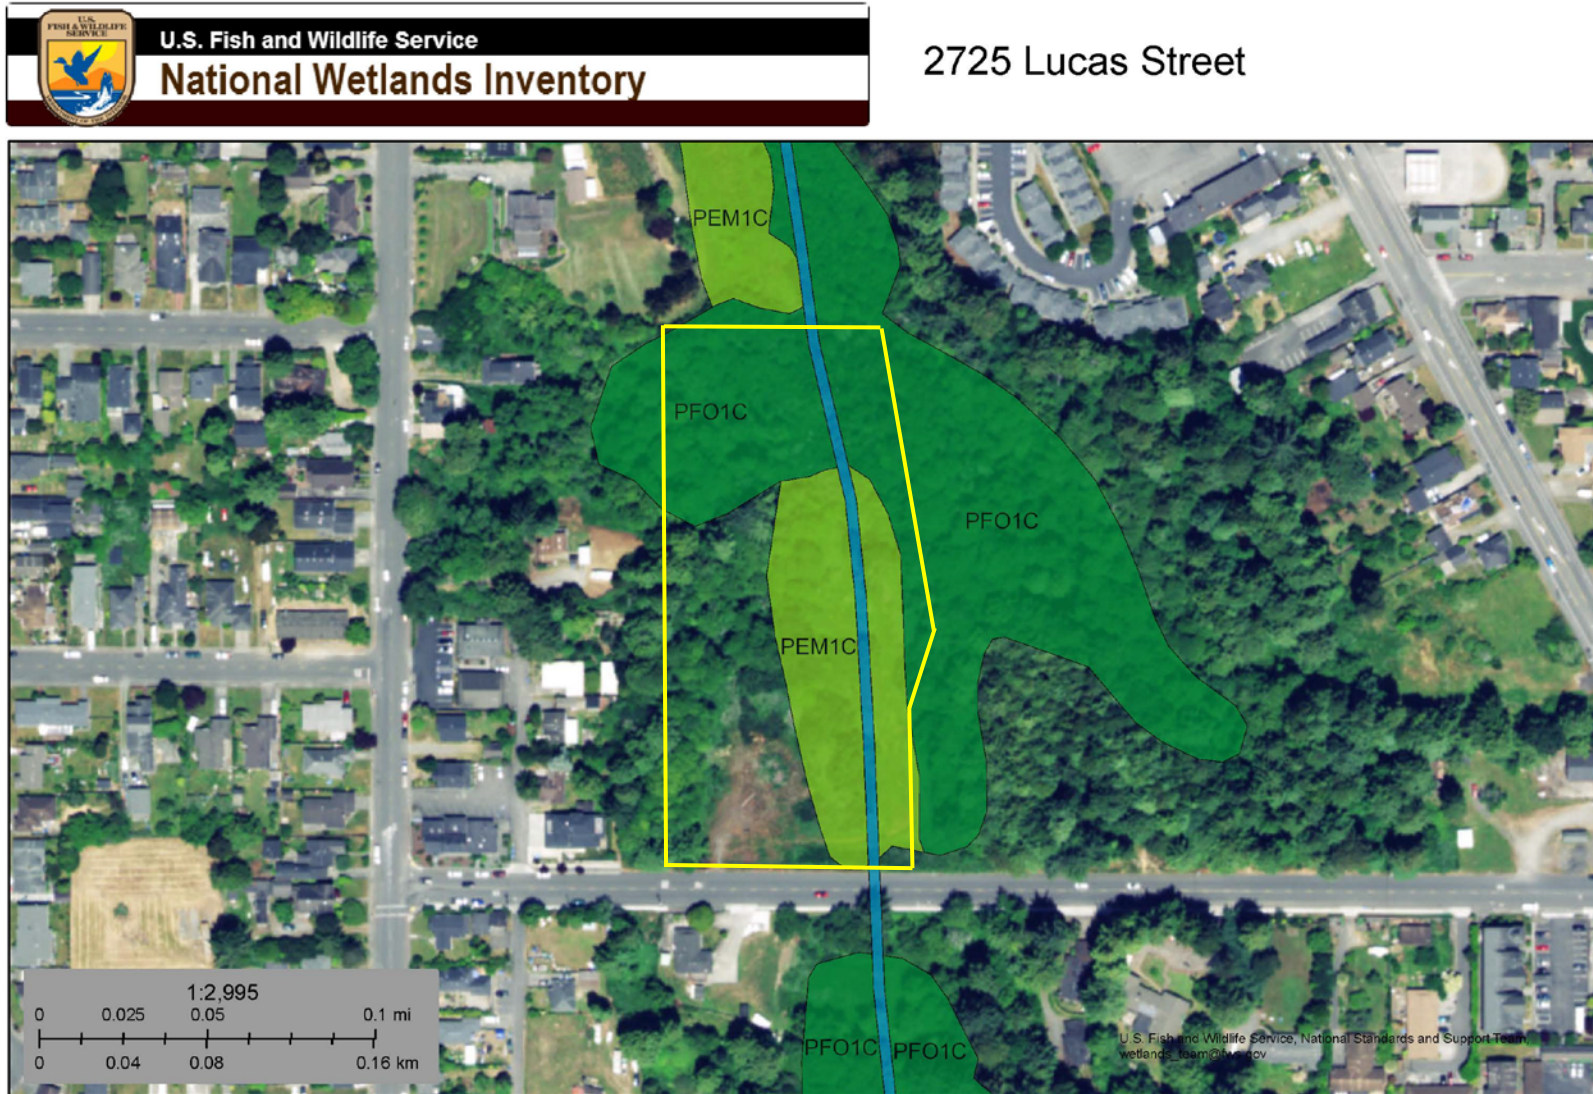
Yellow line denotes approximate parcel boundary. NWI map does not accurately show present day location of Third Slough.
