North Coast Regional Water Quality Control Board

Shadow Light Ranch LLC Property
CIWQS Place ID No. 825542
Inspection Date May 10, 2018
WDID No. 1B16868CHUM

Attachment A:
Photographic Record of May 10, 2018, Inspection of
Shadow Light Ranch LLC (formerly Joshua Sweet) Property including Humboldt County
Assessor's Parcel Numbers 223-073-004-000, 223-073-005-000, 223-061-003-000, 223-
061-038-000, 223-061-039-000, 223-061-043-000, 223-061-046-000 (All photos taken by
Shannon Utley during the May 2018 inspection, unless otherwise noted)

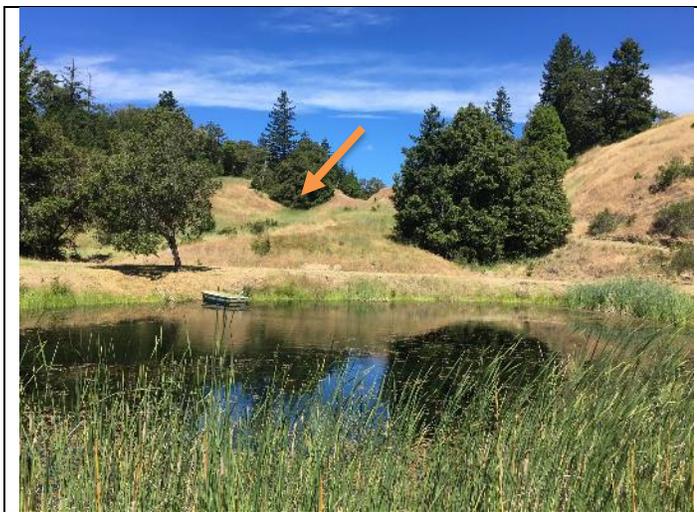
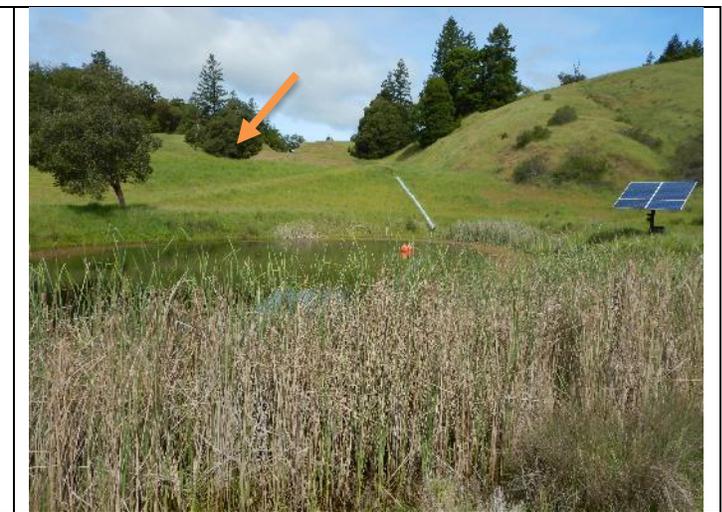
During the inspection, I re-observed a large on-stream pond (POND1) with a berm located in a topographic swale (Photos 1 through 9). DIV staff estimated POND1 to be approximately 24,670 square feet (0.5 acre), and up to 18 feet deep. Pond construction resulted in disturbance of approximately 87,000 square feet (2 acres) (Photos 1 and 2).

The pond construction disturbed a possible wetland located in a topographic swale based on the 2016 NAIP imagery and Photo 1, which shows the pre-pond area to have been well-vegetated with denser, darker vegetation on the northwest side of the pond. During the inspection, I observed rills at the top of the swale close to the ridgeline caused by erosion of the previously graded area that were actively transporting water downhill to POND1 (Photos 3 and 4).

<p>Photo 1: Pre-POND1 construction image looking northwest from POND2 towards the future site of POND1 (photo taken by Joshua Sweet on unknown date and provided by Mr. Sweet on May 17, 2018).</p>	<p>Photo 2: Image looking northwest from POND2 towards POND1. Orange arrow on Photo 1 and Photo 2 shows location of rills and upgradient swale.</p>

Prepare a restoration and protection plan that includes plans for removal of both POND1 and POND2, delineation of wetland extent prior to pond development, and restoration of natural stream and wetland conditions including mitigation for temporal impacts and an immediate stability analysis of the ponds assessing the threat to water quality from potential pond failure.

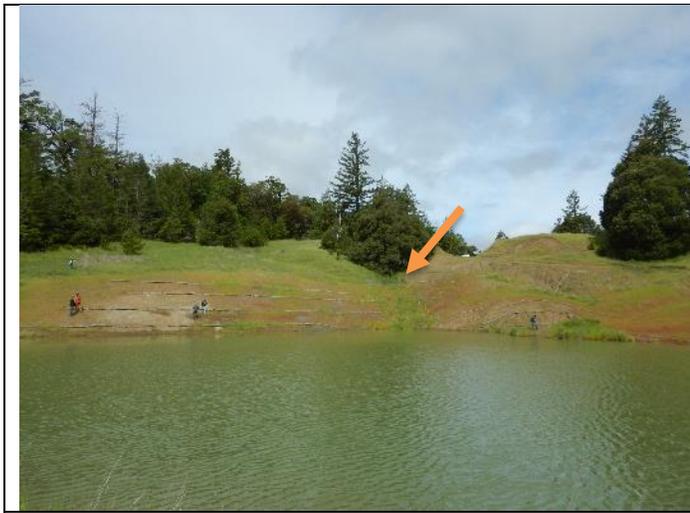
Photo 3: Image of POND1 showing the upgradient topographic swale. Orange arrow shows location of rills and upgradient swale.

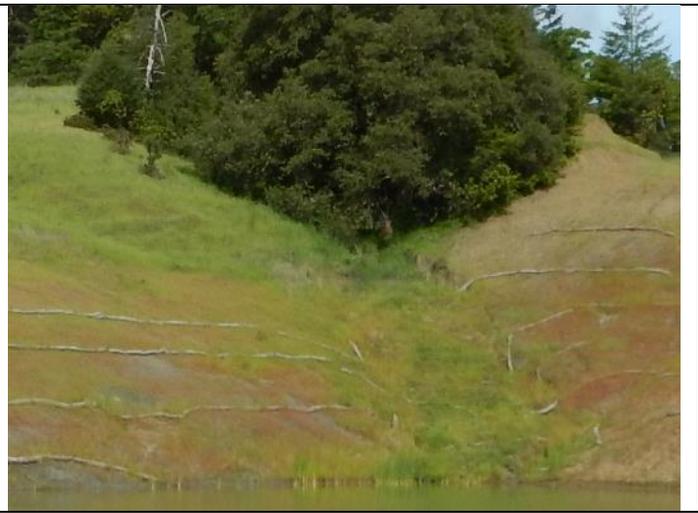
Photo 4: Close up of upgradient topographic swale in Photo 4 showing rills and disturbance of straw wattles.

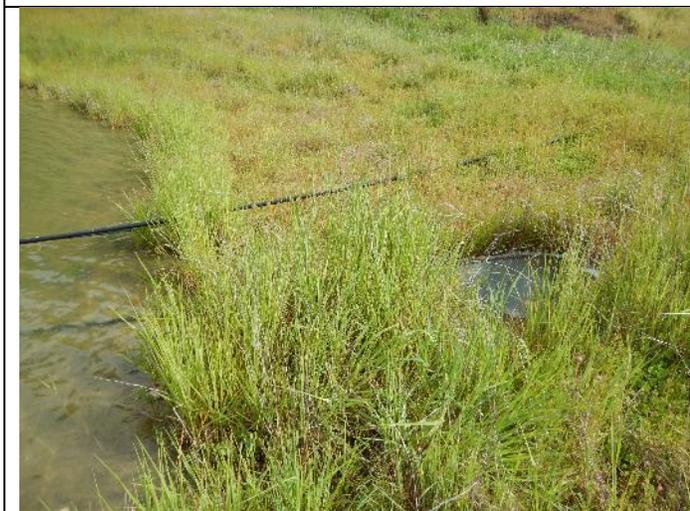
The outflow pipe from POND1 (OUT1) is a 24-inch corrugated metal culvert (Photos 5 and 6). Water from POND1 flows through OUT1 (Photo 11) into the older, lower, on-stream pond (POND2 on Site Map), which in turn outflows to a Class II watercourse. During the inspection I did not observe any active overflow from POND1 to POND2, although the edge of the pond water was within two feet of OUT1 (Photo 5).

Photo 5: Image of POND1 showing the inlet for the pond outflow (OUT1).

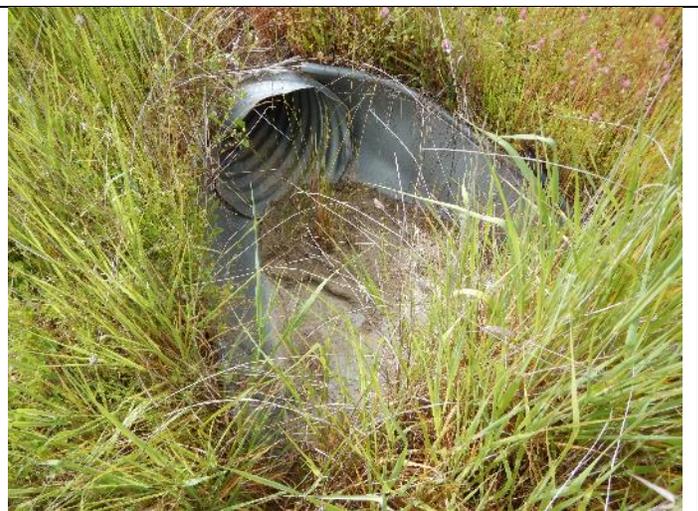
Photo 6: Image of POND1 showing a closer view of OUT1.

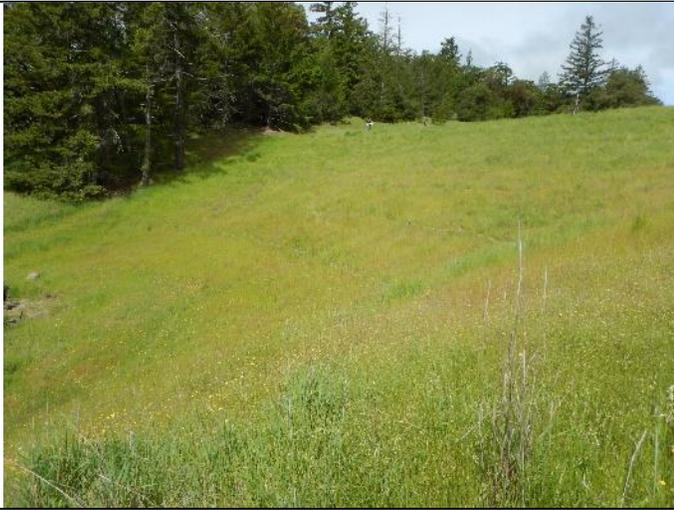
Photo 7: Image of POND1 berm.

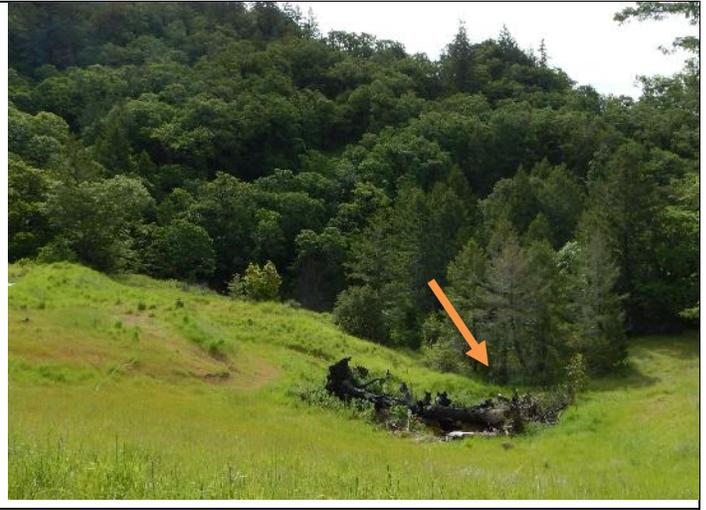
Below the berm for POND1, during the inspection I observed an established Class III stream channel (Photos 8 and 9) that discharges to the Class II stream below. This stream channel connects to the Class II stream downstream of the outflows of POND2 (see Site Map). Based on the topography, available NAIP and Google Earth imagery showing potential wetland features, the active transport and channelized flow of water into POND1 from the upgradient swale, and pre-POND1 photo provided by Mr. Sweet, the water collected in POND1 would have made its way into the Class II stream and therefore POND1 is considered an on-stream pond and a water of the State. As described in the report for the November 2017 inspection the Responsible Party constructed POND1 without the appropriate permits from the Regional Water Board.

Photo 8: Image of headwaters of stream below POND1 berm. Orange arrow shows location of beginning of stream channel.

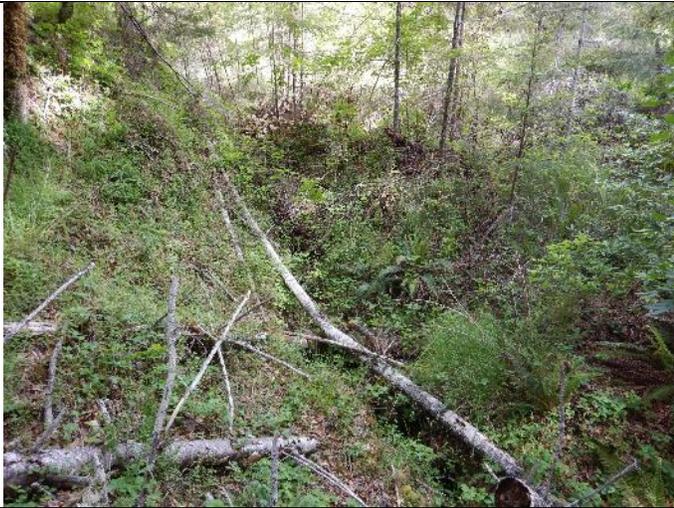
Photo 9: Image of stream channel between POND1 berm (upper left) and Class II stream channel below (bottom right).

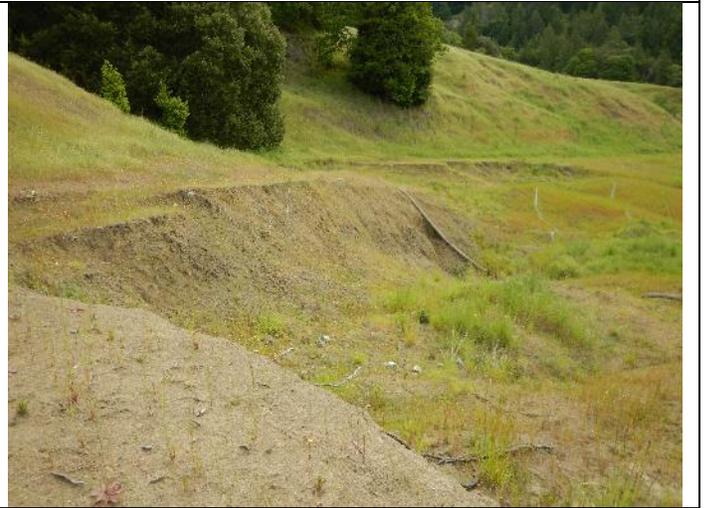
Pond construction reactivated a portion of a historic landslide amphitheater complex of approximately 15,000 square feet (SLIDE1 on Site Map), which delivered sediment into POND1, and damaged the access road to the lower pond to make it impassable by any motorized vehicle (Photo 10). The landslide material in the pond has reduced the pond capacity and likely resulted in increased discharges from POND1 into the lower pond (POND2). Since the November 2017 inspection the landslide scarp and disturbed area associated with the slope failure has continued to revegetate with grasses.

Photo 10: Image of SLIDE showing part of the headscarp and displaced wattles.

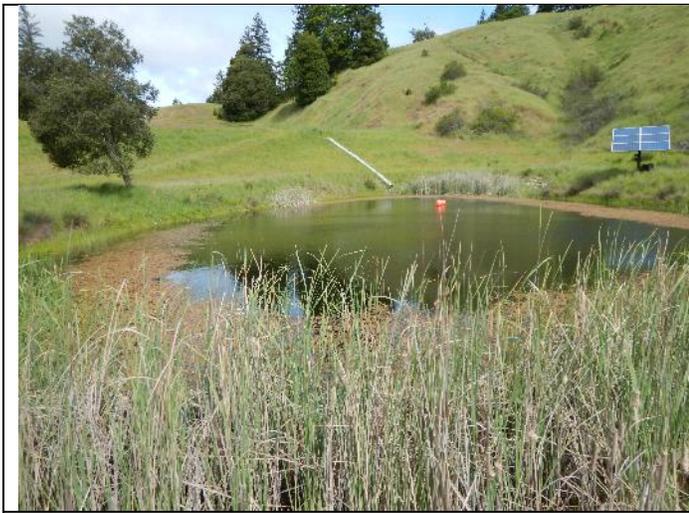
The lower older pond (POND2 on Site Map) is first visible in the available aerial imagery in October 2006. As noted, above, Mr. Sweet purchased the Property in November 2006. The DIV estimated POND2 to be approximately 11,480 square feet (0.25 acres) and up to 14 feet deep (Photo 11).

Photo 11: Image of POND2.

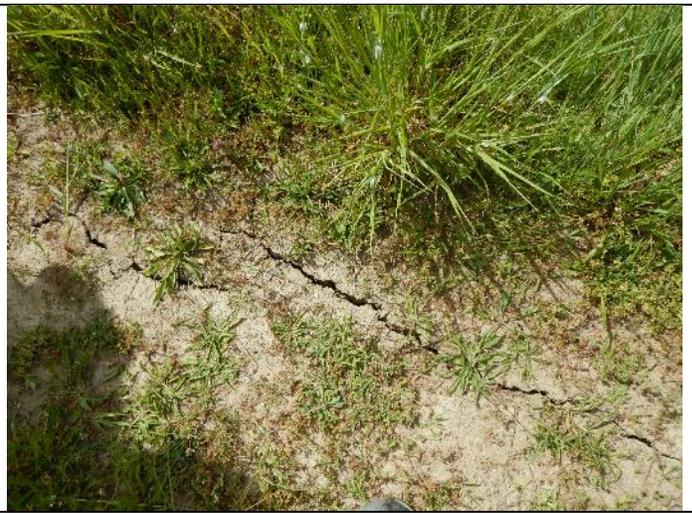
associated with leakage through or under the pond berm, or overflow from OUT2 based on topography and vegetation. I also observed surface cracking on the top of the POND2 berm (Photo 12).

Photo 12: Image of surface cracking within top of POND2 berm

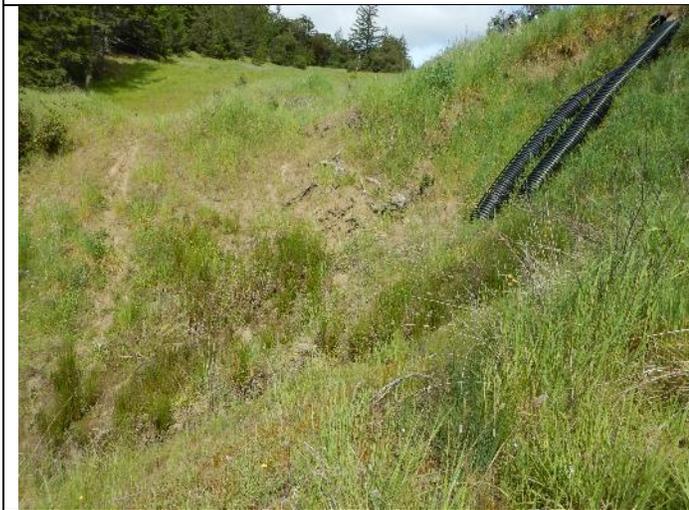
I re-observed one of the two outflow features for POND2, a set of two 24-inch corrugated plastic pipes (OUT2) that flows to a wetland-type area and then to the Class II watercourse (Photos 13 and 14). These outflow pipes were disconnected from the pond when the new outflow OUT3 was installed prior to the November inspection. The wetland-type area below OUT2 appears to be

Photo 13: Image of OUT2.

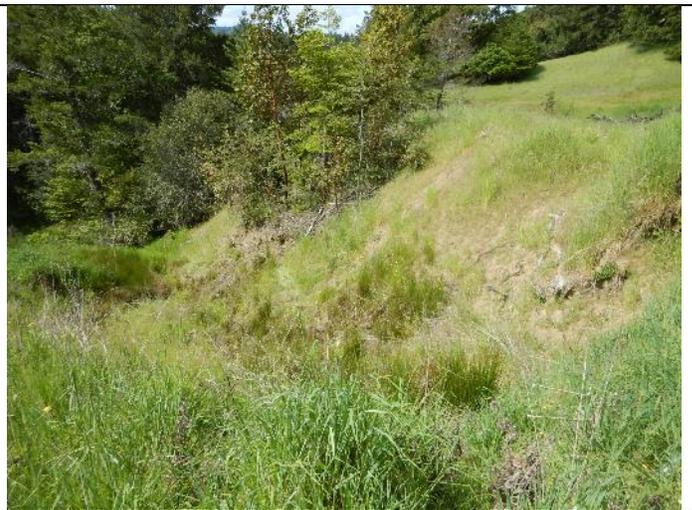
Photo 14: Image of wetland area below OUT2.

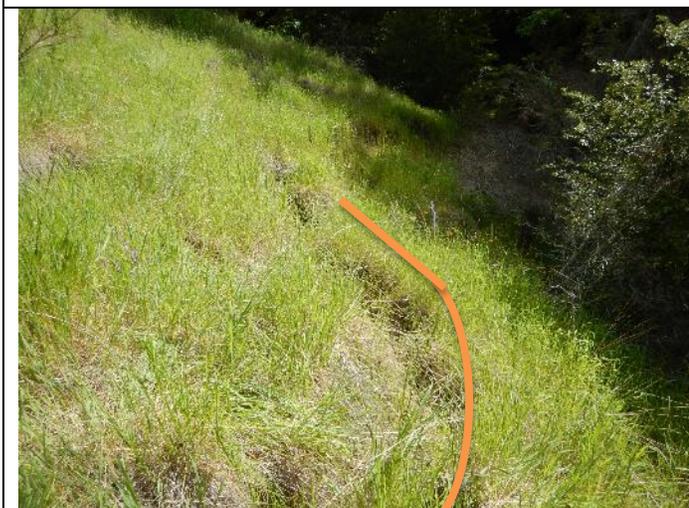
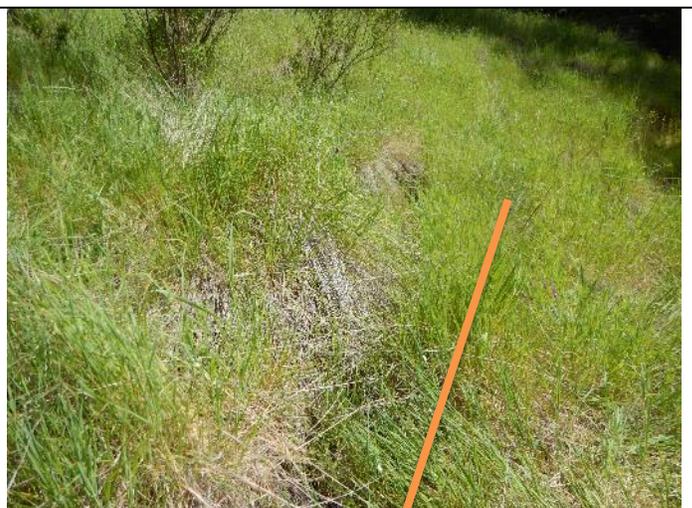
During the inspection I observed numerous lateral surface cracks (CRACKS) parallel to hillslope contours (Photos 15 and 16), some approximately 24-inch deep, below POND2 and adjacent to the Class II stream. This type of ground surface cracking is indicative of mass movement and, therefore, potential structural instability in the pond and presents a threatened discharge to surface waters.

Photo 15: Image of lateral surface cracking below POND2. Orange line is below the lateral crack.

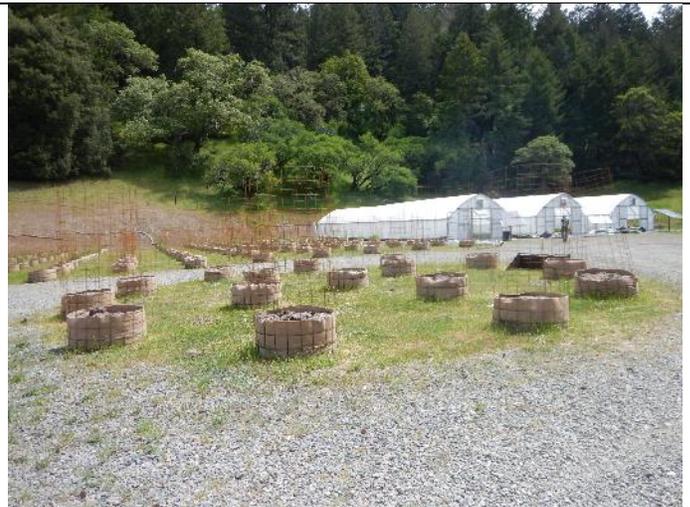
Cultivation area CA1 is a large, graded pad, approximately 150,000 square feet, with approximately 44,100 square feet of cannabis cultivation with cultivation taking place outdoor in smart pots placed on the ground surface and inside three greenhouses, which were all planted with young plants in raised beds (Photos 19 through 22). The appearance of this cultivation area is similar to that observed during the November inspection and without any significantly noticeable differences.

Photo 19: Image of cultivation area CA1 looking east.

Photo 20: Image of CA1 looking north-northeast.

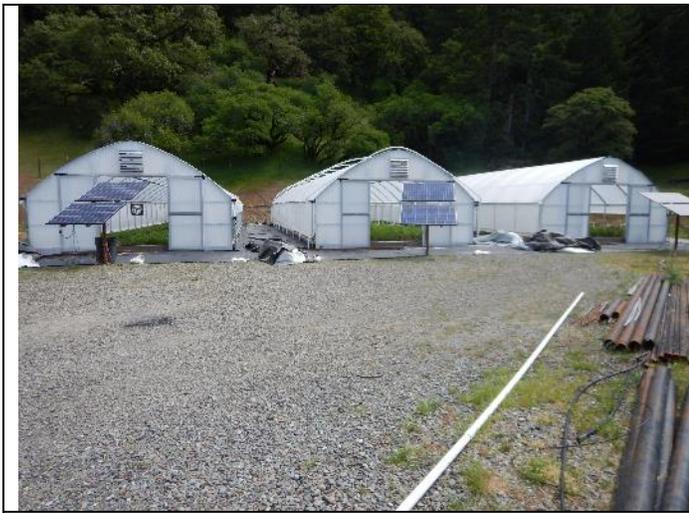
Photo 21: Image of the three fully planted greenhouses at CA1.

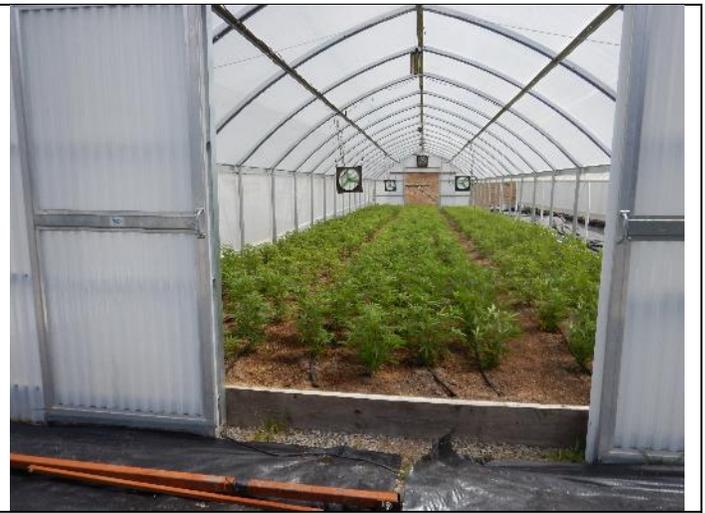
Photo 22: Image of young plants inside one of the CA1 greenhouses.

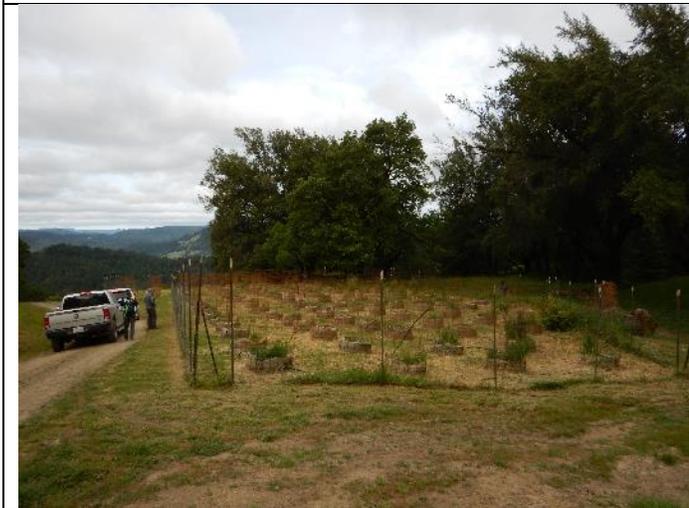
Cultivation area CA4 is approximately 10,600 square feet outdoor cultivation with cultivation taking place within smart pots placed on the ground surface (Photos 23 and 24). The appearance of this cultivation area is similar to that observed during the November inspection and without any significantly noticeable differences.

Photo 23: Image of CA4 showing extent of cultivation area and recent weed-whacking.

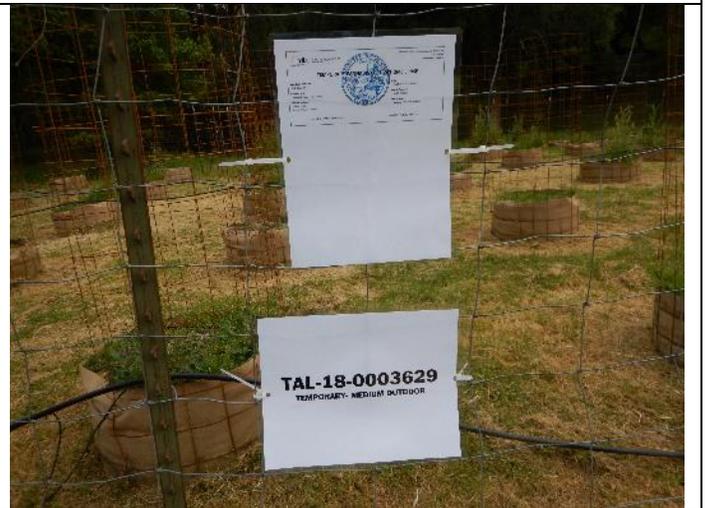
Photo 24: Image of CA4 temporary licences attached to fence, smart pots, and drip lines.

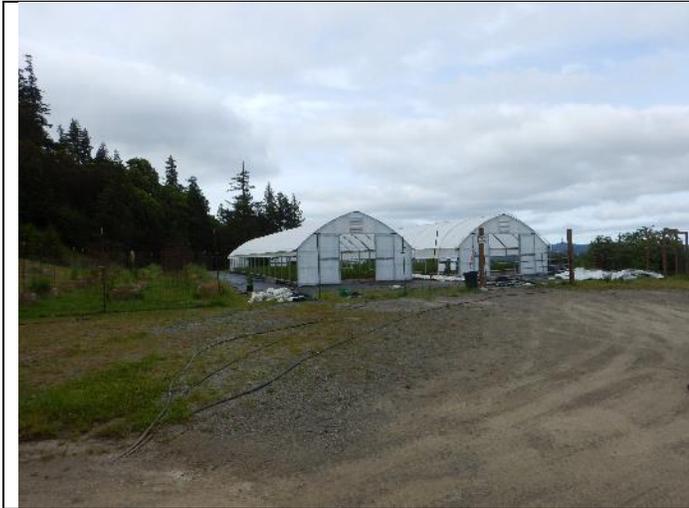
Cultivation area CA5 is approximately 7,000 square feet of cultivation with cultivation taking place outdoor in smart pots and inside two greenhouses with young plants planted in raised beds

Photo 25: Image of CA5 showing the extent of the cultivation area.

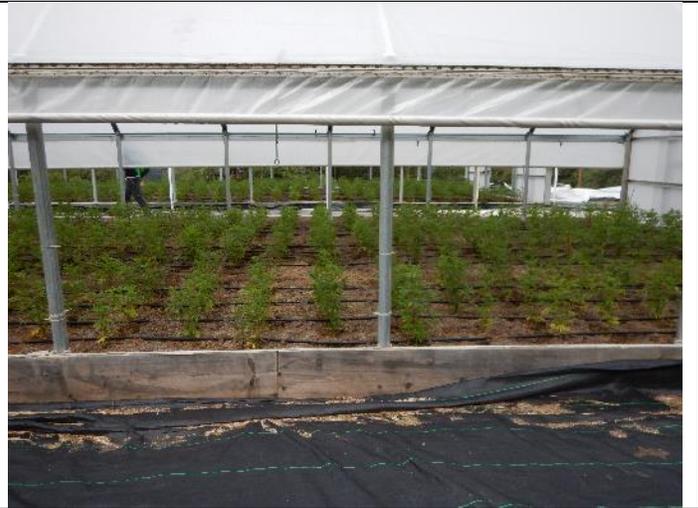
(Photos 25 and 26). The appearance of this cultivation area is similar to that observed during the November inspection and without any significantly noticeable differences.

Photo 26: Image of young plants inside of the two greenhouses at CA5.

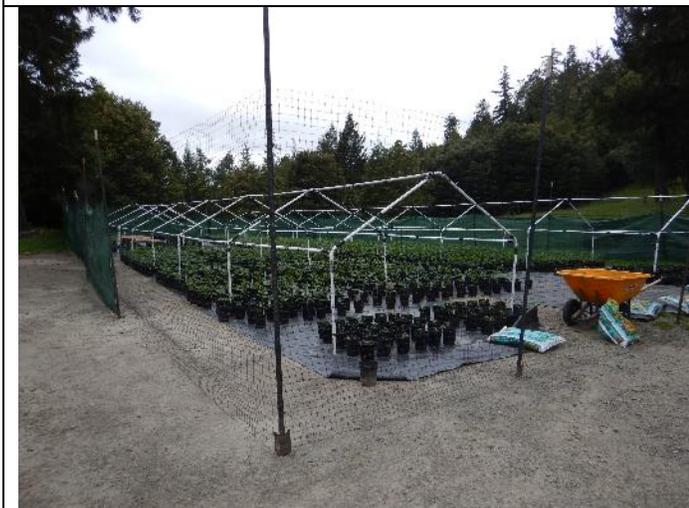
Cultivation area CA7 is a new cultivation area not previously developed during the November inspection and located next to the Property's drying shed and main parking area (see Site Map). CA7 is approximately 3,600 square feet of young plants in plastic pots placed on the ground surface (Photos 27 and 28). Mr. Sweet indicated that this was a temporary nursery location and that the plants would be moved.

Photo 27: Image of CA7 showing extent of temporary cultivation area.

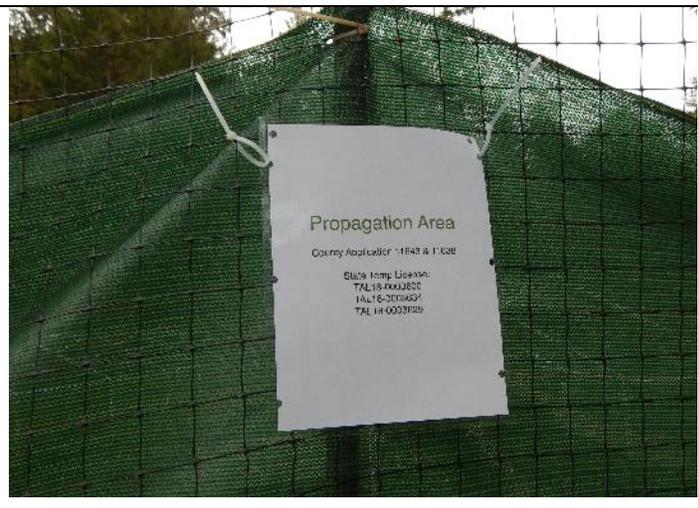
Photo 28: image of sign showing County application number and State licence numbers.

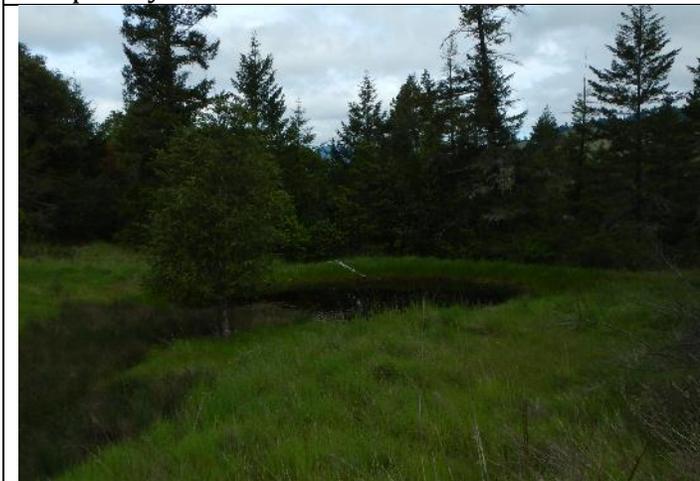
The third on-stream pond (POND3) located on the opposite side of the ridgeline from POND1 and POND2 was full during this inspection (Photo 29). This on-stream pond is much smaller (approximately 3,000 square feet) than either POND1 and POND2. POND3 is visible in all of the available imagery dating back to June 1993 (Google Earth image dated 6/12/1993).

Photo 29: Image of POND3.
