North Coast Regional Water Quality Control Board

July 19, 2018

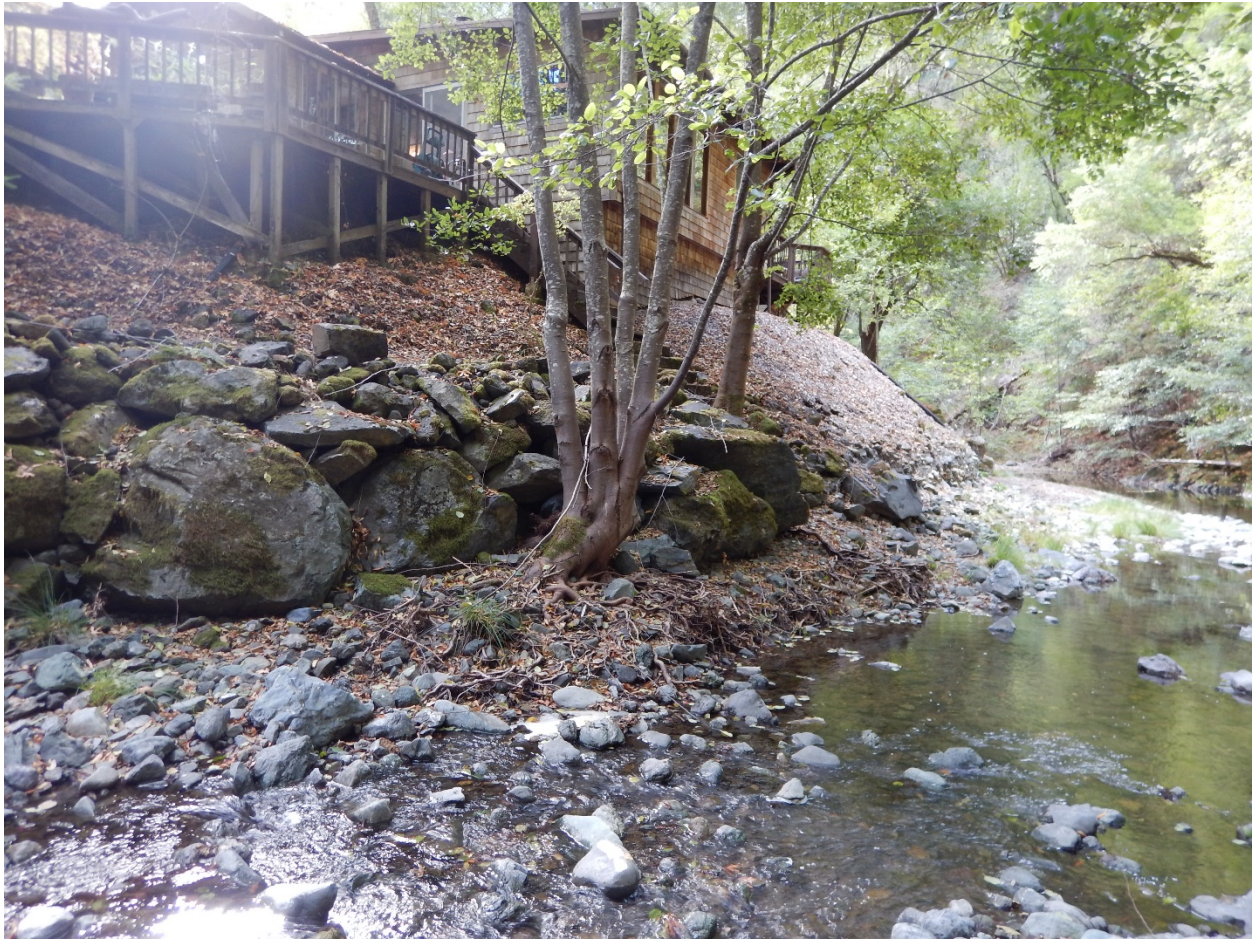
Figure 4: Site overview original condition. Photo taken by Kaete King 9/24/2015.

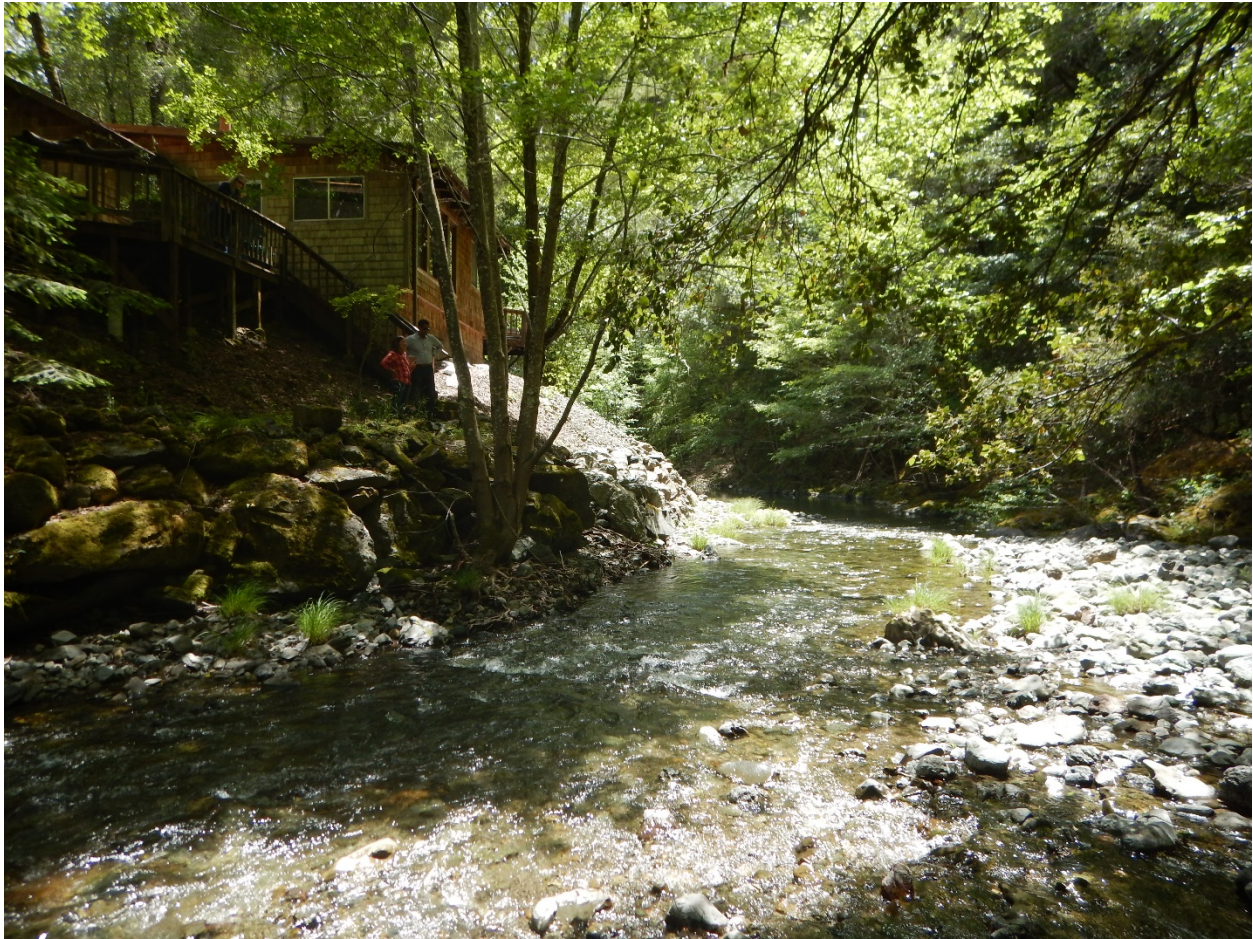
Figure 5: Site overview post-construction. Rip rap visible at toe of slope. Additional fill material behind/upslope from rip rap. Photo taken by Kaete King 5/10/2018.

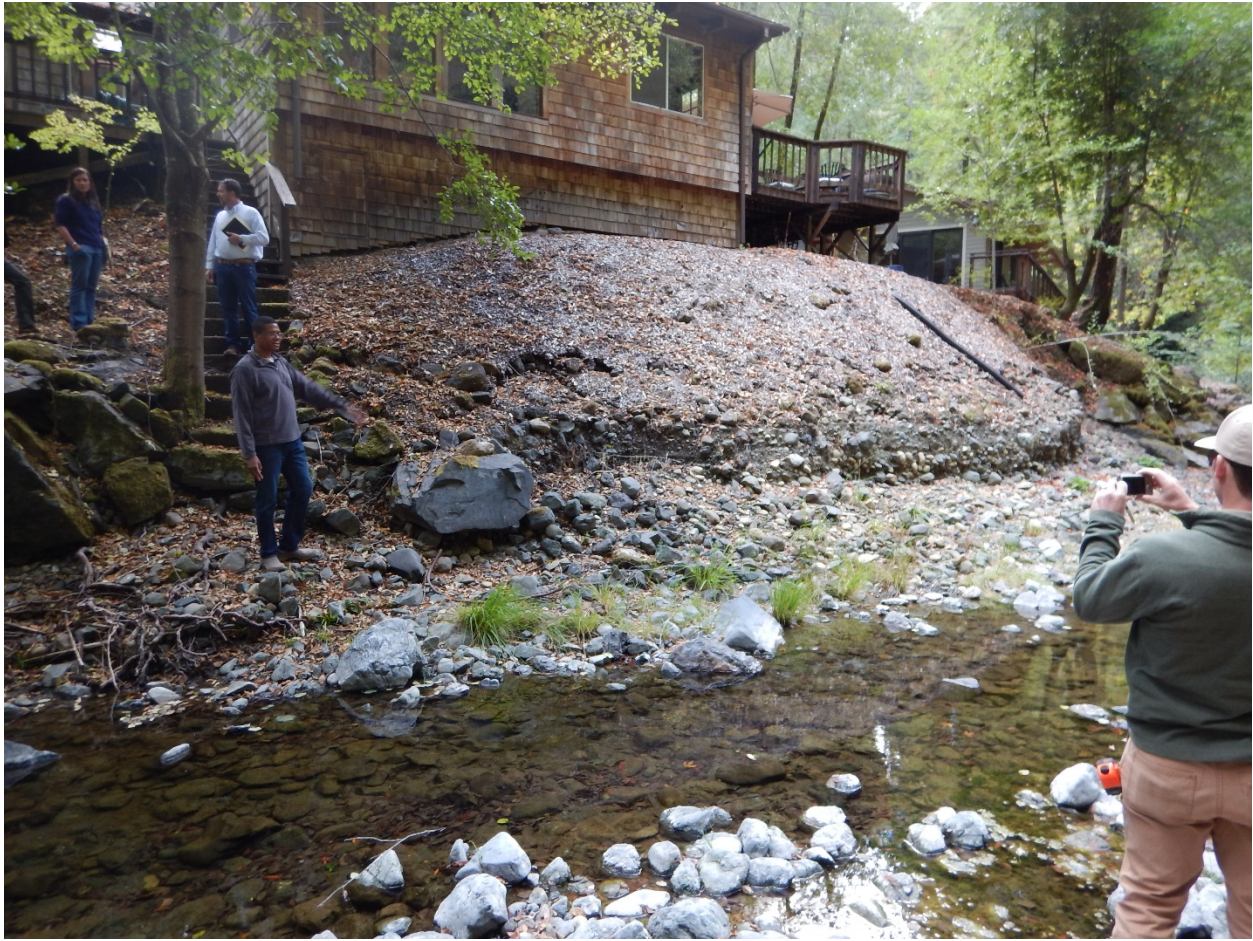
Figure 6: Original condition of northern part of site. Photo taken by Kaete King 9/24/2015

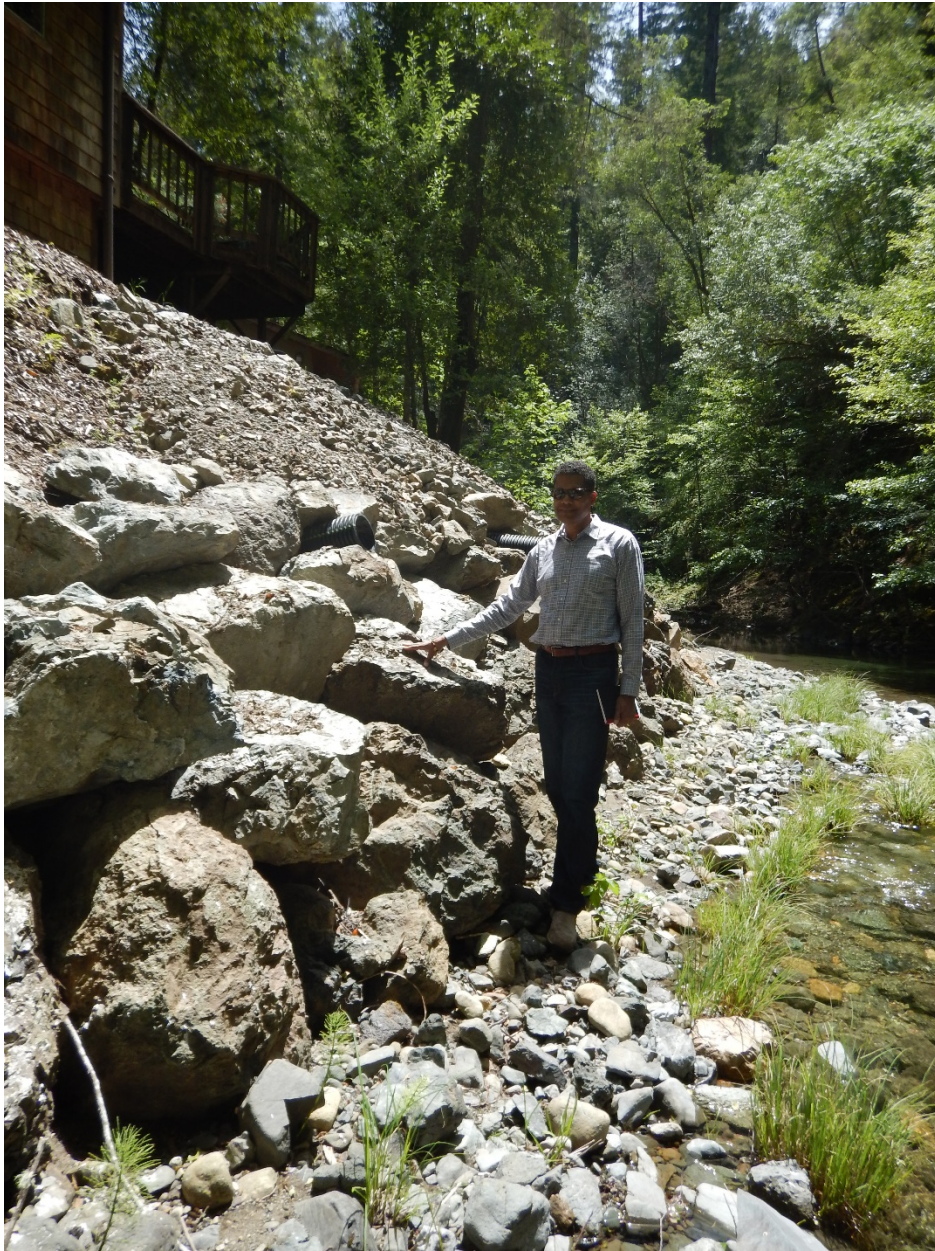
Figure 7: Rip rap, fill, and planting tubes, post-construction. Photo taken by Kaete King 5/10/2018.

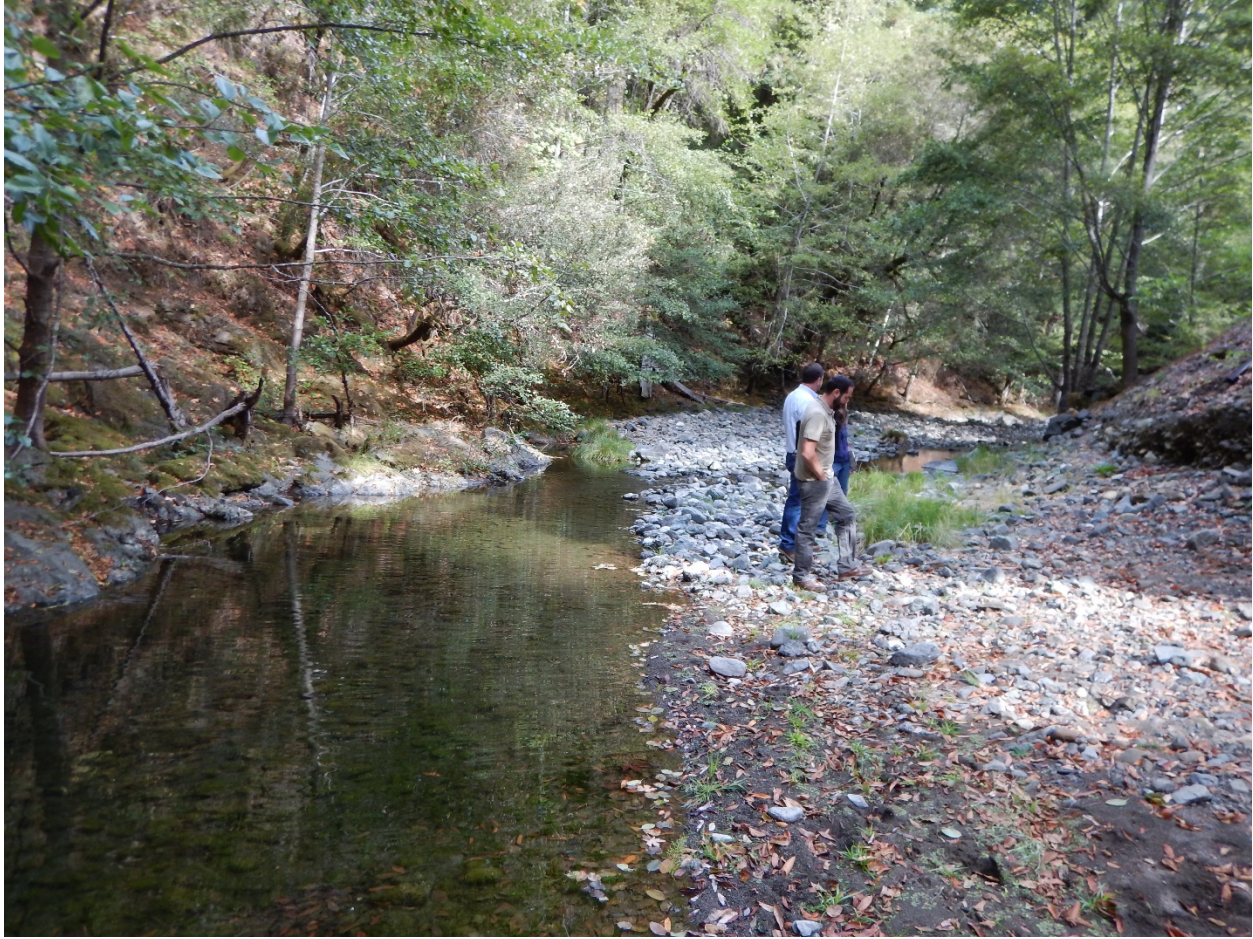
Figure 12: View of channel looking upstream, original condition. Photo taken by Kaete King 9/24/2015.

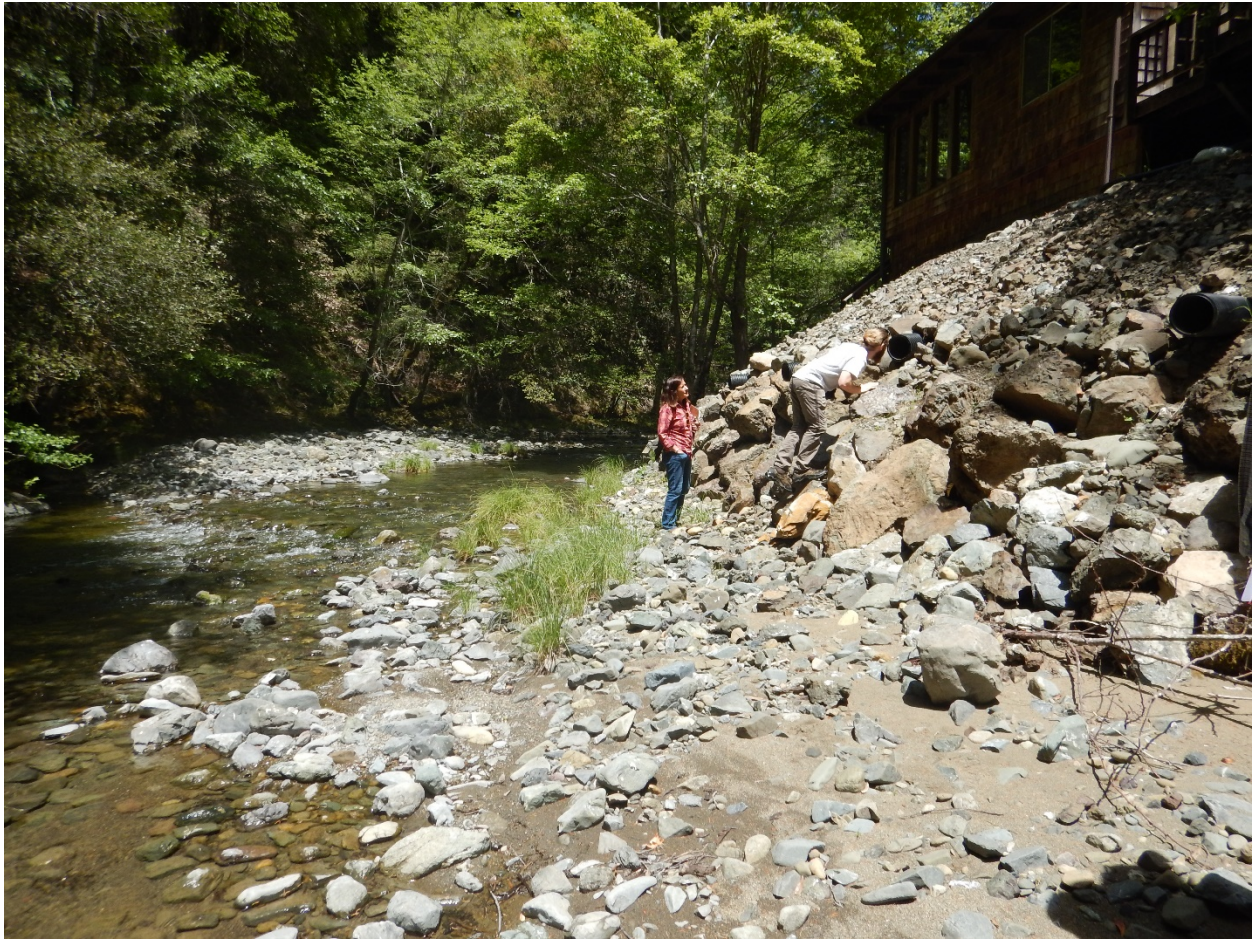
Figure 13: View of channel looking upstream, post-construction. The rip rap seems to have been placed 3-6 feet into the channel. The permitted design did not allow encroachment into the channel and instead required excavation to place rip rap back into the slope. CDFW representative is examining improperly placed planting tube. Photo taken by Kaete King 5/10/2018.

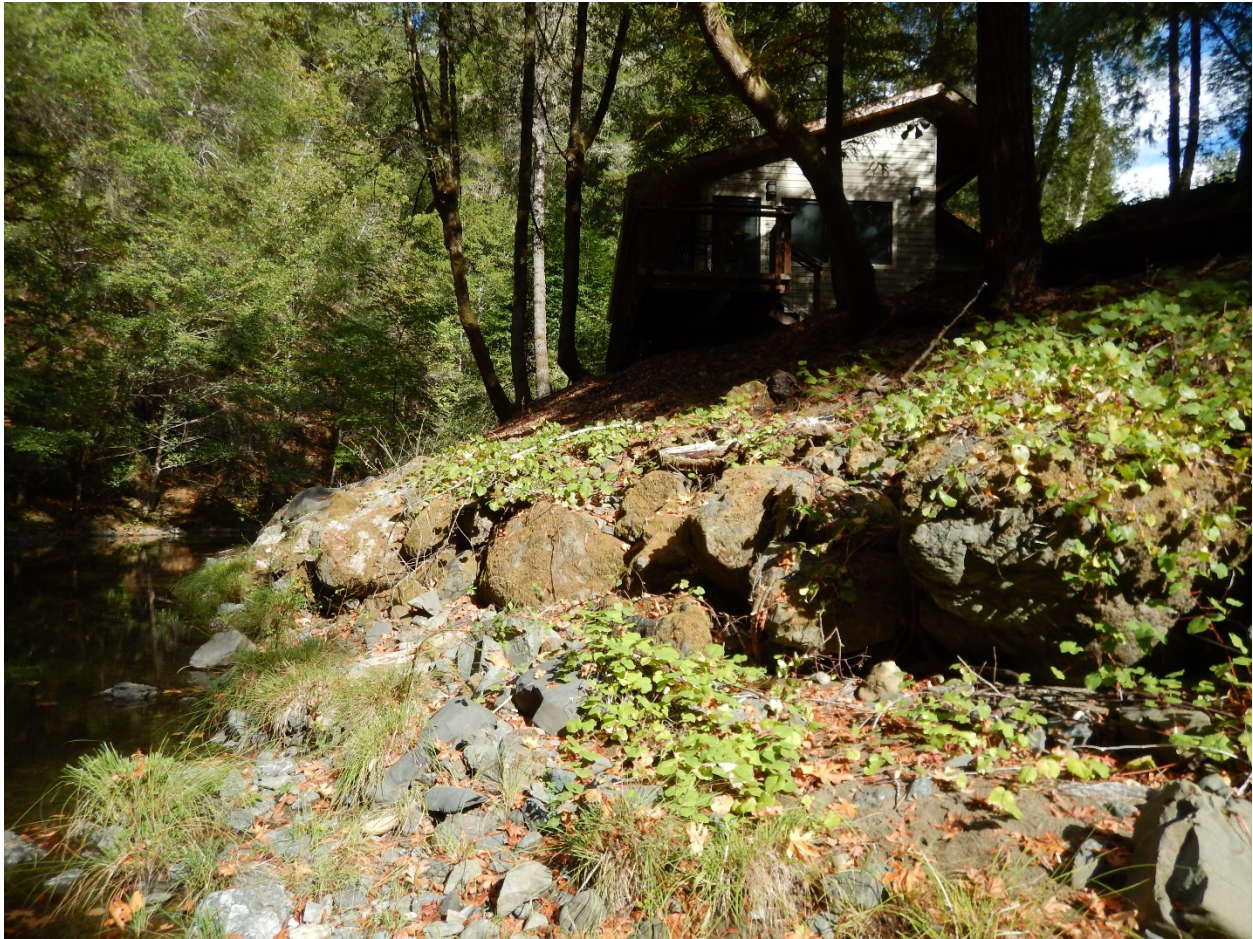
Figure 14: Same location as Figure 15 but looking upstream. An access route was developed here, going around the structure and across the slope in front of the structure, on the bank of Austin Creek. Photo taken by Kaete King 9/24/2015.
