**North Coast Regional Water Quality Control Board**

Inspection Report  
Stanshaw Creek Diversion  
Marble Mountain Ranch  
Douglas and Heidi Cole, Landowners  
92520 Hwy 96, Somes Bar  
Siskiyou County  
WDID No. 1A15024NSI

Date: March 9, 2015

Inspection Date: February 12, 2015

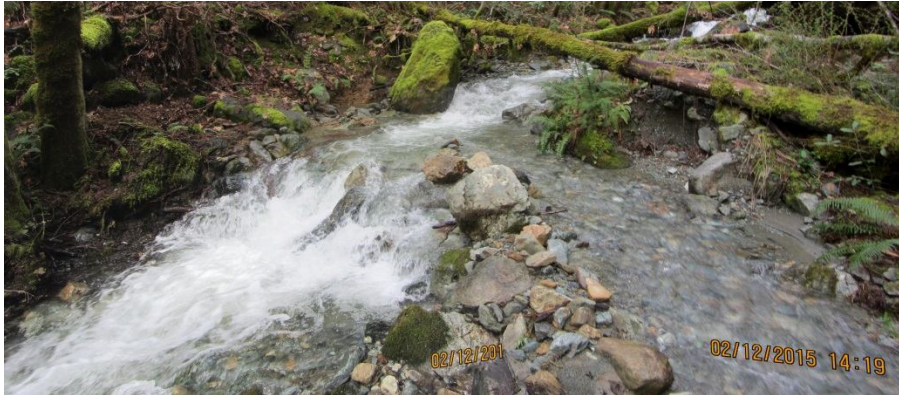
Image 3- shows Point 1, the Point of Diversion. The Stanshaw Diversion flows toward the lower right corner of this image. It appears the rock and cobble diversion structure fails episodically and likely requires periodic modification as Stanshaw Creek's flows change, in order to maintain a diverted flow. (Photos 8459, 8460 and 8461 stitched)

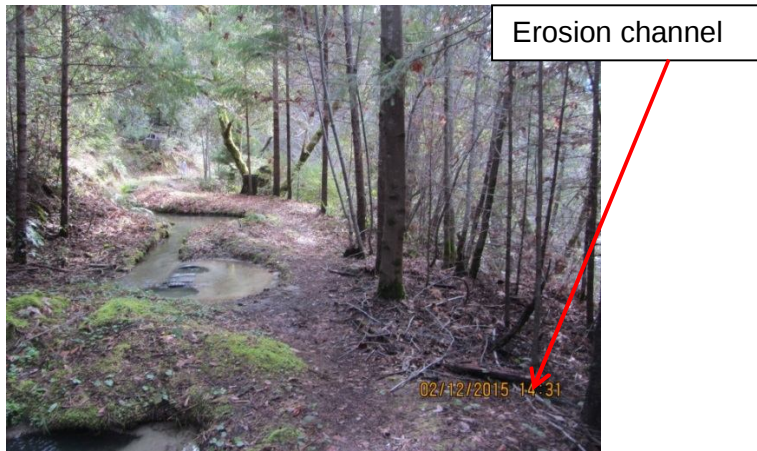
Image 5- shows Point 3, a tank or railroad tank car buried in the ditch channel, likely intended to trap sediment. The tank car is full of sediment. Water flowing in the ditch appears to have overtopped the outboard berm at this location and caused some erosion on the slopes below. (Photo 8467)

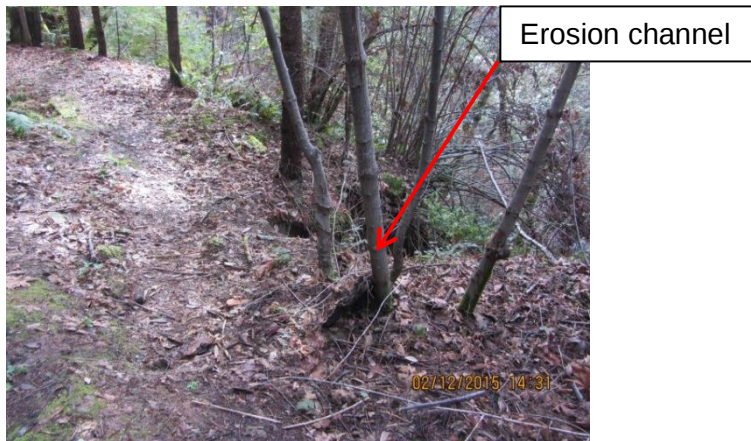
Image 6- shows the erosion channel downslope of Point 3.

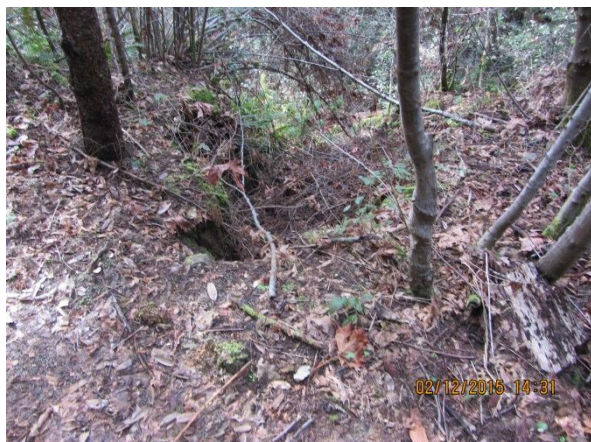
Image 7- shows the erosion channel downslope of Point 3. The void is visible here in the foreground; the erosion extends downslope an unknown distance.

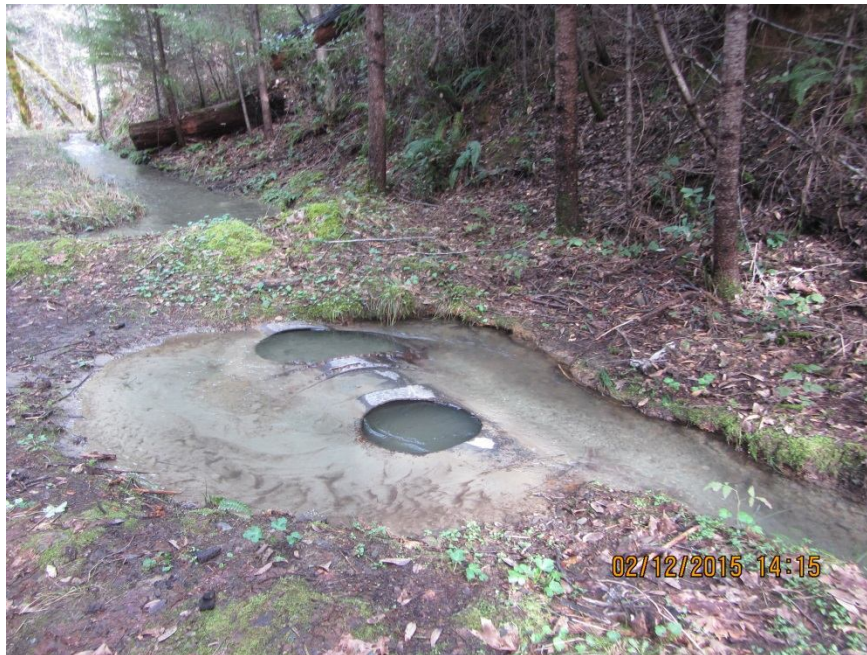
Image 8- at Point 3, shows a closer view of the buried tank car with stored sediments visible. (Photo 8450)

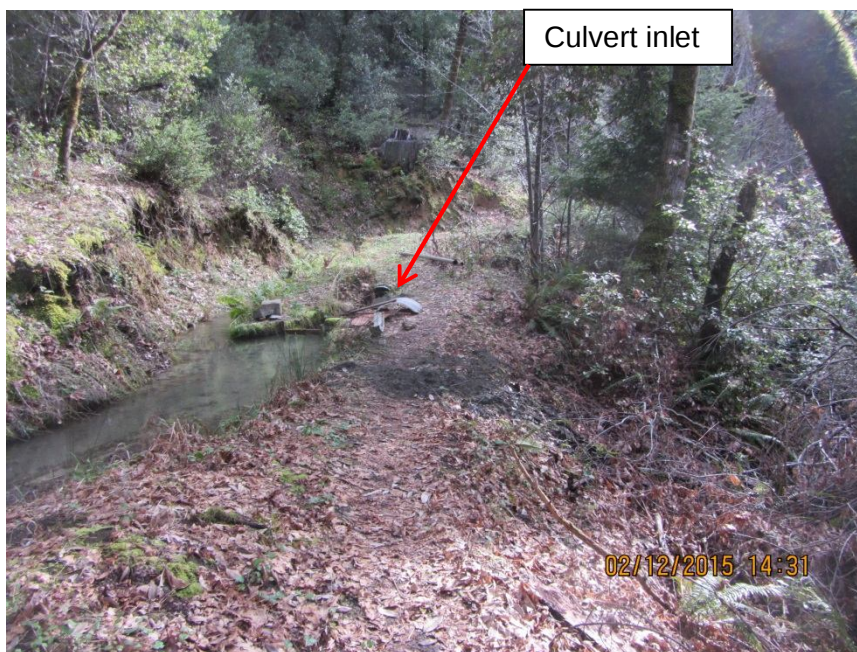
Image 9- at Point 4, shows the partial diversion of the ditch into an unnamed tributary to Stanshaw Creek through the inlet of a 12-inch culvert, before the diversion ditch is routed across the stream in a lined ditch. The culvert is shotgunned, which appears to have caused significant instream erosion in the downslope channel. The stream above the crossing is 3-4 feet wide at bankfull width; the eroded stream channel below the diversion crossing is 12-14 feet wide, and does not appear stable. At this location, I also observed muddy soils in the berm adjacent to the ditch, indicating that seepage from the ditch is saturating surrounding soils, which may lead to catastrophic failure of the ditch. (Photo 8441)

For either alternative, the ditch repair or decommissioning plan shall include specifications to restore the affected stream/unnamed tributary that crosses at inspection points 4/5, replant with native vegetation, and to protect streams from any further impacts or discharges associated with the ditch.

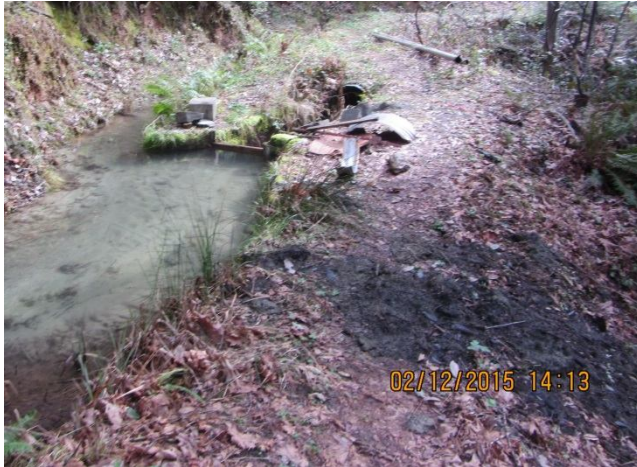
Image 10- at Point 4, shows a closer look at the seepage in the berm; note the muddy soils in the foreground. (Photo 8441 cropped)

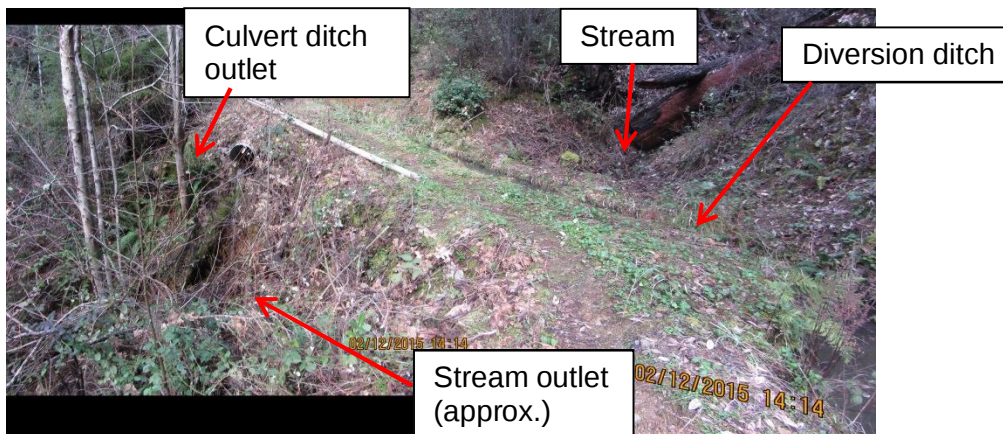
As discussed below, at inspection Points 4 and 5, and visible in image 1, the upper ditch crosses over an unnamed tributary to Stanshaw Creek. The tributary is conveyed under the ditch via culvert. At this location, there is also a culvert that drains a portion of the water in the ditch and discharges it through a shotgunned outlet onto the slope a short distance below the outfall for the stream crossing culvert. The combination of uncontrolled discharges and additional flows into the unnamed tributary has caused significant streambank erosion and channel widening in the tributary downstream of the culvert. The ditch may have historically failed at this location, which has likely also contributed to stream channel enlargement.

Image 9- at Point 5, shows the shotgunned 12-inch ditch culvert outlet, diversion ditch and native stream channel flowing under the diversion ditch. (Photos 8442, 8443, 8444, 8445 composite)

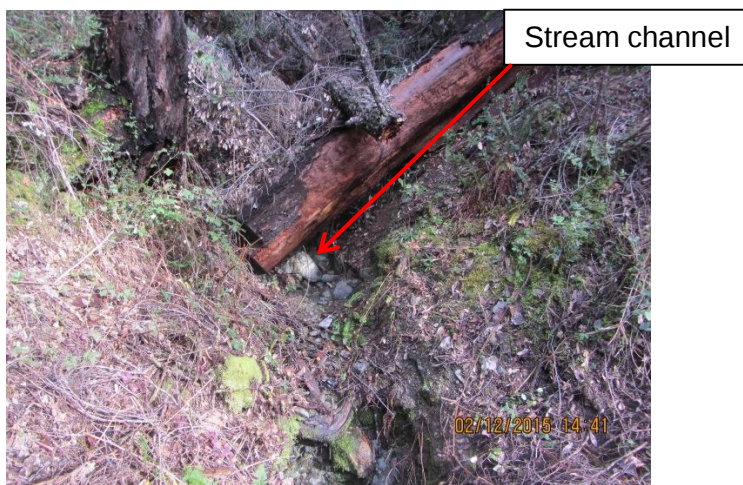
Image 10- shows the unnamed stream channel above Points 4 and 5; the upslope active bankfull stream channel width is approximately 3-4 feet.

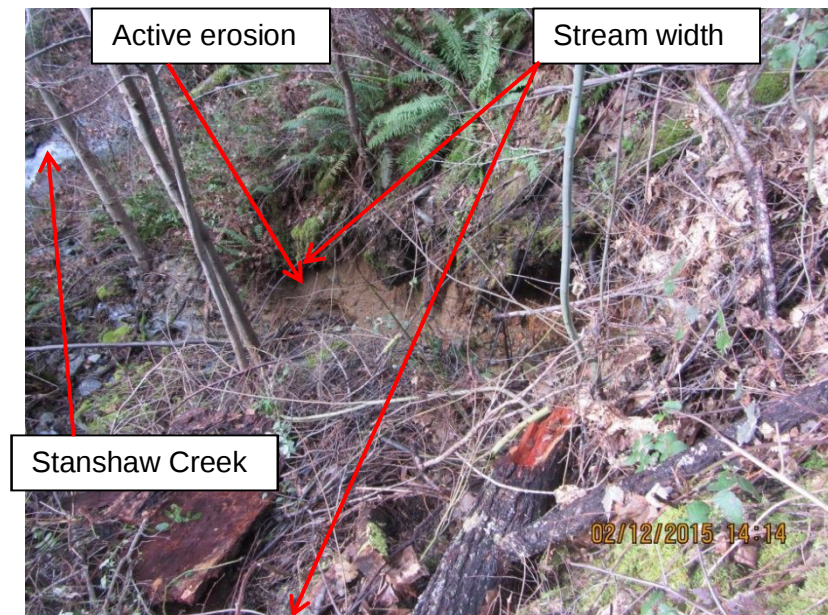
Image 11- shows the unnamed stream channel downstream of Point 5, and the erosion caused by water draining from the shotgunned culvert. Stanshaw Creek can be seen a short distance downslope. I conservatively estimate that this site has delivered 150-300yds<sup>3</sup> of sediment and debris to Stanshaw Creek over the life of the Diversion. (Photo 8478)

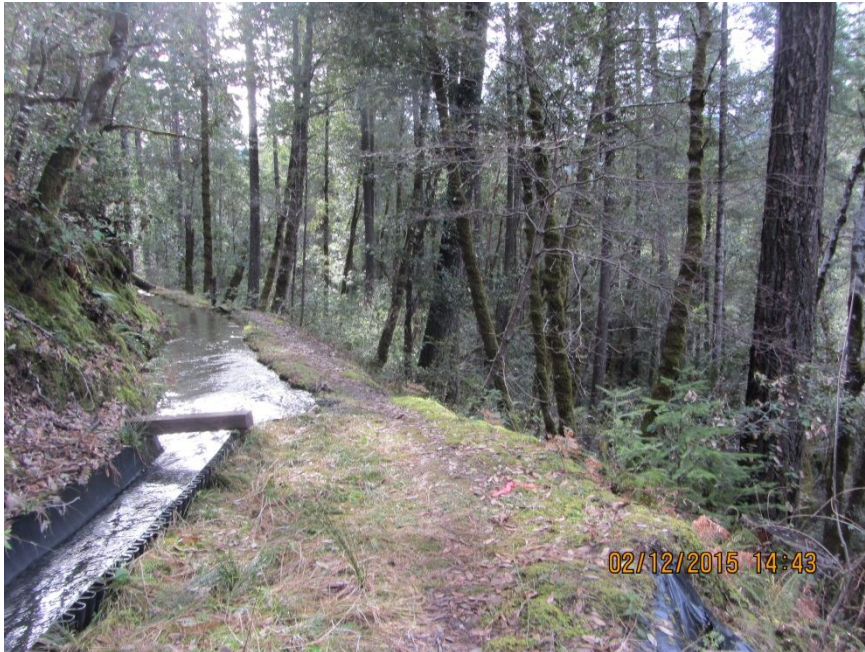
Image 13- point 7, shows the end of the flume in the previous photo; note the black plastic sheeting on the outboard slope face, and the low outboard berm as the diversion ditch exits the flume. The lack of freeboard creates a high potential for overtopping and erosion. The presence of the pipe section and plastic sheeting in the area suggests that the berm or underlying slope in this area has likely failed in the past. (Photo 8483)

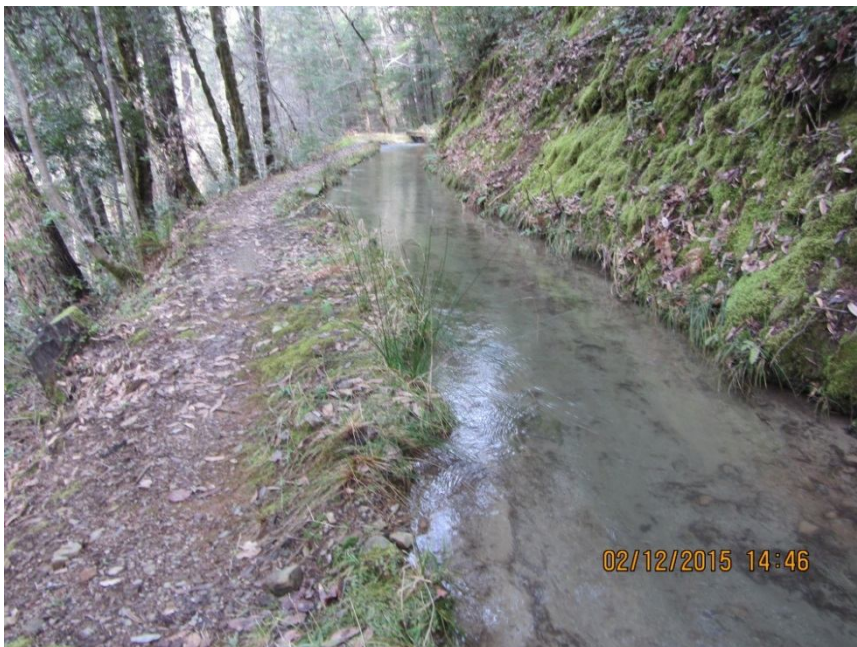
Image 14- shows point 8, an approximately 150-foot section of the channel downstream of Point 7, where the low berm and full ditch likely creates a high potential for berm or slope failure, erosion, and sediment transport downslope. I observed concrete blocks at various locations along the outboard edge of the berm throughout this segment, likely to rebuild or reinforce berm sections. (Photo 8486)

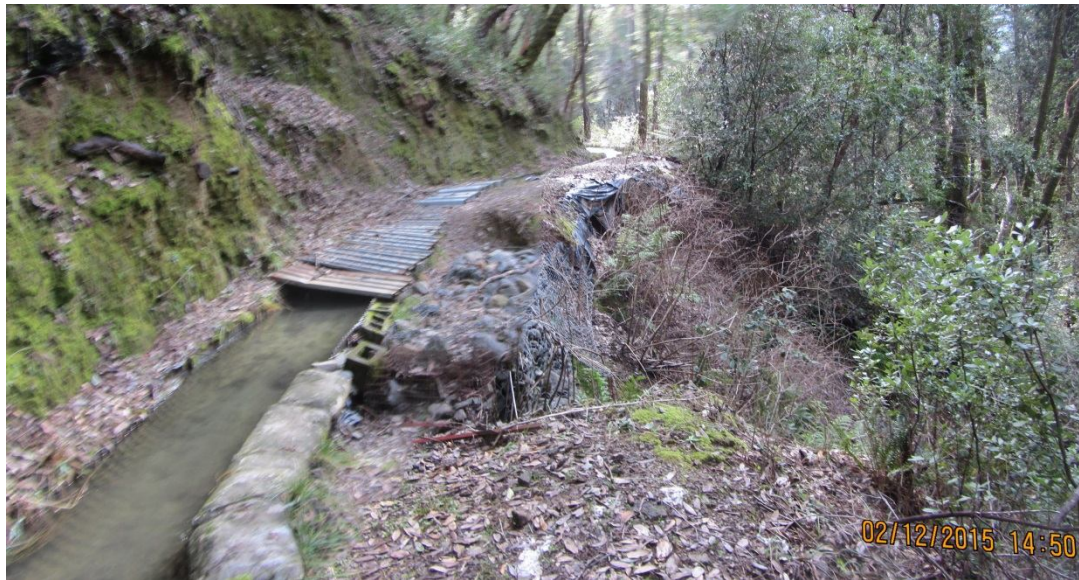
Image 15- shows Point 9, a significant failure point, likely caused by a cut bank slump filling the diversion channel and diverting the stream flow. Note the cut bank slump above and the erosion void downslope. This failure likely accelerated erosion on lower slopes and into the nearby streams. (Photo 8490 and 8491 composite)

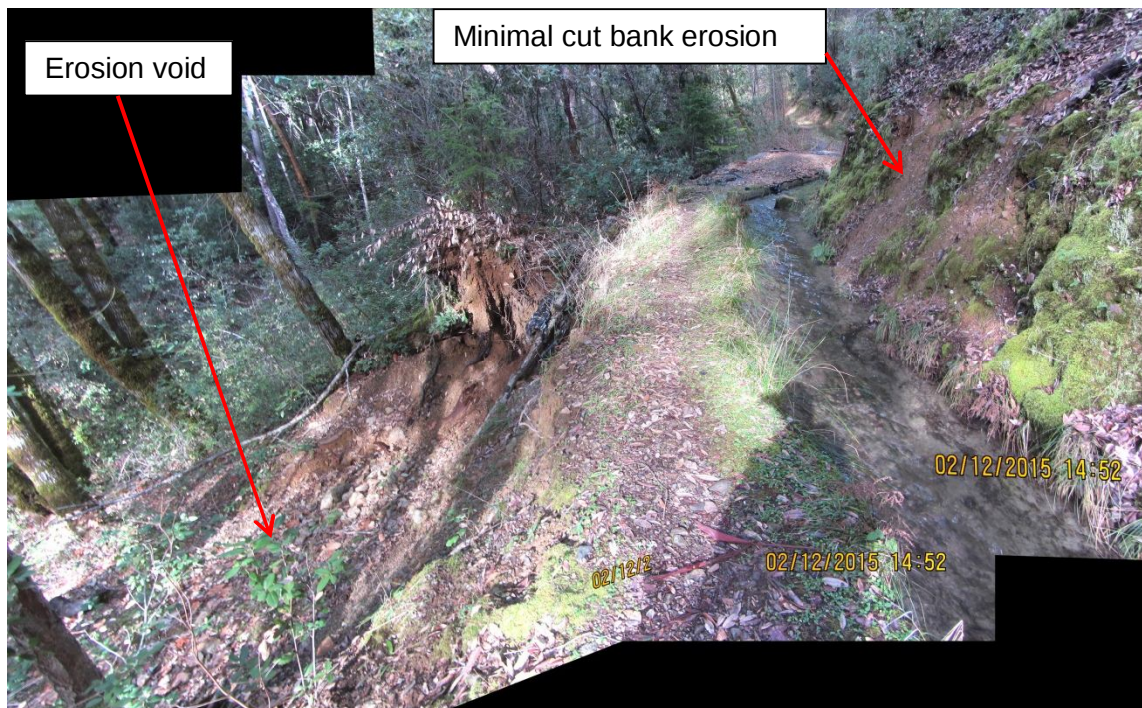
Image 16- Point 10 is an area of concern that includes an erosional channel likely formed by a berm failure and active erosion visible on the cut bank. I observed active cut bank erosion on many of the upper slopes above the diversion ditch and expect that bank slumps have and are contributing significantly to ditch failures. (Photos 8495, 8496, 8497, and 8498 composite image).

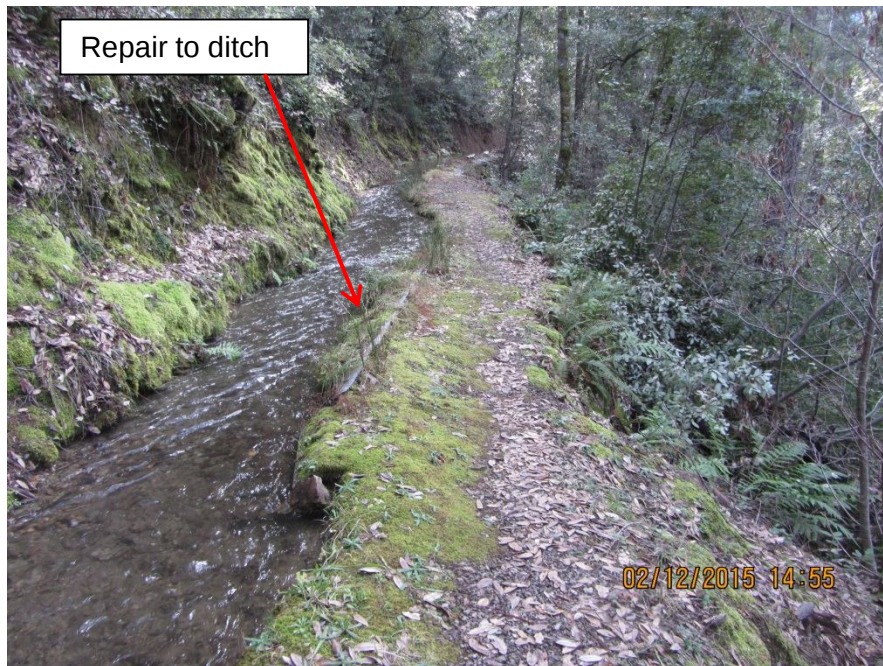
Image 17- Point 11 is another 150-200 feet of ditch with a low freeboard and evidence of past failures; this ditch segment leads to a section of ditch subject to a recent bank failure. I observed erosion scars on the lower slopes that are now overgrown with ferns and small shrubs. (Photo 8499)

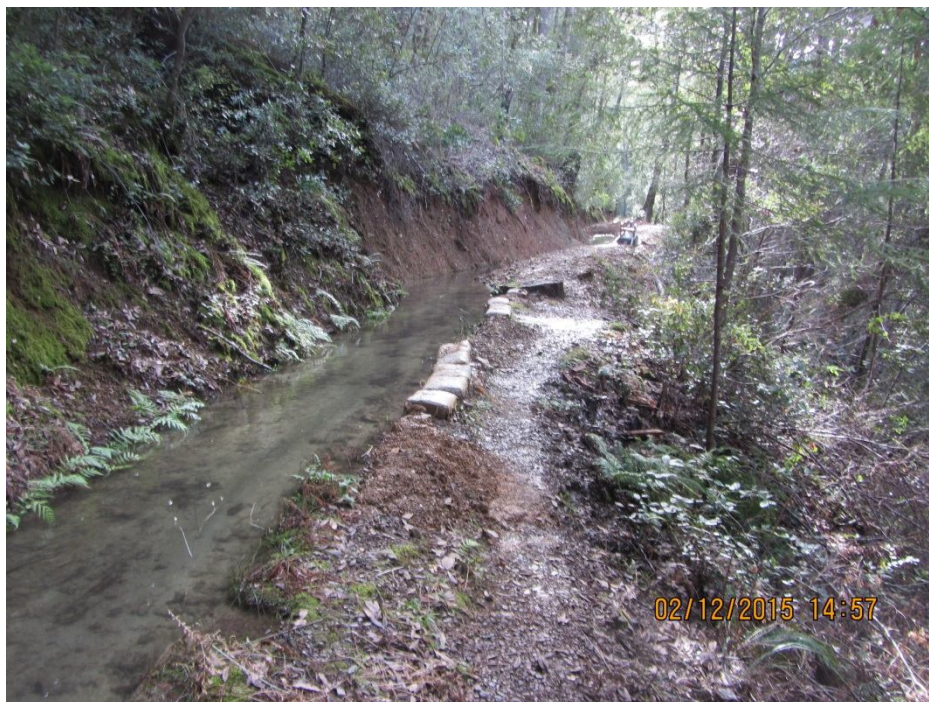
Image 18- Point 12 shows evidence of a recent bank failure that caused water to overtop the outboard berm and erode slopes below the ditch. The outboard ditch shows signs of seepage throughout this length. Note the sand bags and fresh soils along the outboard berm, indicating recent repairs. Also, note the 50-75 foot section of the cut bank with exposed soils. (Photo 8503)

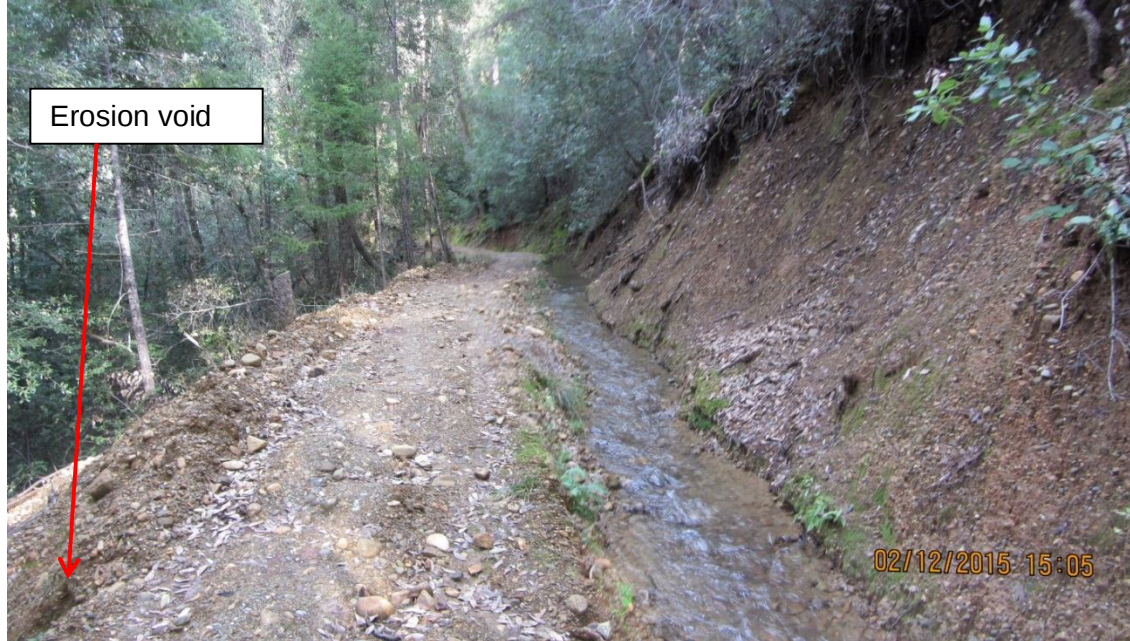
Image 21- Point 14, a cut bank that appears to have slumped in the recent past, causing water to overtop the berm and erode the berm and lower slopes. (Photo 8520 and 8521 composite)

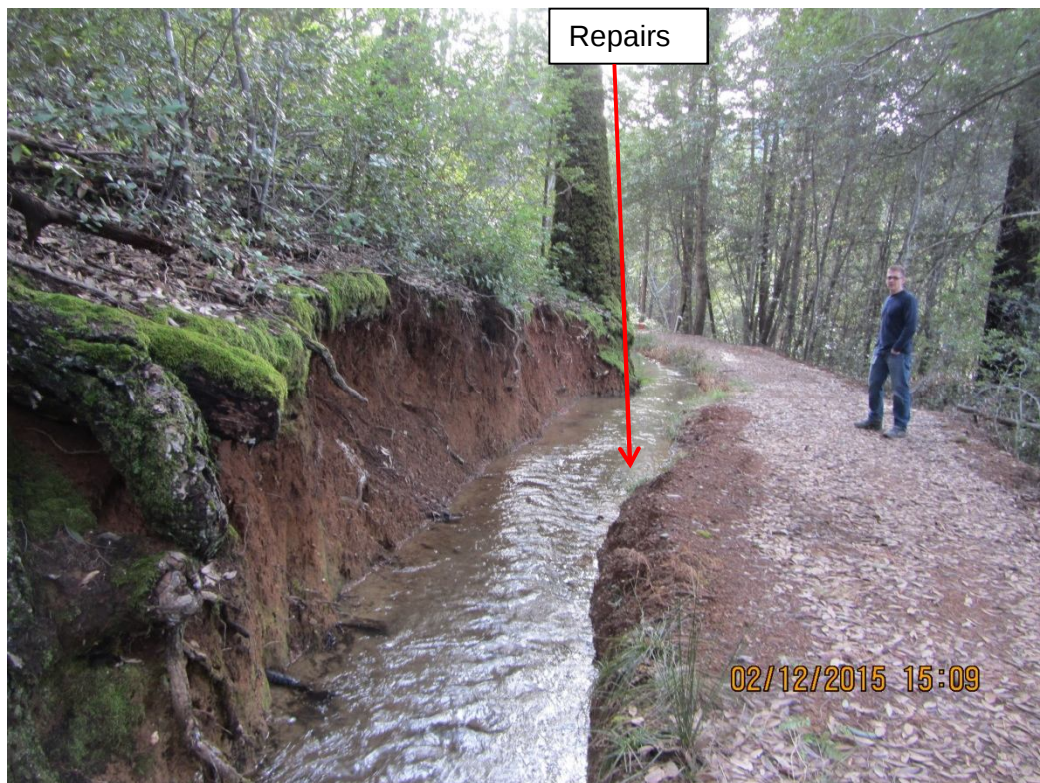
Image 22- Point 15 shows an active cut bank slump, and evidence of recent repairs to the ditch and berm. (Photo 8523)

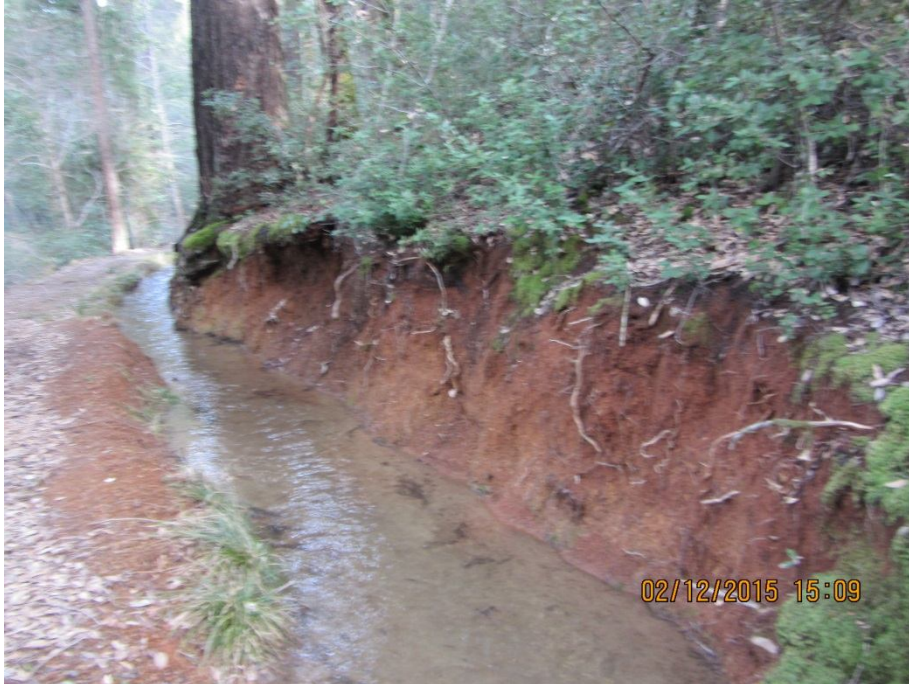
Image 23- Point 16, another cut bank that has a high risk of failure. Note the steep, near vertical slope of this cut bank, which indicates that the bank is still likely to erode. The roots hanging out of the cut bank are indicators of the erosion that has occurred. Most cut banks are originally constructed in a planar form with no visible roots protruding. Over time the cut bank erodes, exposing the roots, and leaving an indicator as to the amount of soil that has eroded or slumped. (Photo 8525)

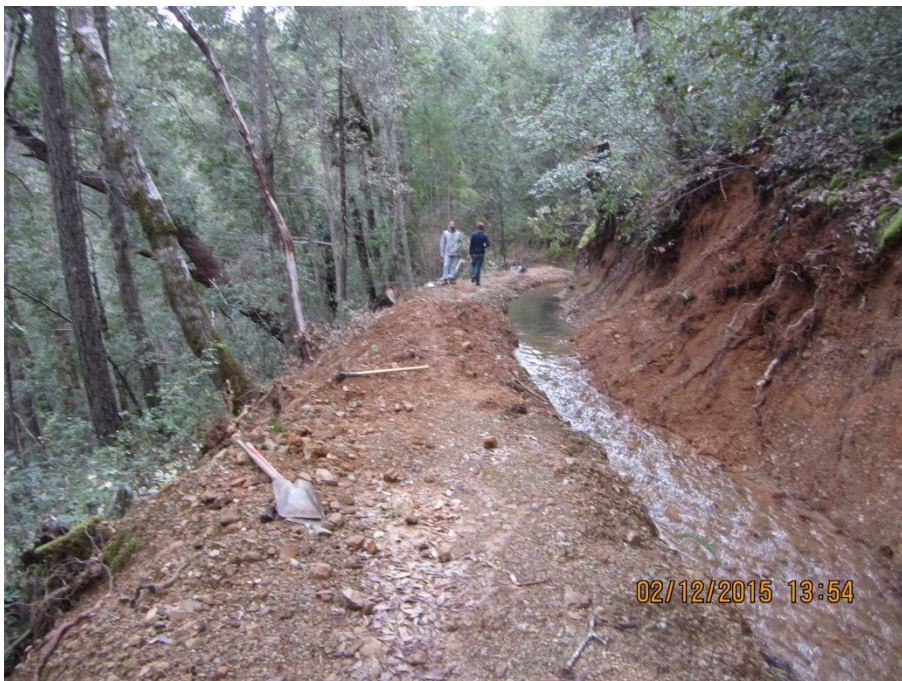
Image 24- Point 17 shows a segment of channel with an active cut bank slump and evidence of recent repairs to the outboard berm.

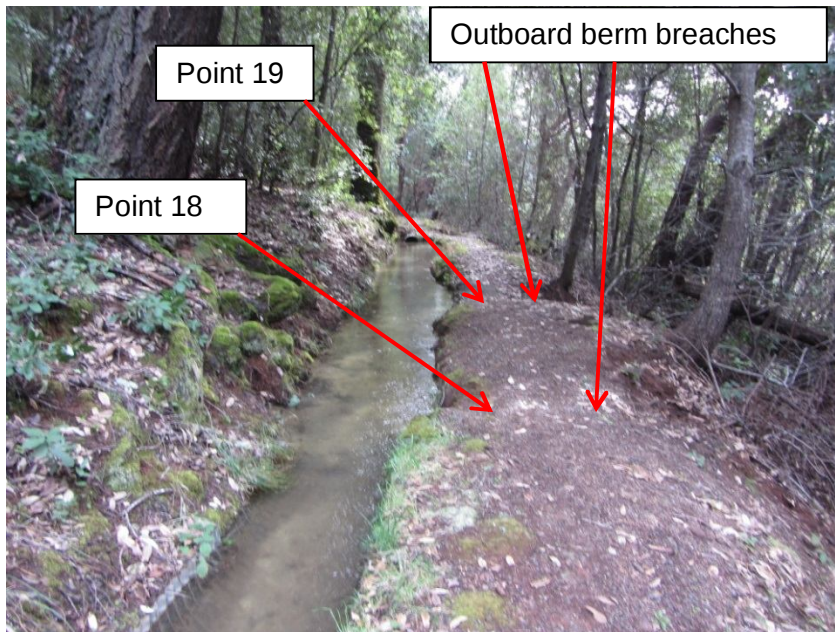
Image 25- shows two locations, points 18 and 19, where the outboard berm has apparently breached in the past, resulting in gully erosion on lower slopes. The failure at Point 19 resulted in the formation of a gully channel for a long distance down the slope, and may have contributed a significant sediment load to the Klamath River and possibly Stanshaw Creek. I did not follow the gully all the way down the slope, but did see an erosion channel from the lower road.

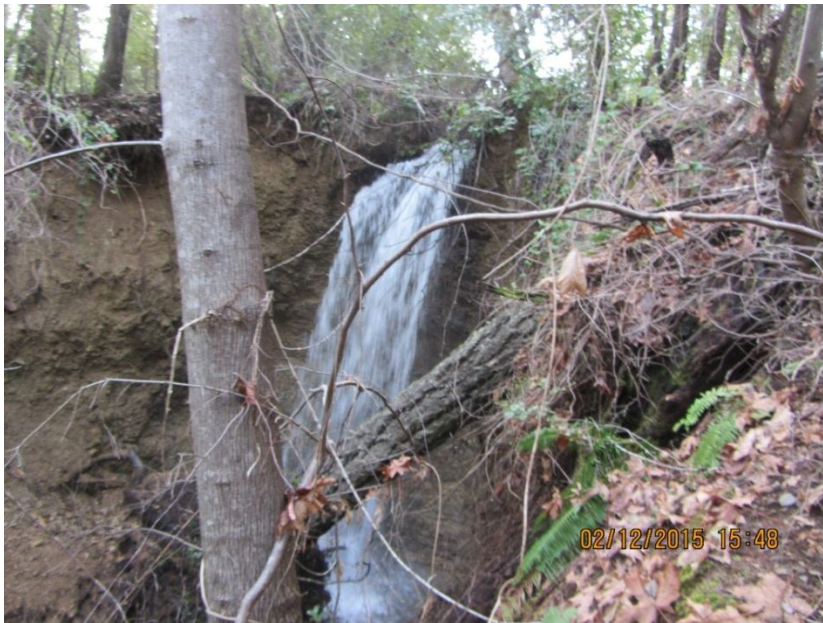
Image 26- Point 20 is the headcut upslope from Irving Creek. This is where tailwater from the Stanshaw Diversion is discharged to an unnamed stream, tributary to Irving Creek. This area is actively eroding. Several trees appear to have fallen recently through erosion of their root masses. I estimate that the headcut erosion has delivered between 1500-2200 yds<sup>3</sup> of sediment to the Irving Creek watershed. (Photo 8529)

On the lower ditch, I observed evidence of significant active erosion occurring at the downstream discharge point to Irving Creek, representing a chronic source of sediment delivery into Irving Creek and, thence, to the Klamath River.

Regional Water Board staff recommend that an appropriately qualified California licensed professional experienced in Geology and stream restoration evaluate the diversion outfall tributary to Irving Creek and develop a stream restoration plan to restore stream side vegetative and hydrological functions of the tributary, if applicable, and to ensure the long term recovery of the affected streams; and 2) replant slopes and streamside areas with native vegetation to prevent erosion and sediment delivery. The plan shall include provisions to ensure that continued use of this tributary, either for diversion outfall flow or for transport of seasonal flows through the ranch property, does not create new or exacerbate existing erosion.
