Field Inspection Report

Report Prepared By:
Stormer Feiler, Environmental Scientist (ES), North Coast Regional Water Board (RWB)

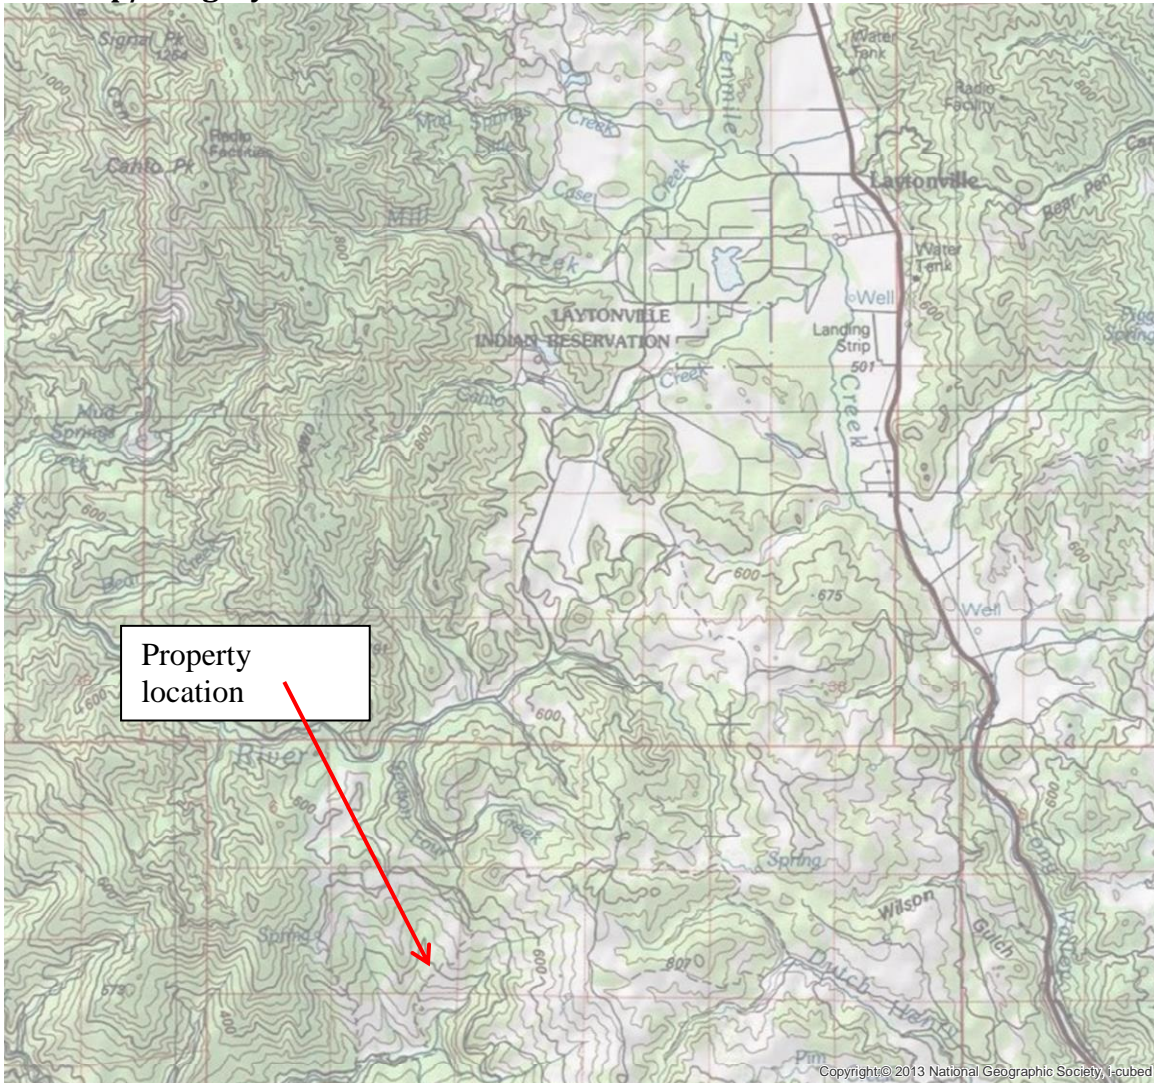
Image 1 – topographic map showing general property location

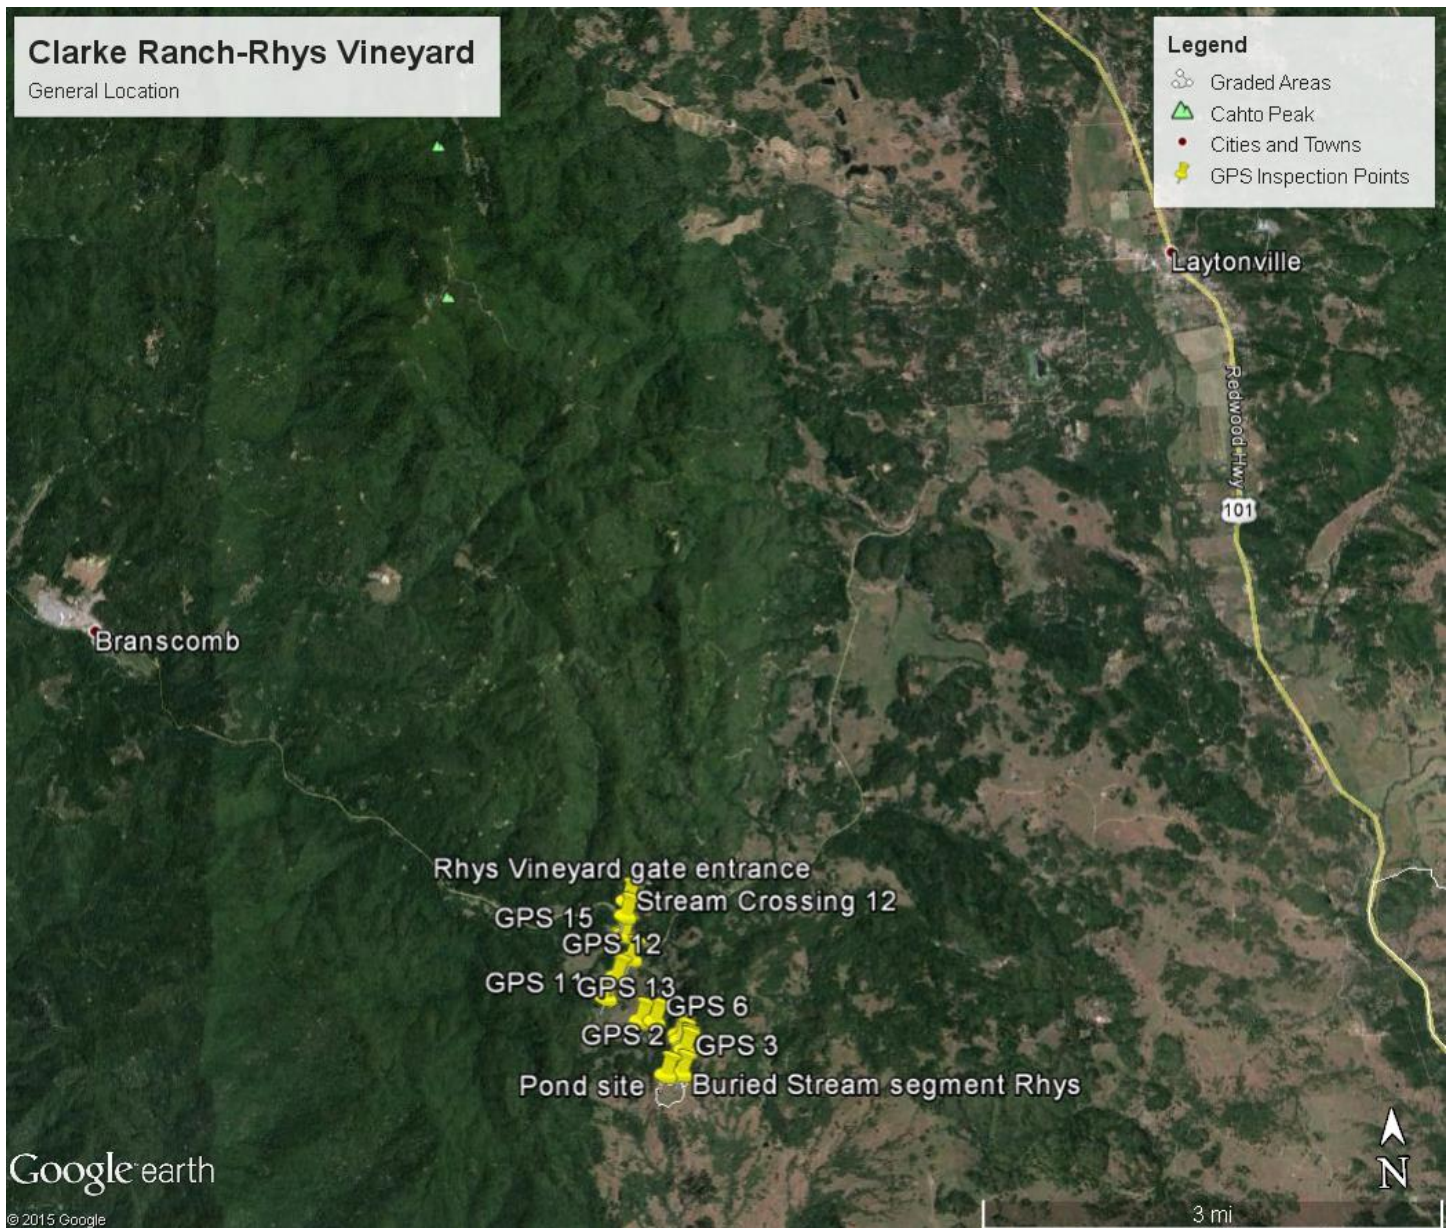
Image 2 – Aerial image from Google Earth showing the general property location; includes inspection points and a rough outline of the graded areas observed.

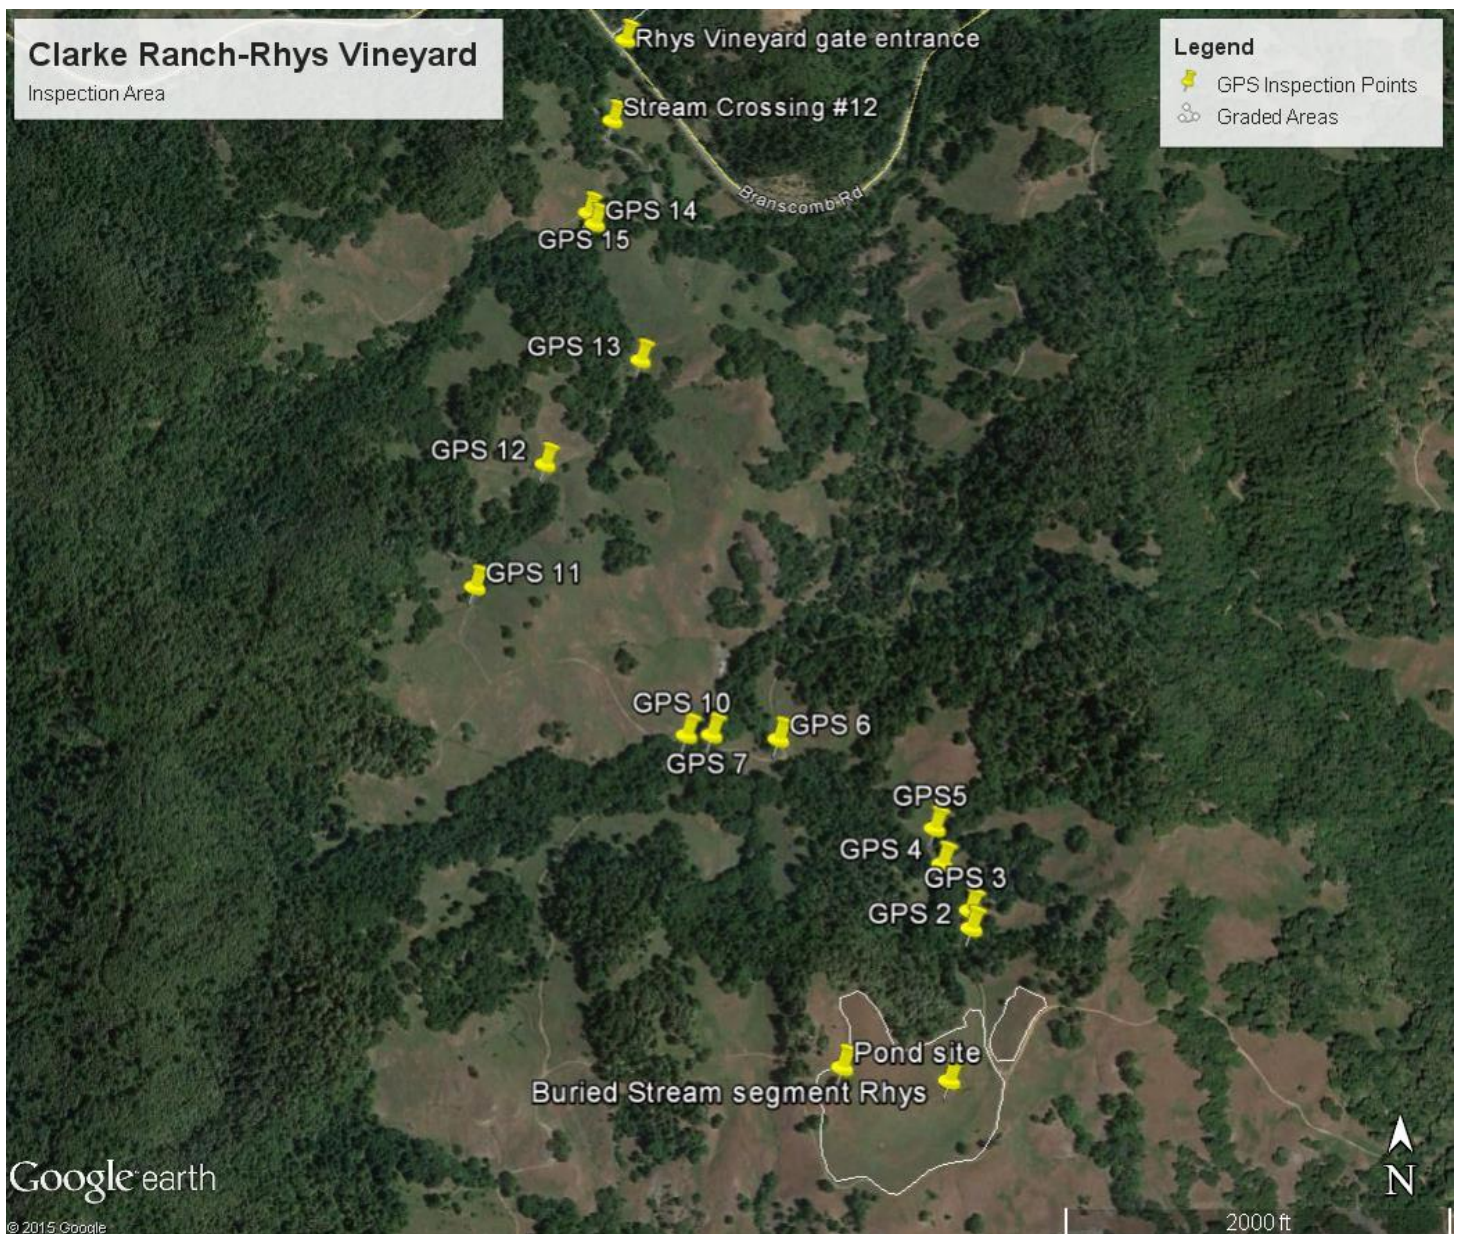
Image 3 - area inspected on September 29, 2015.

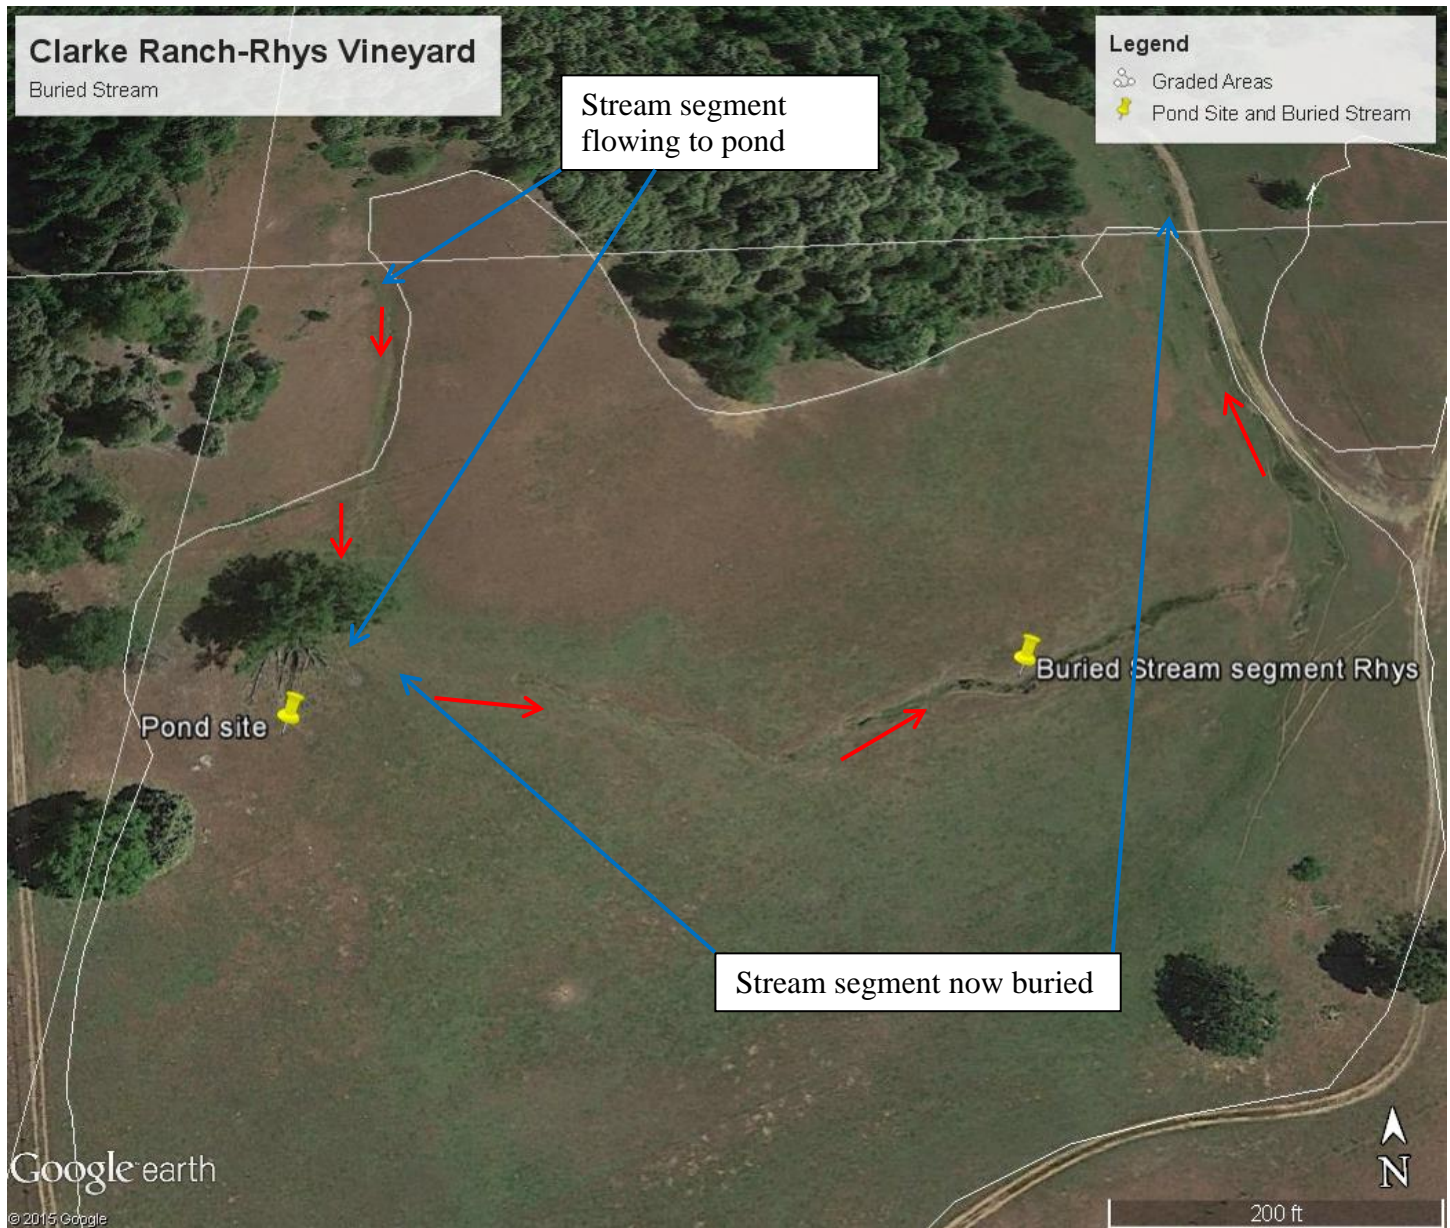
Image 5 - graded area prior to development and pond excavation, showing the affected stream length and area. The red arrows denote flow direction. (Google Earth 5/28/2014 imagery)

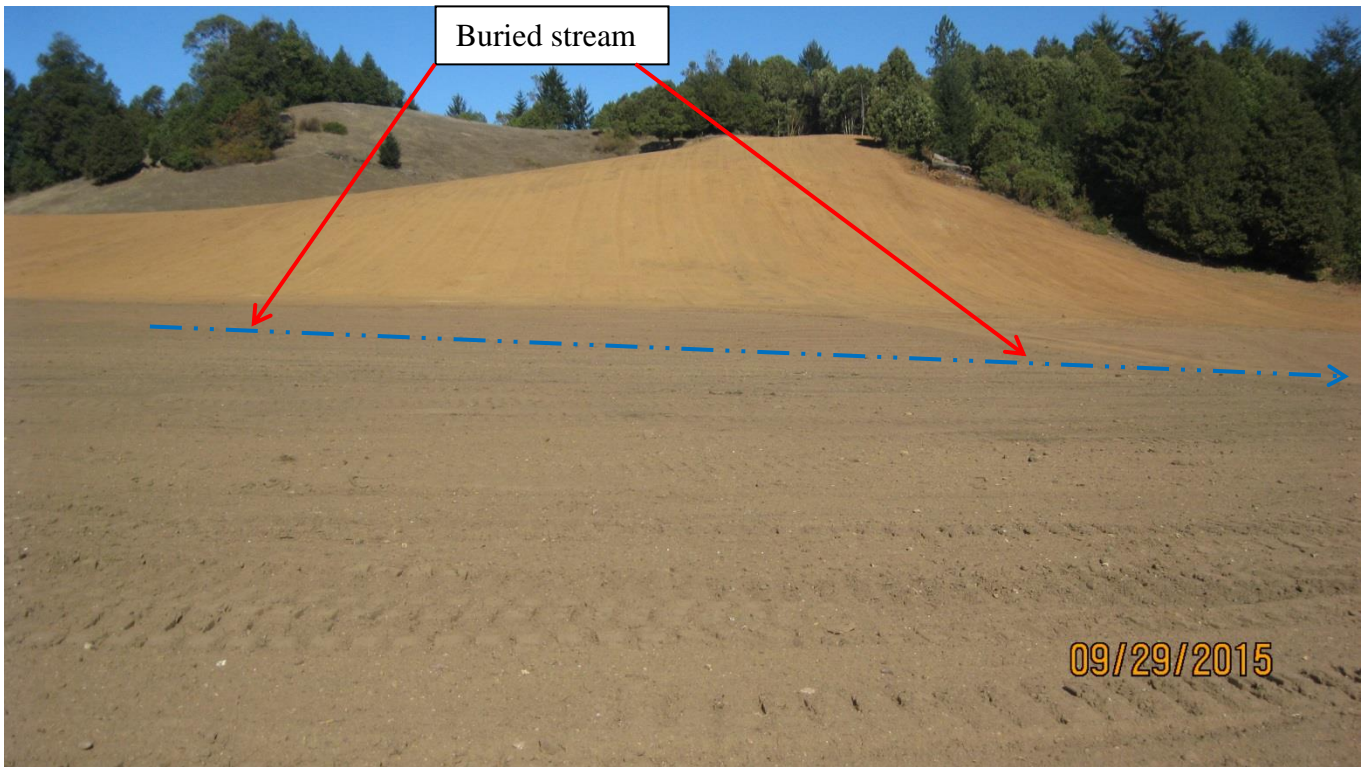
Image 6 shows graded slope to the west of the pond excavation site. Note the two different colors of soils, which is likely a result of spreading the spoils excavated from the pond across the slope and burying the existing stream. (Division of Water Rights inspection photo 0585)

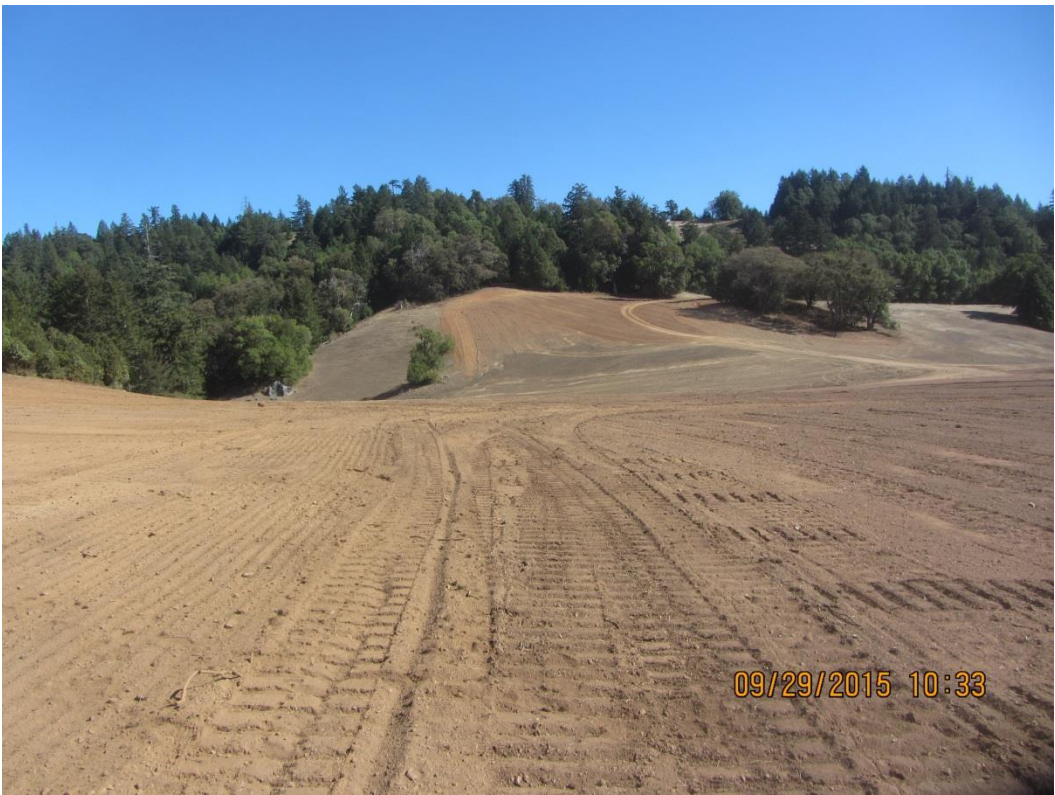
Image 9 shows the slope below the pond looking south at approximately the location where I would expect to see the stream visible in images 4 and 5 flowing to the east across the slope and down to the main stream to the north. (IMG 0219)

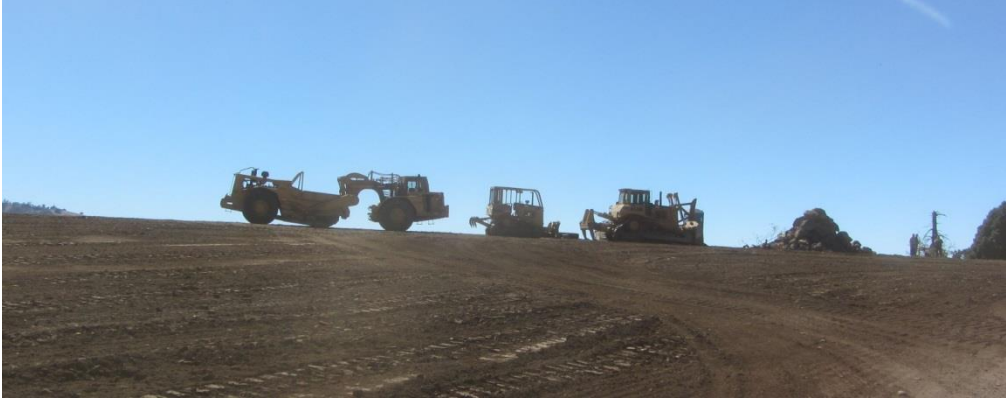
Image 11 shows the equipment observed on site. (IMG 0244 cropped))

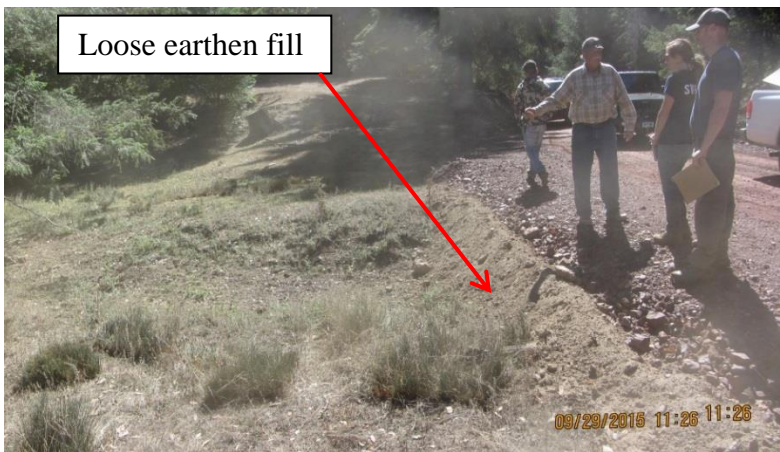
Image 15 shows the road fill in the stream channel on the east (upstream) side of the road at GPS 4. Note there is no culvert visible in the road fills placed into the stream channel on this side of the road. A culvert was visible on the downstream side of the crossing. (Stitch of 0253 and 0254)

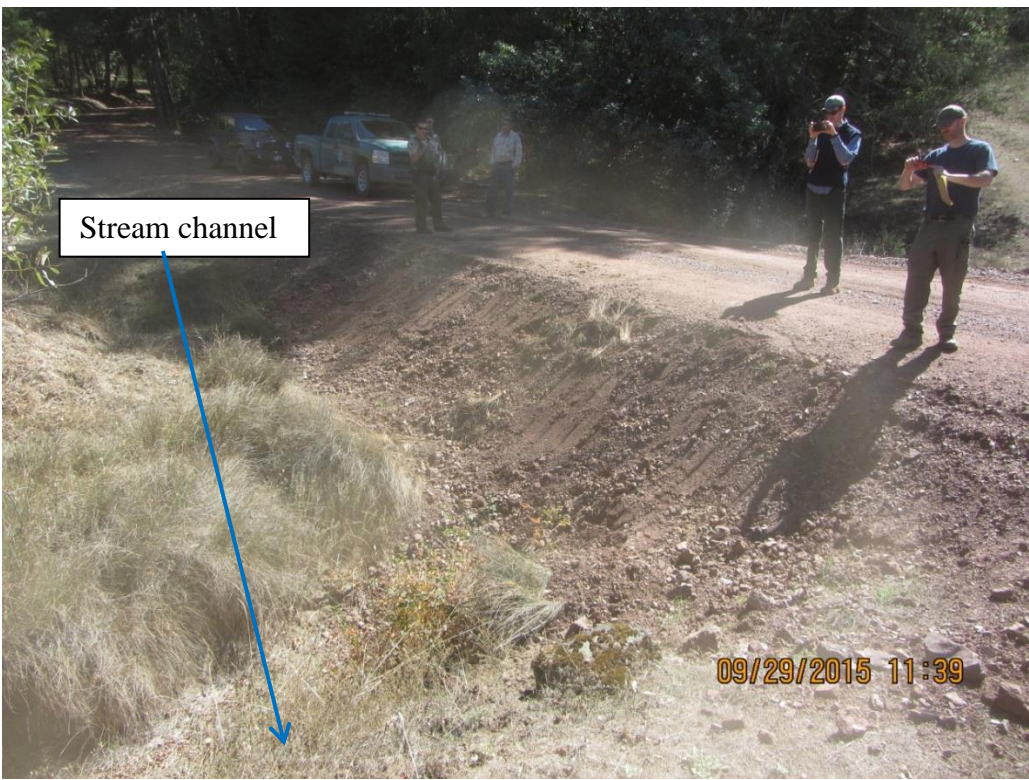
Image 17 shows the upstream east side of the filled stream channel at GPS 5. (IMG 0263)

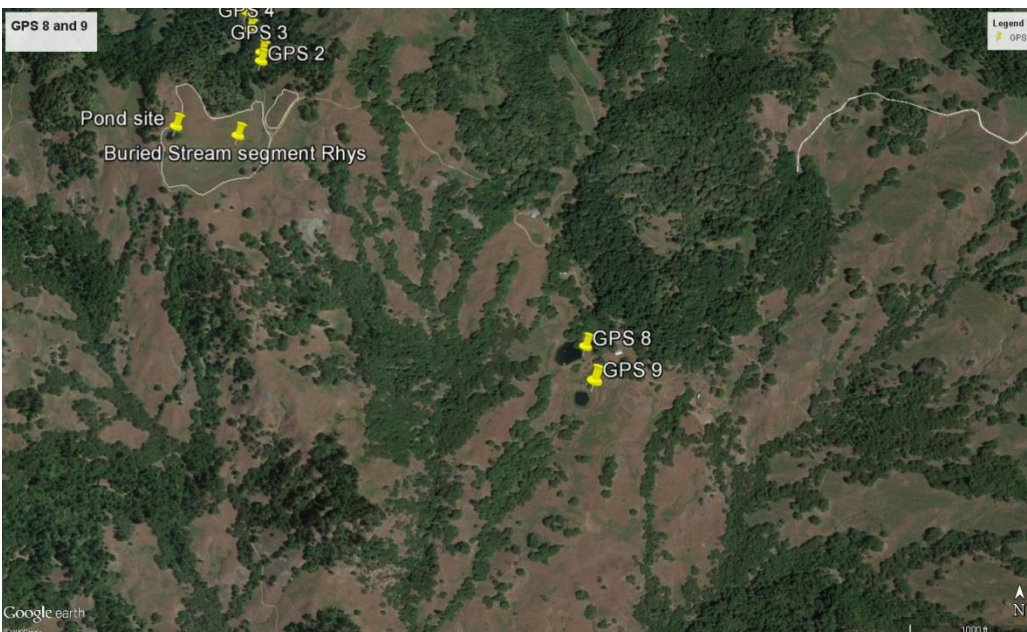
Image 23 - shows the two existing spring-fed ponds

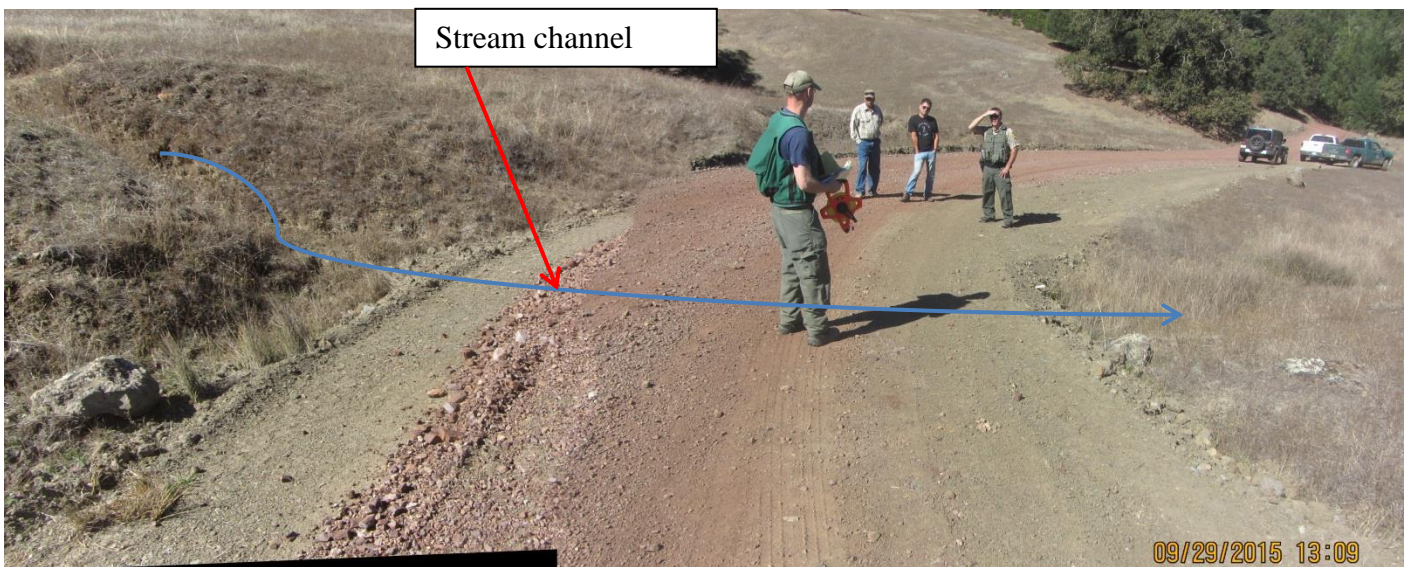
Image 31 shows GPS 10. (IMG 0290-0291 stitch).

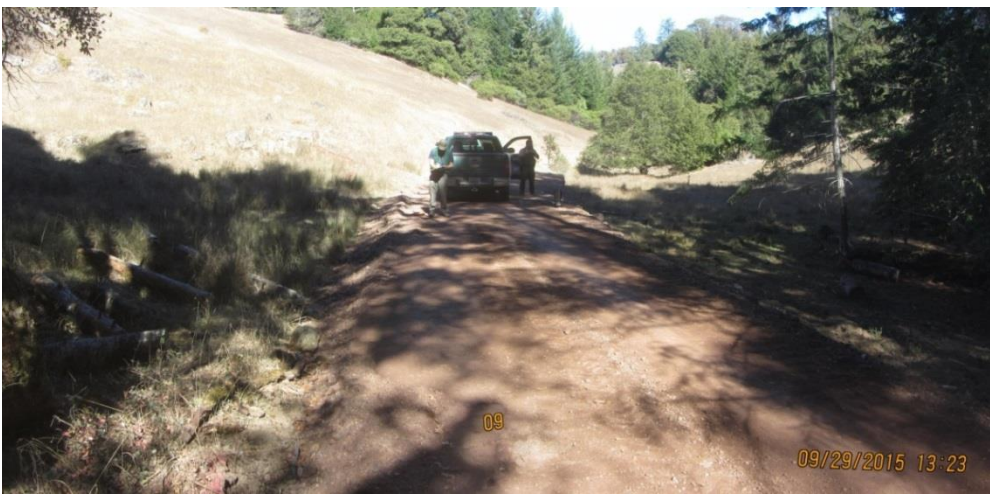
Image 34 shows stream crossing 8 (GPS 12). (IMG 0301_0302stitch).

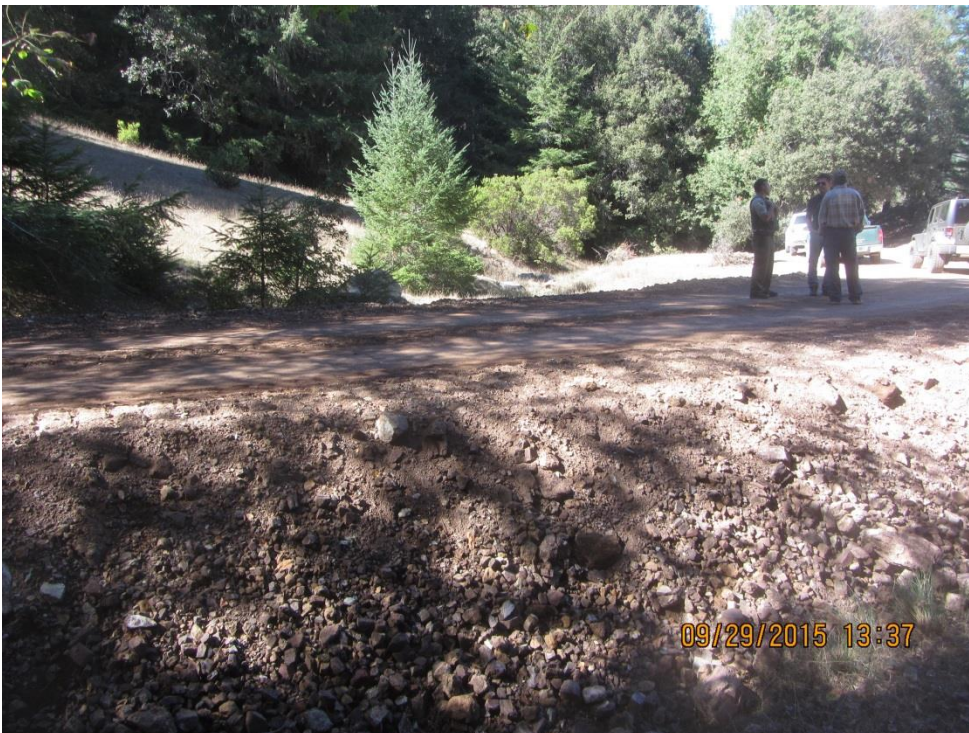
Image 39, looking downstream over the top of the earthen material placed in the stream channel at GPS 13; note the looseness of the materials. (IMG_0314).

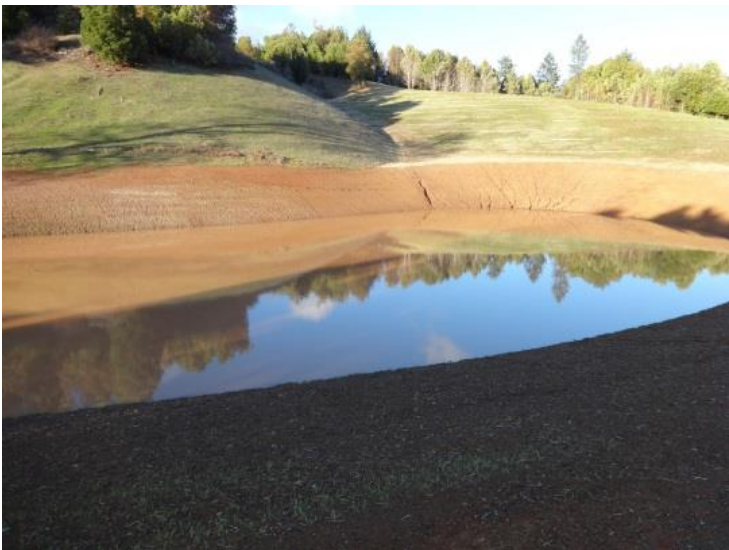
Image 45 shows the new pond now partially filled with water. (Brandon Rose, photo146).
