Field Inspection Report

Name and Location of Facility Inspected	Rhys Vineyard, Clarke Ranch, 6501 Branscomb Road, Laytonville, CA		
Inspection Date & Time:	January 13, 2017 , 0800-1900 Travel time included	Mendocino County Assessor Parcel Numbers (APN)	015-050-061, 015-050-057, 015-050-056, 015-050-055, 015-050-050, 015 050-051, 014-300-019
Names & Titles of On-Site Representatives and Consenting Parties	Consent¹or Warrant		Notified of Inspection?
Javier Tapia Meza, Ken Seckora	Consent Inspection		<input checked="" type="checkbox"/> YES
Property Owner(s):	Rhys Vineyards LLC		
Physical Address:	6501 Branscomb Road, Laytonville, CA.		
Mailing Address:	11715 Skyline Blvd., Los Gatos, CA 95033		
Property Representatives Present:	Randy Jacobszoon, Registered Professional Forester		
Report Prepared By:			
Stormer Feiler, Senior Environmental Scientist Specialist (SES), North Coast Regional Water Board (RWB)			
Report Reviewed By:

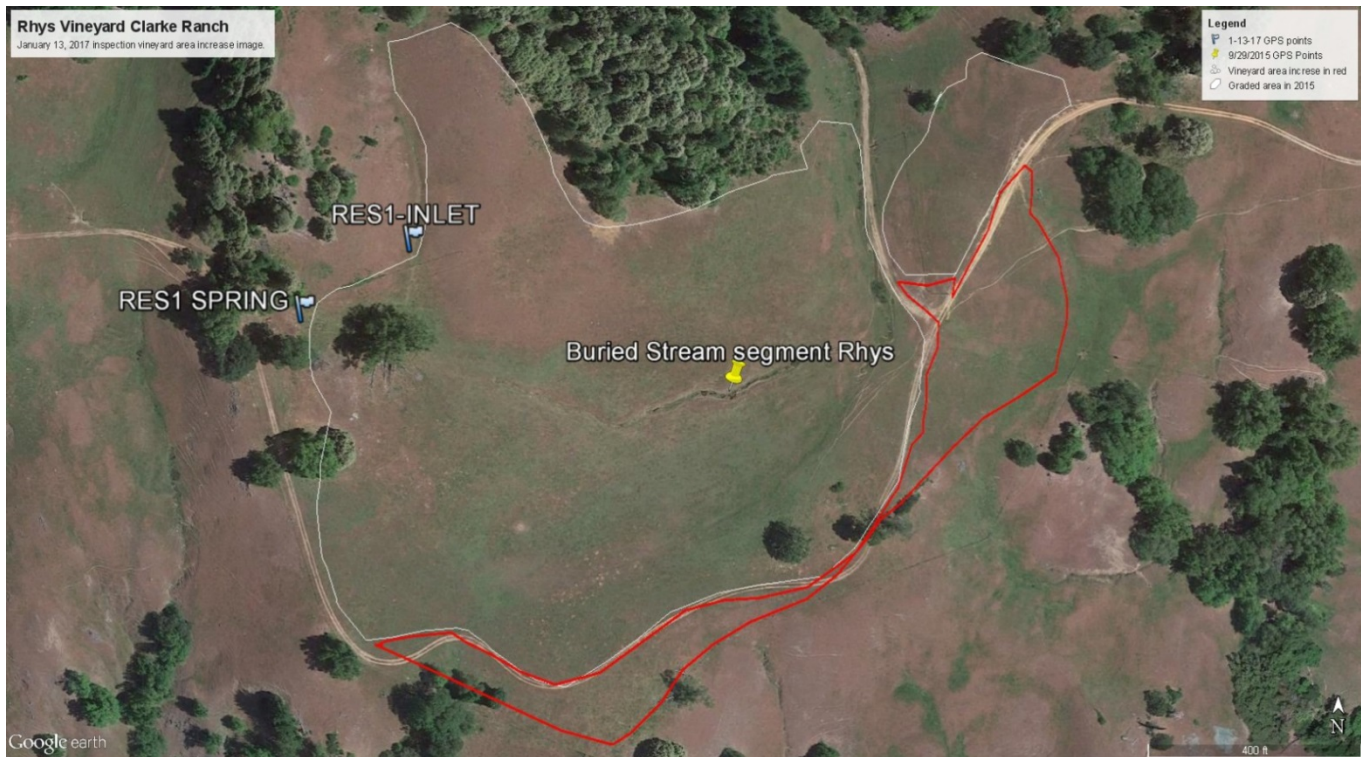
Image 4 – location of large graded area and recently constructed pond, prior to grading and excavation. The vineyard expansion observed on 1/13/2017 subsequent to the September 29 2015 inspection is drawn in red. (Google Earth Pro imagery, image date May 25, 2014)

Image 4, above, shows the recently graded area, prior to grading. In order to estimate the extent of ground disturbance, based upon site observations, I outlined in the 2015 inspection report, on this image, the approximate areas affected by grading. During the 2017 inspection, I noted that the graded areas (vineyard) had increased in size. In addition, the inspection team observed that the vineyard developer had installed a system of underground drainage under the developed vineyard to control surface flows and collect surface runoff. The buried stream channel remained buried.

In 2015, I observed that the grading and excavation conducted to clear and contour slopes and to create the pond resulted in the burial of the stream that was visible on 2014 Google Earth images. The length of stream channel buried by the grading is approximately 1480-1650 feet. During the 2017 inspection, I observed that the buried stream channel appeared remained buried and appeared to be flowing underground and daylighting at the far northeast corner of the vineyard area.

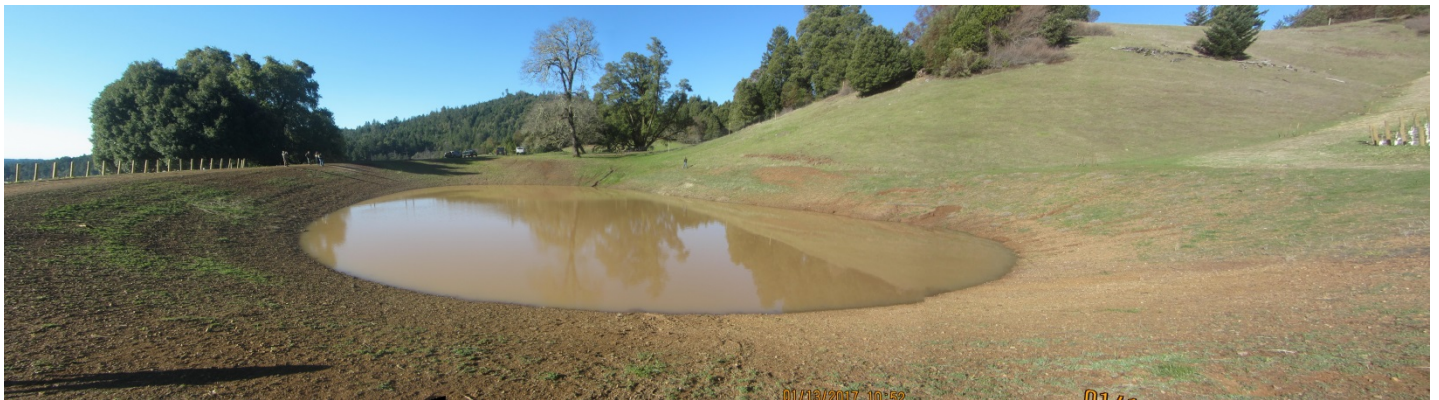
Image 6 shows the developed pond as observed on 1/13/2017. (IMG 2921-2927 stitch)

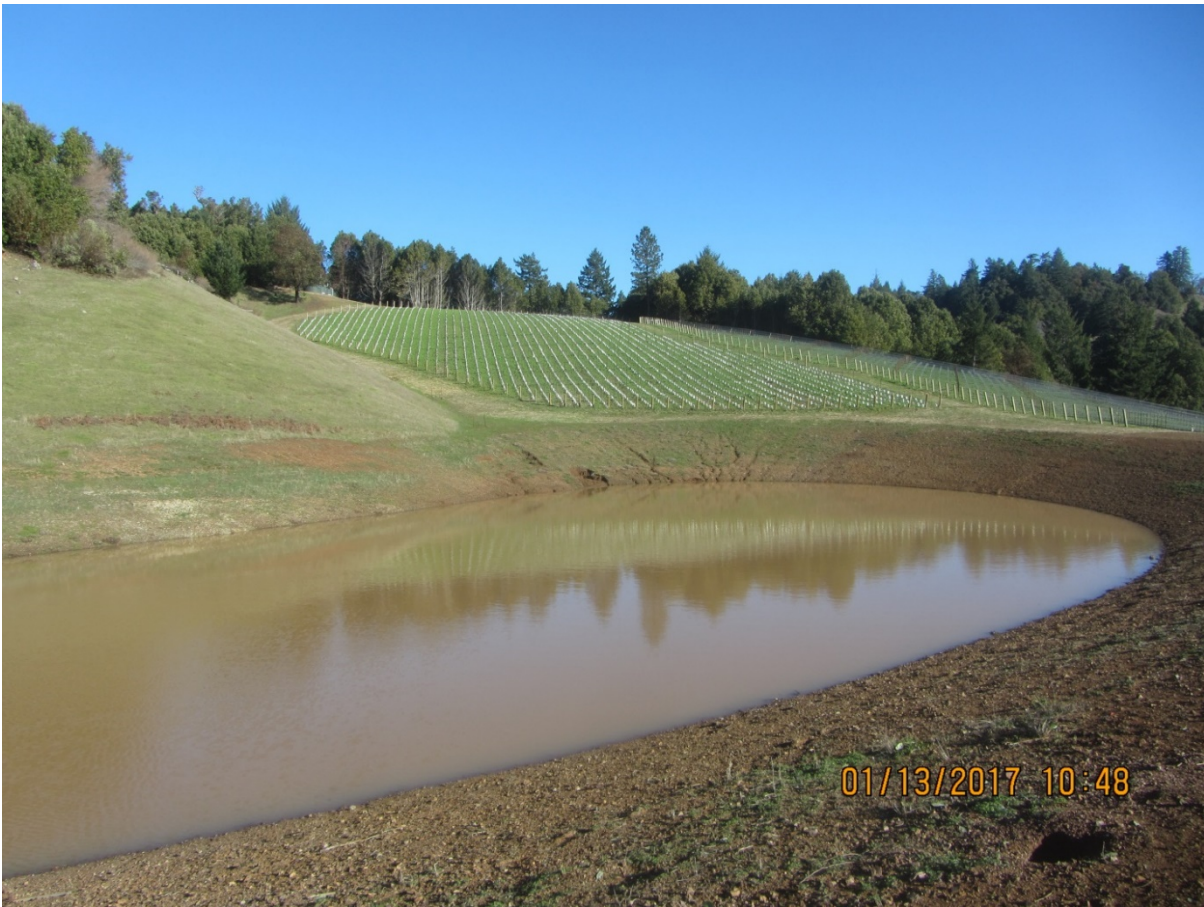
Image 7 shows the pond looking West (note the erosion on the far bank entering the pond). (IMG 2921)

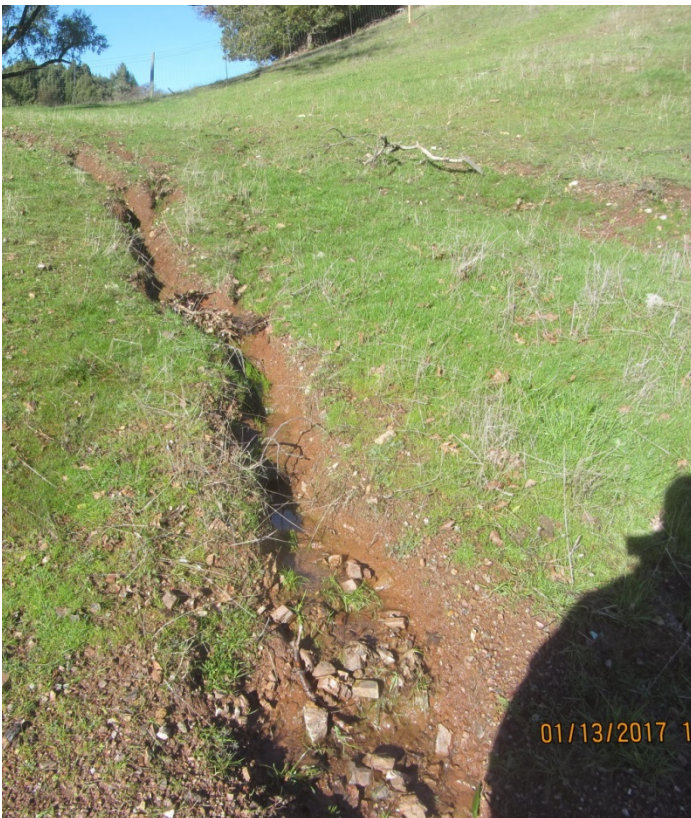
Image 8 shows the spring observed during the inspection flowing into the pond. (IMG 2969-2971)

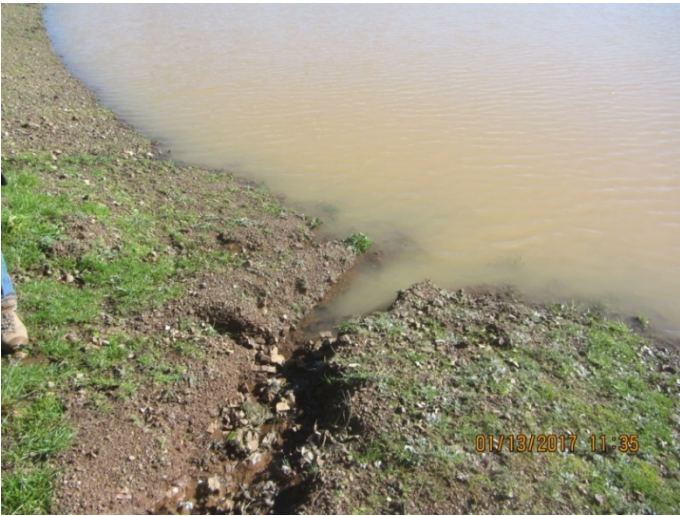
Image 9 shows the spring flow entering the pond. (IMG 2975)

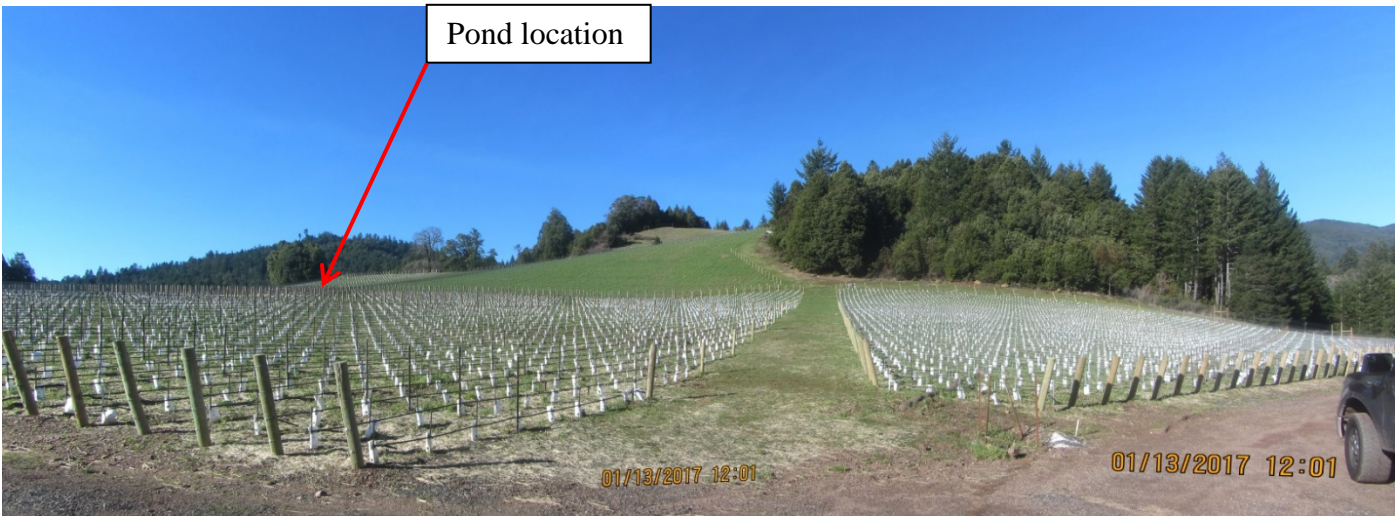
Image 12 shows an overview of the vineyard looking west southwest from the bottom of the slope (IMG stitch 2977-2978).

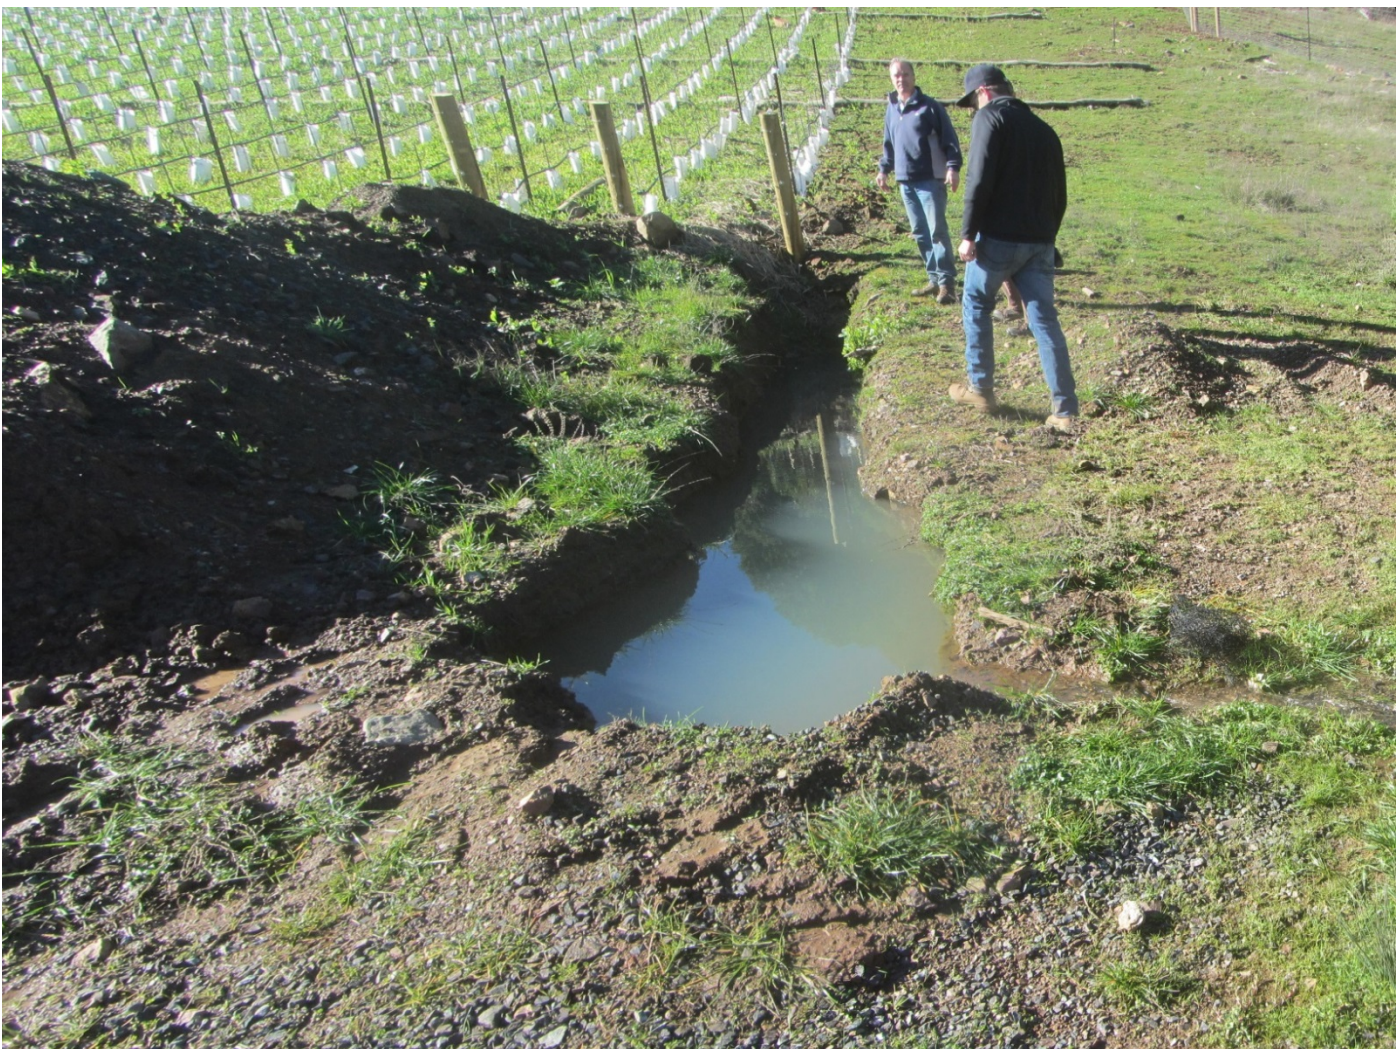
Image 13 shows the downstream slope from the vineyard where a recently dug ditch intercepts what appears to be the buried stream, which was flowing during the inspection. The spoils generated digging the ditch are likely contributing sediment to the stream. (Image 2979-2980 Stitch)

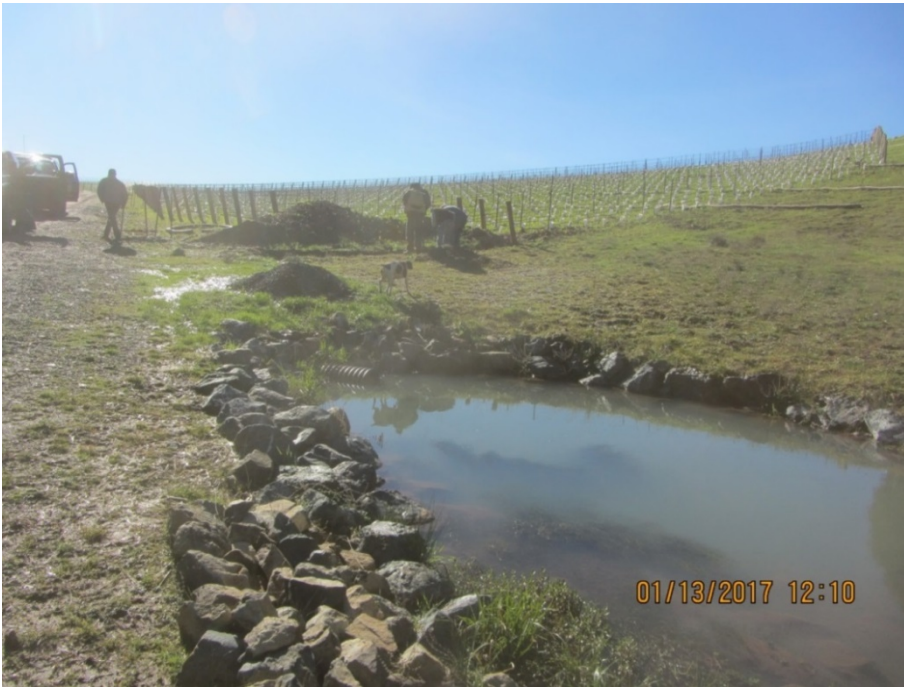
Image 14 looking due South shows the ditch intercepting the buried Class II stream in the background and a culvert leading from the developed vineyard to the detention basin installed in a Class II stream. The retention basin appears to be acting as a settling pond for sediment generated by ditch construction upstream. The road adjacent to the stream is also prone to surface erosion and likely generating sediment during rainfall. We observed that Rock fill appeared placed directly on wetland obligate plant species; Gil Falcone identified the species as sedges (*Carex*) and rushes (*Juncus*). (IMG 2982)

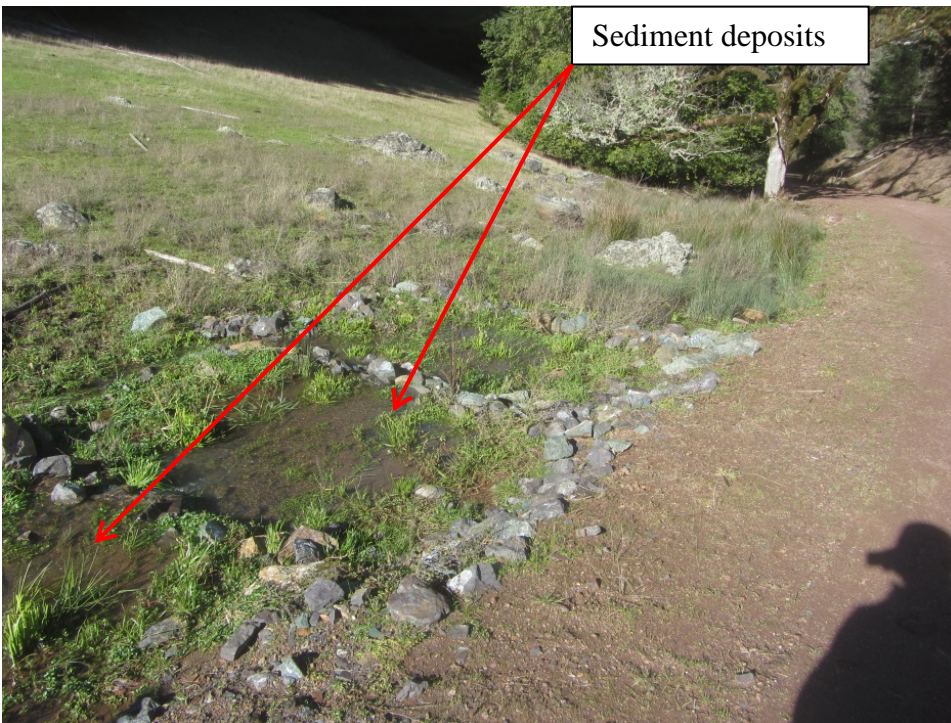
Image 15 shows the Class II stream downstream of the detention basin. (Note the check dams installed in the stream). Note the proximity of the road to the stream and the fine sediment accumulated along the bed of the stream behind check dams. These rocks used for fill were placed in areas where obligate wetland plant species were present. (IMG 2990)

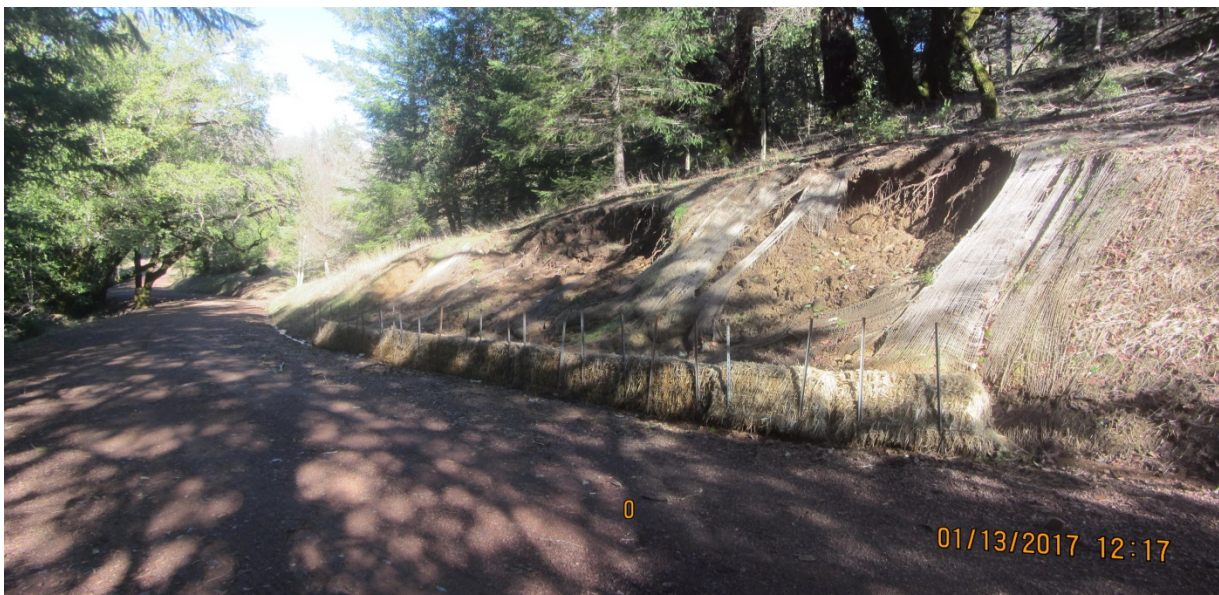
As the inspection team entered the forested area downstream of the vineyard, we encountered a sizeable bank slump along the recently reconstructed access road. The bank slump obliterated the inside ditch and appeared to have been treated to try to control erosion and bank failure. The erosion controls applied were minimally functioning.

Image 17 shows the bank slump along the access road; note the flow in the ditch along the front of the slump. This flow is continuous to the next cross drain at Stream Crossing 2 where the flow discharges to the culvert inlet. Bank slumps such as this are common along the recent construction of the access road.

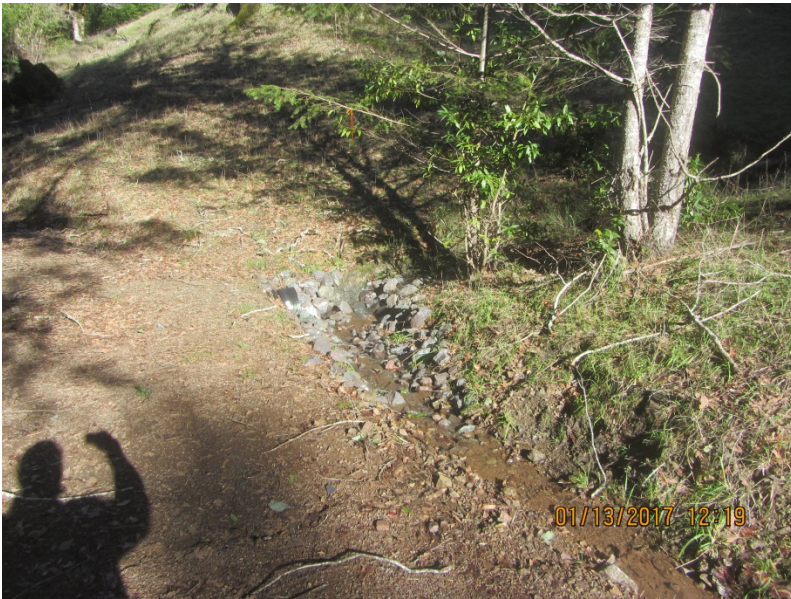
Identifies the location a Class II stream crossing that consists of an 18-inch plastic culvert. The inside ditch on the upstream side of the road is connected to the Class II stream and culvert crossing. Fine sediment and bank erosion is evident along and in the inside ditch leading to the stream.

Image 18 shows stream crossing 2 inlet and inside ditch; note the fine sediment in the ditch and erosion of ditch banks delivering to the stream. (IMG 3003)

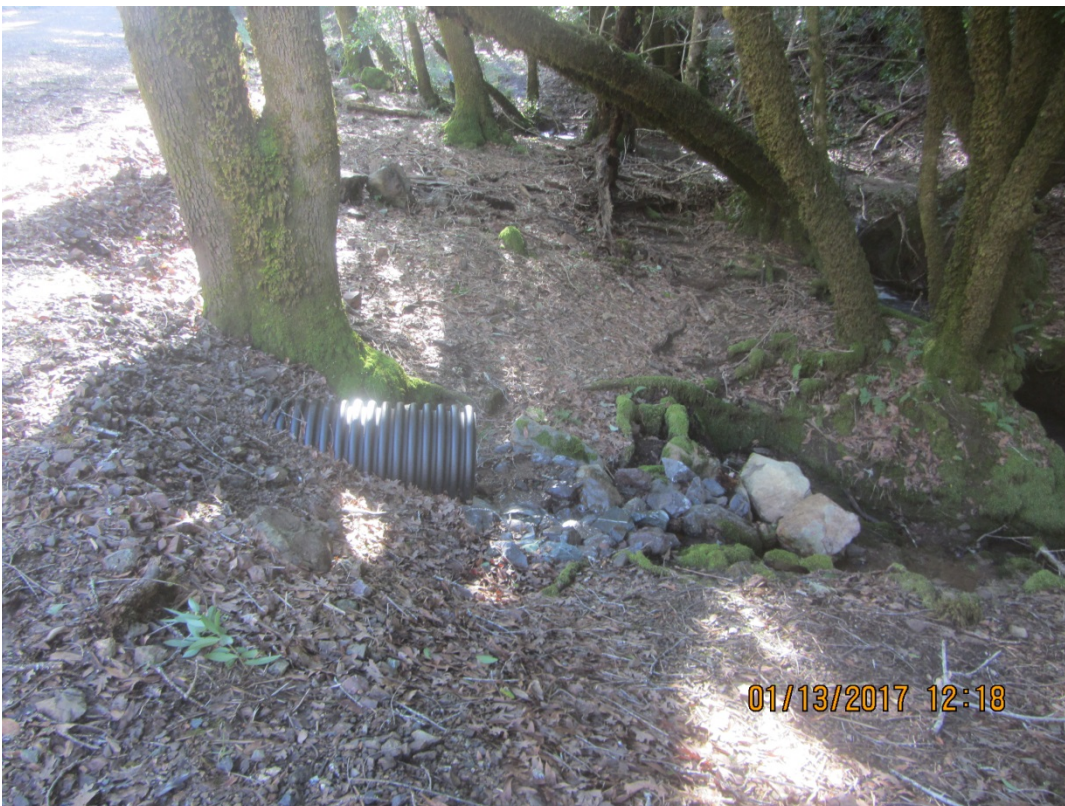
Image 19 shows the stream crossing 2-culvert outlet to the Large Class II stream originating at the vineyard. (IMG 3001)

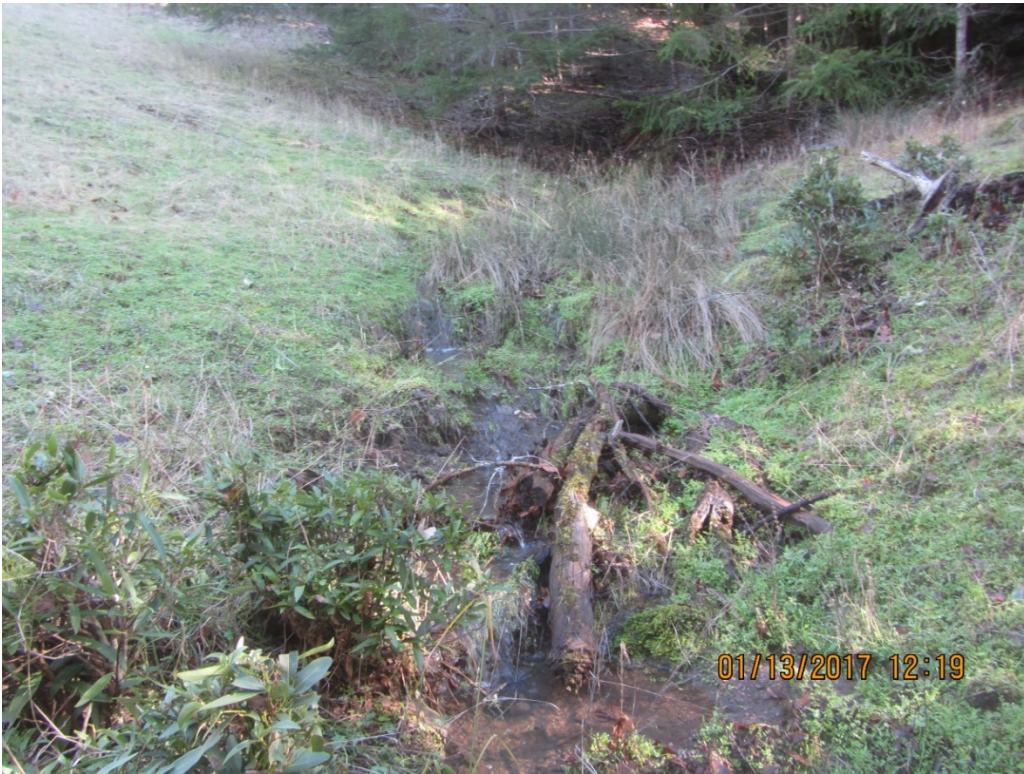
Image 20 shows the Class II stream associated with stream crossing 2 upstream of the crossing. (IMG 3005)

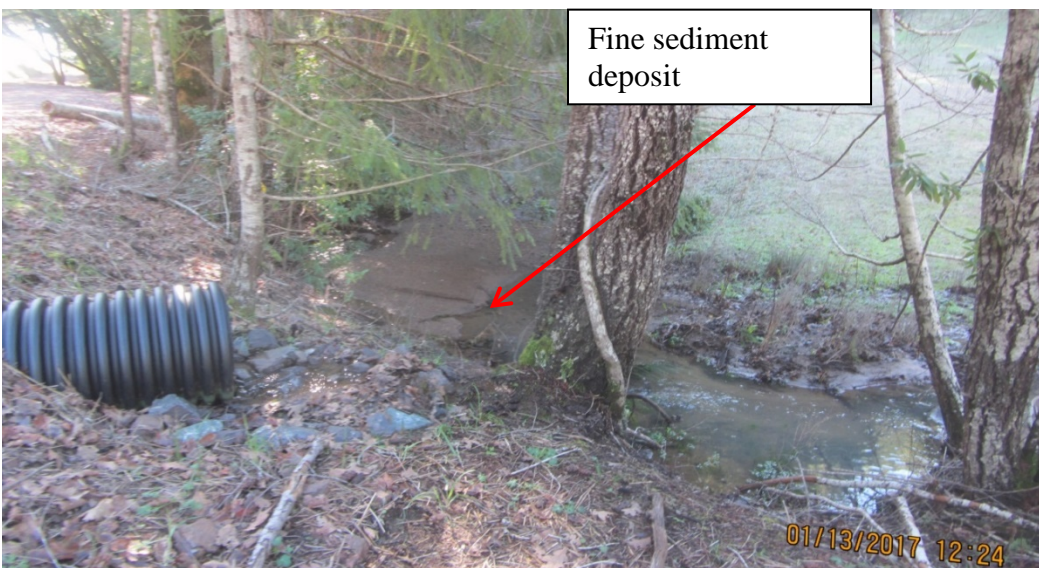
The image of the outlet of Stream Crossing 3 below shows the amount of fine sediment observed in stream channels associated with the recently constructed/reconstructed access road. The inside ditches and connection to the recently graded and ditched vineyard area appear to be generating large volumes of surface erosion visible as sediment deposits in stream depositional areas.

Image 21 shows the outlet of Stream Crossing 3 and an example of instream fine sediment deposited upstream of the culvert outlet. The observation is of background fine sediment loading in the stream flowing from the developed vineyard, and not one associated with the functionality of this culvert. (IMG 3014-3015 stitch)

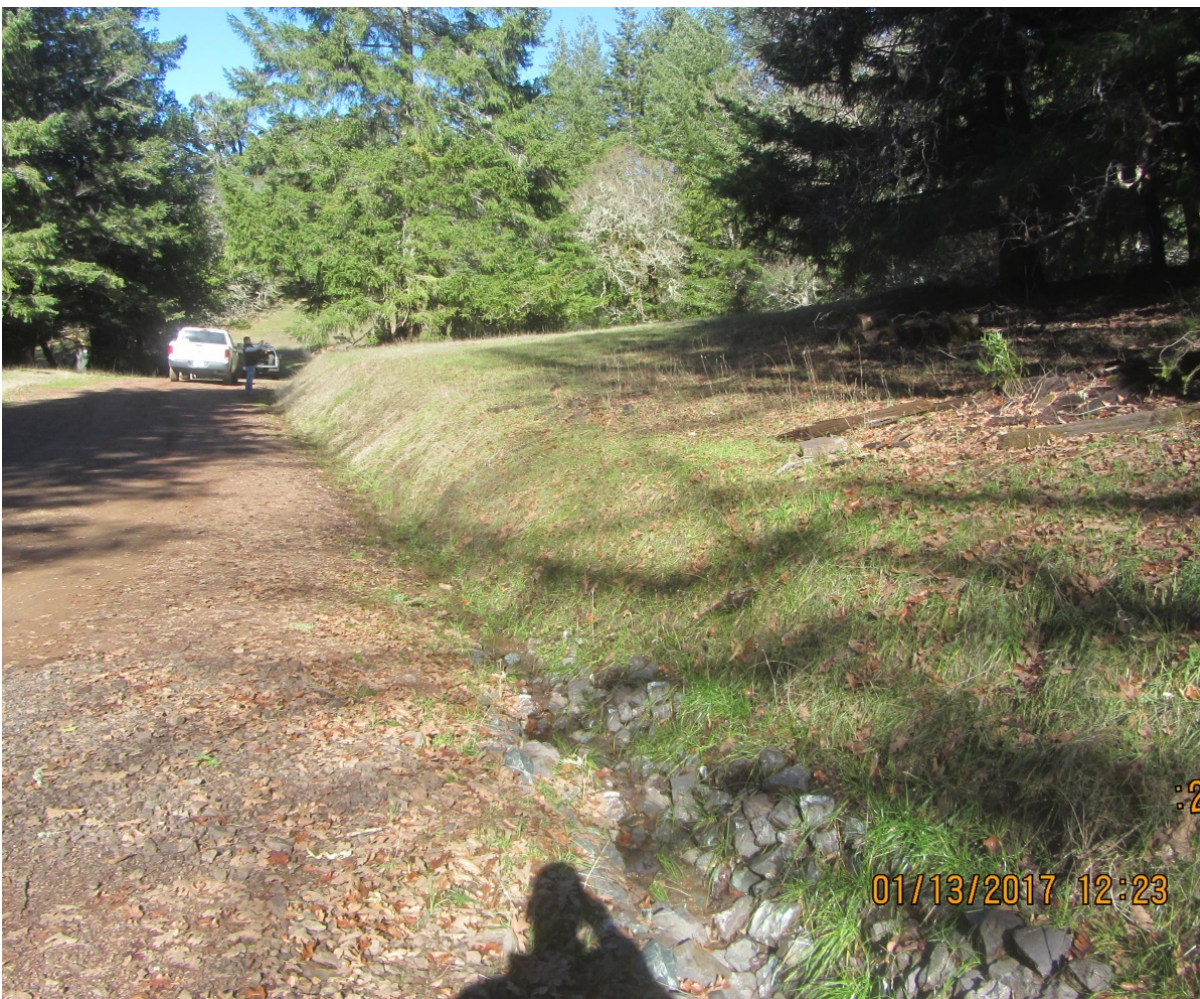
Image 22 shows the inside ditch along the access road near stream crossings 2 and 3. (IMG 3008-3009-3010 stitch)

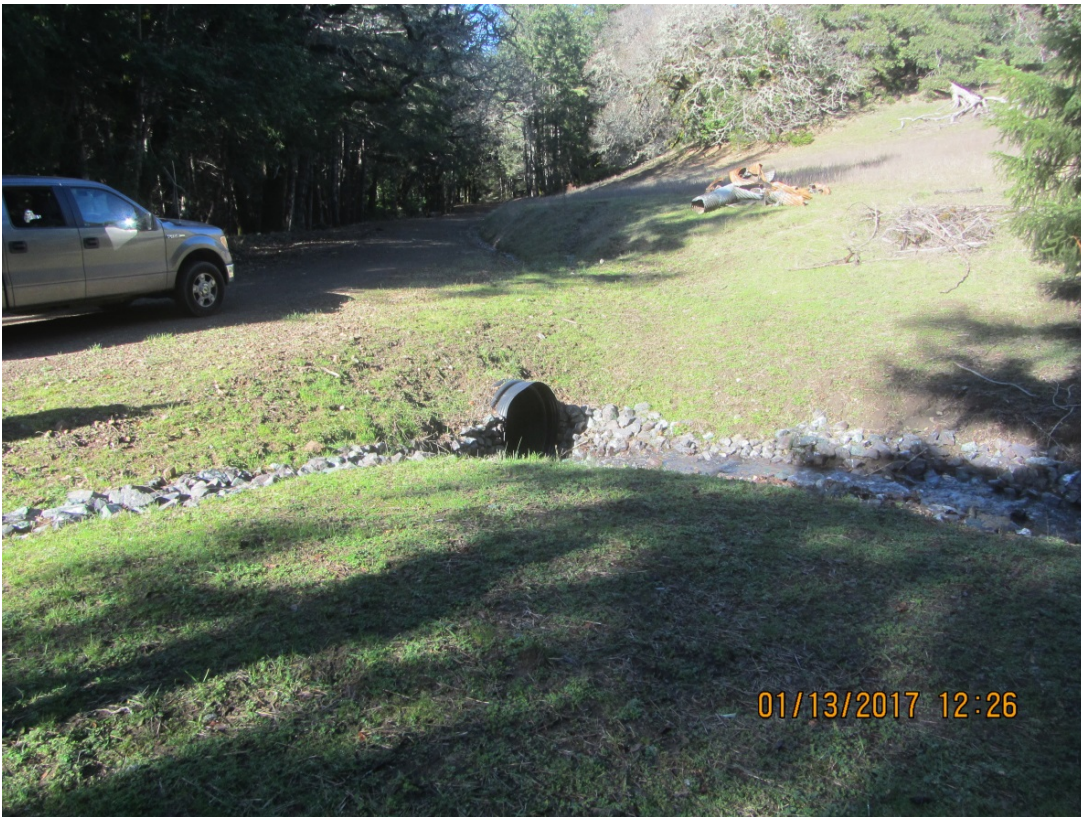
Image 23 shows the inside ditch along the access road delivering to the inlet of Stream Crossing 4. (IMG 3019)

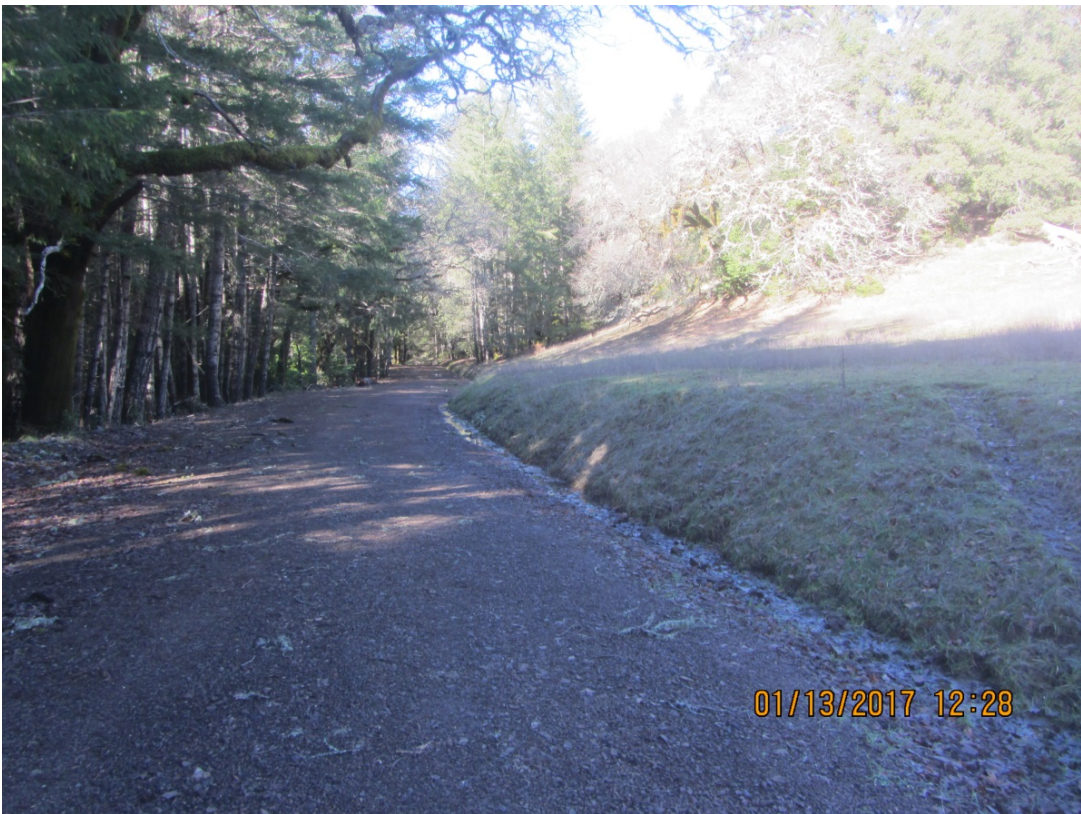
Image 24 shows the inside ditch North of Stream Crossing 4 – note the long length of uninterrupted ditch capturing road surface runoff. (IMG 3027)

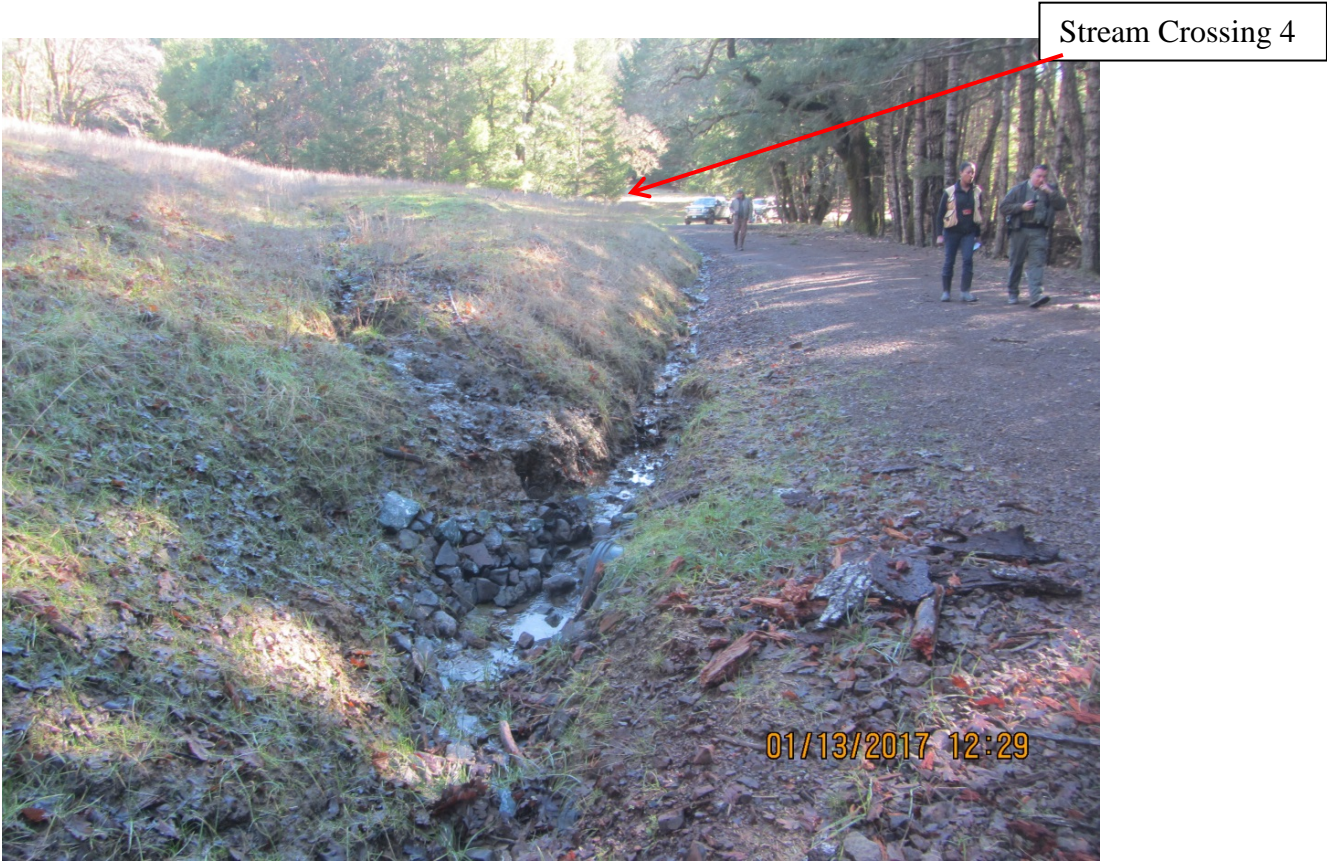
Image 25 shows the inside ditch intercepting a Class III stream originating upslope from a meadow area. (IMG 3030)

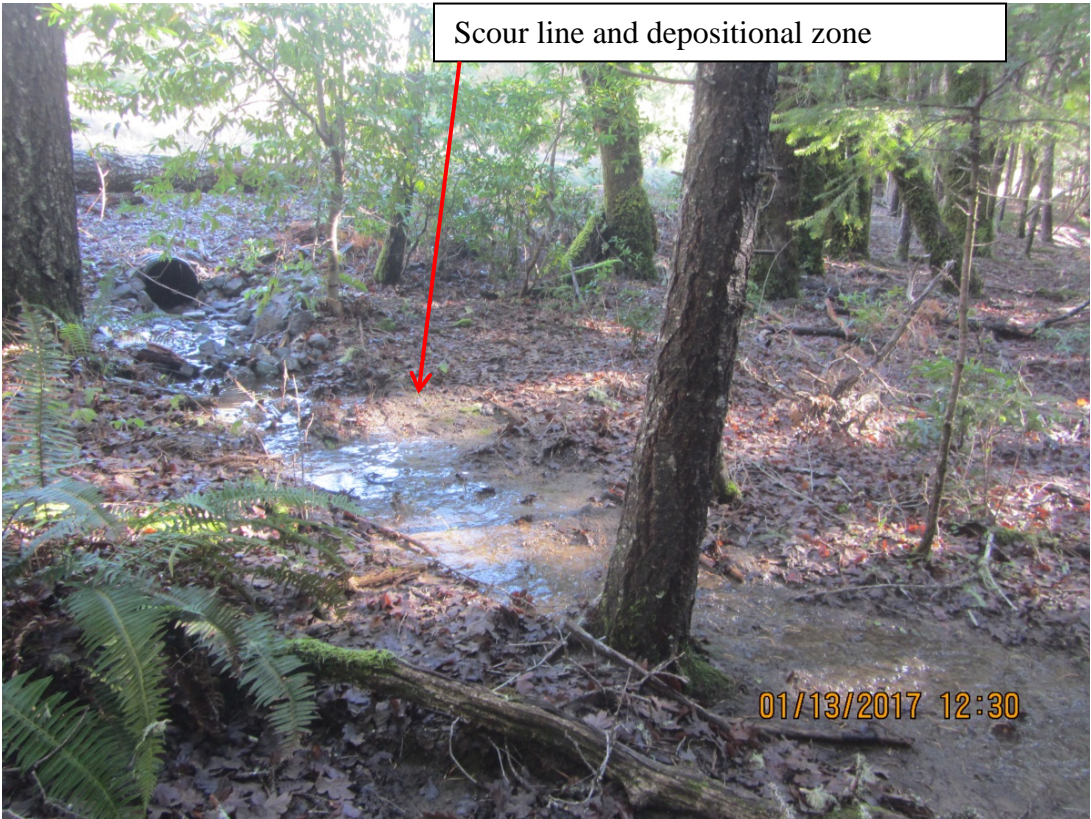
Image 26 shows the outlet of Stream Crossing 5; note the scour line from high flows and deposition of fine sediments along the stream margins. (IMG 3032)

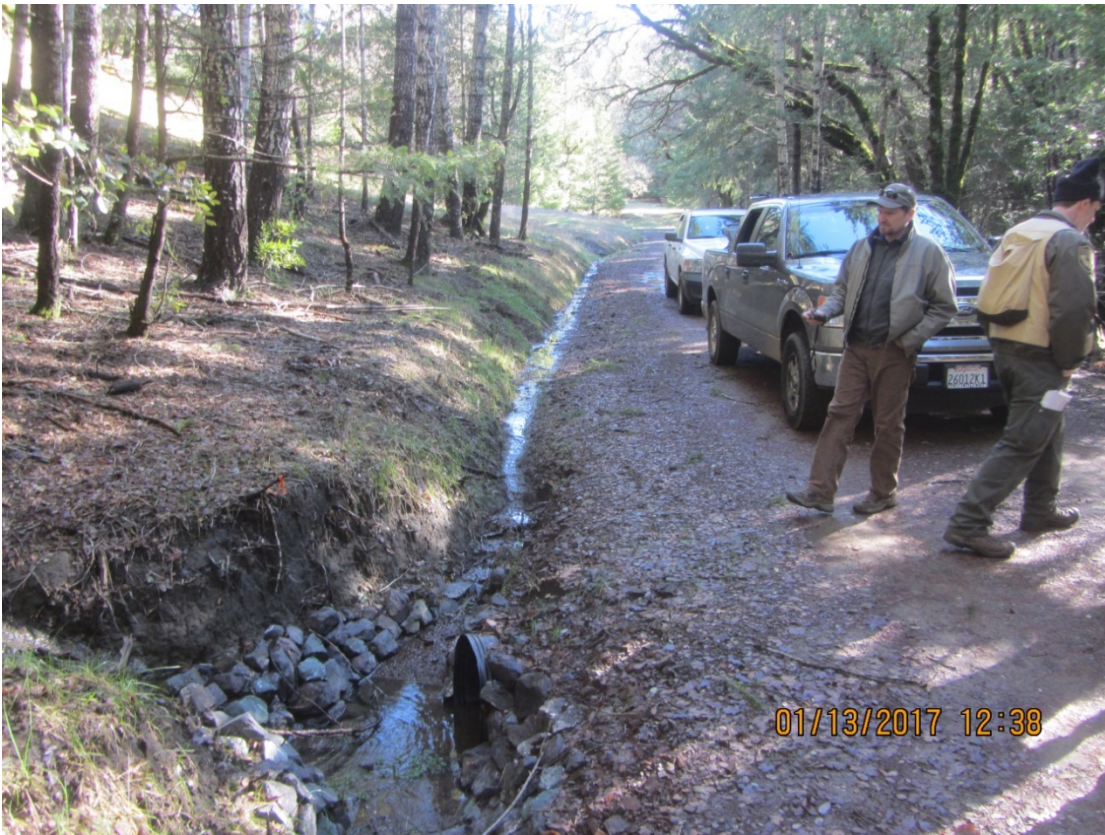
Image 27 shows the connection of the inside ditch to the stream at Stream Crossing 6. (IMG 3035)

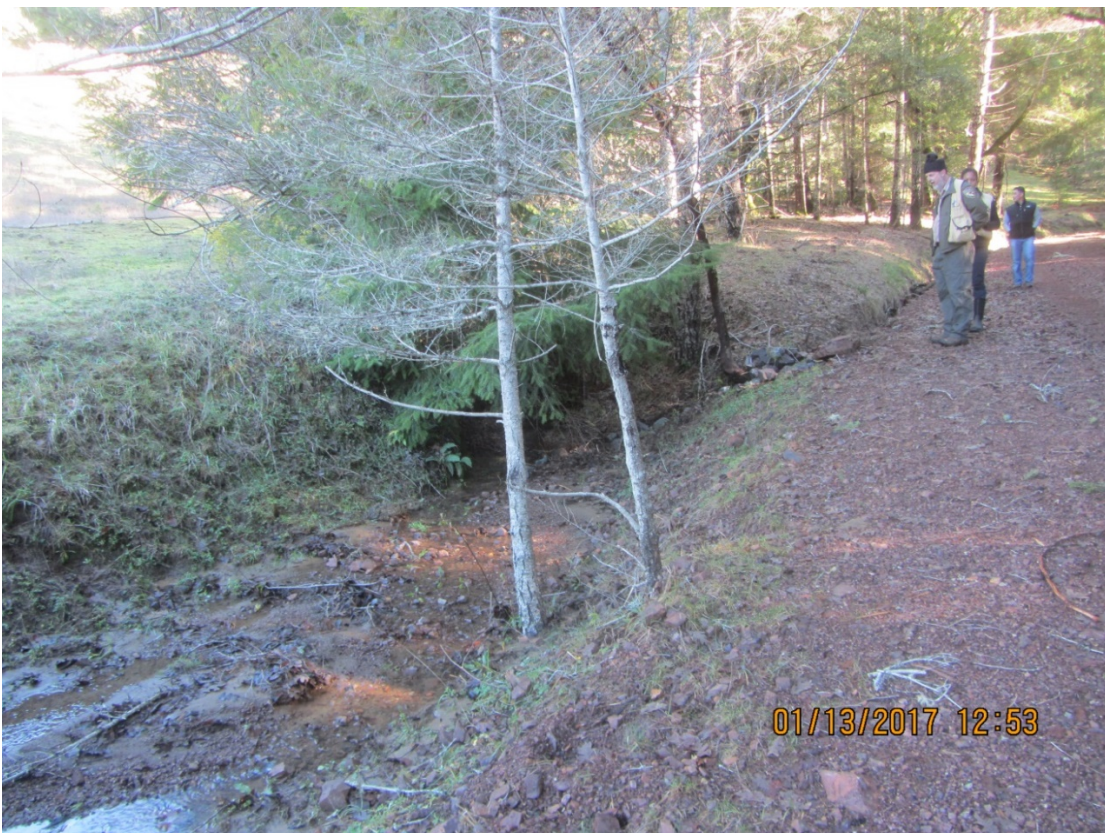
Image 28 shows the connection of an inside ditch and intercepted Class II/III stream to the outlet of Stream Crossing 7. Note the visible sediment deposits in the foreground of the image. (IMG 3044)

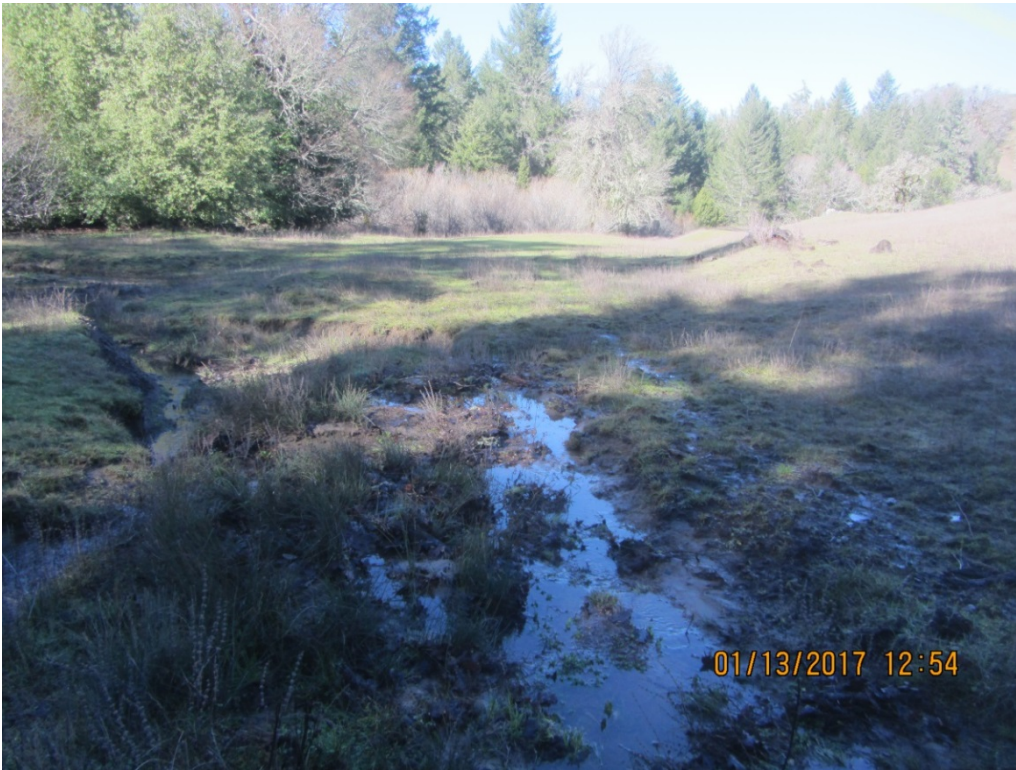
Image 29 shows the stream and ditch in Image 28 discharging to a Large Class II stream at the outlet of Stream Crossing 7. Note the sediment deposits throughout the flow path and along the margins of the stream flow. (IMG 3048)

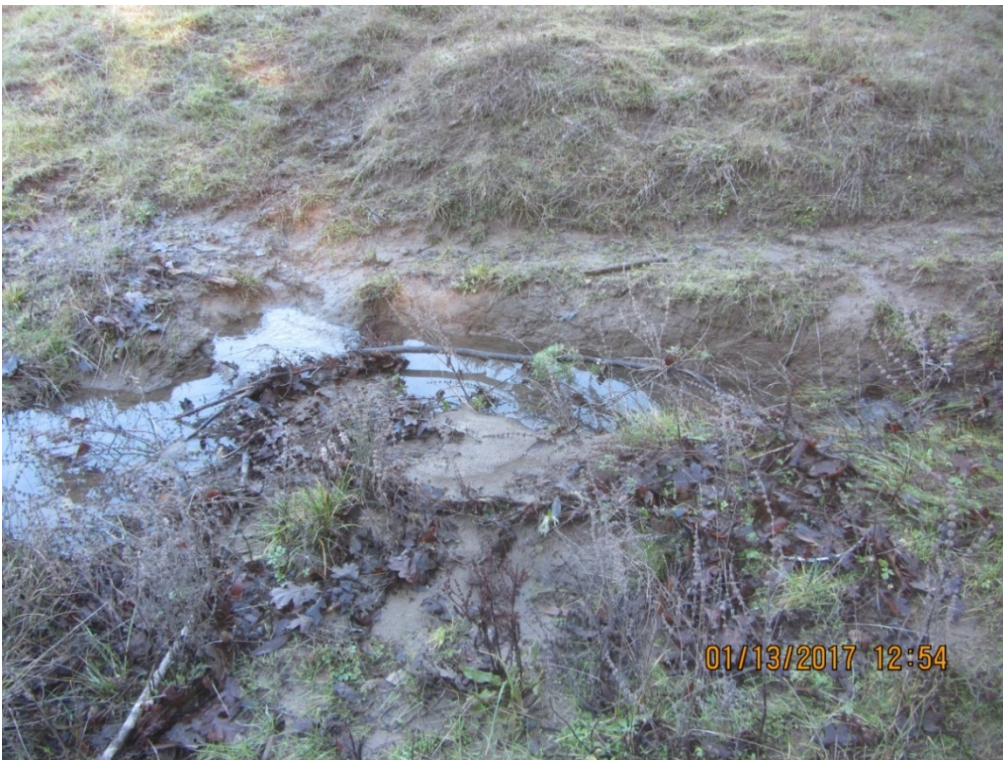
Image 30 shows a close up of the fine sediment deposits mentioned in the caption of image 29 preceding this image. These fine materials are transporting and delivering to the Class III stream intercepted by the inside ditch and to the Large Class II stream at Stream Crossing 7. (IMG 3047)

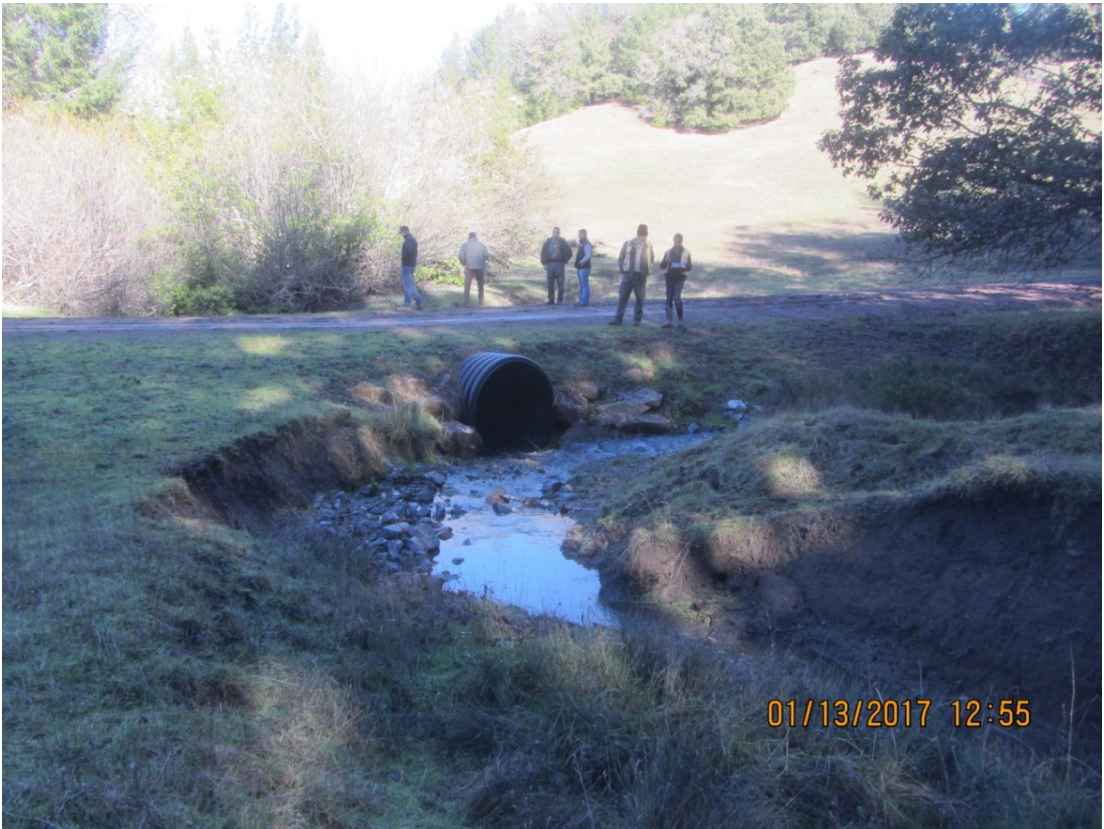
Image 31 shows the inlet of Stream Crossing 7. (IMG 3049)

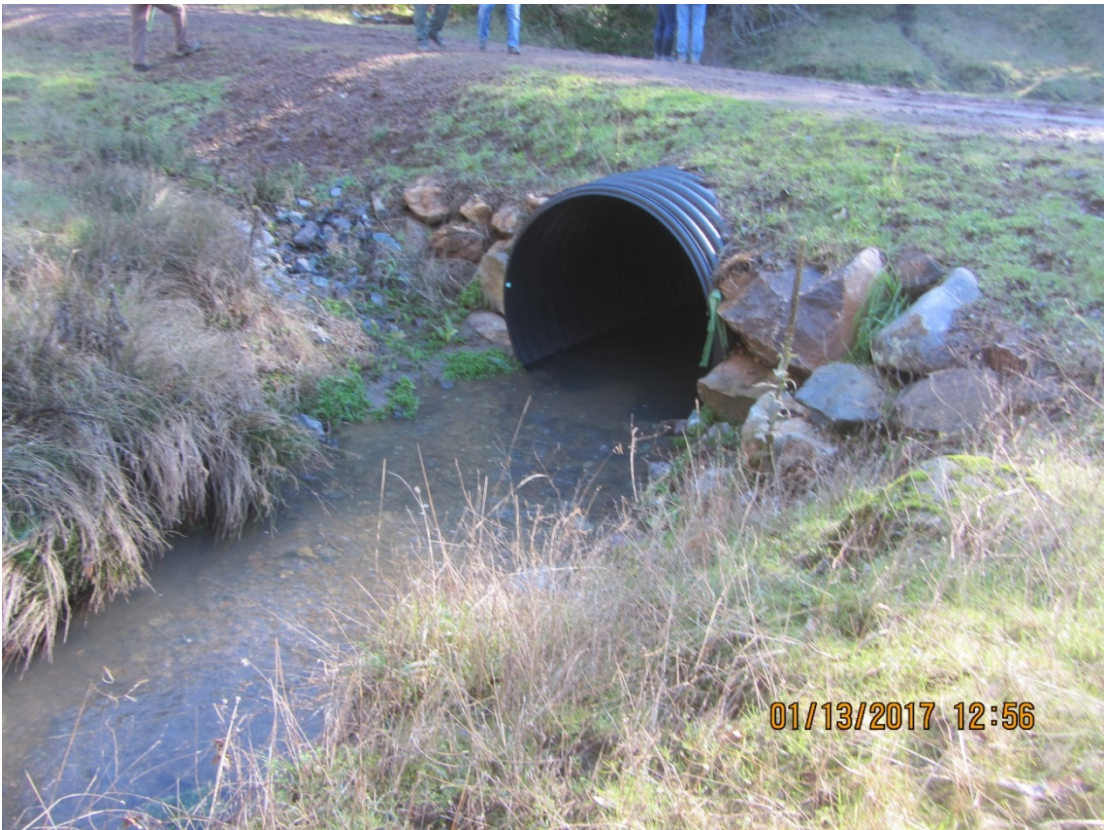
Image 32 shows the outlet of Stream Crossing 7, note the connection of the inside ditch and intercepted stream in the upper left hand corner of the image.
