Field Inspection Report

Name and Location of Facility Inspected	Rhys Vineyard, Clarke Ranch, 6501 Branscomb Road, Laytonville, CA		
Inspection Date & Time:	January 13, 2017 , 0800-1900 Travel time included	Mendocino County Assessor Parcel Numbers (APN)	015-050-061, 015-050-057, 015-050-056, 015-050-055, 015-050-050, 015 050-051, 014-300-019
Names & Titles of On-Site Representatives and Consenting Parties	Consent¹or Warrant		Notified of Inspection?
Javier Tapia Meza, Ken Seckora	Consent Inspection		<input checked="" type="checkbox"/> YES
Property Owner(s):	Rhys Vineyards LLC		
Physical Address:	6501 Branscomb Road, Laytonville, CA.		
Mailing Address:	11715 Skyline Blvd., Los Gatos, CA 95033		
Property Representatives Present:	Randy Jacobszoon, Registered Professional Forester		
Report Prepared By:			
Stormer Feiler, Senior Environmental Scientist Specialist (SES), North Coast Regional Water Board (RWB)			
Report Reviewed By:

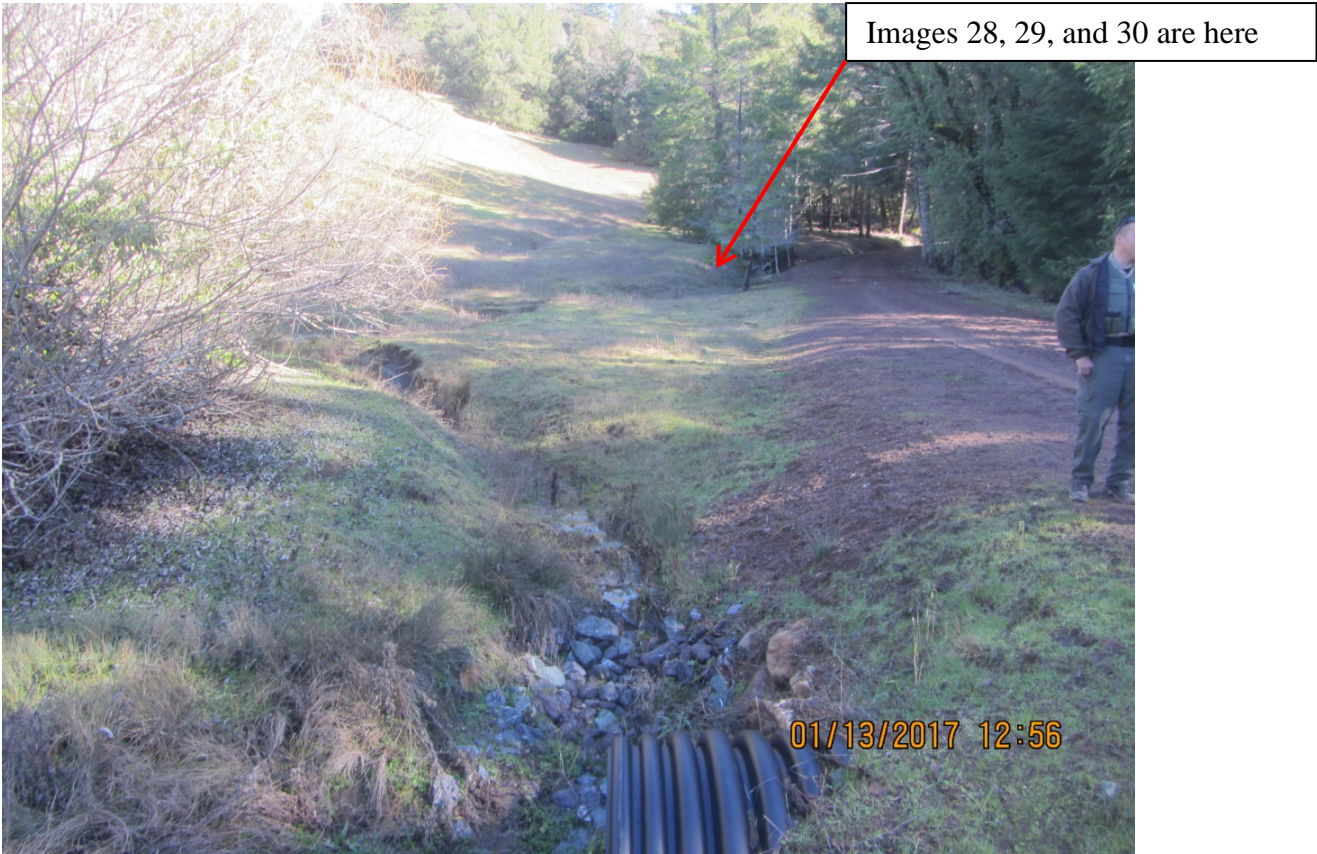
Image 33 shows the inside ditch and intercepted stream leading to the culvert outlet of Stream Crossing 7 in image 32 above. (IMG 3053)

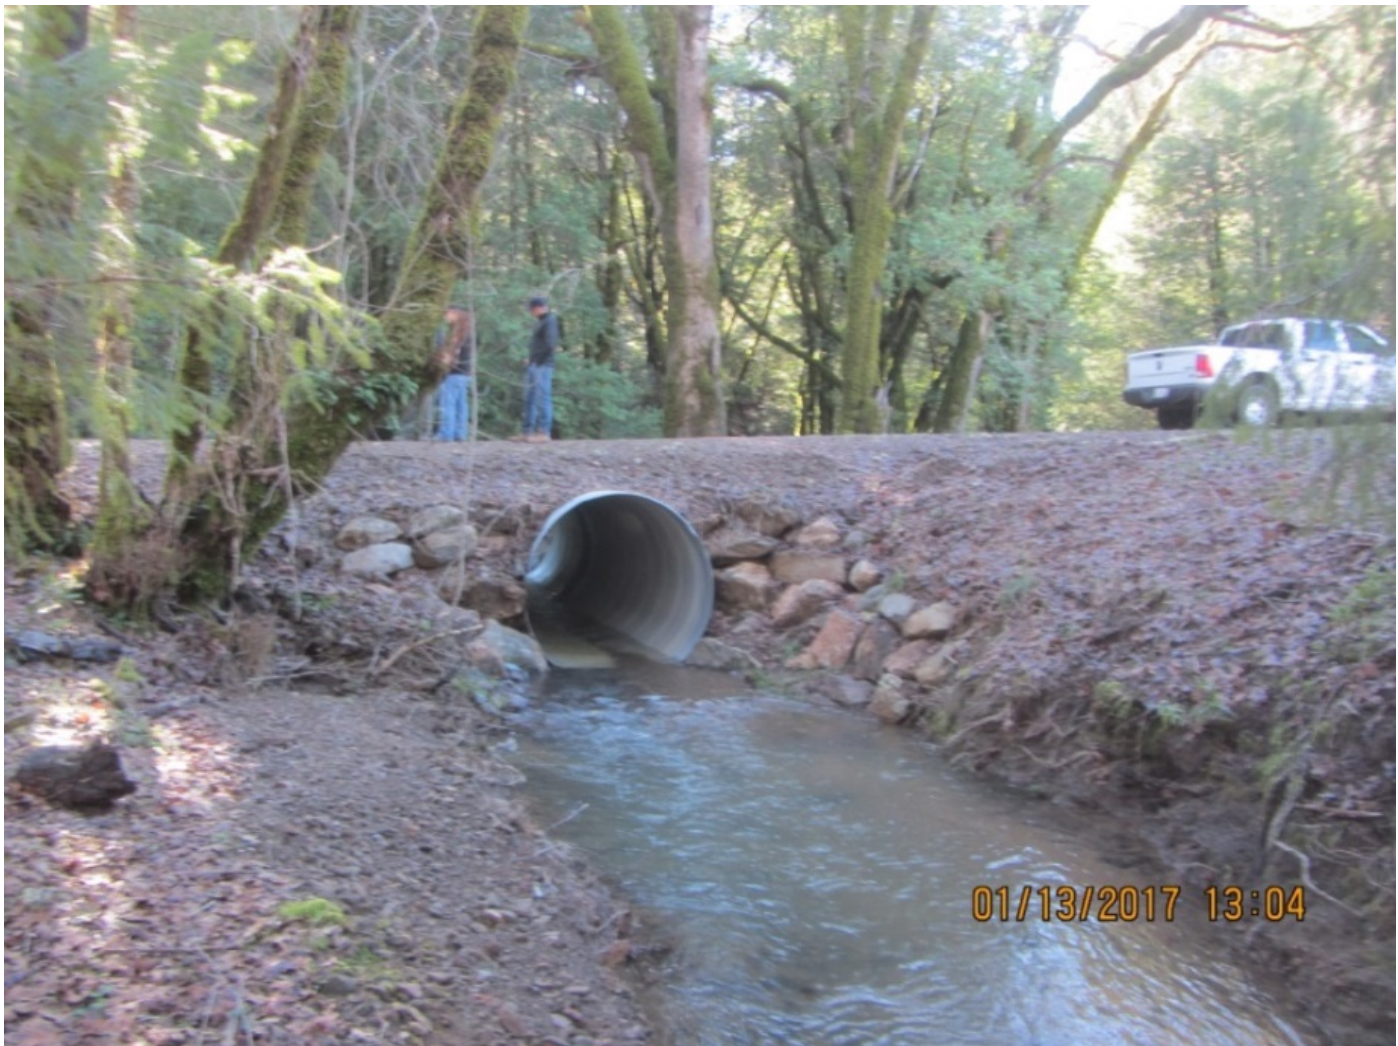
Image 35 shows the outlet of Stream Crossing 8. (IMG 3056)

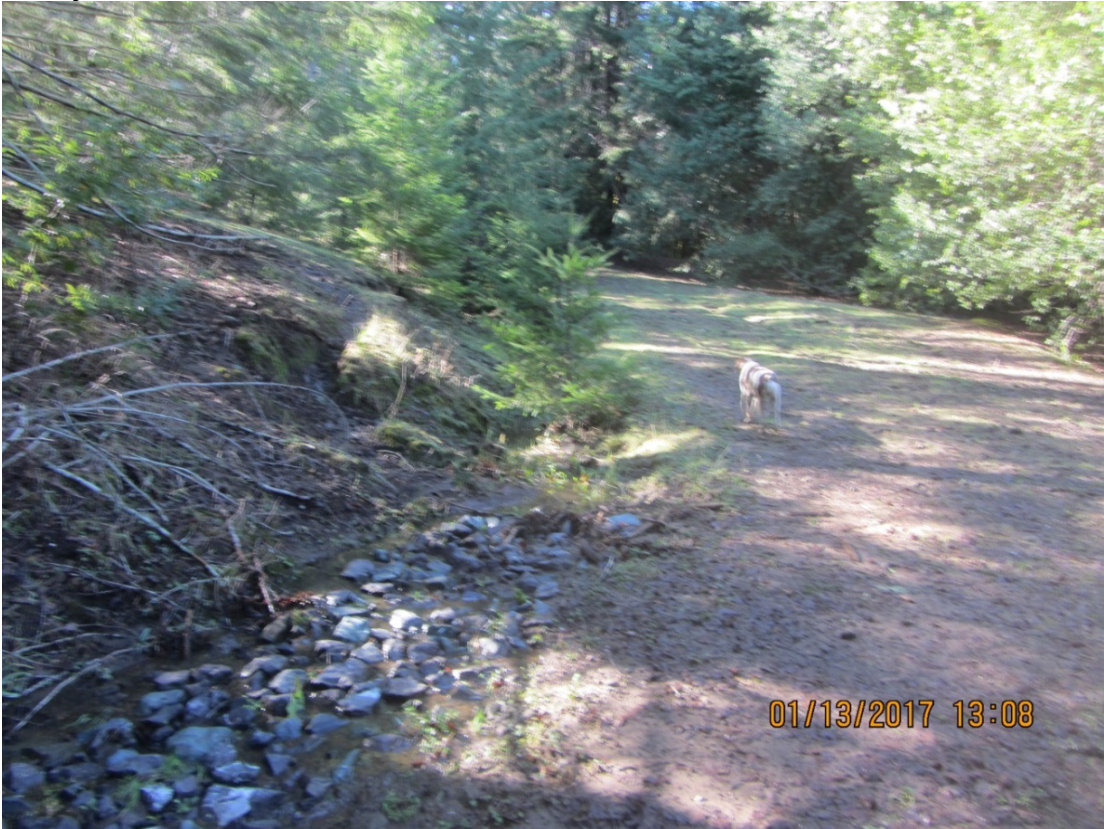
Image 37 shows the Class II stream diverted down the inside ditch of the road west of Crossing 9. (IMG 3064)

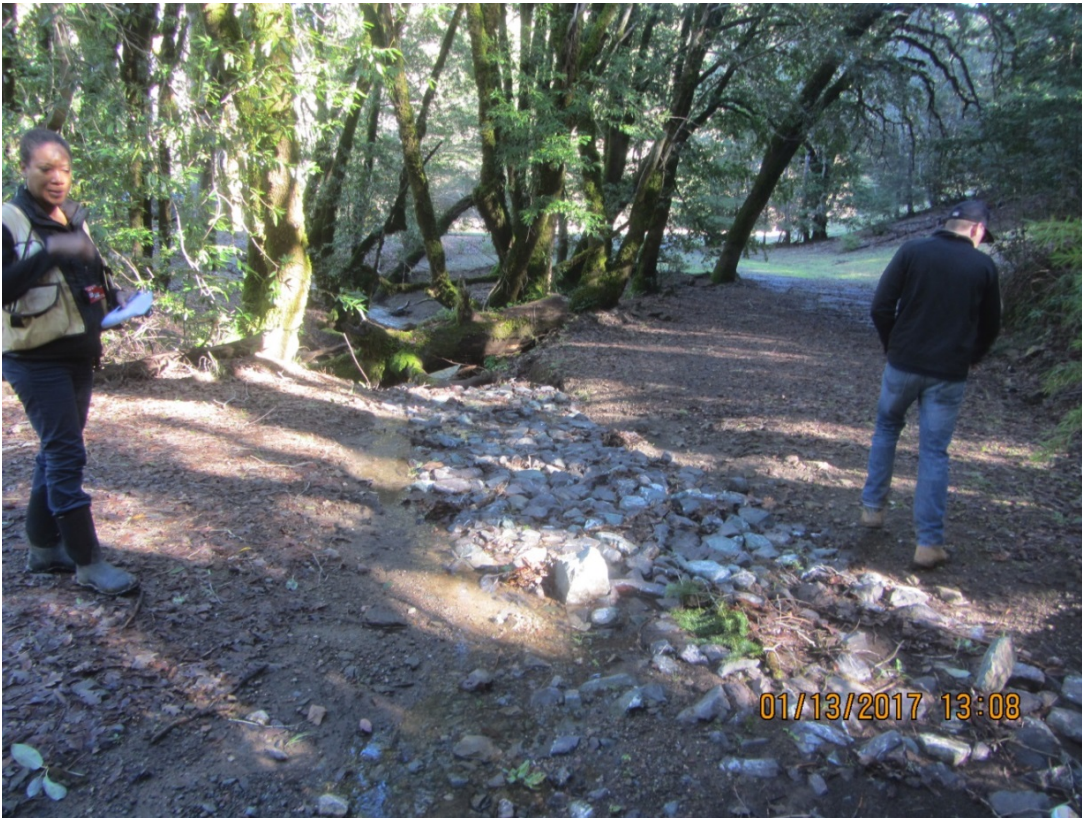
Image 38 shows the Class II stream diversion crossing the road in a shallow ford (installed subsequent to the 2015 inspection,) and the stream diversion leading to the flat that then flows into the inlet of Stream Crossing 8. (IMG 3065)

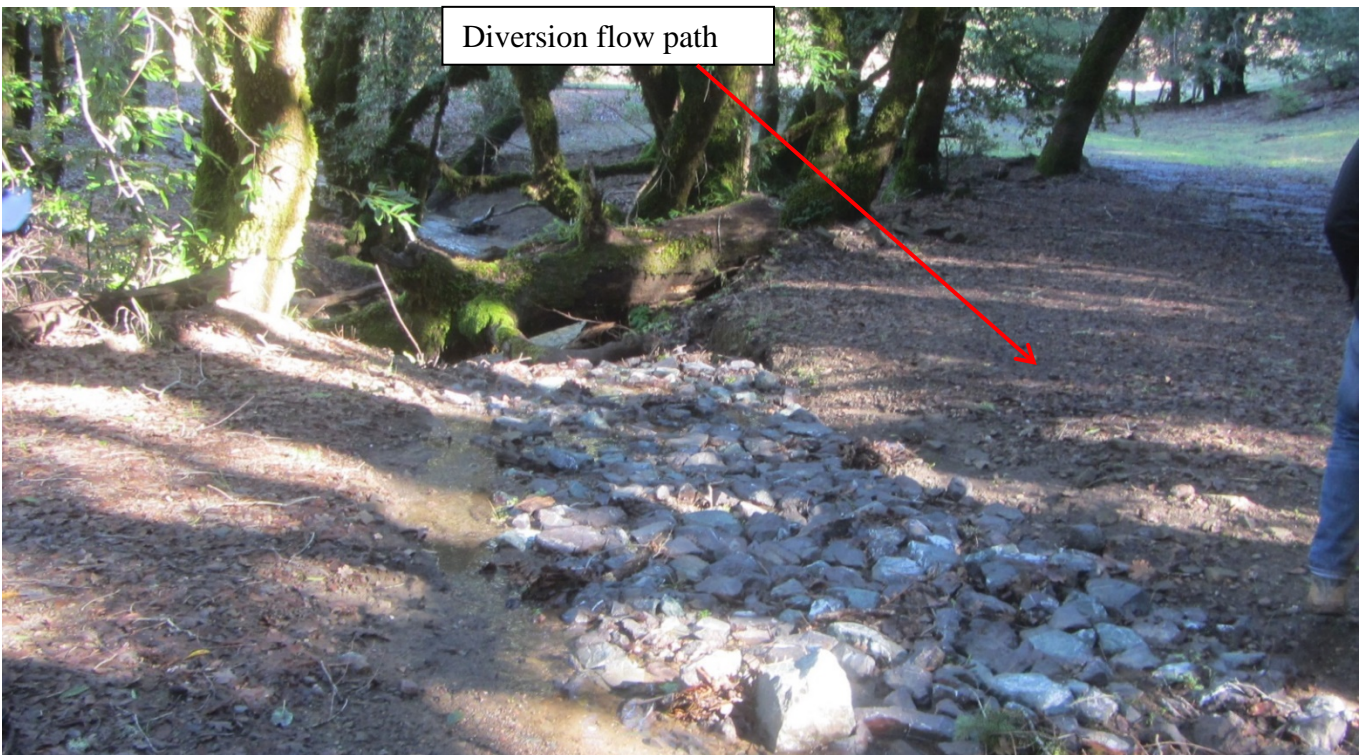
Image 39 shows a closer view of the shallow ford and the diversion of flows out of the channel and down the road surface to the flat area in the far right of the image. (IMG 3065 cropped)

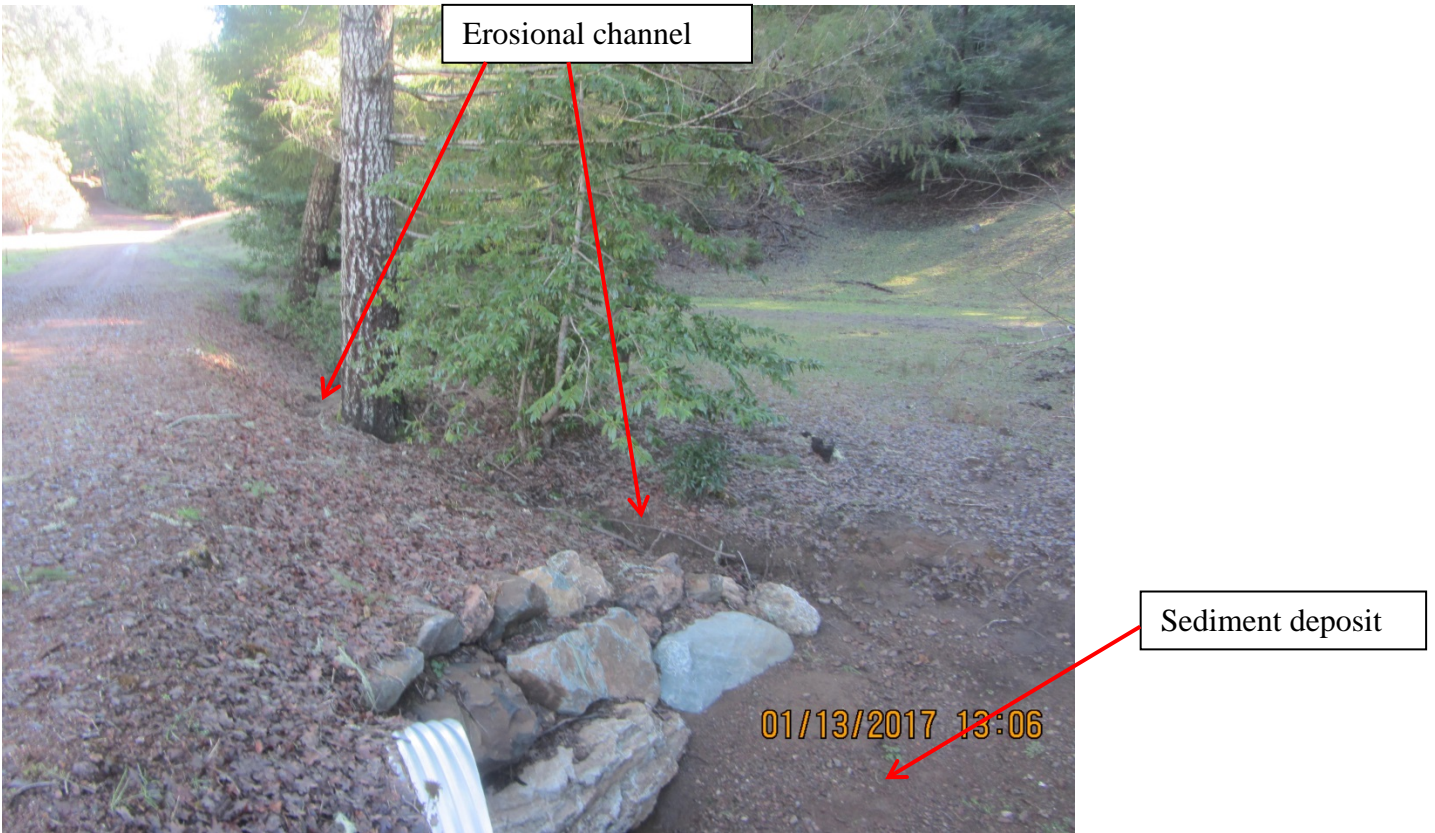
Image 40 shows the flat and the erosional channel off the flat at the inlet of Stream Crossing 8. (IMG 3059-3060 Stitch)

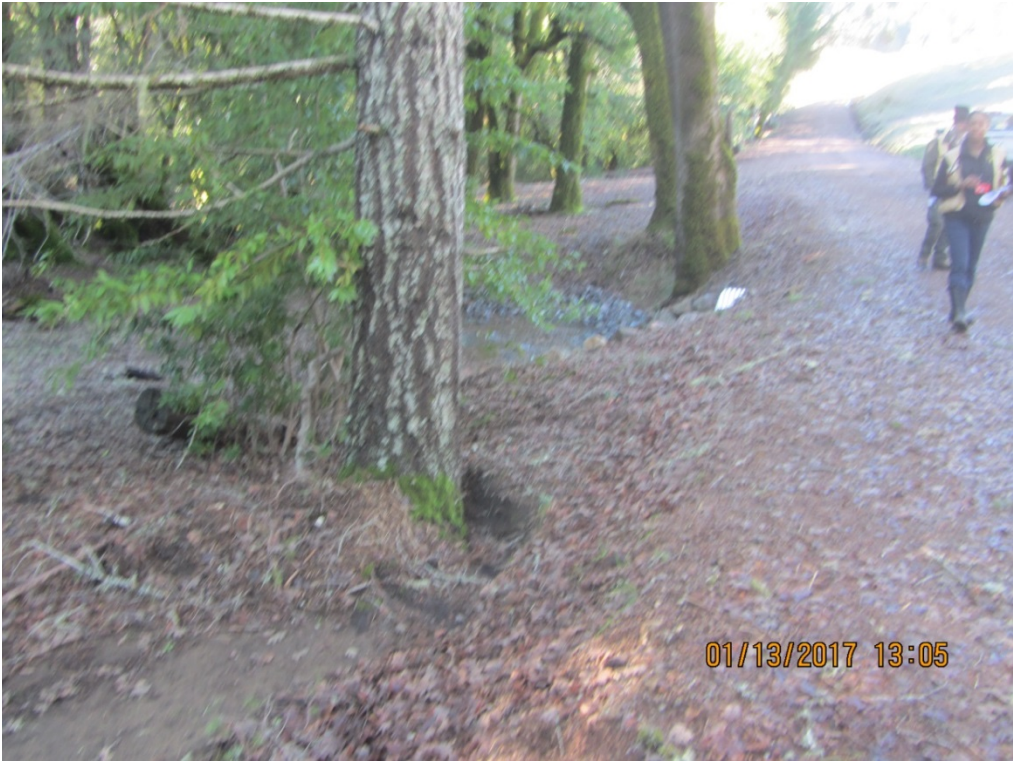
Image 41 shows the erosional channel off the flat as it is leading to the inlet of Stream Crossing 8. (IMG 3058)

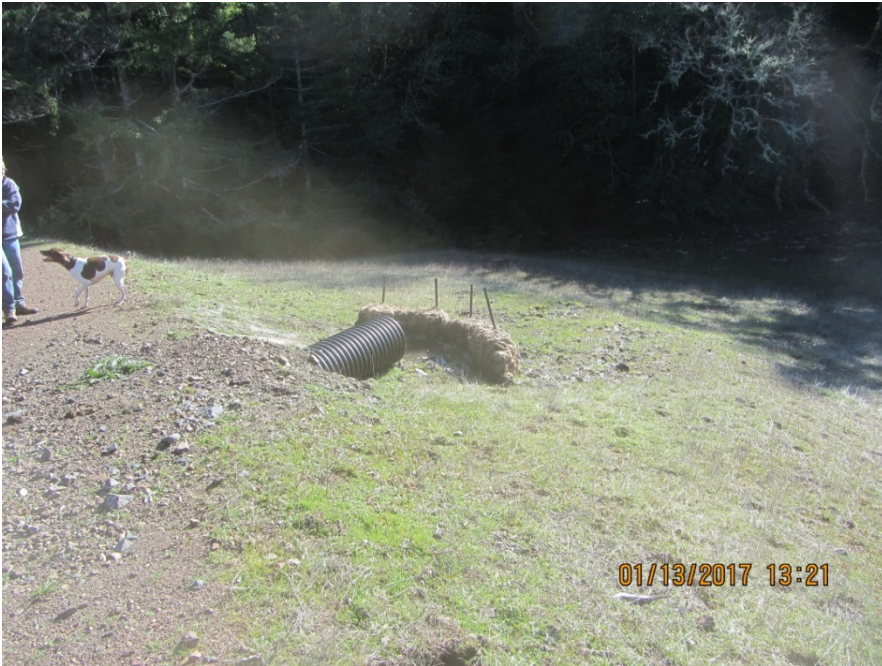
Image 42 shows the outlet of Stream Crossing 10 which is a ditch relief culvert installation on the recently constructed/reconstructed access road; the culvert was installed to relieve the inside ditch drainage; the outlet discharge, onto an open meadow slope, has been mitigated with hay bales placed to disperse flows. This type of installation will require regular seasonal monitoring and maintenance and may result in erosion of the meadow slope over time. (IMG 3068)

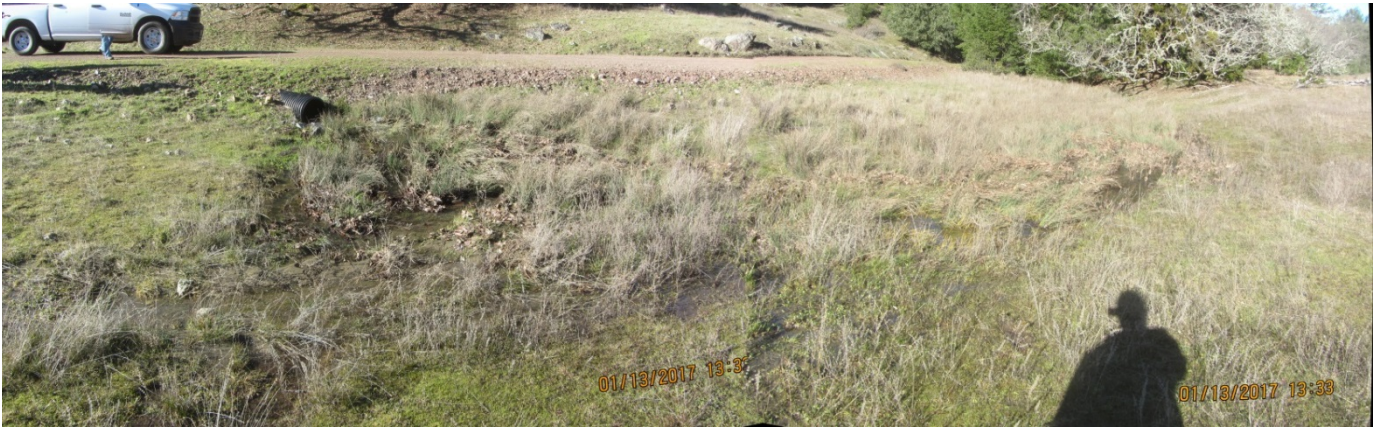
Image 44 shows the outlet of Stream Crossing 12; note the flows from the culvert outlet support a wetland. (IMG 3076-3080 stitch)

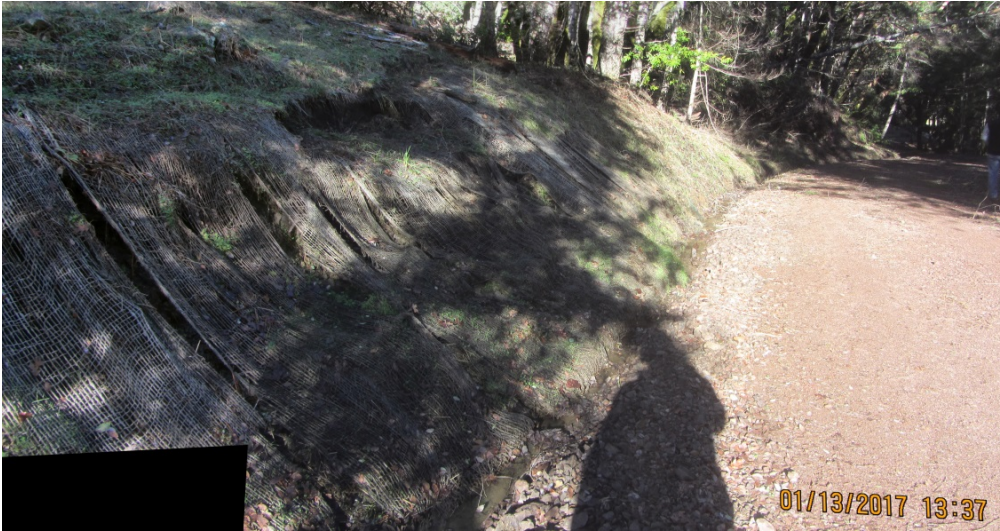
GPS Points 13-15 identify three ditch relief culverts relieving the inside ditch along a road segment that parallels a Class II stream. The cut bank of the road upslope of ditch relief crossing 14 is unstable and failing. Each outlet was delivering sediments to the stream during the inspection. Above Crossing 14, the unstable cut bank slope was treated with jute netting, and the slope was visibly failing; the slope failure is likely to pose a potential plugging problem for the inside ditch and to increase the delivery rate of sediment to the stream through the inside ditch connection to the failing slope and the stream.

Image 46 shows the failing cut bank treated with jute netting. (IMG 3085-3086 stitch)

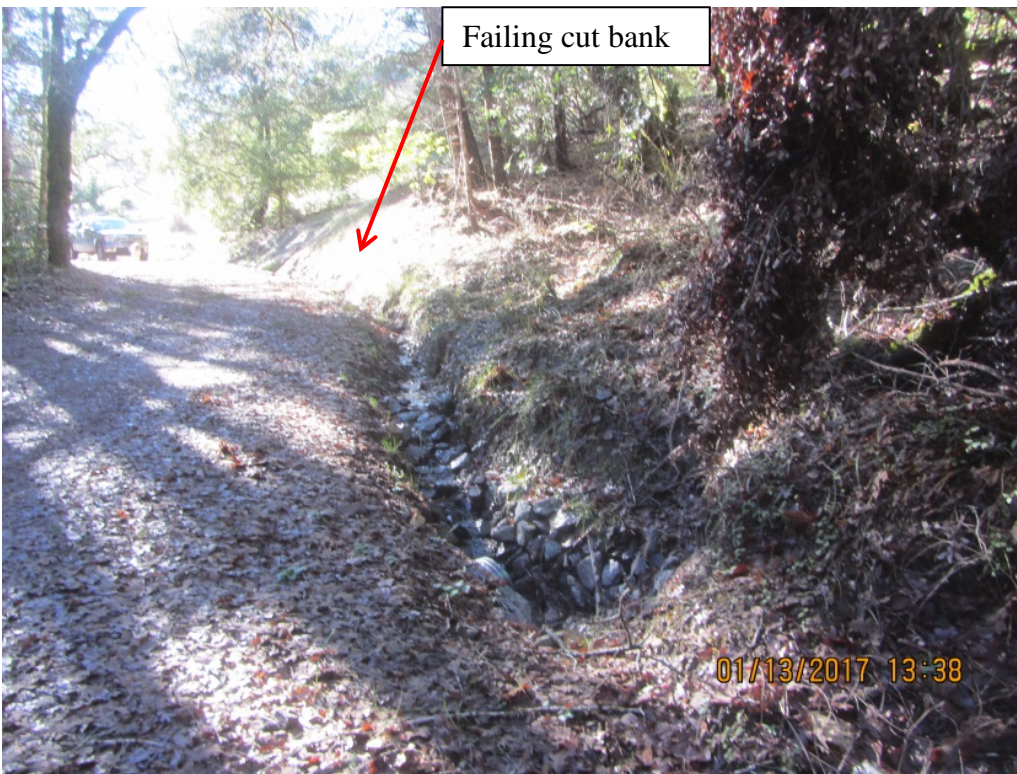
Image 47 shows the inside ditch and the failing cut bank connection. This ditch relief culvert corresponds to Crossing 14 in table 1. (IMG 3088)

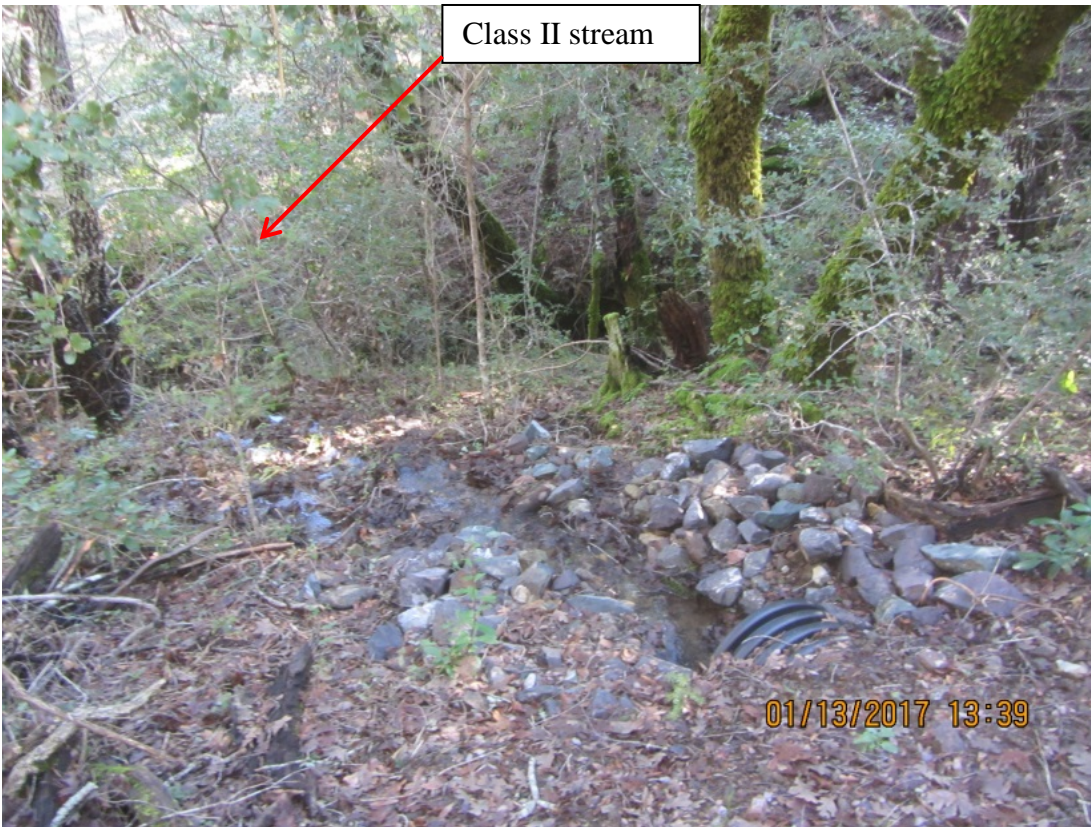
Image 48 shows the outlet of the ditch relief culvert at Crossing 14. (IMG 3089)

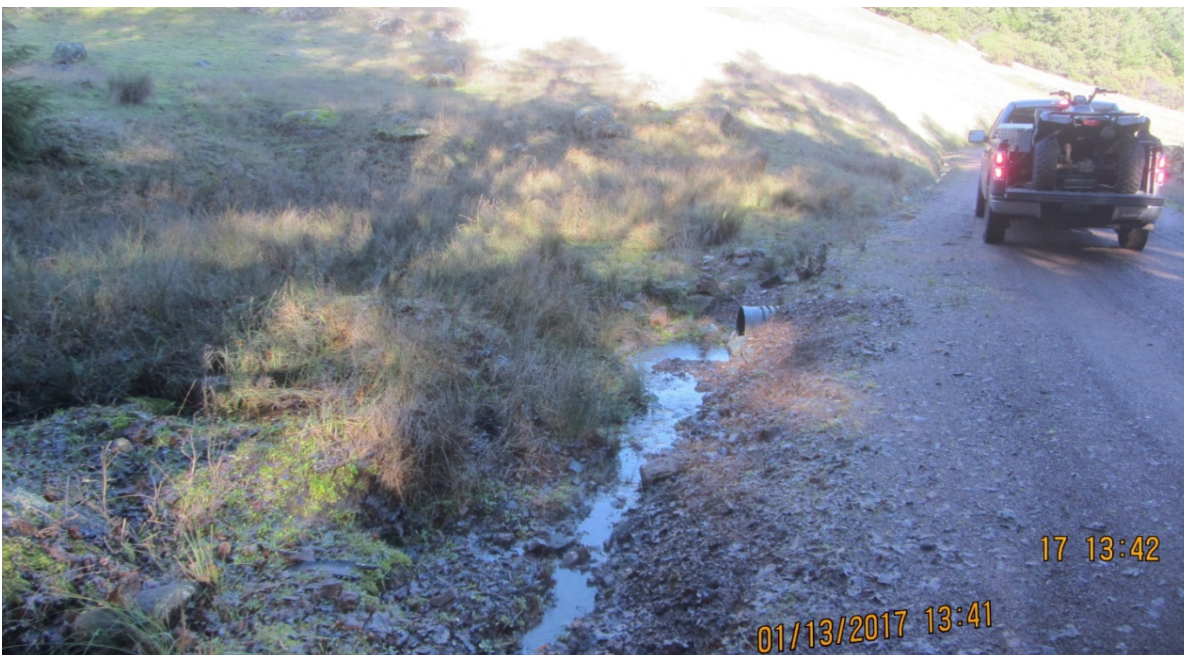
Image 49 shows Stream Crossing 16 inlet; note the connection of the inside ditch along the road to the culvert inlet. The road is constructed through a wetland in this location. (IMG 3092-3094 stitch)

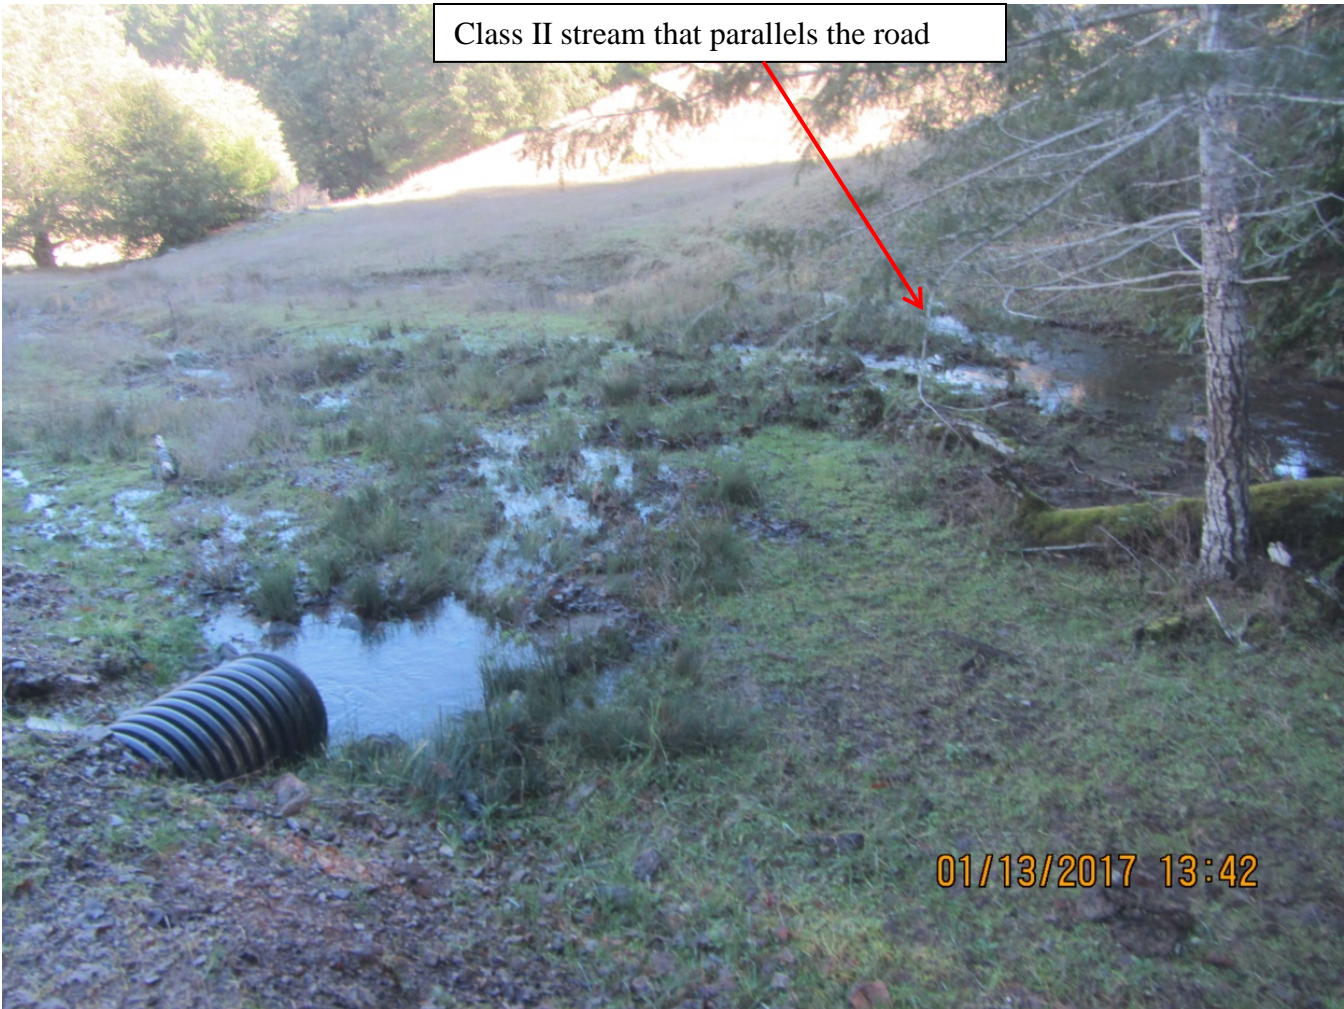
Image 50 shows the outlet of Crossing 16, note the heavily grazed juncus and spread of water through wetland vegetation. (IMG 3097)

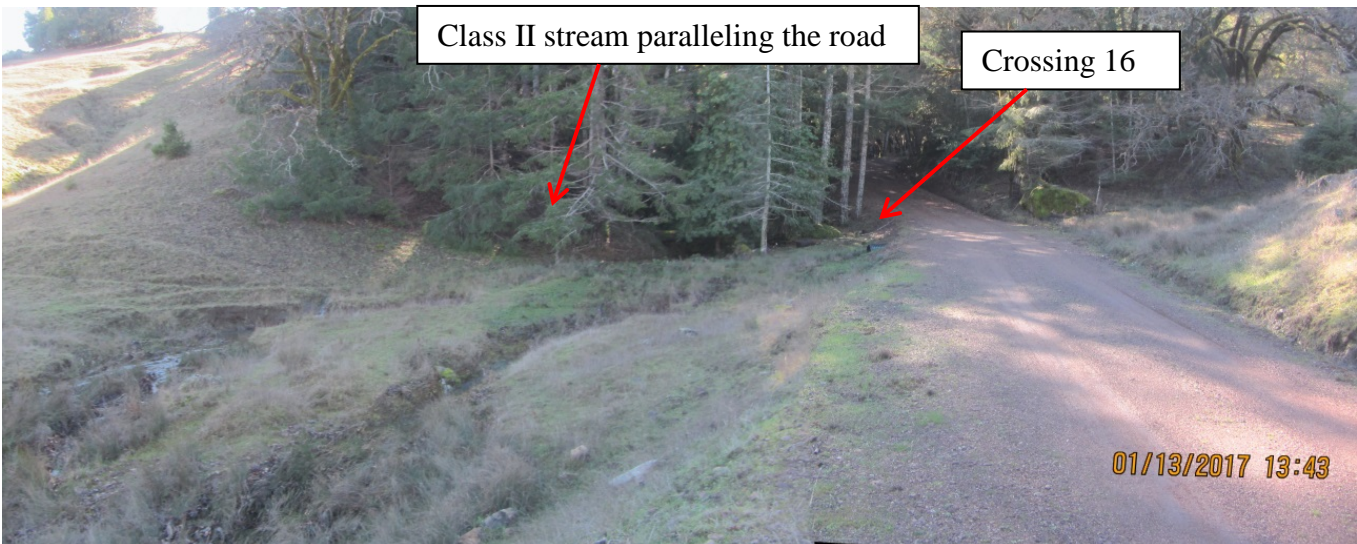
Image 51 shows the Stream Crossing 16 wetlands and the Class II stream that parallels the access road. (IMG 3103-3104 stitch)

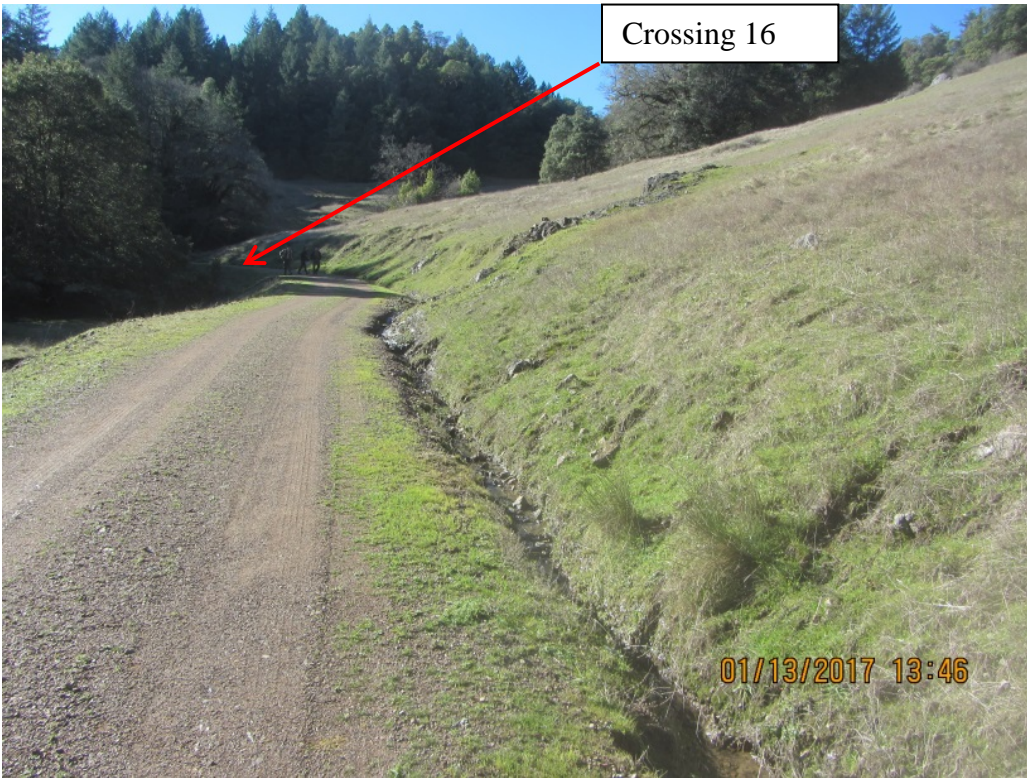
Image 52 shows the long extent of inside Ditch leading from Crossing 16 to an unstable cut bank above Ditch Relief Crossing 17. (IMG 3105)

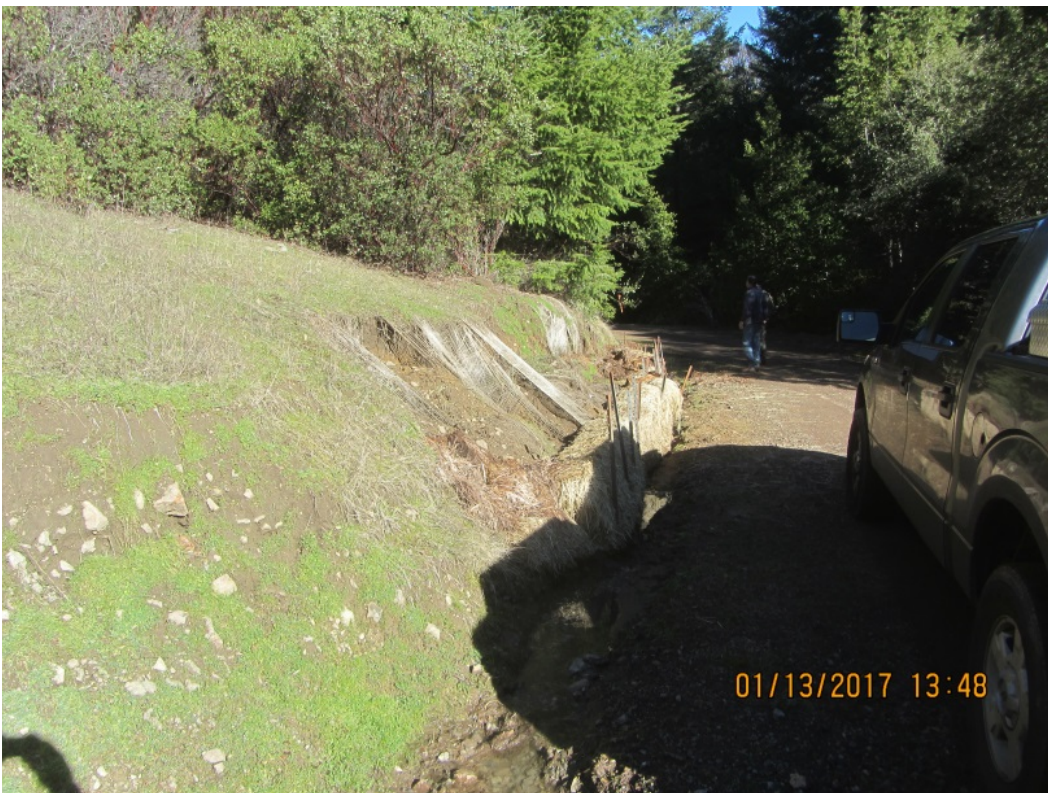
Image 53 shows one of several unstable cut banks on the approach to Stream Crossing 17. (IMG 3106)

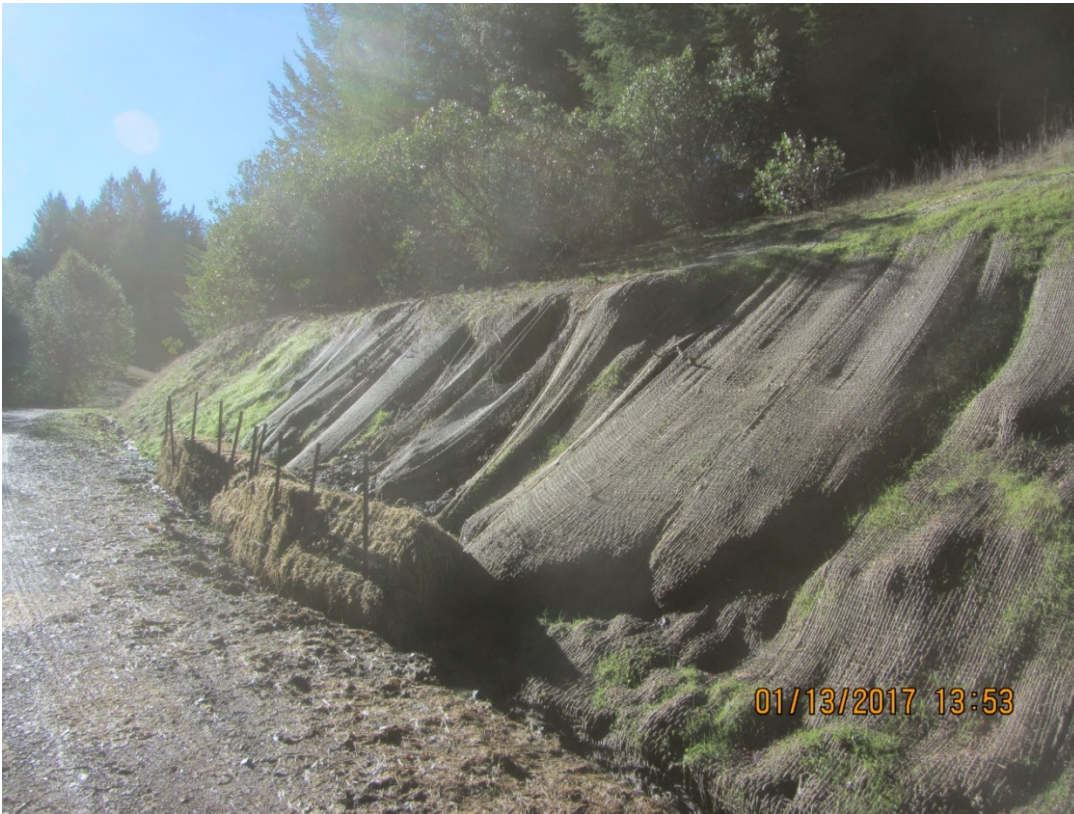
Image 54 shows the top of the second unstable cut bank on the approach to Stream Crossing 17. (IMG 3112)

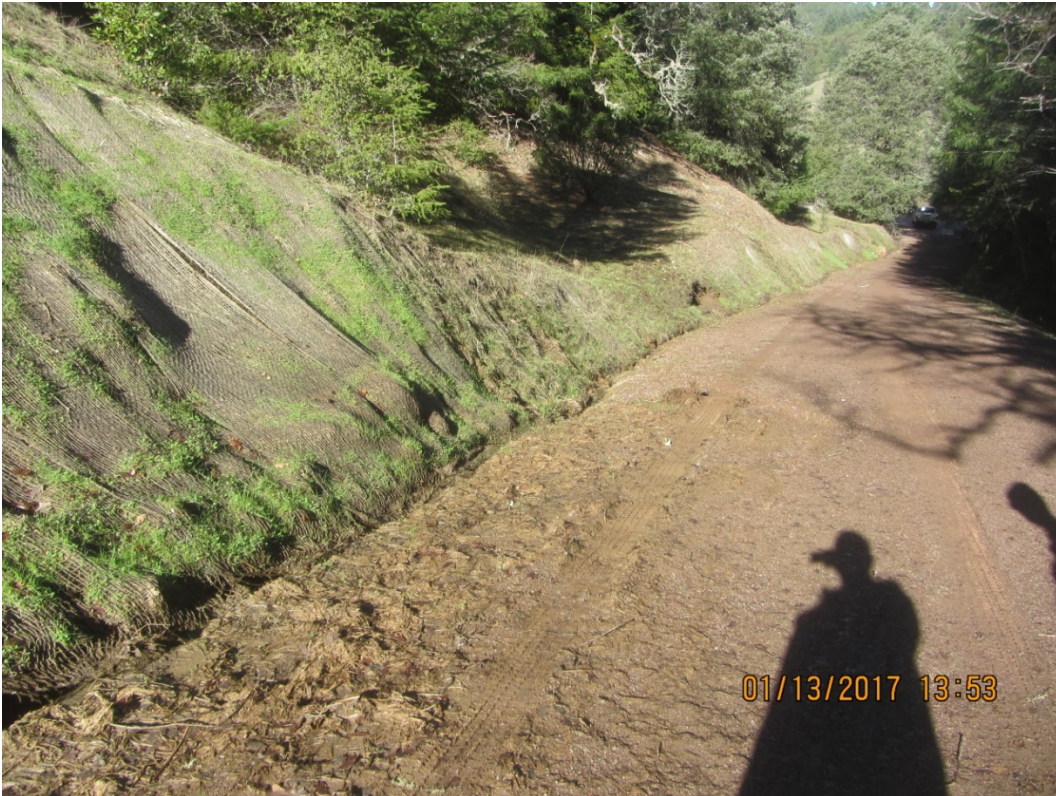
Image 55 shows a series of unstable cut banks on the approach to Stream Crossing 17. Note the long unbroken stretch of inside ditch. The truck in the distance is parked at the crossing.(IMG 3113)

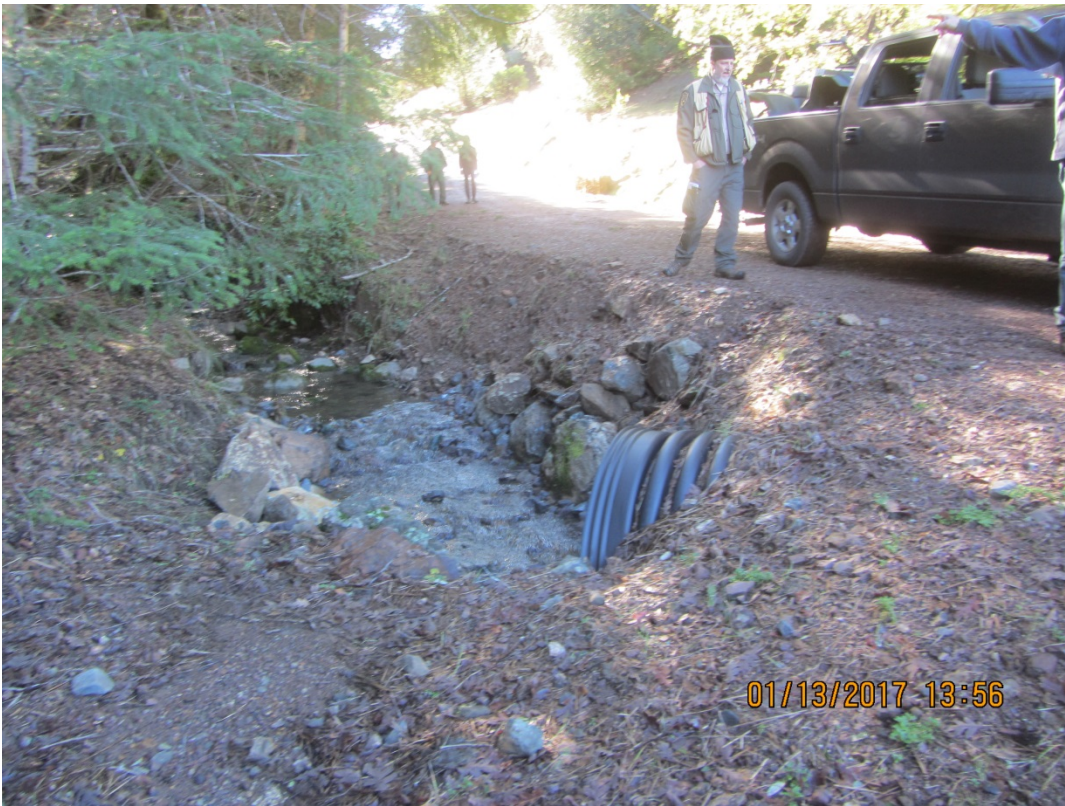
Image 56 shows the inlet of Stream Crossing 17 note the poor alignment of the inlet and the unstable cut bank in the background. (IMG 3117)

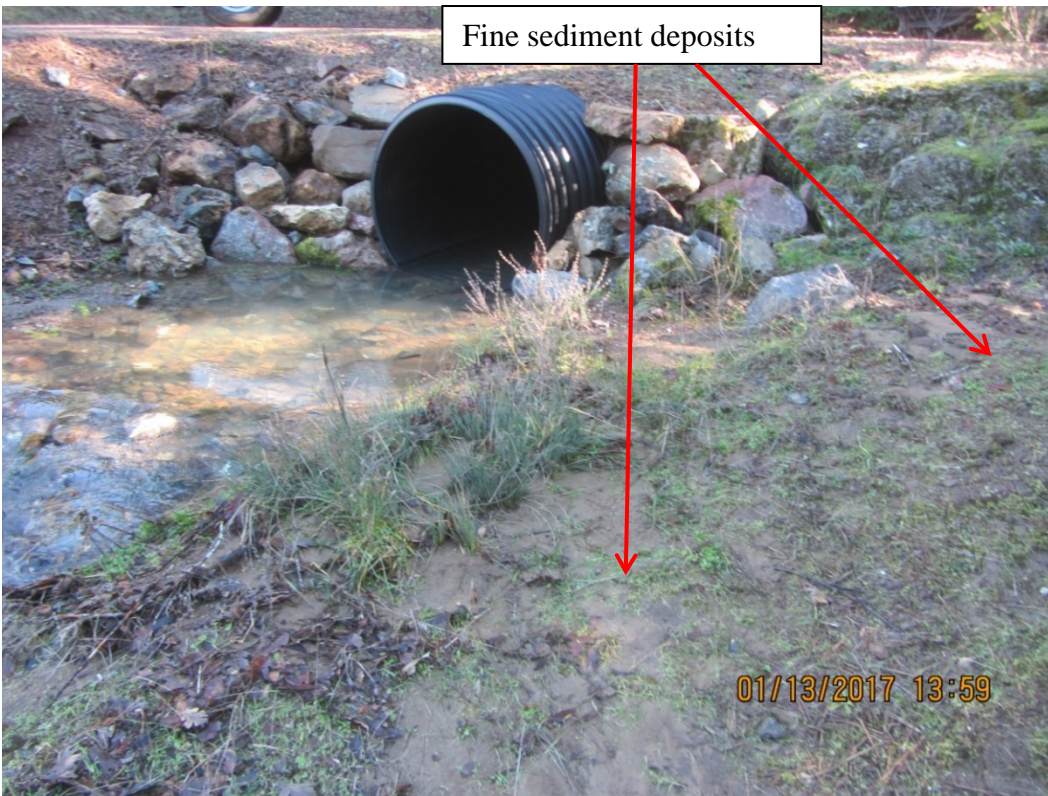
Image 57 shows the Stream Crossing 17 outlet; note the fine sediment deposits from road surface runoff and the active high flow channel. (IMG 3126)

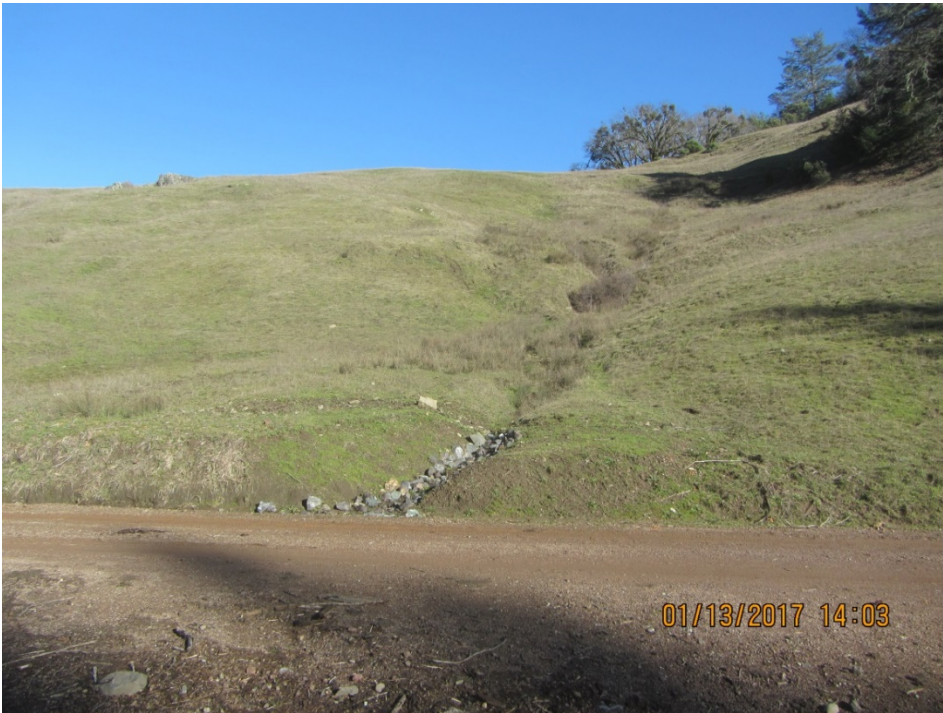
Image 58 shows the Stream Crossing 18 location, which identifies a Class III stream intersecting the road without a drainage structure in place to catch the flows. (Note the rock fill placed in the stream)(IMG 3128)

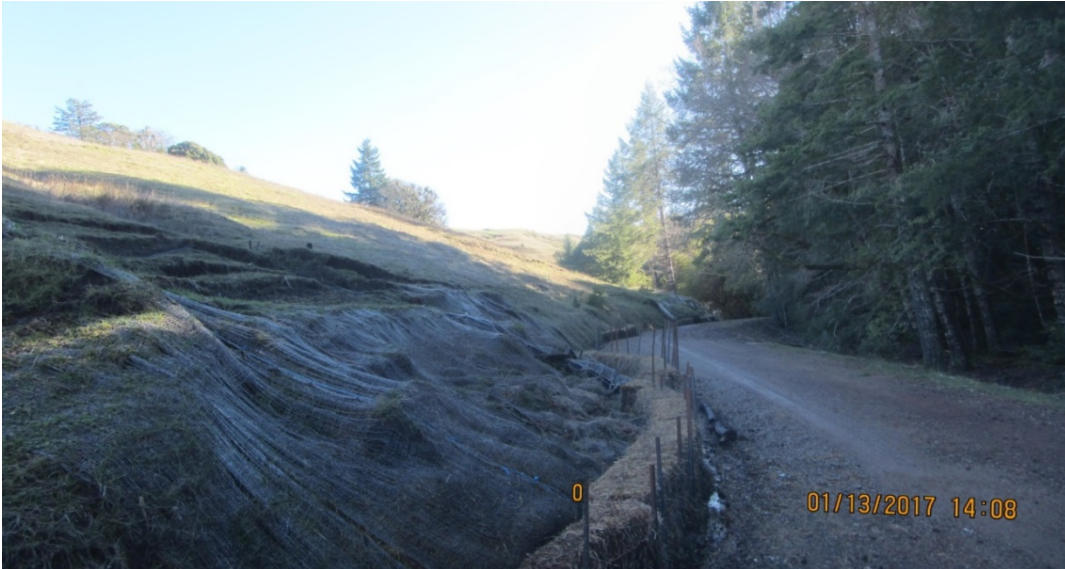
Landslide 1

Image 60 shows GIS point Landslide 1; note the multiple scarps slumping towards the road. (IMG 3132_3133 stitch)

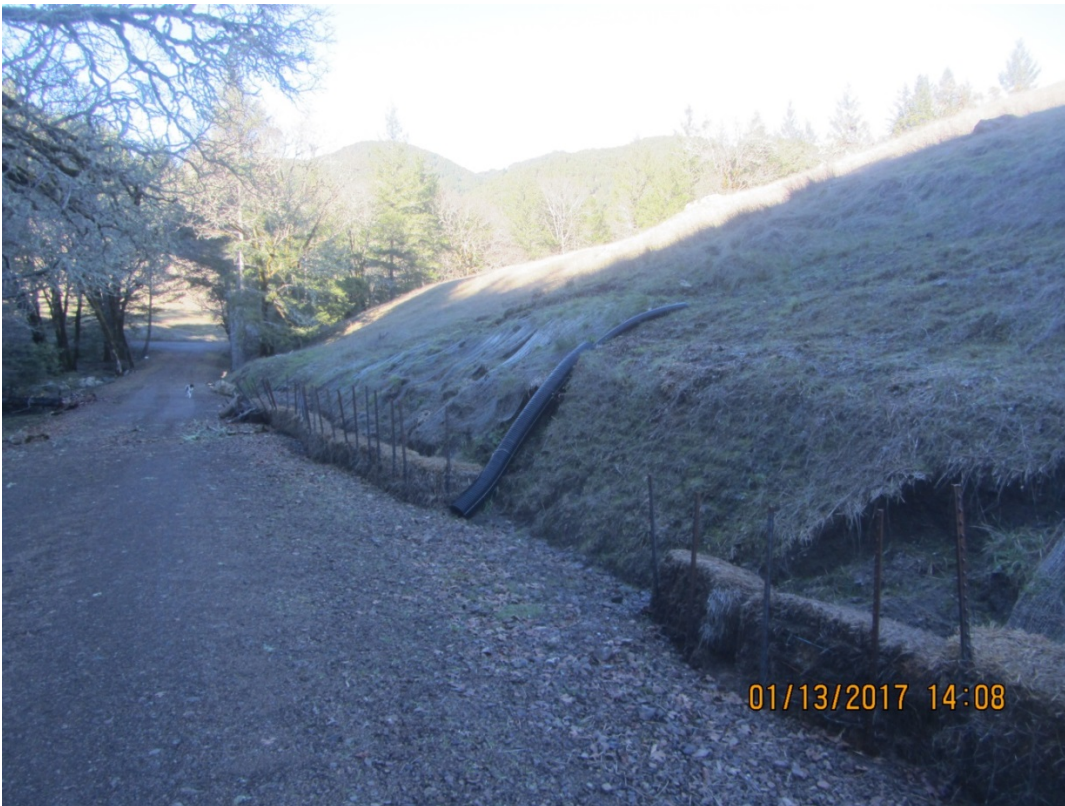
Image 61 shows the Landslide 1 from a different vantage point- of note is that access road in this vicinity parallels a Class I or Large Class II stream for a significant distance, increasing the delivery potential of these unstable slopes. In these images one can also see the connection of the inside ditch along the road with the landslide materials. (IMG 3135)

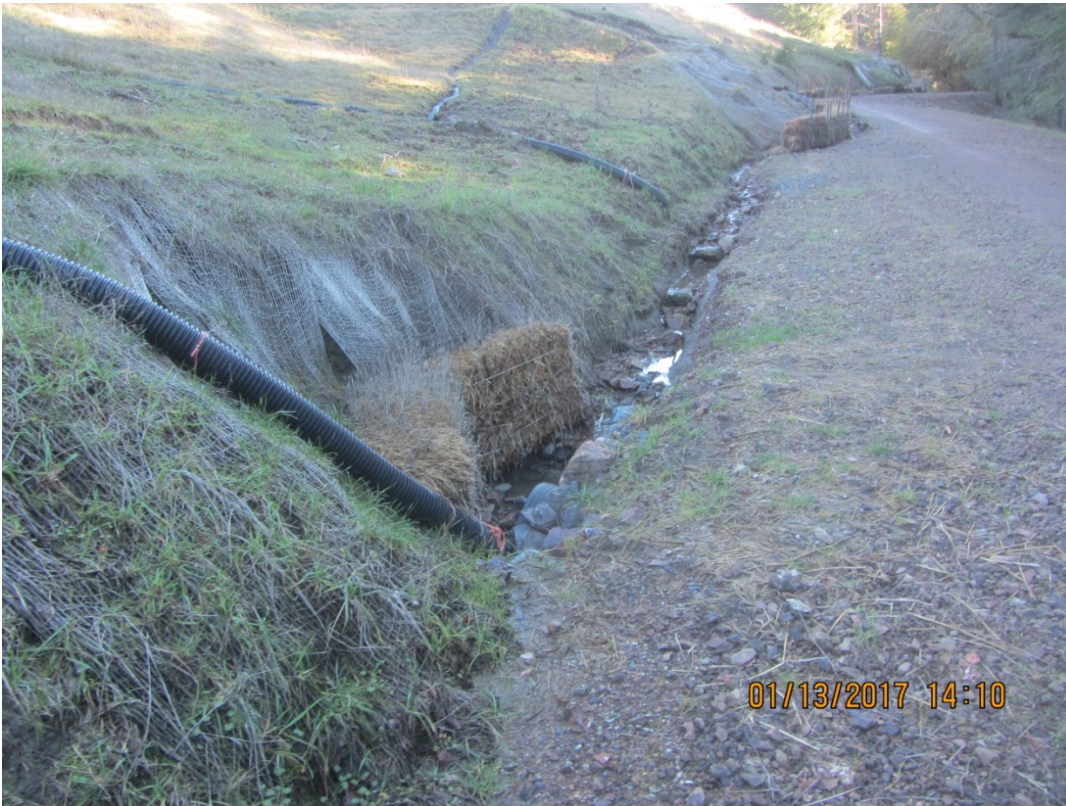
Image 62 shows the inside ditch along the road beneath a series of unstable slopes at inspection point Landslide 1. (IMG 3137)
