Field Inspection Report

Name and Location of Facility Inspected	Rhys Vineyard, Clarke Ranch, 6501 Branscomb Road, Laytonville, CA		
Inspection Date & Time:	January 13, 2017 , 0800-1900 Travel time included	Mendocino County Assessor Parcel Numbers (APN)	015-050-061, 015-050-057, 015-050-056, 015-050-055, 015-050-050, 015 050-051, 014-300-019
Names & Titles of On-Site Representatives and Consenting Parties	Consent¹or Warrant		Notified of Inspection?
Javier Tapia Meza, Ken Seckora	Consent Inspection		<input checked="" type="checkbox"/> YES
Property Owner(s):	Rhys Vineyards LLC		
Physical Address:	6501 Branscomb Road, Laytonville, CA.		
Mailing Address:	11715 Skyline Blvd., Los Gatos, CA 95033		
Property Representatives Present:	Randy Jacobszoon, Registered Professional Forester		
Report Prepared By:			
Stormer Feiler, Senior Environmental Scientist Specialist (SES), North Coast Regional Water Board (RWB)			
Report Reviewed By:

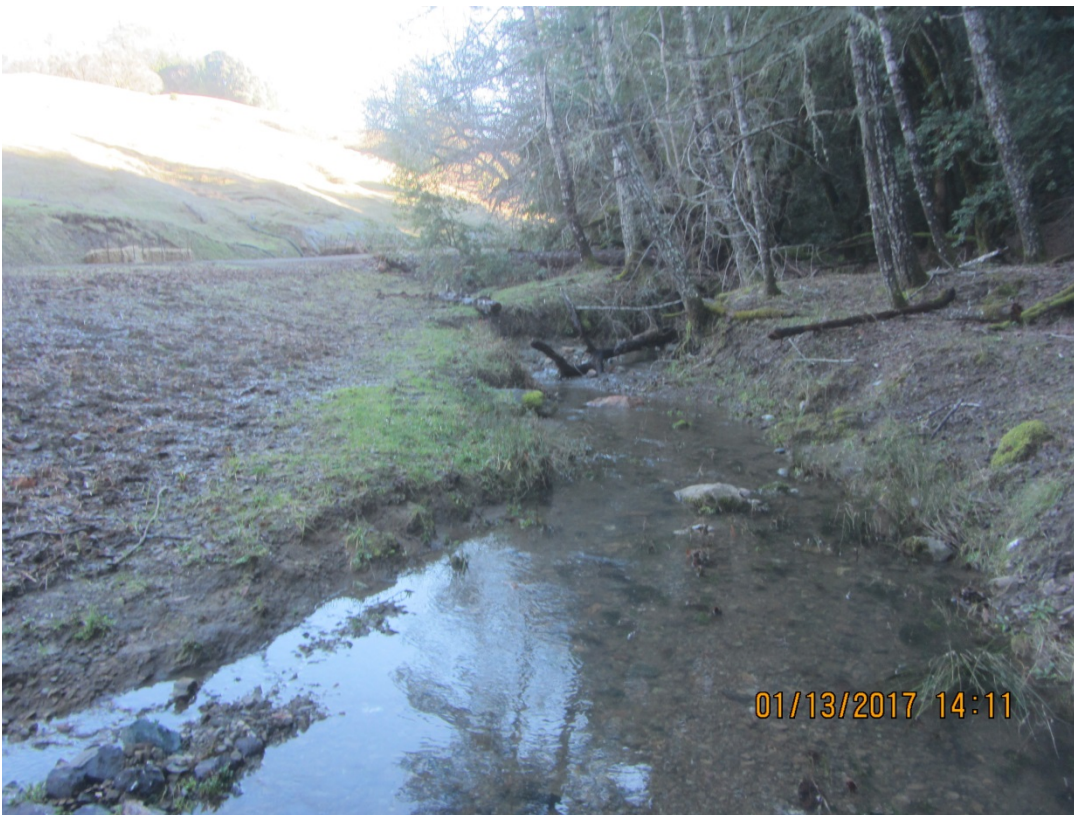
Image 63 shows the stream flowing parallel to the road; in the background the inside ditch and road segment shown in Image 62 is visible. (IMG 3141)

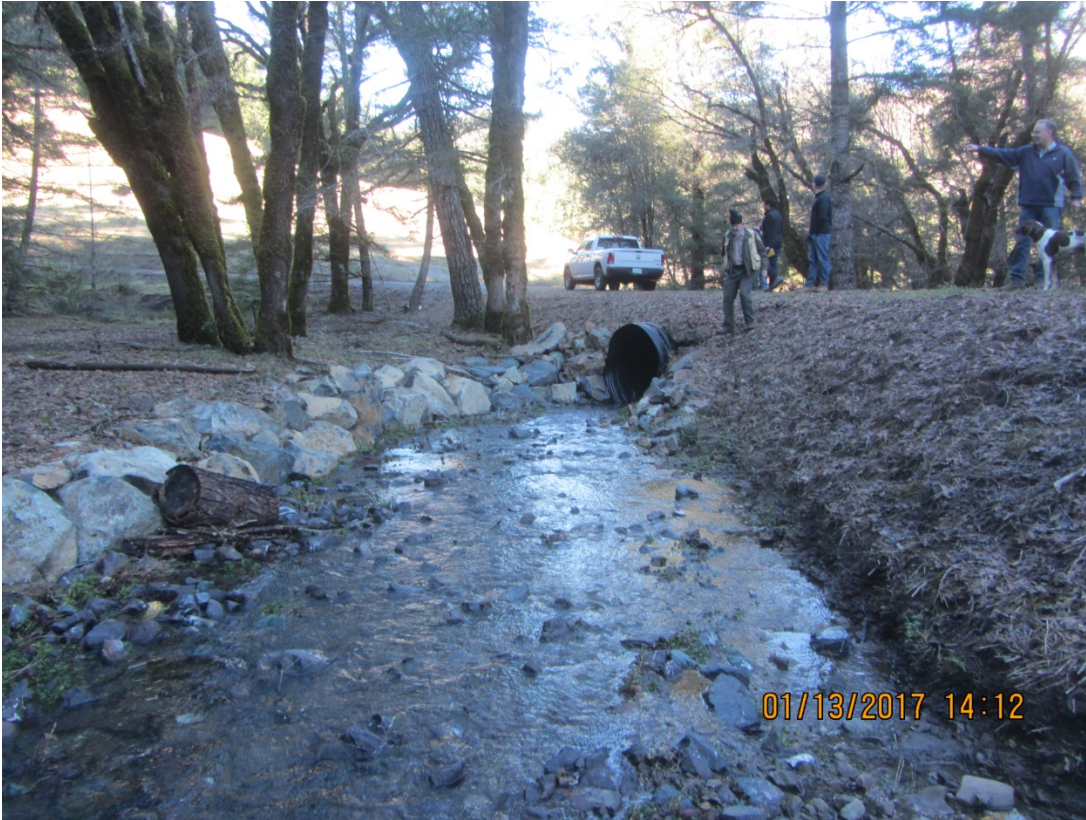
Image 64 shows the inlet of Stream Crossing 19, note the rock fill placed in the stream. (IMG 3143)

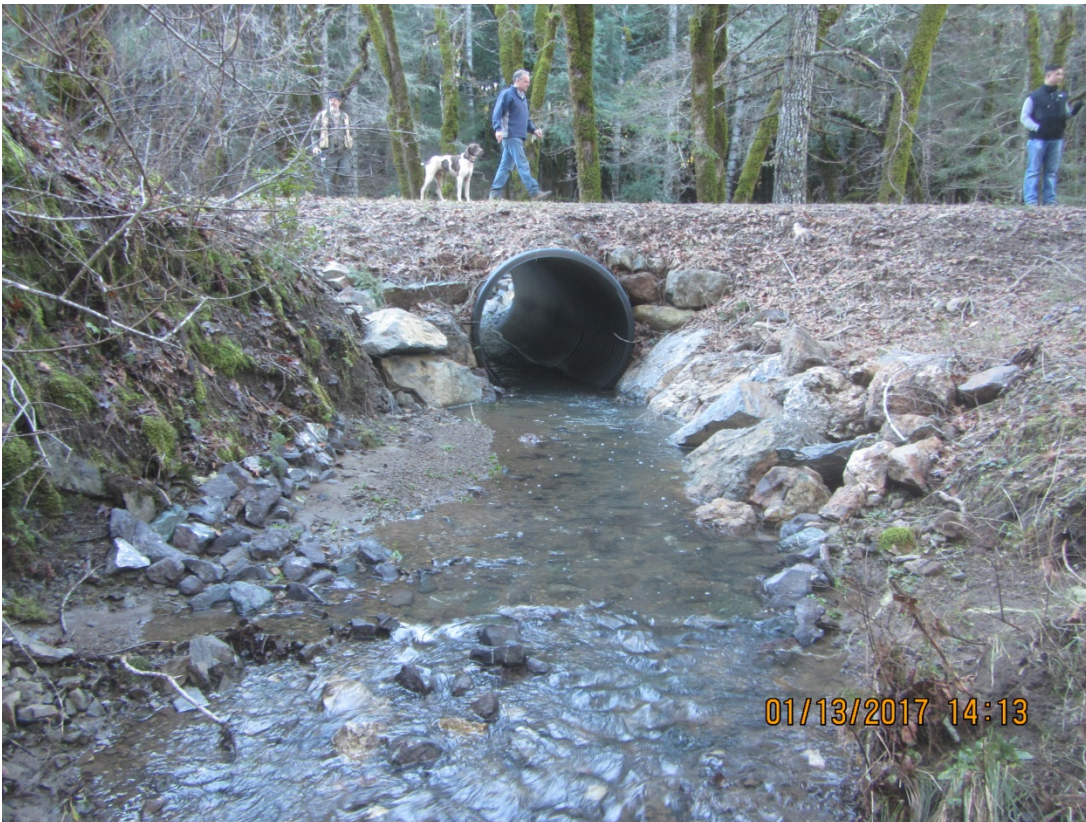
Image 65 shows the outlet of Stream Crossing 19 and rock fill placed in the stream. (IMG 3147)

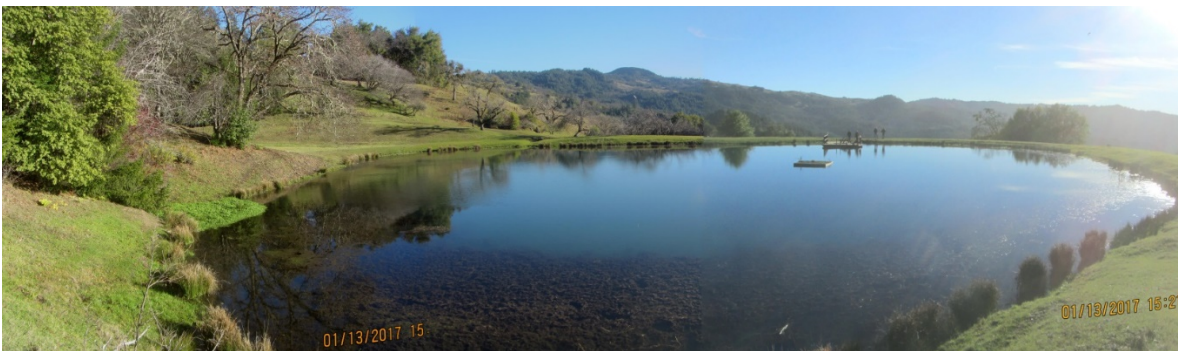
Image 68 existing pond located at GPS8. ((IMG 3170-3172))

Both of the existing ponds are spring fed and were overflowing during the inspection. The larger pond, GPS8, is constructed on top of or directly adjacent to a slope evincing hummocky topography. The dam of earthen materials is steep along this northern side. Native American arrowhead chips and broken chert tools were evident in gopher and squirrel holes and along the margins of the springs feeding the ponds. Spillways of both ponds remained as observed previously. The spillways are a concern, as the outlets concentrate flows into eroding channels below the ponds. In addition, due to the way the outlets were installed and constructed these drainage features likely increase the discharge velocity of water leaving the pond increasing the erosive force of the discharge. I observed that the outlet of GPS8 is head cutting into the dam face due to the erosion of earthen materials at the outlet.

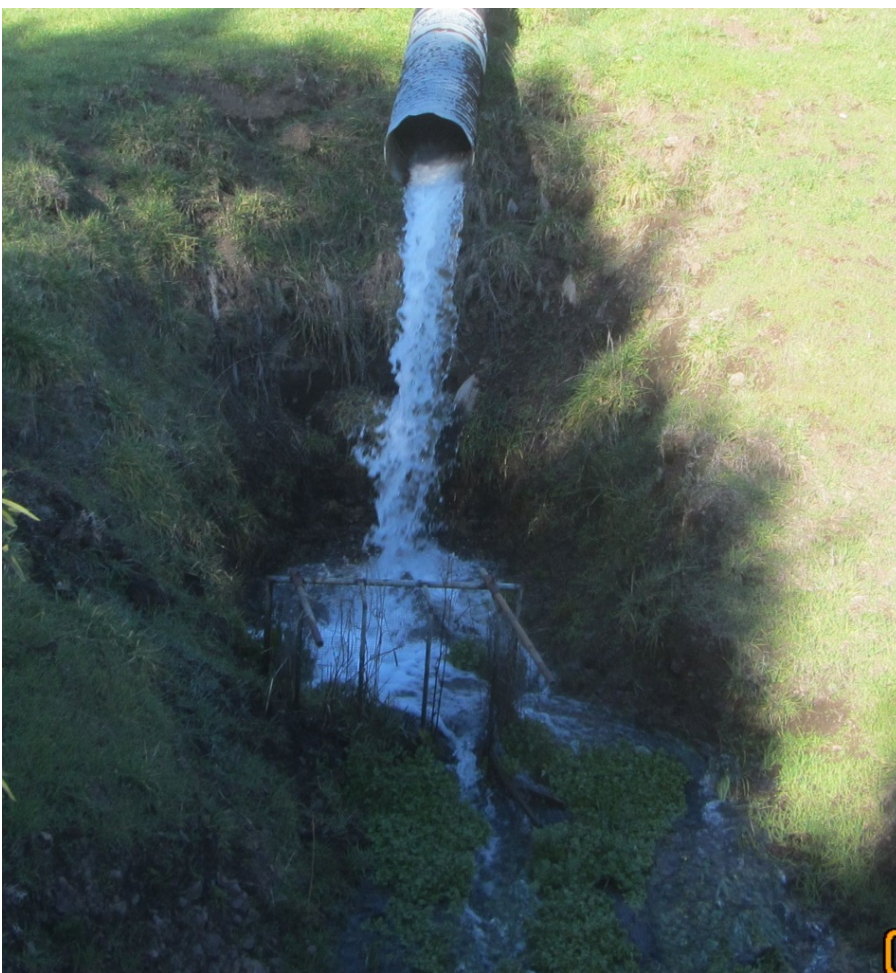
Image 70 shows the Spillway in a closer view note the head cut visible behind the falling water. (IMG 3179 cropped)

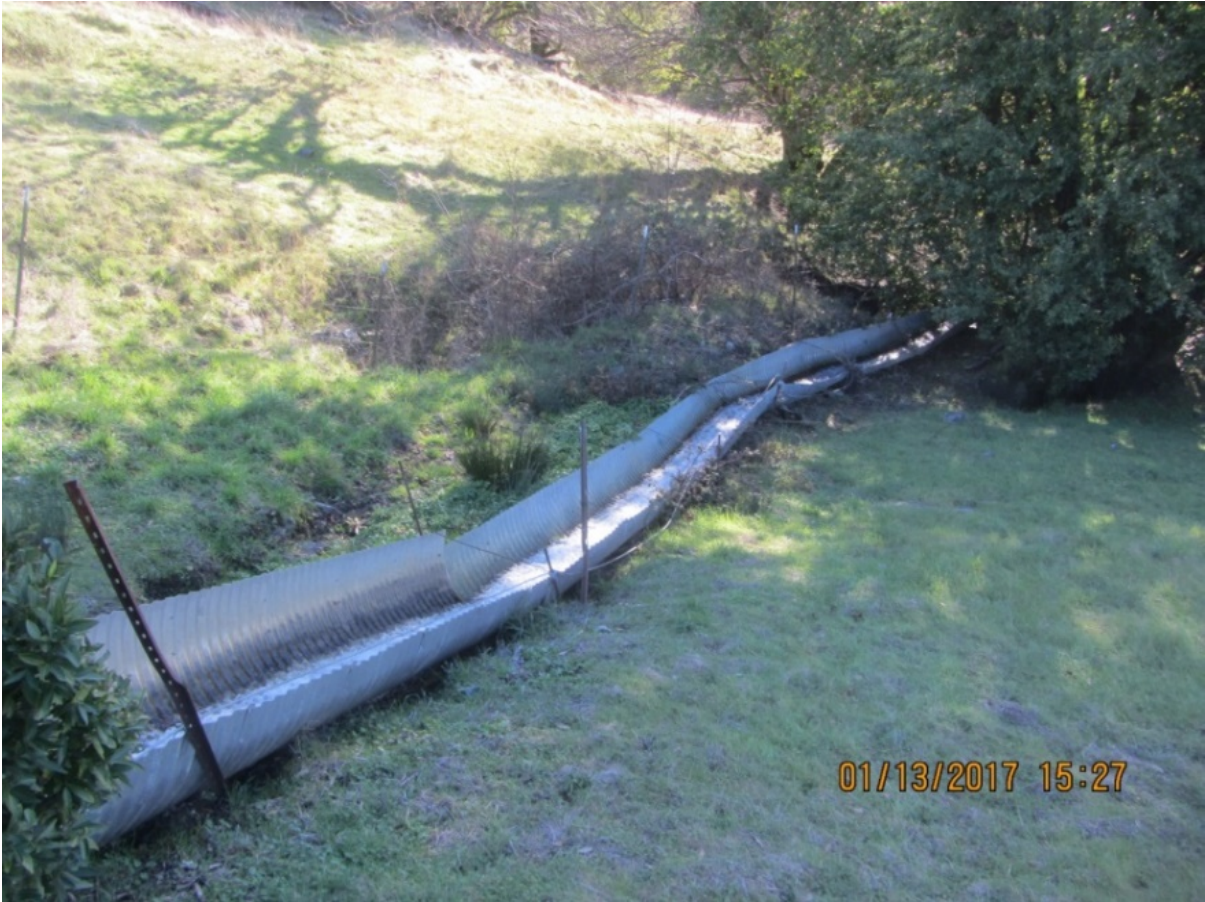
Image 72 shows the spillway of the pond located at GPS8. At the outlet of this structure there is about an 8' drop into an earthen channel that shows signs of down cutting and erosion. (IMG 3188)

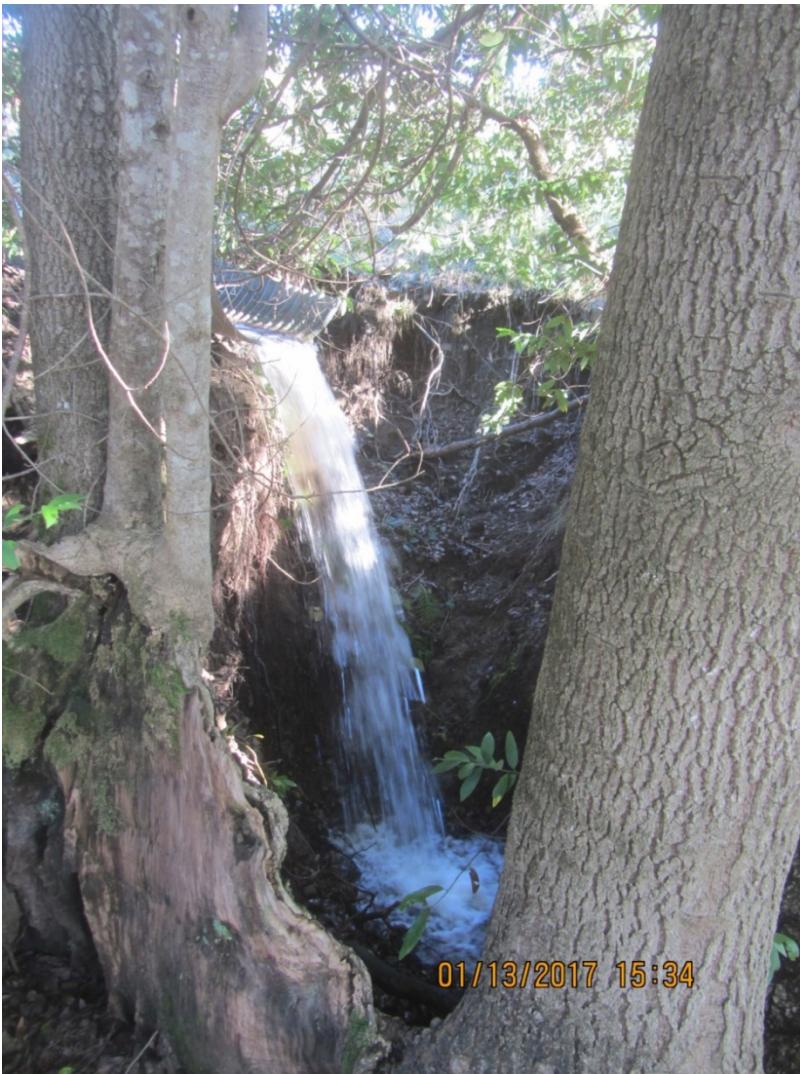
Image 73 shows the outfall of the half-round spillway of the pond located at GPS8. (IMG 3200)
