# Attachment C

## Field Inspection Report

<b>Name and Location of Facility Inspected</b> Telles Property Trinity County APN 015-170-07 Douglas City, CA	<b>Inspection Date</b> April 9-10, 2015	<b>Inspection Time</b> 13:30
--	--	---------------------------------

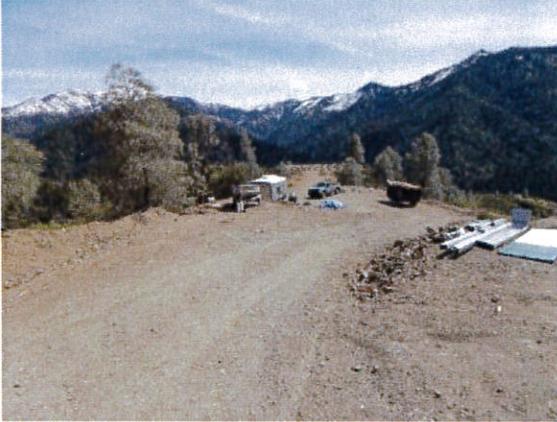
Photo 1

Staff began by walking along the road (Photo 1) between the latrine (L1) and the outdoor cultivation area (OG1) and taking measurements of slope and fill length along the top of the large graded pad's fill slope (Photo 2). The slope around the graded path was steep, consistently measuring between 30 and 40 degrees (Attachment 4). The soil was bare throughout the pad and loose along the fill slopes. On the west side of the pad, we observed rills of varying size and erosion (Photo 3 and 39). Also, on the west side of the pad, there was an area that had erosion, likely due to runoff flow down the slope as it was not near the grow pad. At one location on the west side of the pad was a gully with a width ranging from 2 feet to 4 feet and its depth ranging from 1 foot to 1.5 feet (Photo 4).

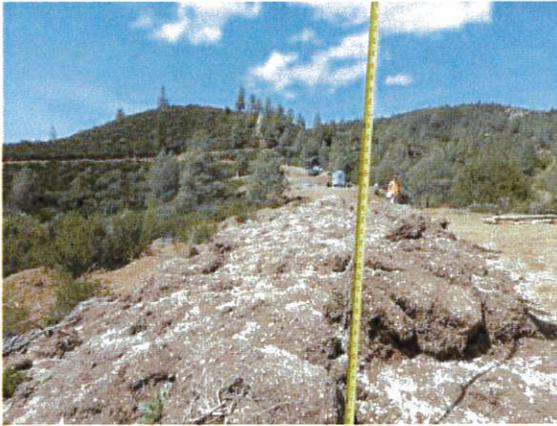
Photo 5 (Grady)

Just north of OG1, staff noted a large, exposed pile of potting soil or mulch (hereafter, mulch pile or MP1) (Photo 5). My colleagues, Kason Grady and Derek Magnuson took measurements of the pile. We took a conservative estimate, measuring the mass as a rectangular prism, and found the average length, width, and depth to be 40', 10', and 2' respectively. This equates to a volume of 30 yd<sup>3</sup> or 12 pickup trucks full. A full-size standard pickup truck holds only 2.5 yd<sup>3</sup> when filled to the top of its bed<sup>2</sup>.

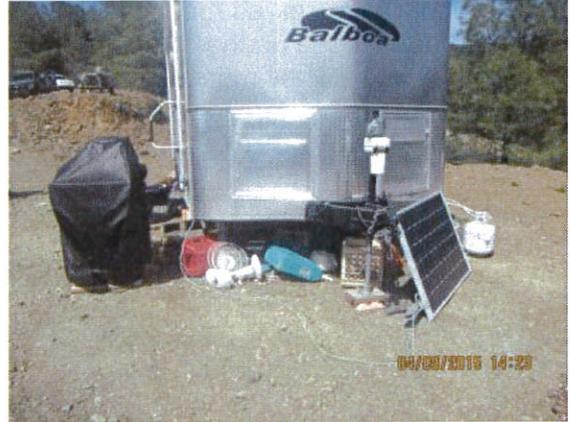
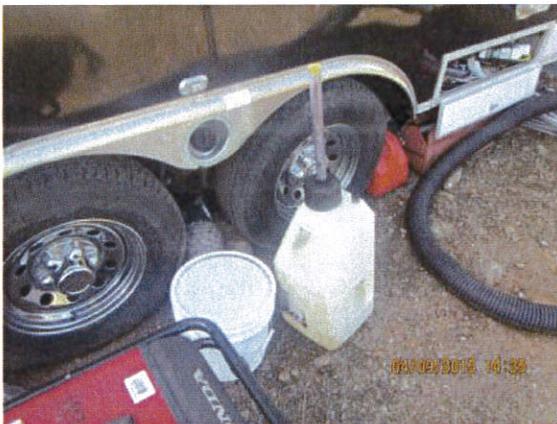
In addition to the mulch pile, I observed a small amount of miscellaneous garbage, including an empty fertilizer container near the grow area. Near the trailer, I observed more fertilizer and fuel containers (Photos 6 and 7). My colleagues, found fertilizer containers near the water tank (Photo 8).

Recommendation 3: Store or dispose of fertilizers, fuels, and refuse in an enclosed area to prevent contact with rainfall or runoff, and transport/delivery to surface waters. Ensure that all spoils are properly stabilized.

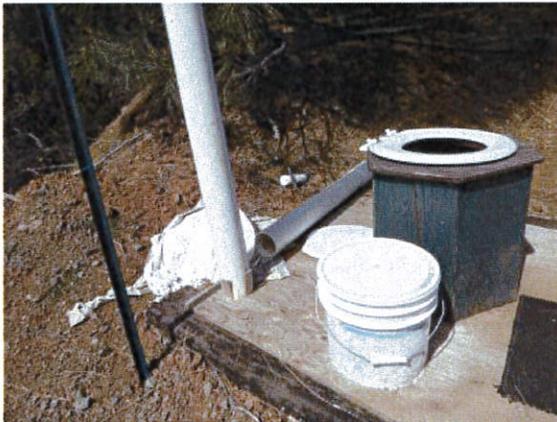
Photo 9 (Grady)

We observed a latrine (L1) with exposed chemicals on the northwest corner of the graded pad, near its edge (Photo 9).

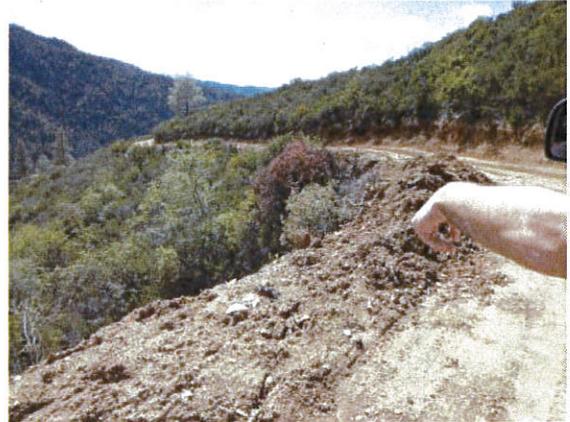
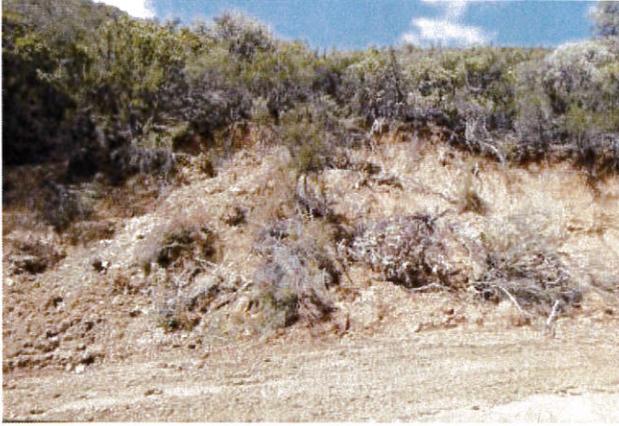
After making these observations, we got in our vehicles to drive to the other graded clearing. As we were still on APN 015-170-07, we noted the condition of the road, which generally featured loose sidecast soil and slash, as well as occasional spoils piles along on its downhill edge (Photo 10), nearly sheer cut slopes with no erosion control (Photos 10 and 11) and rilling and rutting throughout (Photo 12).

Recommendation 1: Hydrologically disconnect and improve the surface and drainage of roads throughout the parcel by consulting a California licensed professional to redesign and resurface roads and install crossings. Roads should be redesigned to prevent high runoff velocities, erosion, and sediment transport to receiving waters. The roads should be continuously maintained to prevent erosion.

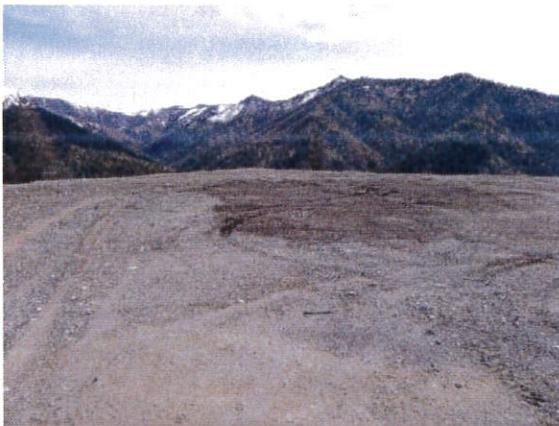
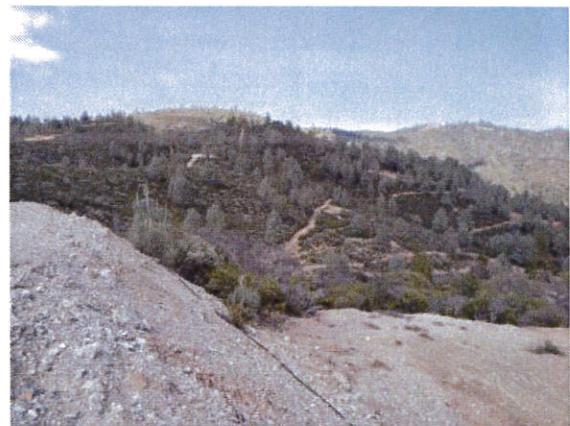
The other large, graded pad did not appear to be actively used (Photos 13 and 14). There were no plants or equipment for planting. On the eastern side of the pad, we observed erosion (E2) (Photos 15 and 16).

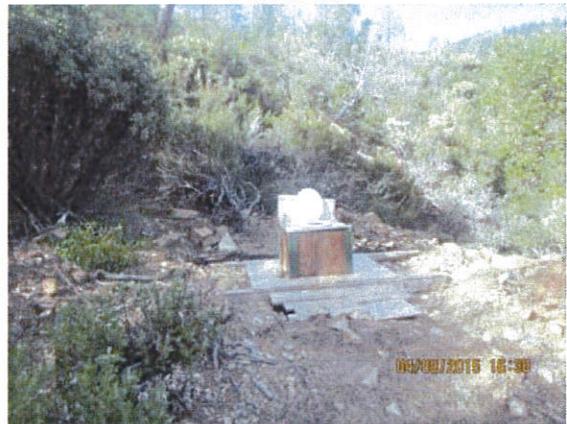
Photo 22

On the property there is an existing latrine (L2) near OG2 (Photo 22) and there was a hole for what Mr. Richter said would be a latrine (L3) near the greenhouse (GH2) (Photo 23). There was also a small pile of soil amendment near the greenhouse (Photo 24). I observed bags of fertilizer on the ground near the outdoor cultivation area (Photo 25). However, they didn't appear to be open. I also observed erosion on the northern slope where the ground was cut to create the clearing for the outdoor cultivation area (Photo 26). The erosion is indicative of an unstable slope configuration. The side slopes of the clearing were cut so steep that large pieces of soil are starting to break off.

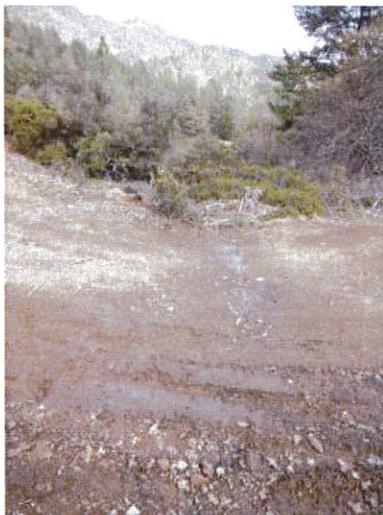
Photo 27 (Grady)

While I was inspecting Mr. Richter's portion of the property, my colleague Derek Magnuson and Kason Grady were inspecting Mr. Rama Zarcufsky's portion. My colleagues noted a watercourse channel without a proper crossing (C1) (Photo 27). From the photo and other photos we obtained, we can come up with an estimate of less than 1 cubic yard of fill placed in the channel. Around the greenhouse (GH1), they observed bare soil that had rills and forming (Photo 28). The eastern edge of the greenhouse was located approximately 20 feet upgradient from a watercourse. There was garbage, open fertilizer bags, and a white substance on the soil and in the rills and gullies draining toward the channel (Photo 29). The white substance may be vermiculite. There was uncontained potting soil strewn about the area (Photo 30). Staff also observed an actual discharge (Photos 31 and 32). Photo 31 was taken from the creek bed and shows the side slope with fill covering the vegetation (E3) and extending toward the creek bed. Photo 32 shows loose, dark-colored sediment which represents the downgradient continuation of the fill shown in Photo 31; indicative of sediment transport into the stream from the upgradient cleared area. Staff observed more sidecast soil, slash, and evidence of erosion near the water tank (T1) and more containers of fertilizer (Photo 33). The tank is upgradient, approximately 50 feet from the watercourse.

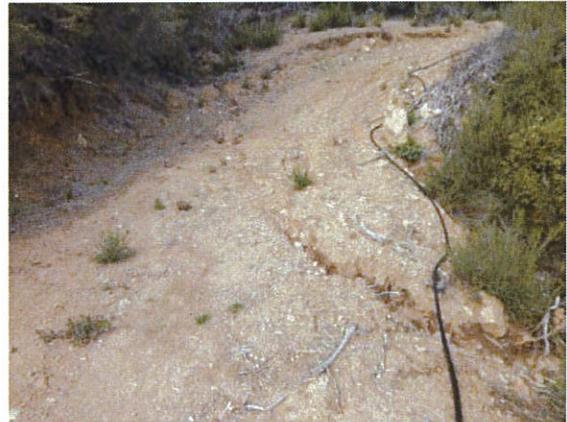
Photo 34 (Grady)

Along the road on the way to a clearing on Mr. Zarcufsky's portion of the property, staff noted another channel without a proper crossing (C2) (Photos 34). They measured the dimensions of the fill over the watercourse and estimated its volume to be between 6 and 7 cubic yards. Staff noted rills forming in the road continuing east from the crossing (Photo 35). Northeast of crossing C2 is another cleared area with an upper and lower pad; with what once was an outdoor cultivation area on the lower pad and a residence (trailer) on the upper pad. They observed evidence of slumping at E4 (Photo 36) and tension cracks along the edges of the upper and lower fill slopes at E5 (Photo 37). On the upper pad, there was some chemical spilled on the bare soil (Photo 38).

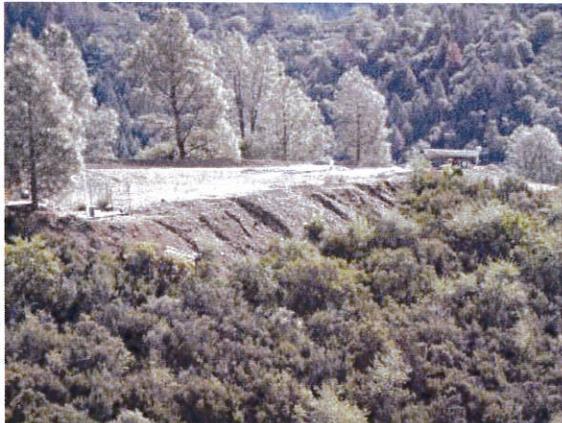
Photo 39 (Magnuson)

On the way back to the Telles portion of the property, Mr. Grady and Mr. Magnuson observed the grow pad on the Telles portion from a distance and its evidence of erosion along its fill side slopes (Photo 39).

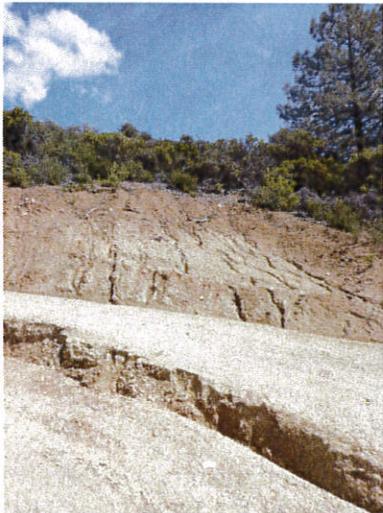
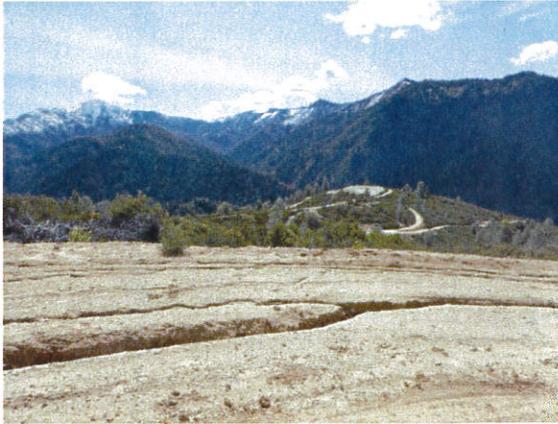
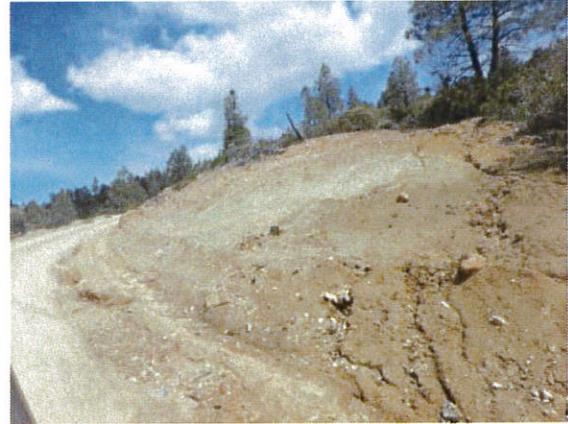
On April 10<sup>th</sup>, we documented more features of concern on the access road within the western side of the property (Photo 40 through 41). We also noted another channel without a proper crossing along the southern boundary of the property (C3) (Photos 43). The crossing featured an undersized culvert consisting of an approximately 36-foot long, 8-inch diameter corrugated

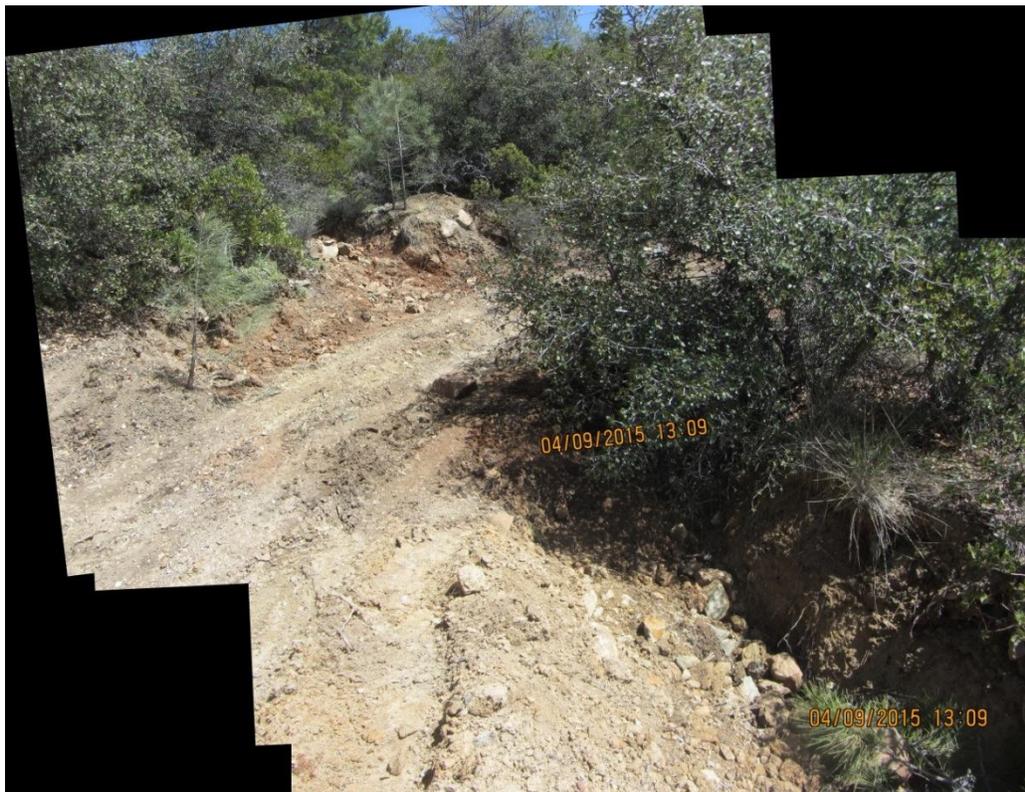
Inspection point C1 is located along a dirt road, and identifies a location where the road crosses an ephemeral, Class III<sup>1</sup> watercourse. The crossing appeared to have been constructed by placing brushy vegetation into the stream channel and spreading soil over the vegetation to create a road surface. There was no apparent culvert or other drainage structure installed within the brush/earthen fill prism.

I measured the road fills at this location, and estimate that there are about 5 cubic yards<sup>2</sup> of erodible earthen materials left in the road surface and perched at the outlet where discharge will continue with rainfall. The winter has eroded an estimated 1 cubic yard from the road surface including the earthen materials and woody debris placed in the stream. The crossing upon initial construction likely contained approximately 6 yds<sup>3</sup> or earthen fill and woody debris.

Image 1 shows crossing 1 (C1). Note the earthen fill in the stream channel and perched along the road at the outlet. (Stitch of photos 8925, 8926, 8927, and 8928)

<sup>2</sup> 2.2 yds<sup>3</sup> in the 10' of road fill in the crossing, and 2.6 yds<sup>3</sup> perched along the 18' of road edge above the stream at the outlet. Average depth of fill was 2'; average width of channel was approximately 2 feet. Fill was deeper at the outlet.

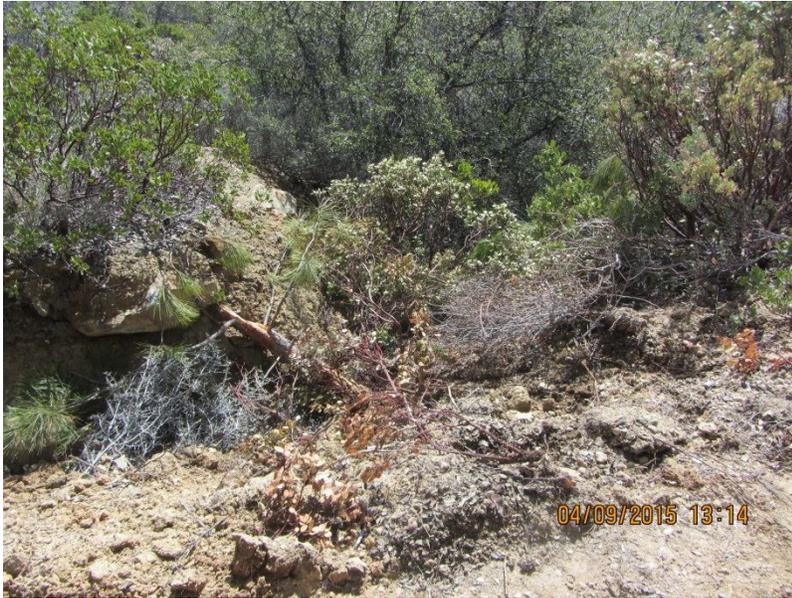
Image 2 shows the stream channel downstream of the road at C1 (note the brush covered with earthen fills in the stream). (Photo 8935)

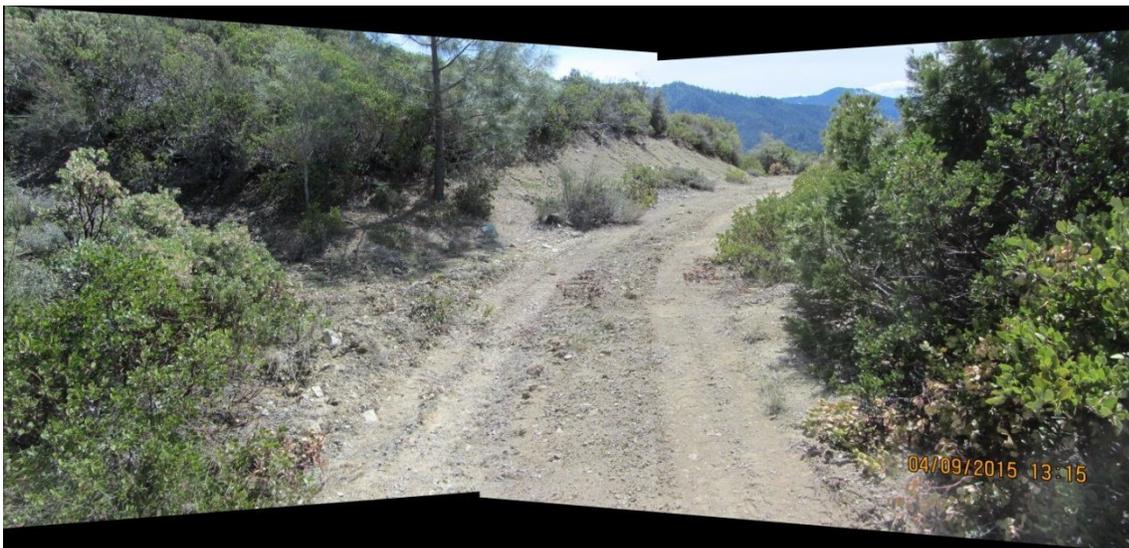
Inspection point C2 is located along the same road as C1, and is also a location where the road crosses a Class III stream without the benefit of a culvert or other properly designed structure. In this case, material placed in the stream channel appears to be earthen material only, rather than including any brushy or woody material. I estimate that there is approximately  $<1 \text{ yard}^3$  within or at a location where it can enter the stream channel. Minor erosion was visible on the road surface. I did not observe a defined channel downslope, however, I observed evidence of older road fills perched down slope of the existing road grade with an erosional channel through the fills leading to what I assume is the natural channel further in the brush. I did not climb through the dense brush very far. This is a very minor crossing in terms of fill and impacts, but does constitute earthen fills placed into a seasonal stream channel.

Image 3 - the road surface at point C2. Note that this crossing shows little effect from the winter rains. This stream is near the ridge top and likely is influenced by large storms but not minor rain events. (Stitch of photos 8936, 8937)

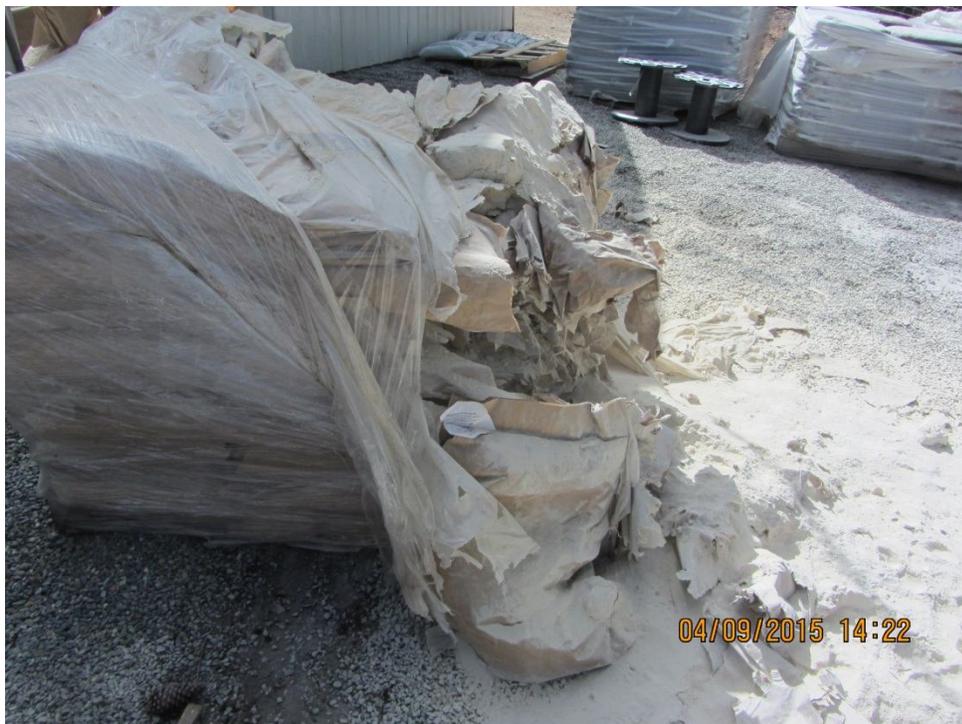
The residence, greenhouse and associated development were well sited to minimize potential for impacts to water quality. The greenhouse was constructed to allow for growing crops under light deprived conditions, making it possible to have multiple harvests within one growing season. Growing multiple crops in a year increases water usage. The greenhouse held 96 grow bags, 4 feet in diameter, as counted by Justin Smith. Housekeeping was adequate with the exception of the pallet with bags of bone meal stored in a location where bears could access the pallet and eat the bone meal.

Image 5 shows the pallet of bone meal bags with bear damage. (Photo 8967)

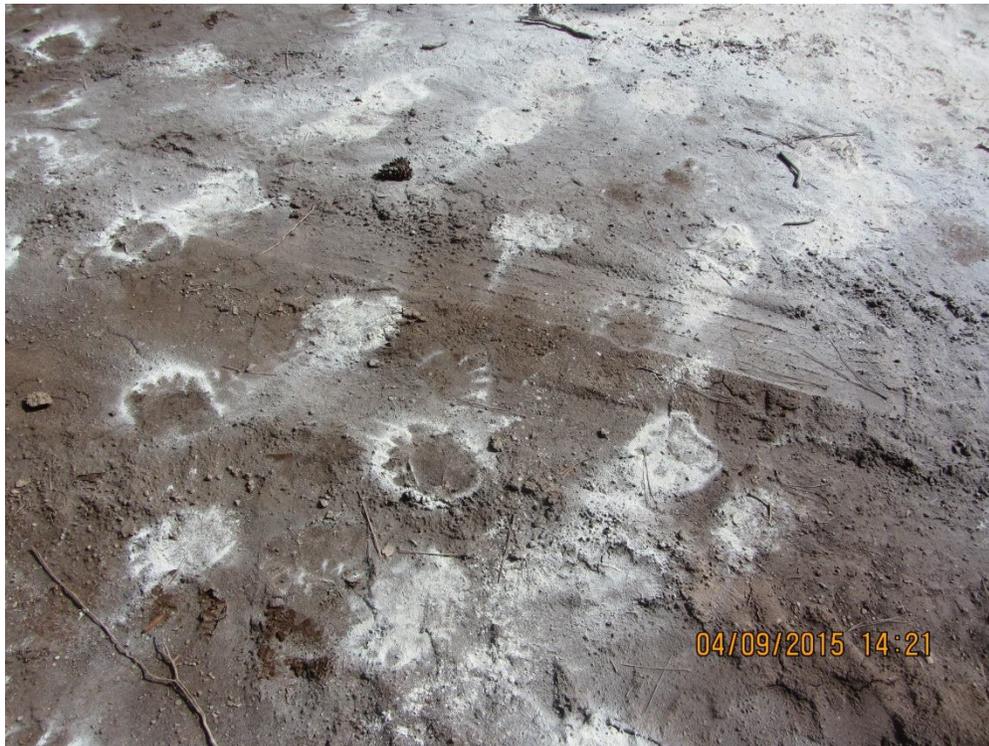
Image 6 shows bear tracks near the pallet of bone meal. (Photo 8963)

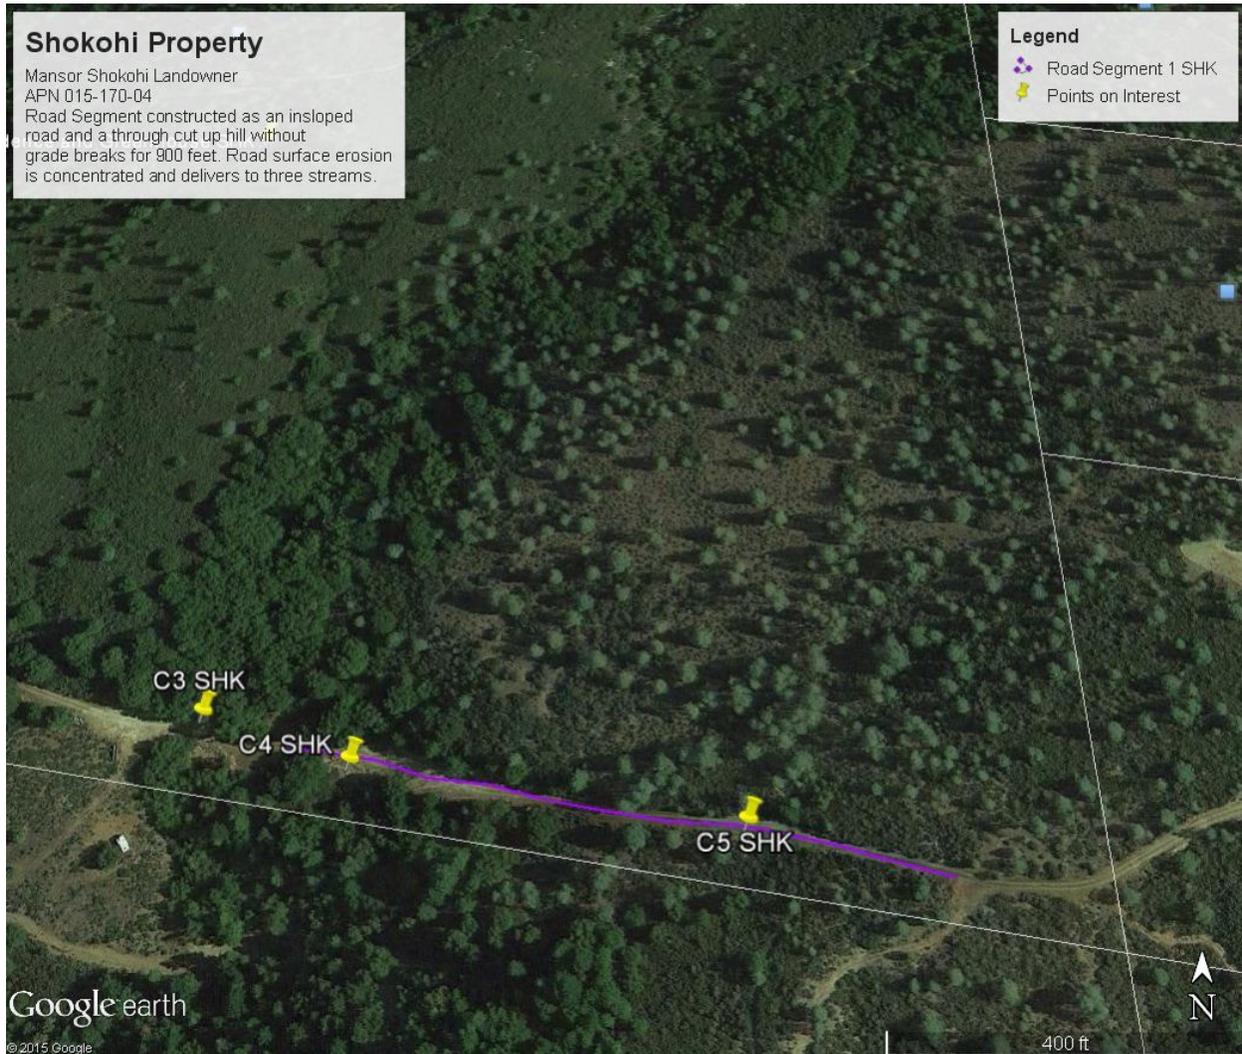
The inspection team continued east along the segment of road beyond the blown out crossing and observed additional water quality concerns. Specifically, an approximately 910 foot long segment<sup>3</sup> of this road is constructed straight up a hill and is both insloped and through cut. The earthen materials used in road construction are base materials from surrounding slopes comprised of rock, and fines with some clays intermixed. The fine materials in the soil matrix appear to be highly erodible. Runoff from this road segment drains into the streams at crossings C3, C4, and C5.

Figure 3 – shows the road segment with crossings C3, C4, and C5; the purple line shows the approximate portion of the road that drains from east to west to streams at C5, C4, and C3.

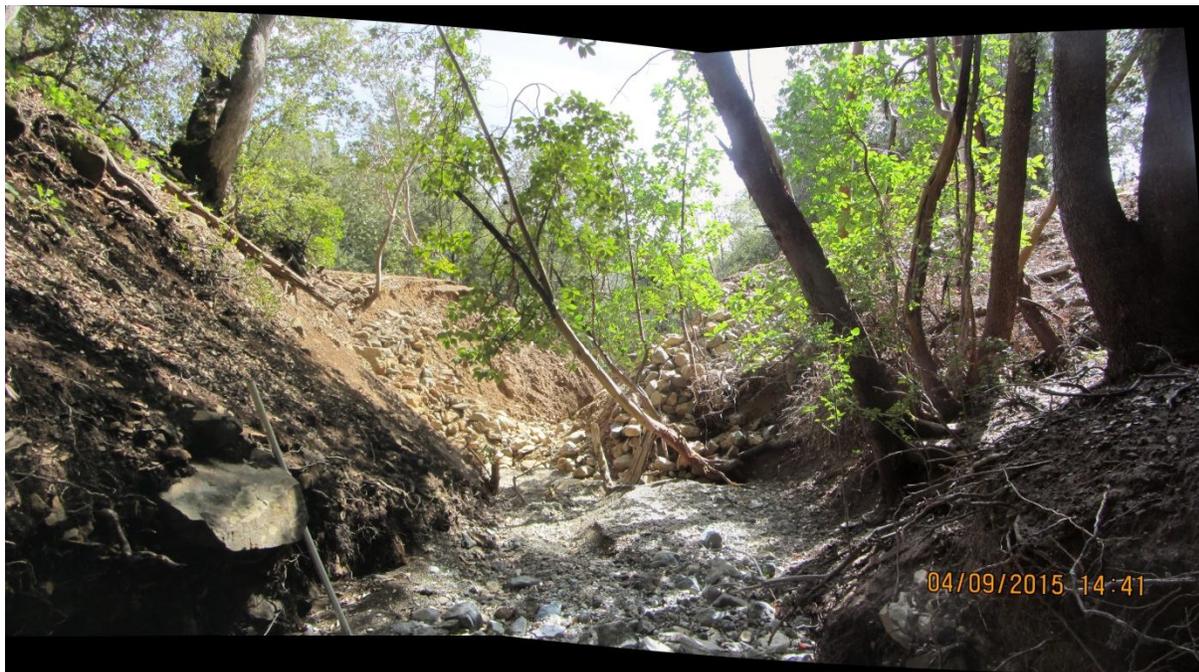
Crossing C3 is a blown out stream crossing on a Large Class II<sup>4</sup> watercourse. DFW representatives advised other members of the inspection team that the crossing had been replaced pursuant to a

1600 agreement issued by the DFW to an individual named Clay Tucker. The 1600 agreement indicated that work at this crossing included installing a 54" arched culvert with an angle iron attached to the culvert base. Based on observations in the field, the 54" culvert proposed, and installed at this location was undersized. I observed that the natural stream channel was more than 54 inches wide. I then took three measurements of bank full stream width upstream of the crossing, and calculated an average width of 11.8 feet,<sup>5</sup> or approximately 142 inches at bank full, more than 2.5 times wider than the 54" culvert width. A standard approach to evaluating culvert sizing in the field is to see whether the diameter or span of the culvert is at least as wide as the natural bank full channel. By that metric, the culvert was significantly undersized, and based on observations in the field, the 54" culvert clearly failed to pass instream flows and debris. This resulted in significant amounts of sediment delivery to downstream receiving waters. I observed sediment deposits in the stream channel at and downstream of Crossing 3. The entire culvert was buried by deposition except for a segment of the culvert that had washed downstream. The culvert did not appear to have been installed correctly; an arched culvert would require a foundation; there was no foundation or means of anchoring the culvert in stream visible on the washed out segment.

Crossing 3 potential delivery remaining is estimated at **558 yds<sup>3</sup> overall.**

Image 9 shows Crossing 3 and the eroded fills looking downstream. (Photos 8971, 8972, 8973, 8974, 8975, 8976 composite)

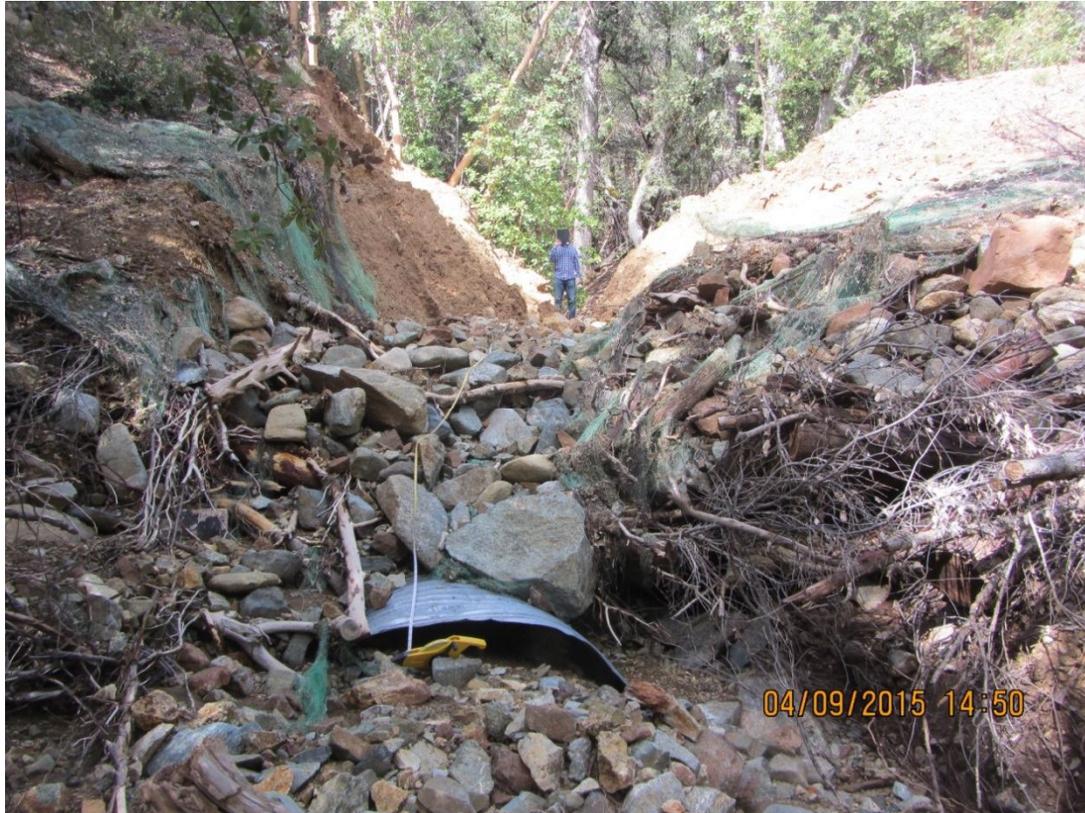
Image 10 shows Crossing 3 looking upstream; note the erosion control fabric displaced on the side slopes of the crossing from fill failures, and the culvert buried in the foreground. (Photo 8980)

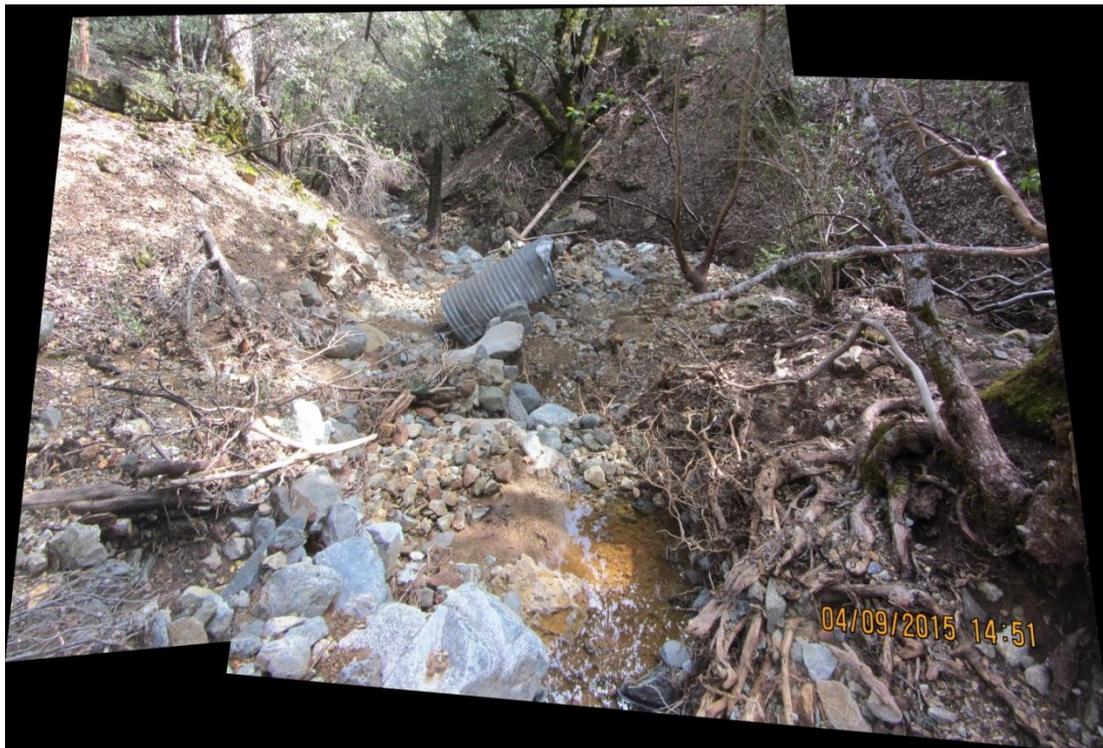
Image 11 shows the stream looking downstream from the outlet of Crossing 3. Note the sediment deposited in the foreground and the mass erosion instream around the trees likely increasing the channel margins. (Stitch of Photos 8988-8989)

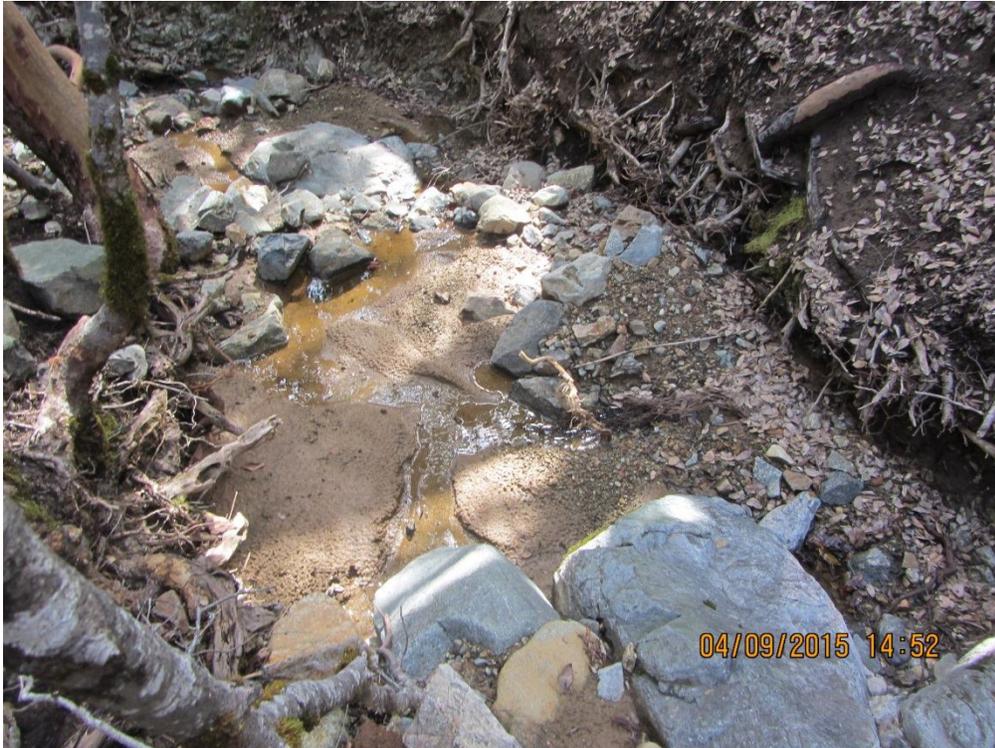
Image 12 shows another sediment deposit downstream of Crossing 3. (Photo 8990)

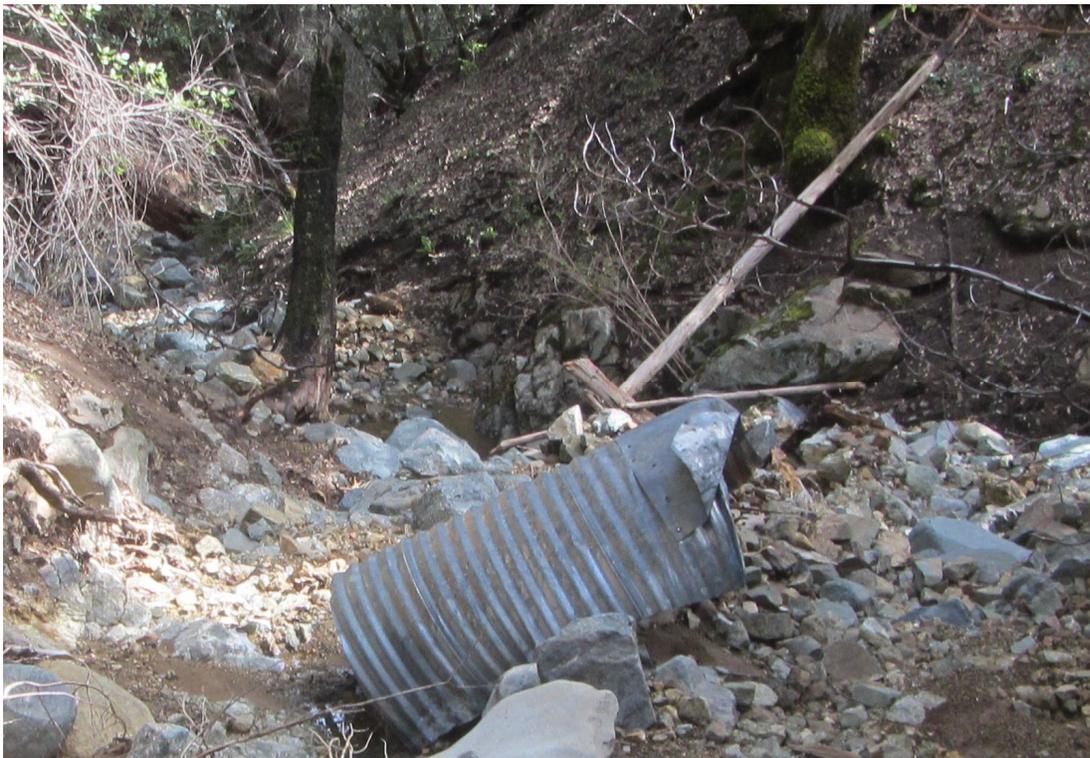
Image 13 shows a section of the 54" culvert torn out and displaced downstream from Crossing 3. Note that there does not appear to be any evidence to indicate the culvert was installed with a flange of angle iron as specified in the 1600 application, and as would at minimum be required to maintain the culvert in the stream if it were sized adequately. (Photo 8988 cropped)

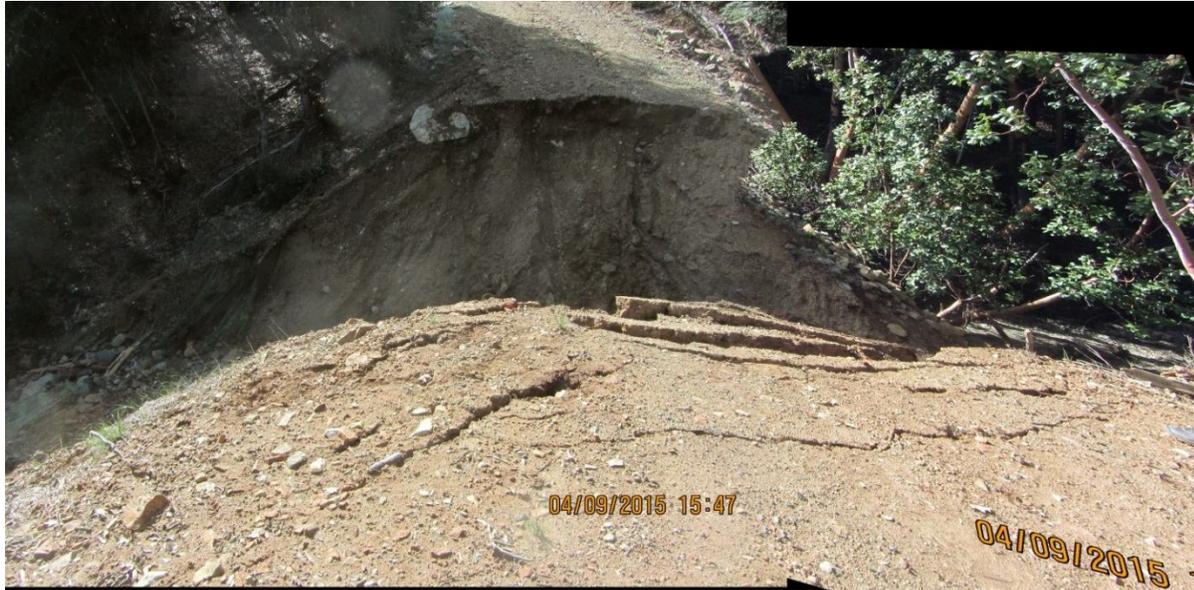
Image 14 shows Crossing 3 as viewed from above looking east. Note the tension cracks expanding back from the failure edge. These earthen fills will continue to erode with wind and weathering events; any material that erodes here will fall into the stream. The extent of tension cracks can indicate the rate of compaction. Soils lacking compaction often crack more and further back from the edge. (Stitch image of Photos 8995 -8996)

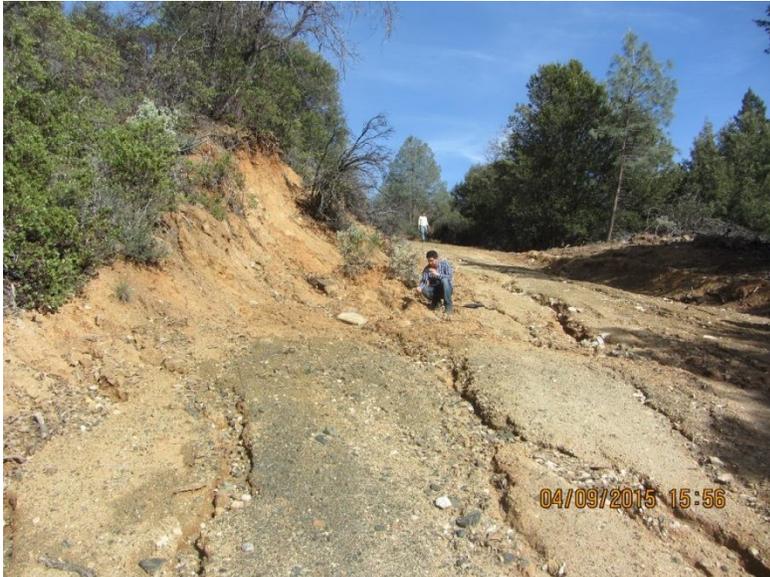
As mentioned above, this road segment is poorly sited, designed, and constructed. The road delivers sediment to streams during each runoff event. Sediment from the road was visible in the streams below the C4 and C5 culvert outlets. The road is on an average 26% slope. The underlying soils are of a fine-grained composition with varying levels of colloidal materials and rock intermixed, which may increase the potential for erosion of the road surface, stream crossing fills and the potential for sediment transport. Due to the way this road is built, it acts as a stream, concentrating all surface drainage straight down the road surface, discharging a portion or all of the runoff at watercourse crossing(s) along the road. Because surface flows are concentrated, the road surface erodes into rills and gullies, which further exacerbate and increase flow concentration resulting in additional erosion and sediment delivery. Given the siting, this road cannot be adequately improved or upgraded to correct the drainage and erosion issues. As noted in the recommendations below, this road segment and all associated Crossings (3, 4, and 5) should be decommissioned, slopes stabilized and replanted with native vegetation suitable to survive the site conditions.

Image 15 = Road segment 1 – shows the erosion on road surface. (Photo 9018)

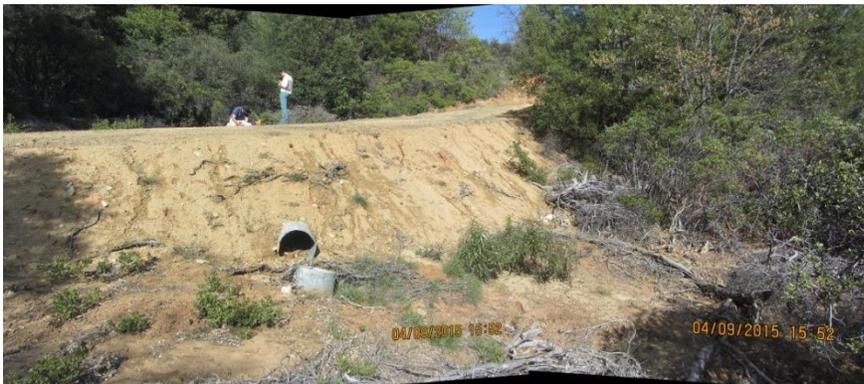
Image 16 – Crossing C4 outlet – note evidence of runoff and erosion over the side of the road at this location. (Photo 9006)

Crossing 4 is a 40-foot long, 24-inch diameter culvert; the road width over the culvert is 16 feet. The culvert is holding some sediment in the outlet. The culvert may be adequately sized. However, as discussed above, the road is not conducive to long term usage and is likely a significant contributor of sediment to the watershed. Decommissioning the road, per recommendation below will include removal of this culvert and restoration of the watercourse in the vicinity of the stream crossing.

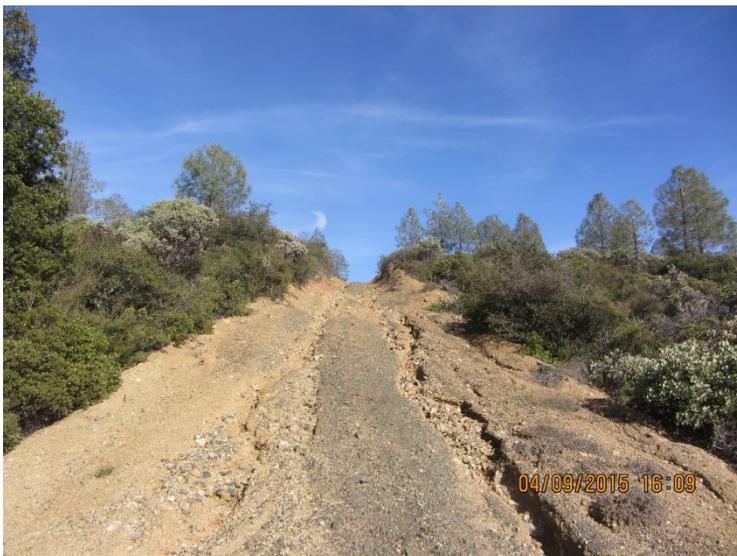
Image 17 – Road segment 1 – shows erosion on the road surface looking east toward the through cut. (Photo 9043)

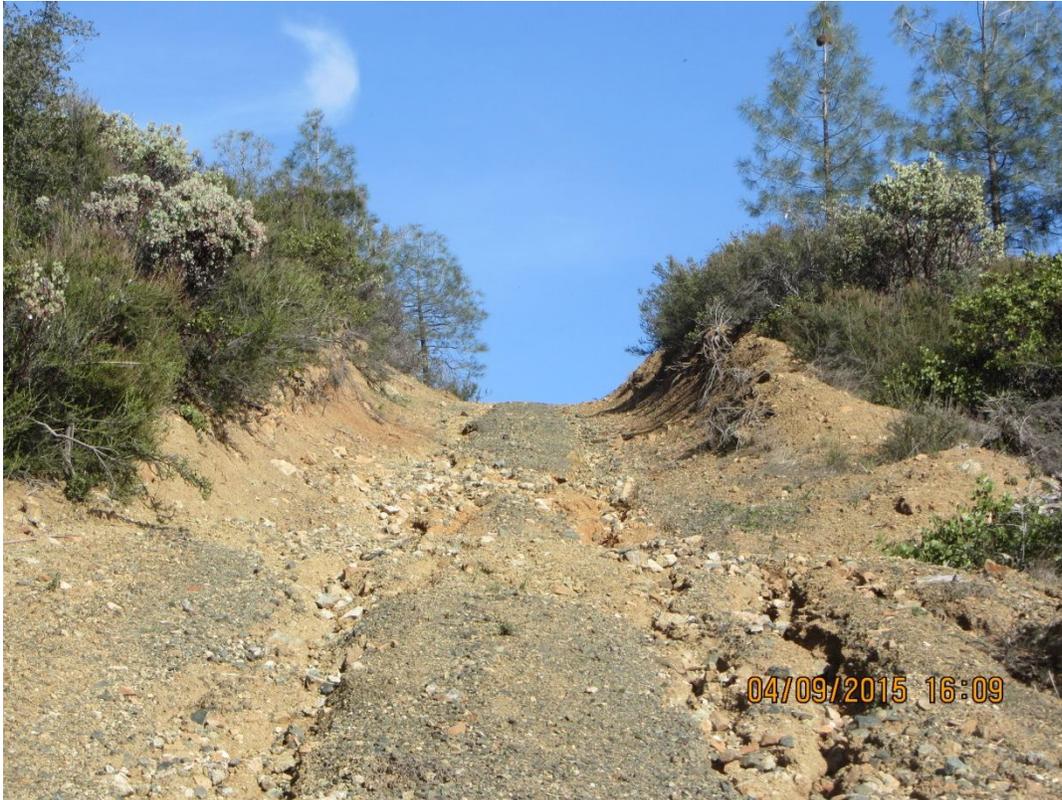
Image 18 – Road segment 1 – a closer view of the through cut at the top of the ridge that starts the concentration of flows and encourages road surface erosion. (Photo 9044)

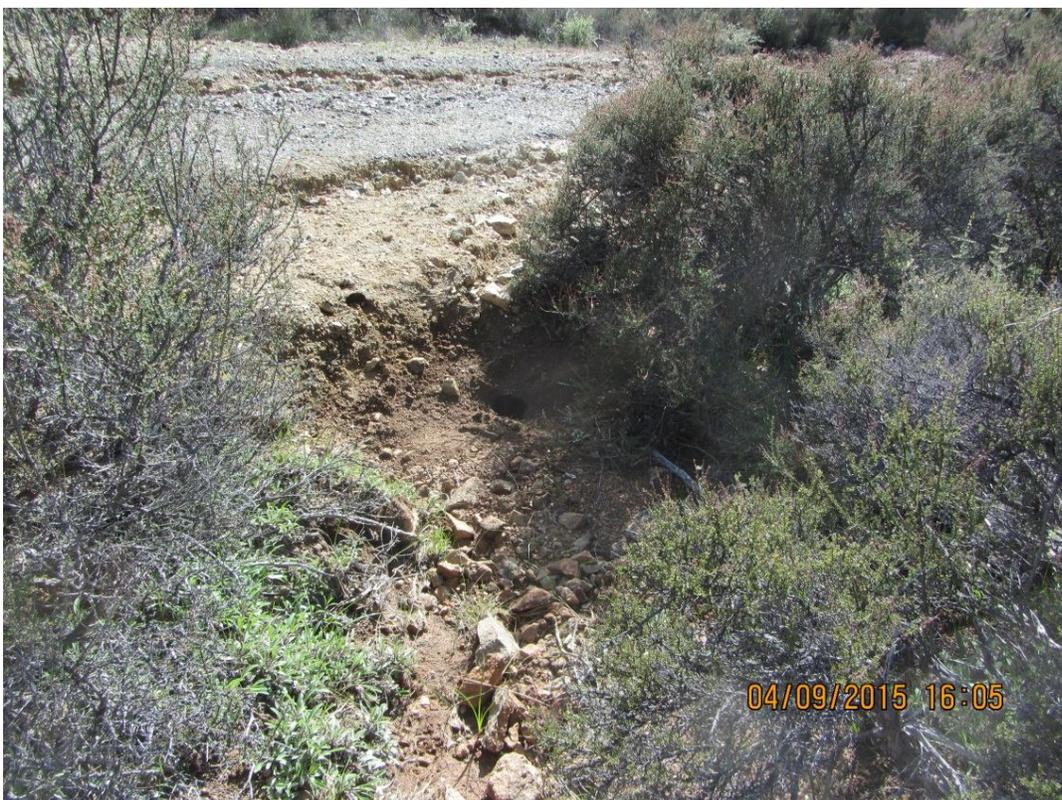
Image 19 – Crossing C5 inlet. C5 is a 6-7 inch flex pipe, undersized for this crossing. The inspection team excavated the inlet in order to photograph the pipe. (Photo 9040)
