Attachment D

Field Inspection Report		
Name and Location of Facility Inspected Indian Creek Watershed Trinity County APN 015-170-24 Douglas City, CA	Inspection Date April 10, 2015	Inspection Time ~10:30 a.m.
Names & Titles of On-Site Representatives	Contact Information	Notified of Inspection?
Andrew Carey	3025 Osceola Street Denver, CO 80212 Phone: (530) 784-3551	<input checked="" type="checkbox"/> NO
Howard Randol Jr.	7450 W 52nd Ave M208 Arvada, CO 80002	<input checked="" type="checkbox"/> NO
Names & Titles of Property Owner¹ at Time of Inspection	Address	Consent Provided?
RNC Holdings, LLC	PO Box 2954 Weaverville, California 374 Clarkson St. Denver, CO 80218	Administrative Warrent
Names & Titles of Current Property Owner	Address	Consent Provided?
Eduardo Guerrero	4708 Millbrook Way Bakersfield, CA 93313-4004	N/A
WQ Inspector Name(s) & Title(s)² Erin Mustain, Senior Water Resource Control Engineer, State Water Resources Control Board (SWRCB) Office of Enforcement (OE) Derek Magnuson, Engineering Geologist (EG), North Coast Regional Water Quality Control Board (NCRWQCB) Kason Grady, Water Resource Control Engineer (WRCE), NCRWQCB

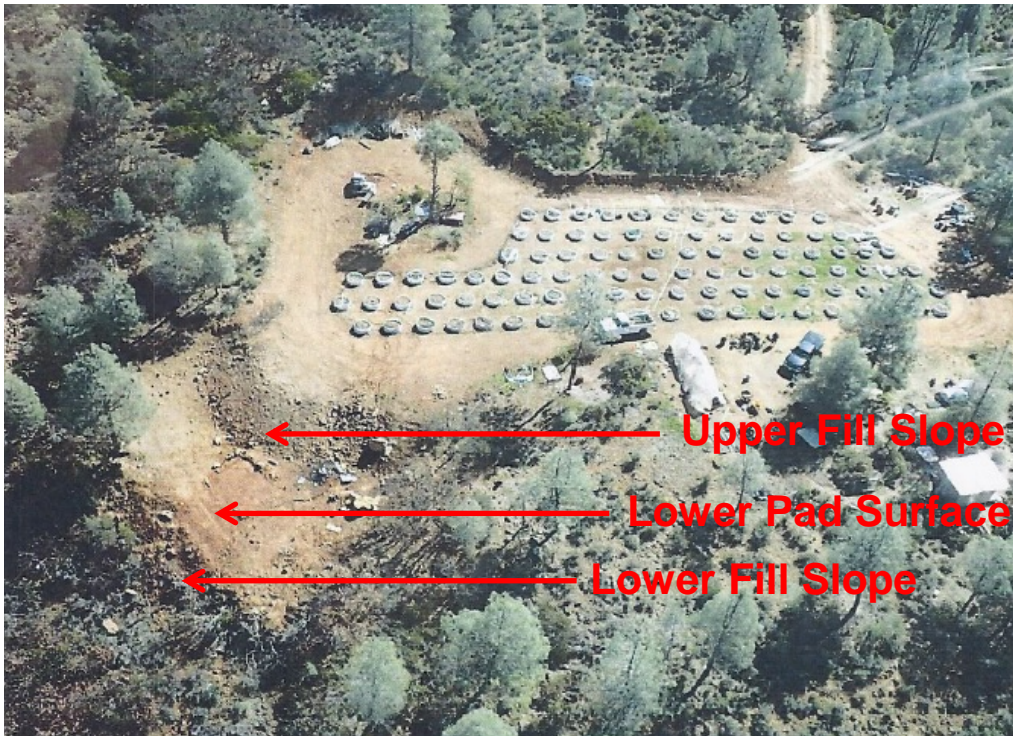
Pre-inspection reconnaissance through review of satellite and aerial imagery, including a March 2015 overflight by CDFW staff, identified one cultivation area or potential cultivation area and features of concern related to grading more than one acre of soil with no evidence of erosion control efforts or measures (Appendix A, Photograph 1).

Photograph 1: Developed site overview, looking eastward. Photo by Steve Crawl on 3-26-15 during overflight.

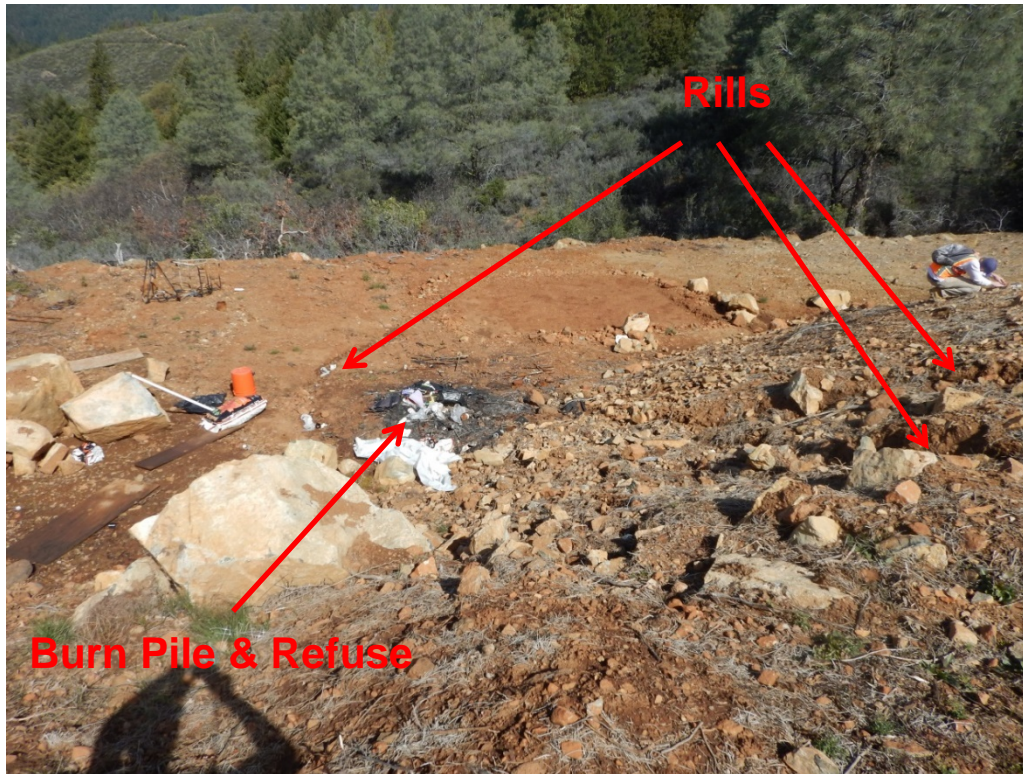
- The upper fill slope is approximately 6 to 12 feet in height, approximately 60 feet in length along the top of the slope, and varies in angle from approximately 25 to 35 degrees. Rills are present on the steeper portion of the upper slope (Map Point E1, Photograph 2).

- The lower pad surface between the upper and lower slopes is approximately 25 to 40 feet wide between the toe of the upper slope and the top of the lower slope. We observed rills and a burn pile on the lower pad surface below the steeper portion of the upper slope (Photograph 2).

slope above this burn pile. Rills were also present on the fill pad and on the slope down-gradient from the burn pile in the direction of Frietas Gulch. In a significant rainfall event, there is a high likelihood of delivery of burn pile material to Frietas Gulch based on the existing presence and pattern of erosion; the erosion pathway can be seen in Photograph 2.

Photograph 2: Rills observed on upper fill slope and lower pad at Location E1. Note position of burn pile (location R3) & refuse relative to rills. Photo by Kason Grady.

Recommendation 3: Identify and stabilize actively eroding features on the site as soon as possible. The goal of this recommendation is to reduce the amount of sediment delivered into surface waters (streams).

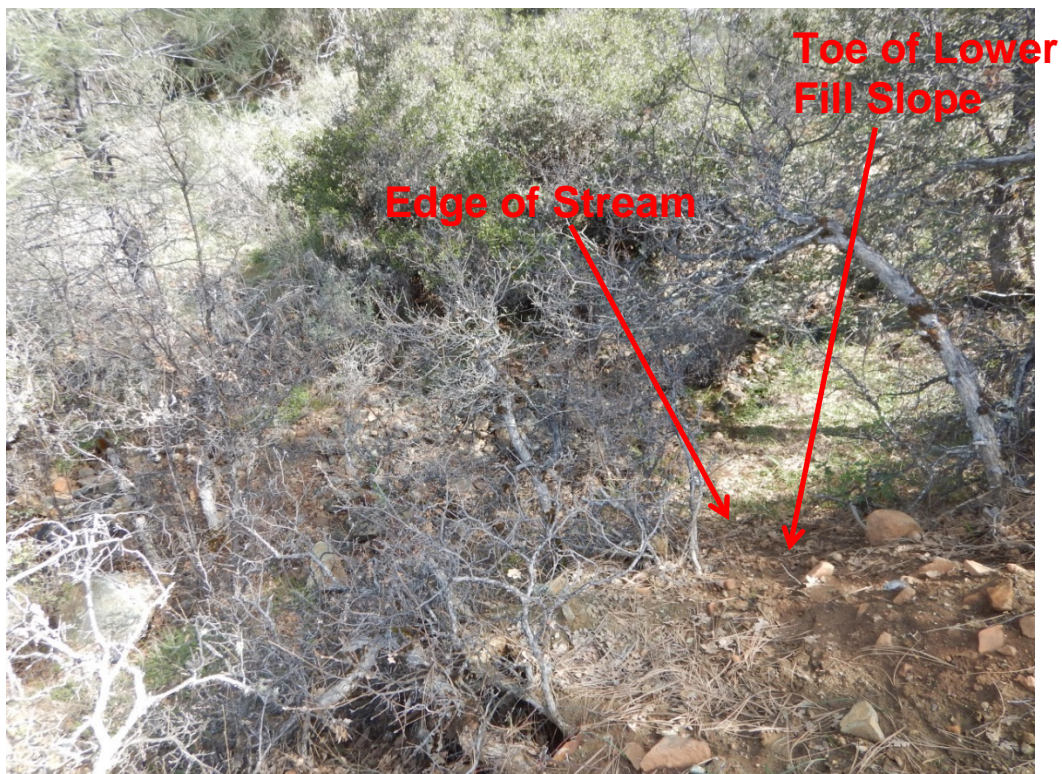
- The lower fill slope is approximately 2 to 6 feet in height, approximately 80 feet in length along the top of the slope, and varies in slope angle from approximately 25 to 35 degrees. The down-gradient distance between the toe of the fill slope and Frietas Gulch varies from 0 feet at the northeastern extent to approximately 150 feet at the southwestern extent. Beneath the location where the toe of the lower fill slope coincides with the bank of Frietas Gulch, minor amounts of fill sediment were observed in the streambed (Map Point IF1, Photographs 3 & 4). Abundant organic material is exposed at the surface of portions of the lower fill slope, consisting of grubbed roots and tree stumps (Photograph 5). Staff observed rilling at several locations along the lower fill slope (Photograph 5). On the natural chaparral-covered slope below the lower fill slope, staff observed evidence of scour in the surficial soil and evidence of recent sediment deposition (Map Point E2, Photograph 6).

Photograph 3: Northeastern extent of lower fill slope where fill slope toe coincides with stream bank at location IF1, looking north. Photo by Kason Grady.

Recommendation 4: In consultation with a licensed California professional engineer or professional geologist with experience in slope stability, erosion control and water resource protection, remove and/or re-grading of the fill immediately adjacent to the stream in the northwest corner of the graded area to minimize the potential for sediment delivery to the stream. Spoils moved or removed shall be placed where it cannot enter surface waters, and ensure that all spoils are properly stabilized. The fill slopes and restored slopes should be replanted with native vegetation to restore shading, prevent erosion, and minimize the potential for sediment delivery to the stream. The cleanup and restoration plan should include the following:

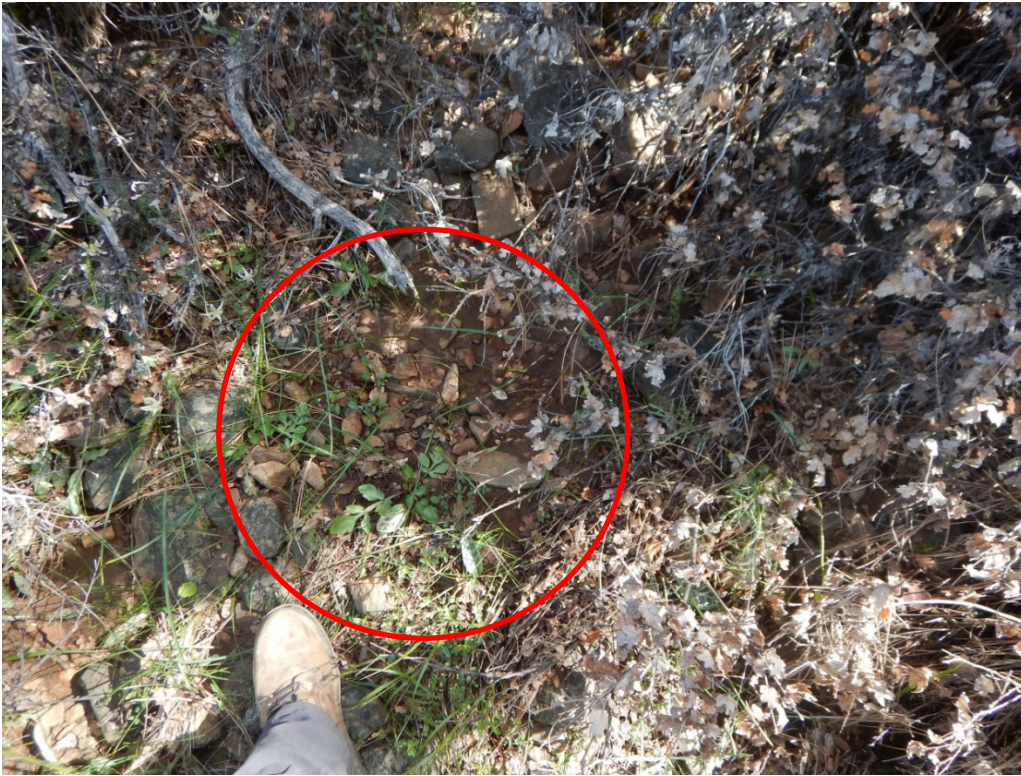
Photograph 4: Fill slope sediment in stream (circled); location IF1. Photo by Kason Grady.

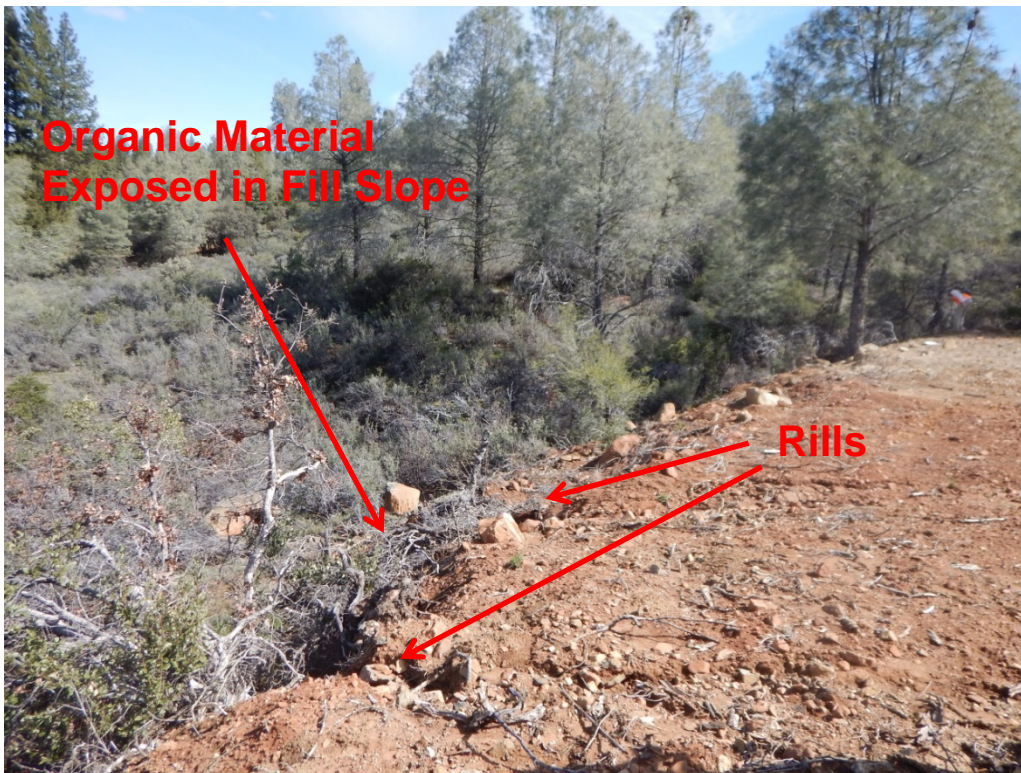
Photograph 5: Rills & organic material in lower fill slope. Photo by Kason Grady.

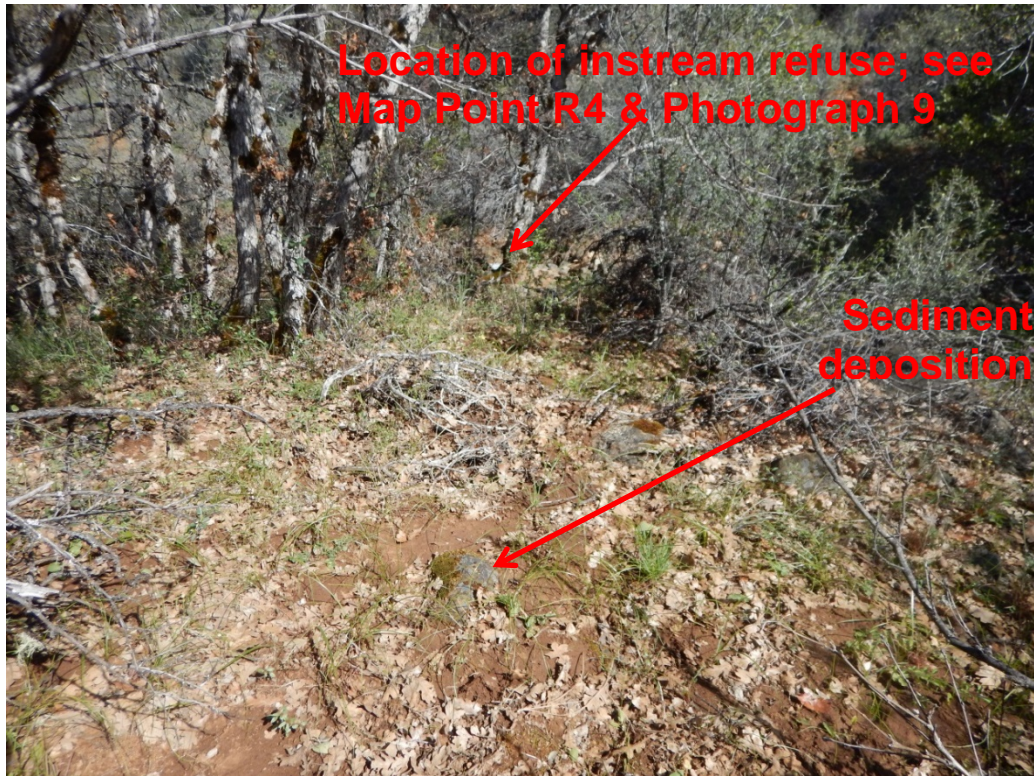
Photograph 6: Relatively recent sediment deposition observed between lower fill slope and stream; downgradient of location E2. Photo by Kason Grady.

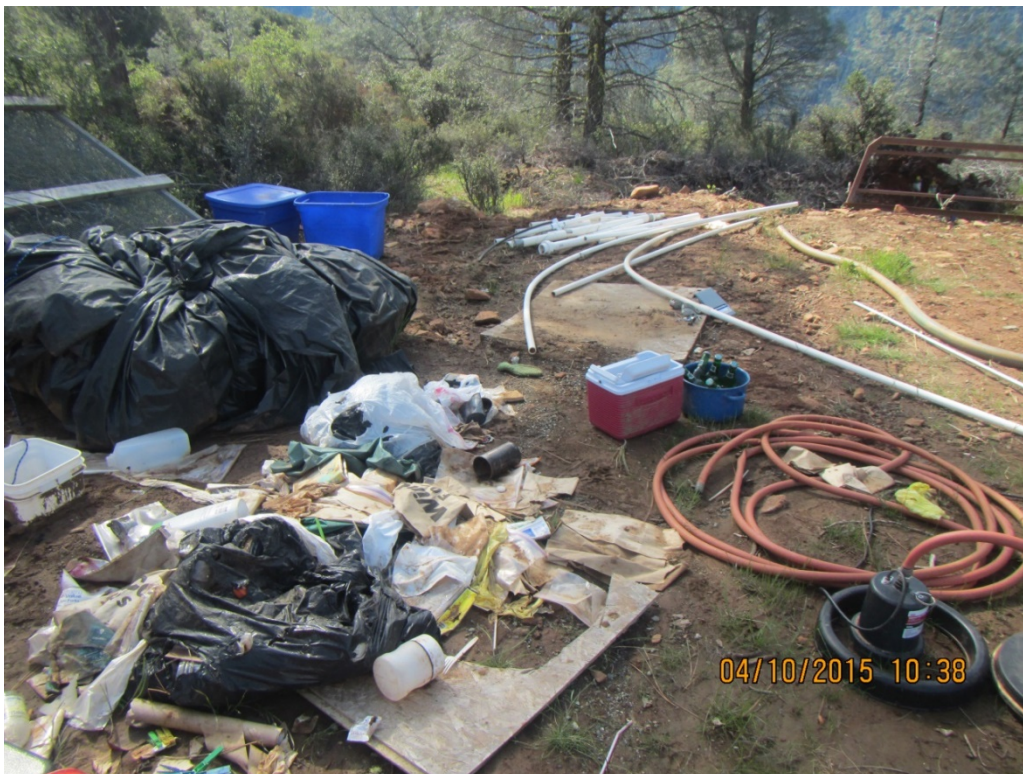
- Refuse: Staff observed refuse throughout the site, with notable locations discussed below:
 - At location RF1 as shown on Figure 2, staff observed a pile of full trash bags, construction debris, tent poles, and other miscellaneous debris (Photograph 7).

Photograph 7: Various refuse at location R1. View to south. Photo by Erin Mustain

- Removal and proper disposal of rubbish, refuse, garbage, waste oil, waste chemicals, burn piles, etc. The goal of this recommendation is to collect items that are in or that may be blown into or be carried by stormwater runoff into surface waters and to properly contain these items onsite (e.g. in secure, covered containers) or to dispose of offsite at a legal point of disposal and to retain copies of any receipts or other documentation associated with that offsite disposal.
- Storage of soil amendments, fertilizers, pesticides, fuels, and other chemicals in a manner consistent with product labeling and in a manner that prevents potential discharge to

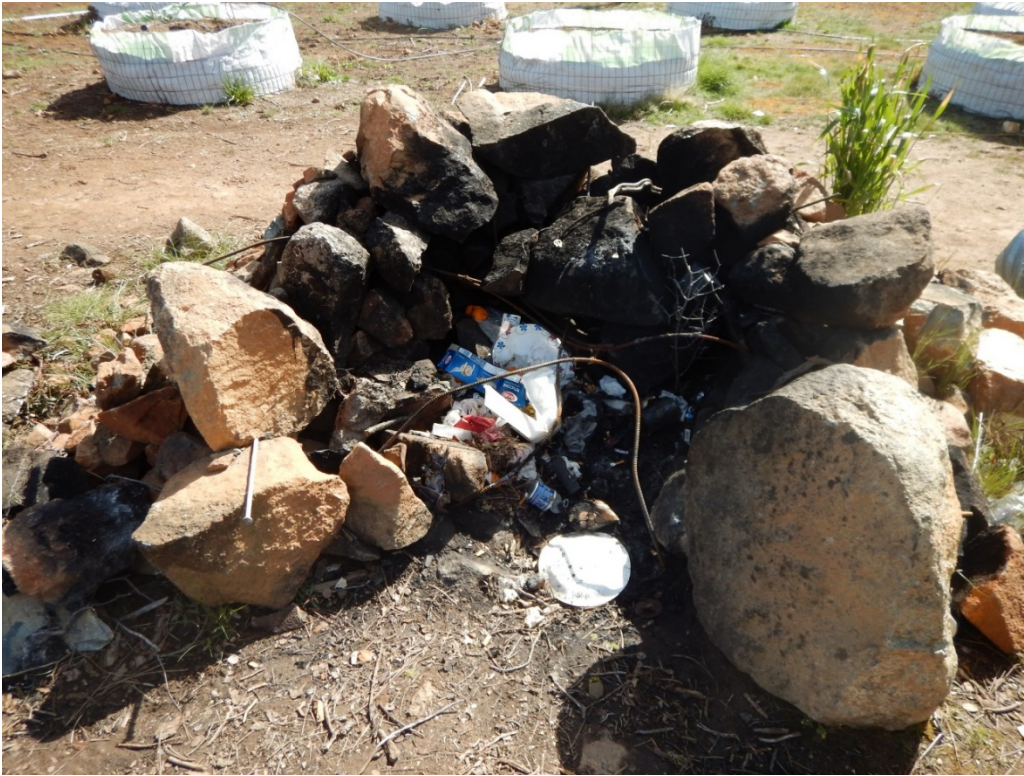
- At location RF2 as shown on Figure 2, staff observed an unenclosed burn pile with miscellaneous trash atop the pile (Photograph 8).
 - At location RF3 as shown on Figure 2, staff observed an unenclosed burn pile which was located at the toe of the upper pad fill slope. Several rills were present on the fill

Photograph 8: Burn pile at location R2; note unenclosed setup. Photo by Kason Grady

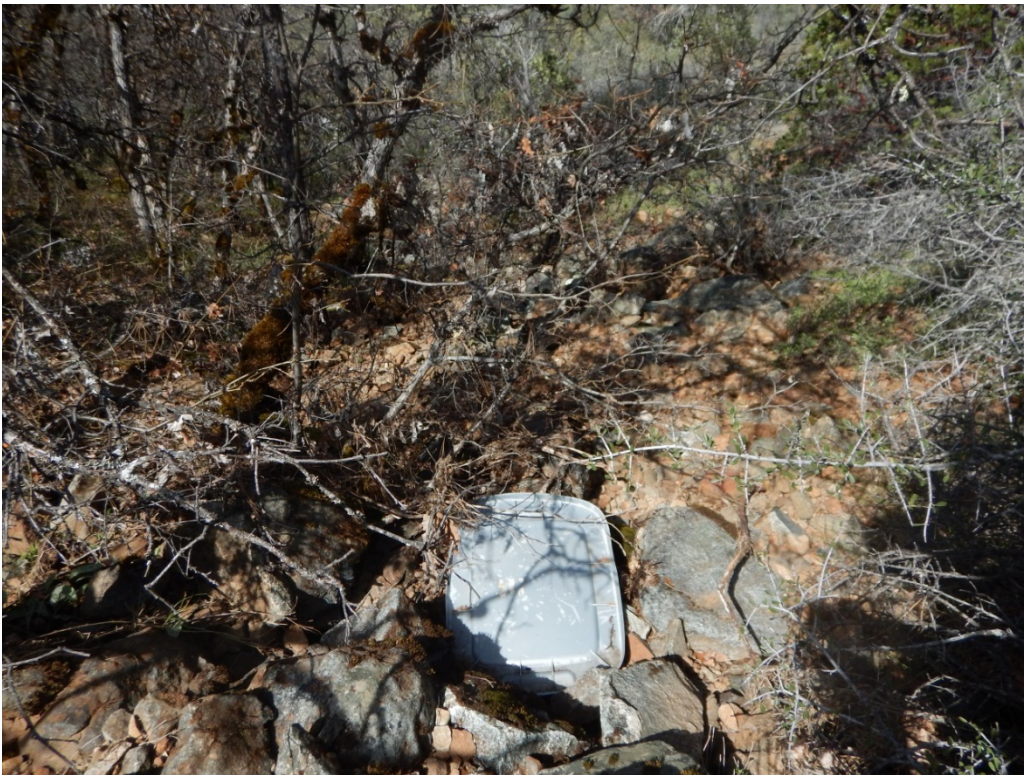
- At location RF4 as shown in Figure 2, staff observed debris in Frietas Gulch consisting of a gray plastic storage container and an associated container lid (Photograph 9).

Photograph 9: Debris observed in watercourse at location R4. Photo by Kason Grady.

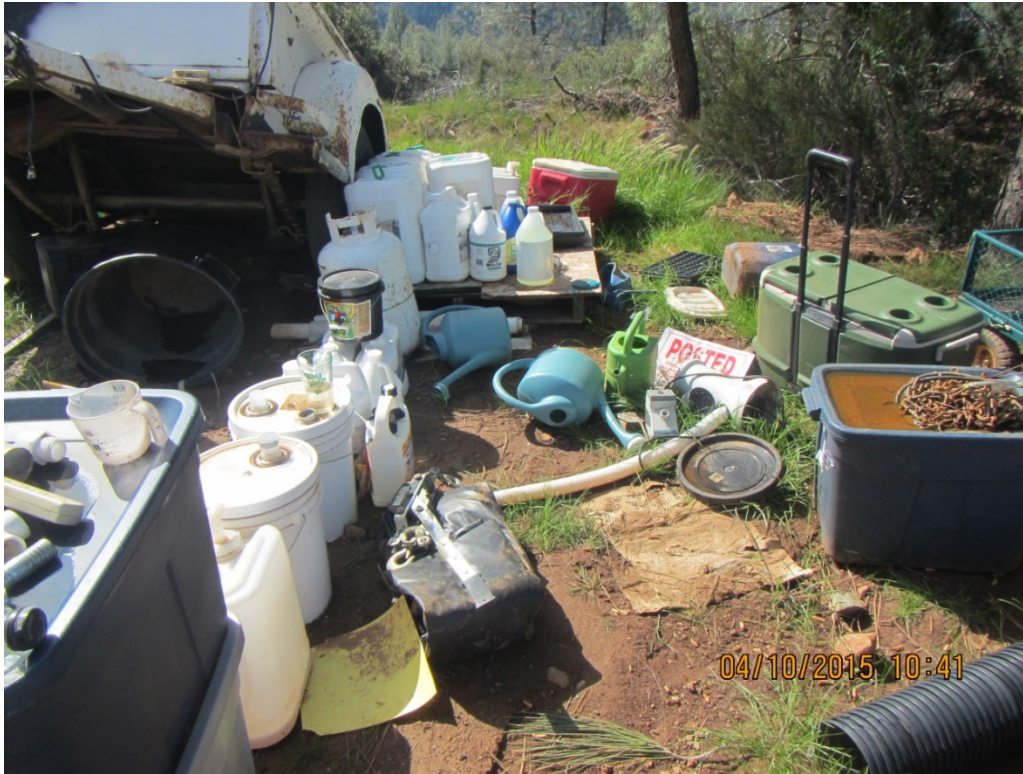
- Soil amendments/pesticides/petroleum products/other chemicals: A variety of fertilizers, nutrients, a container of insecticide, butane, propane, gasoline, and other chemicals were stockpiled at a location in the southern portion of the graded area without overhead cover (Map Point SA1). Some of their respective containers were resting on bare ground (Photograph 10). Additional soil amendments were stockpiled atop pallets at a location on the northern portion of the graded area. Many of the plastic bags containing soil amendments at this location were ripped and were not otherwise covered at the time of our inspection, although black visqueen lay adjacent to the stockpile (Map Point SA2, Photograph 11).

Photograph 10: Soil amendments, fertilizers, nutrients, insecticides, & other chemicals on bare ground with no overhead cover at location SA1. Photo by Erin Mustain.

surface water or groundwater. Specifically, unused chemicals or fluids to be kept onsite should be placed in covered/secure containers or structures. Liquid chemicals stored or used outdoors should be provided secondary containment, and spill cleanup materials should be available onsite. Soils contaminated by spilled chemicals or fuels should be collected, placed in appropriate containers, and properly disposed of at a legal point of disposal, and all receipts and other documentation of this disposal should be retained.

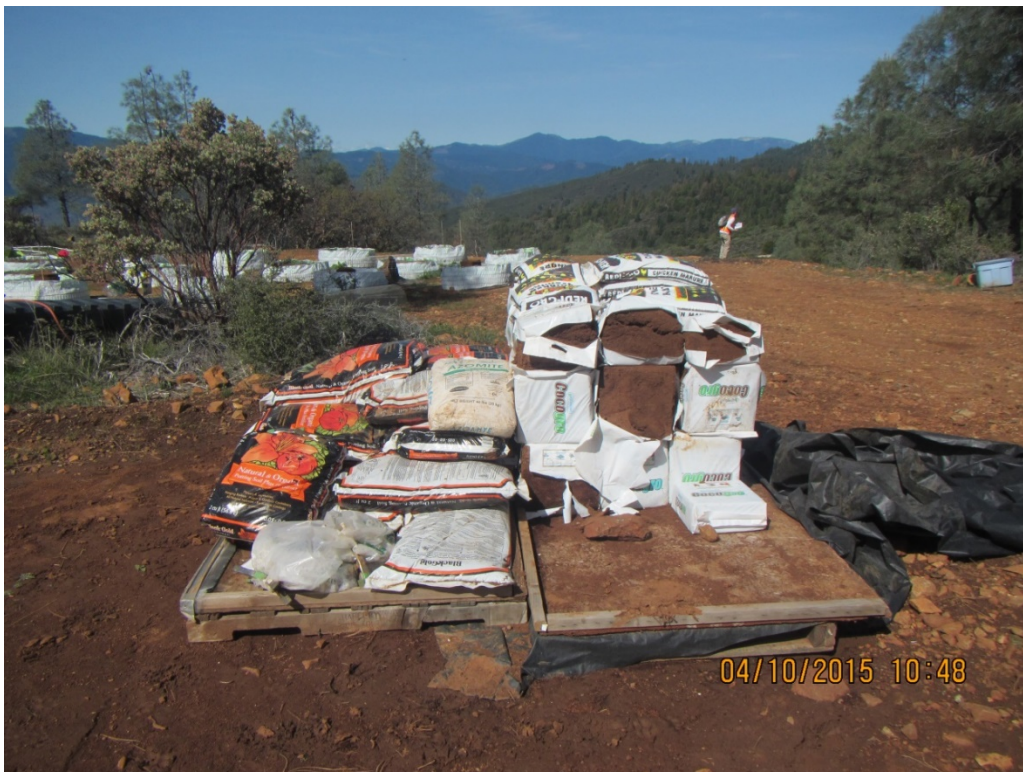
Photograph 11: Soil amendments at location SA2. Note uncovered, ripped bags. Photo by Erin Mustain.

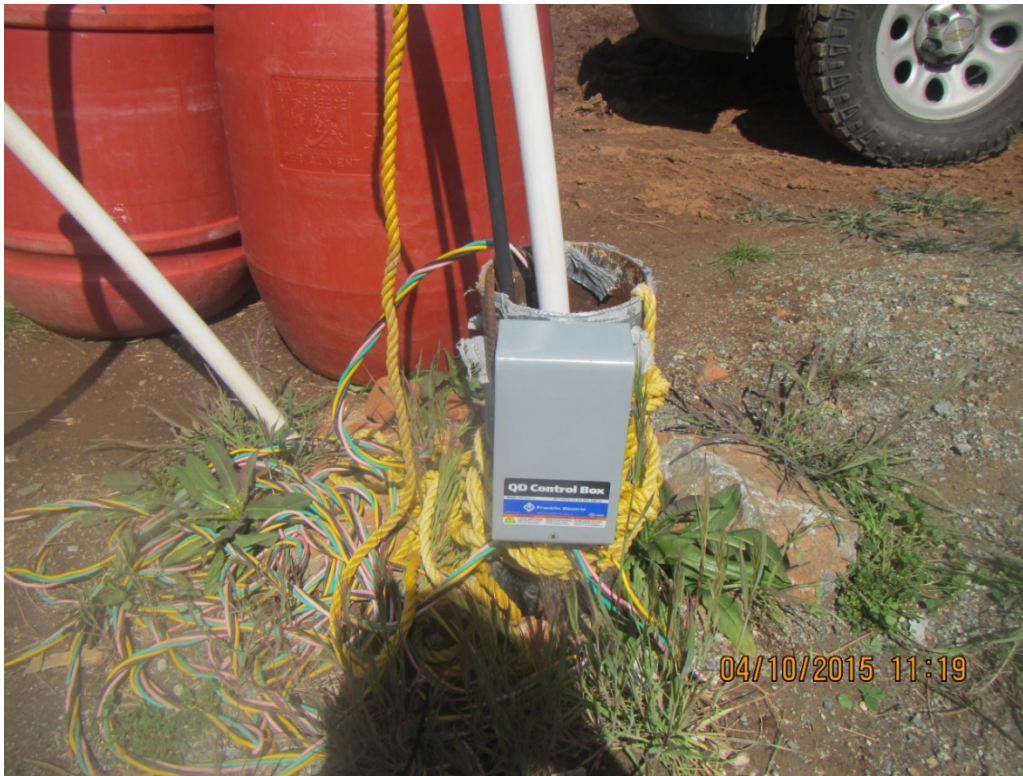
- Water supply well: The well observed on site (Map Point W1), apparently used for onsite water supply, was not capped during the April 10 inspection (Photograph 12).

Photograph 12: Uncapped water supply well at location W1. Photo by Erin Mustain

Recommendation 2: Immediately install a cap on the groundwater supply well and provide the North Coast Regional Water Quality Control Board with photographic evidence of its installation.

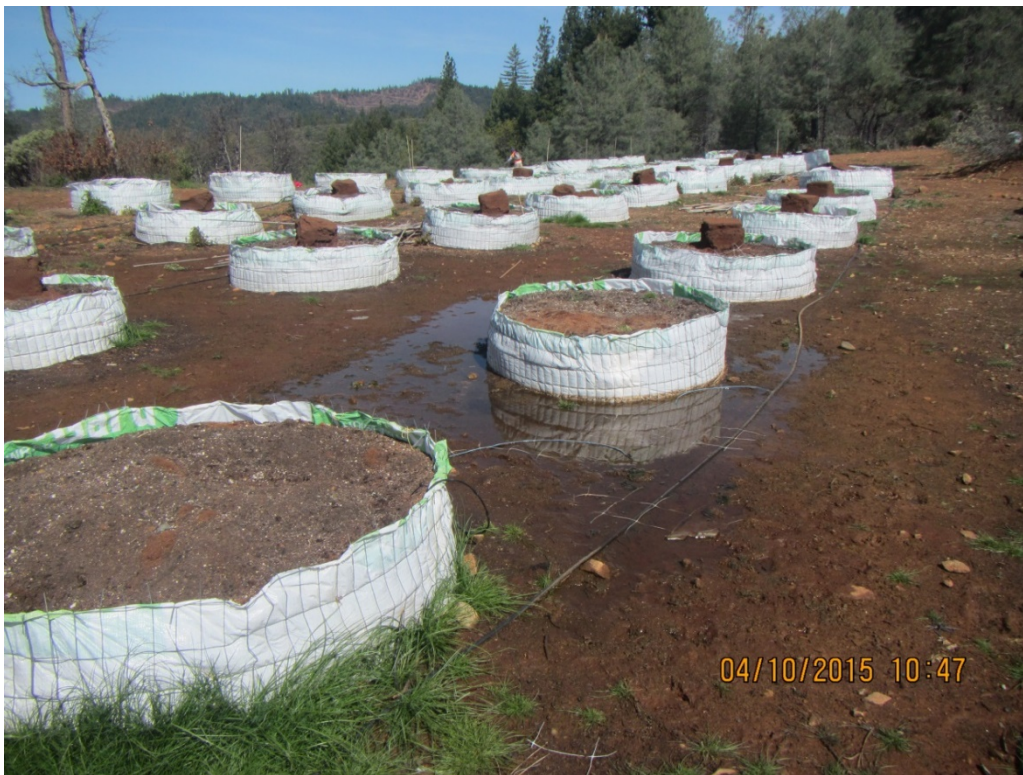
- Ponding in the cultivation area, possibly from over-irrigation (Photograph 13).
- Gasoline in red, plastic containers were lying directly on the ground without secondary containment (Photograph 14).

Photograph 13: Ponding observed in cultivation area. Note irrigation lines and surrounding saturated soil as indicated by dark brown color. Photo by Erin Mustain.

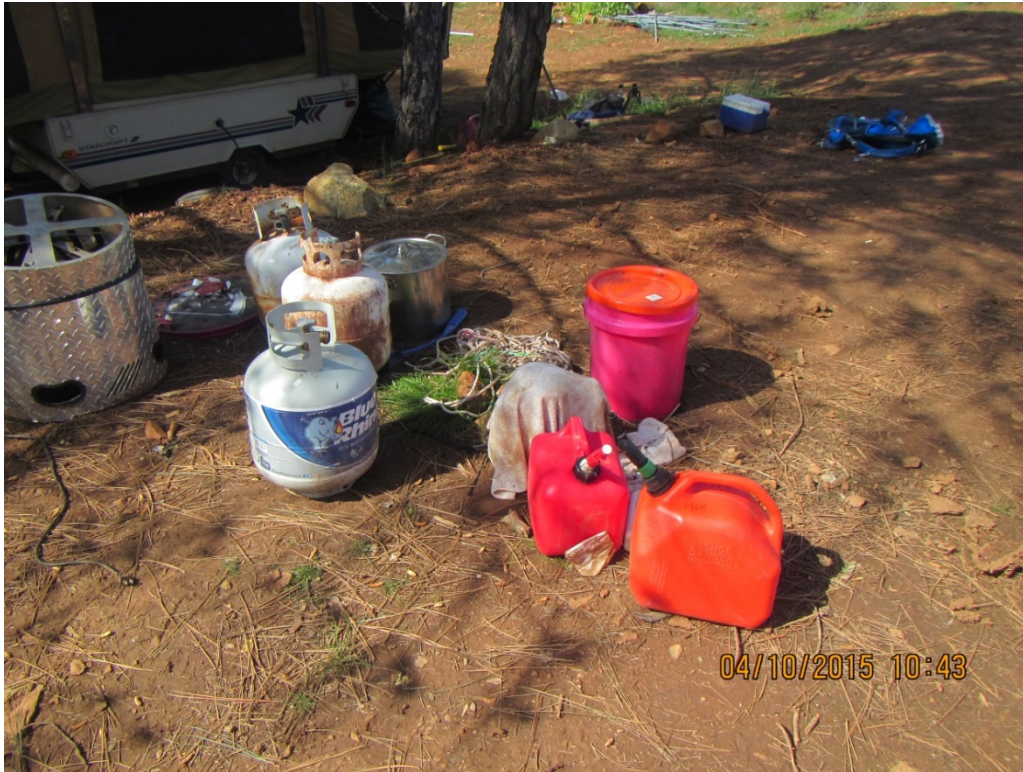
Photograph 14: Fuel storage containers with no form of secondary containment. Photo by Erin Mustain.

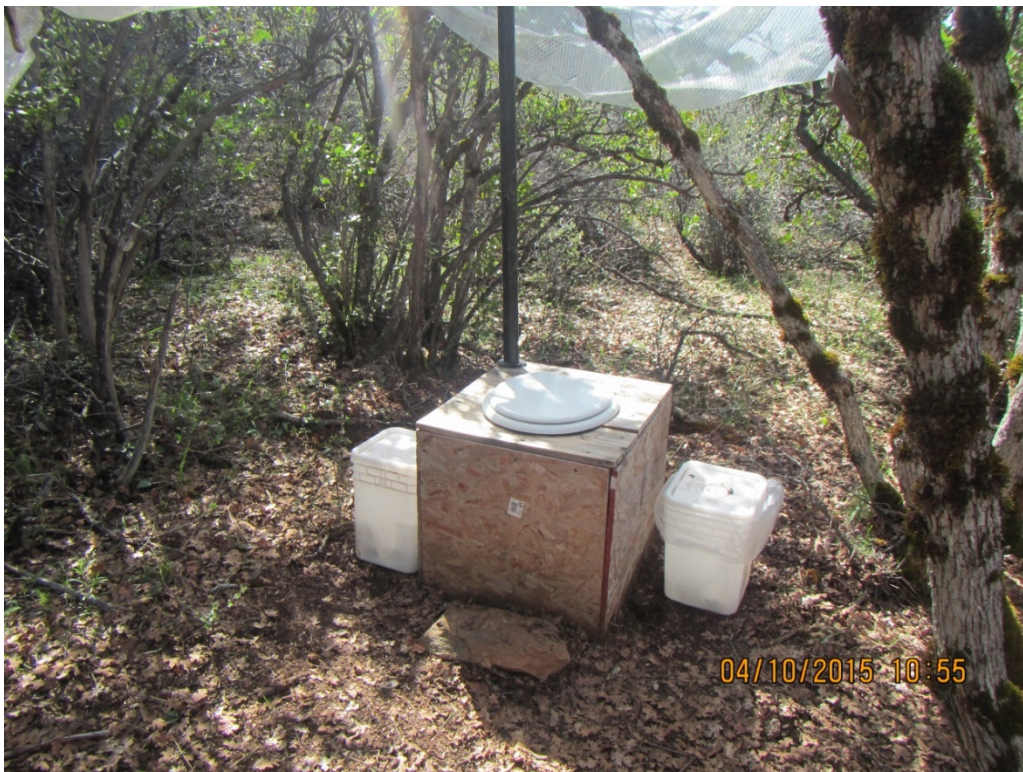
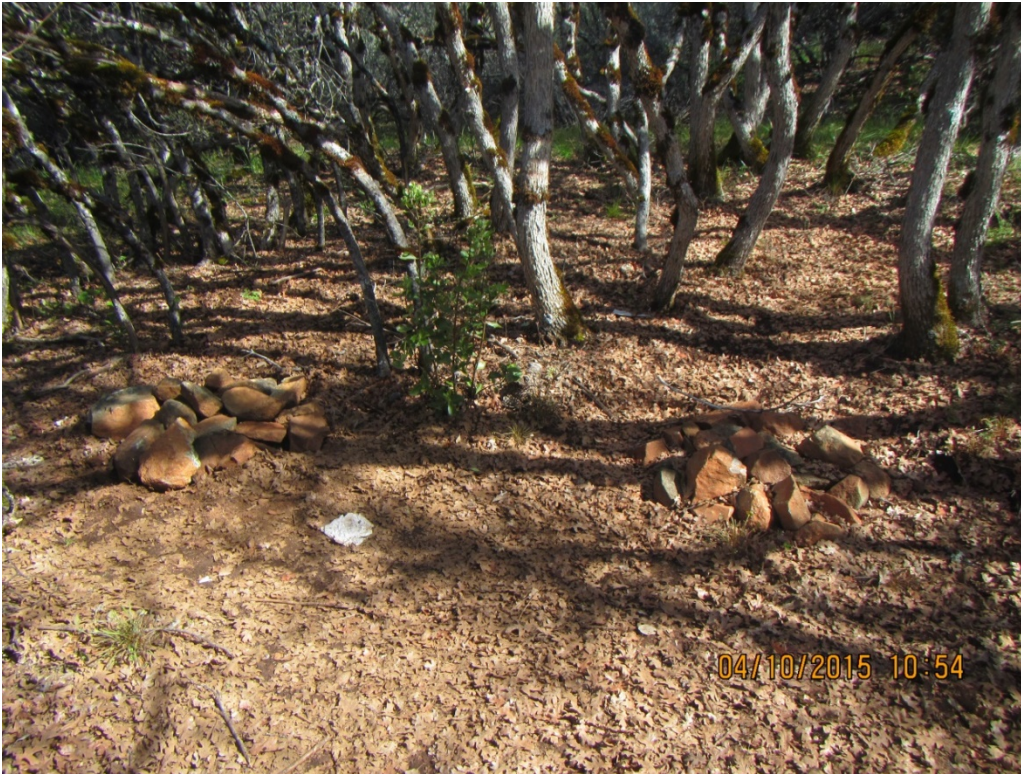
- Human waste disposal consisted of shallow pits (Photographs 15 and 16).

Photograph 15: Pit toilet observed at location PT1. Photo by Erin Mustain.

Photograph 16: Rock piles adjacent to the observed pit toilet are presumed to represent former pit toilet locations. Photo by Erin Mustain.
